**SITE PHOTOGRAPHS
FOR
STRUCTURE
SURVEY REPORT**

**USH 53 SB Over Knapp St.
B-3-26
TOWN OF PRAIRIE LAKE, WI
BARRON COUNTY**

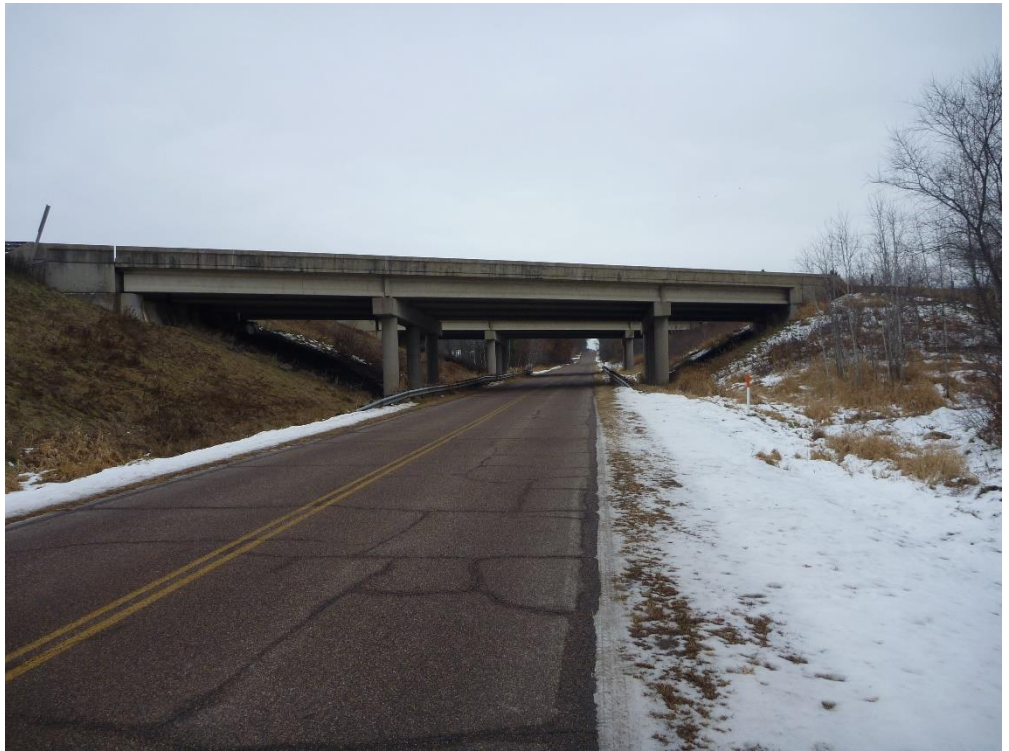
View from Knapp St.
looking east at B-3-26.

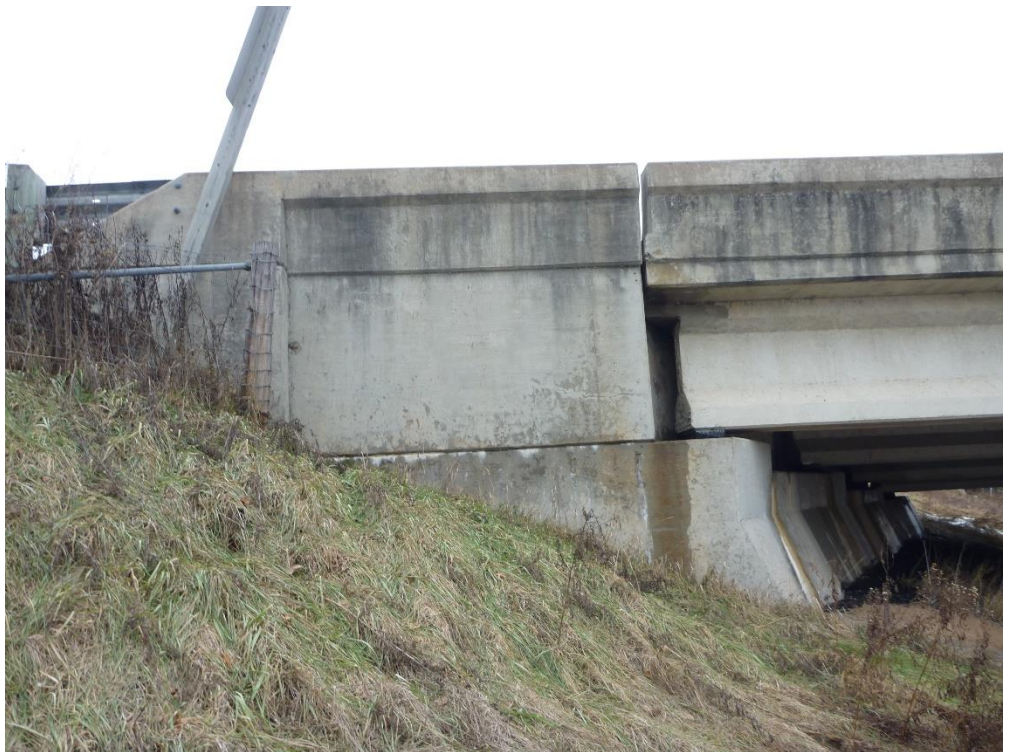
Typical view of wing on
B-3-26. Upper wings of
structure to be removed
and replaced during
rehabilitation.

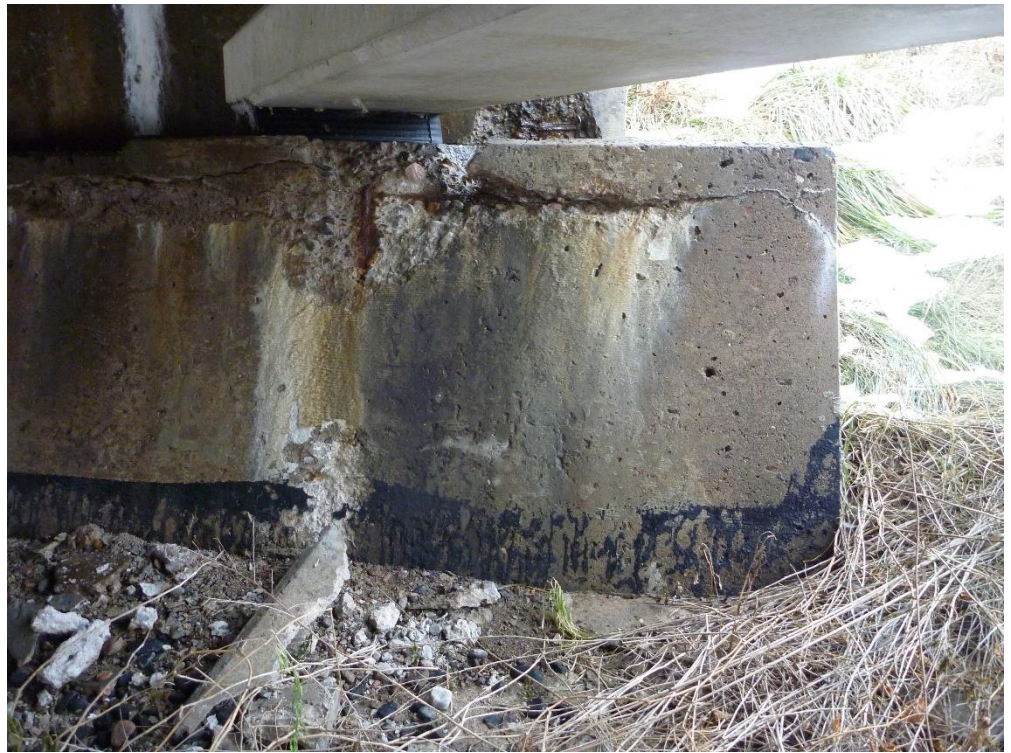
Concrete spalling at north abutment of B-3-26.

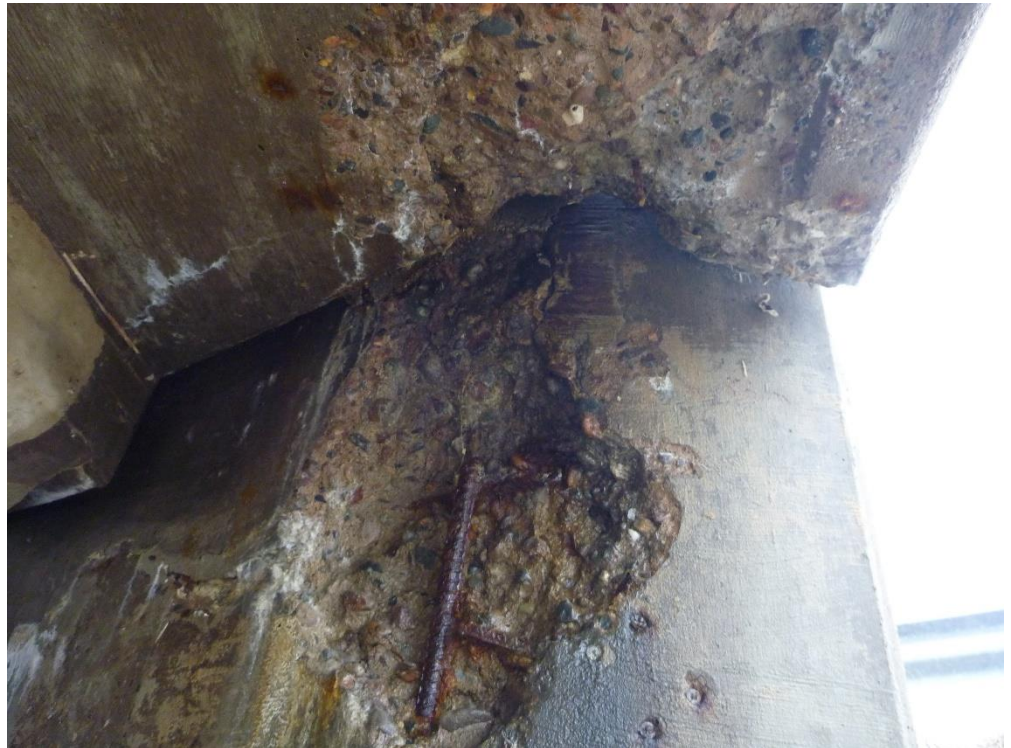
Concrete spalling at north abutment of B-3-26.

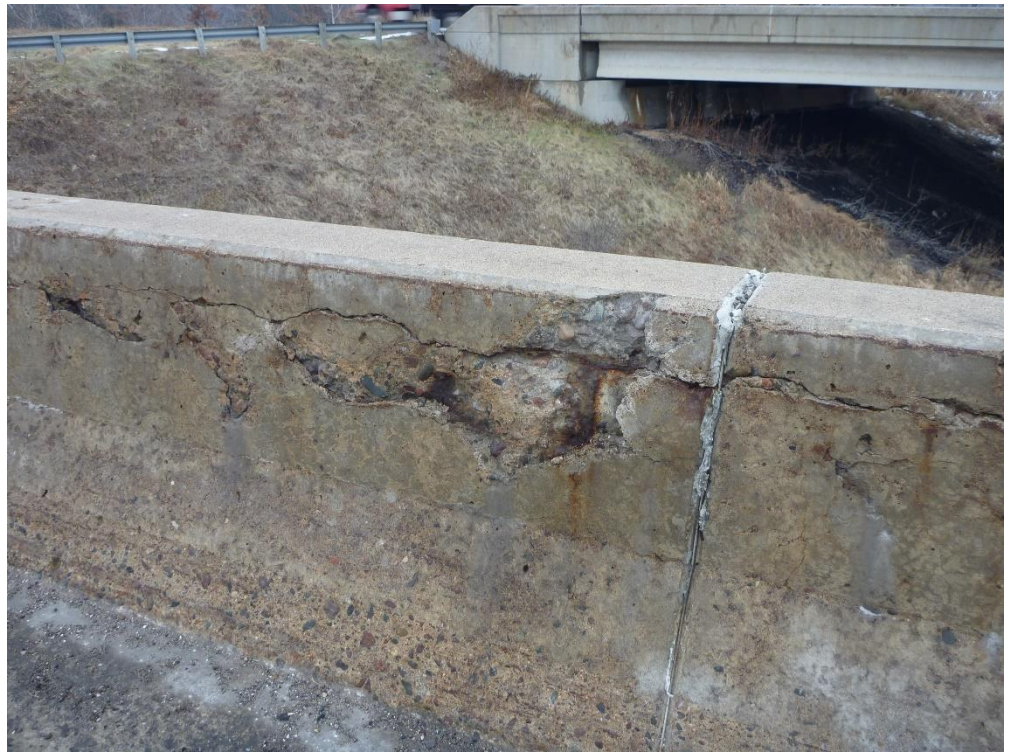
Typical spalling on concrete parapet of B-3-26.

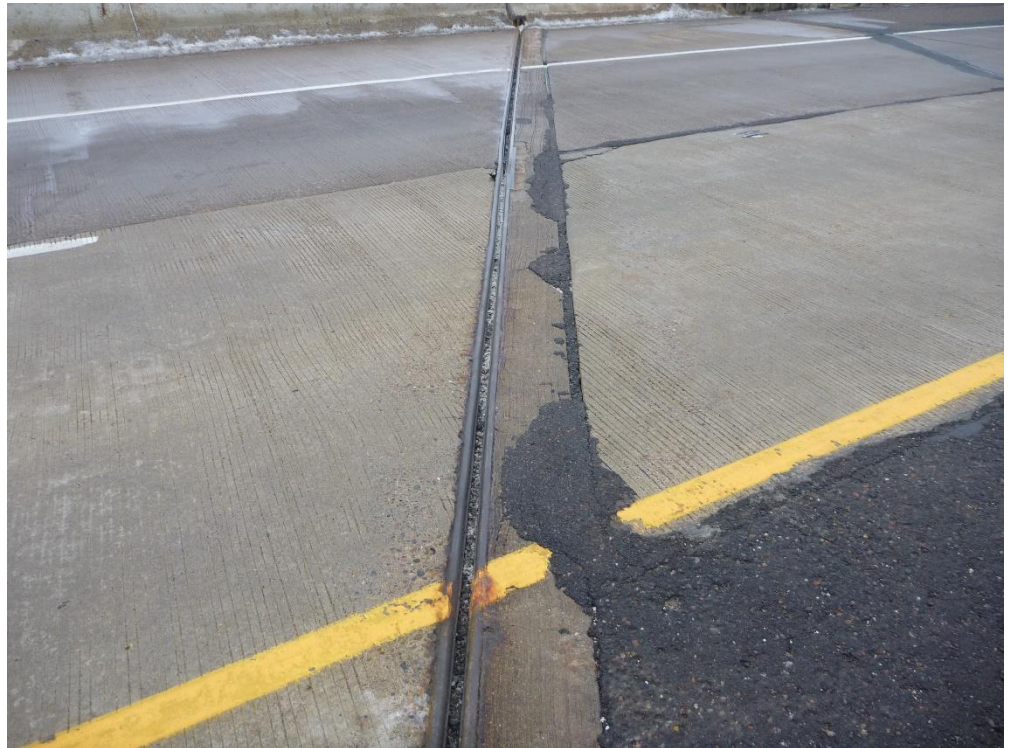
Expansion joint to be replaced during rehab.

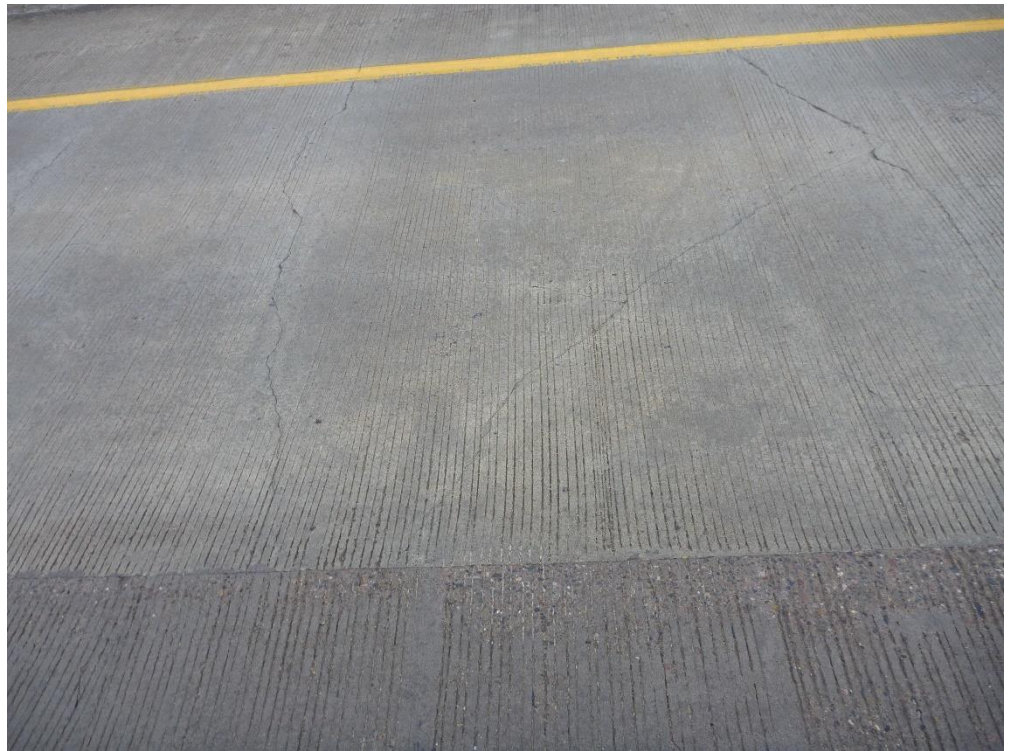
Typical map cracking in existing concrete overlay.

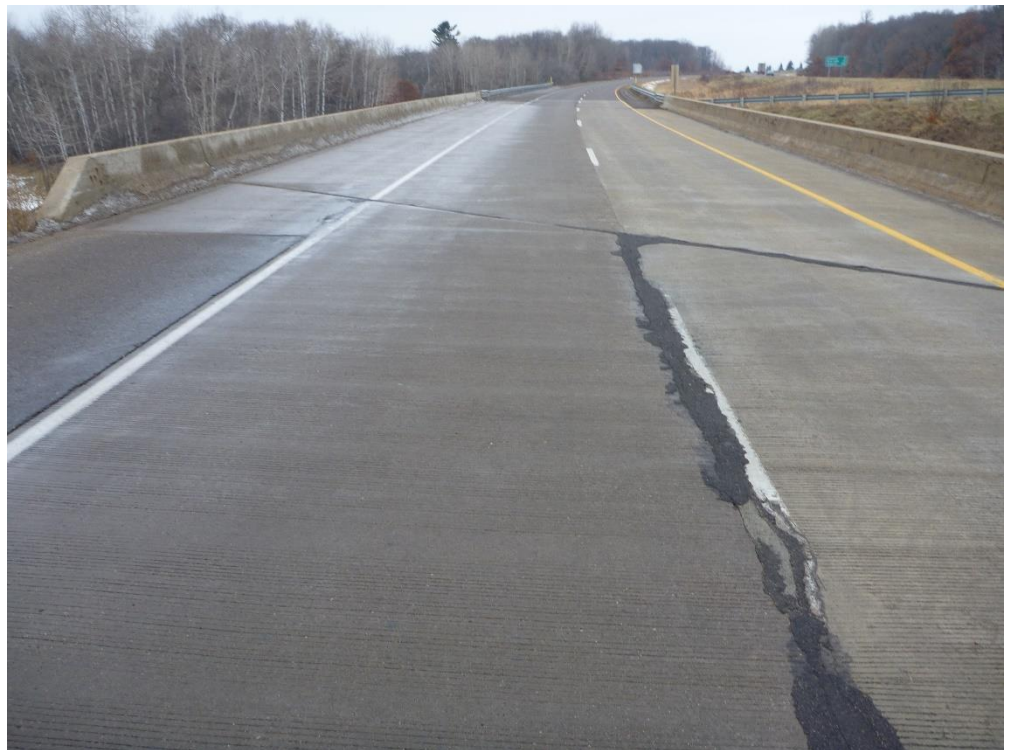
View from USH 53 SB looking north at B-3-26.
