## Bridge Asbestos Inspection Report

**WisDOT Project ID:** 1196-04-02  
**Structure Number:** B-03-030  
**Structure Name:** USH 53 SB over 20<sup>th</sup> Street  
**City/County:** Town of Prairie Lake, Barron County, Wisconsin  
**GEI project Number:** 1901822  
**Date Inspected:** April 4, 2019  
**Inspected by:** Kyle C. Sandmire  
**Asbestos Inspector License Number:** All- 217616  
**Consultant Company:** GEI Consultants, Inc.

Inspection Report for  
B-03-030 ( 20TH STREET )

USH 53 SB over 20TH ST  
May 09,2017

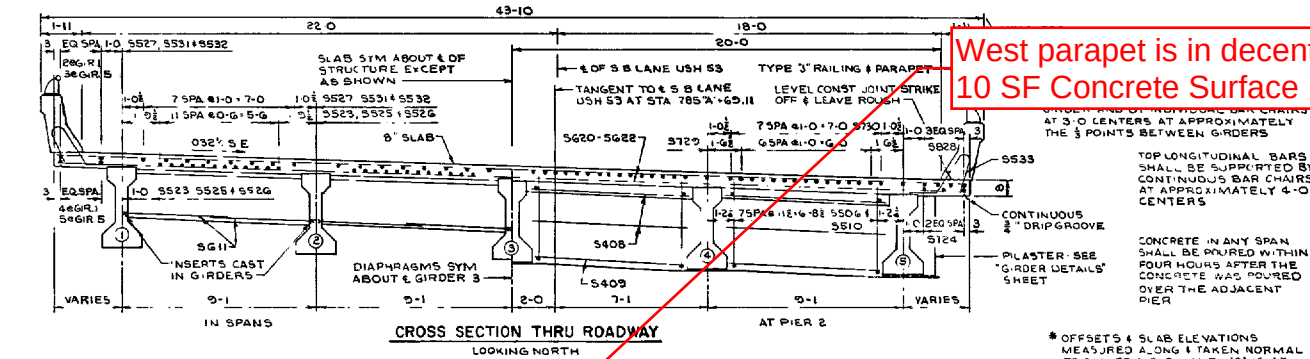
West parapet is in decent condition, approx. 10 SF Concrete Surface Repair.

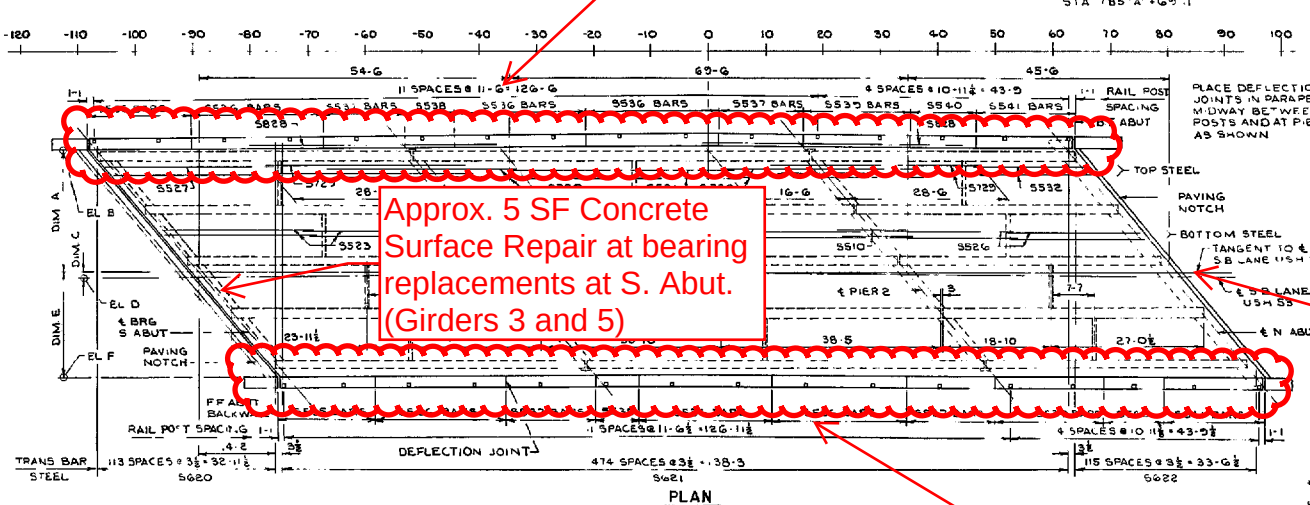
Approx. 5 SF Concrete Surface Repair at bearing replacements at S. Abut. (Girders 3 and 5)

Approx. 5 SF Concrete Surface Repair at N. Abut.

East parapet has crack at top about 80% of the length, approx. 140 SF Concrete Surface Repair.

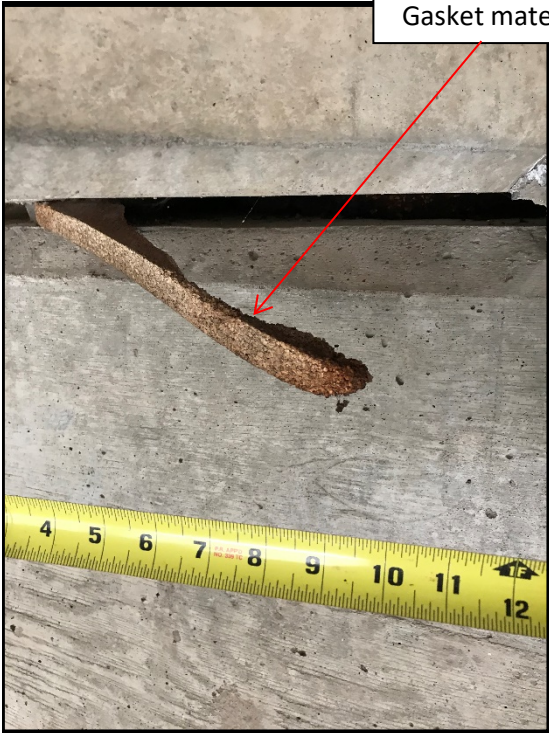
| <b>PHOTOGRAPH NO: 4</b> | |

| <b>DESCRIPTION:</b><br><br>View of the brown gasket material between the bridge deck and the north abutment. The gasket material is not ACM. | |

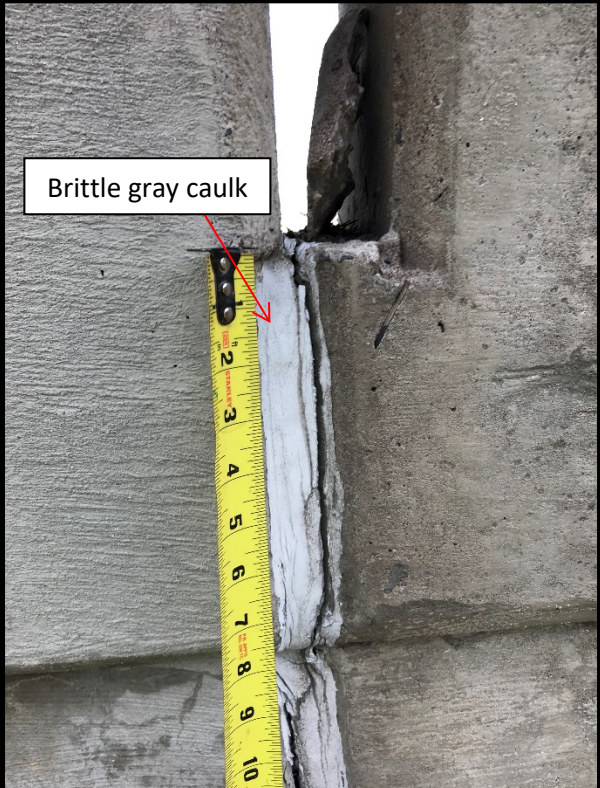
| <p><b>PHOTOGRAPH NO: 5</b></p> | |

| Sample # | Sample Description | Sample Location | Method and Analytical Results | Category I or II non-friable or No ACM | Total Amount of Material on Structure |
|---|---|---|---|---|---|
| B-03-030-2A | Brittle gray caulk | Bridge deck wall joints and abutment joints | PLM, 5% Chrysotile Asbestos | Category II Non-friable | 30 LF |

| <p><b>DESCRIPTION:</b></p> <p>View of the brittle gray caulk on the bridge wall joints and abutment joints. <b>The gray caulk is non-friable ACM containing 5% Chrysotile asbestos.</b></p> | |

Asbestos-containing material has been found in Structure B-03-030. Standard Special Provision 203-005 shall be included in the plans and abatement will be required. The contractor will be responsible for completion of the Notification of Demolition and/or Renovation (DNR form 4500-113) if required. A copy of the inspection report is available from the region office.

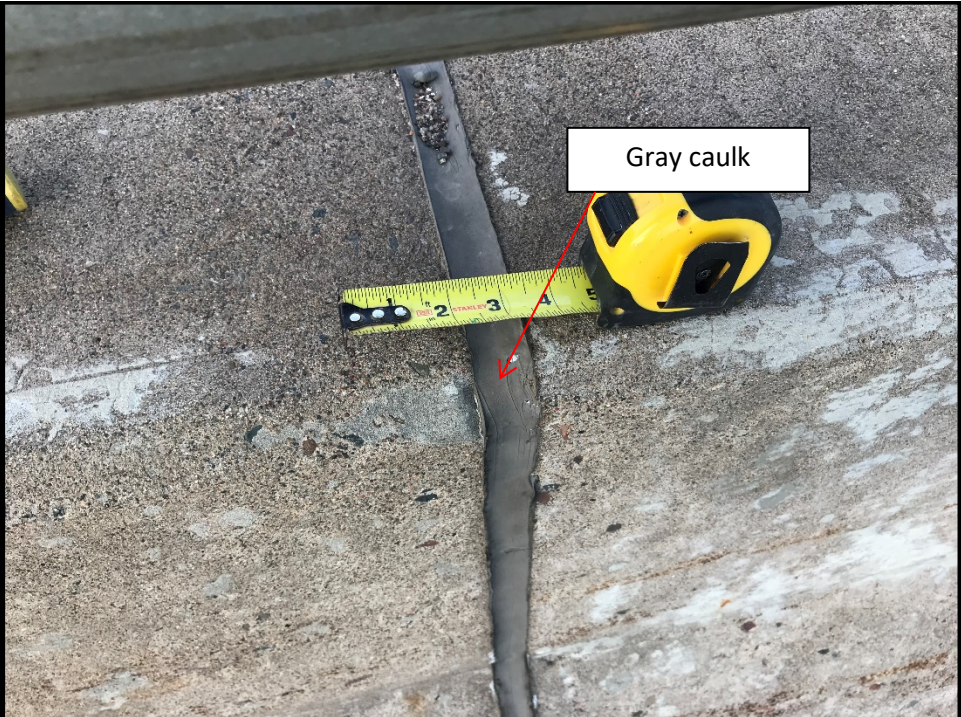
| <p><b>PHOTOGRAPH NO: 6</b></p> | |

| B-03-030-3A | Gray caulk | Between several bridge deck wall joints | PLM, 5% Chrysotile Asbestos | Category II Non-friable | 20 LF |

| <p><b>DESCRIPTION:</b></p> <p>View of the gray caulk on the bridge deck wall joints. <b>The gray caulk is non-friable ACM containing 5% Chrysotile asbestos.</b></p> | |

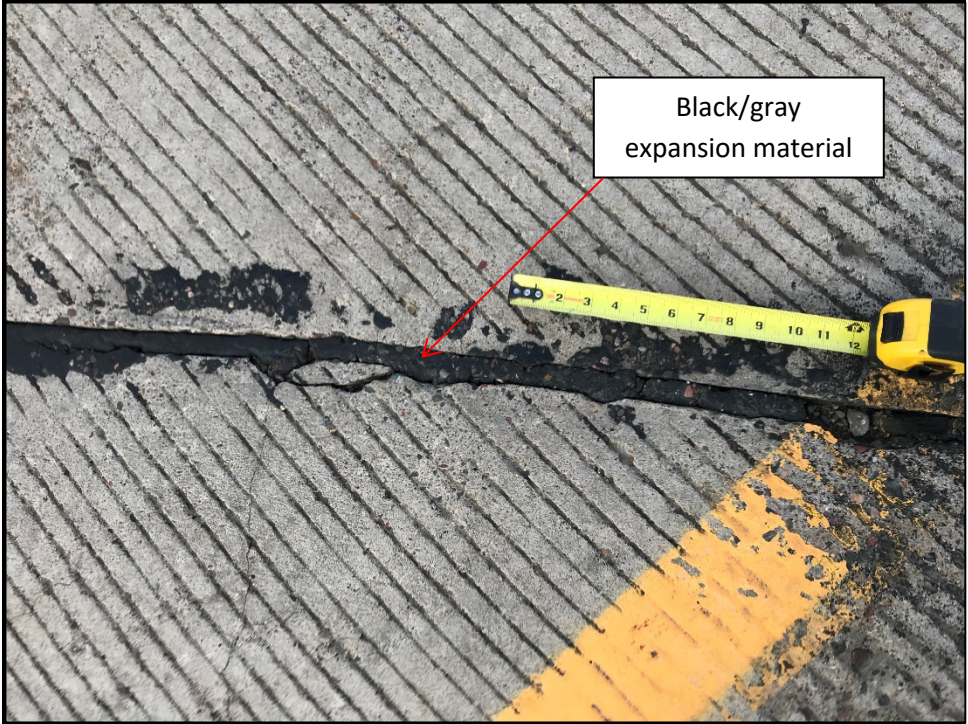
| <b>PHOTOGRAPH NO: 7</b> | |

| <b>DESCRIPTION:</b><br><br>View of the black/gray expansion material on the bridge deck joints. The black/gray expansion material is not ACM. | |

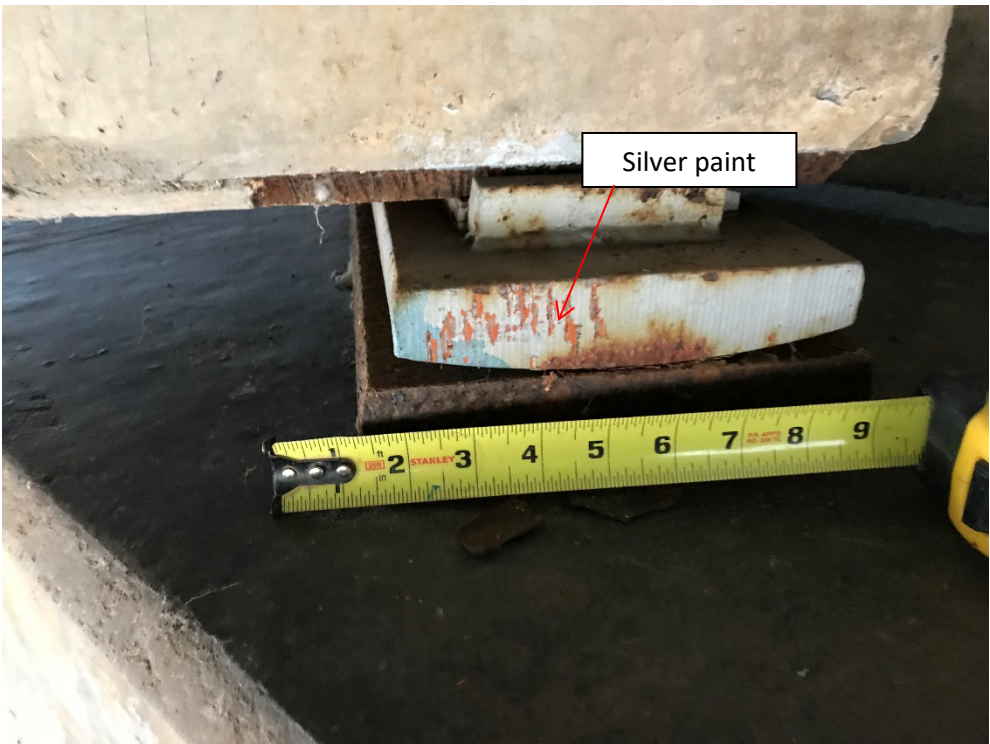
| <b>PHOTOGRAPH NO: 8</b> | |

| <b>DESCRIPTION:</b><br><br>View of the silver paint on the steel plates between the south bridge deck and abutment. The silver paint is not ACM. | |
