No.	Date	Rev.	Top	By
STATE OF WISCONSIN DEPARTMENT OF TRANSPORTATION DIVISION OF HIGHWAYS				
STRUCTURE B-3-37				
U-S-H "53" OVER U-S-H "8"				
From BARRON		To TH. STANLEY		
Iss on Sep	A A B H O 1969	Drawn	H S D O	Check Date 1969
Designed by	C D W	Lead Engineer	RWA	Permitted By
Approved	W A Kline		3-3-72	RLP
(Chief Bridge Engineer)		Dra		
GENERAL PLAN			SHEET 1 OF 18	
			X46904

Bridge Asbestos Inspection Report

Structure Number: B-03-037

Inspection Report for B-03-037 (USH 8)

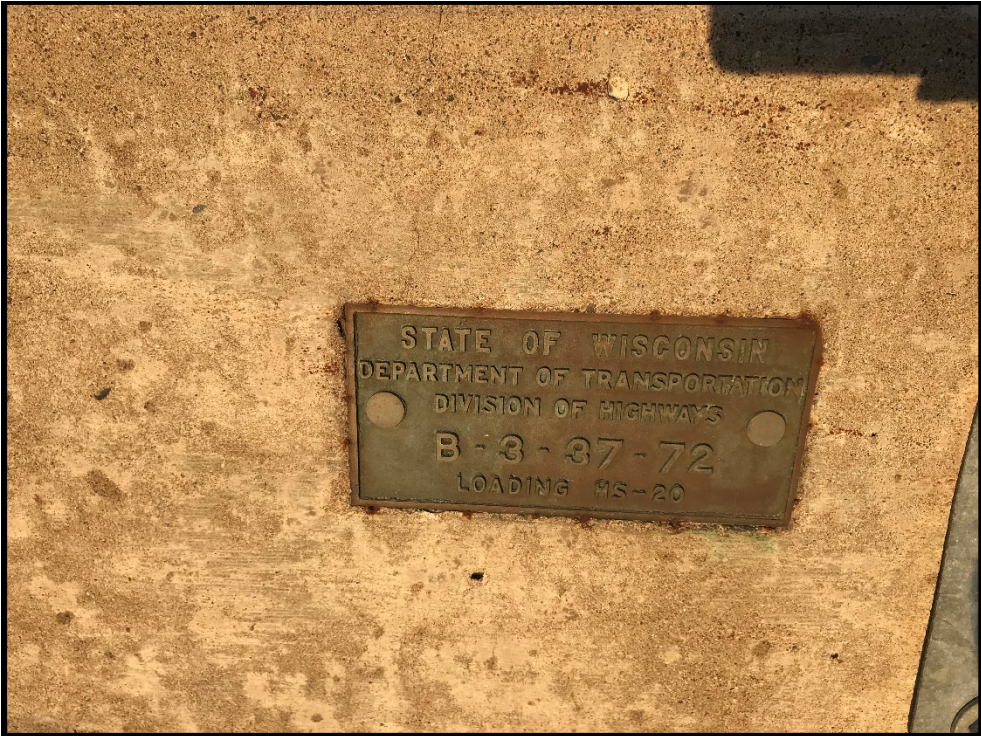
PHOTOGRAPH NO: 3

DIRECTION: SW	
DESCRIPTION: View of the bridge identification plate.

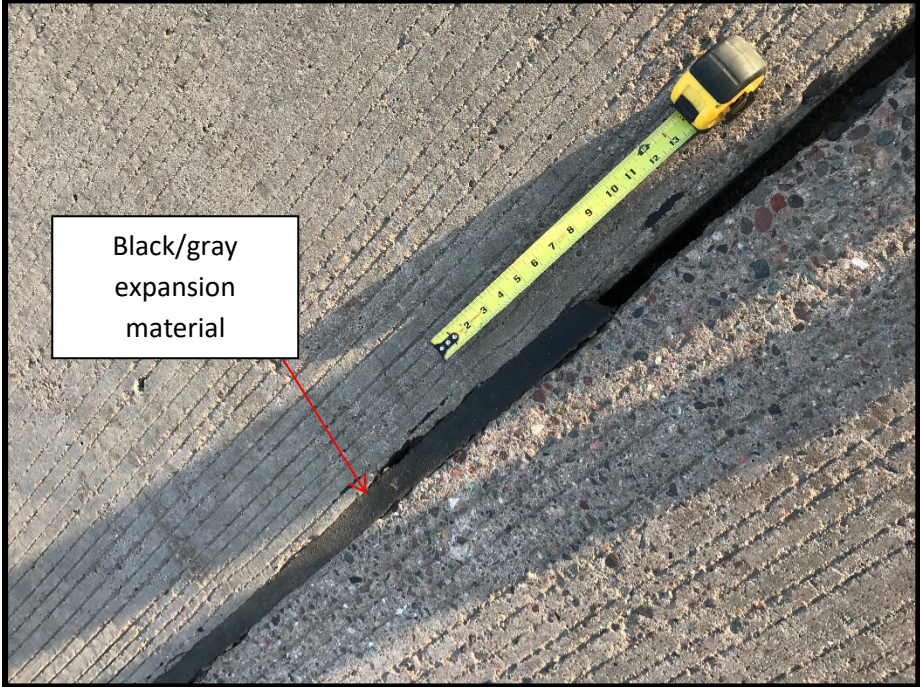
PHOTOGRAPH NO: 5

DIRECTION: Down	
DESCRIPTION: View of the black/gray expansion material on the bridge deck joints. The black/gray expansion material is not ACM.

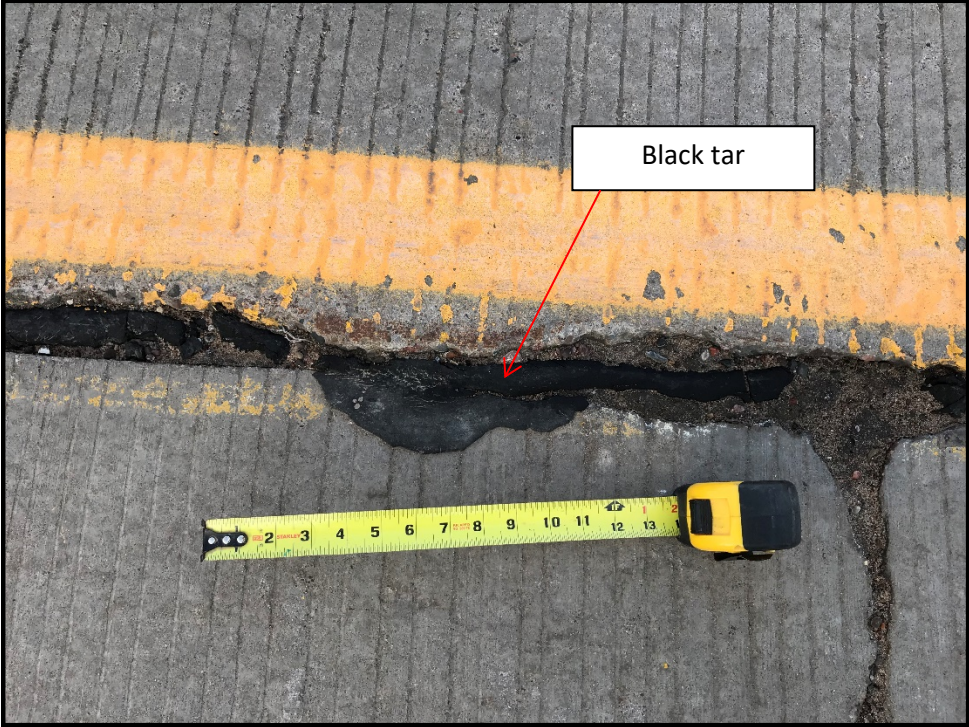
PHOTOGRAPH NO: 6

DIRECTION: Down	
DESCRIPTION: View of the black tar on the south bridge deck wall joints. The black tar is not ACM.
