**SITE PHOTOGRAPHS
FOR
STRUCTURE
SURVEY REPORT**

**USH 53 SB Over USH 8
B-3-37
TOWN OF STANLEY, WI
BARRON COUNTY**

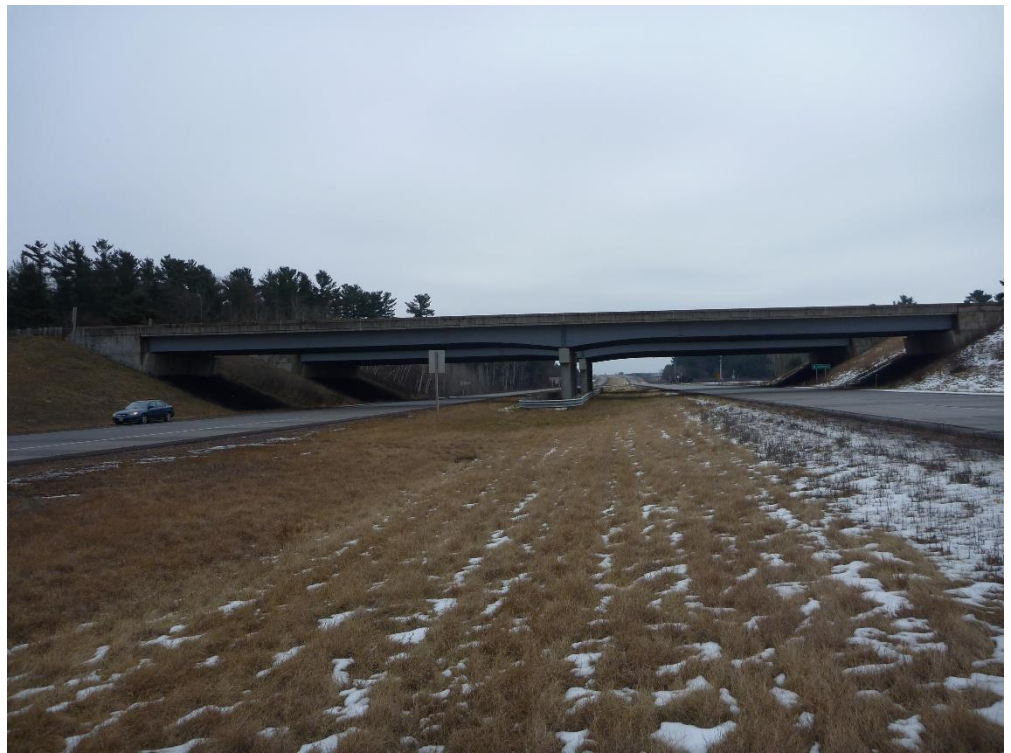
View from USH 8 looking east at B-3-37.

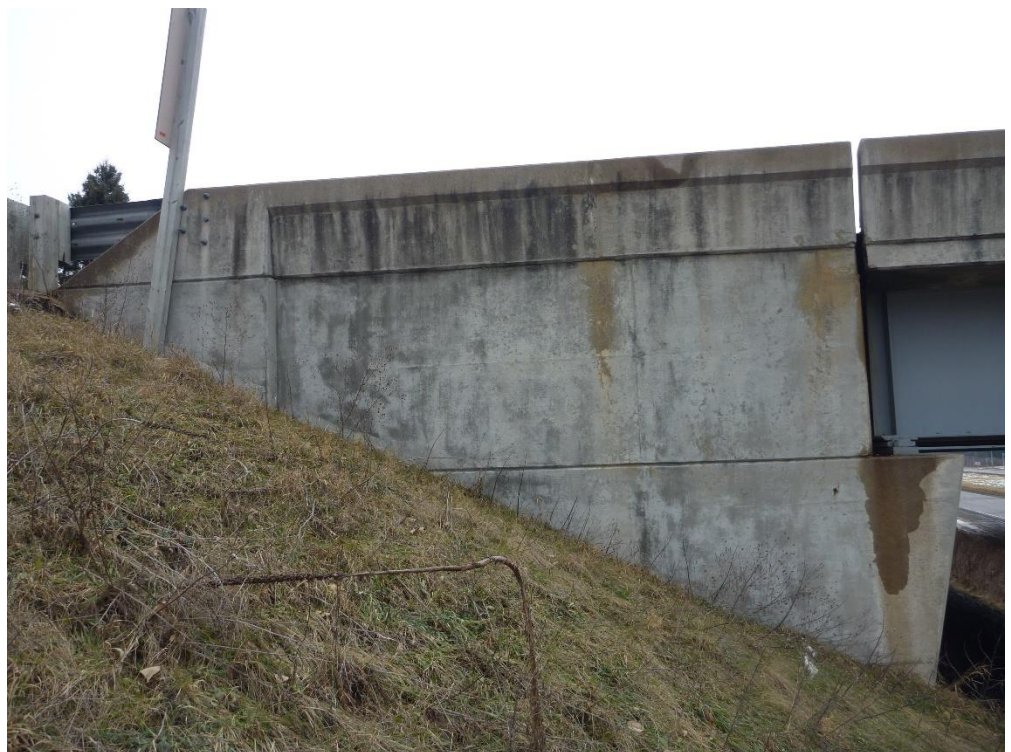
Typical view of wing on B-3-37. Upper wings to be removed and replaced during rehabilitation.

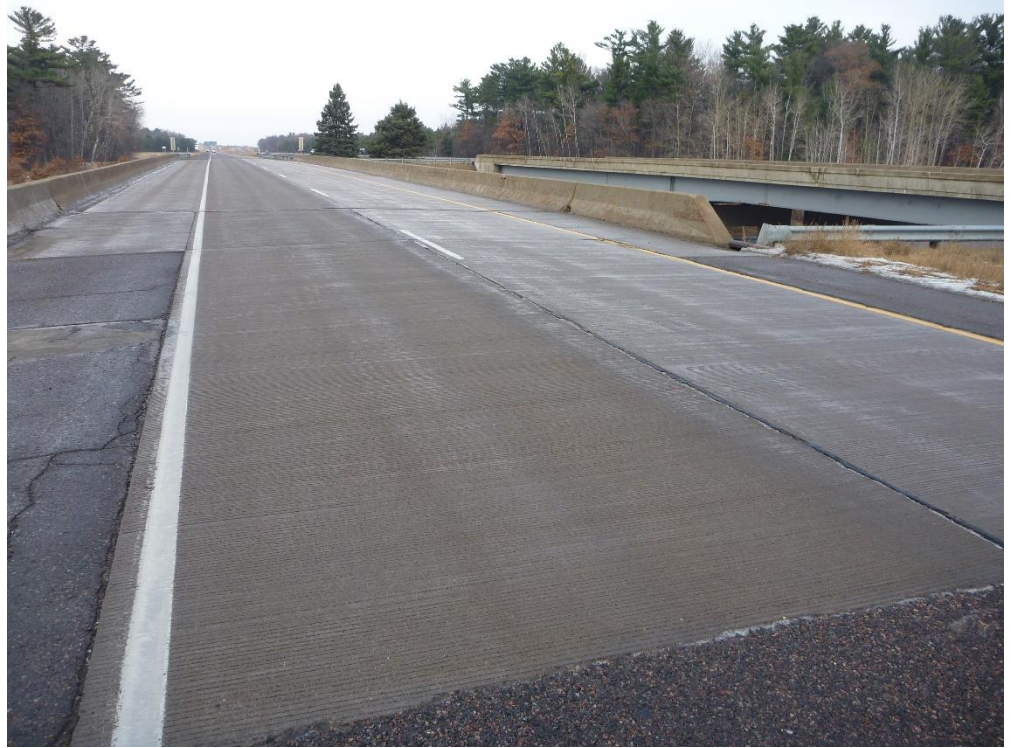
View from USH 53 SB
looking north at B-3-37.
Approaches to be
replaced during rehab.

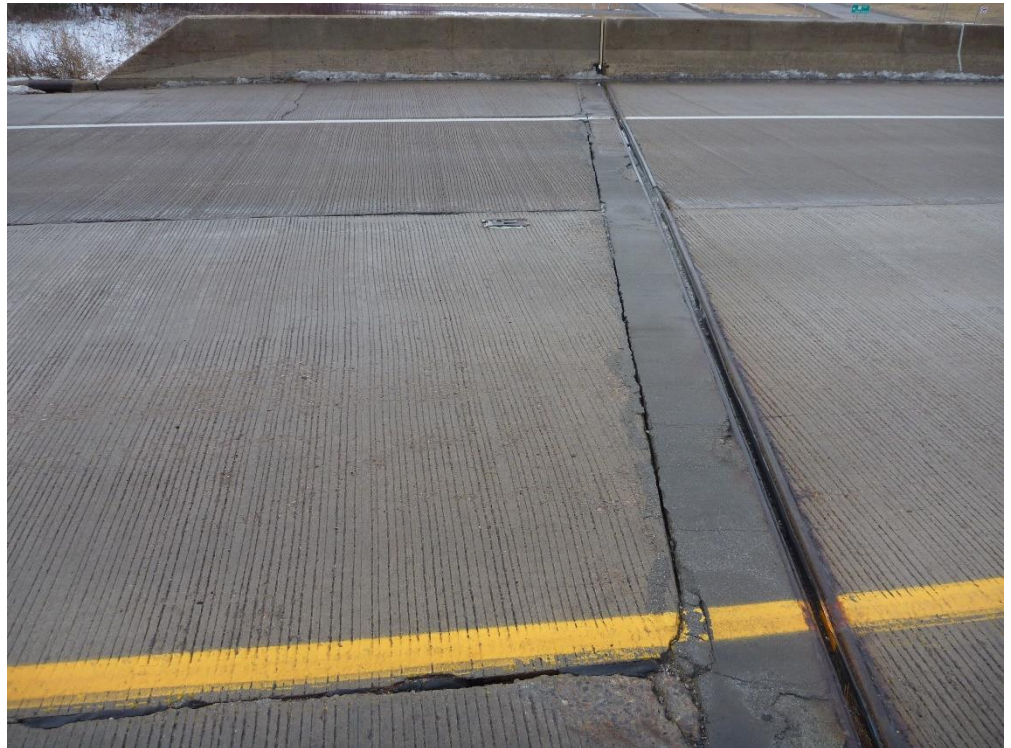
View of south expansion
joint on B-3-37.
Expansion joints at both
abutments to be replaced
during rehabilitation.

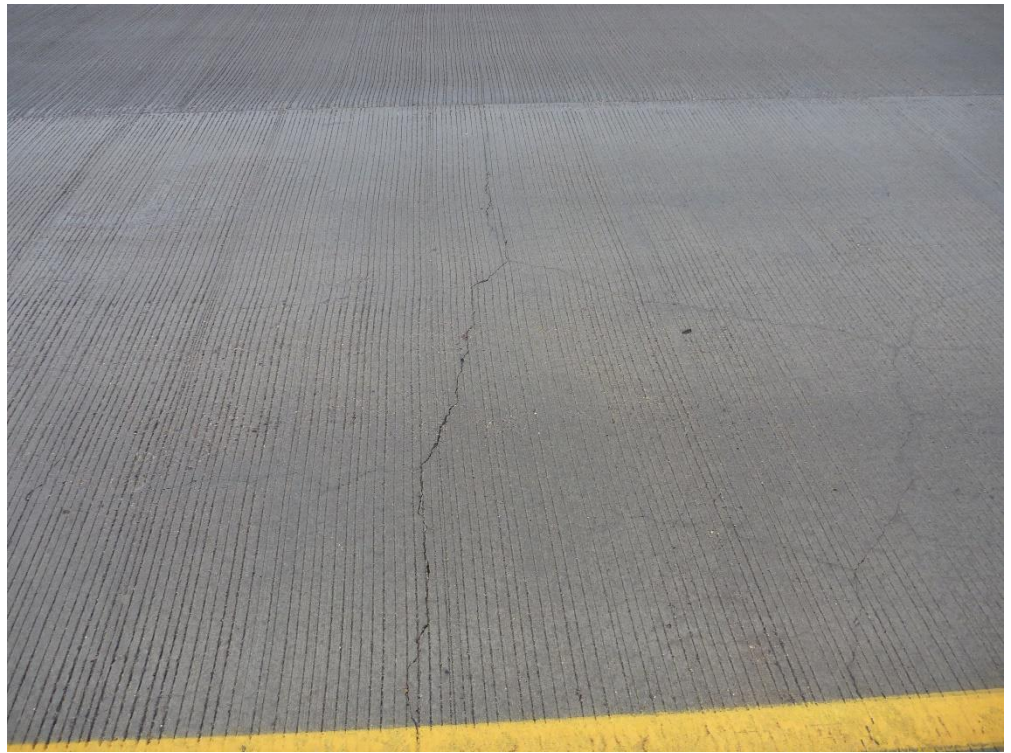
Typical map cracking in existing concrete overlay.

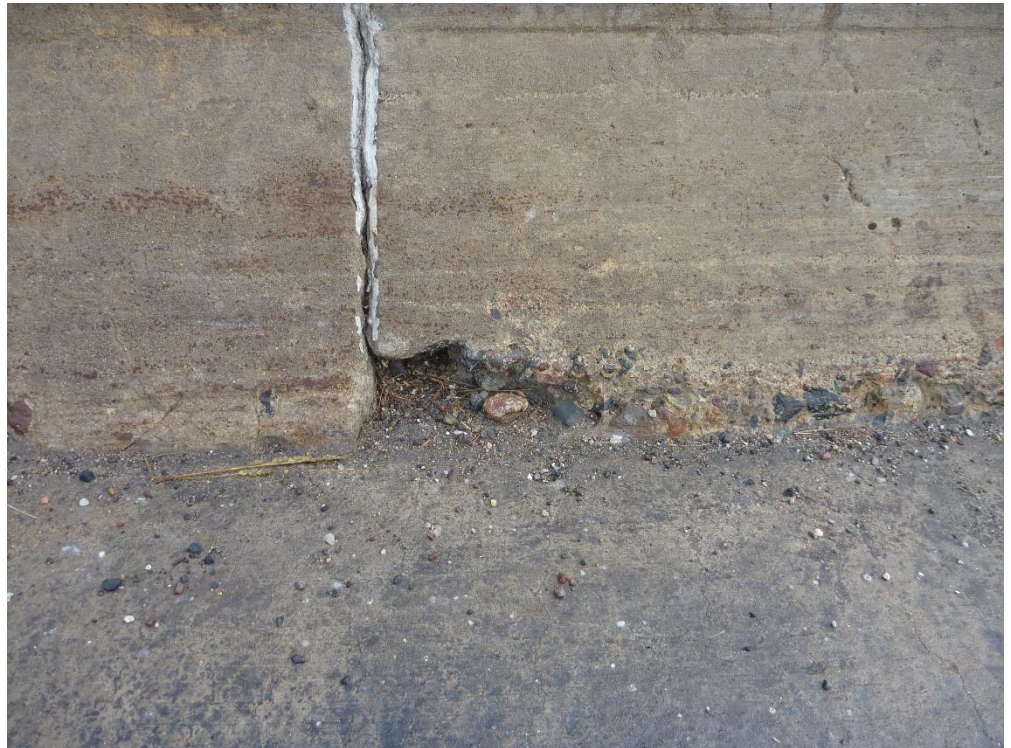
Spalling at concrete parapet on B-3-37.

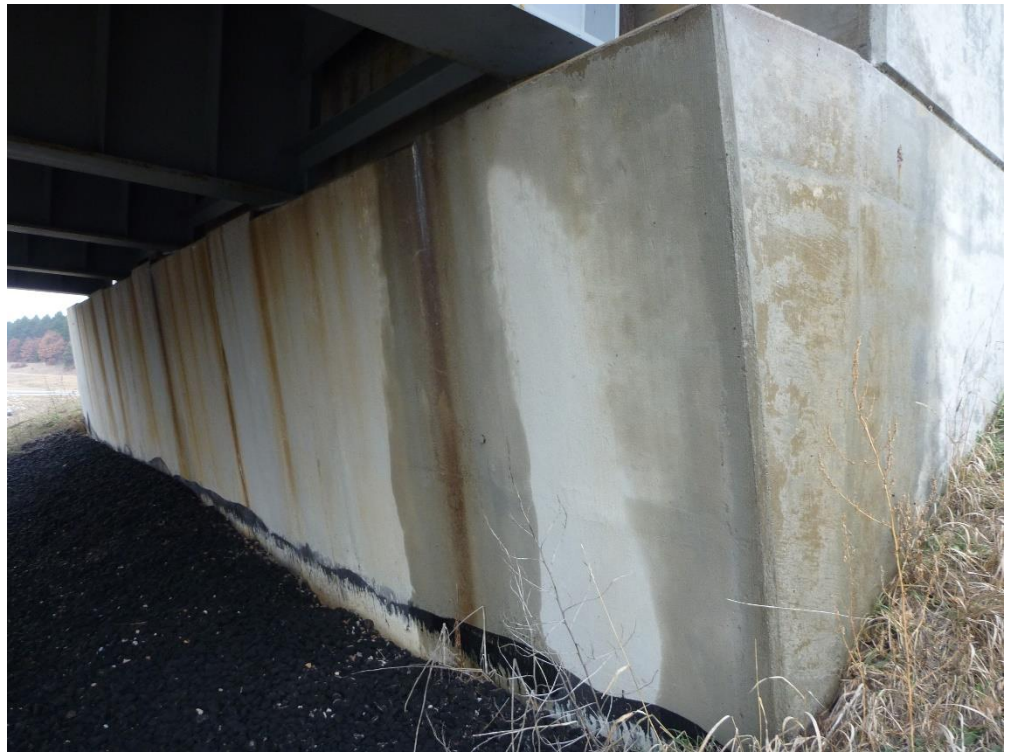
Vertical cracks in abutment with rust stains, typical at north and south abutments.

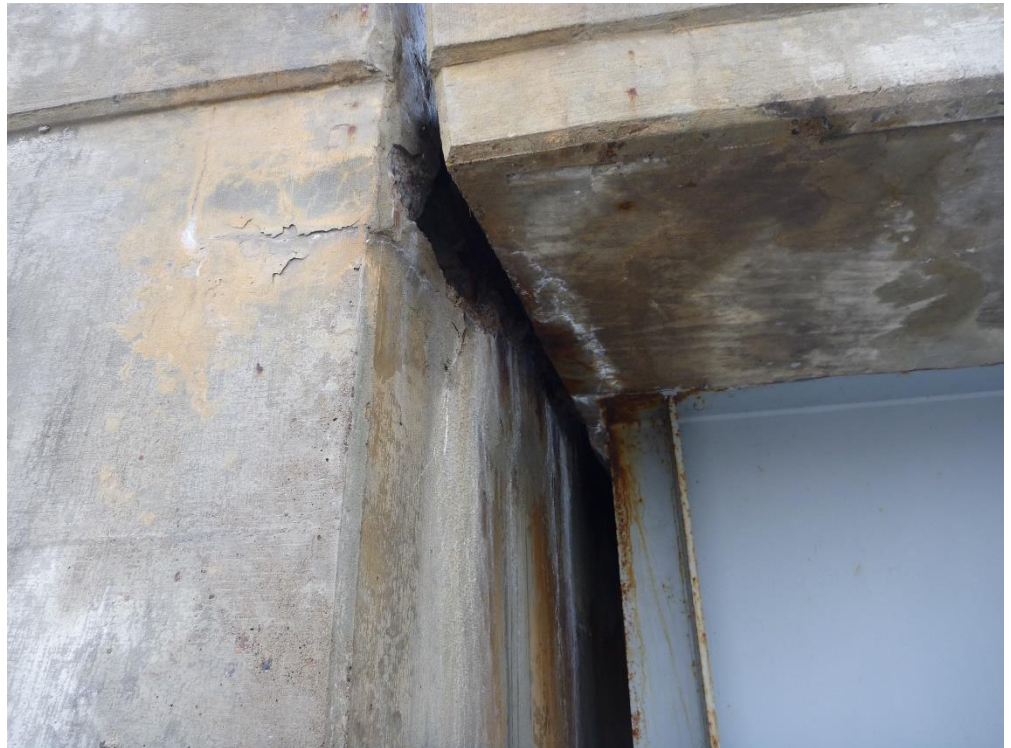
Spalling south abutment backwall.
