STATE OF WISCONSIN
DEPARTMENT OF TRANSPORTATION

Inspection Report for
B-32-015

STH 162 over DUTCH CREEK
Aug 02, 2017

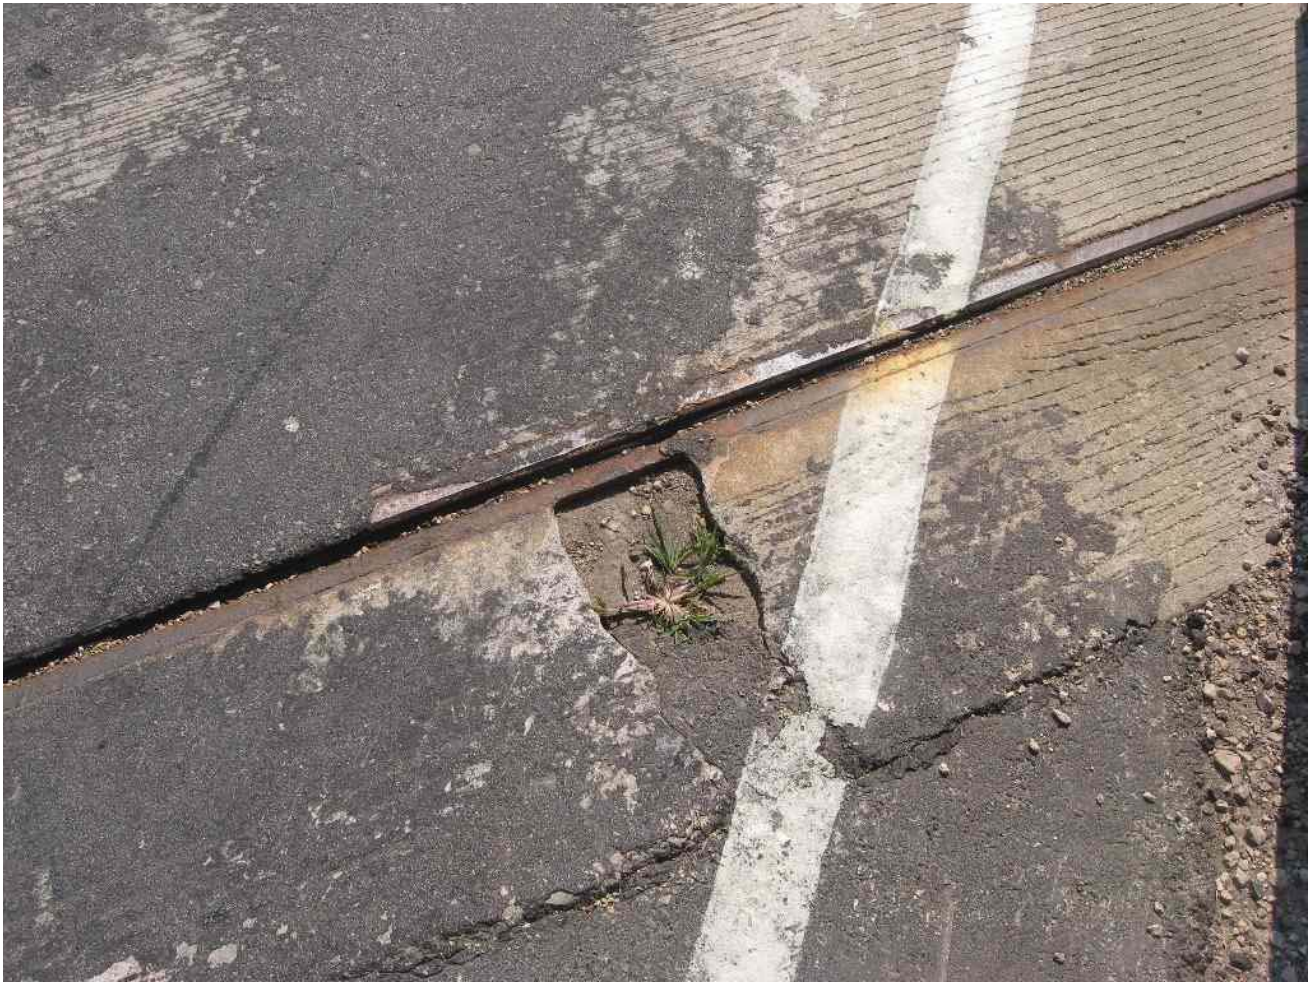
NW corner paving block spall

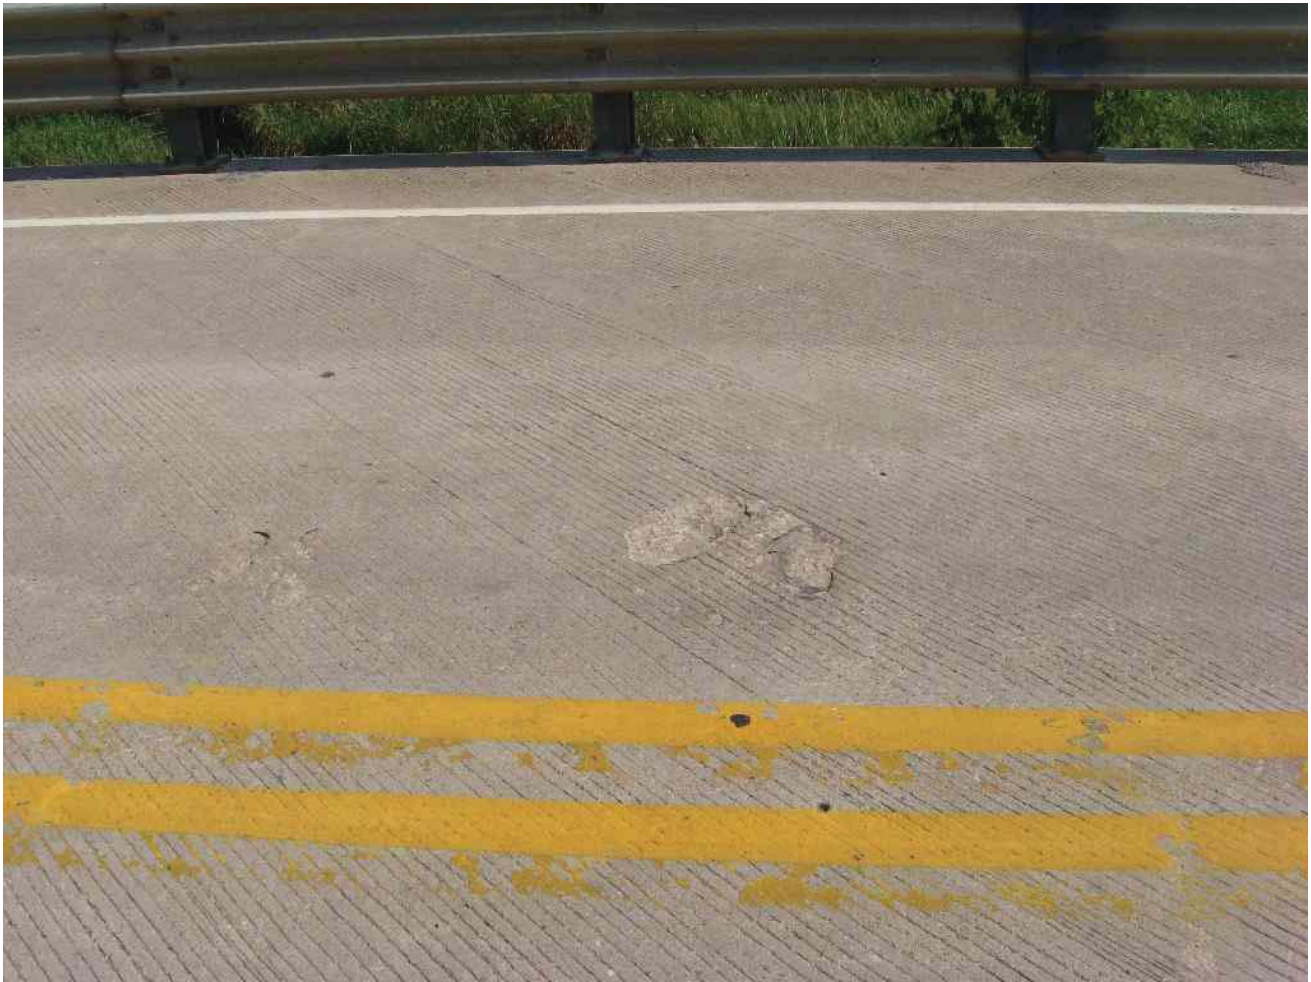
Spalling in NB lane

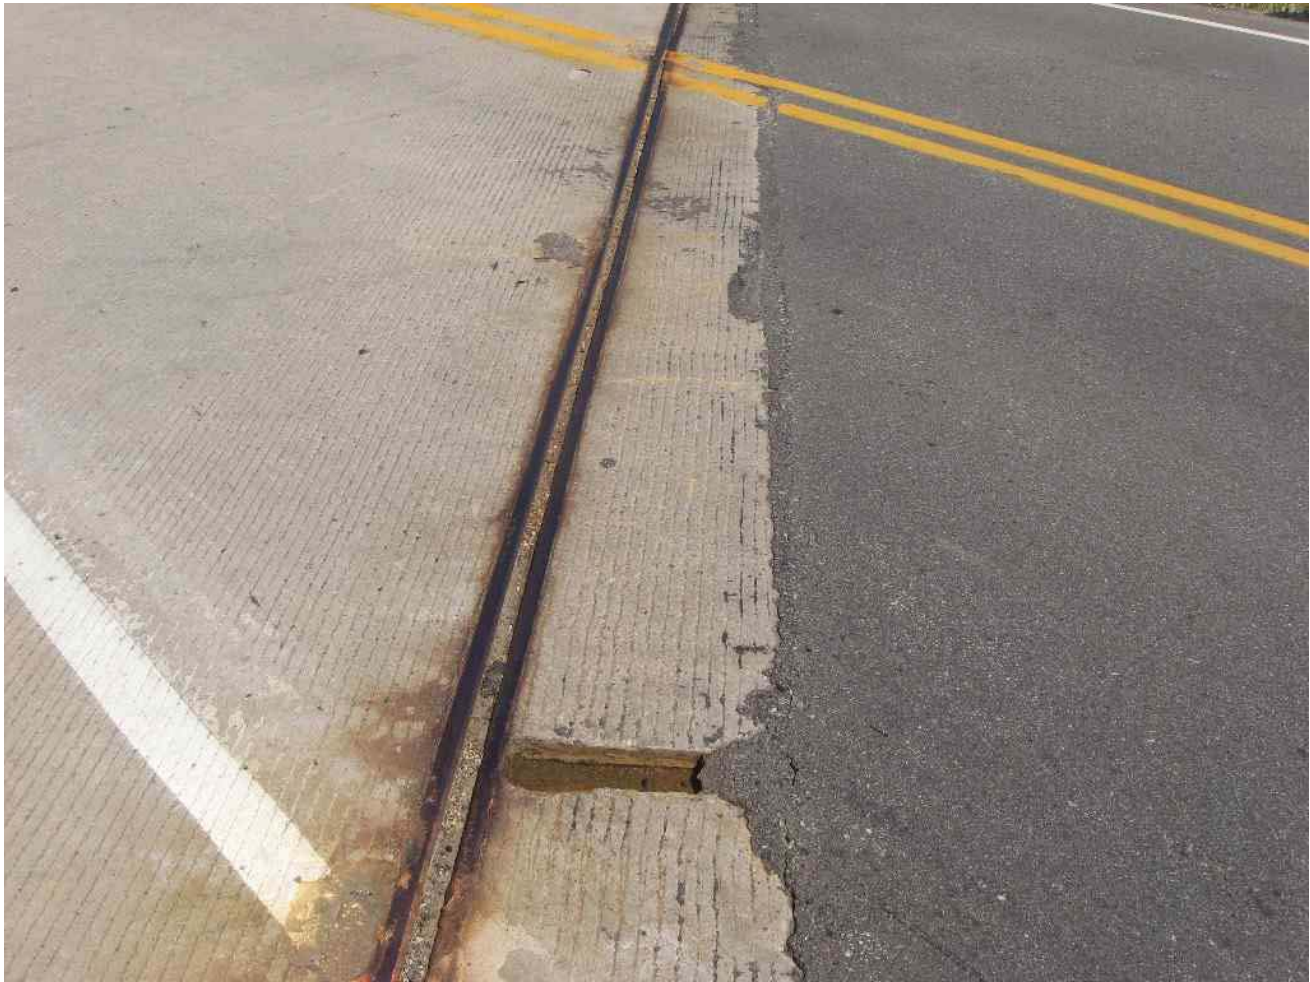
Spalling and delamination of paving block and edge of deck south end of structure

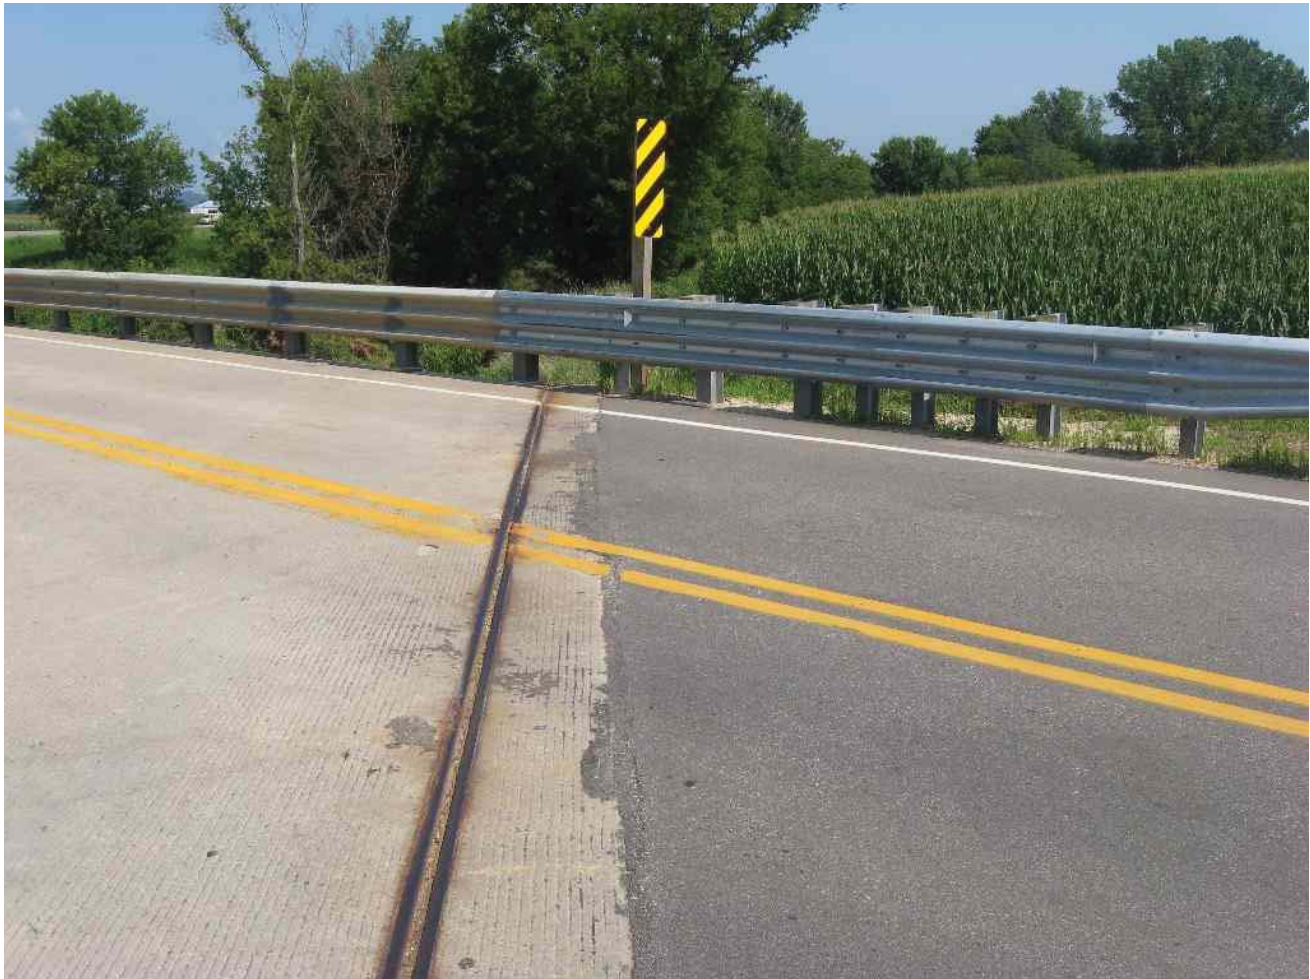
Spalling and delamination of paving block and edge of deck south end of structure

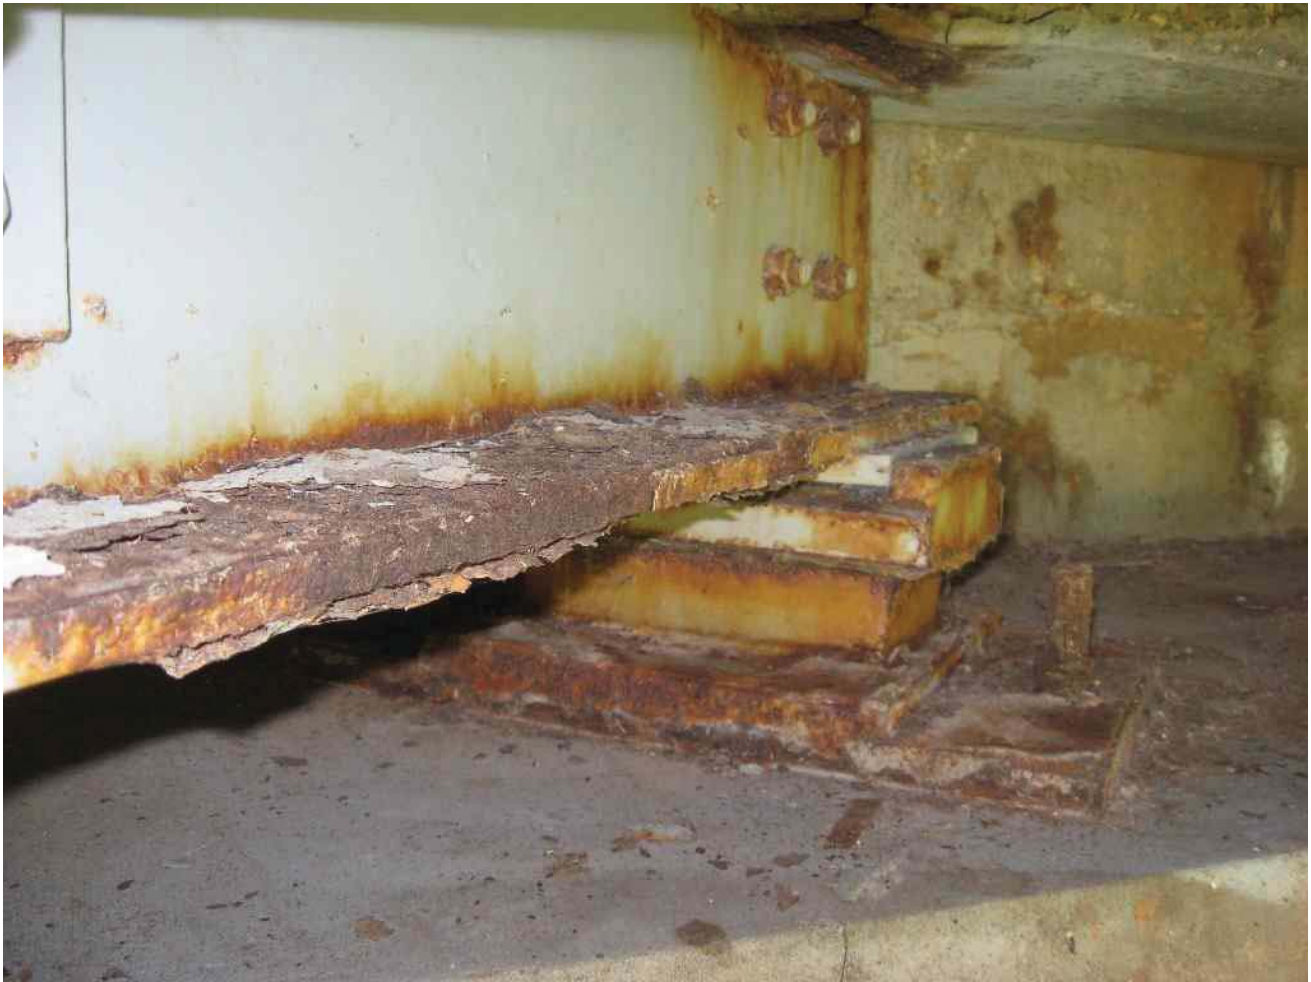
G2 South abutment heavy corrosion of bottom flange at bearing location

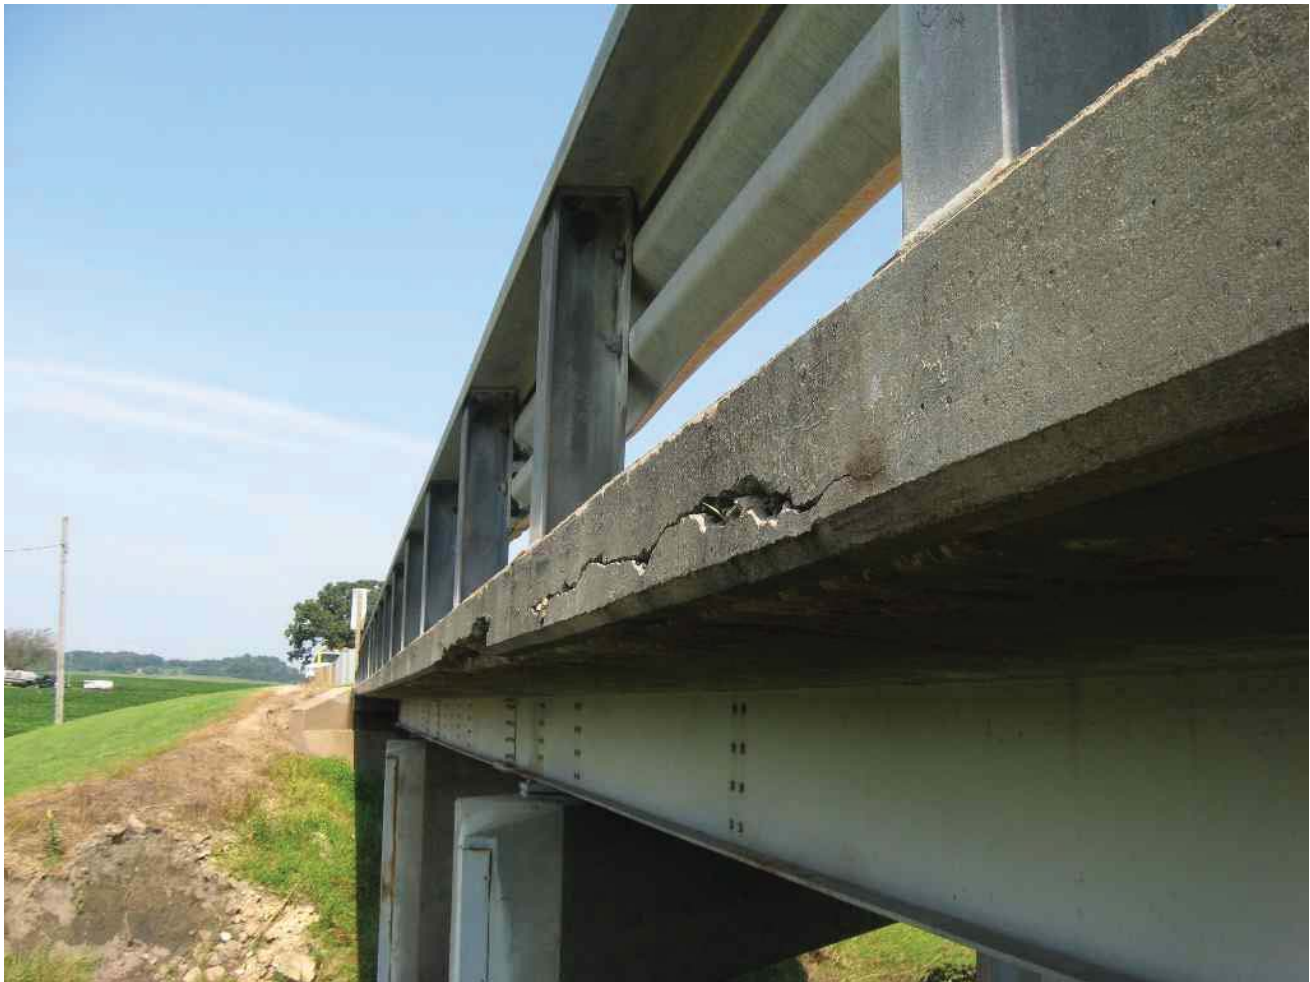
Soffit along west edge starting to spall and crack from drip edge failure similar condition east edge

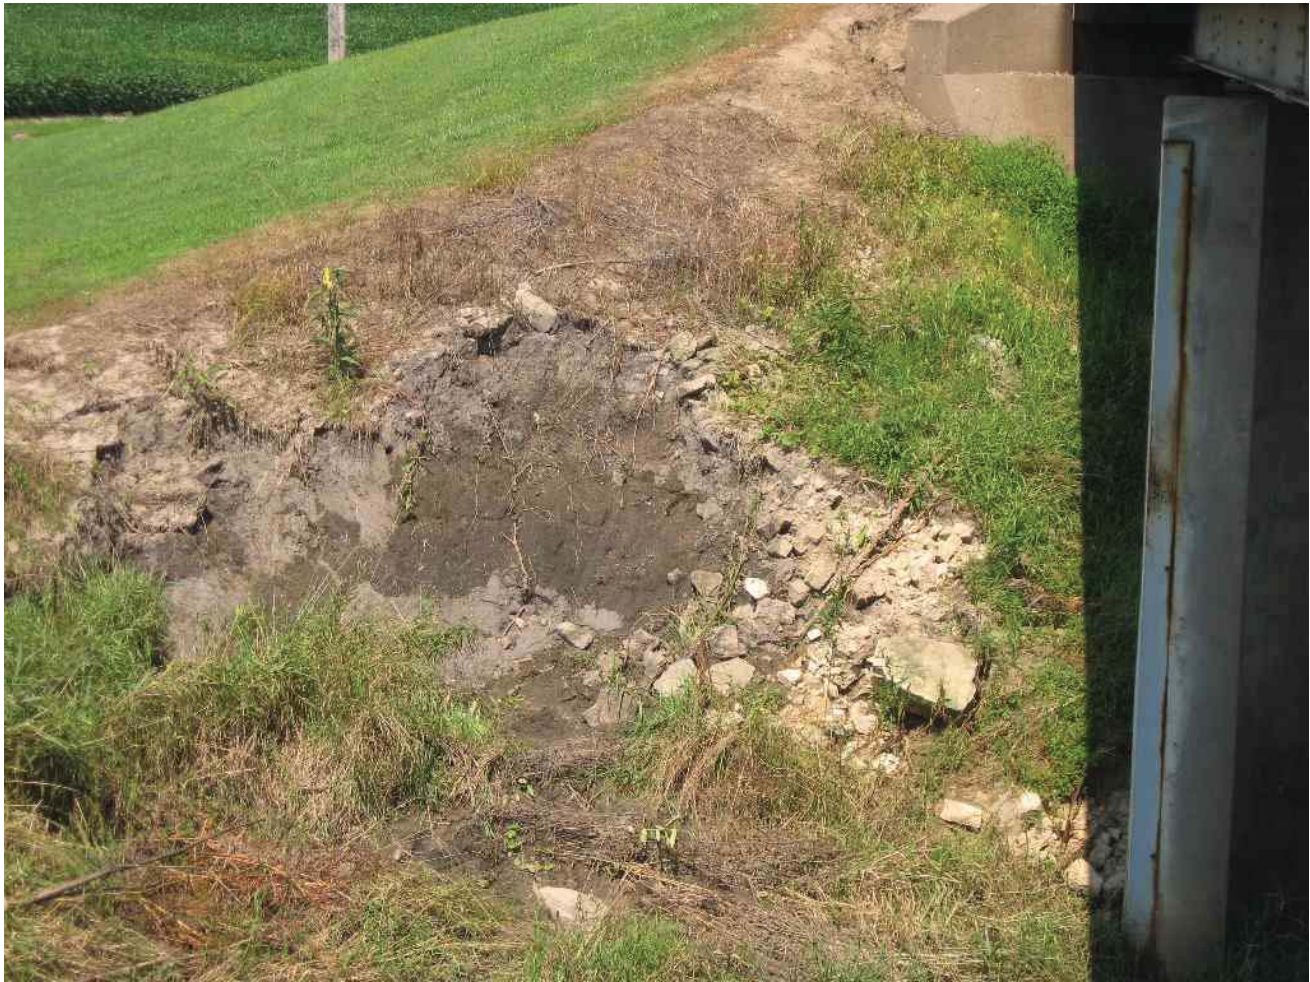
NW corner of upstream bank has severe erosion from recent flood event (17)

Recent high water event caused NW bank upstream of structure to erode away

Upstream north west corner of channel needs rip rap placed to control erosion

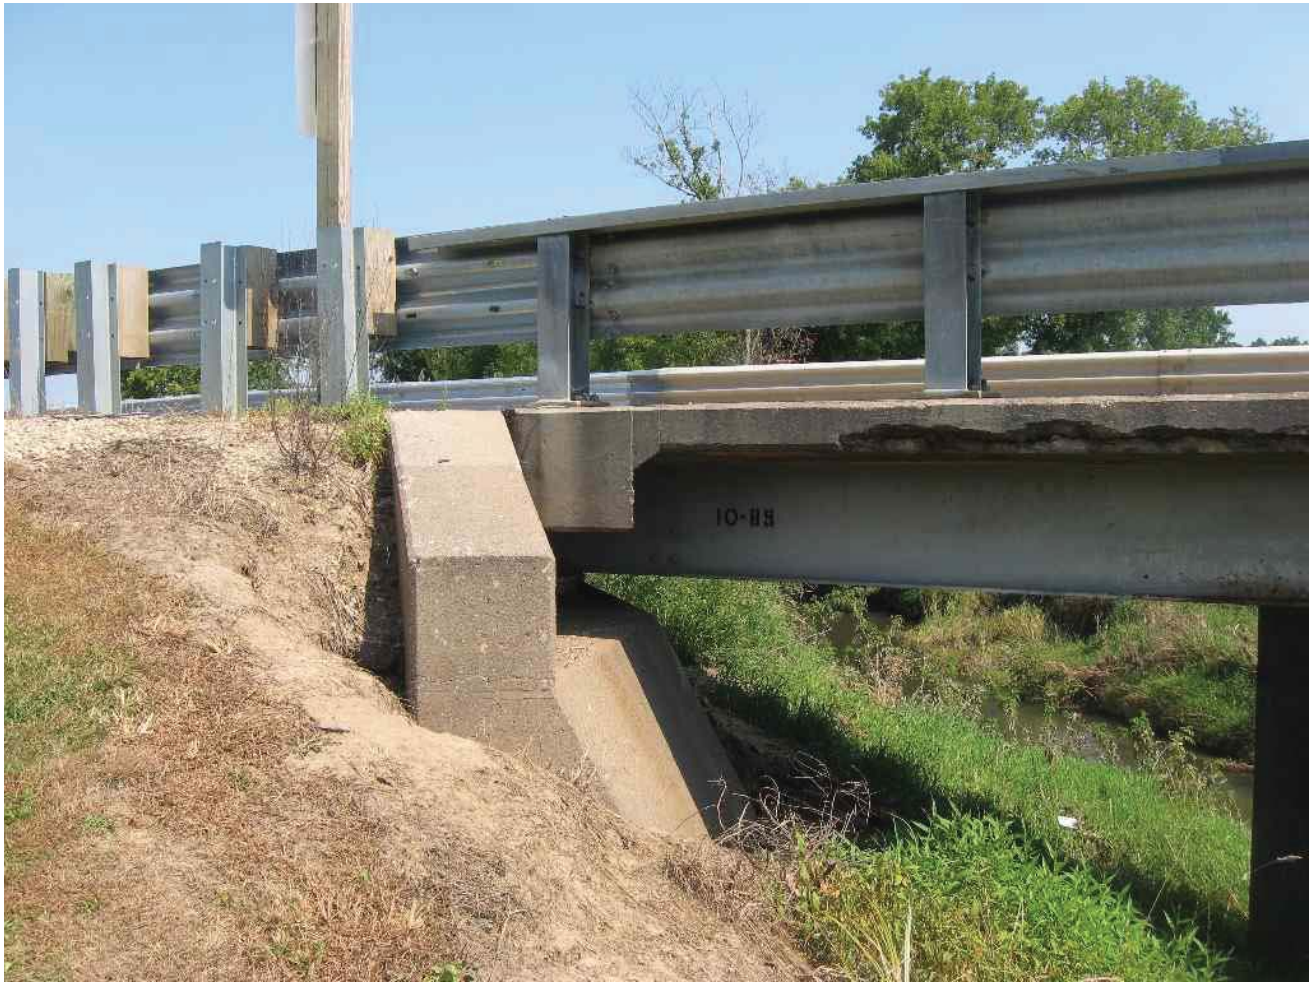
NW wing erosion around the wing and bank

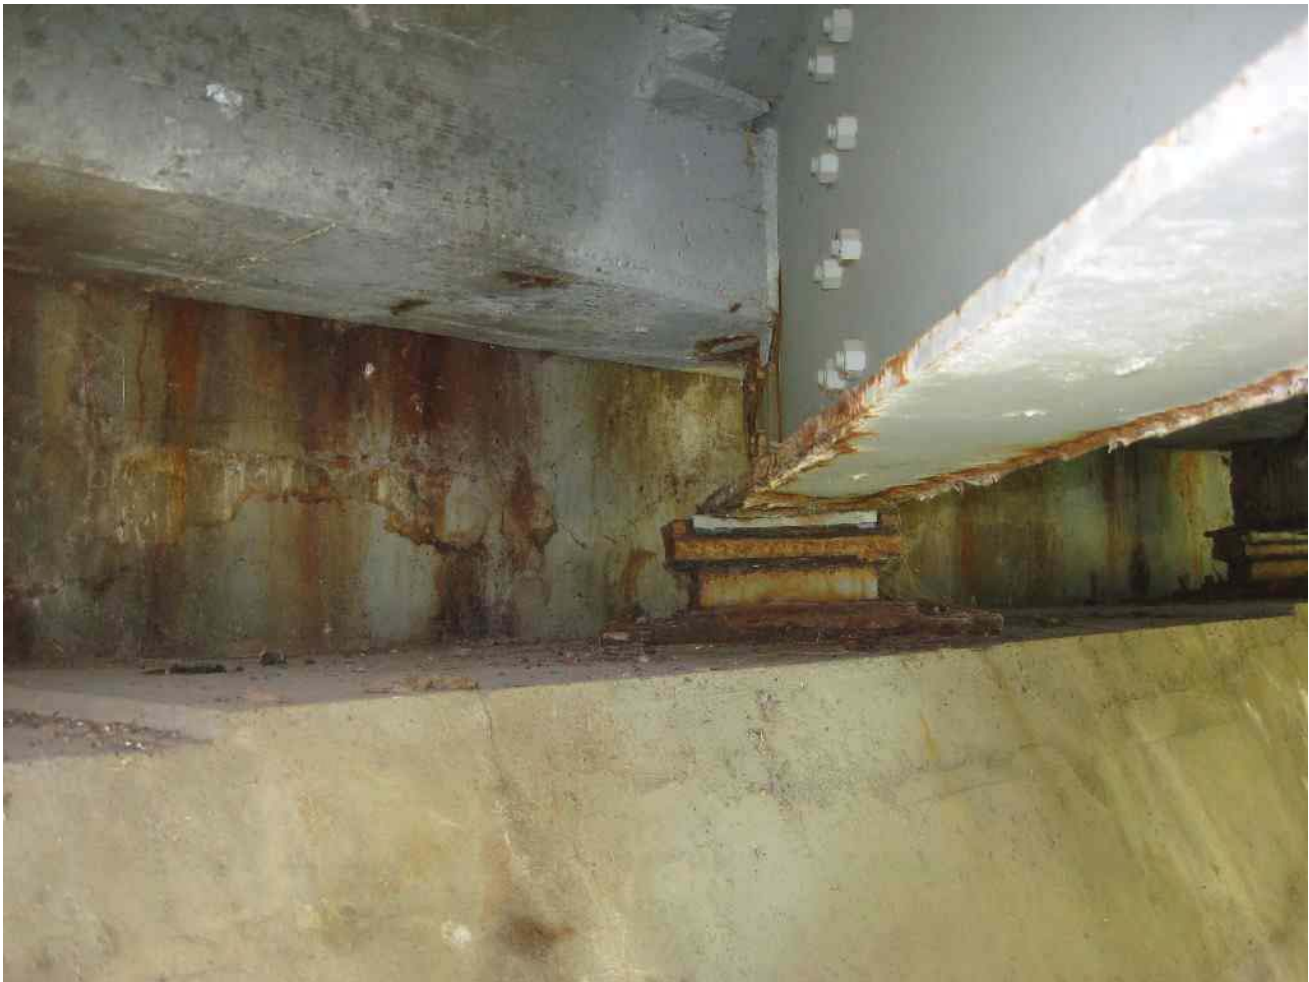
G2 span 3 heavy corrosion on girder flange and bearing area. Also back-wall in this area severe delamination and staining .
