# Inspection Report for B-38-015

USH 8-USH 141 over CRAIN LANE  
Oct 02,2018

| Feature On:<br>USH 8-USH 141 | Section Town Range:<br>S26 T37N R20E | Structure Number:<br><br><b>B-38-015</b> |

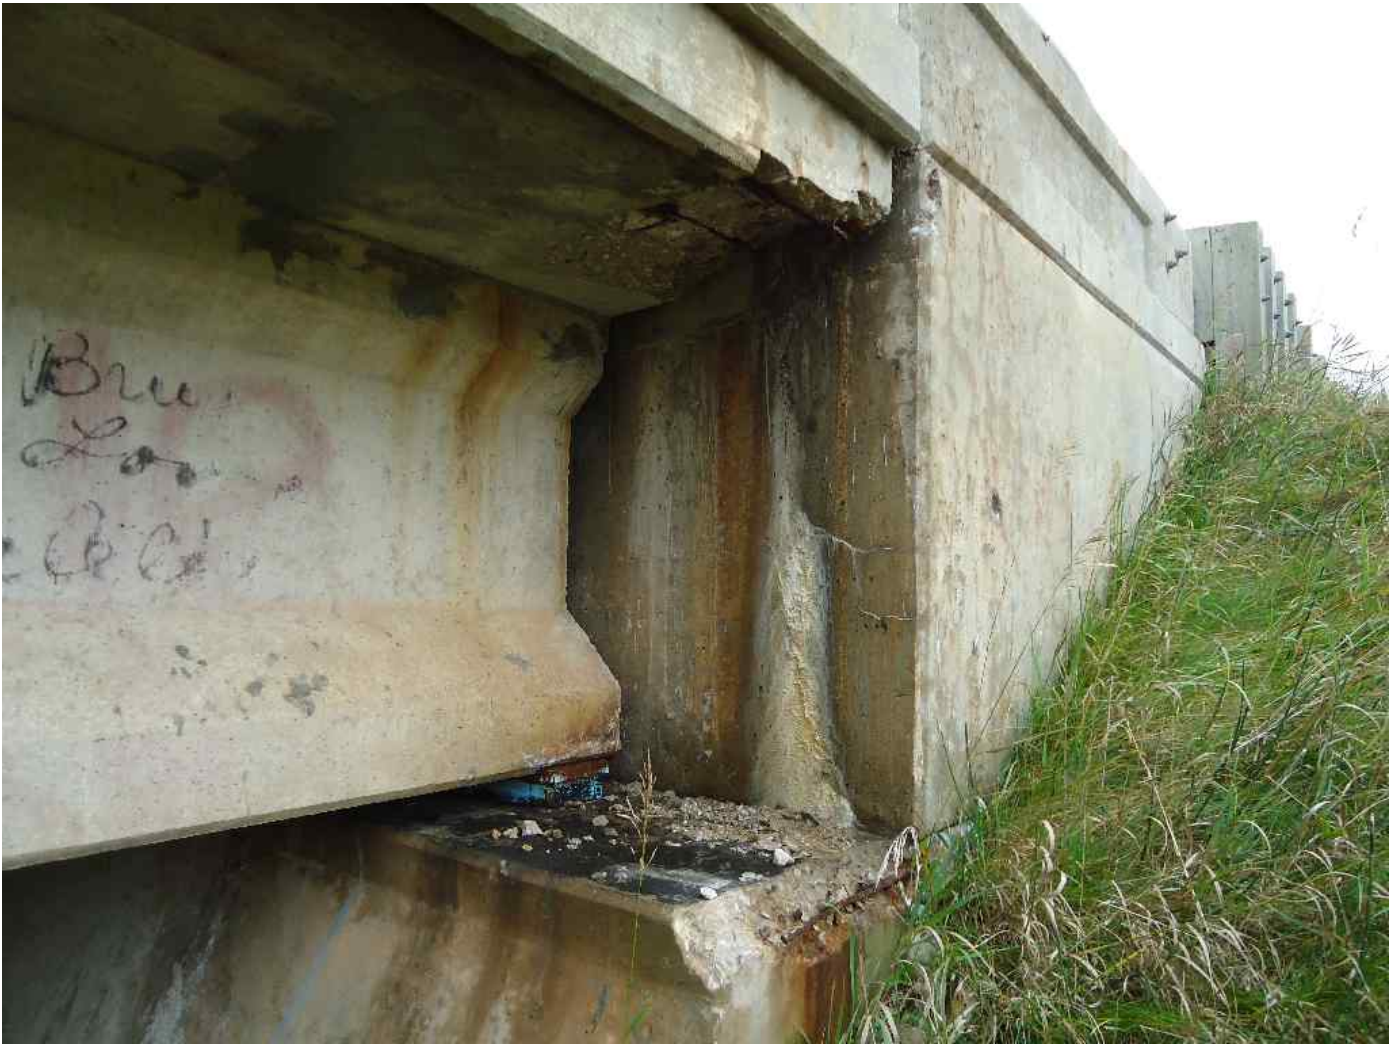
CS-3 Spalling at W corner of S abut & SW underdeck (10/4/16)

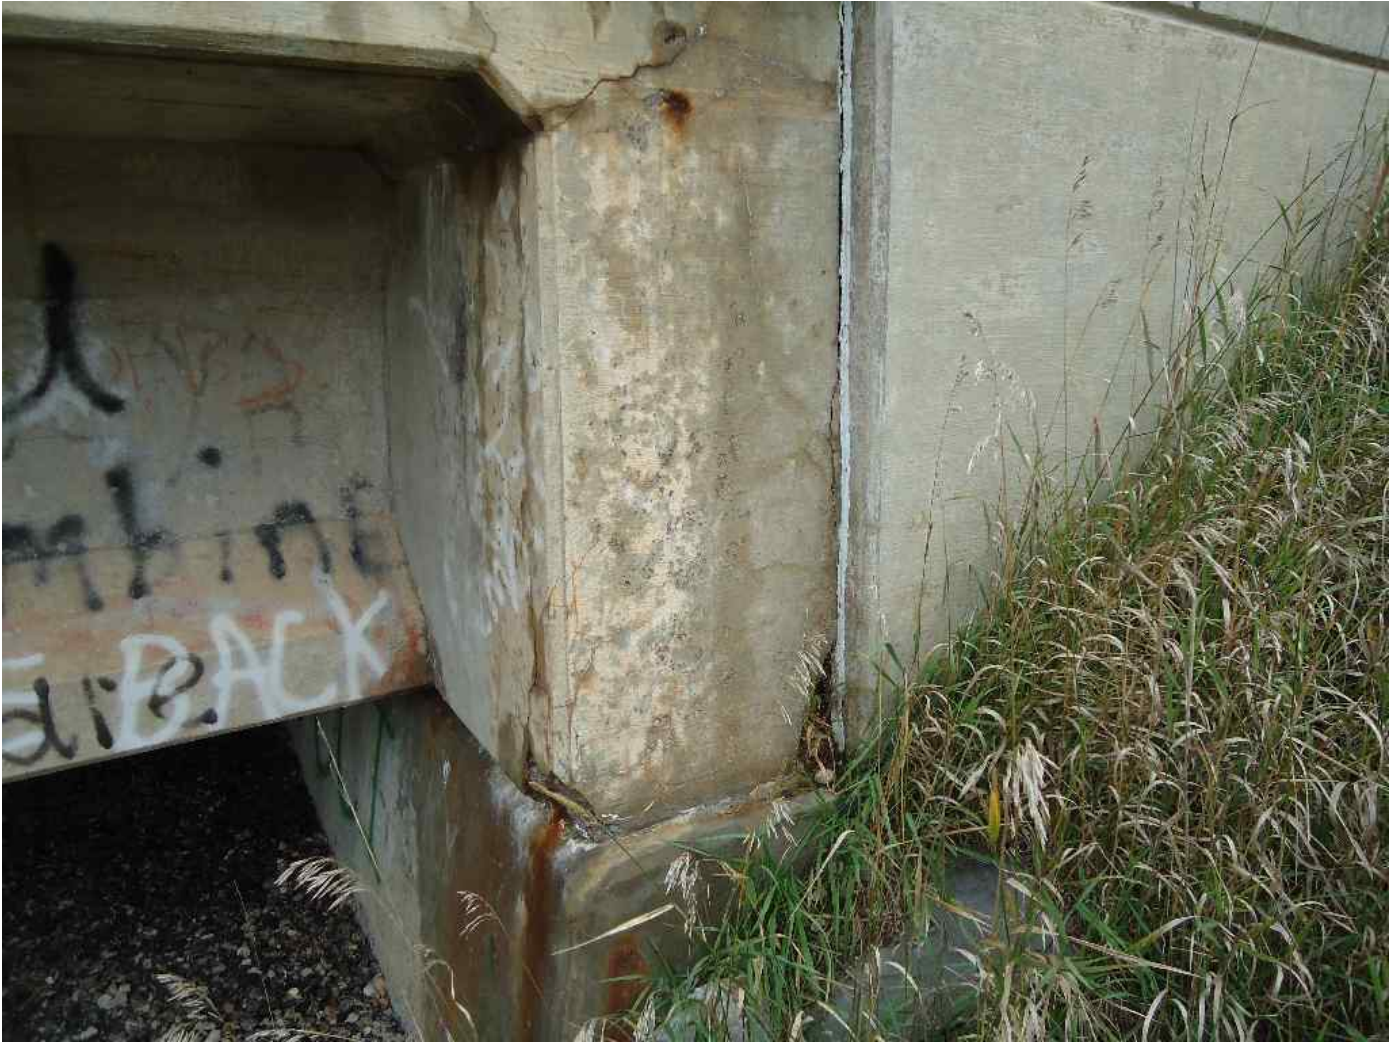
CS-3 Spalling at E corner of N abut (10/4/16)

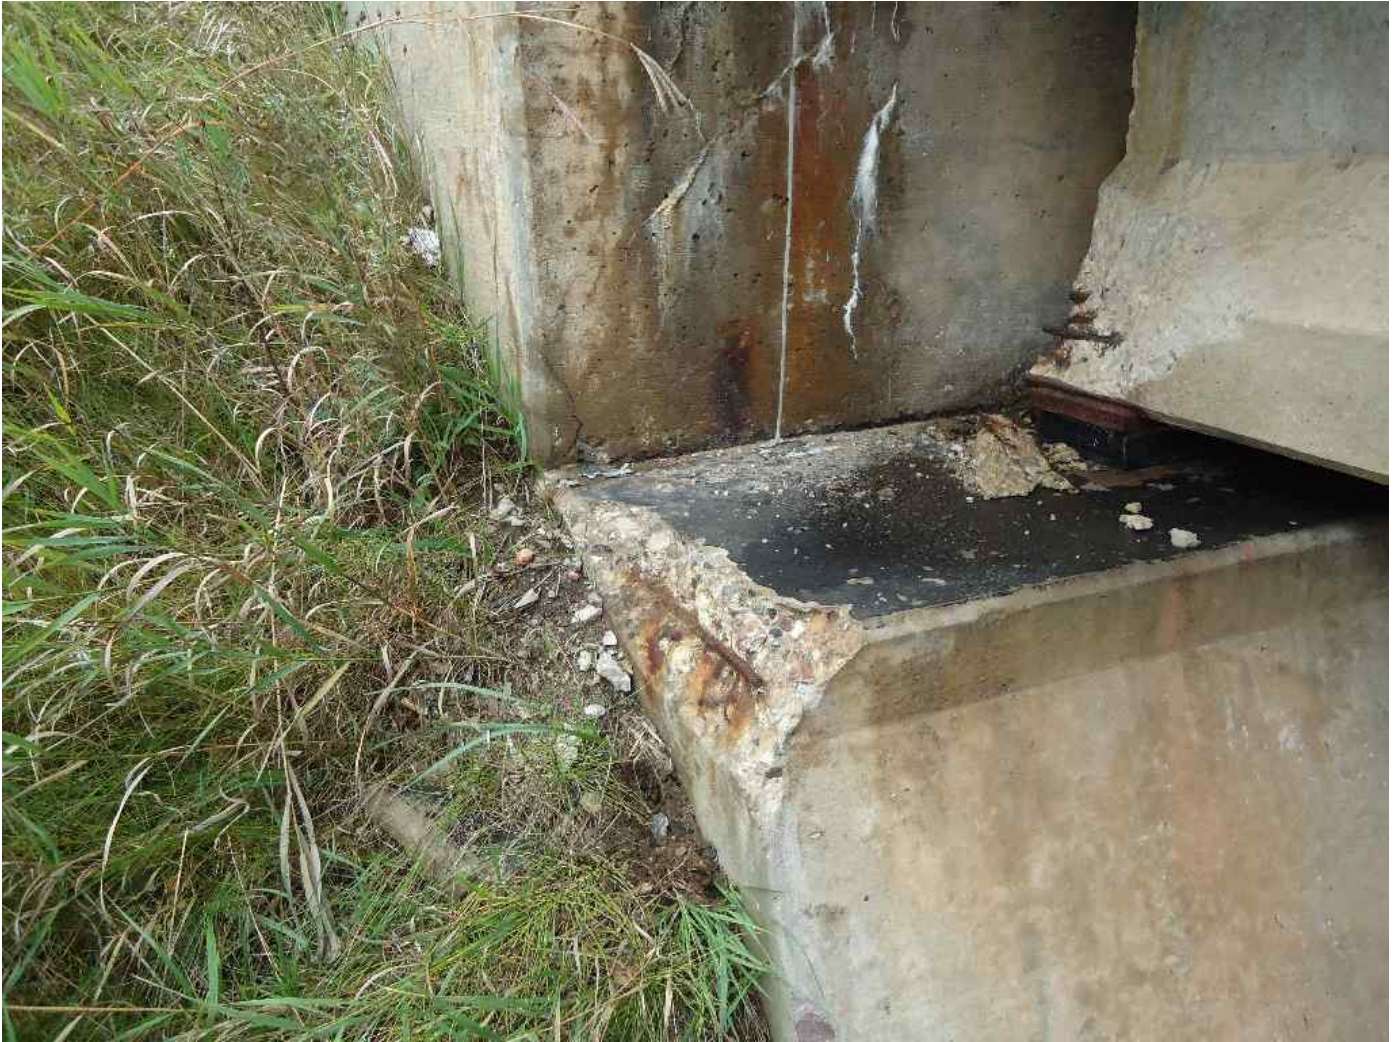
CS-3 Spalling at E corner of S abut (10/4/16)

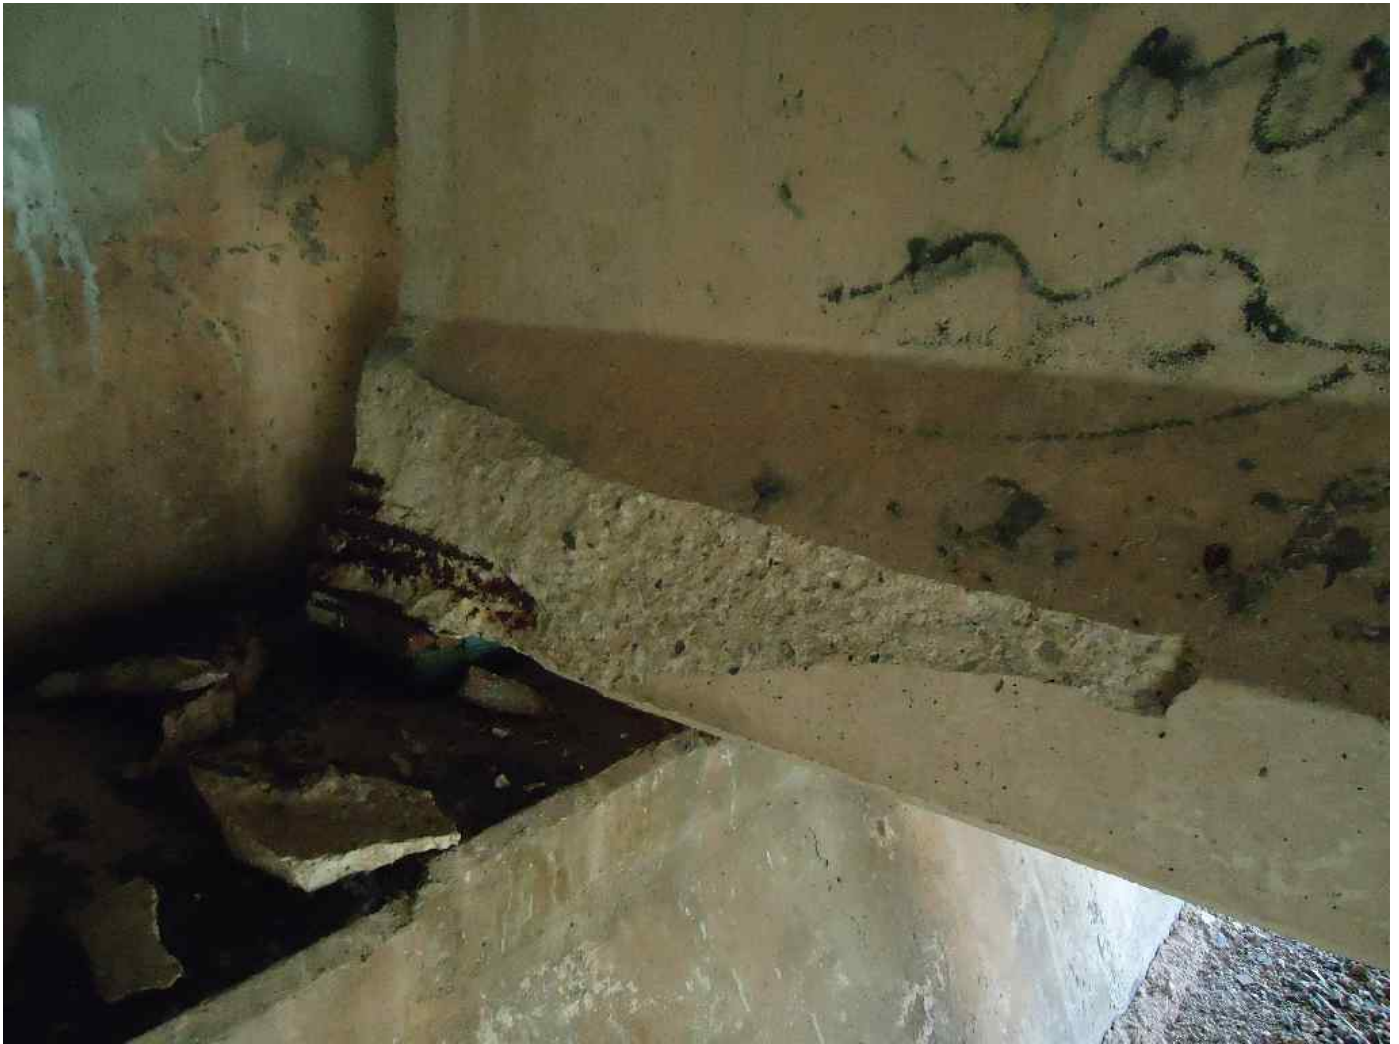
CS-3 Spalling in G2 at S abut (10/4/16)

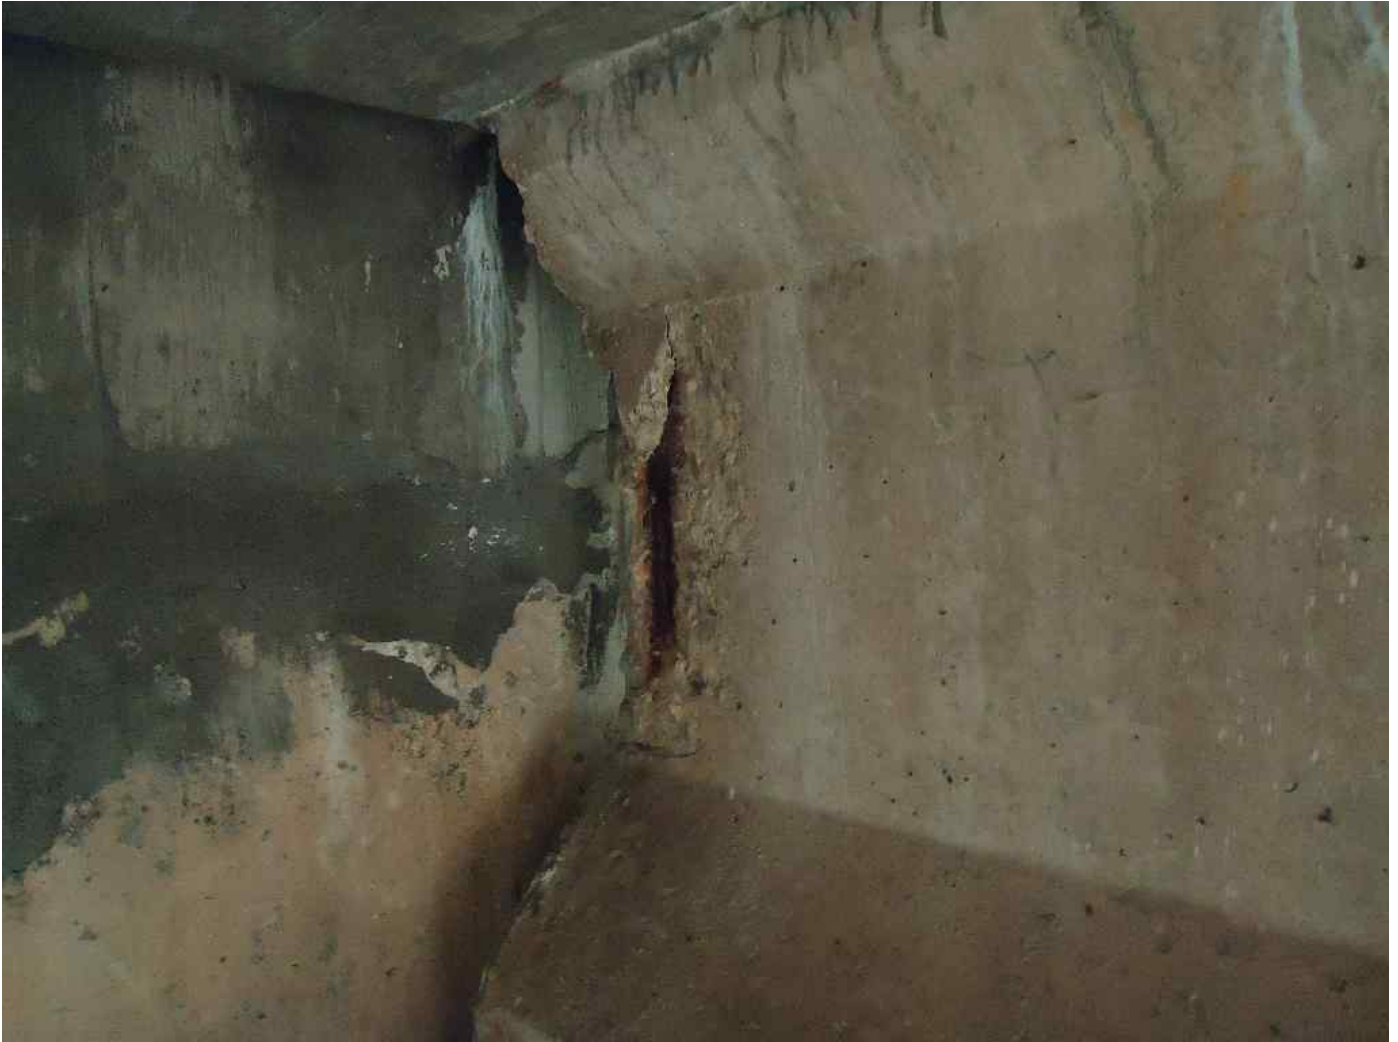
CS-3 Spalling in G3 at S abut (10/4/16)

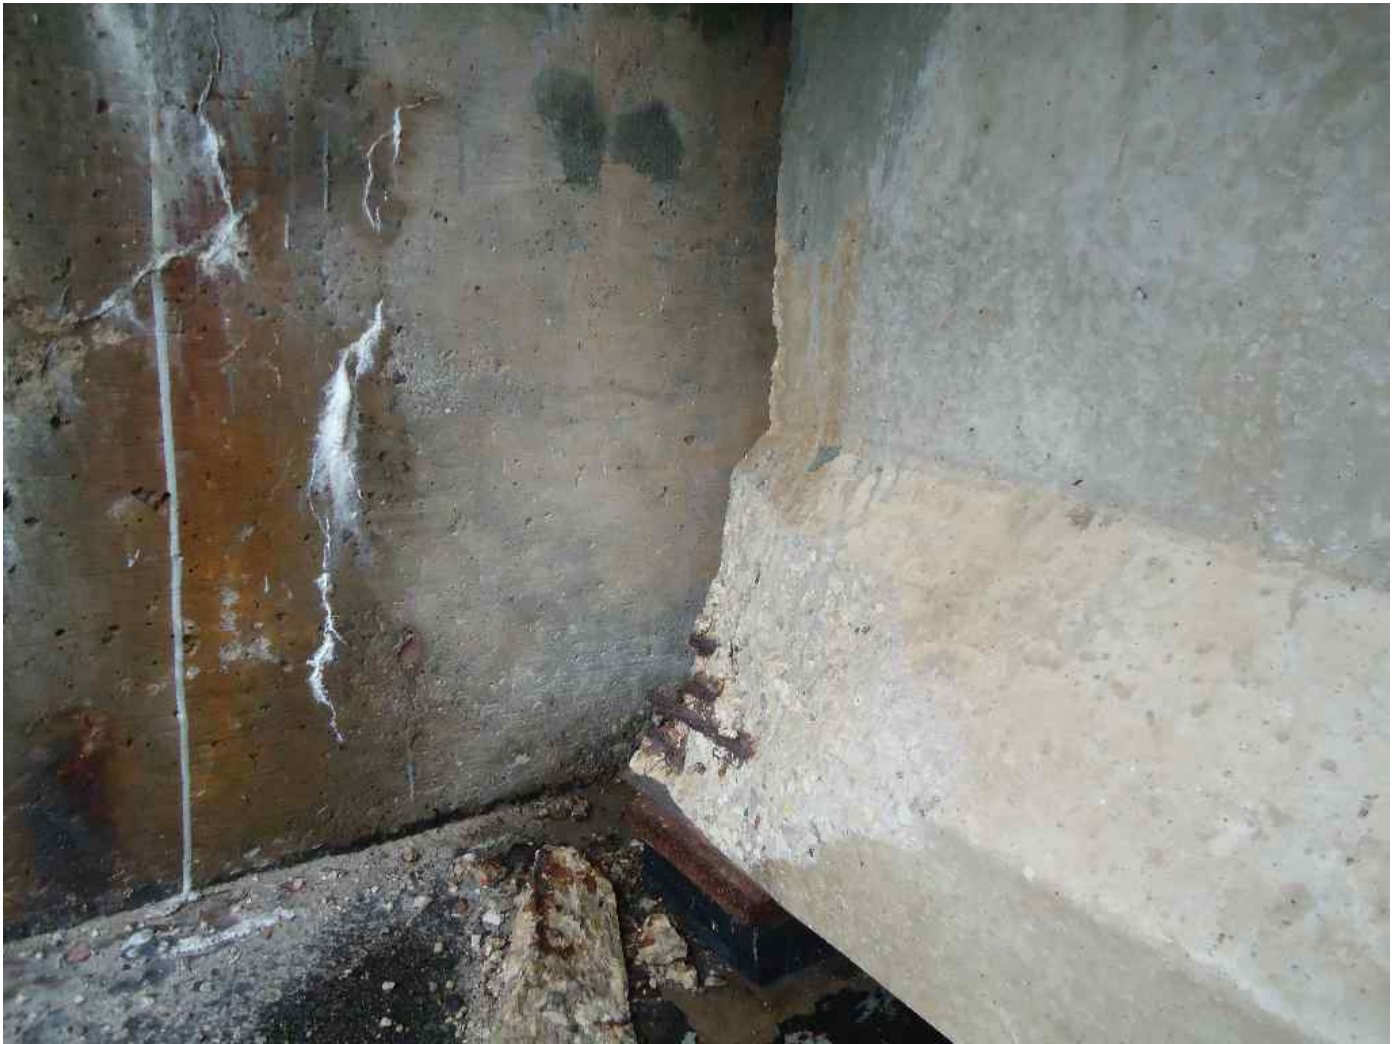
CS-3 Spalling in G5 at S abut (10/4/16)

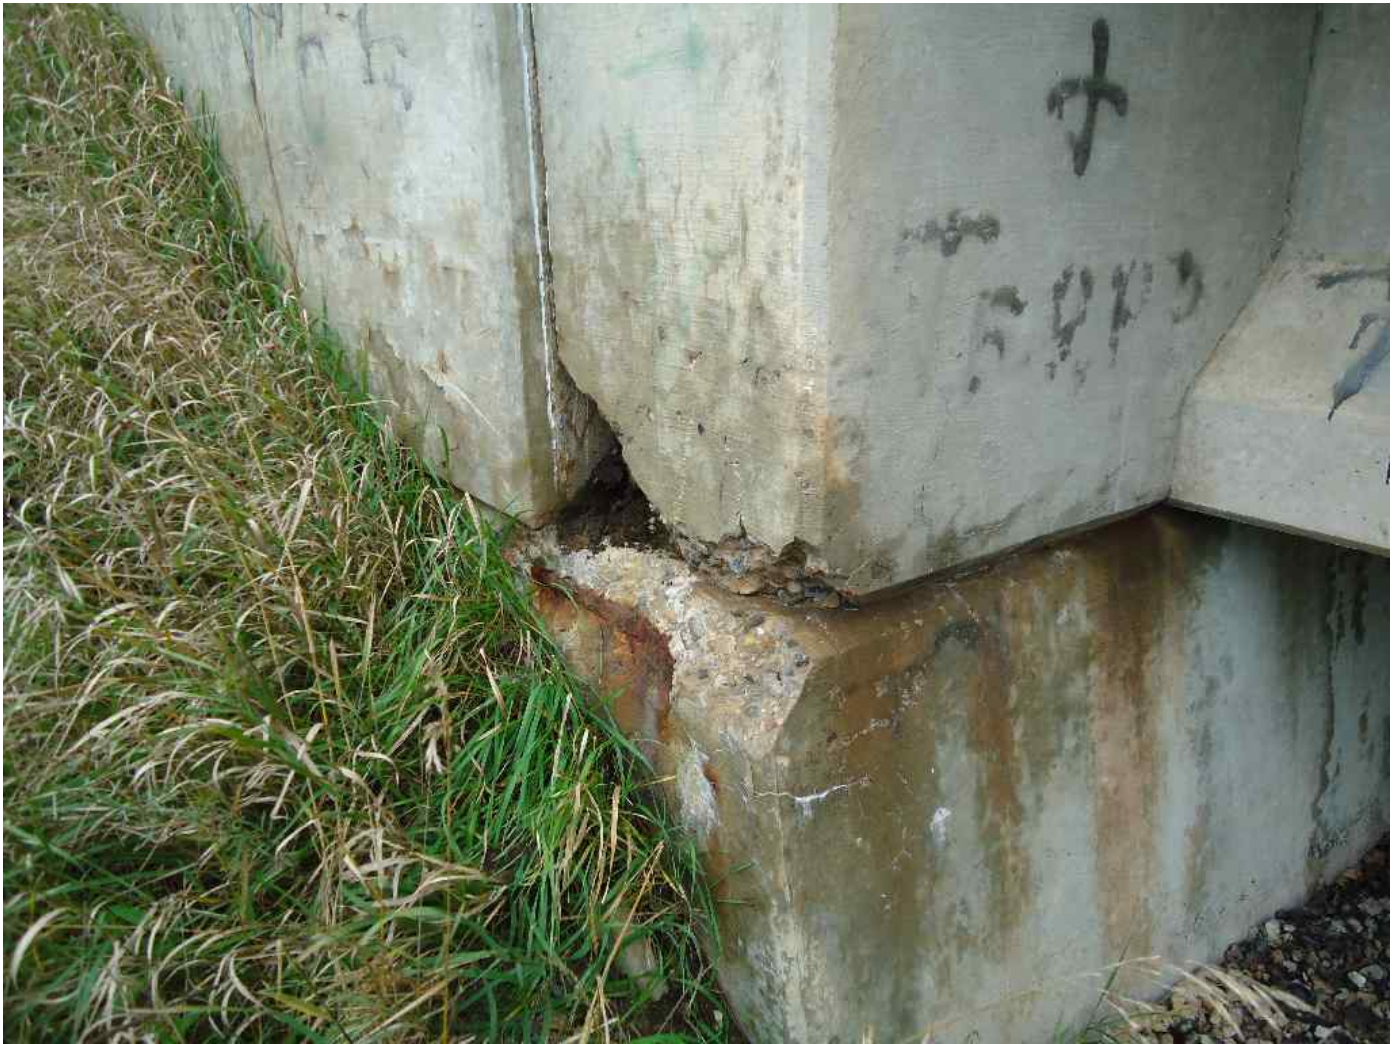
CS-3 Spalling at W corner of N abut (10/4/16)

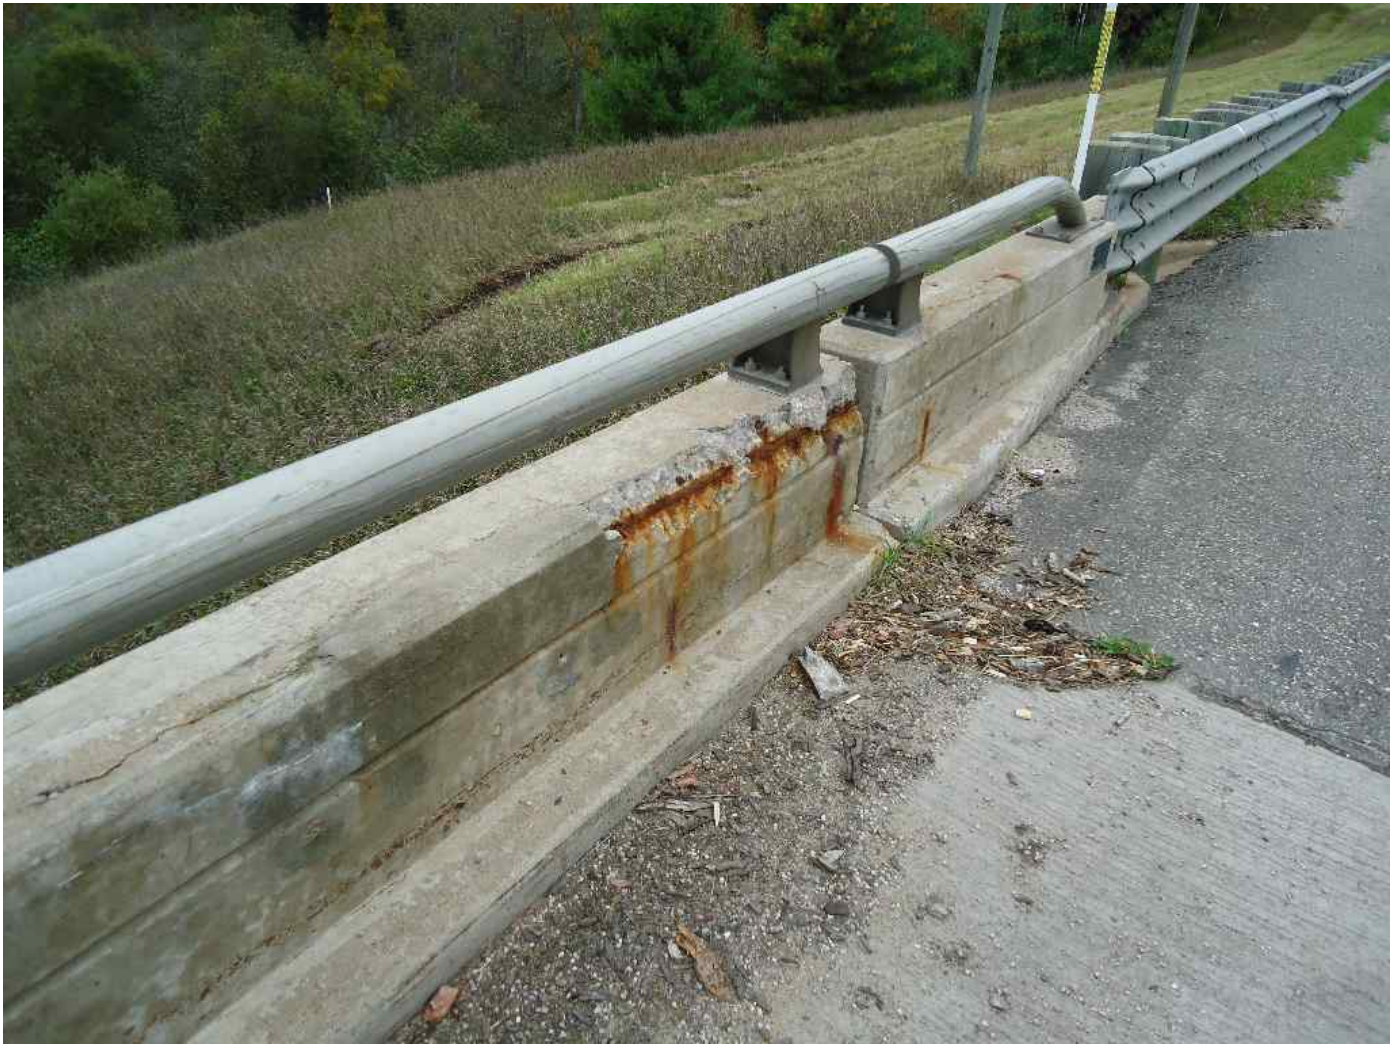
| | | 1080 | Delamination - Spall - Patched Area<br>CS-2(W Side 125' & E Side 150') Delaminations<br>CS-3(W Side <b>100'</b> & E Side <b>100'</b> ) Large spalls | LF | | 0 | 275 | 200 | 0 |

CS-3 Spalling in parapet (Typ) (10/4/16)

| Item | Priority | Recommended by | Status | Status change |
|---|---|---|---|---|
| Knock off loose parapet concrete over road & R/R | | | | |

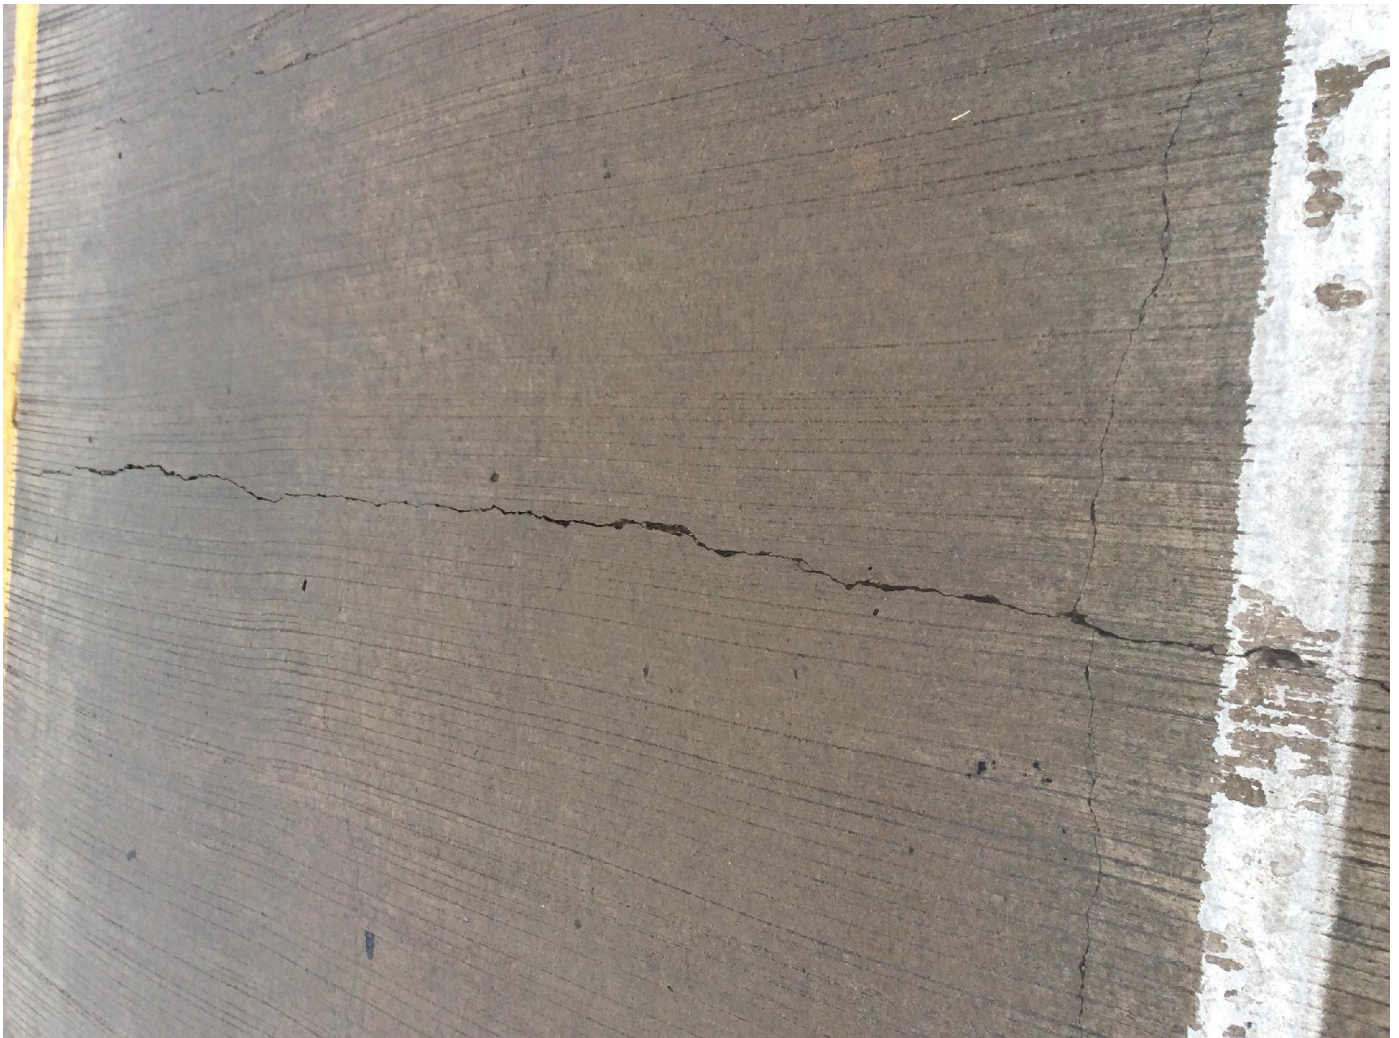
CS-3 Deck cracking over piers  
Same 10/4/16 DSW
