B-38-15 USH 8/141 over Crain Lane

Photos of Existing Structure

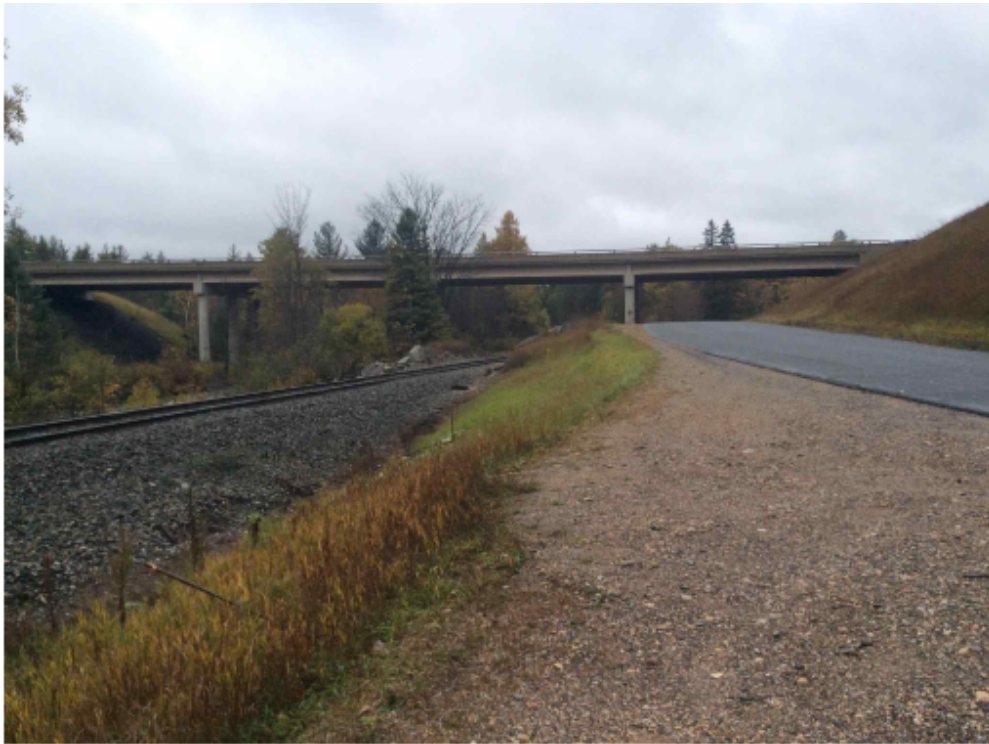
Elevation of existing bridge, looking West

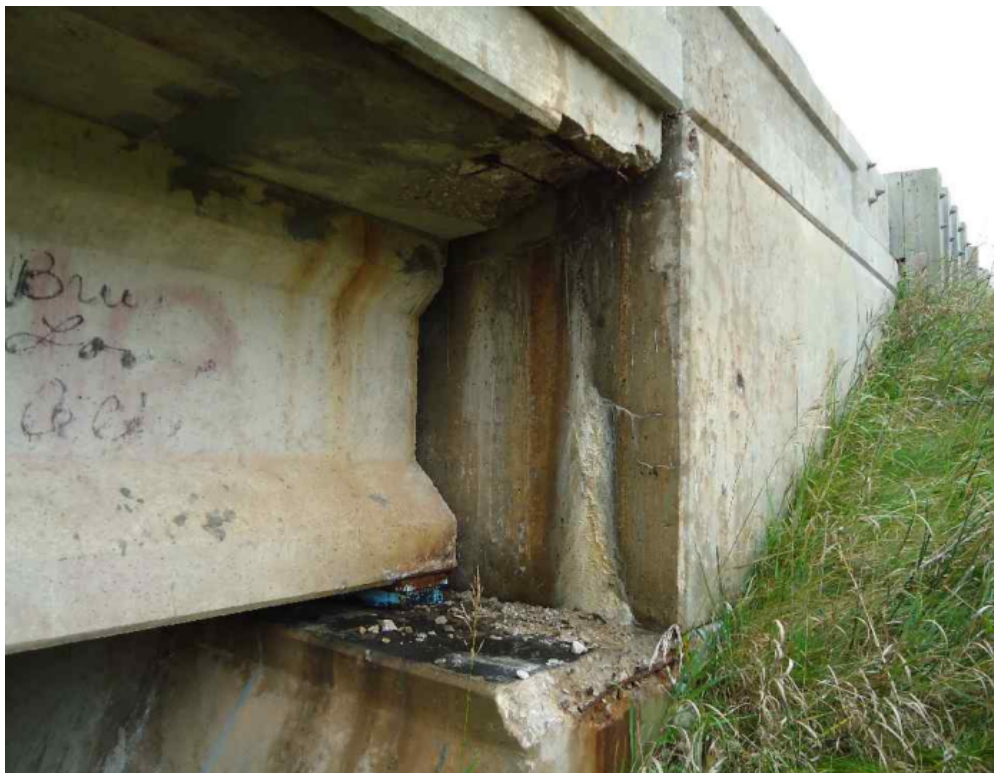
Spalling at West corner of South abutment

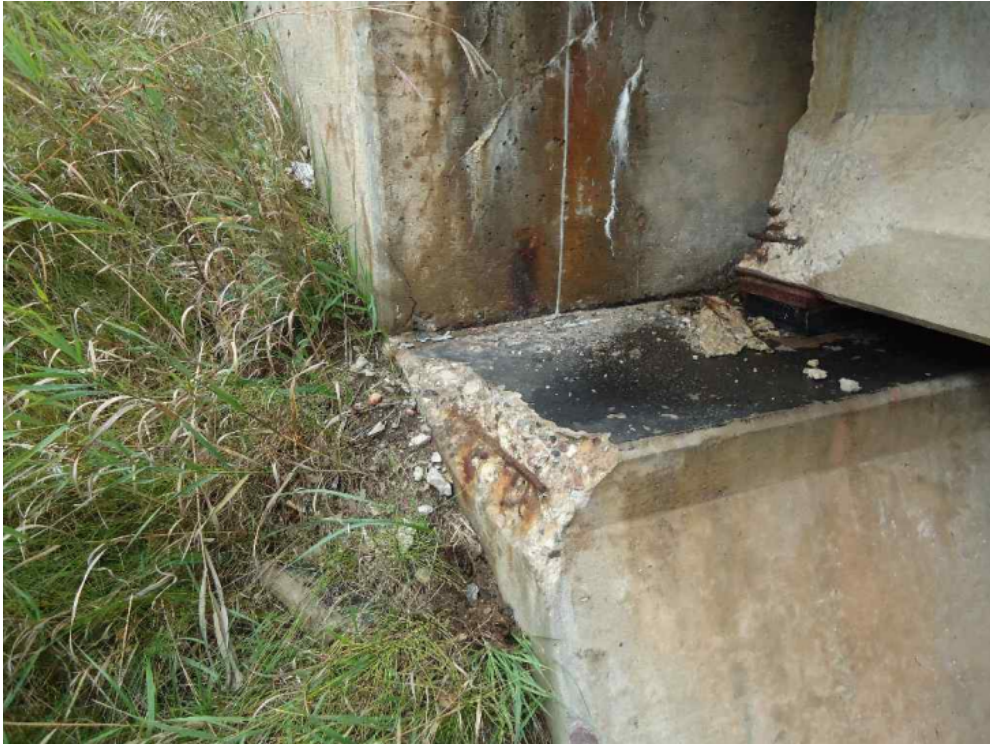
Spalling at East corner of South abutment

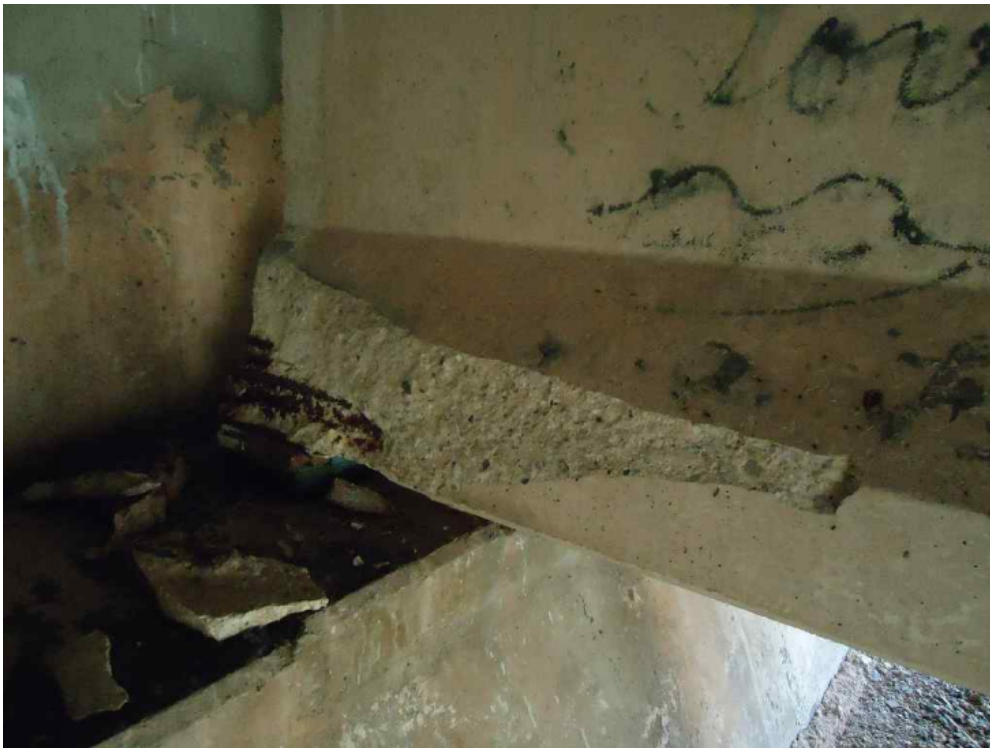
Spalling in Girder 2 at South abutment

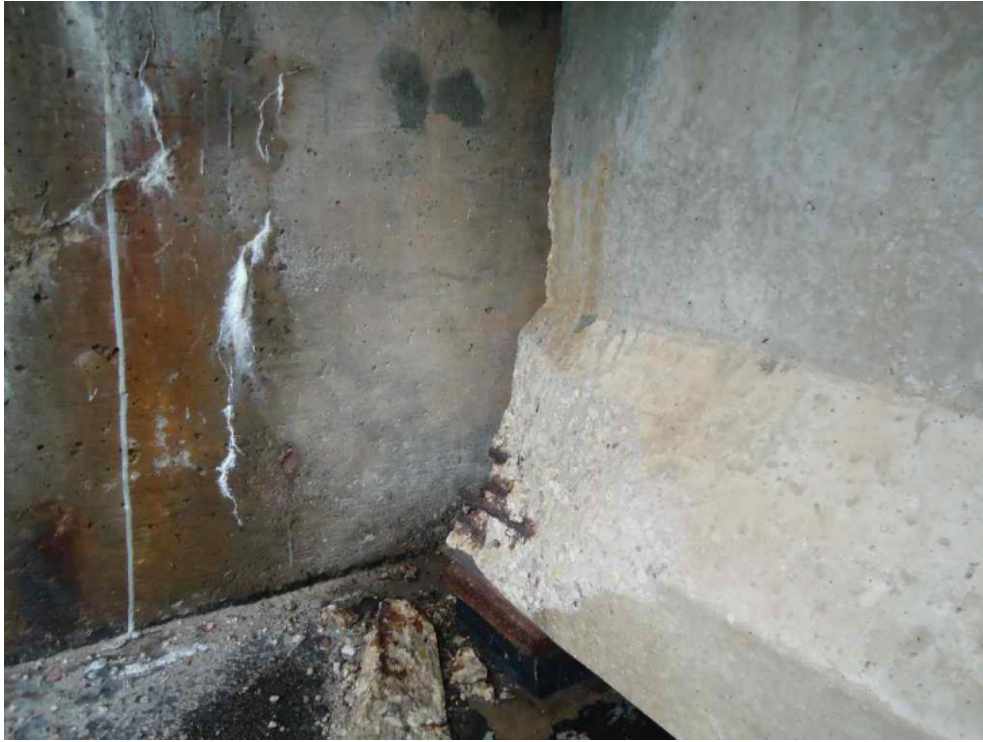
Spalling in Girder 5 at South abutment

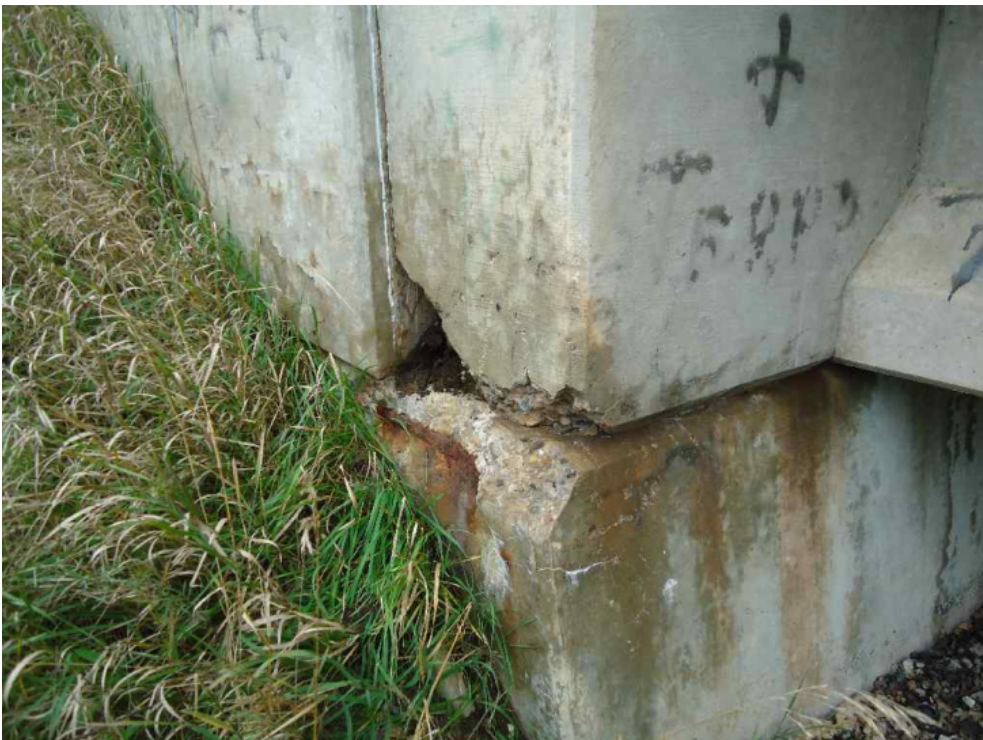
Spalling at West corner of North abutment

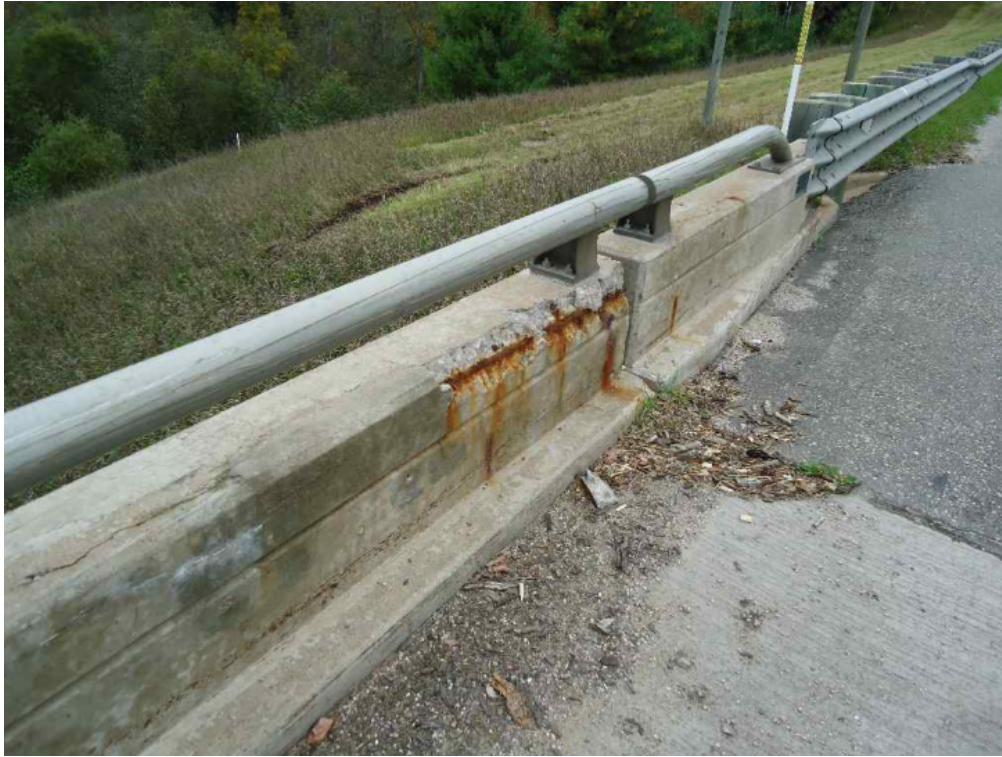
Spalling at West parapet at North end of bridge

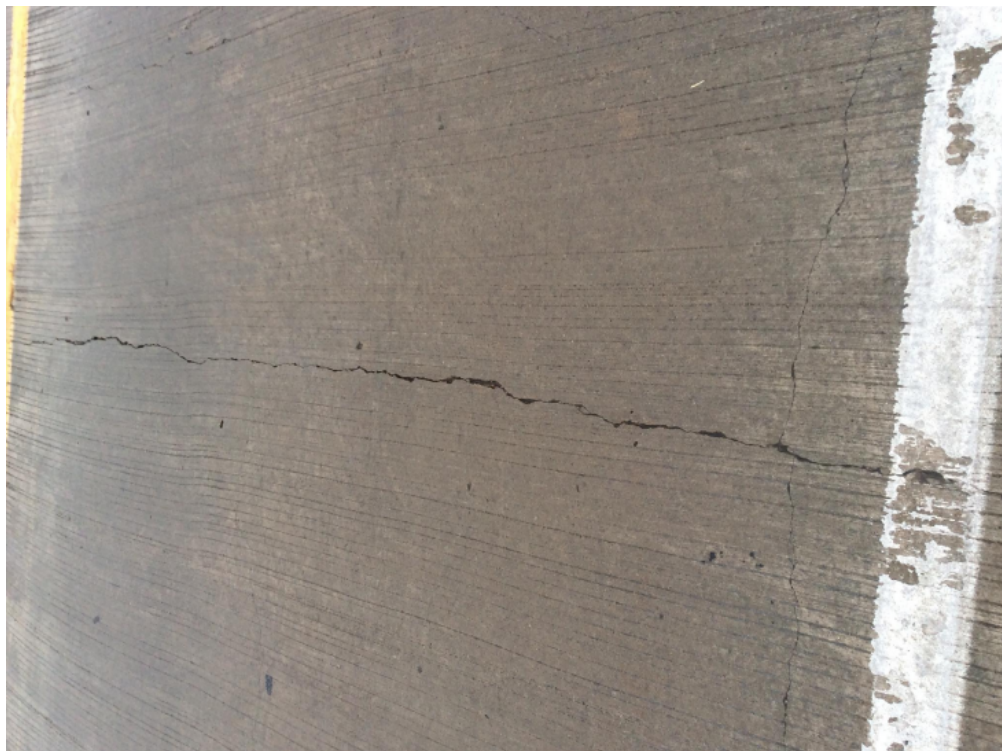
Deck cracking over piers
