ATTACHMENT 1
INSPECTION REPORT

Inspection Report for B-40-280

W GRANTOSA DR WB over STH 145-W FOND DU LAC AV
Jul 21,2018

B-40-280
W GRANTOSA DR WB over STH 145-W FOND DU LAC AV
North Elevation
7/21/2018

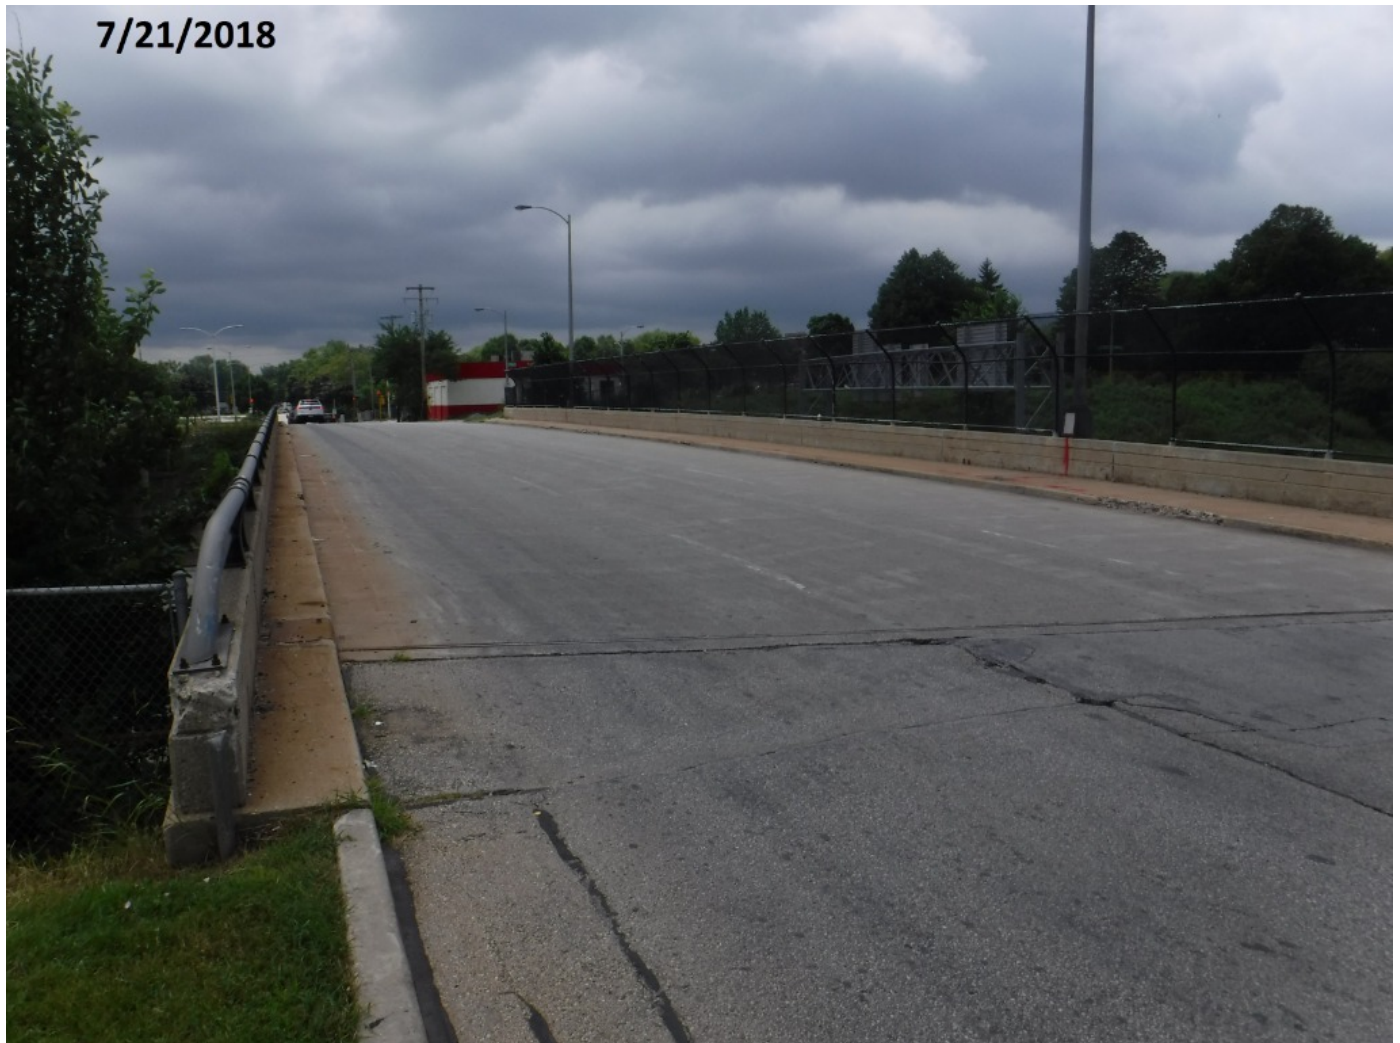
Top of deck looking west.

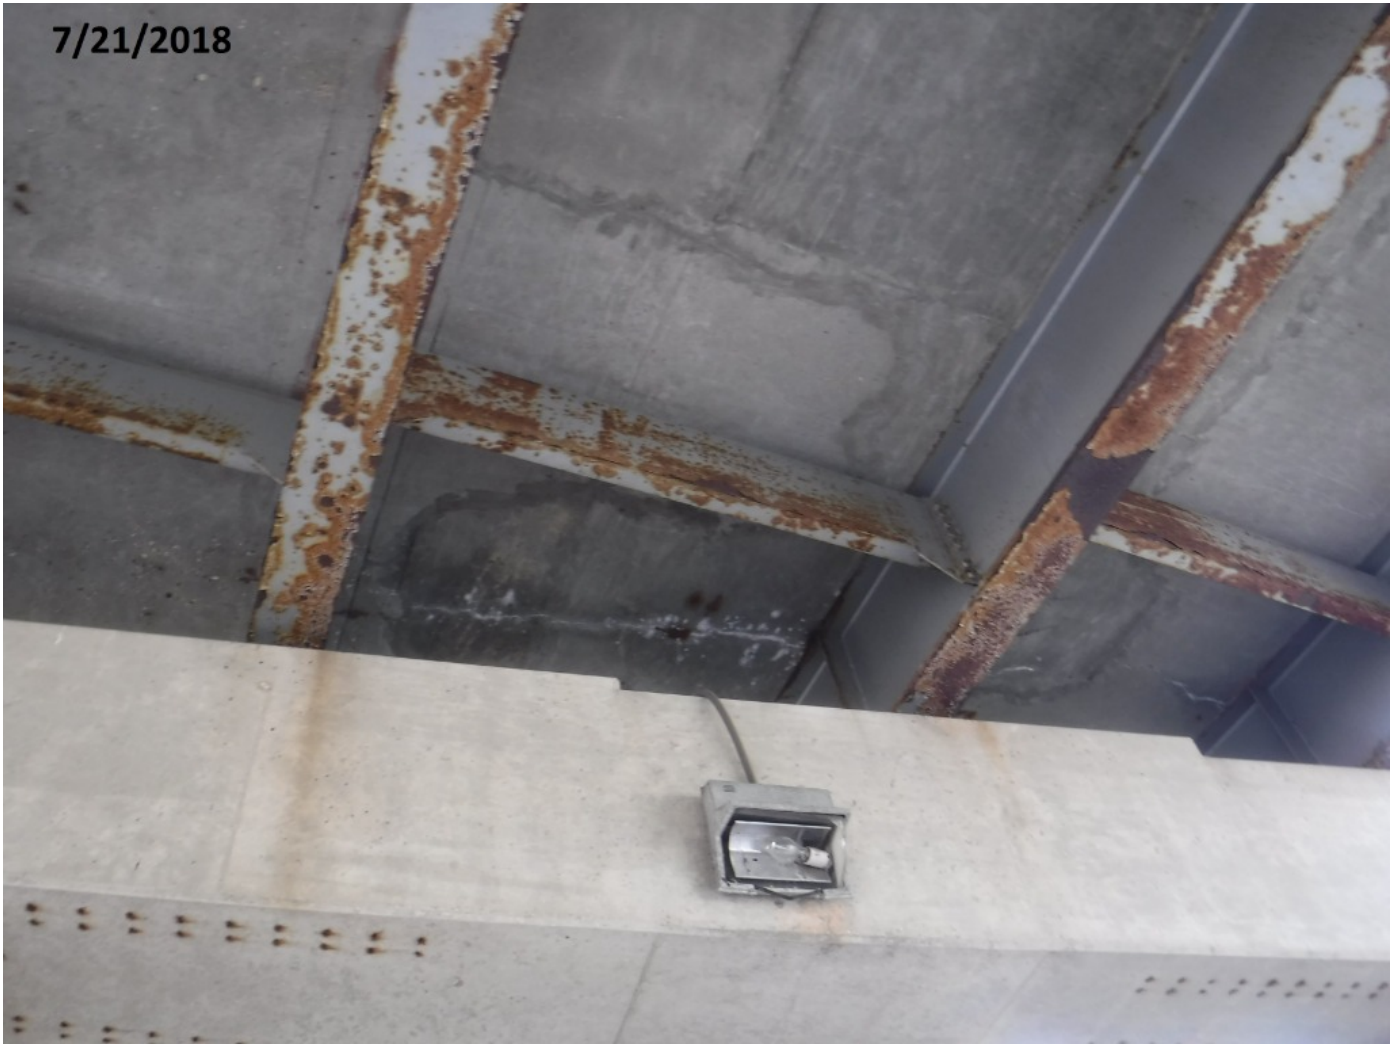
RC Deck - Sound and unsound full depth patches.

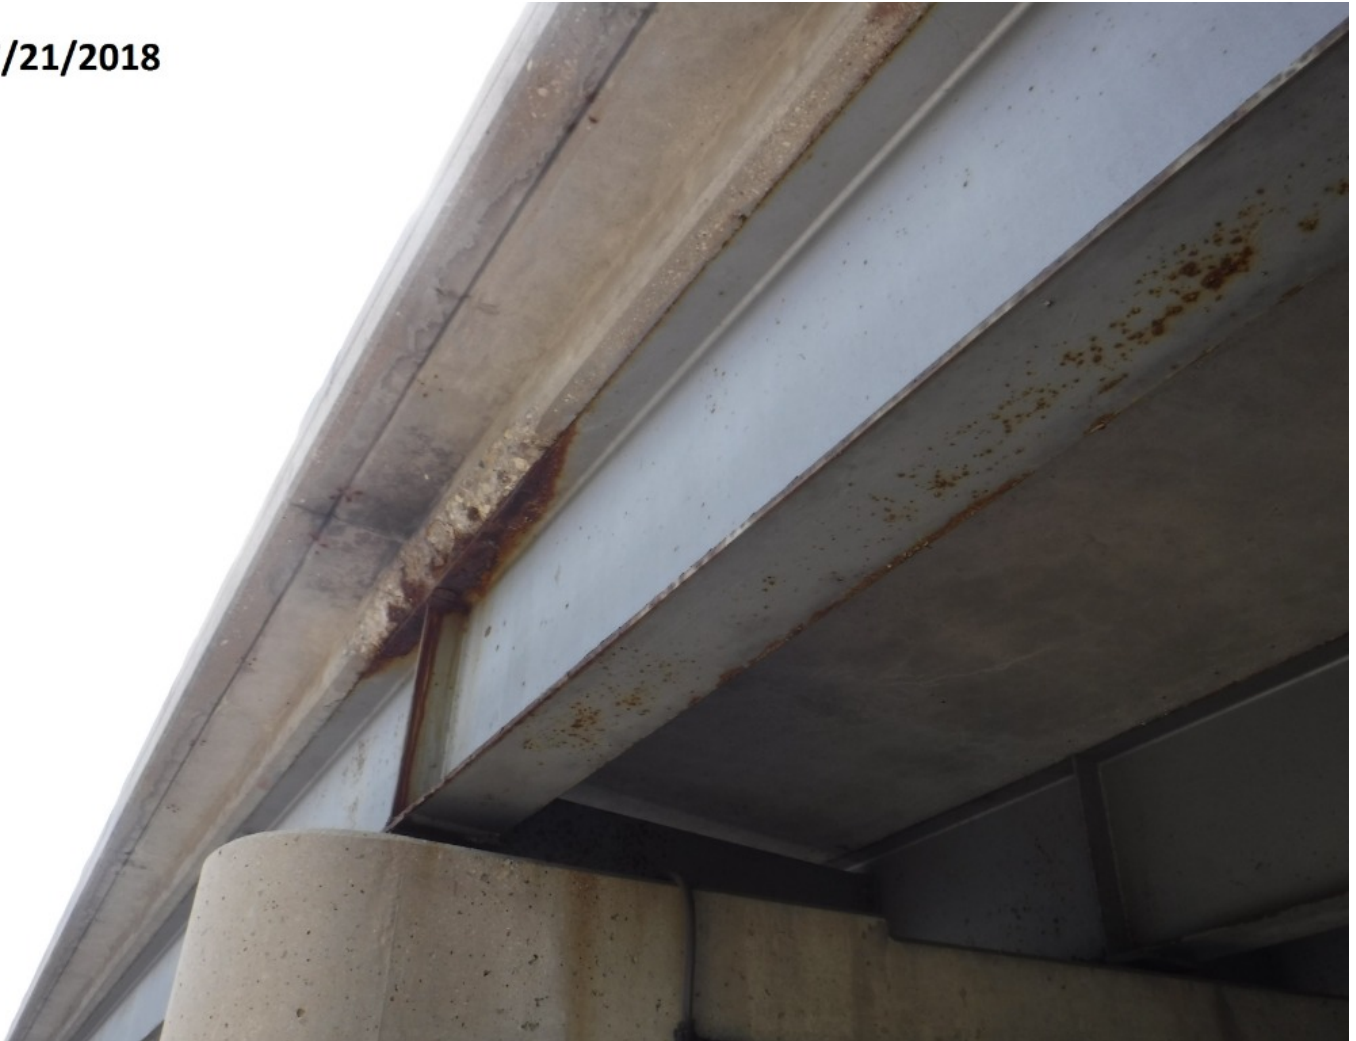
RC Deck - Spalls Span 3 at South overhang over pier.
Steel Open Gir - Top flange corrosion.

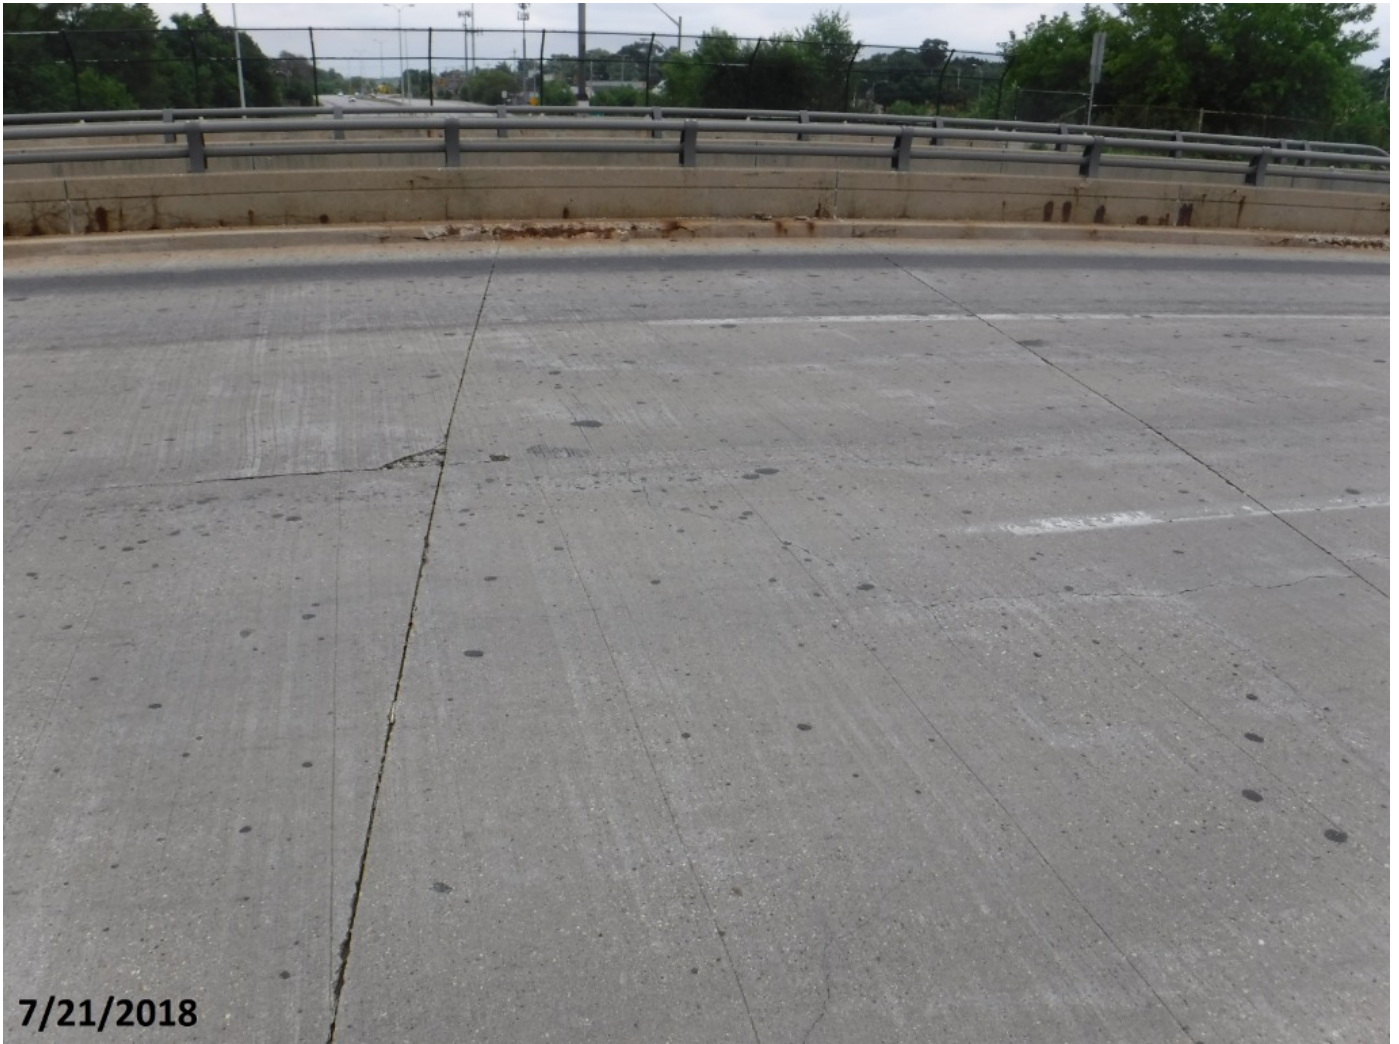
Conc OL - Asphalt patch near Pier 1 and cracking.

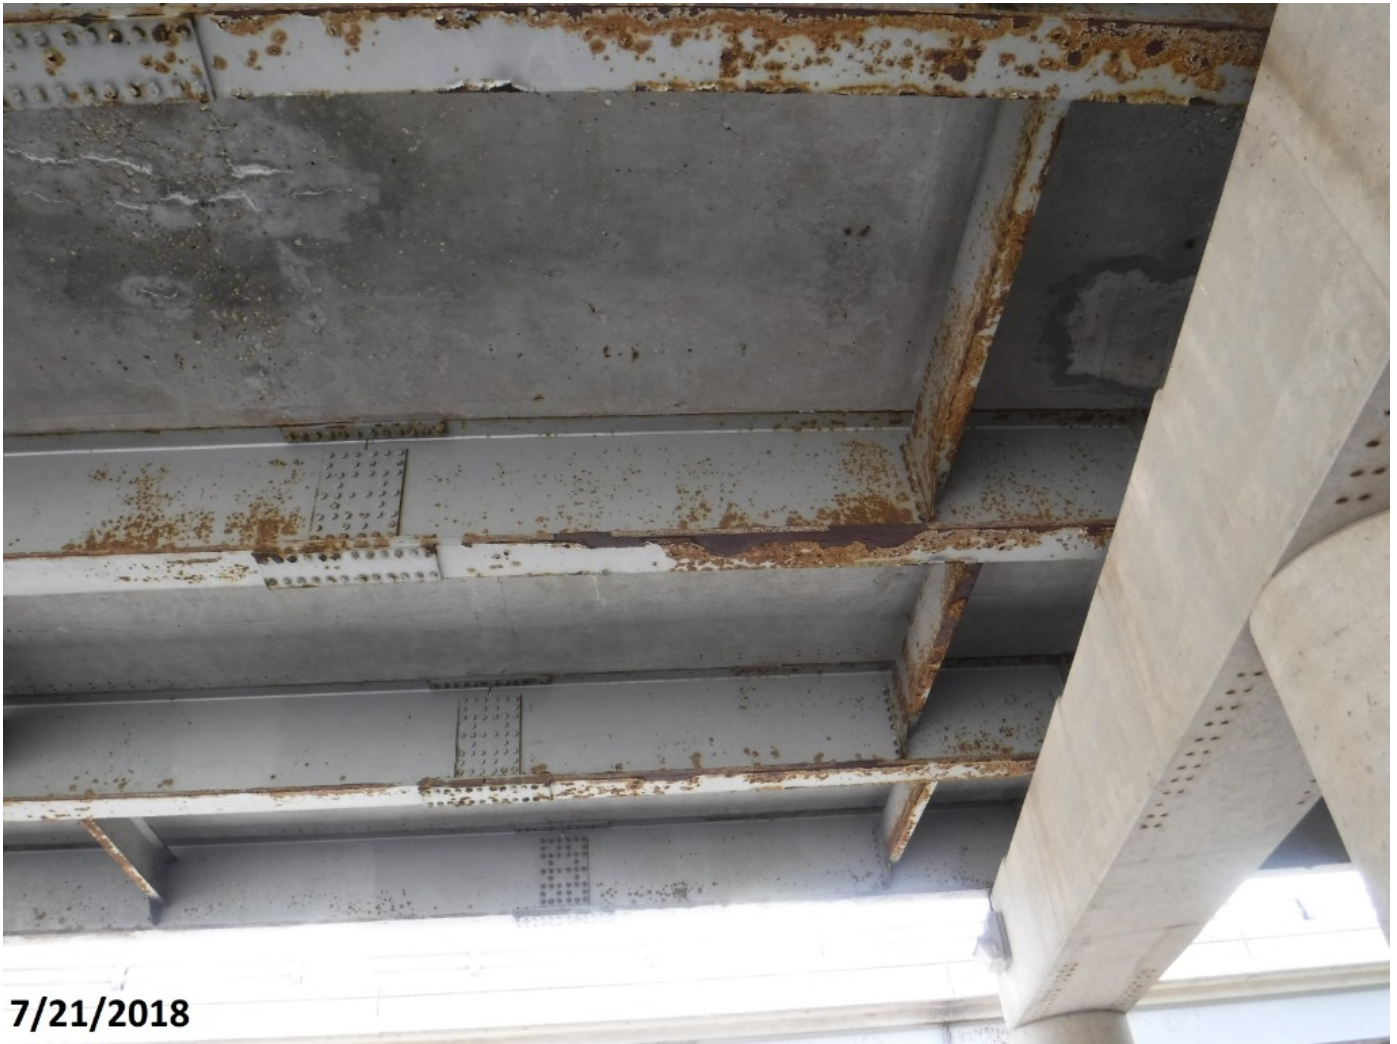
Steel Open Gir - Corrosion with section loss initiated at Span 2 Girder 4.

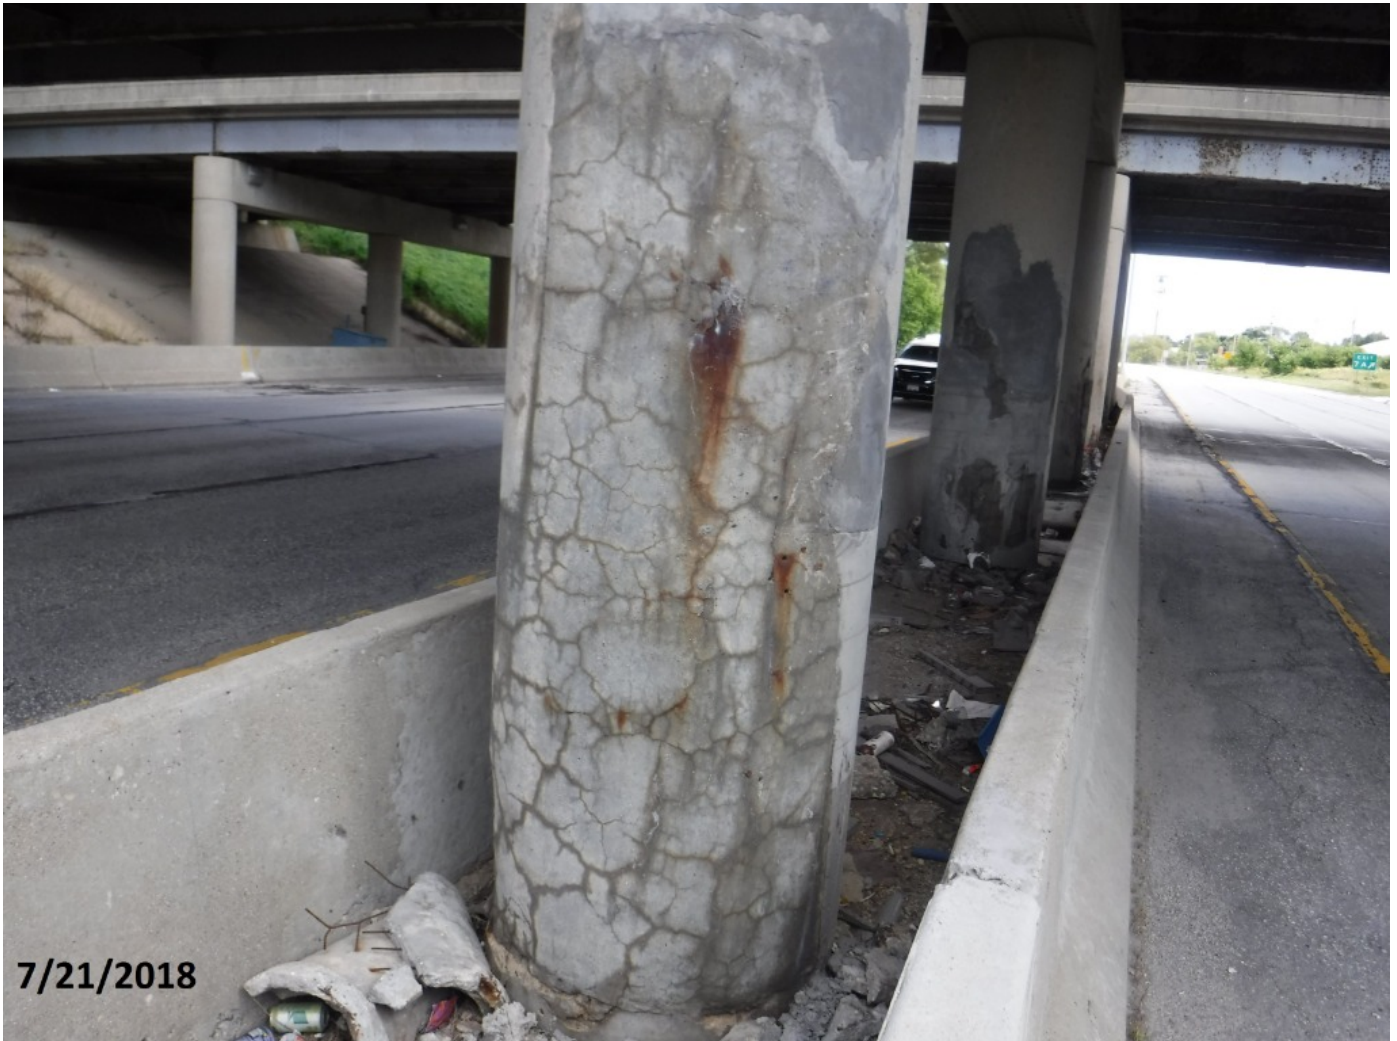
RC Col - P2: Unsound patch @ all 3 Cols. Photo shows Col 1 patch cracking and spall developing.

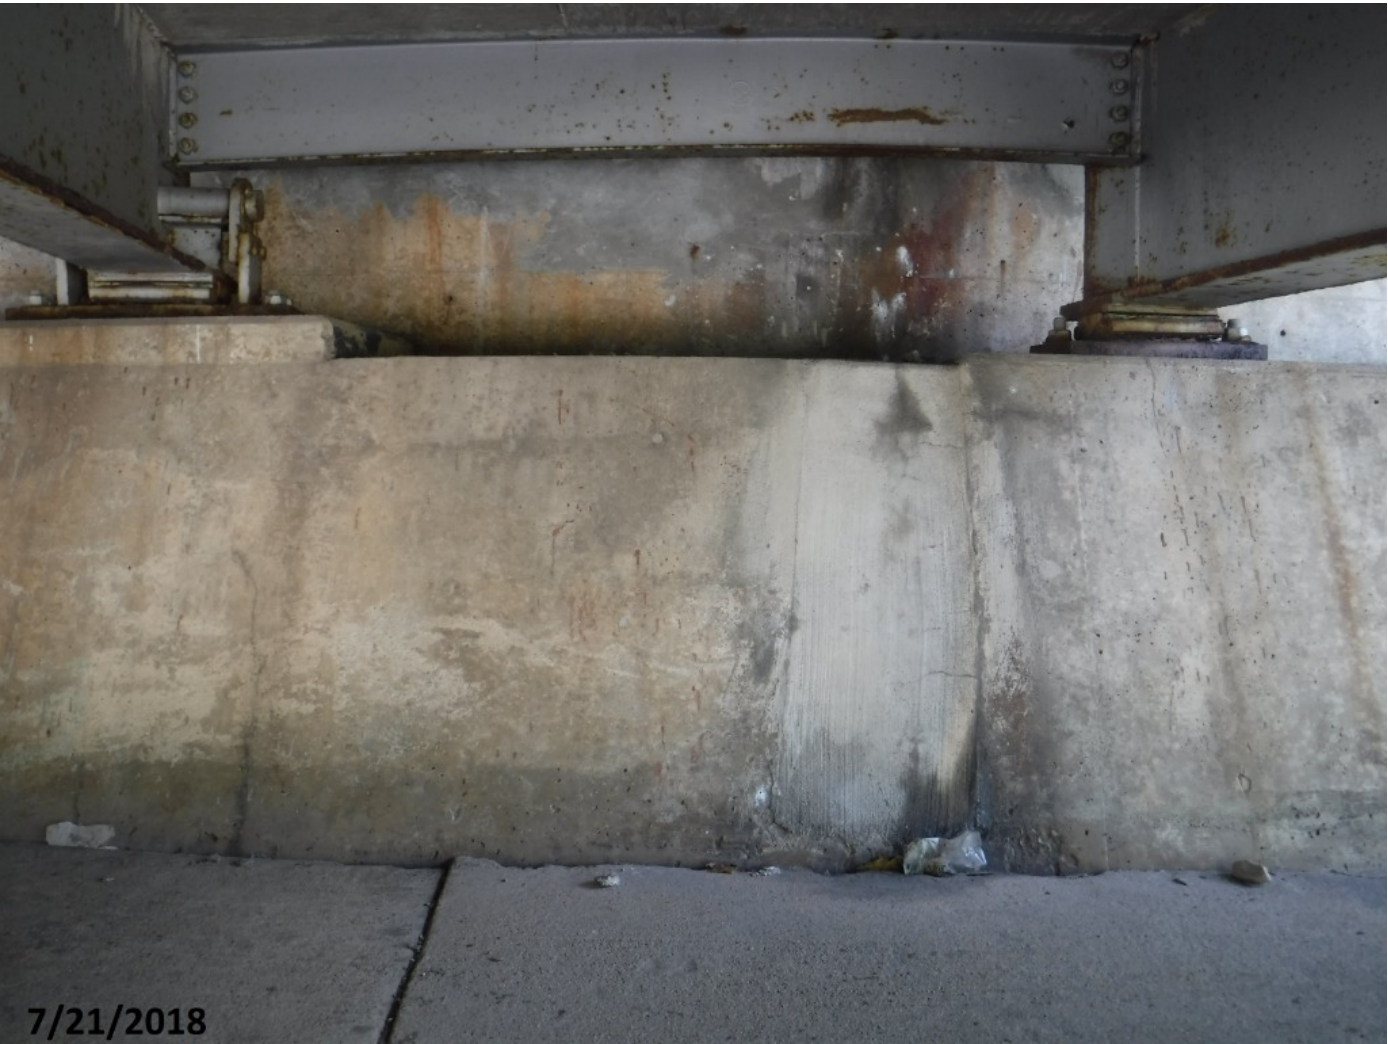
RC Abut - W Abut - Typical sound patches and vertical cracks. Photo shows Bay 1.

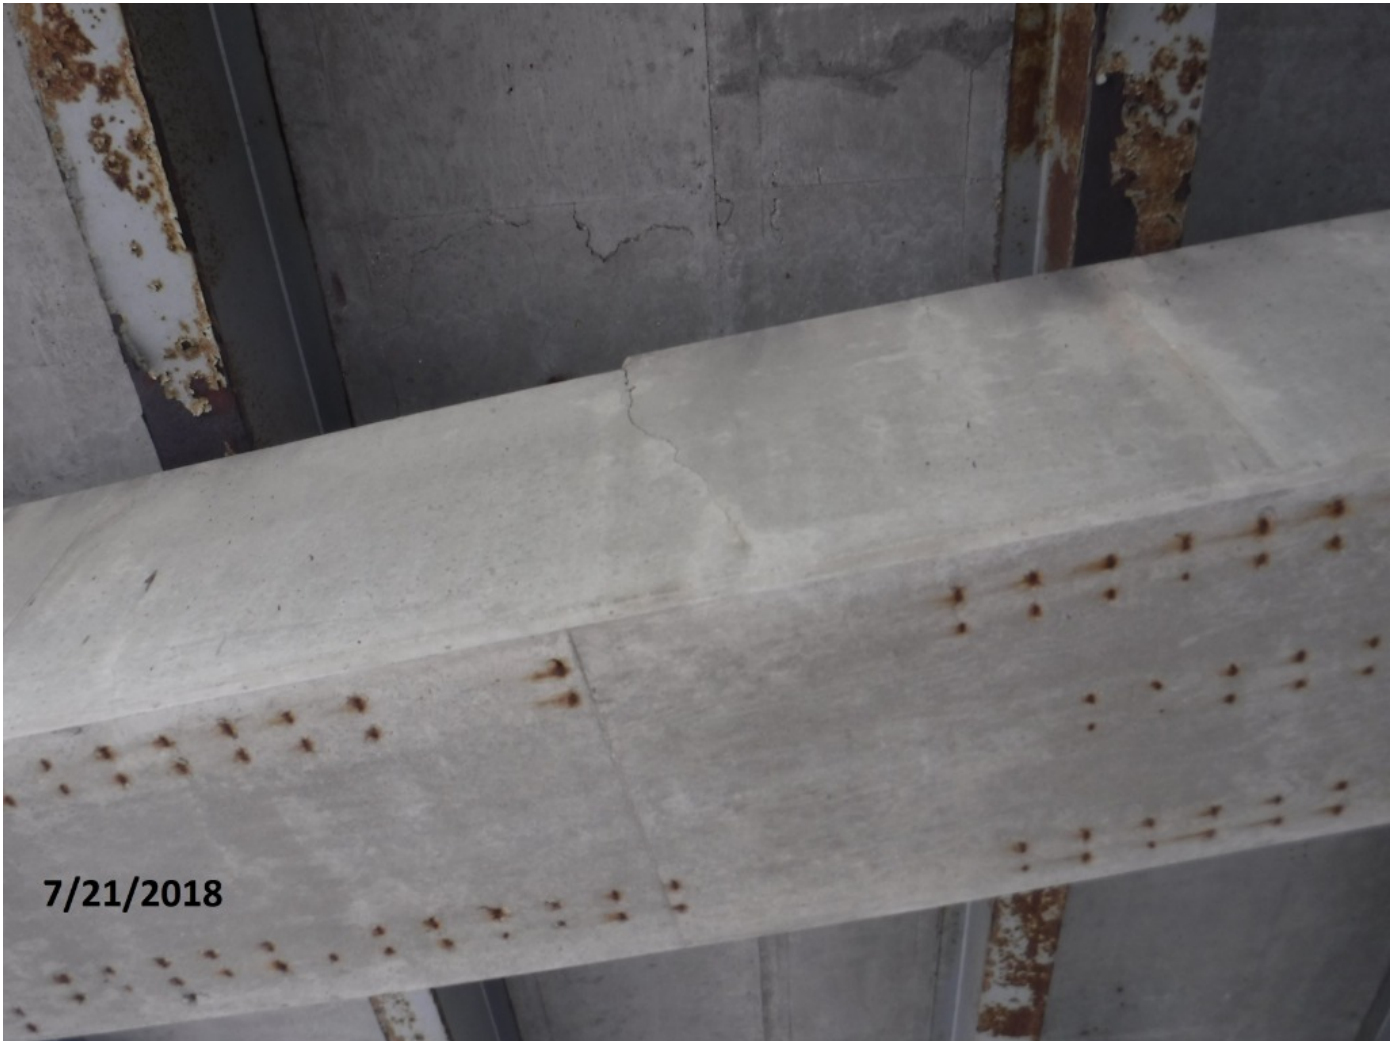
RC Cap - P2: Med diag. crk between Col 1-2 extends through cap to both faces - 2' CS3.

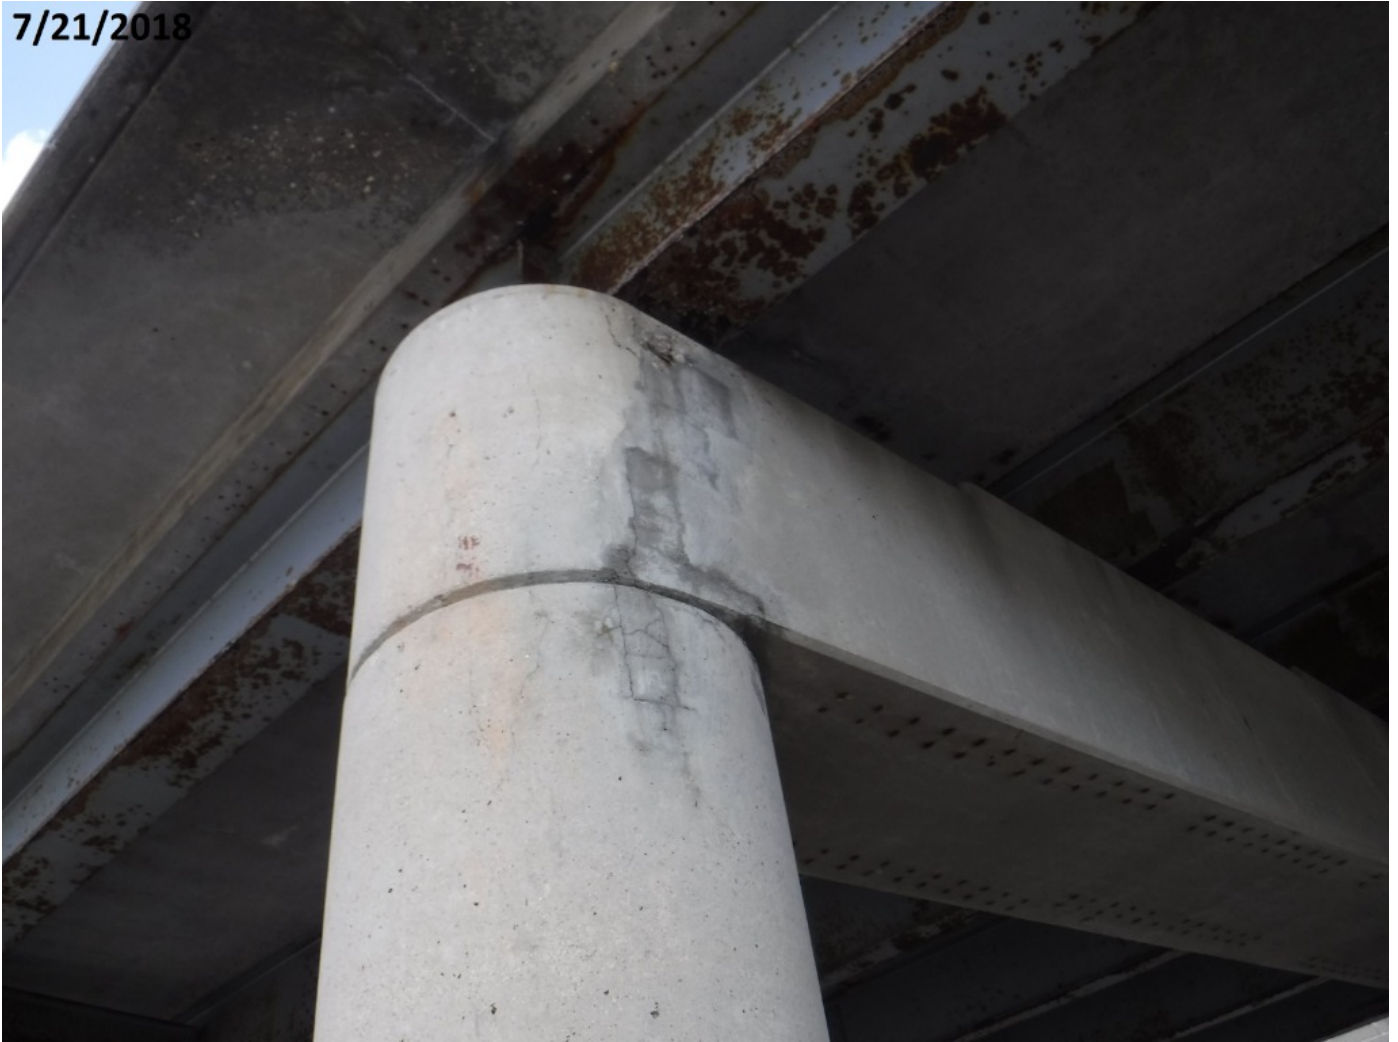
RC Cap - Spall and failed patch at N End Pier 2.

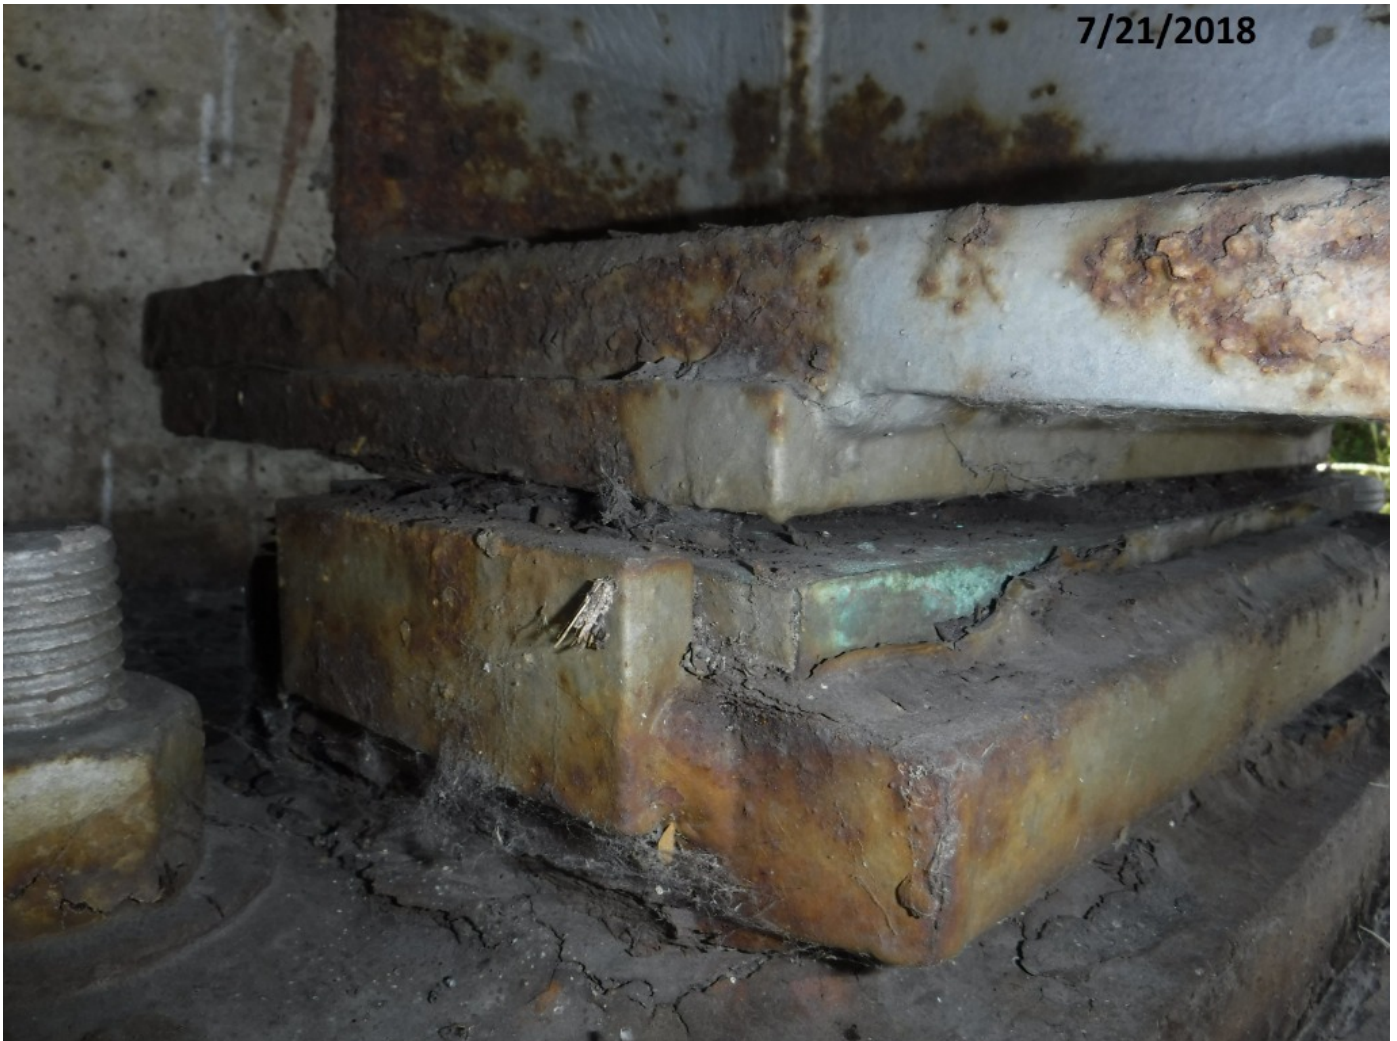
Moveable Bearings - West abut, G1. Corrosion on bearing and bronze plate is not in contact with girder sole plate.

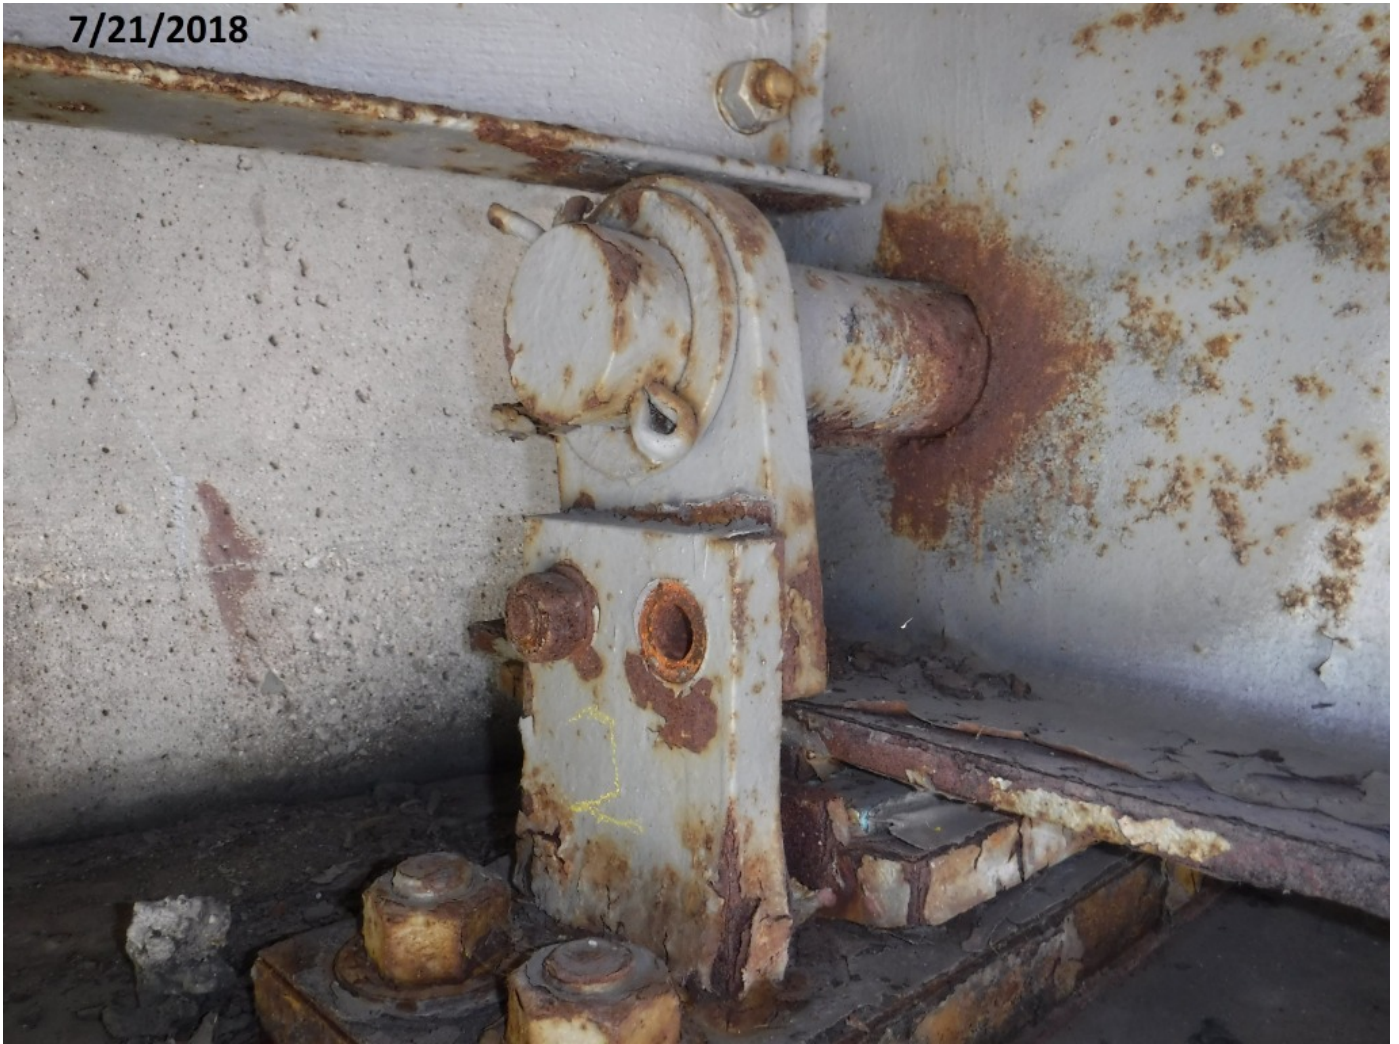
Moveable bearings - West Abut G2 broken bolt at hold down assembly.

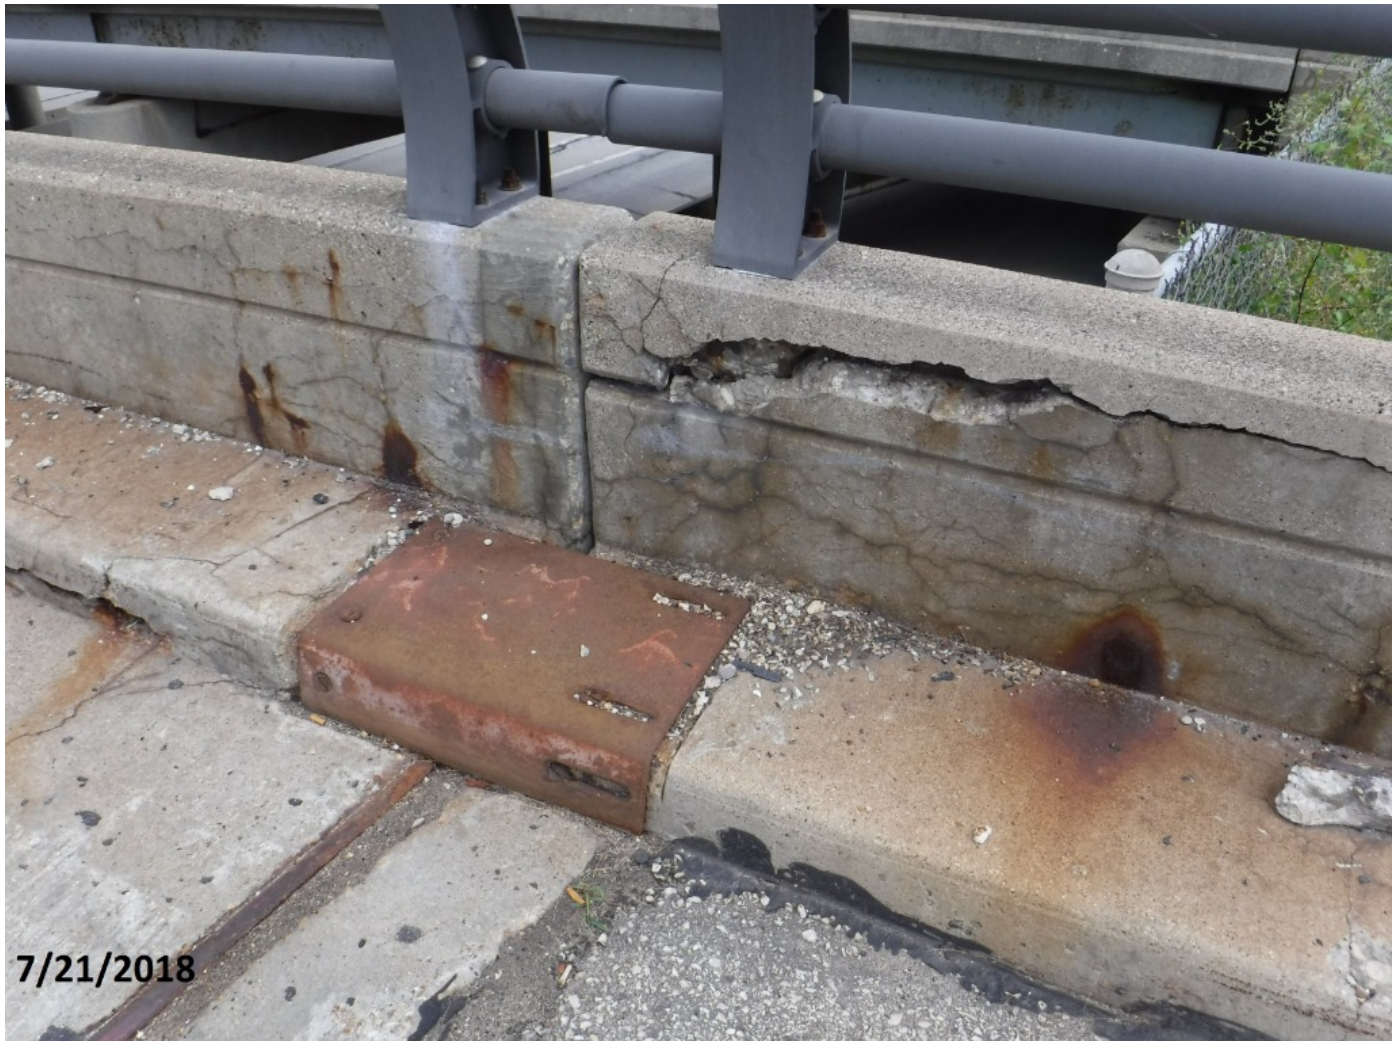
RC Bridge Rail - West end of South Rail, spalling in rail, cracking with rust stains, and spalls in curb section.

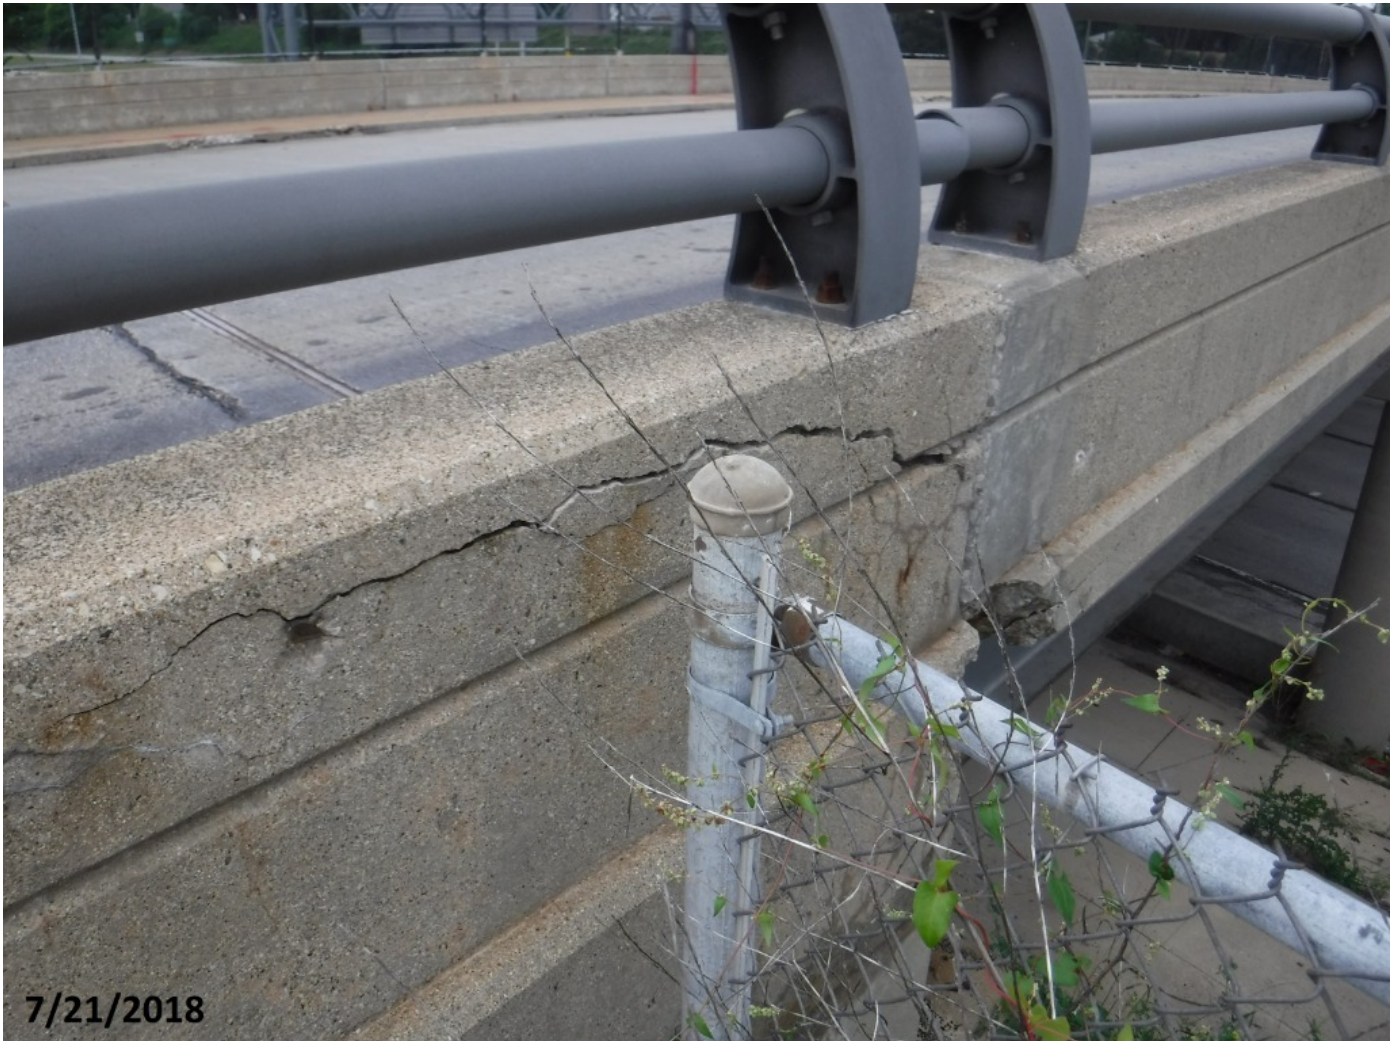
RC Bridge Rail - West end of South Rail - Wide crack at joint where joint is tight.

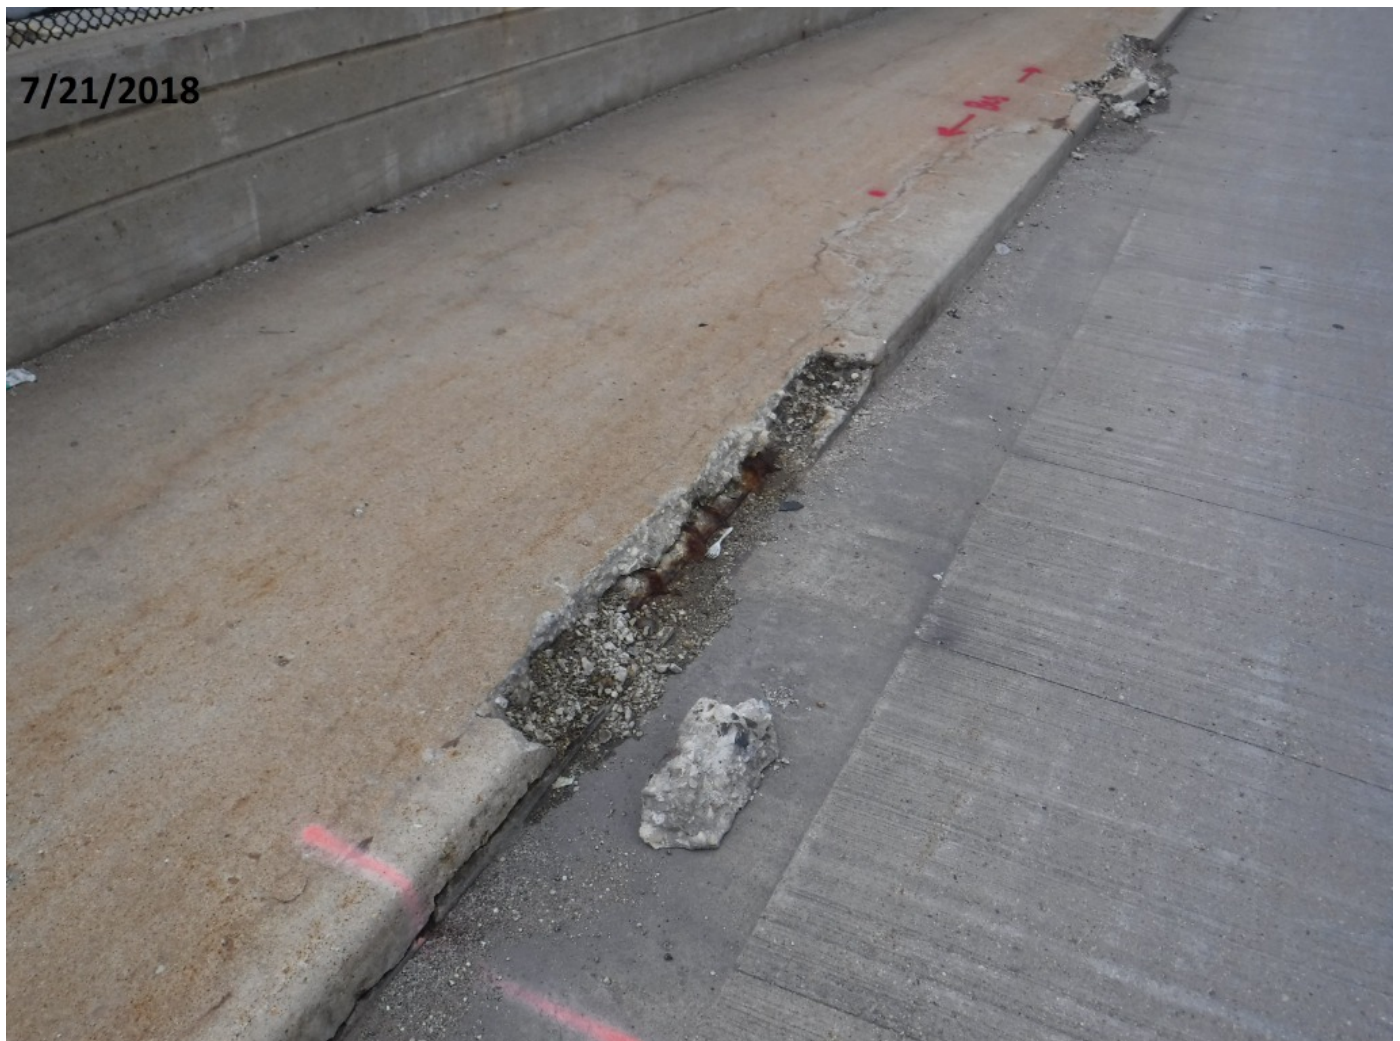
Sidewalk - Transv and long HL crks throughout; Large spalls at curb, some have fallen into shoulder. Many delams and exist. patches at curb.

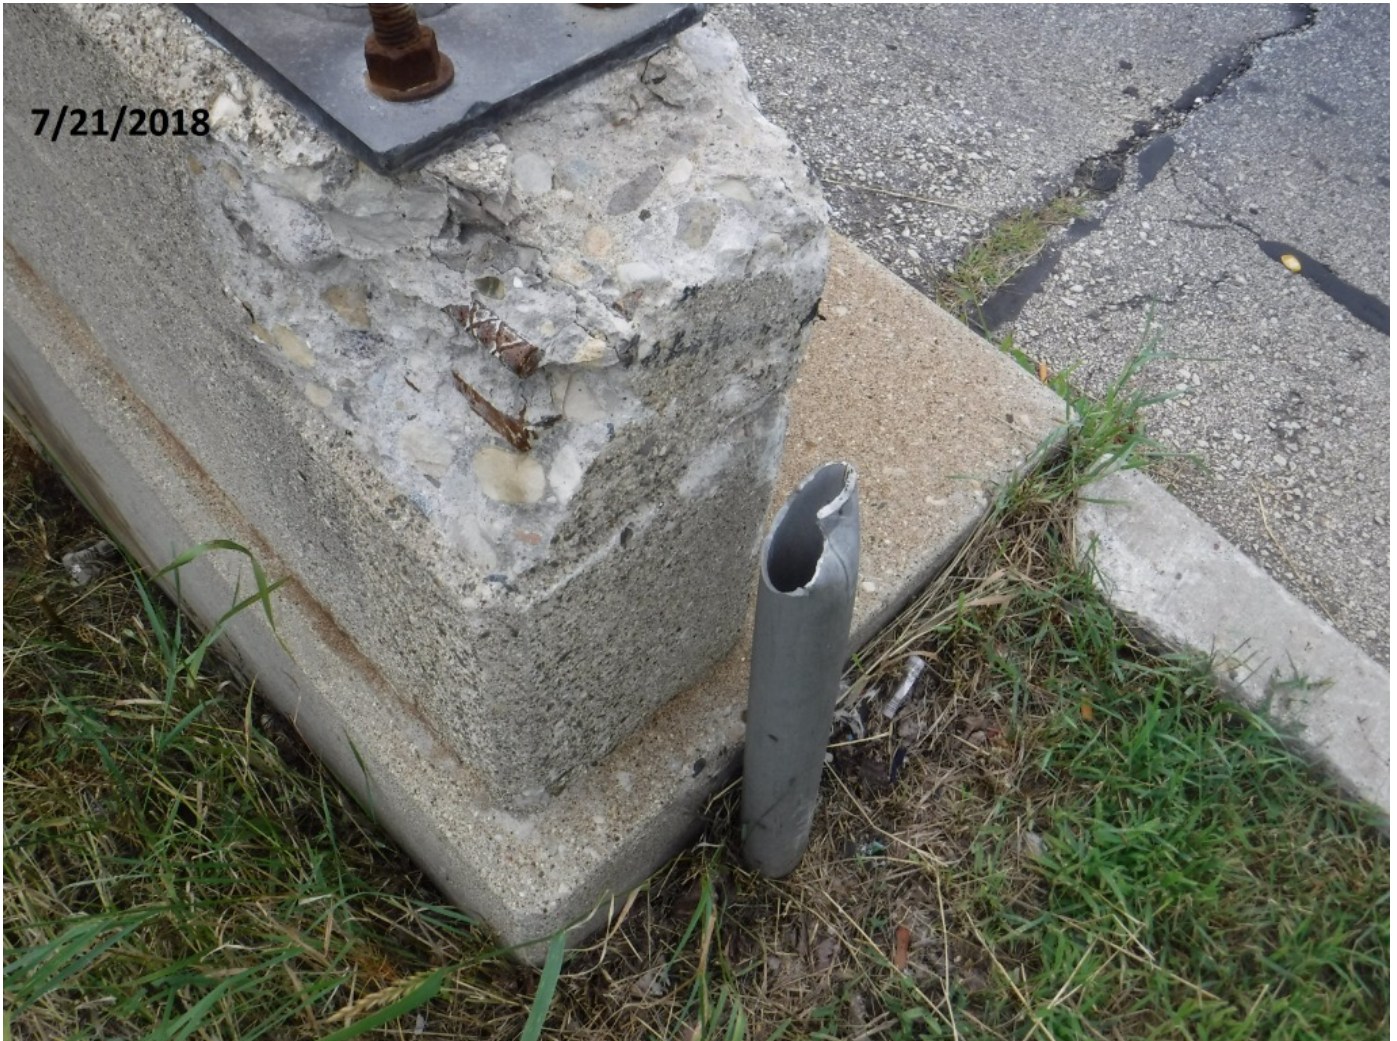
Obj Marker sign: Sheared off with impact at SE corner.
