ATTACHMENT 1
INSPECTION REPORT

Inspection Report for B-40-280

W GRANTOSA DR WB over STH 145-W FOND DU LAC AV
Jul 21,2018

B-40-280
W GRANTOSA DR WB over STH 145-W FOND DU LAC AV
North Elevation
7/21/2018

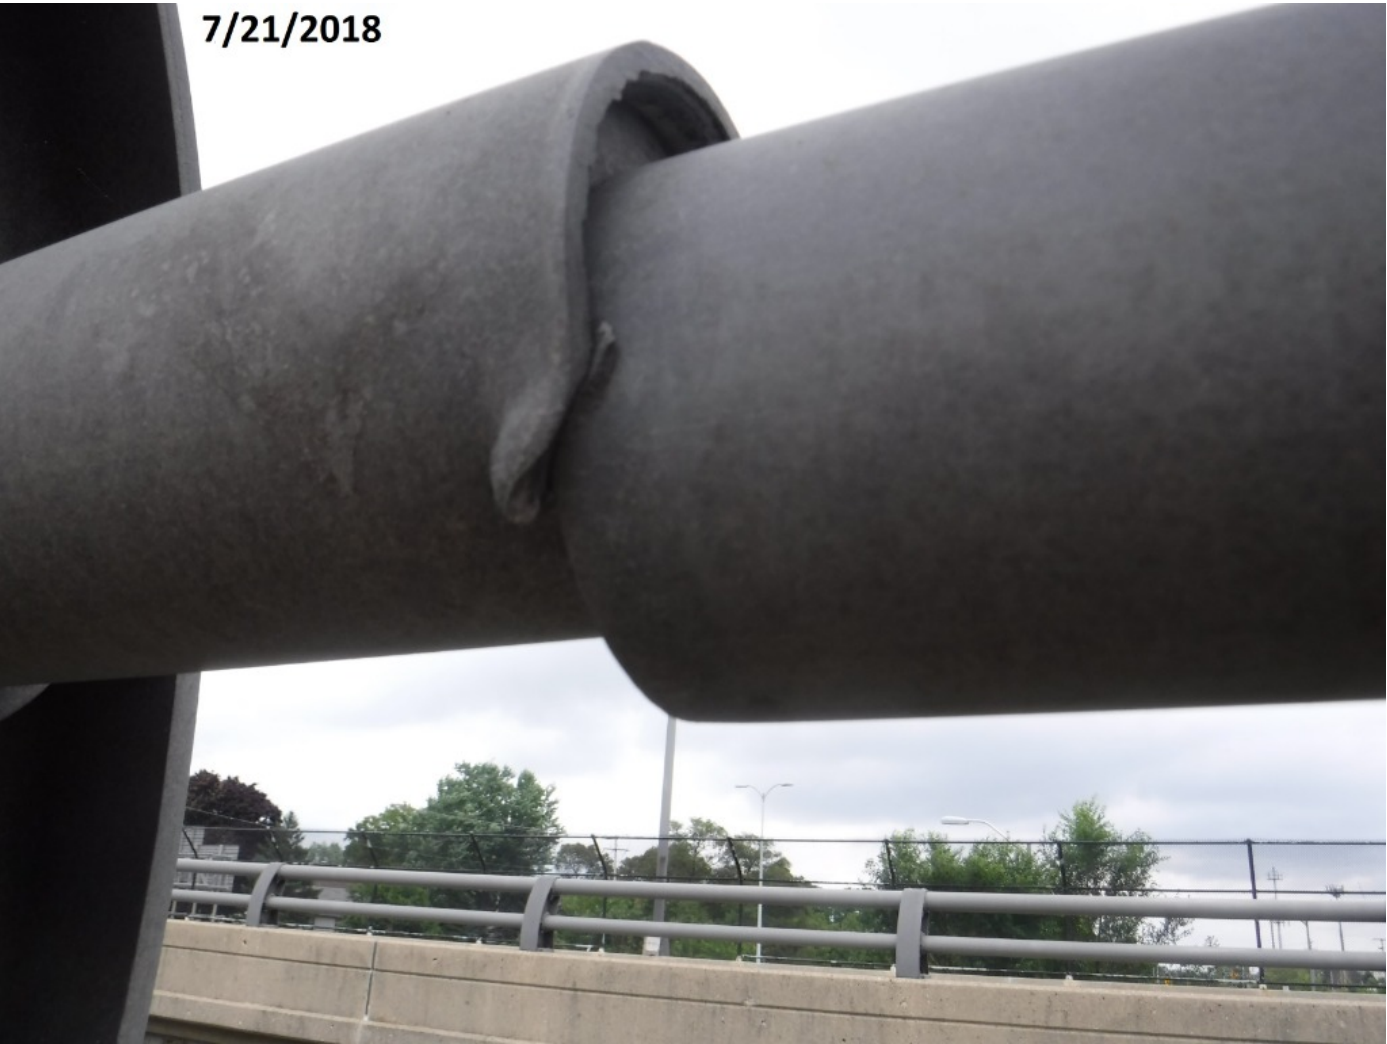
X	9335		Decorative Rail Lt rust on anchor bolts. Scrapes/gouges from traffic impact at E end. At SW Corner, rail tubes are wearing into each other where exp jt has closed.	EA	1	0	1	0	0
X	9336		Luminaire Bases	EA	2	2	0	0	0
X	9337		Protective Screening Peeling paint on galvanized posts and rails, Bottom Rail broken at end post connection at WE wingwall.	EA	1	0	1	0	0

Dec rail: At SE Corner, rail tubes are wearing into each other where exp jt has closed.

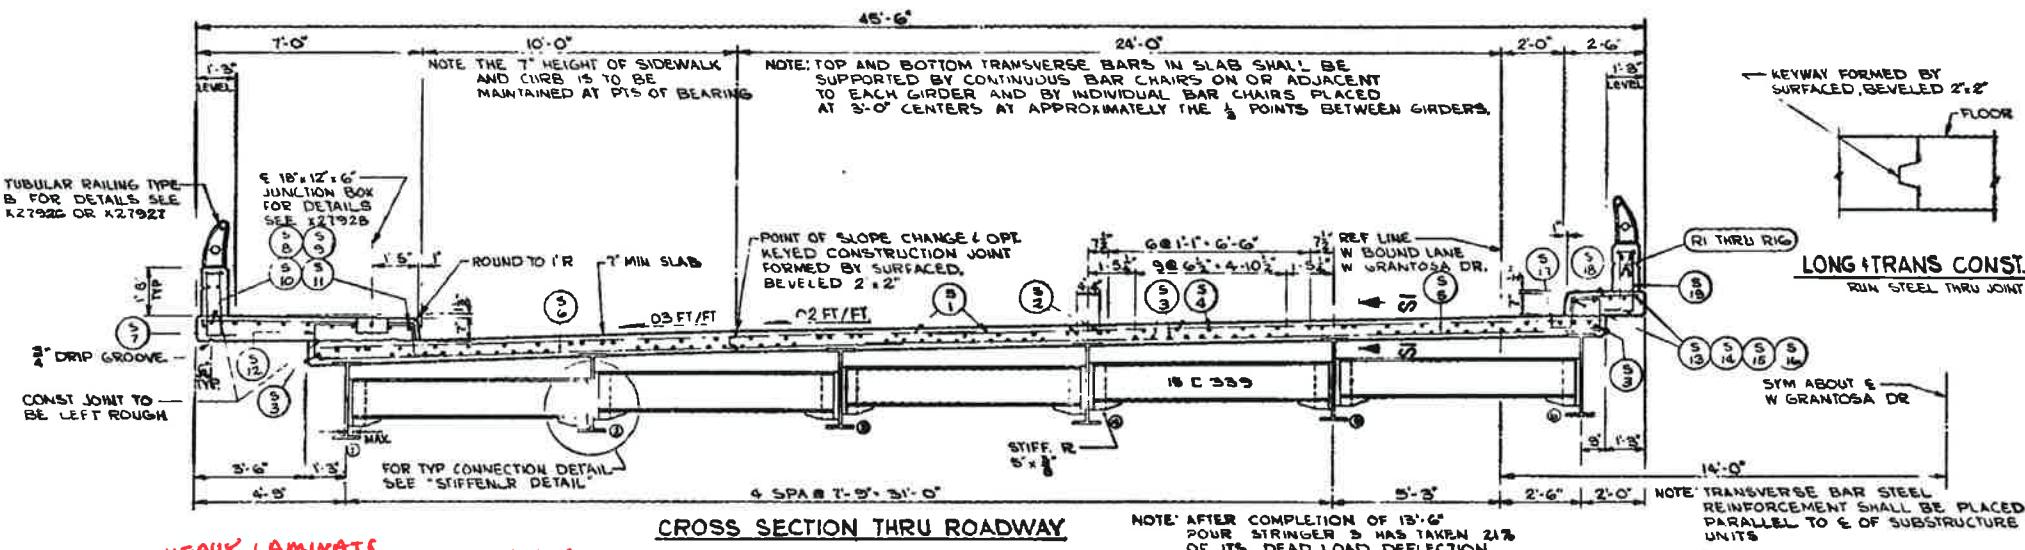
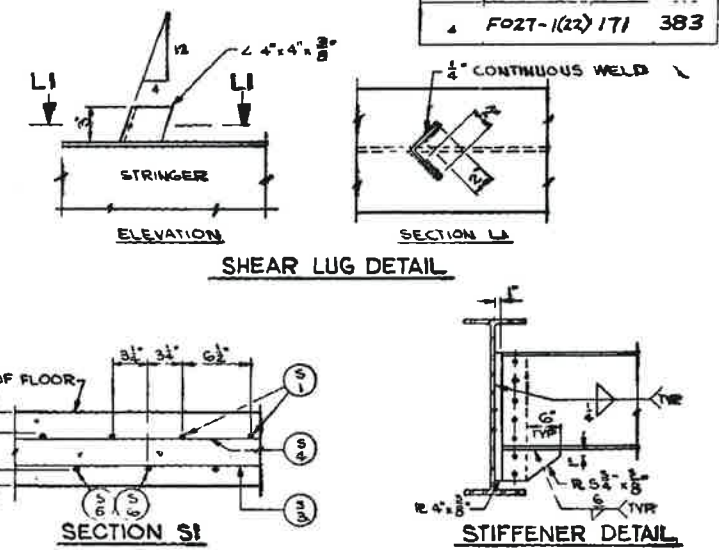
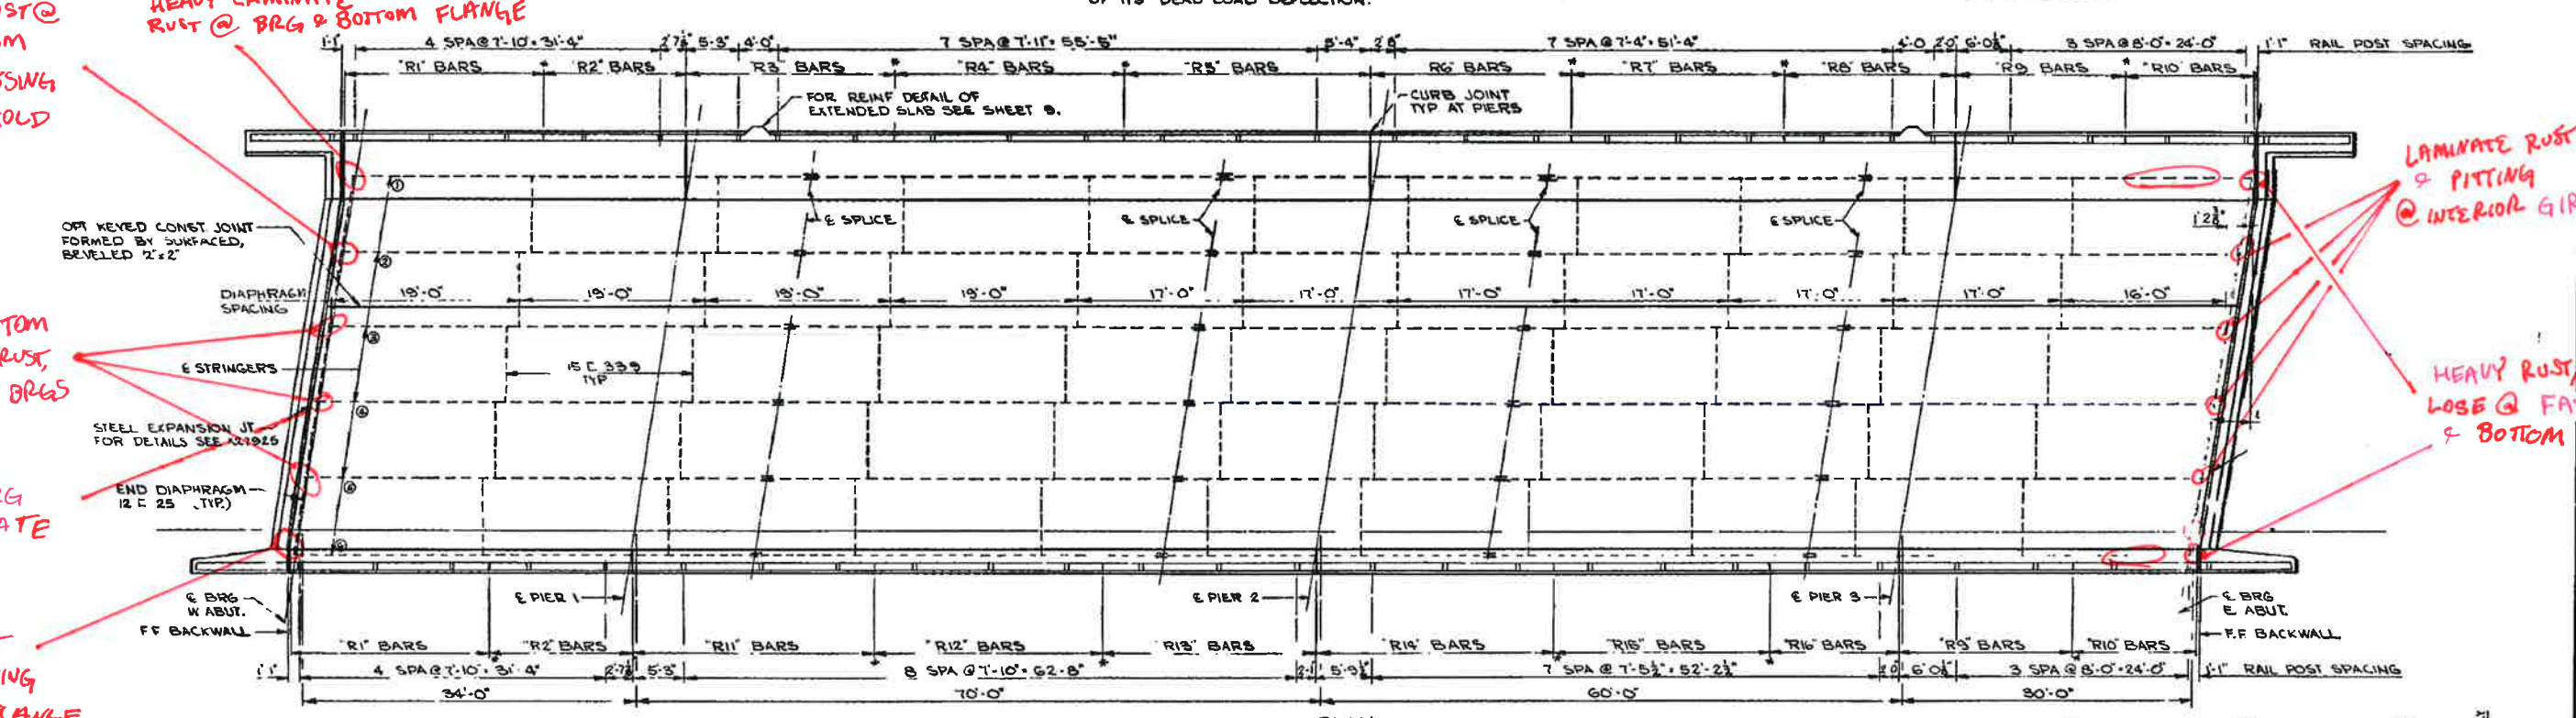
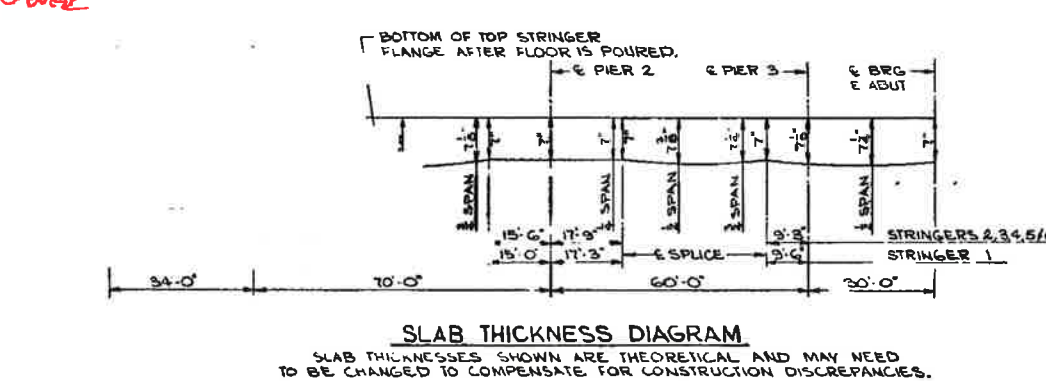
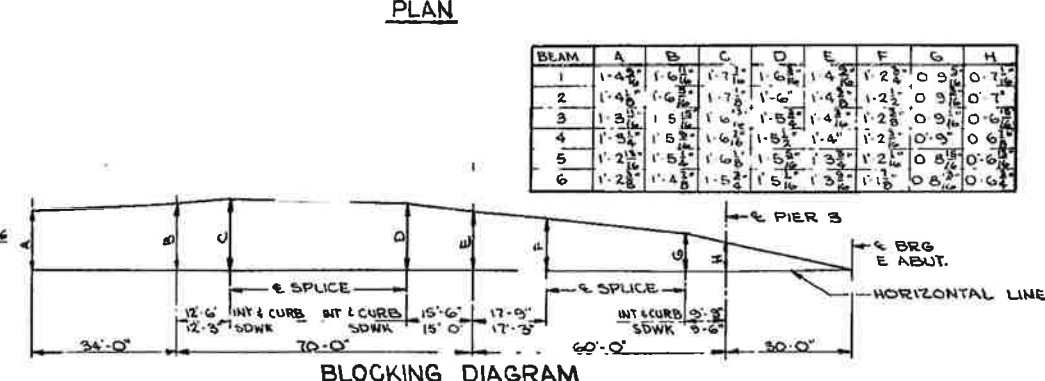
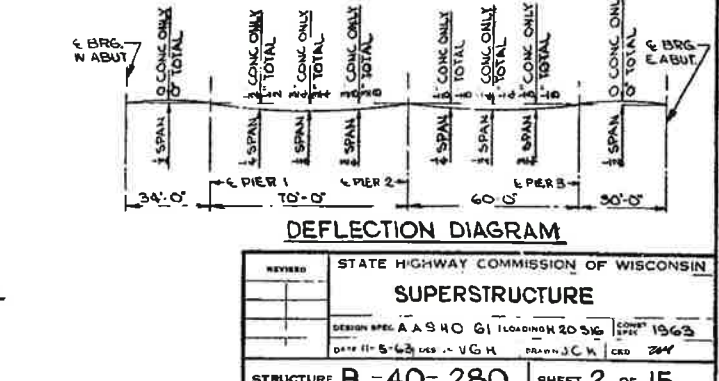
HEAVY RUST @ BRG & BOTTOM FLANGE, MISSING BOLTS @ HOLD DOWN.

HEAVY LAMINATE RUST @ BRG & BOTTOM FLANGE

LAMINATE RUST & PITTING @ INTERIOR GIRDERS

HEAVY RUST/SCORING LOSE @ FASCIA BRG & BOTTOM FLANGE

HEAVY BOTTOM FLANGE RUST, PITTING @ BRGS

BENT BRG SOLE PLATE

HEAVY RUST @ BRG, PITTING @ BOTTOM FLANGE

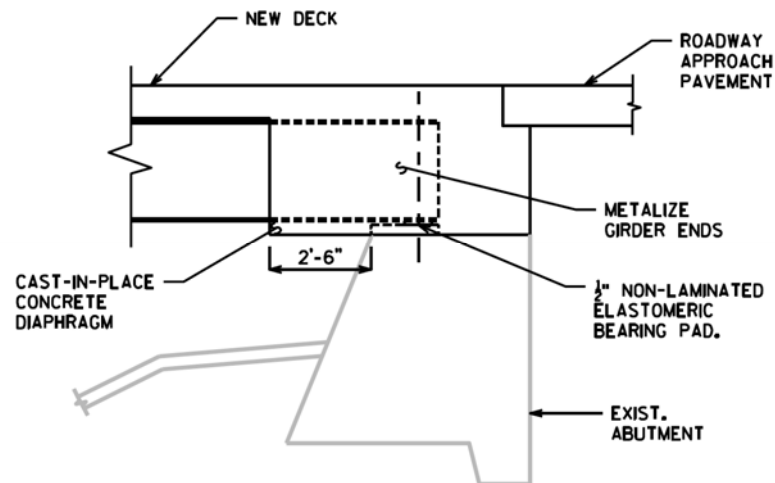
Figure 1: Conversion to Semi-expansion Abutment

A second feasibility check for this alternative was performed to address girder uplift. AASHTO Standard Specifications 3.17.1 was checked using results from an MDX line girder model. Preliminary calculations indicate that the end diaphragm will need to be extended 2.5-ft beyond the abutment front face to provide adequate dead load to resist uplift forces. See Figure 1.
