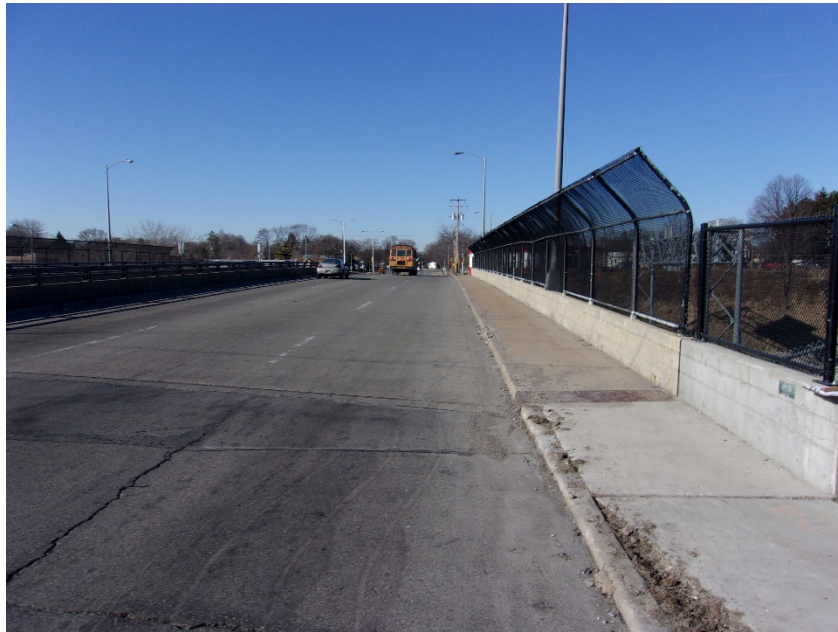
1) Top of deck looking west

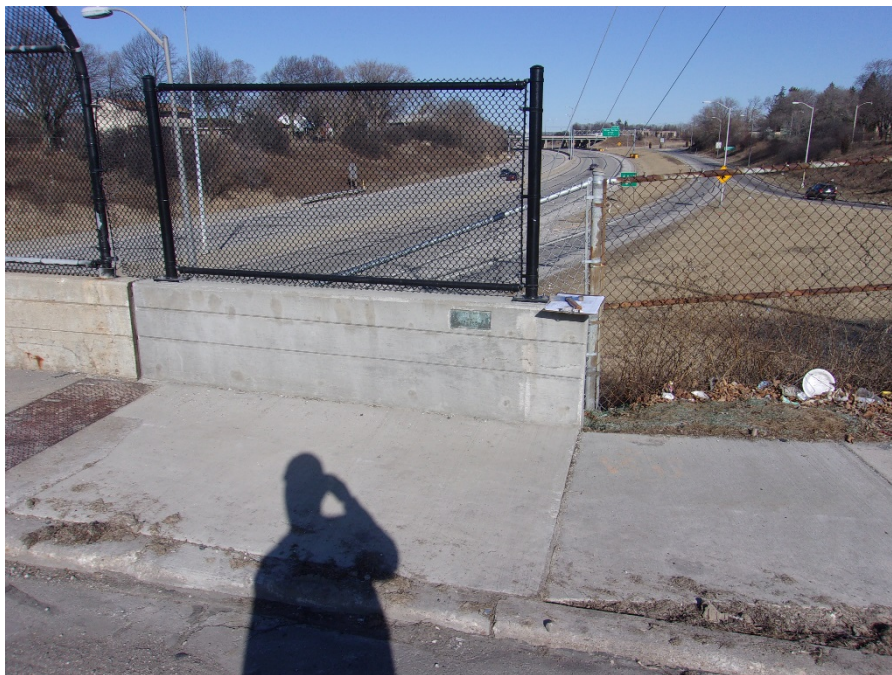
2) Inside face of northeast wingwall, replaced 09/2017, looking north

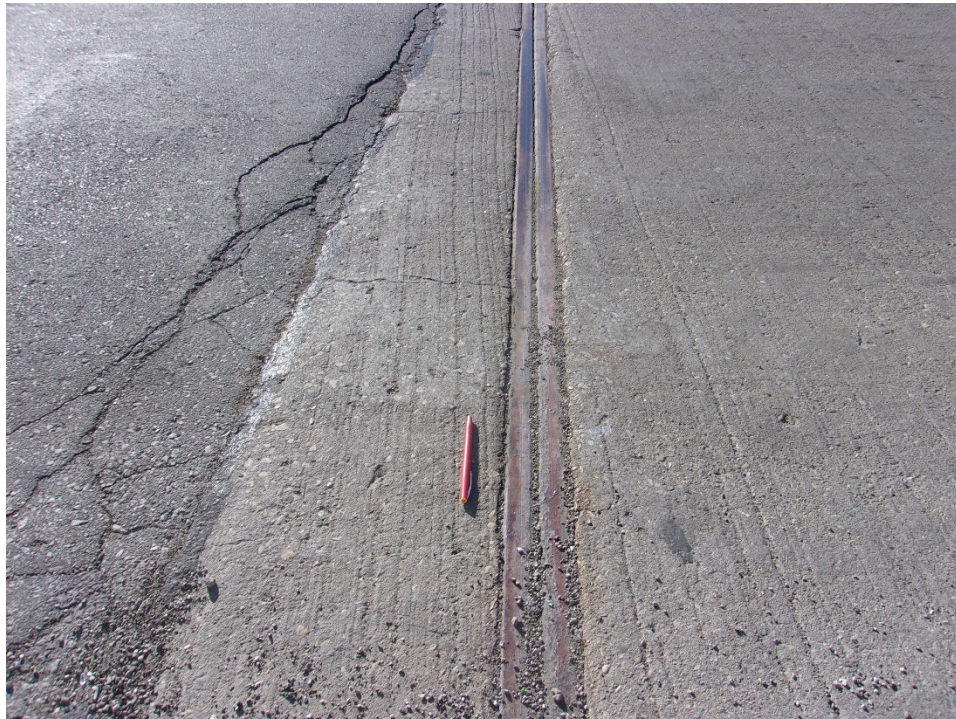
3) Expansion device at east abutment, joint is nearly closed

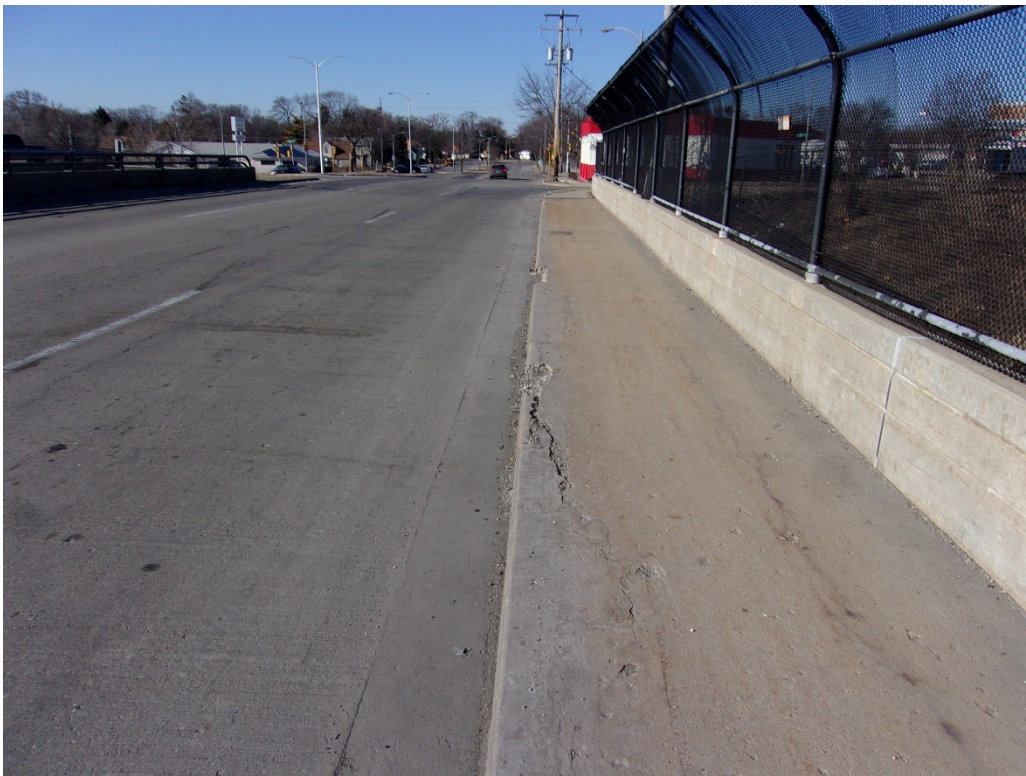
4) View of deck/curb condition looking west

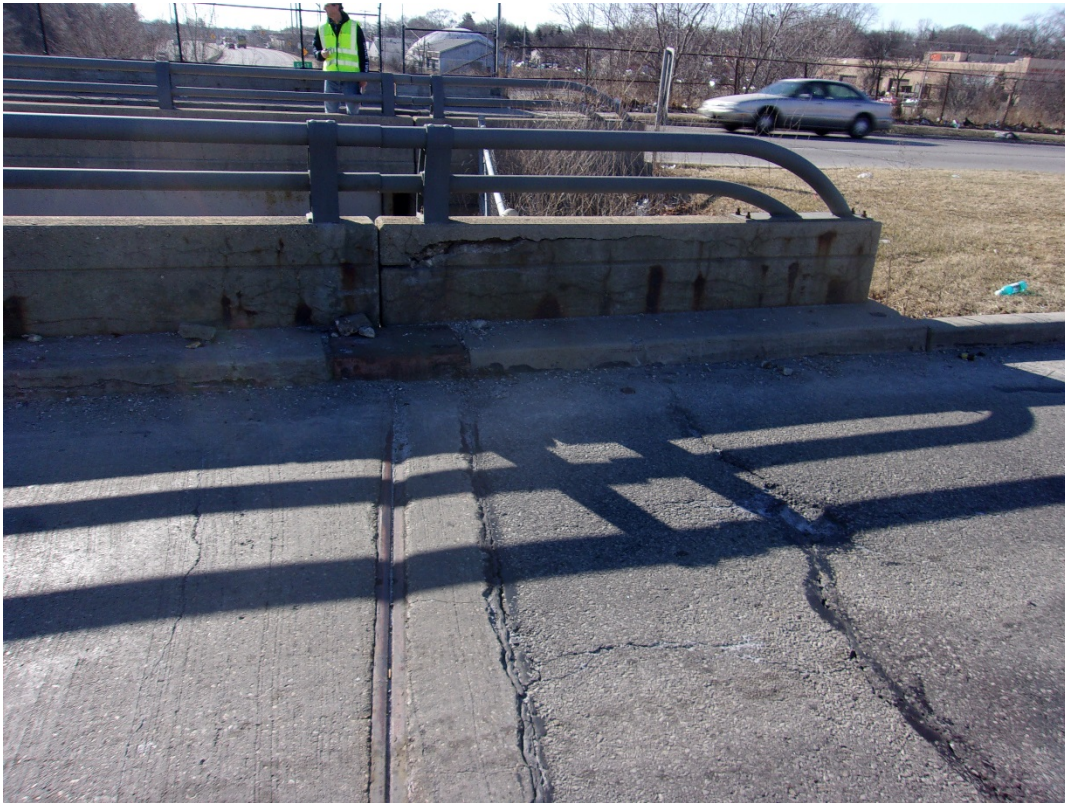
5) Inside face of southwest wingwall

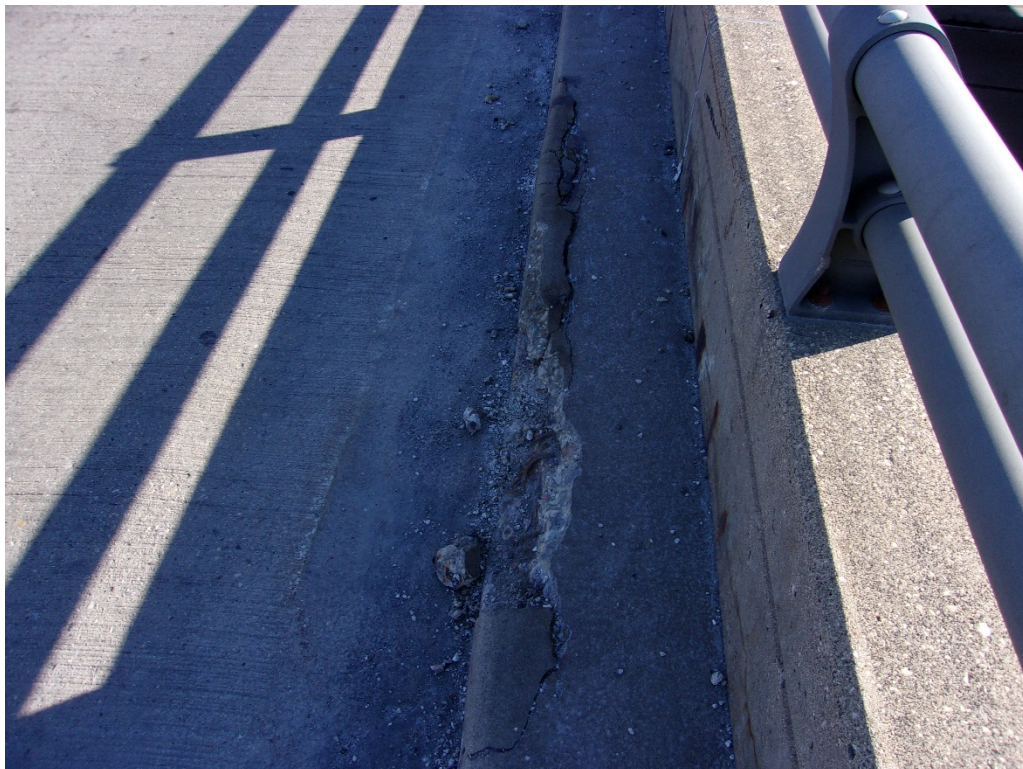
6) Curb deterioration/spall at south of structure

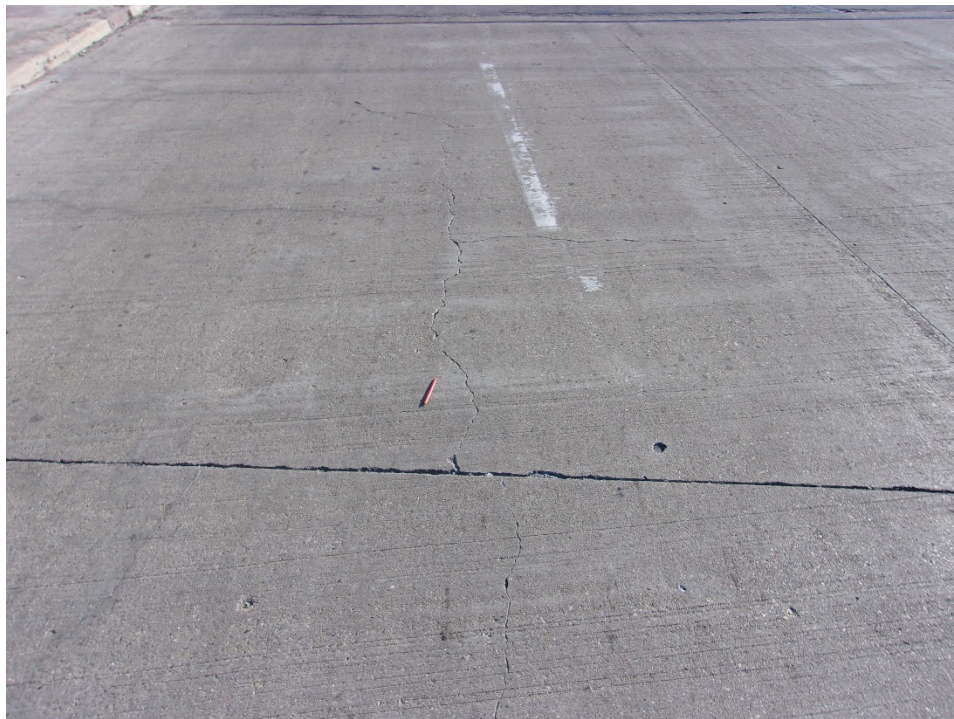
7) Deck condition (looking east)

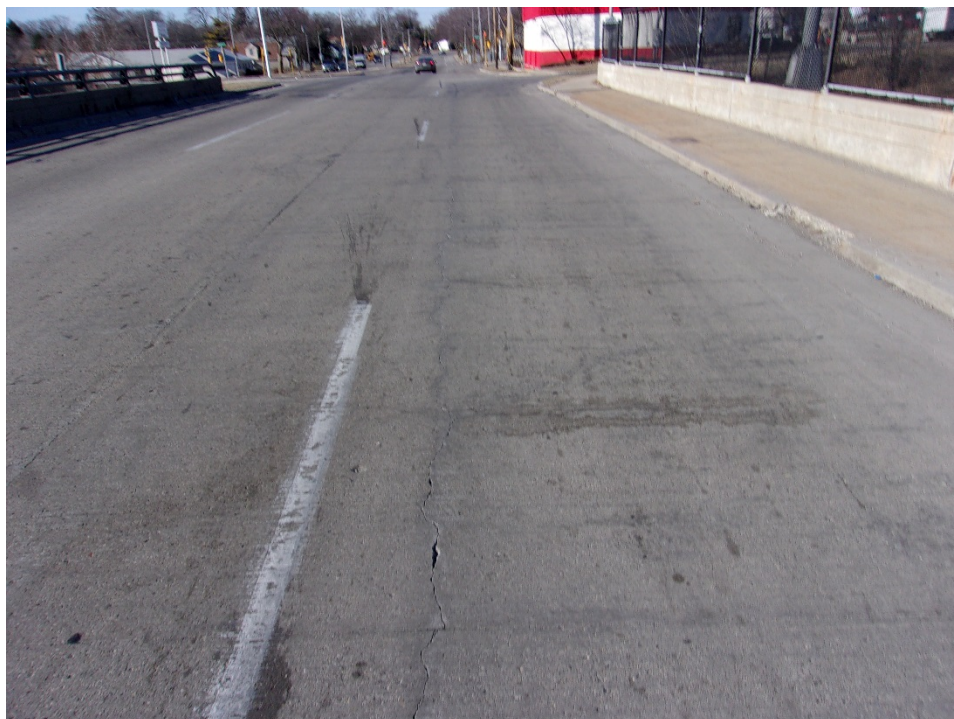
8) Deck condition (looking west)

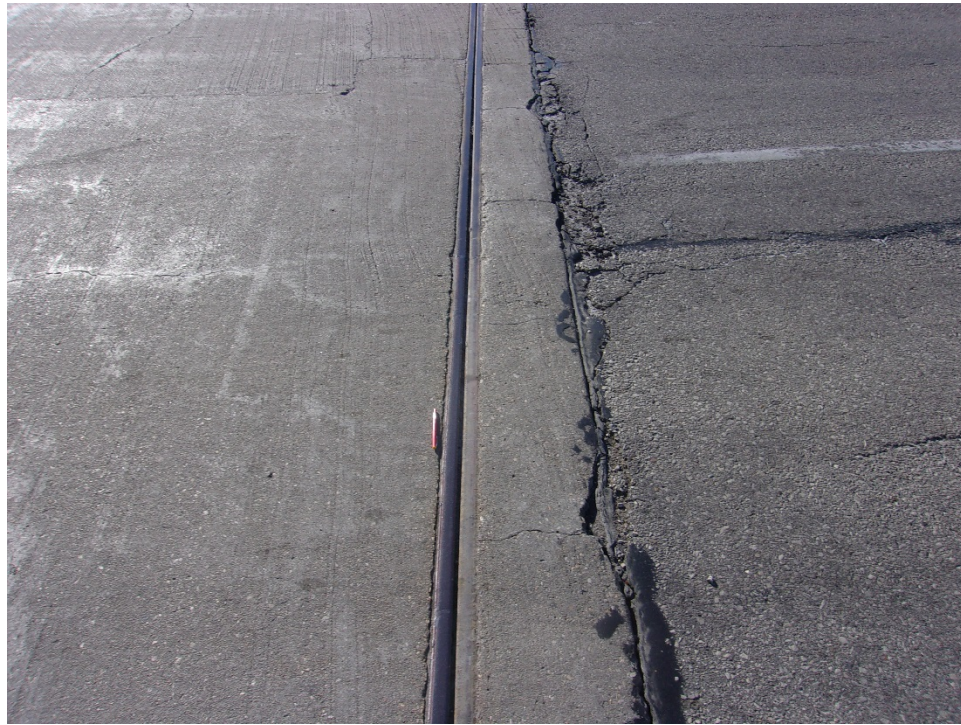
9) Expansion device at west abutment, joint is nearly closed

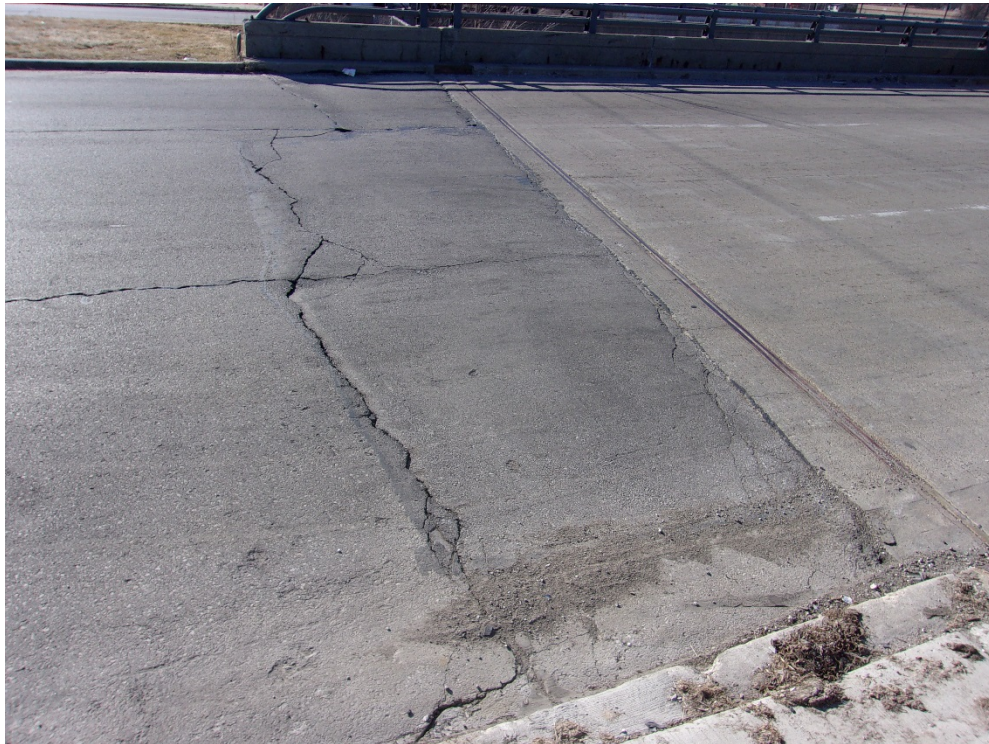
10) Approach pavement over east abutment

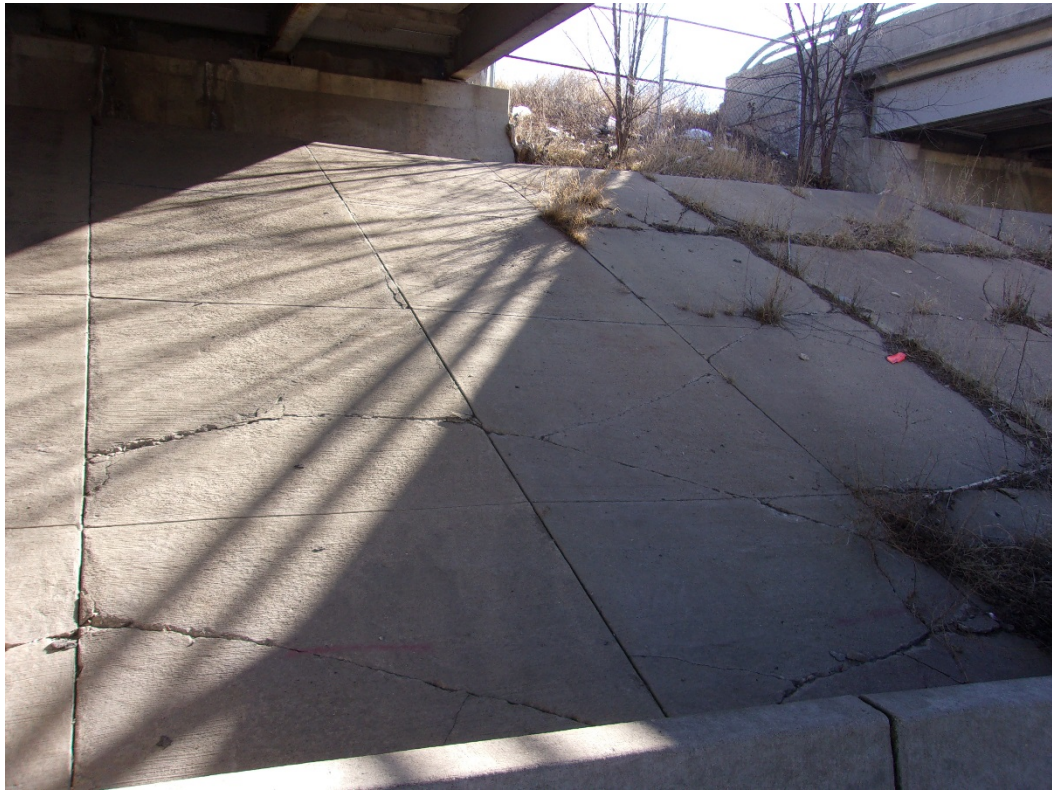
11) Slope paving condition in front of east abutment

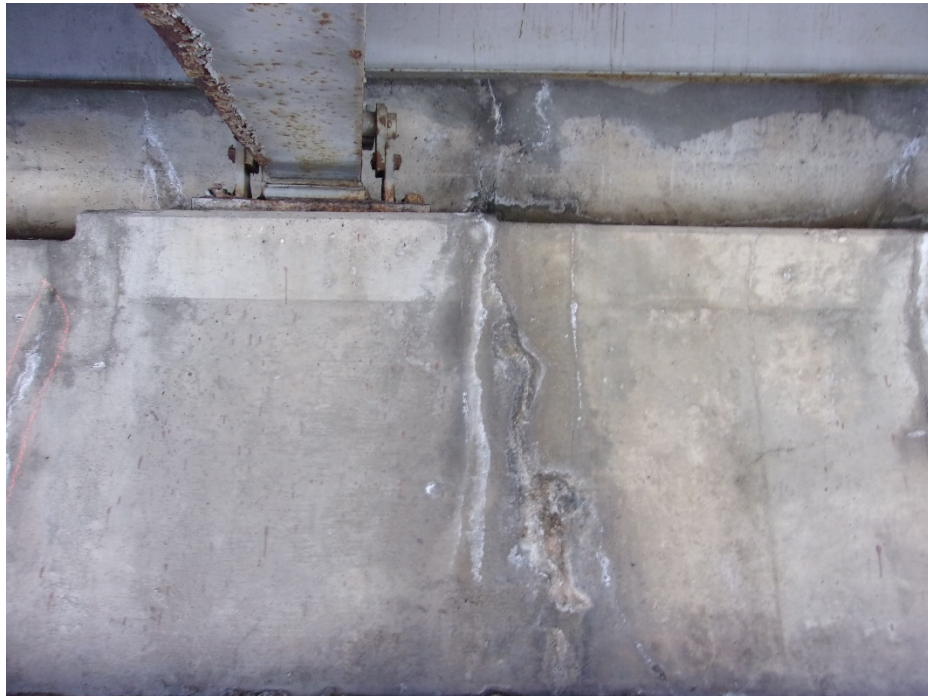
12) Typical abutment frontface/backwall deterioration at east abutment

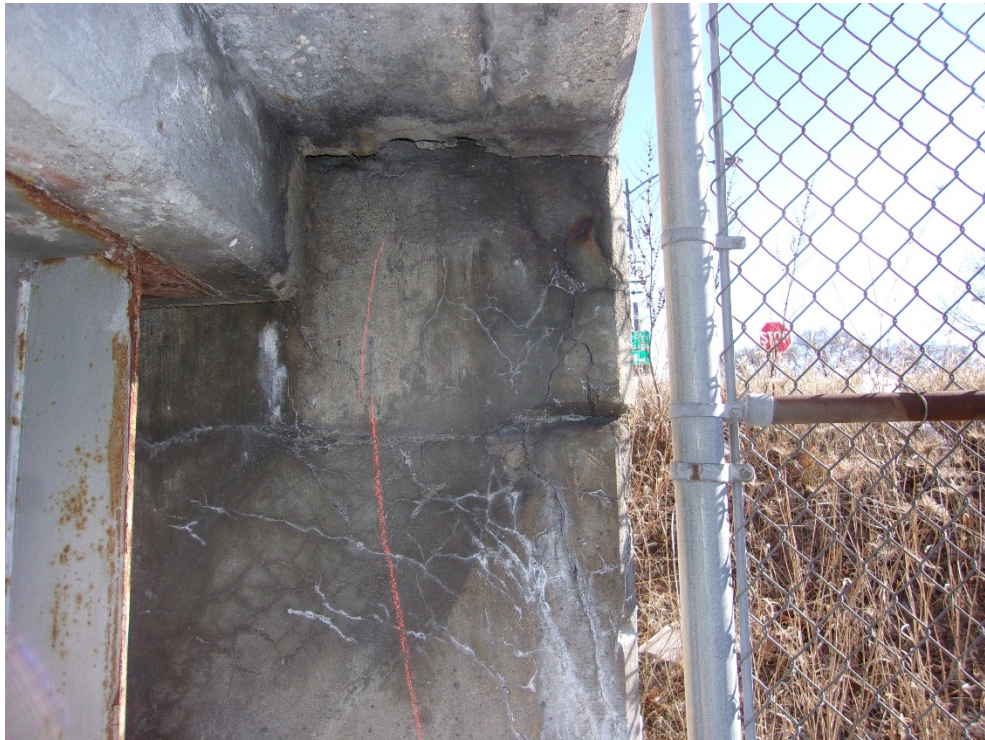
13) Leaching map cracking at southeast corner of east abutment backwall

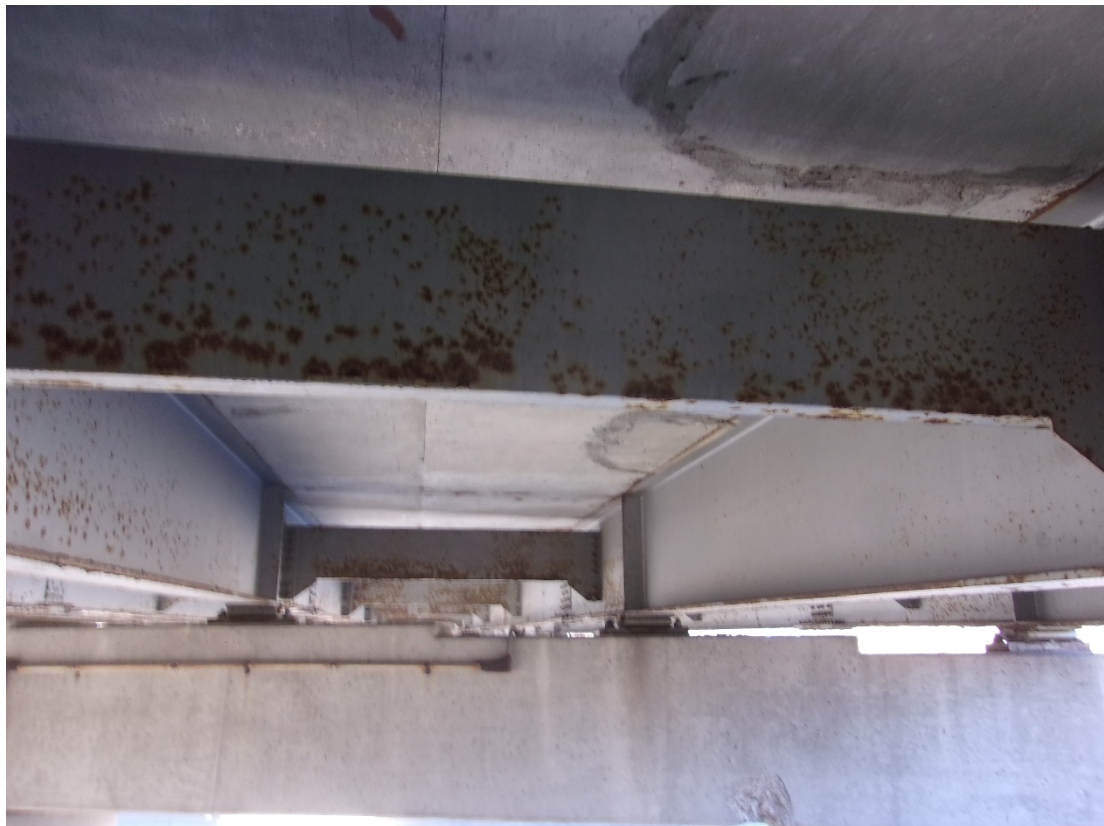
14) View of paint system condition looking west

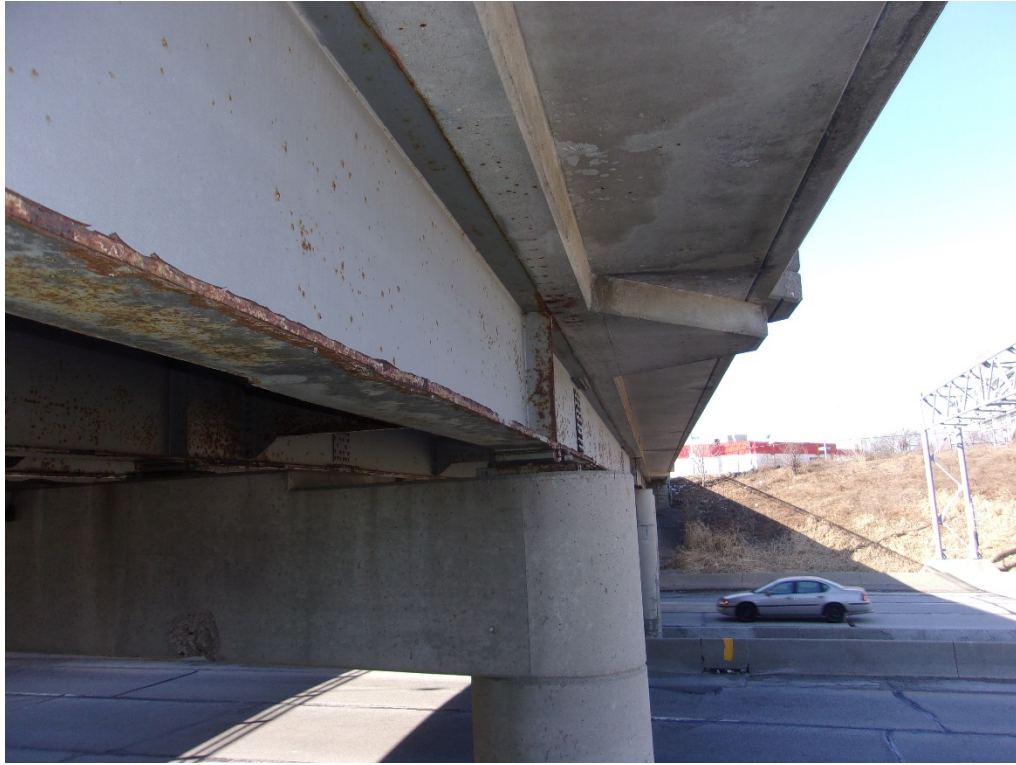
15) Fascia girder paint system condition looking west

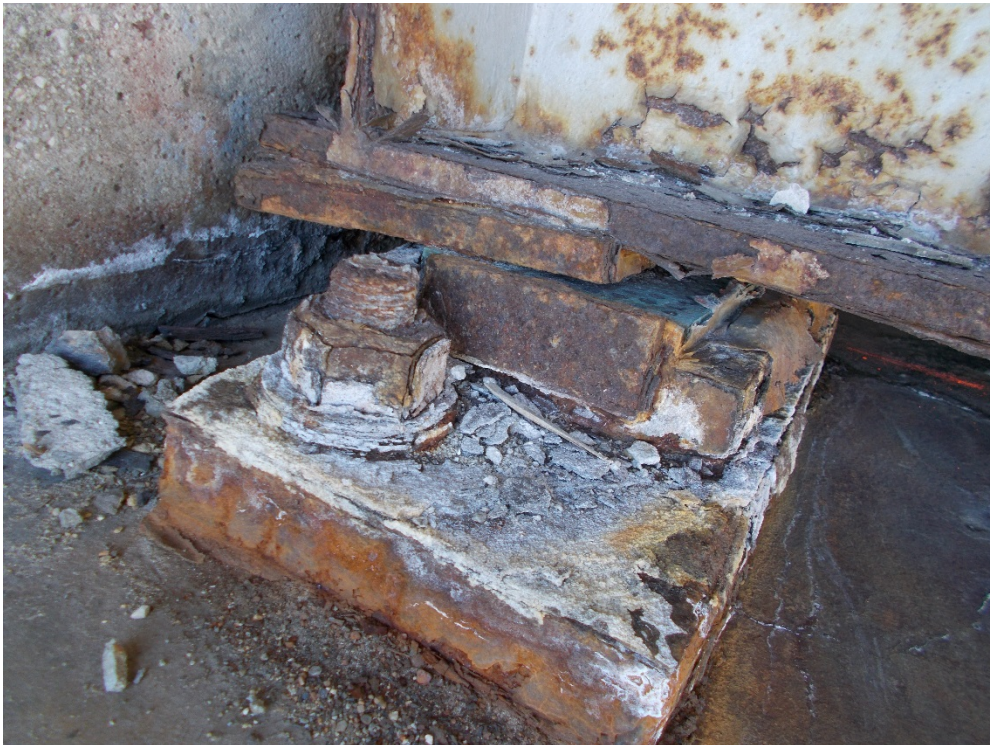
16) Girder 1 east abutment bearing condition, top plate is excessively beyond bearing anchorage. Bronze plate is exposed.

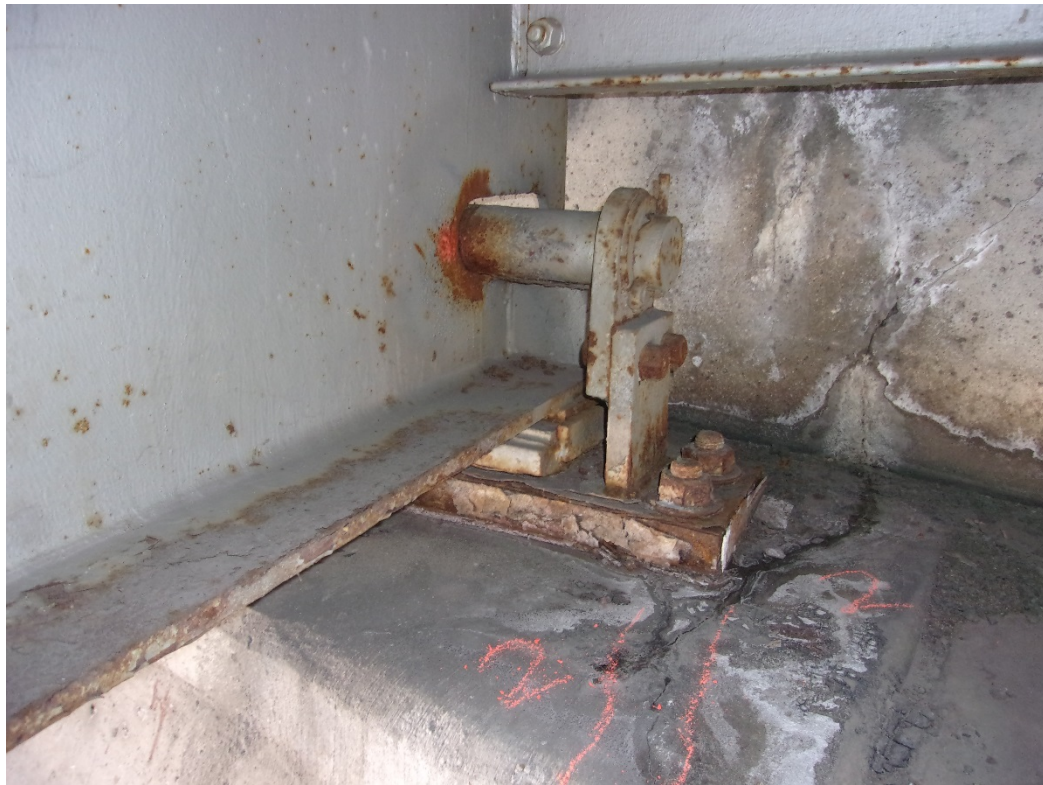
17) Girder 2 east abutment bearing condition, slot in girder is tight to hold down pin

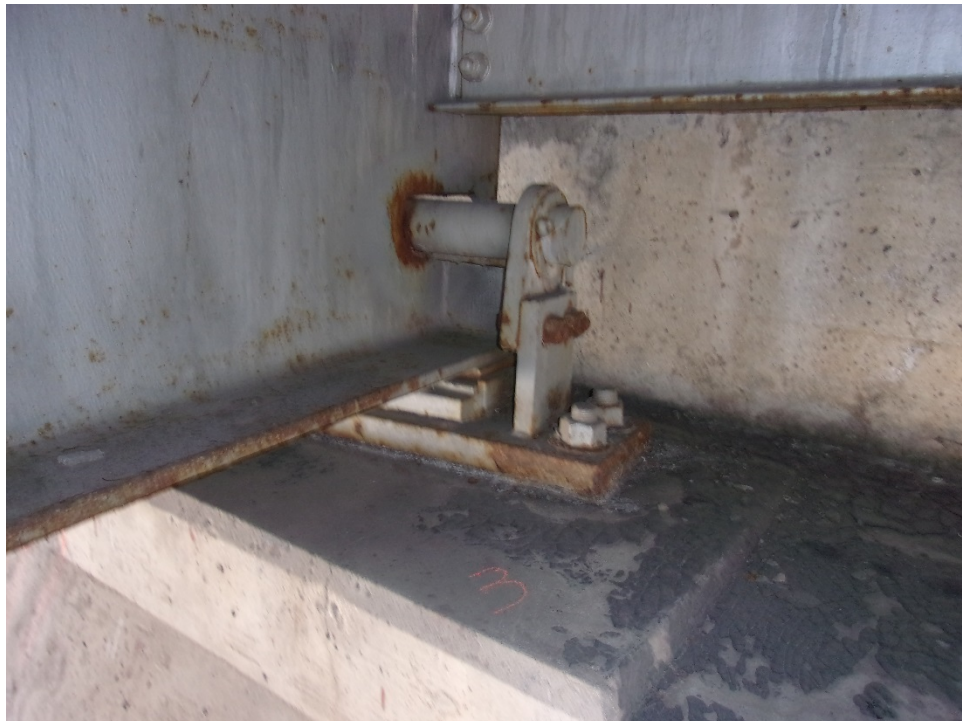
18) Girder 3 east abutment bearing condition, slot in girder is tight to hold down pin

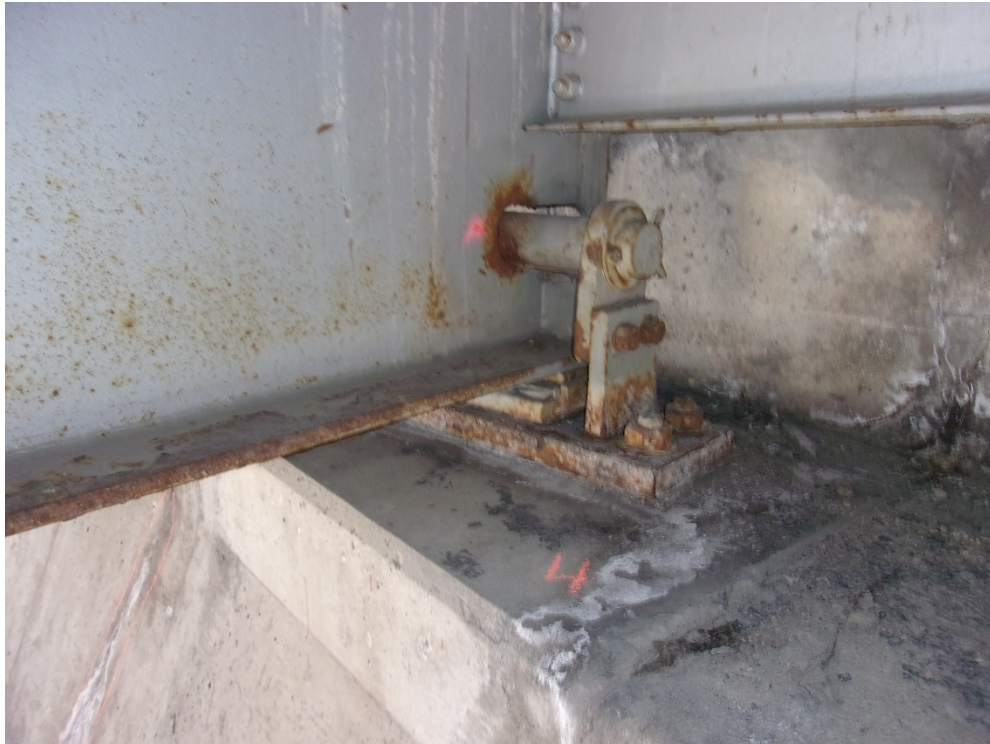
19) Girder 4 east abutment bearing condition, slot in girder is tight to hold down pin

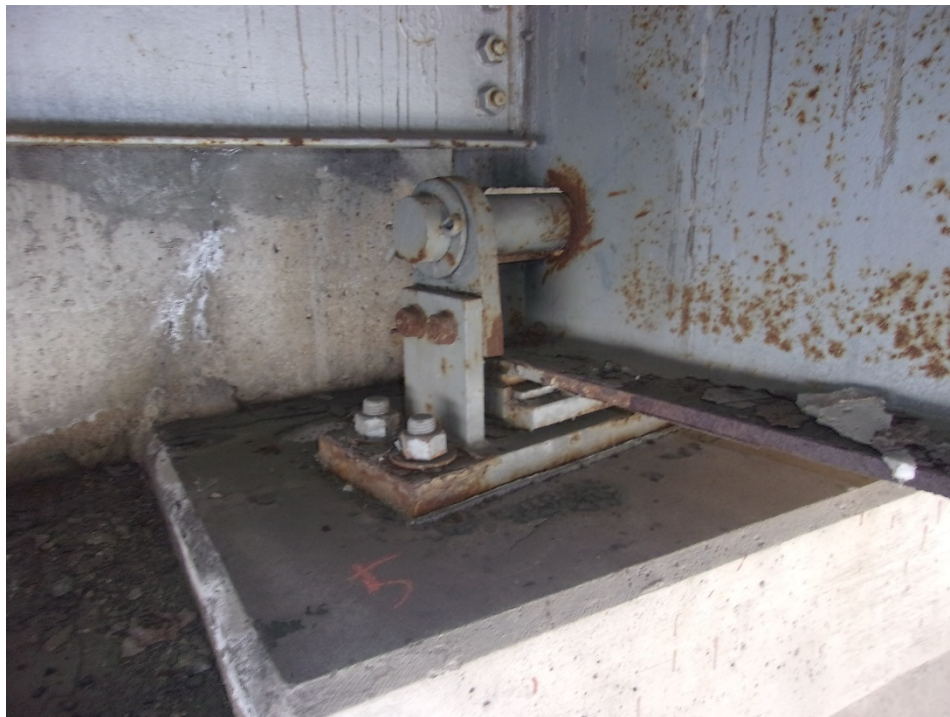
20) Girder 5 east abutment bearing condition, slot in girder is against hold down pin

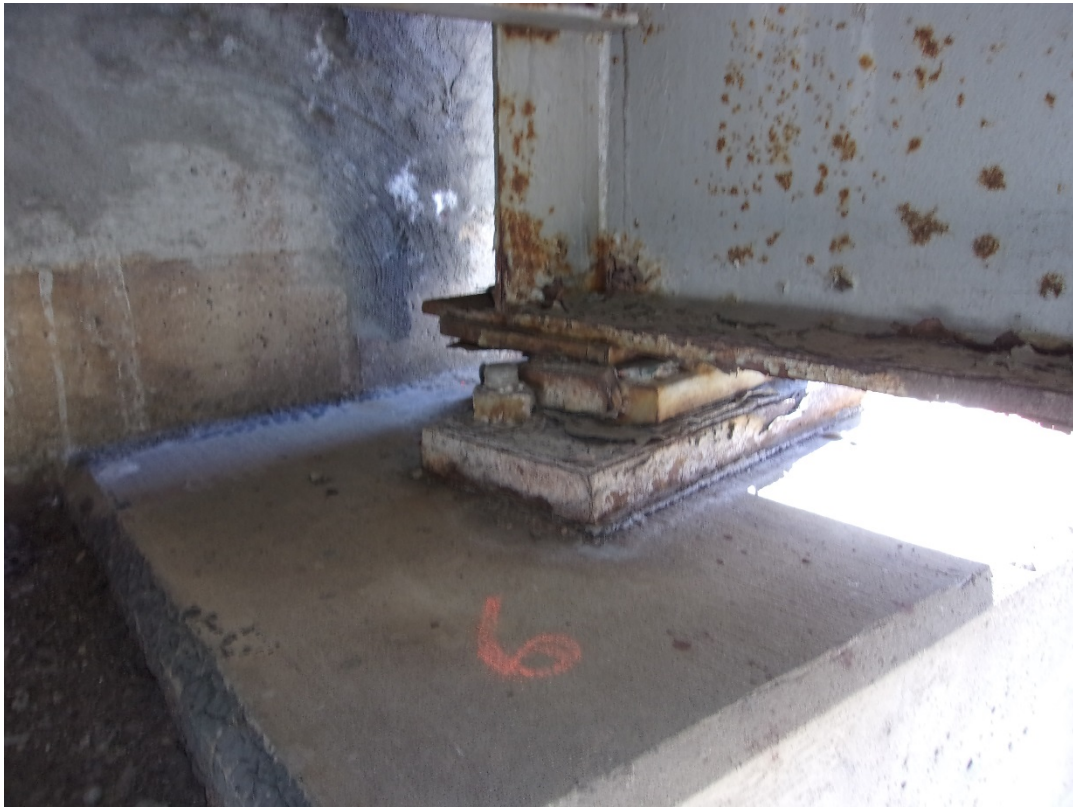
21) Girder 6 east abutment bearing condition

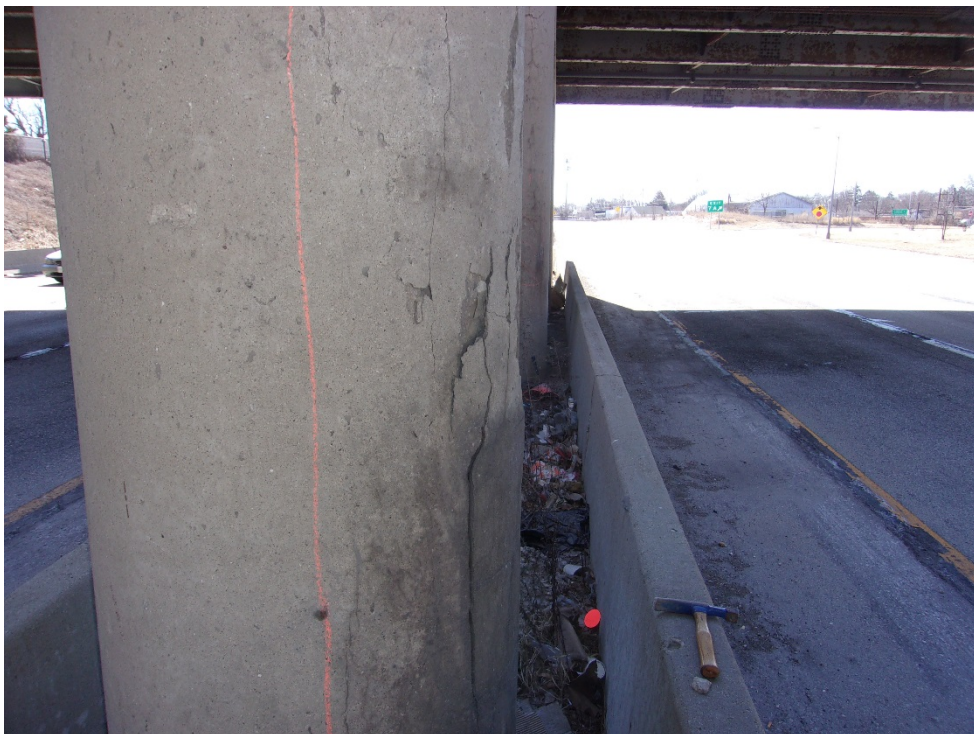
22) Large delam at Pier 3 column

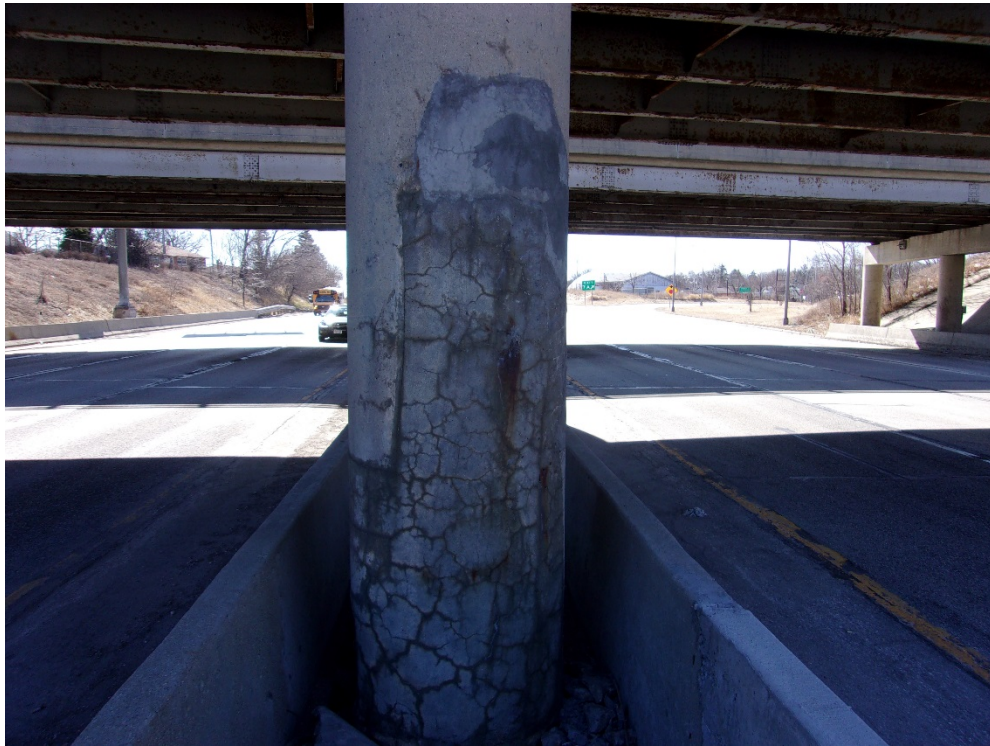
23) Condition state of Pier 2 Column 1 north face

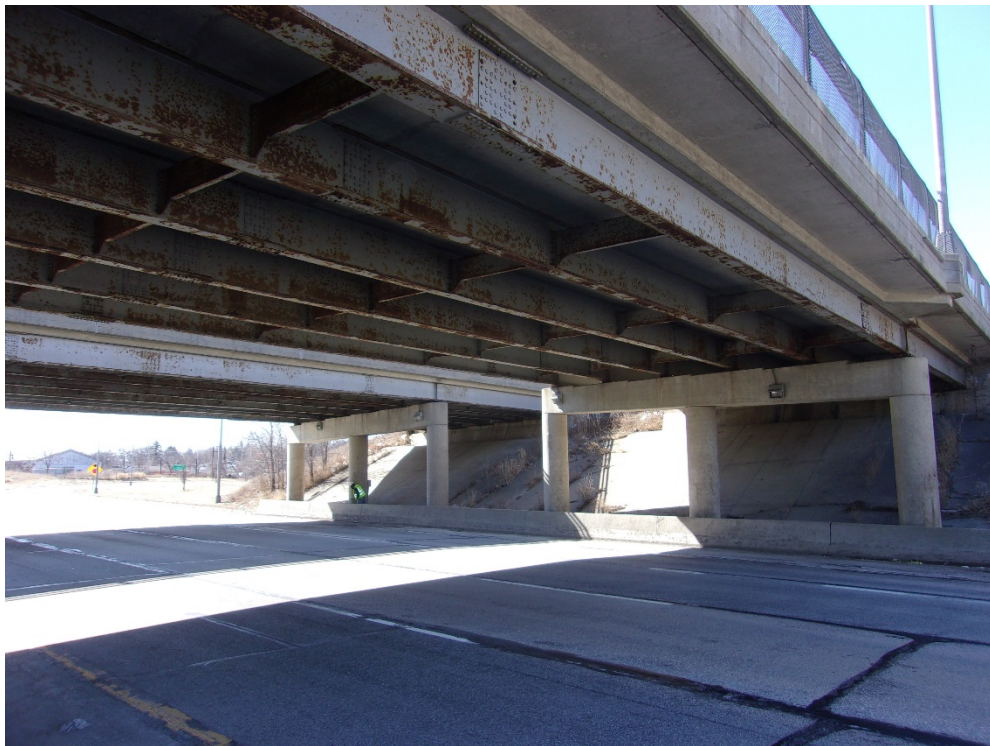
24) Girder/paint system condition state of span 2 (looking southwest)

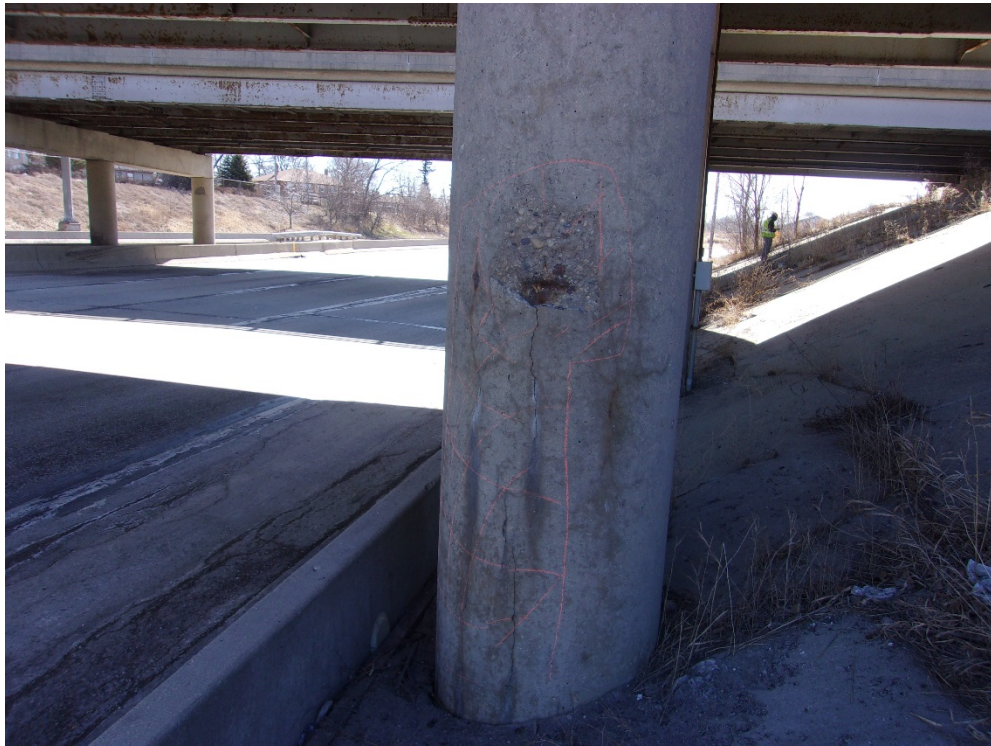
25) Delam at Pier 1 Column 1 north face

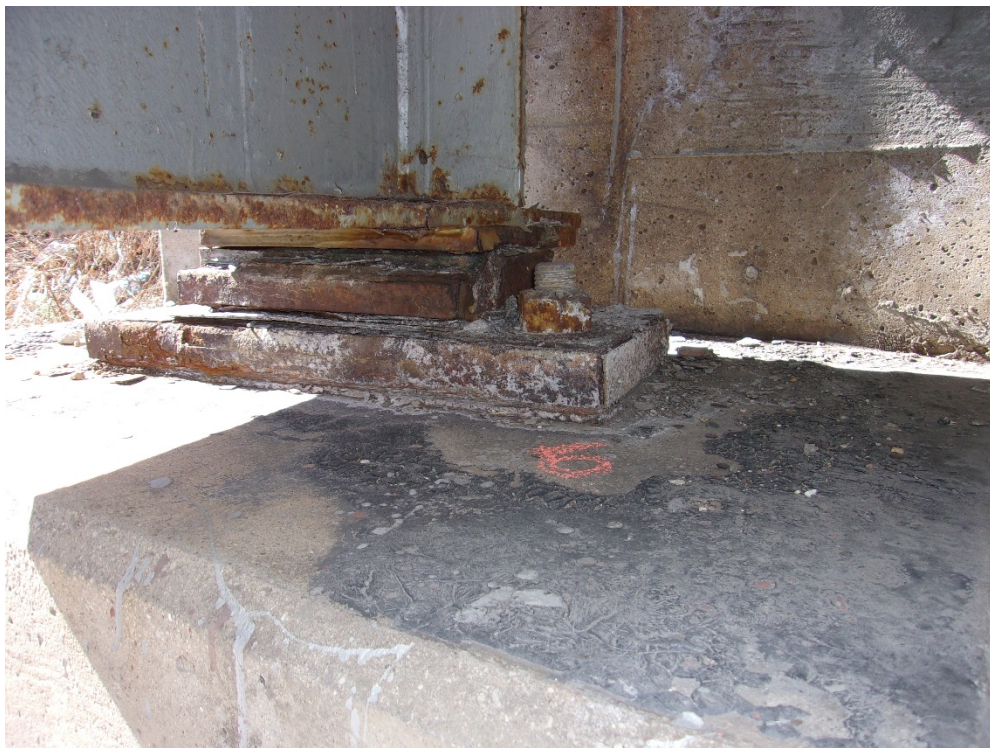
26) Girder 6 west abutment bearing condition

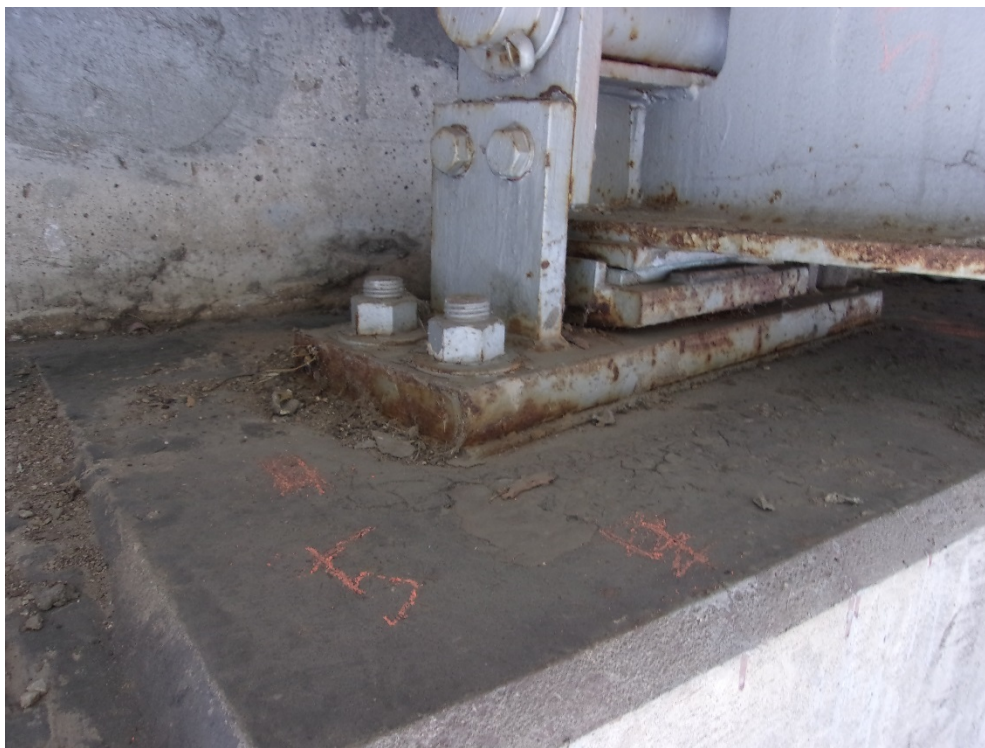
27) Girder 5 west abutment bearing condition

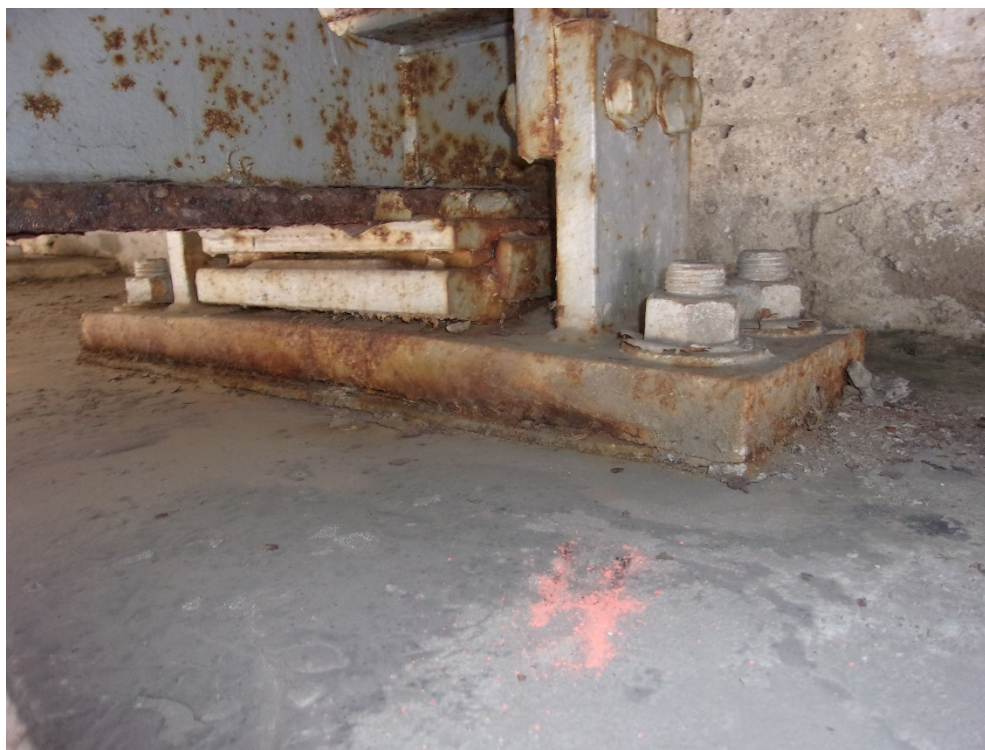
28) Girder 4 west abutment bearing condition

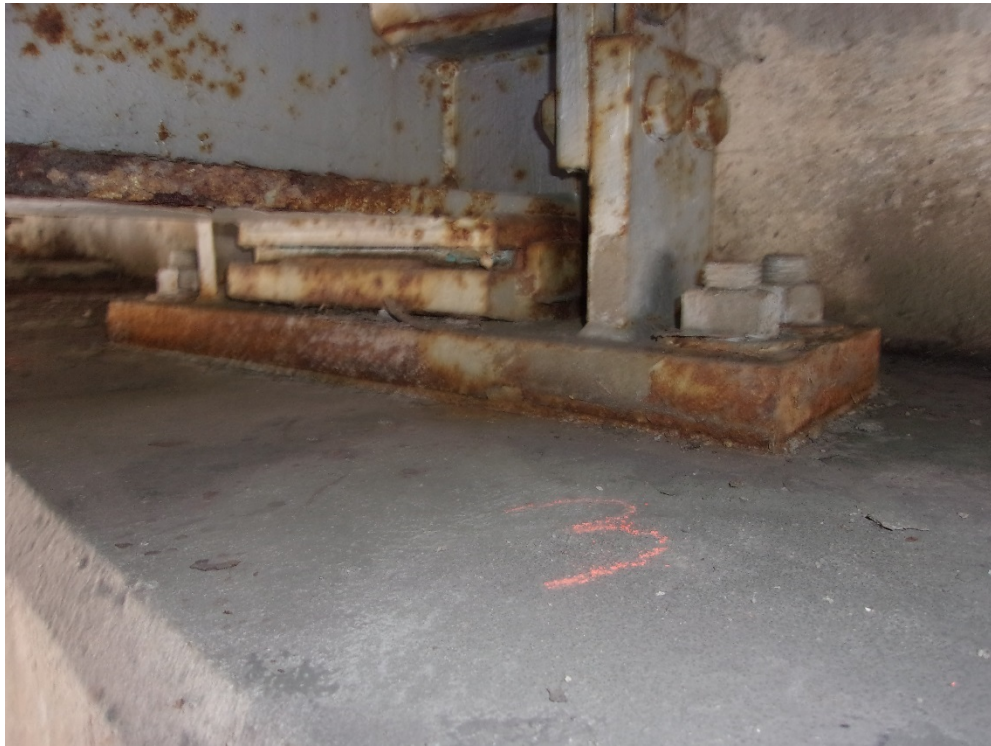
29) Girder 3 west abutment bearing condition

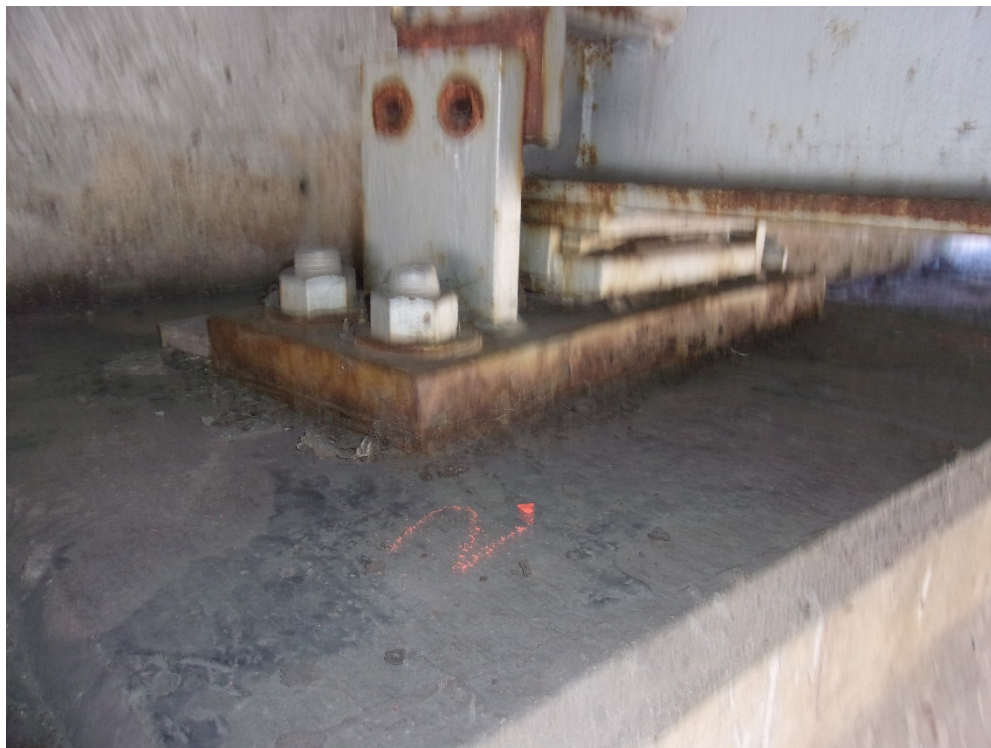
30) Girder 2 west abutment bearing condition. Missing bolts at hold down. Noticeable vertical displacement of hold down.

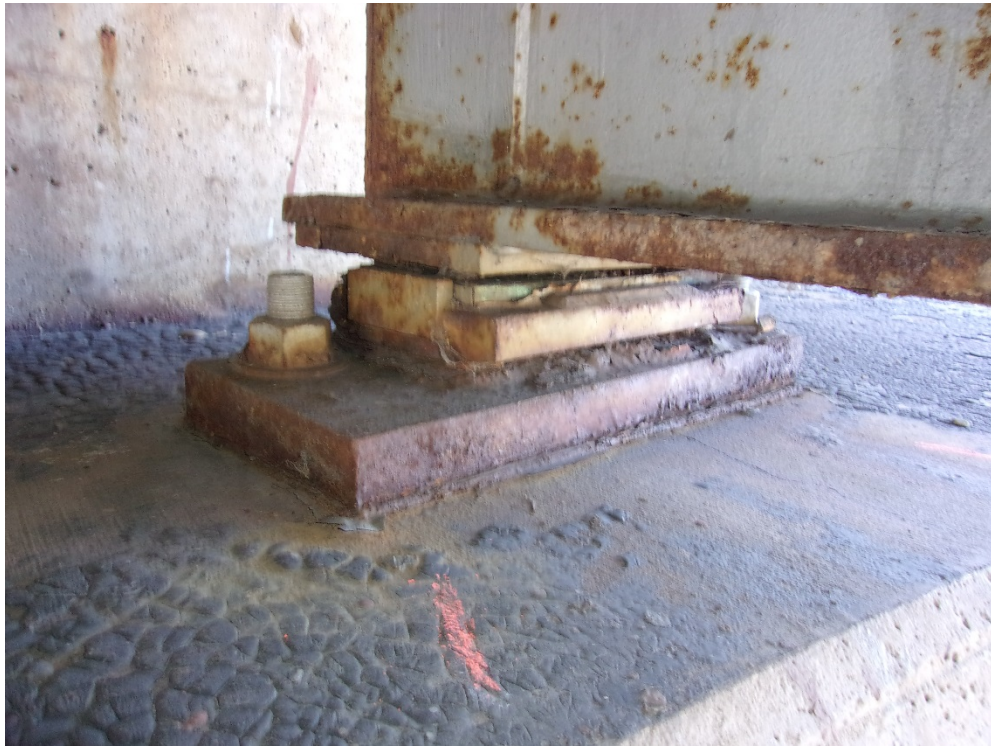
31) Girder 1 west abutment bearing condition
