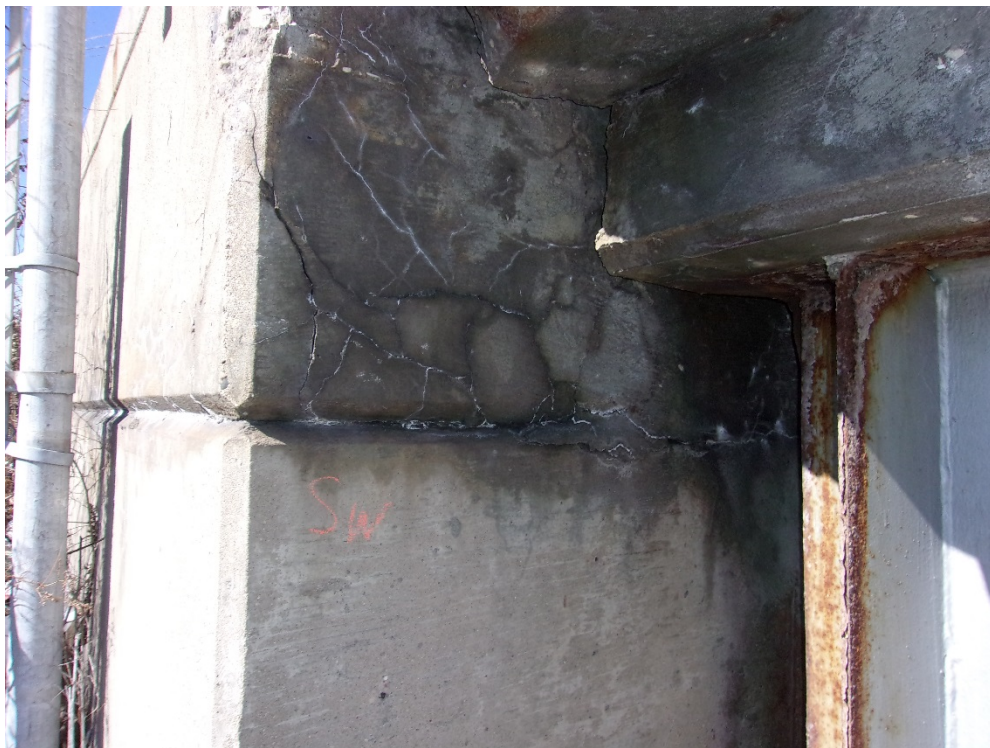
32) Leaching map cracks at southwest wingwall/abutment backwall

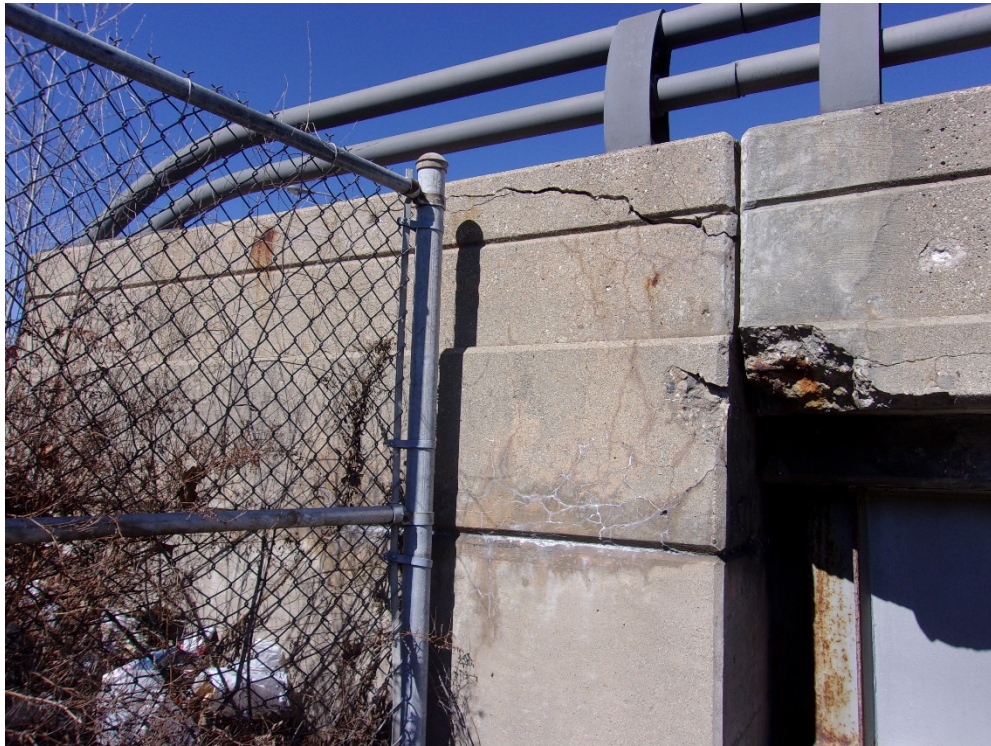
33) Front face of southwest wingwall condition.

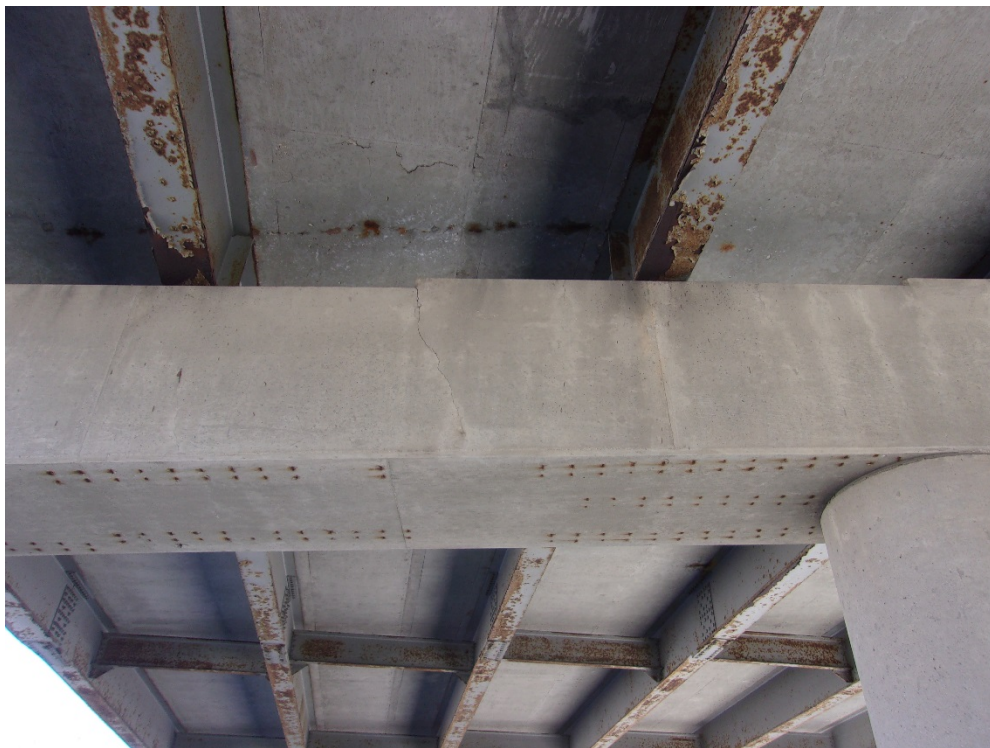
34) Vertical shear crack at Pier 2 between girders 2 and 3 (looking east)
