ATTACHMENT 1
INSPECTION REPORT

Inspection Report for B-40-281

W GRANTOSA DR EB over STH 145-W FOND DU LAC AV
Jul 21, 2018

B-40-281
W GRANTOSA DR EB over STH 145-W
FOND DU LAC AV
South Elevation
7/21/2018

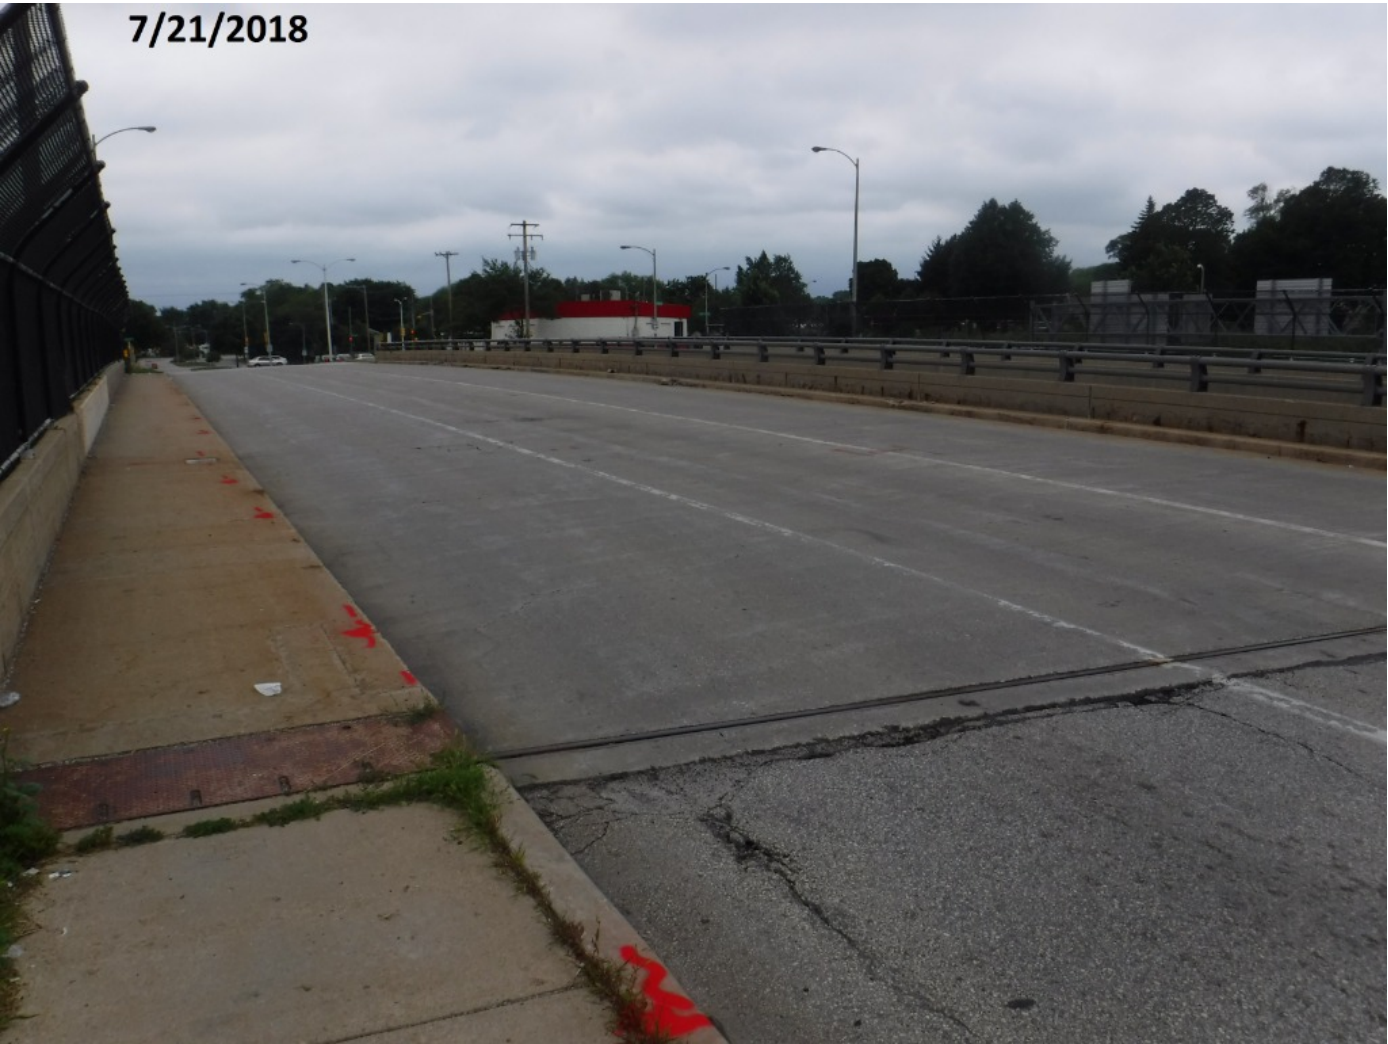
Routine
Document Comment/Description
Top of deck looking West

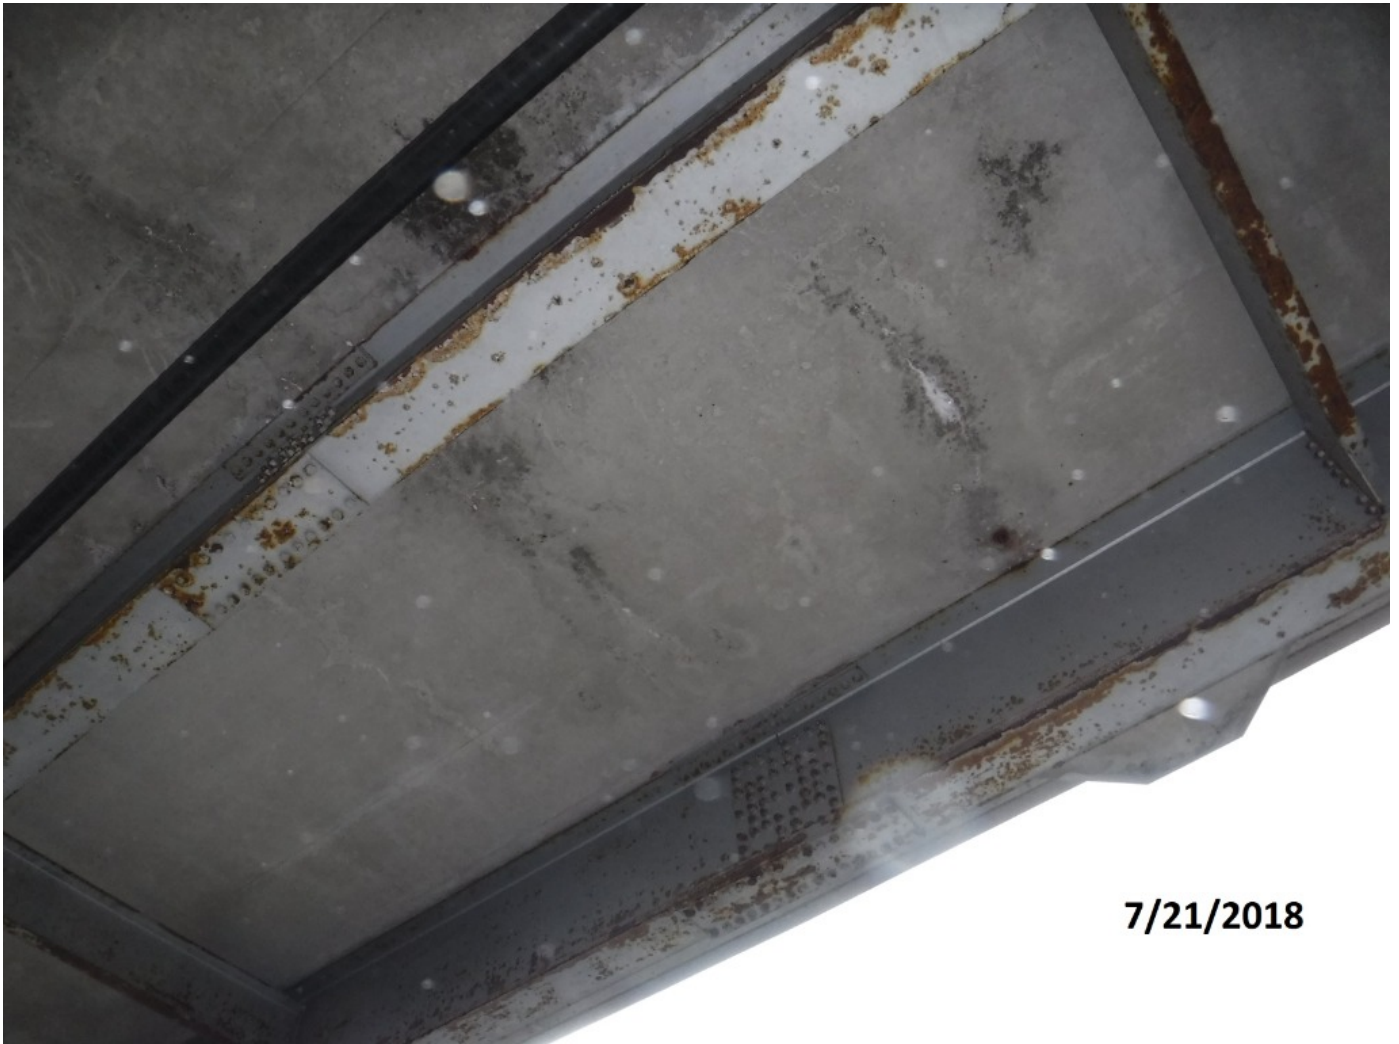
RC Deck - Typ transv crack with efflorescence. Photo shows Span 2 Bay 5.

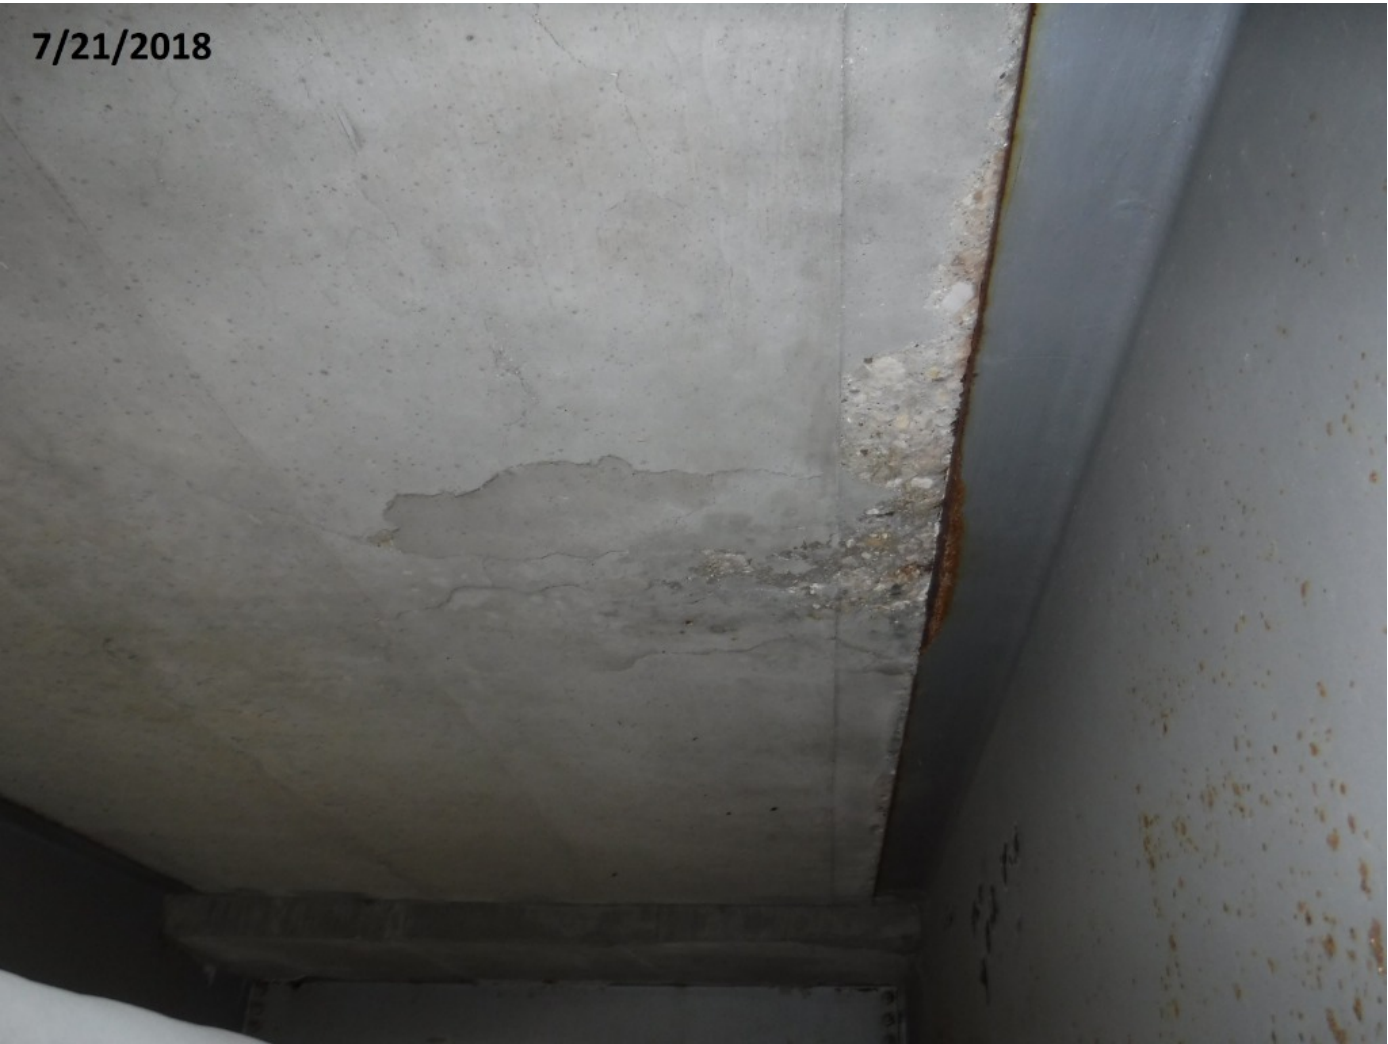
3210	Debonding/Spall/Patched Area/Pothole May 2015 IR: "Numerous large delaminations throughout the deck." 30-35% Delam. Two 2 ft spalls at West Abut (Lane 1 and Lane 2). 10SF Delam with concrete close to popping out Span 3.	SF		0	0	2,514	0
		3220	Crack (Wearing Surface) Narrow to medium longit and map cracking throughout deck. Some overlap with delams above. Approx 10% additional CS2 and 10% additional CS3.	SF		0	715	715	0

RC Deck - Large area of delam with spalling. Span 4, Bay 4.

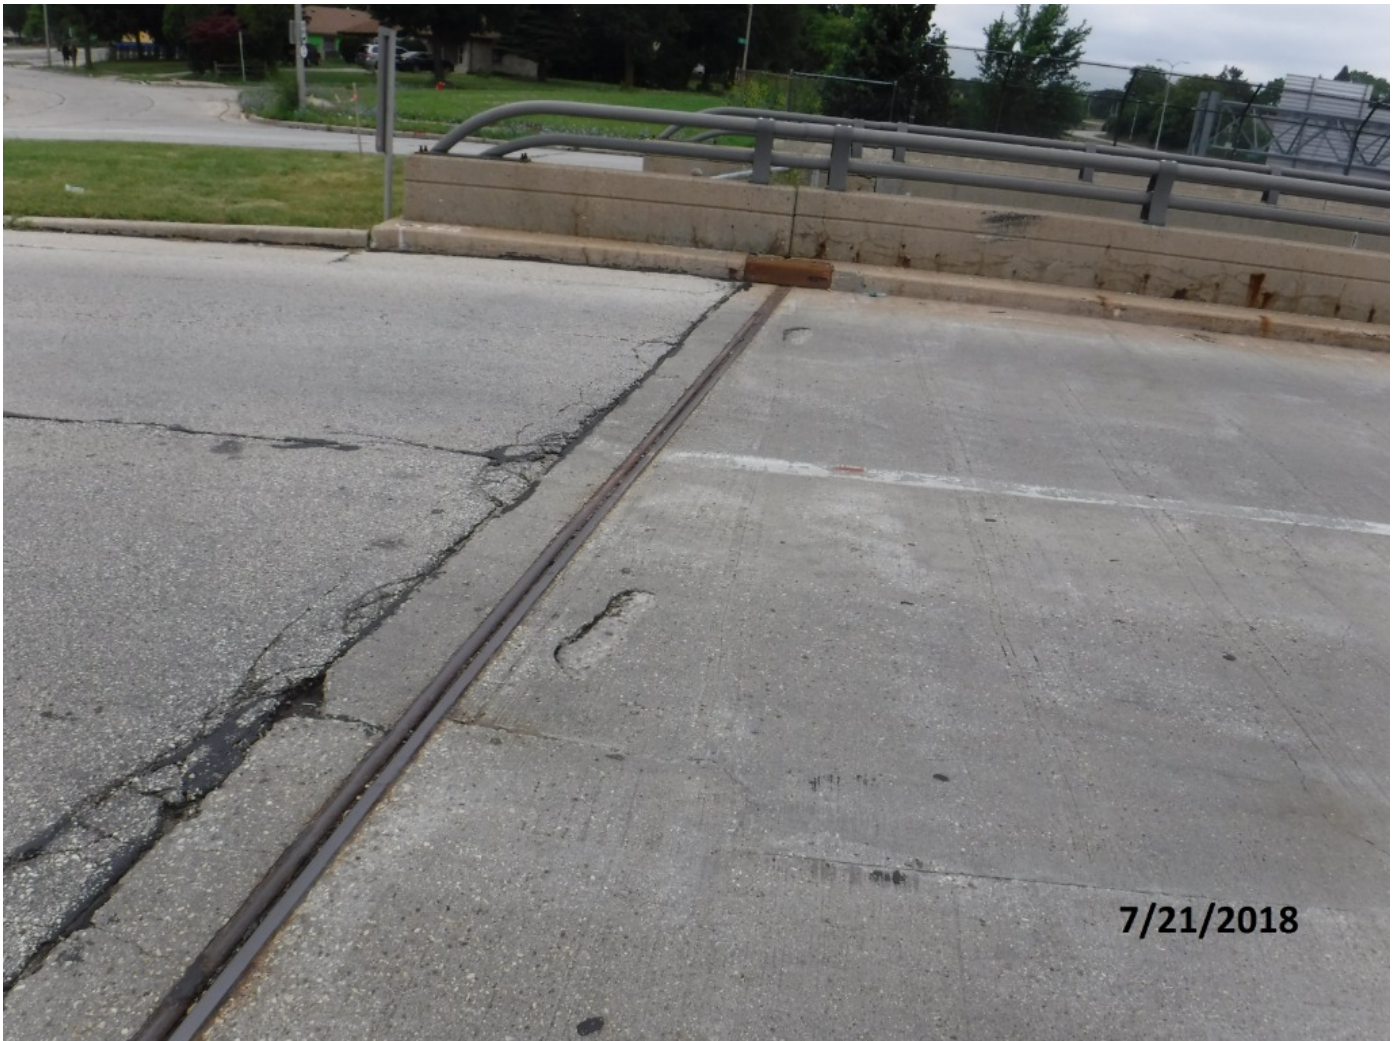
Conc OL - Two 2 ft spalls at West Abut (Lane 1 and Lane 2).

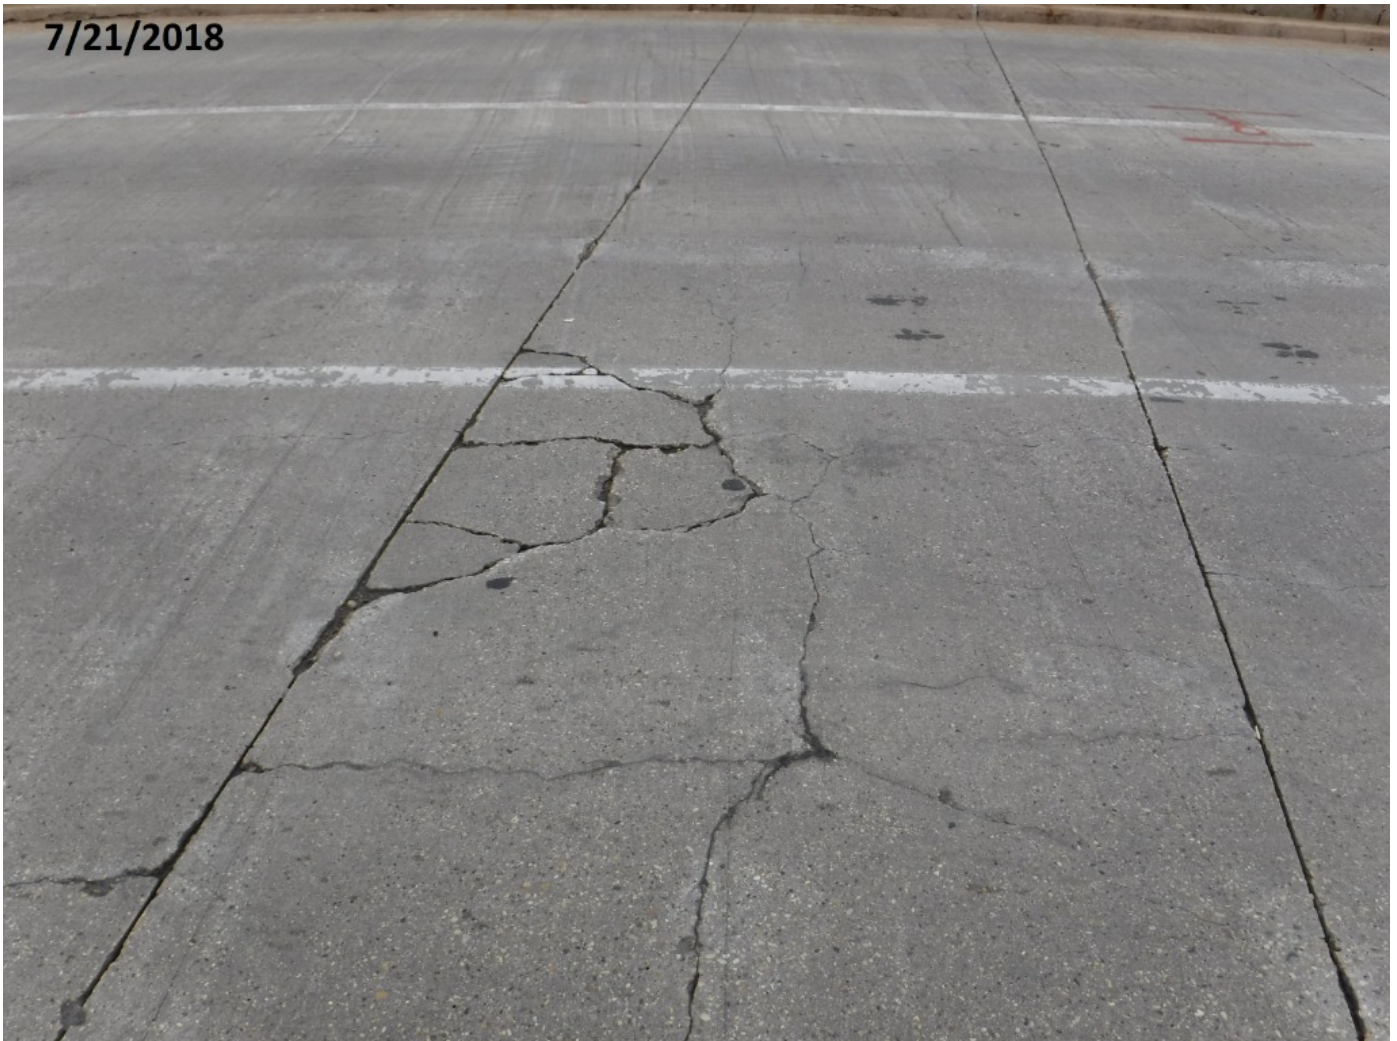
Conc OL - 10SF Delam with concrete close to popping out Span 3.

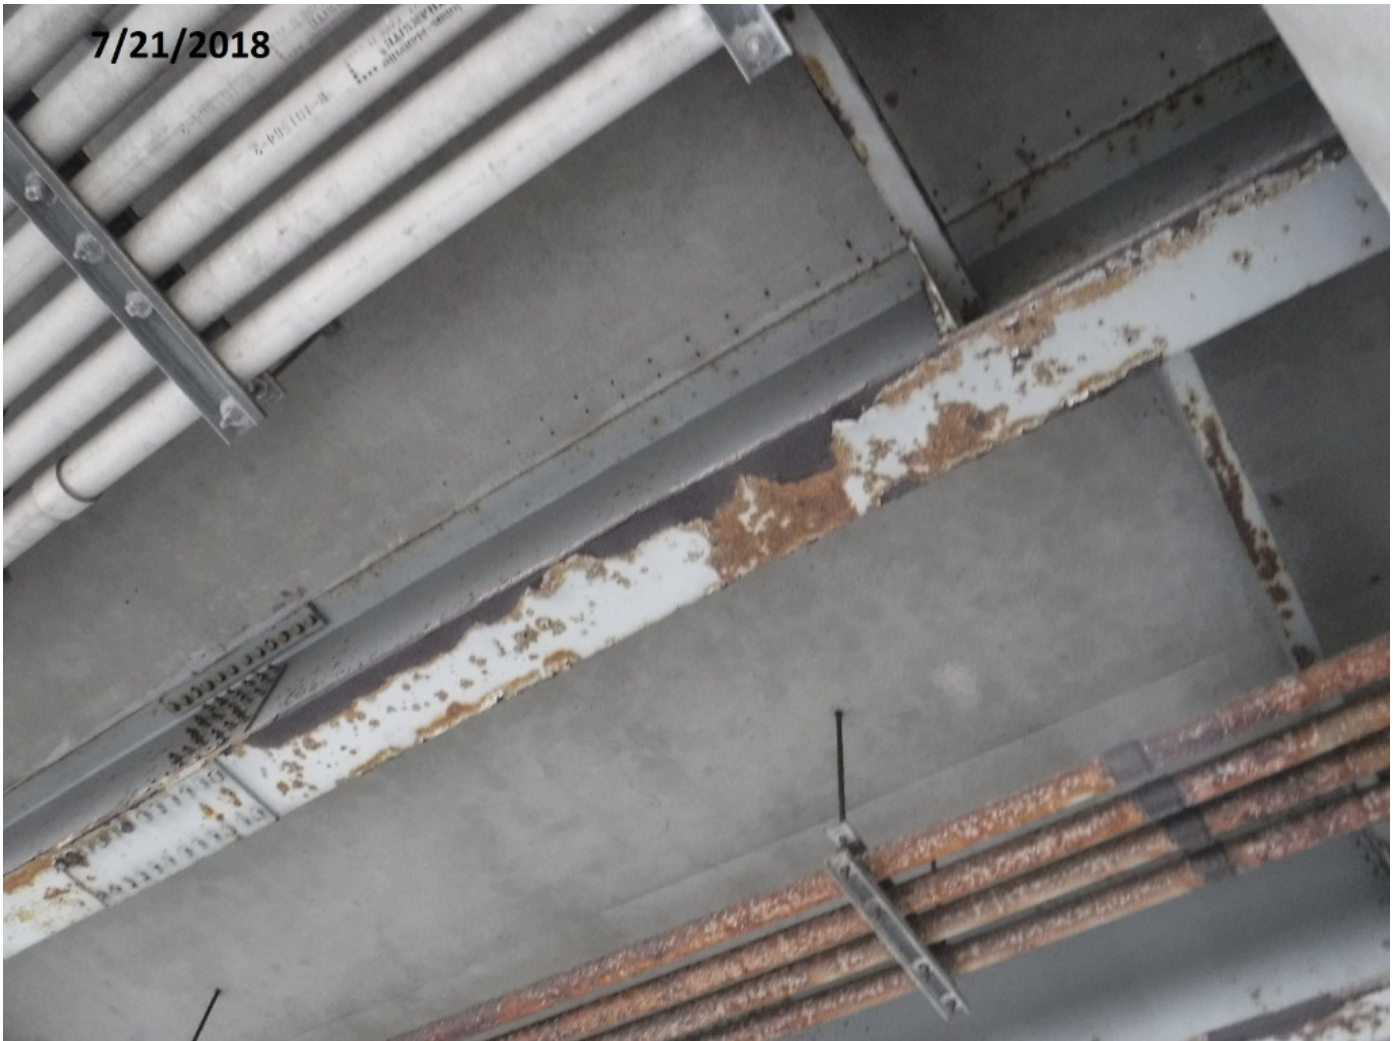
Steel Open Girder - Rust heavier over Rdwys with approx 60LF CS3 corrosion. Photo shows Span 2, girder 2.

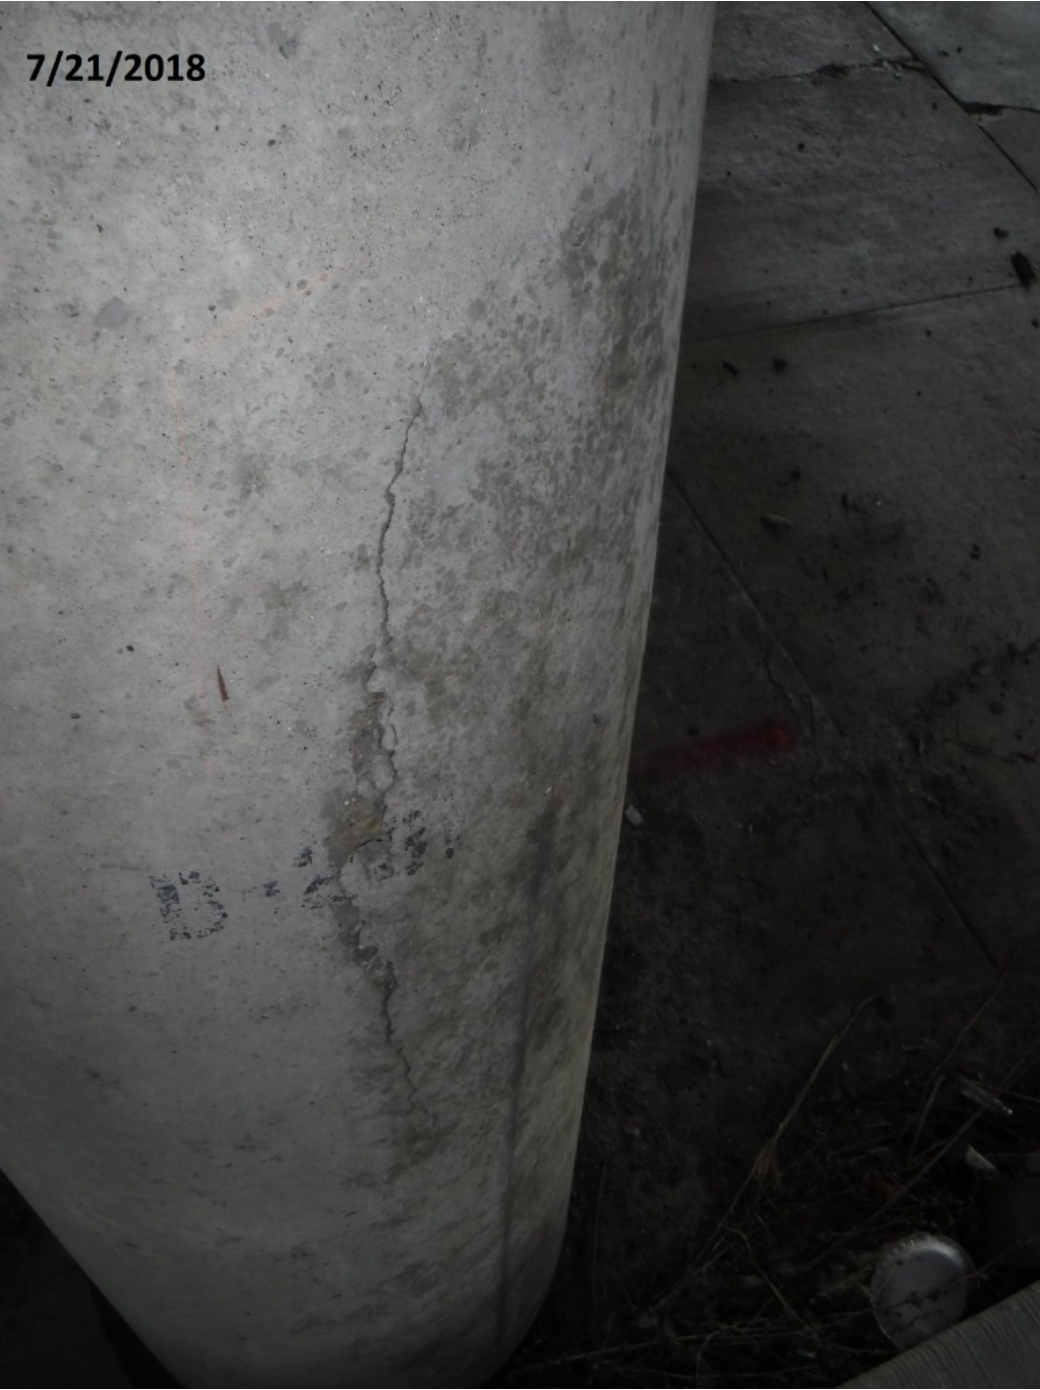
RC Col - Large delam Col 2, Pier 1.

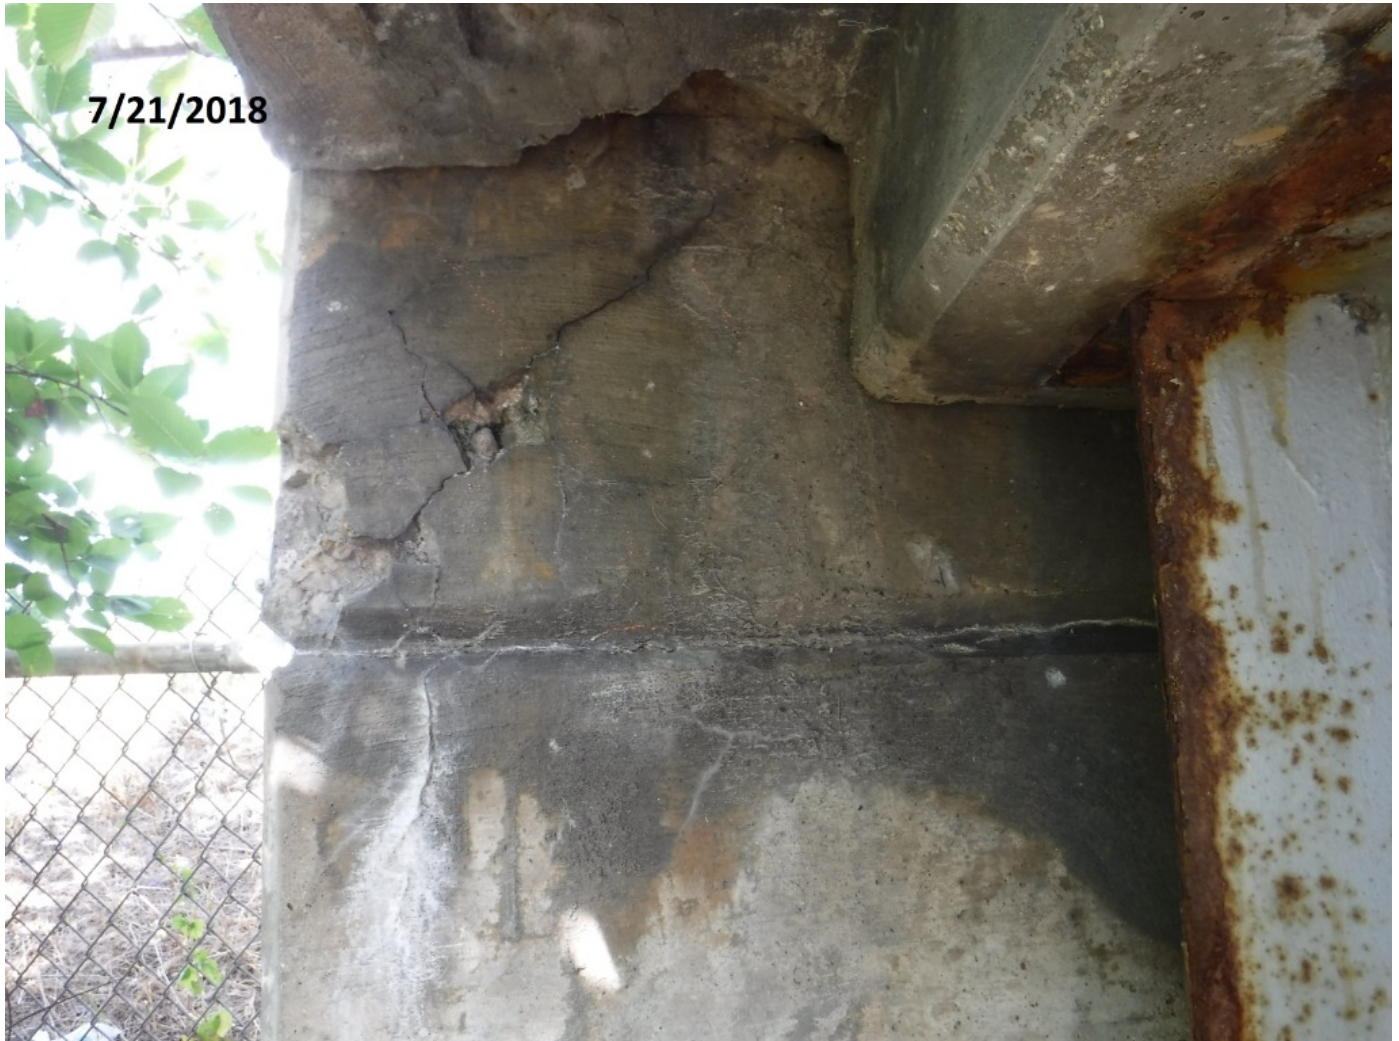
RC Abut - E. Abut: Small spall at north end - 1 LF CS3.

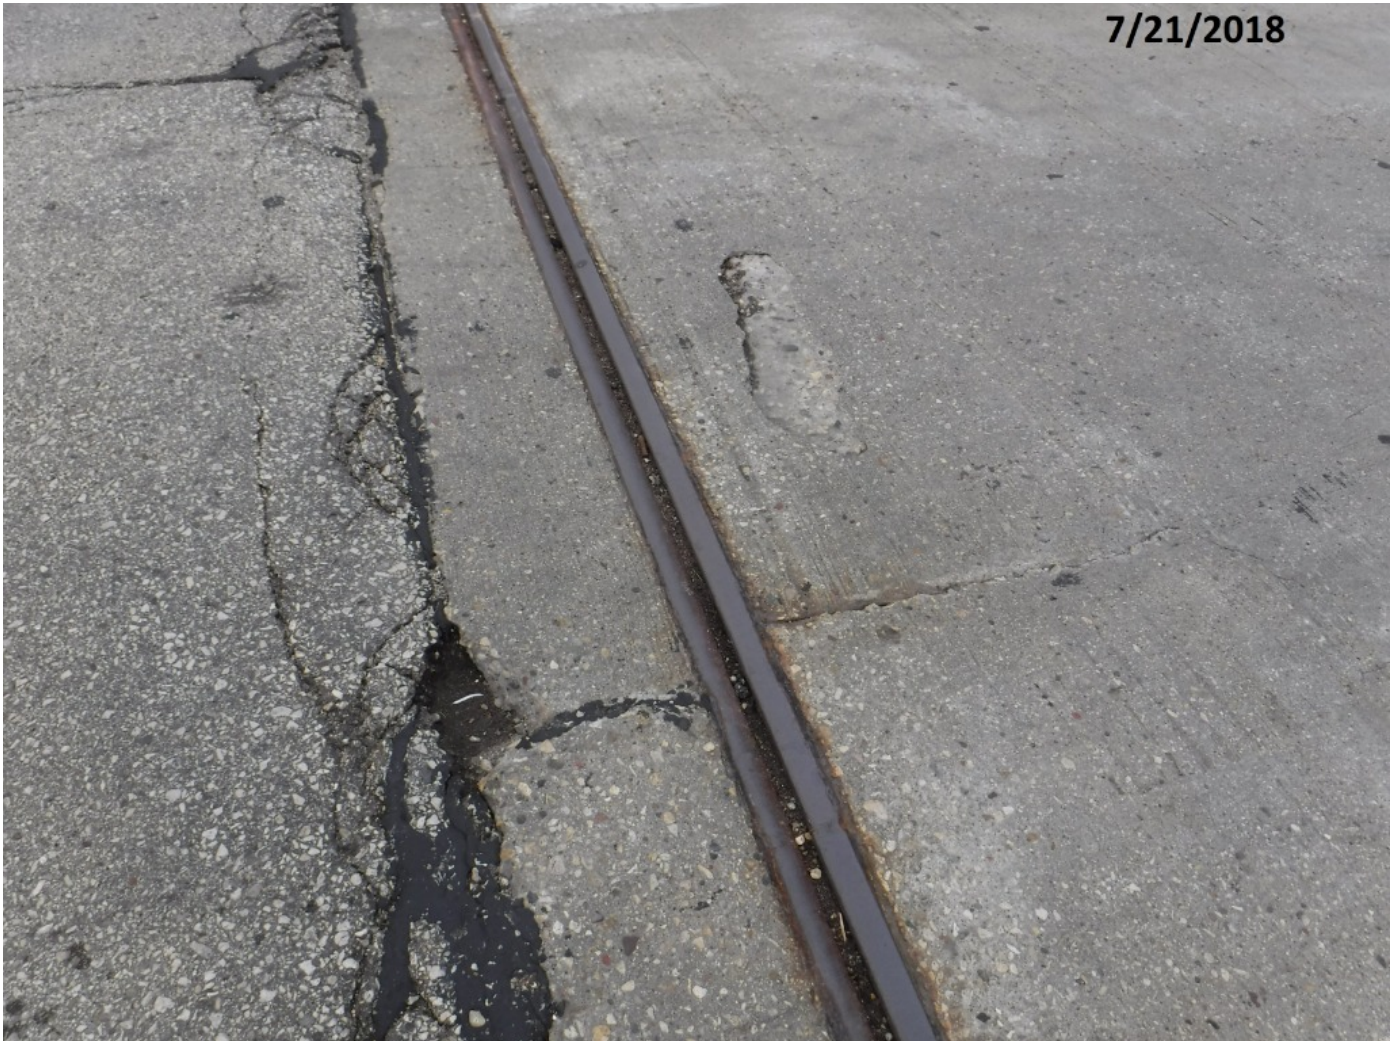
Strip Seal Exp Jt - West Abut: Spall at CL.

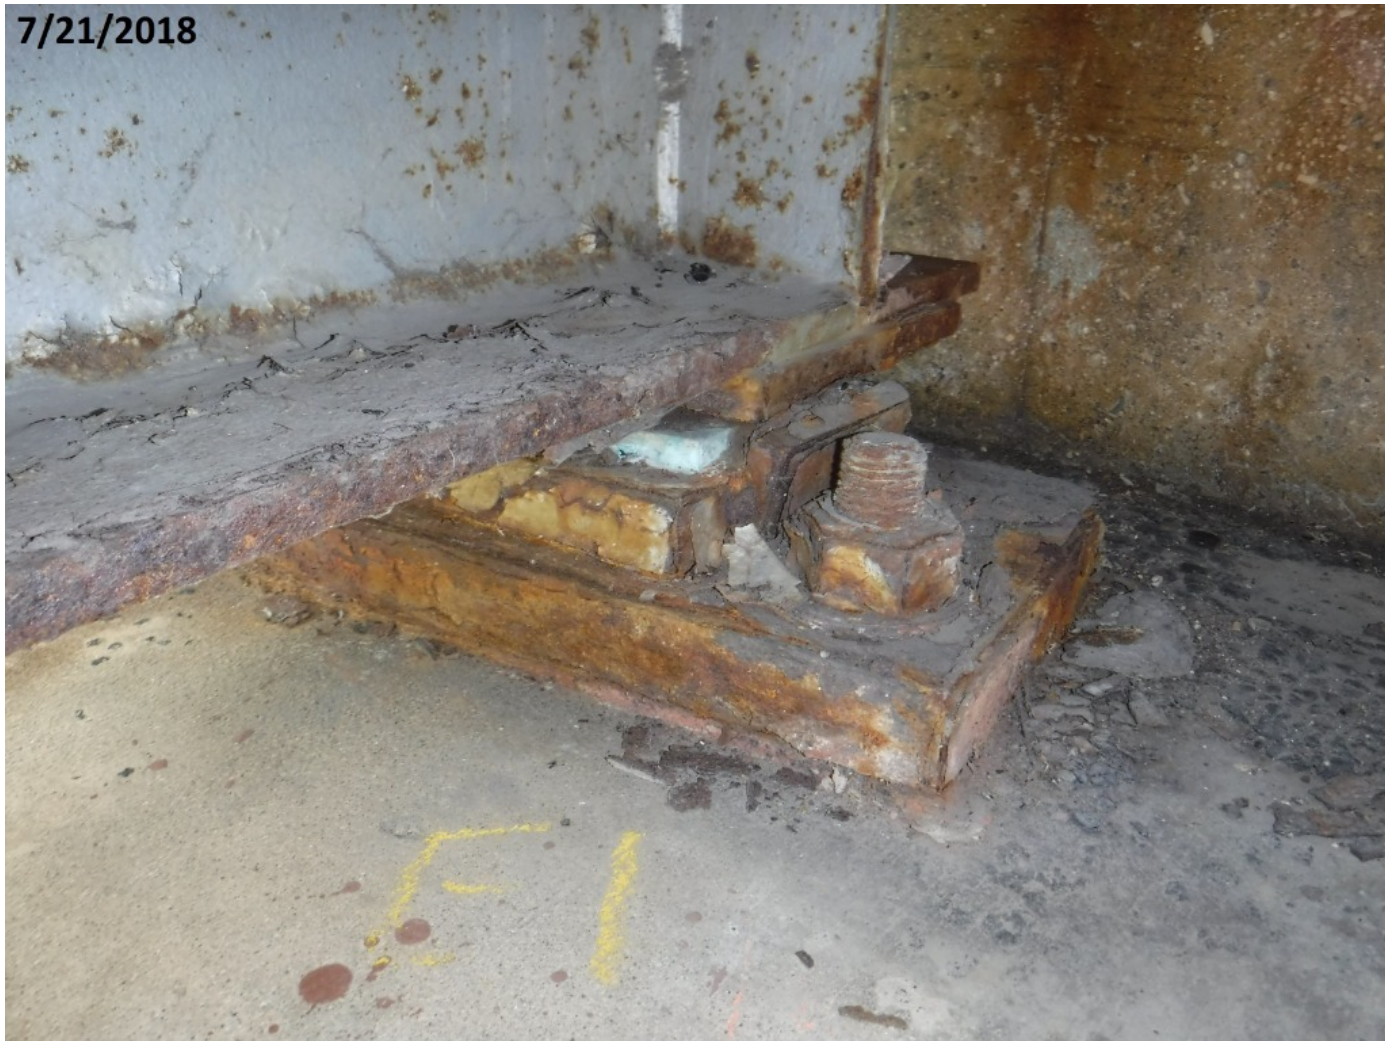
W. Abut: Hvy Rust @ G1, Mod Rust on G2-6 masonry plates - 5 @ CS2, 1 @ CS3. P1: Mod Rust - 6 @ CS2; P3: Lt Rust - 6 @ CS2; E. Abut: Mod/Hvy Rust - 4 @ CS2, 2 @ CS3;						
		1020	Connection	EA		0	0	0	0
			East Abut: Broken keeper G1. Pier 3: Broken keeper G6. West Abut: Broken keeper G1. Quantities overlap corrosion.						
		2220	Alignment	EA		0	0	6	0

E. Abut: Brgs at or past expansion limits.						
		2240	Loss of Bearing Area	EA		0	0	0	0
			E Abut: Hold down pins bearing at the back of slot. Bronze Plate loss of bearing 1/2" to 3/4".						
X	313		Fixed Bearing	EA	6	0	6	0	0
			Located at Pier 2						
		1000	Corrosion	EA		0	6	0	0
			Lt Rust - 6 @ CS2						
X	331		Reinforced Concrete Bridge Rail	LF	219	4	175	40	0
		1080	Delamination - Spall - Patched Area	LF		0	150	40	0

Moveable bearing: E Abut, G1. Corrosion, broken inside keeper, and loss of bearing 3/4" above bronze plate.

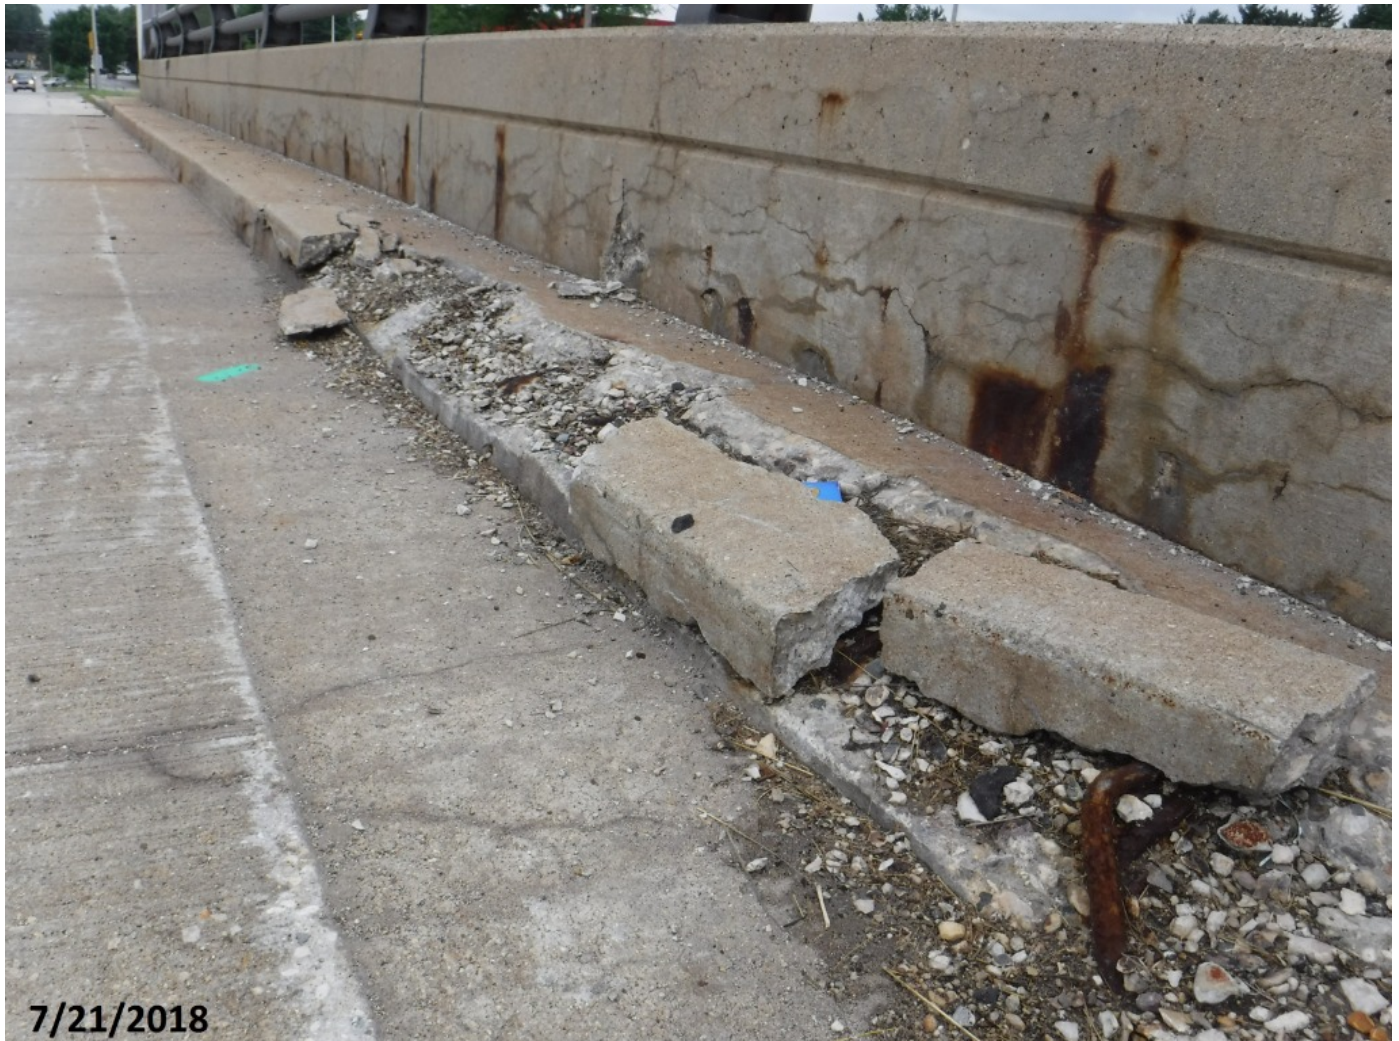
N. Rail: Rust stains at shallow rebars - 50' @ CS2; delams at curb face - 50' @ CS2, Spalls w/exp rebar at curb face - 30' @ CS3 S. Rail: Rust stains, shallow delams at Front face - 50' CS2						
		1130	Cracking (RC)	LF		194	25	0	0

RC Bridge Rail - N. Rail: Rust stains at shallow rebars, delams at curb face, Spalls w/exp rebar at curb face. Photo near middle of bridge.

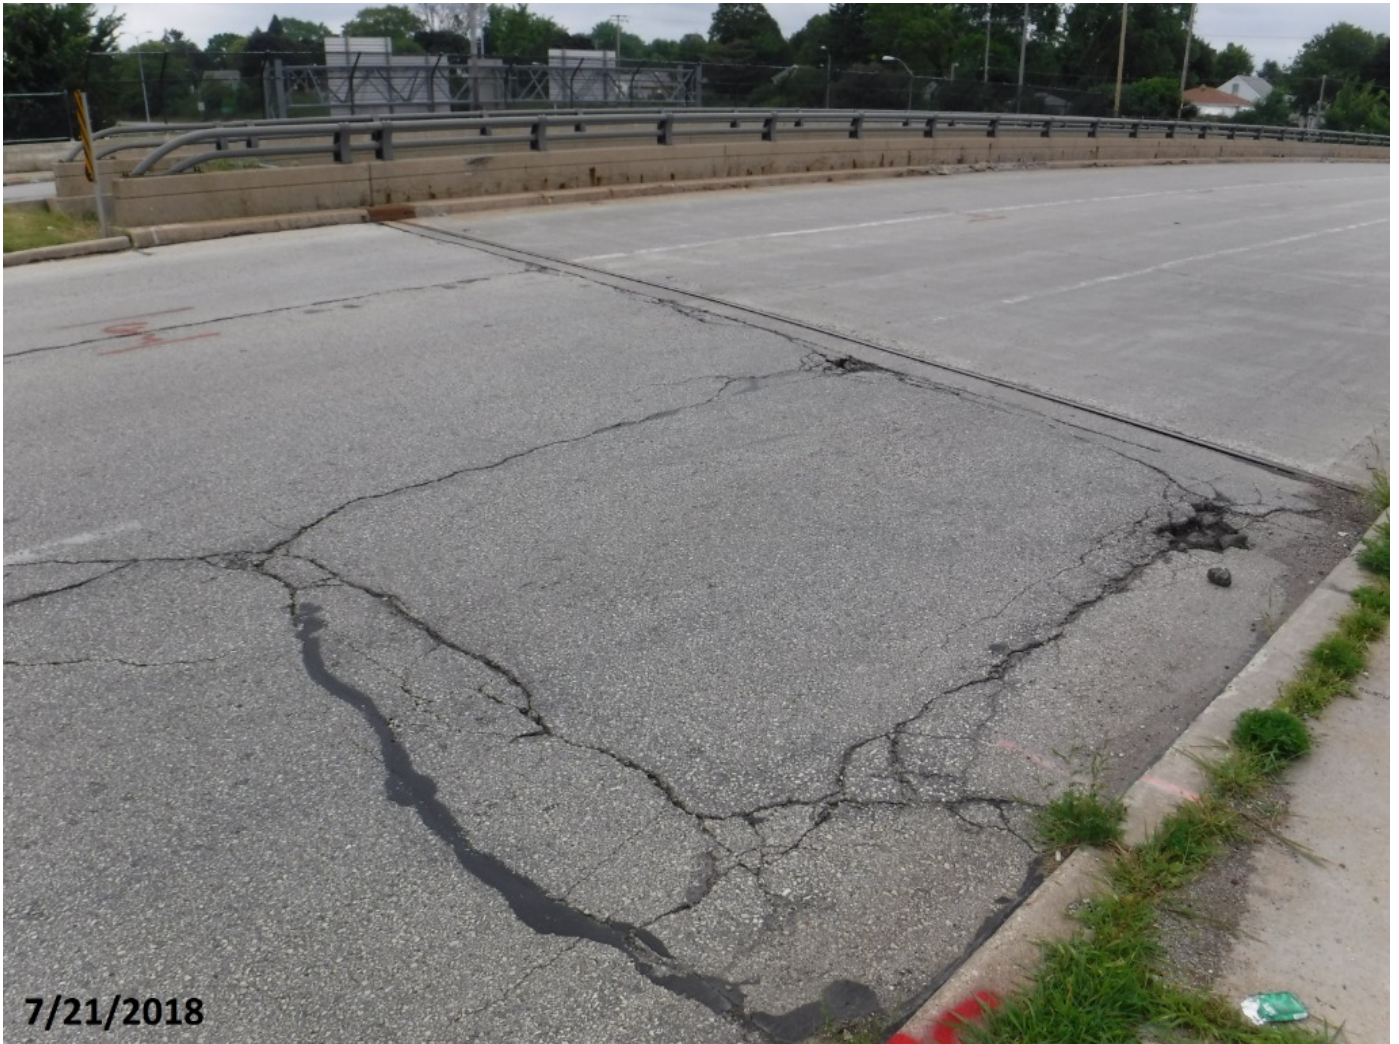
Asphalt Appr: Cracks and potholes forming at west appr.

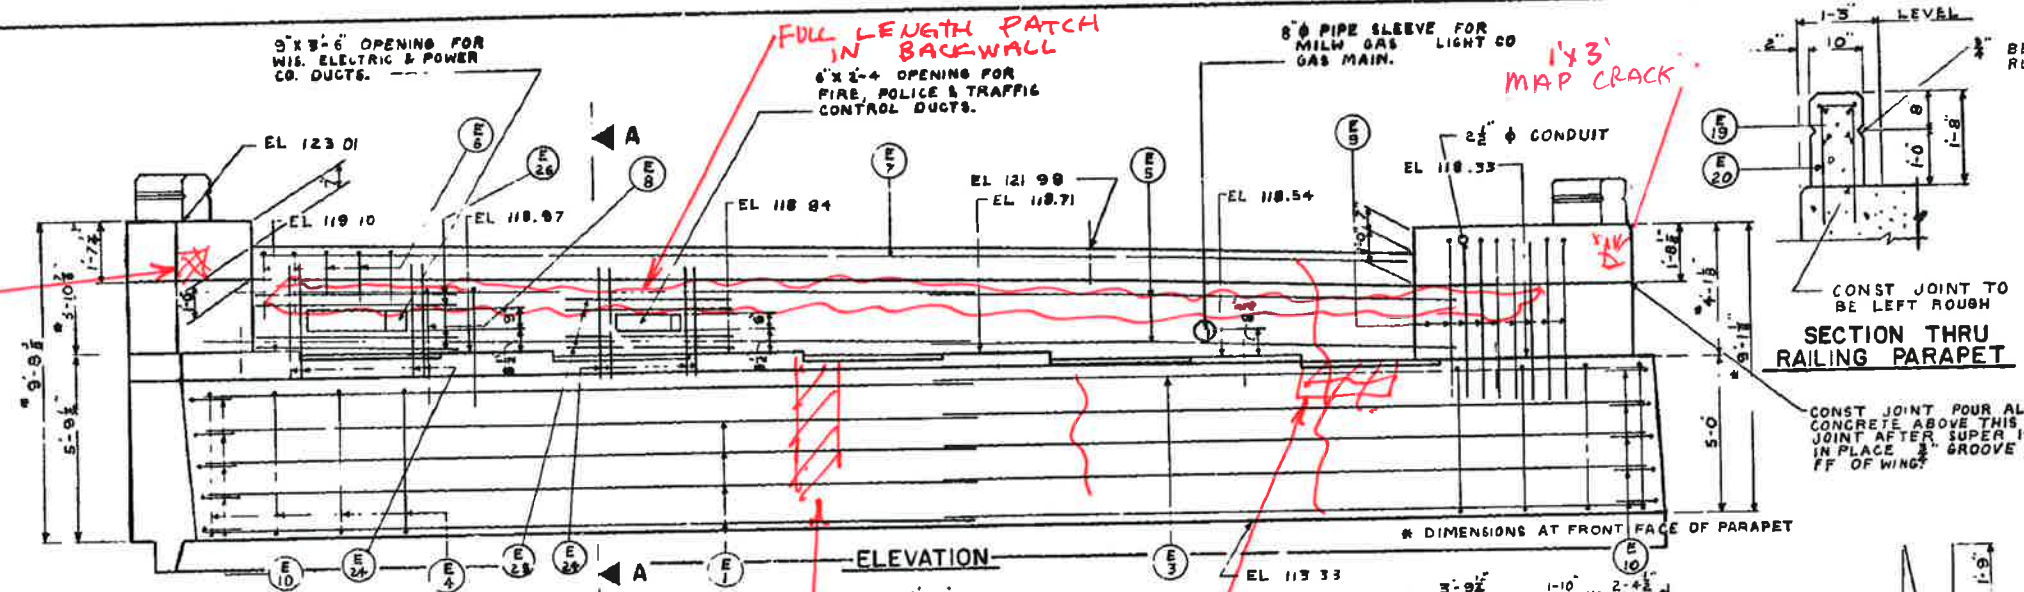
2'x1' SPALL

0.5'x3.5' DELAM

2'x1' DELAM

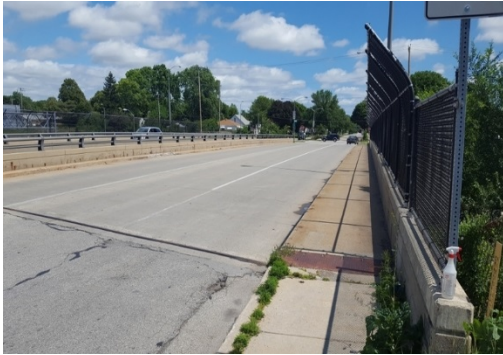
Black paint on pedestrian fence and railing

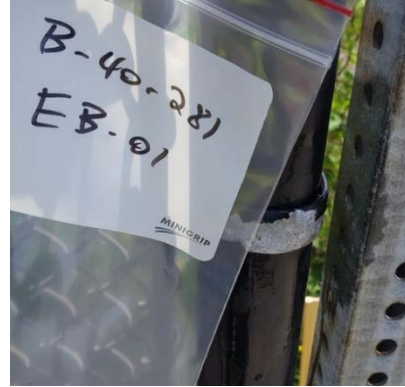
Caulk in parapet expansion joint and sidewalk joint

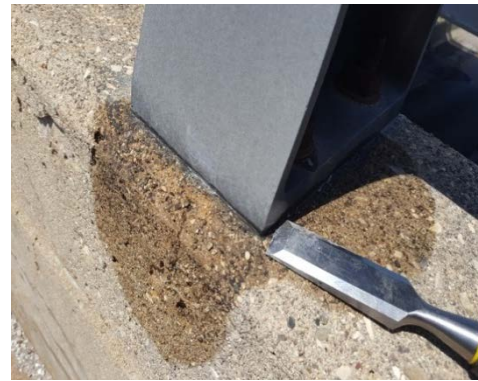
Gasket under railing attachment plate

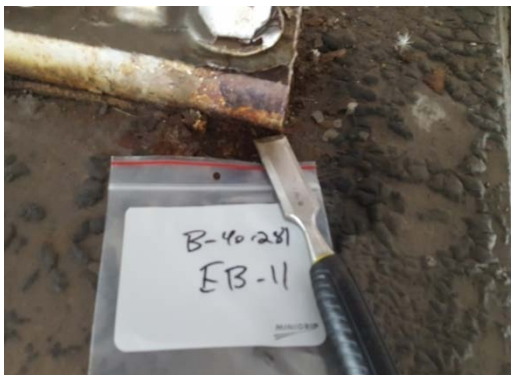
Tar on bearing support piers

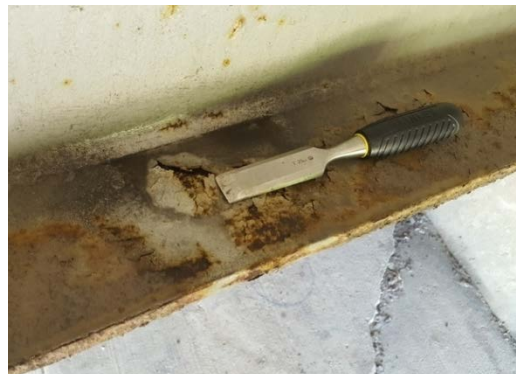
Silver paint on girder

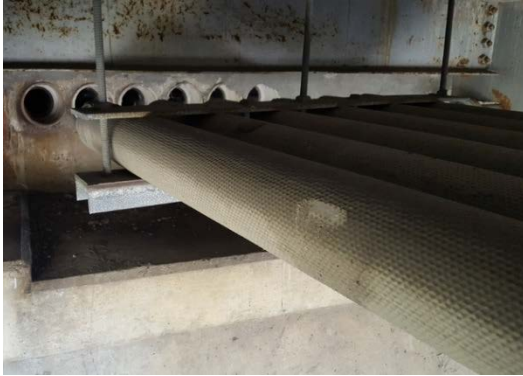
Transite piping

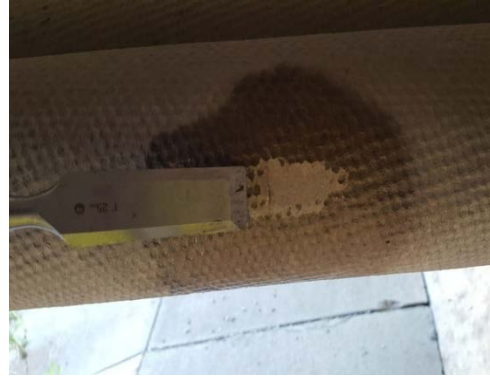
Transite piping
