From: [Parve, Lance - DOT](#)
To: [Mohammed H. Zaghloul, S.E., P.E.](#)
Subject: FW: For your Review and Comments from Consultant - 1090-05-02/72 and 1090-35-00/70 I-43 Rock Freeway Bridges: Rehab Items - feel free to further comment
Date: Monday, March 25, 2019 9:38:02 AM

WisDOT Project ID: 1090-05-02
Structure Number: B-40-0376
Structure Name: 124th Street over IH 43
City/County: City of Greenfield, Milwaukee County
Lat/Long Coordinates: 425726.39/ 880408.99
TRC Project Number: 258938.0000.0000
Date Inspected: June 21, 2016
Inspected By/License Number: John Roelke, All-119523

Inspection Report for B-40-376

S 124TH ST over IH 43
Mar 28, 2018

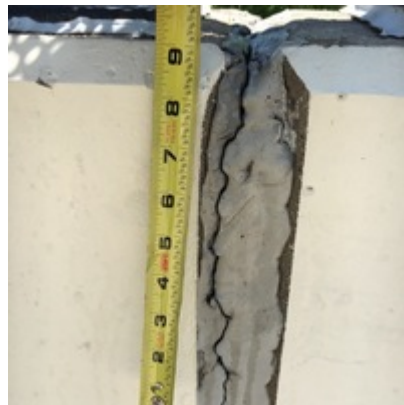
Caulk in abutment joint

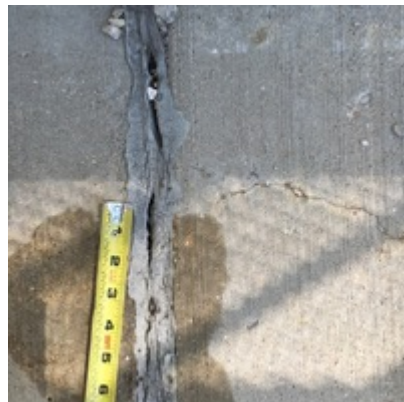
Caulk in parapet and sidewalk joints

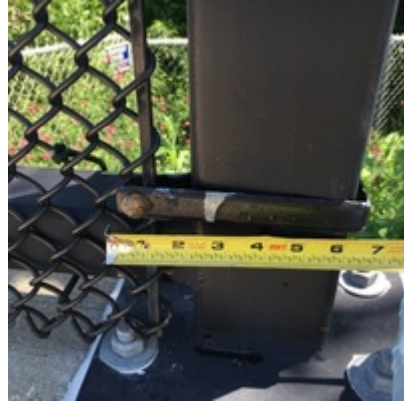
Black paint on pedestrian fence

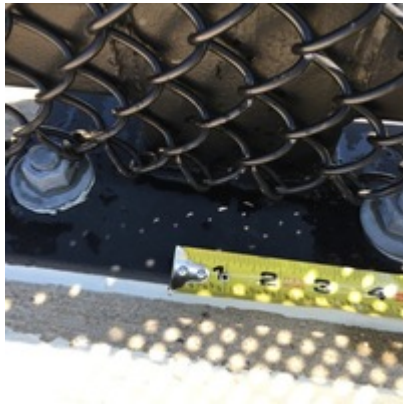
Caulk around pedestrian fence attachment plate and around bolts in plate (did not observe any gaskets under plate)

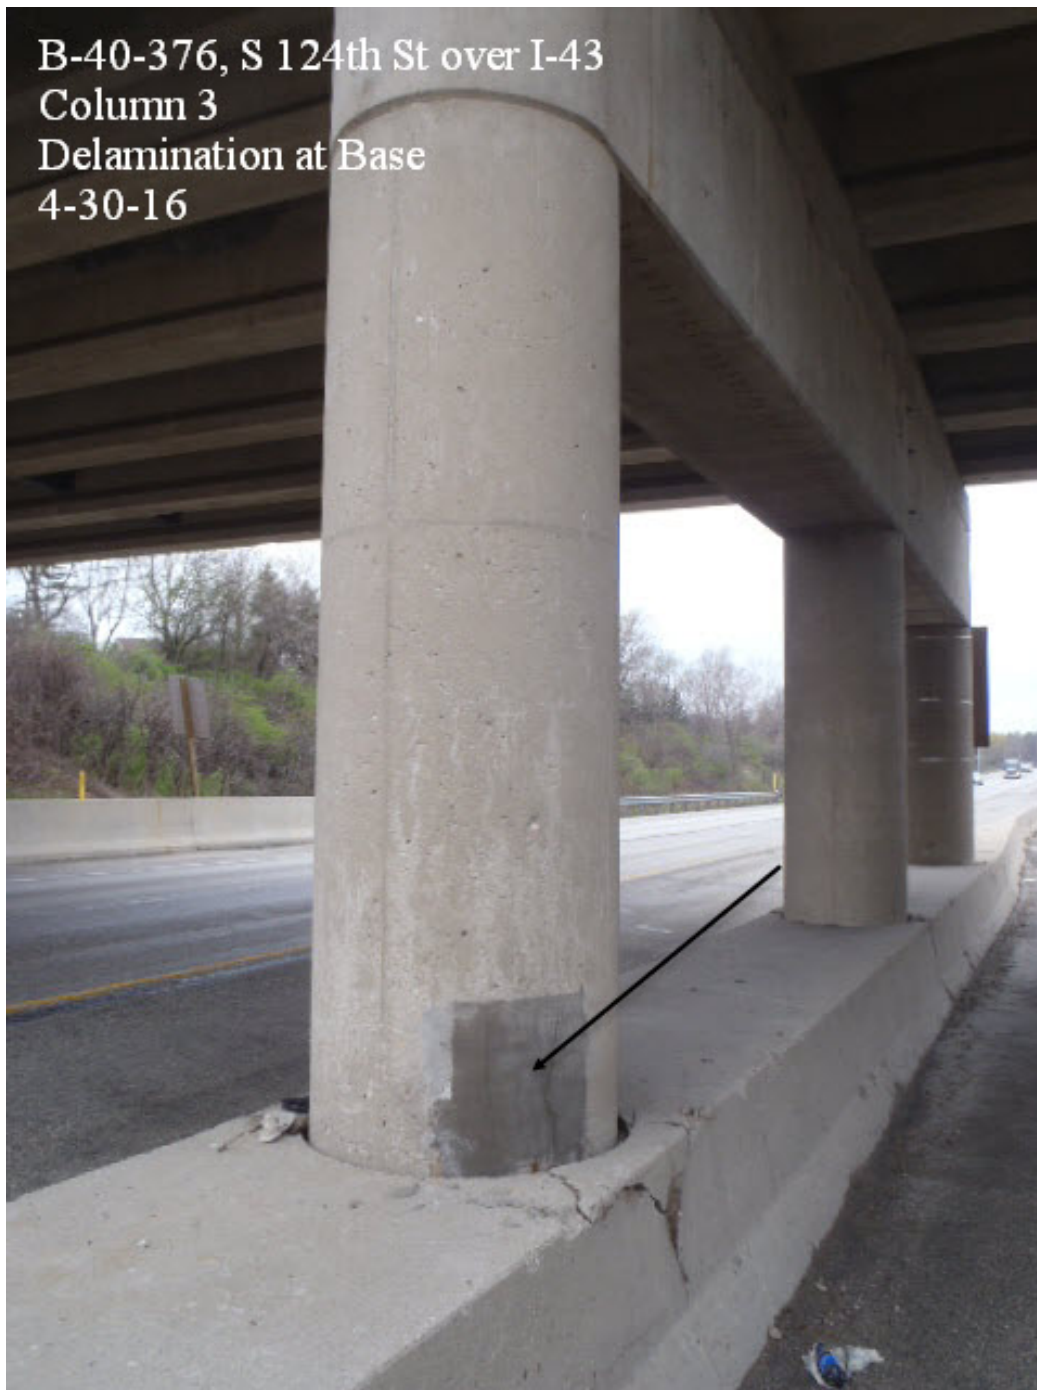
Pier, Column 3.
Photo copied from 2016 inspection report - no change 2018.

2. Repair failed patch at the pier (column 3) This would be done under the Concrete Surface Repair item.
3. Place AC curb at SW wing tip Could be done with milling and overlaying the approaches.

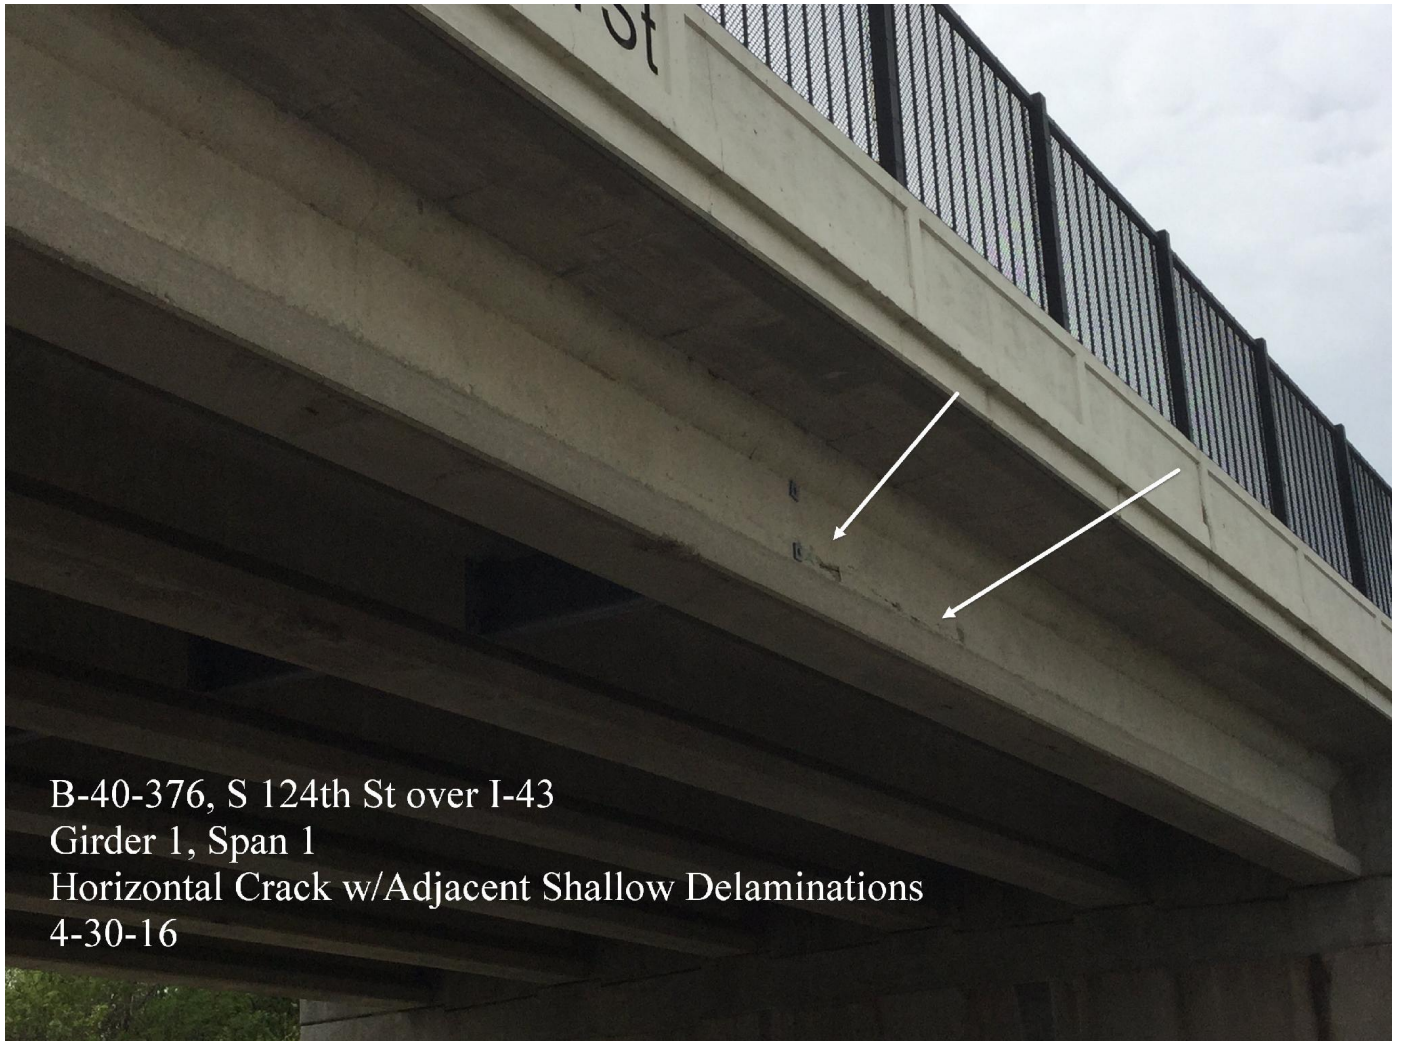
Girder 1, Span 1.
Photo copied from 2016 inspection report - no change 2018.

B-40-376, S 124th St over I-43
Girder 1, Span 1
Horizontal Crack w/Adjacent Shallow Delaminations
4-30-16

Cracks in the girders should be filled using the Epoxy Crack Injection item. (This crack filling would only be used on the girders – not abutments or other reinforced concrete elements such as parapets.)

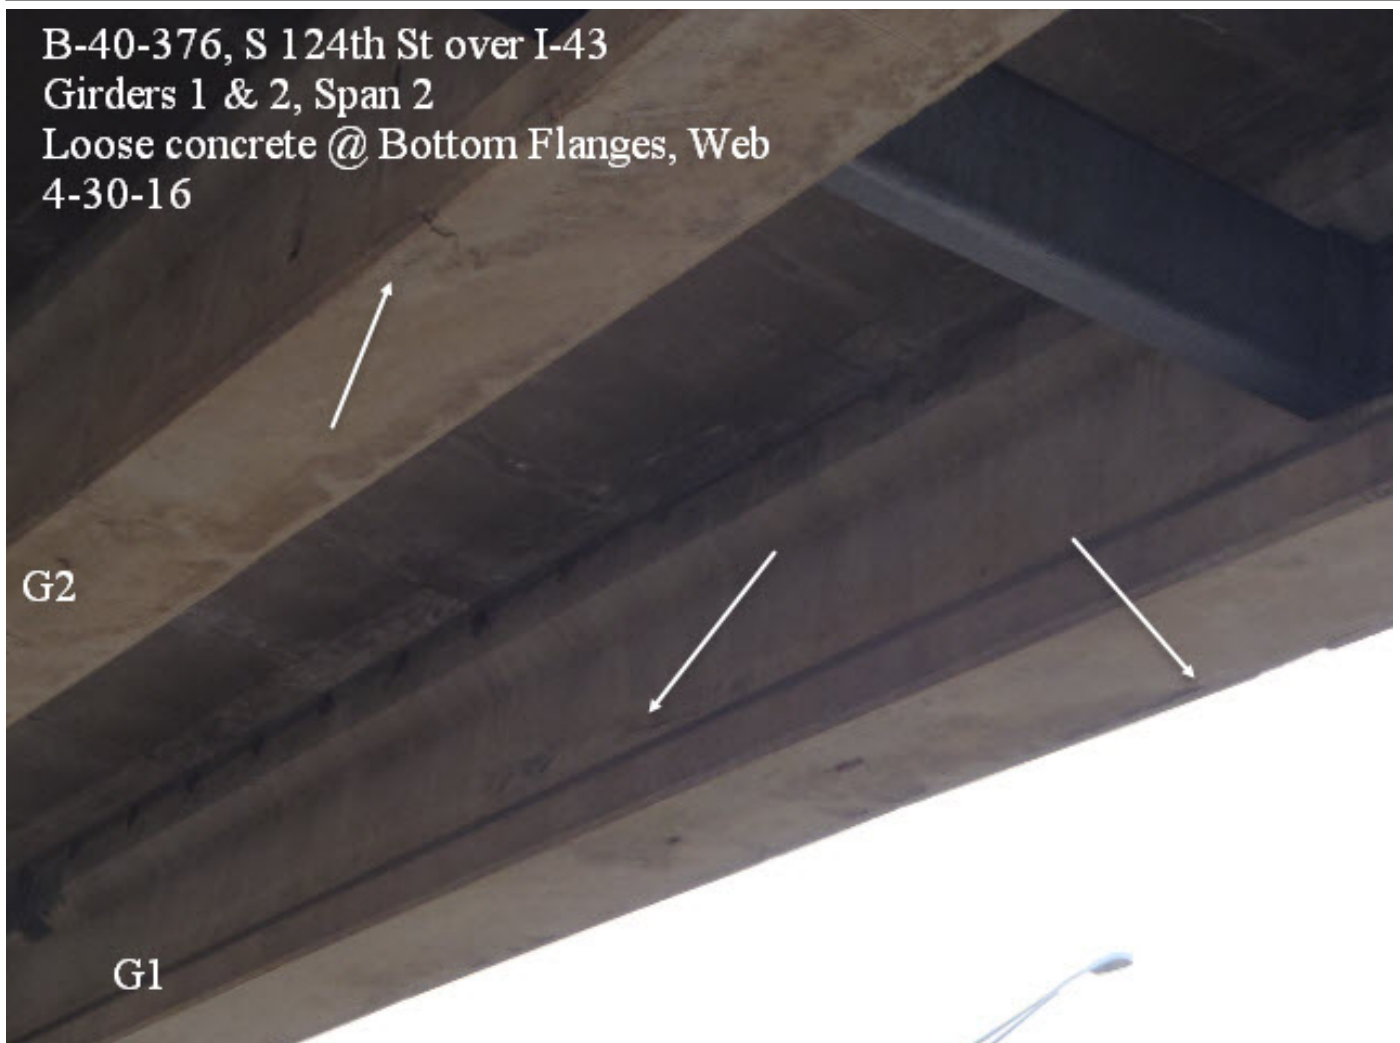
Girders 1 & 2, Span 2.
Photo copied from 2016 inspection report - no change 2018.

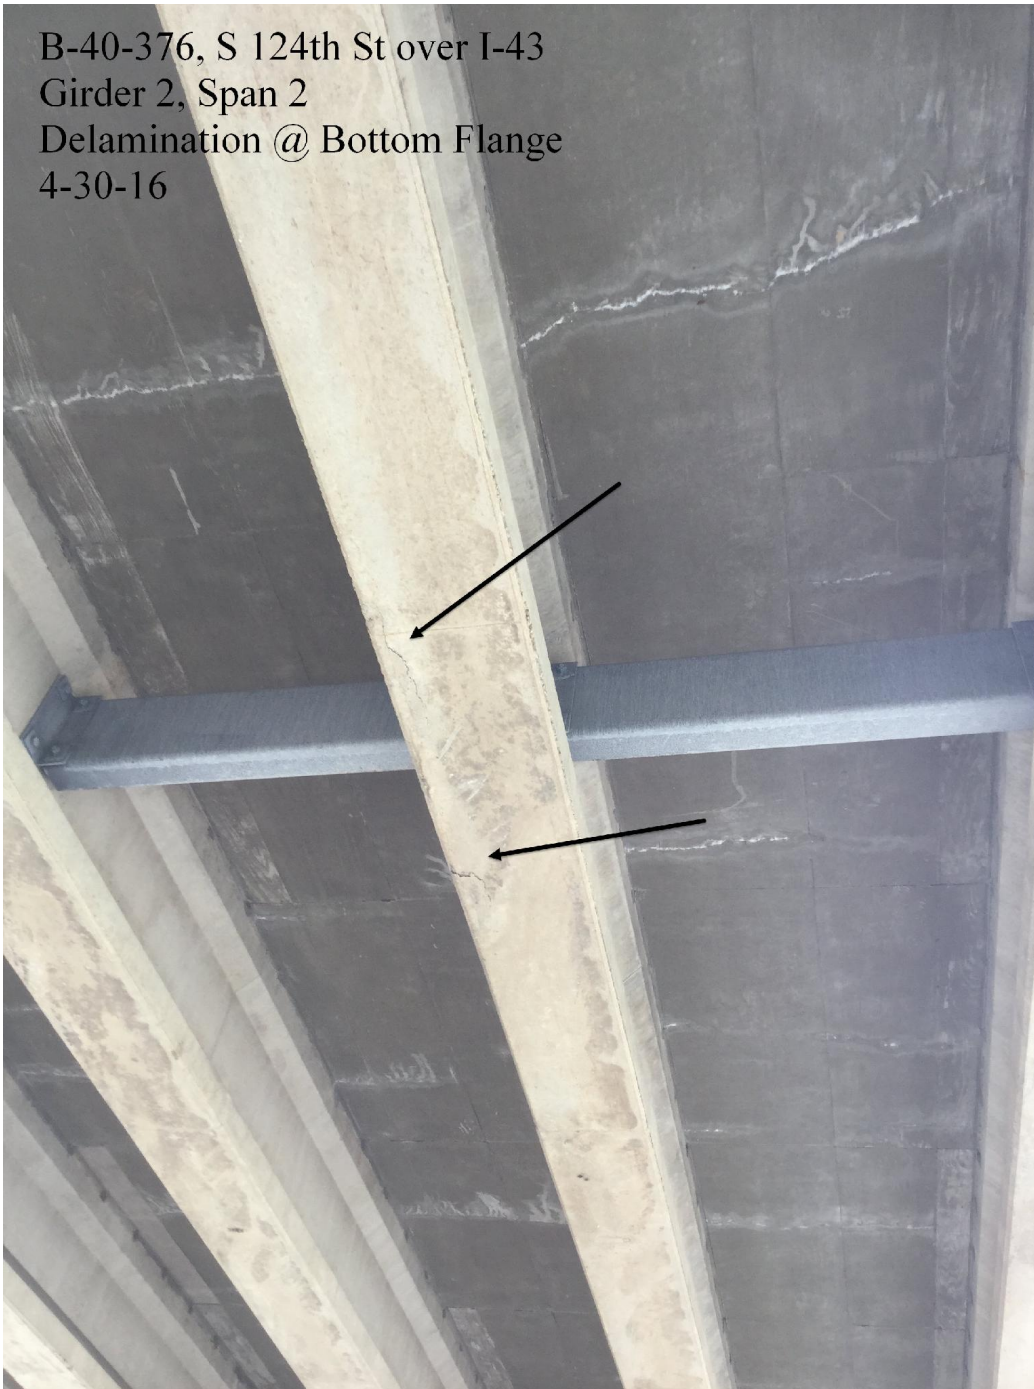
Girder 2, Span 2.
Photo copied from 2016 inspection report - no change 2018.

B-40-376, S 124th St over I-43
Girder 2, Span 2
Delamination @ Bottom Flange
4-30-16

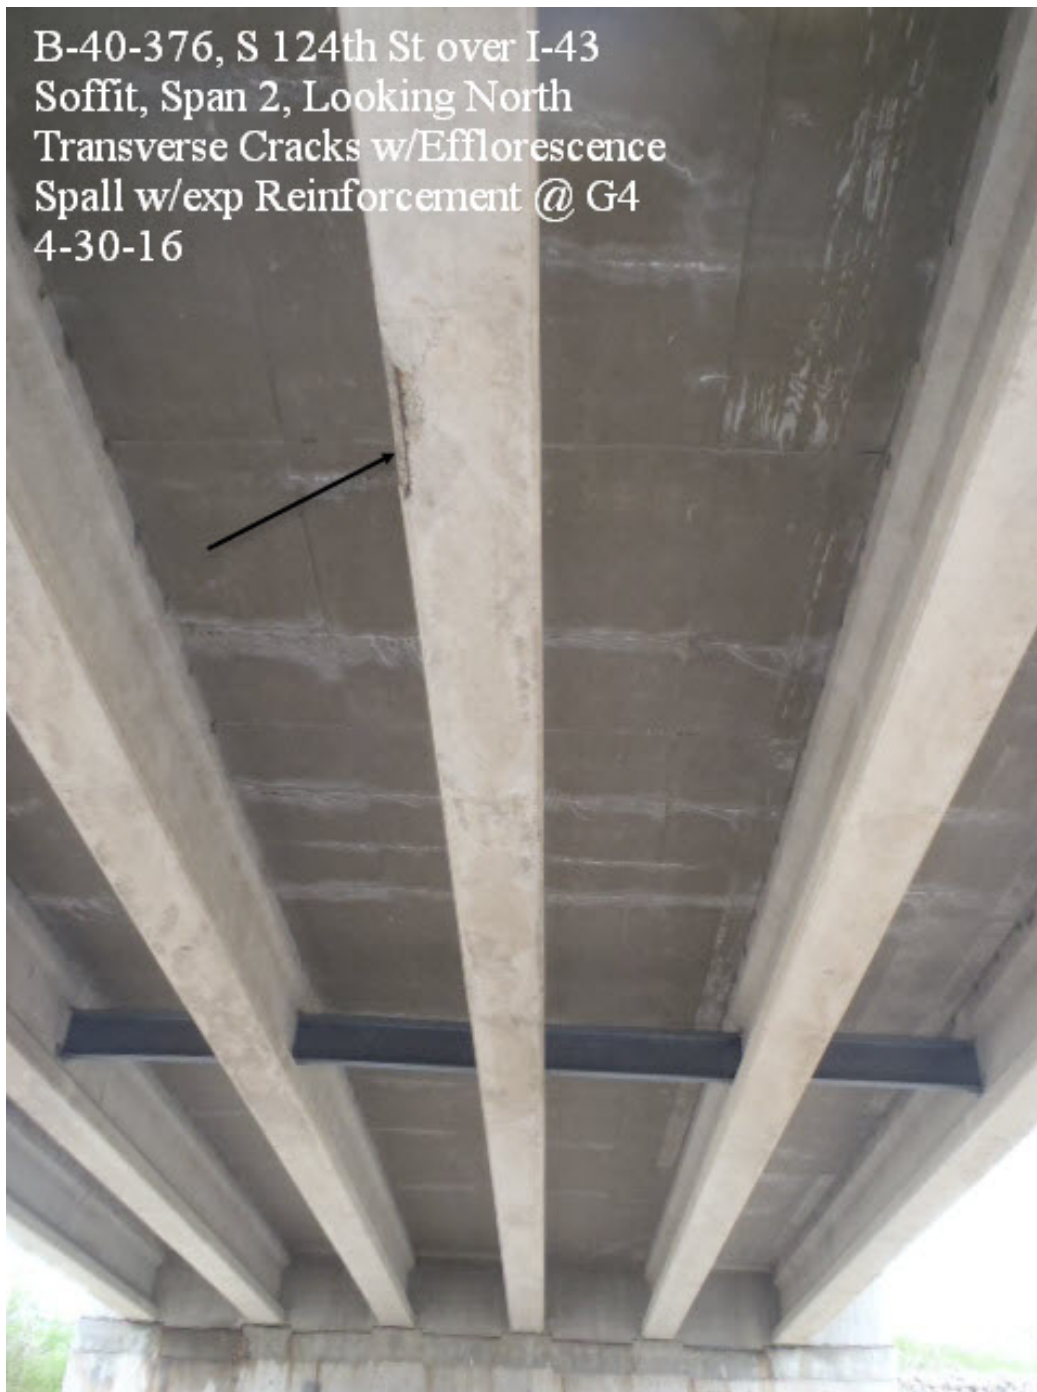
Girder 4, Span 2.'
Photo copied from 2016 inspection report - no change 2018.

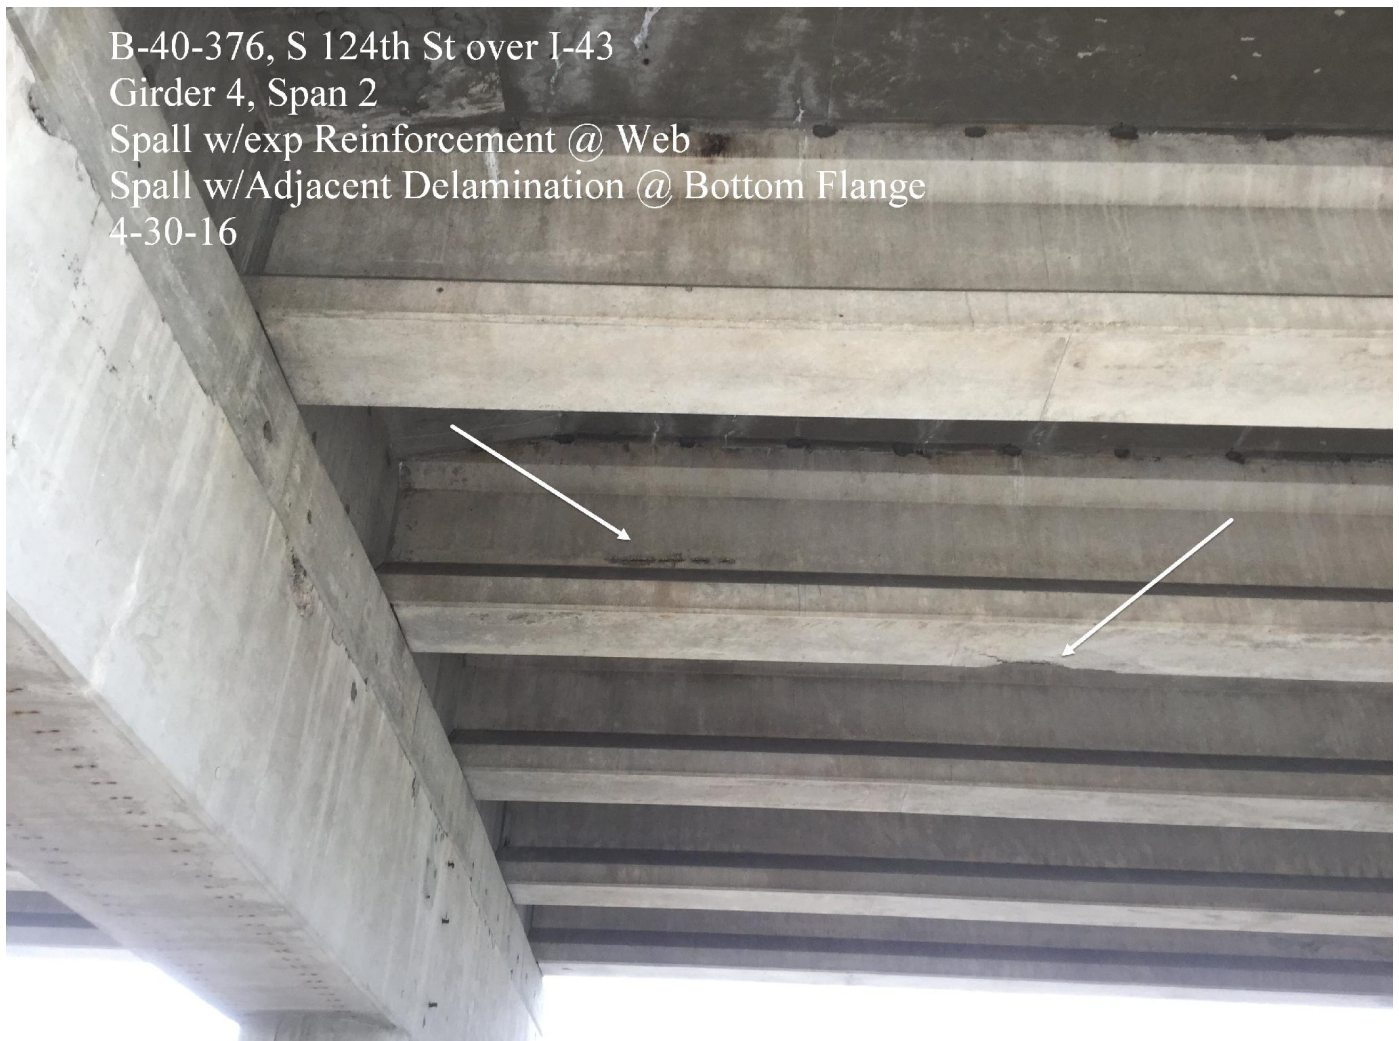
Girder 4, Span 2.
Photo copied from 2016 inspection report - no change 2018.

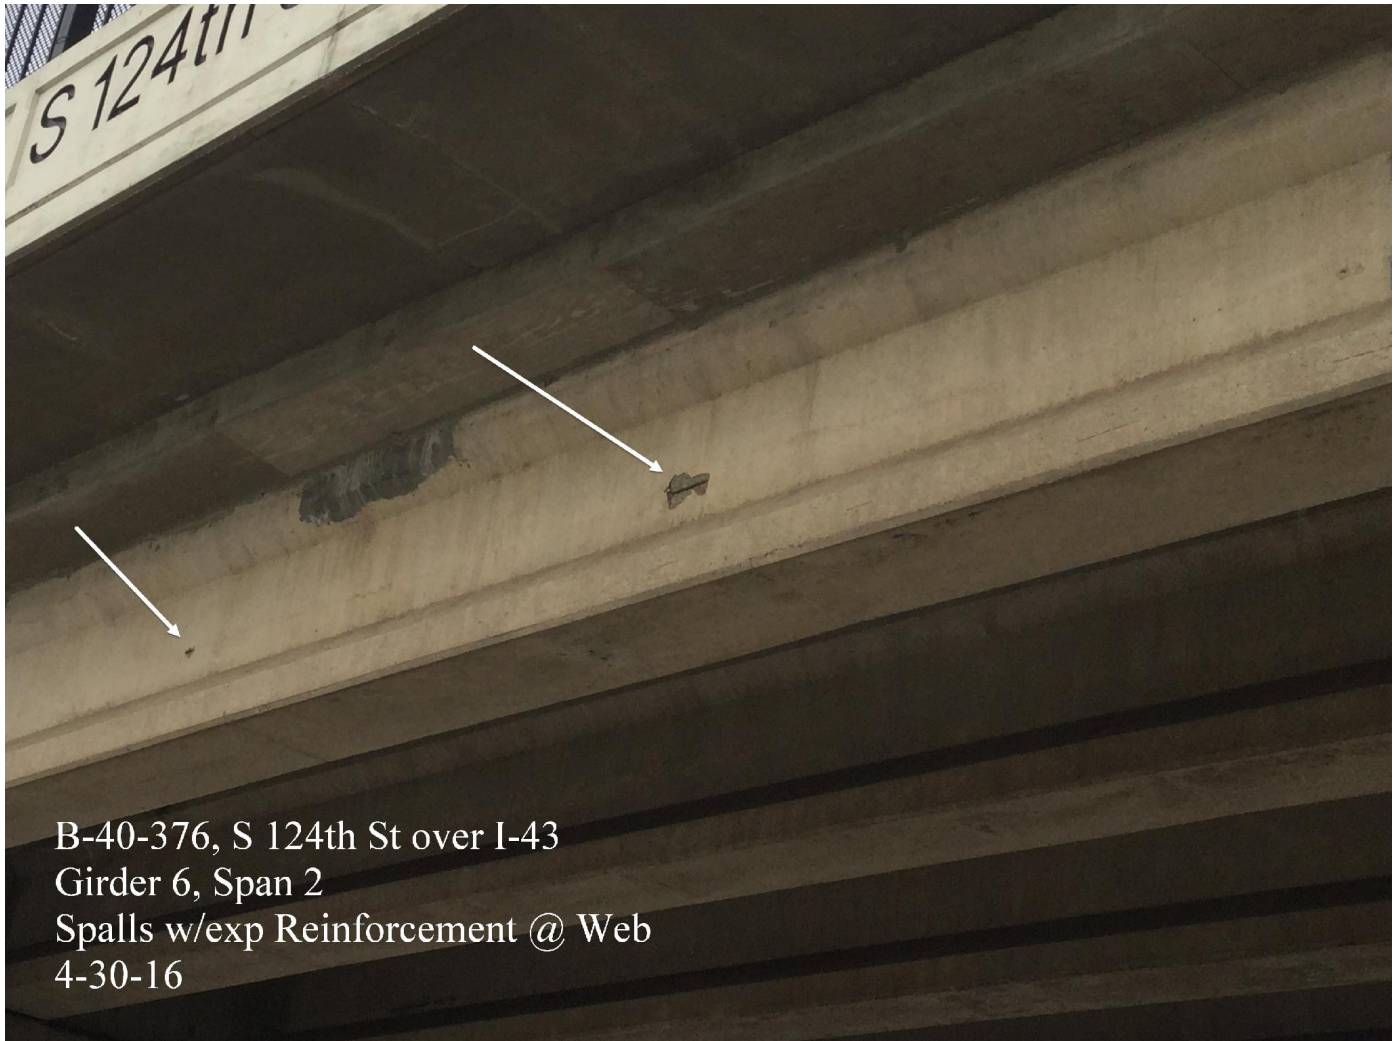
Girder 6, Span 2.
Photo copied from 2016 inspection report - no change 2018.

B-40-376, S 124th St over I-43
Girder 6, Span 2
Spalls w/exp Reinforcement @ Web
4-30-16

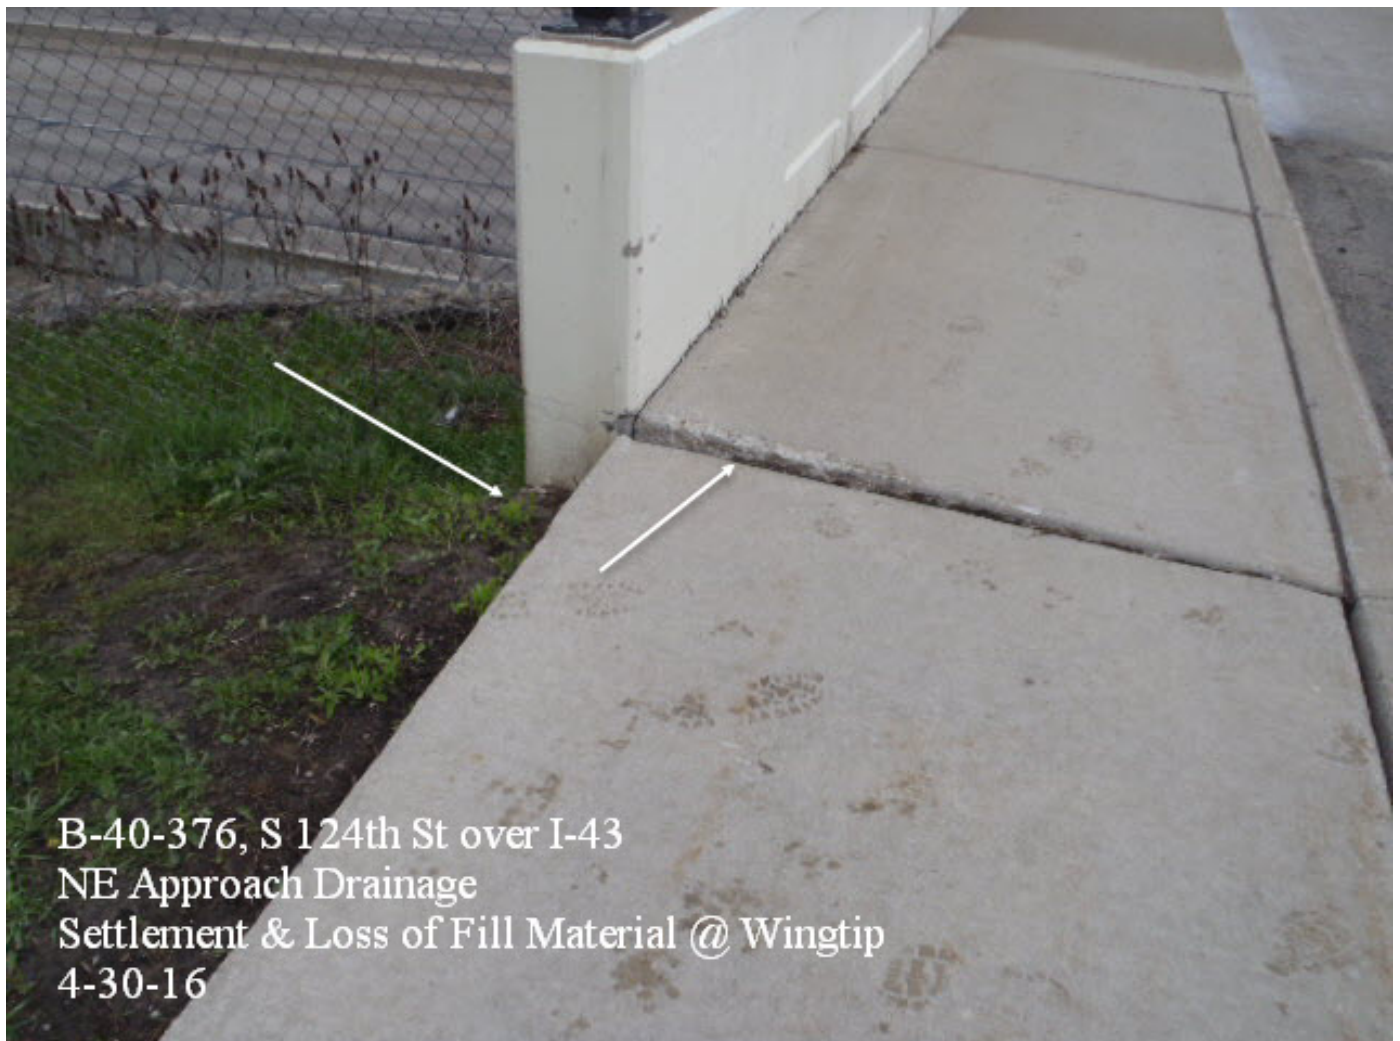
NE Approach Drainage.
Photo copied from 2016 inspection report - no change 2018.

4. Repair approaches from settlement and drainage issues Since the approaches are settling, they should be milled and overlaid.
5. Seal approaches at paving blocks Could be included with milling and overlaying approach.

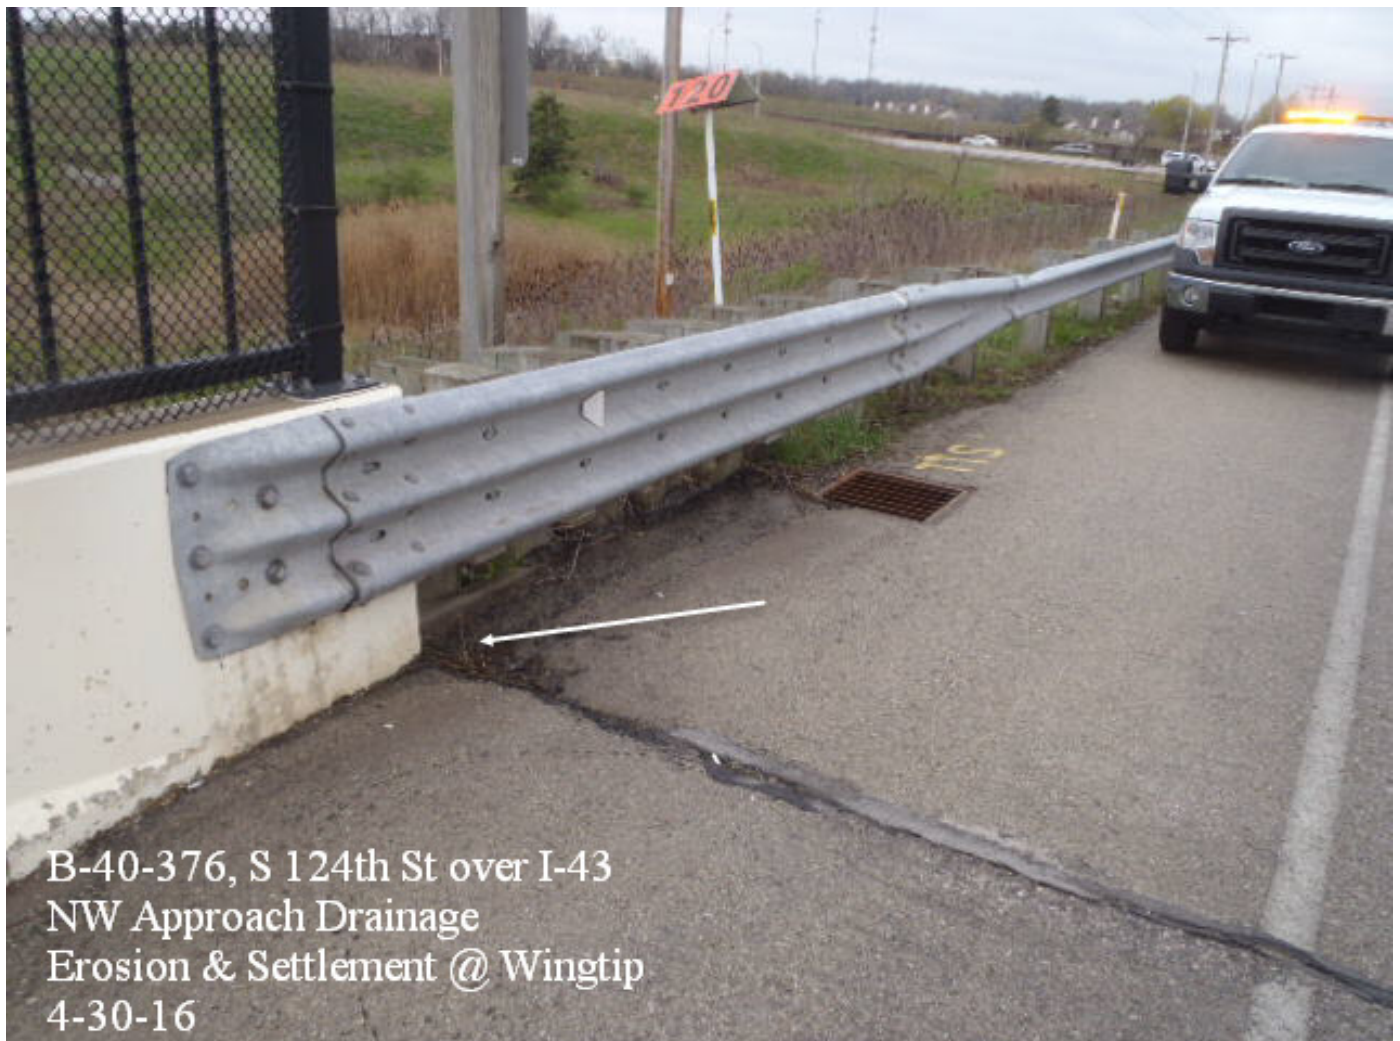
NW Approach Drainage.
Photo copied from 2016 inspection report - no change 2018.

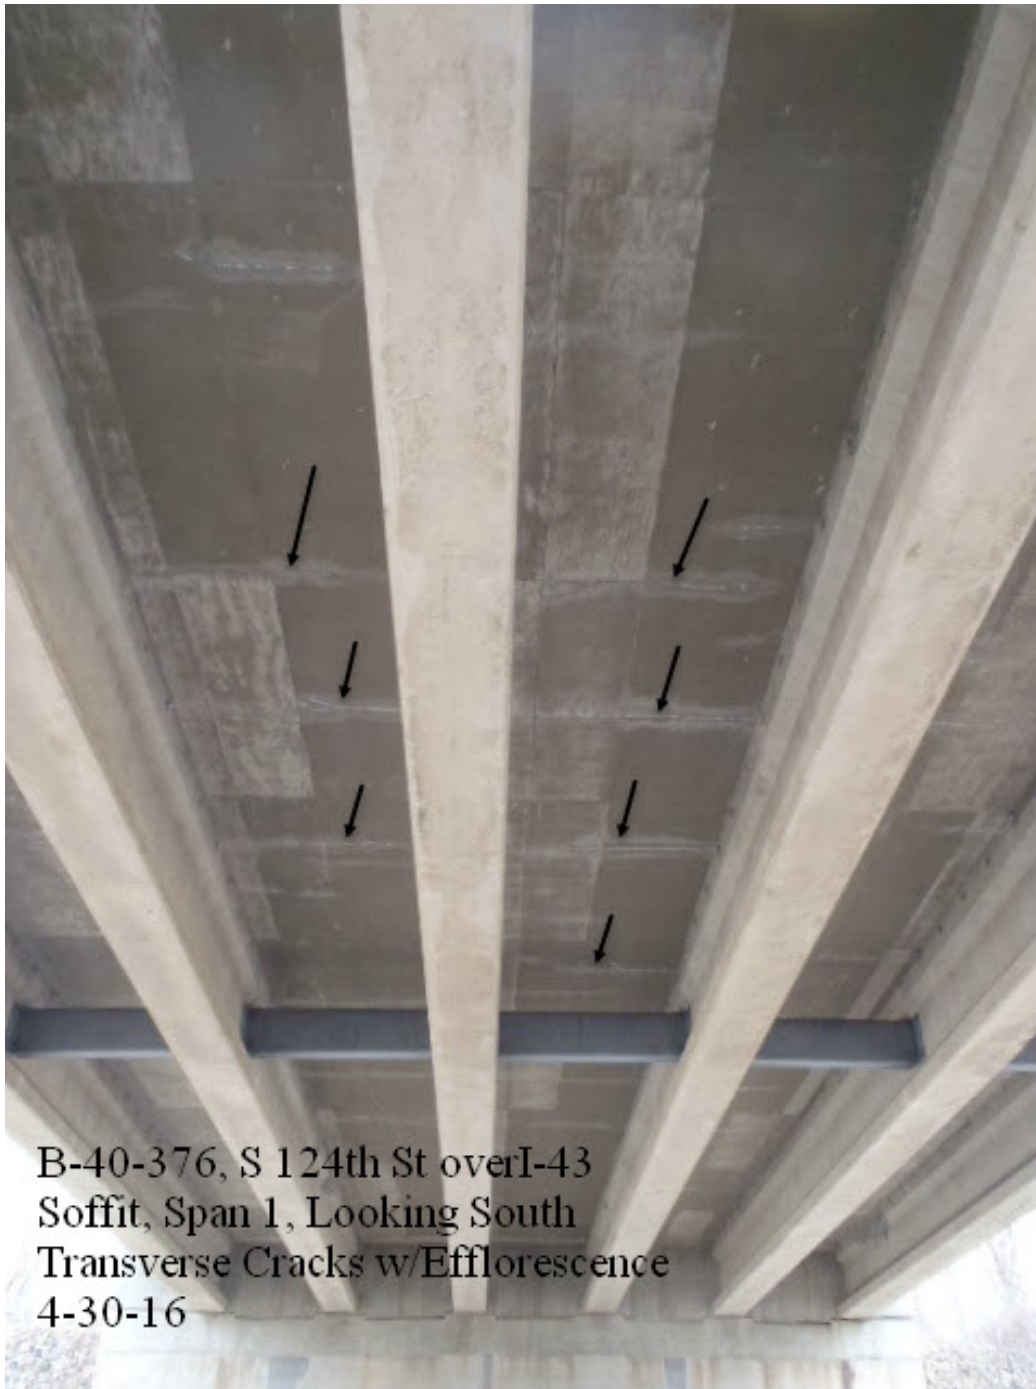
Soffit, Span 1.
Photo copied from 2016 inspection report - no change 2018.

B-40-376, S 124th St over I-43
Soffit, Span 1, Looking South
Transverse Cracks w/Efflorescence
4-30-16

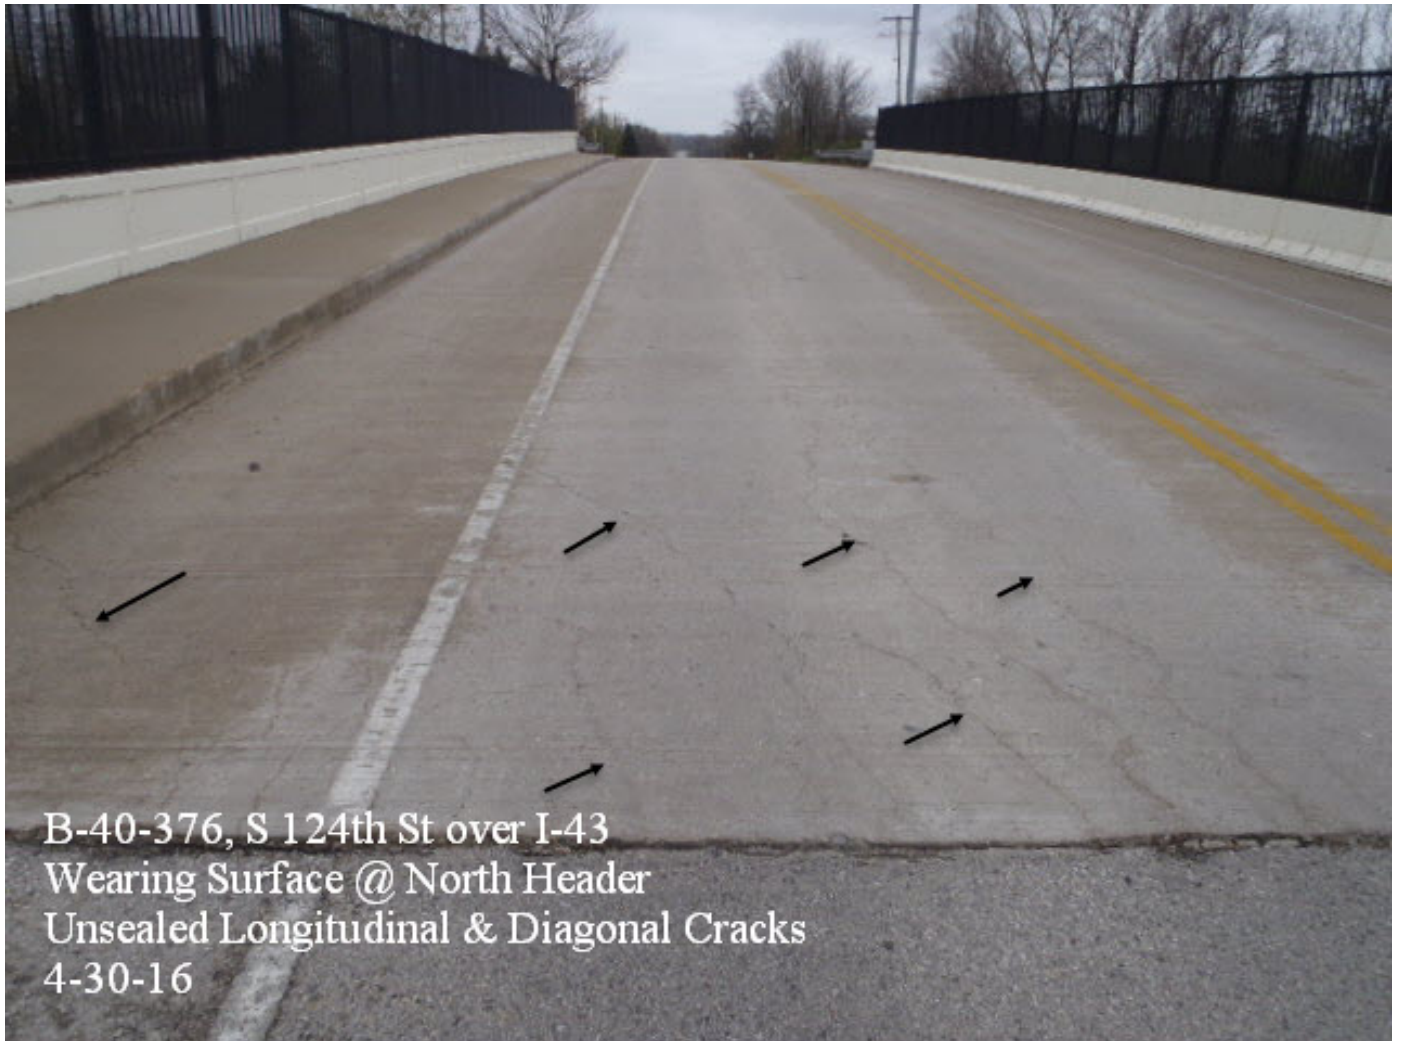
Wearing Surface.
Photo copied from 2016 inspection report - no change 2018.
