ROUTINE INSPECTION REPORT

Inspection Report for  
**B-52-035**

**STH 56 over FANCY CREEK**  
Mar 08,2018

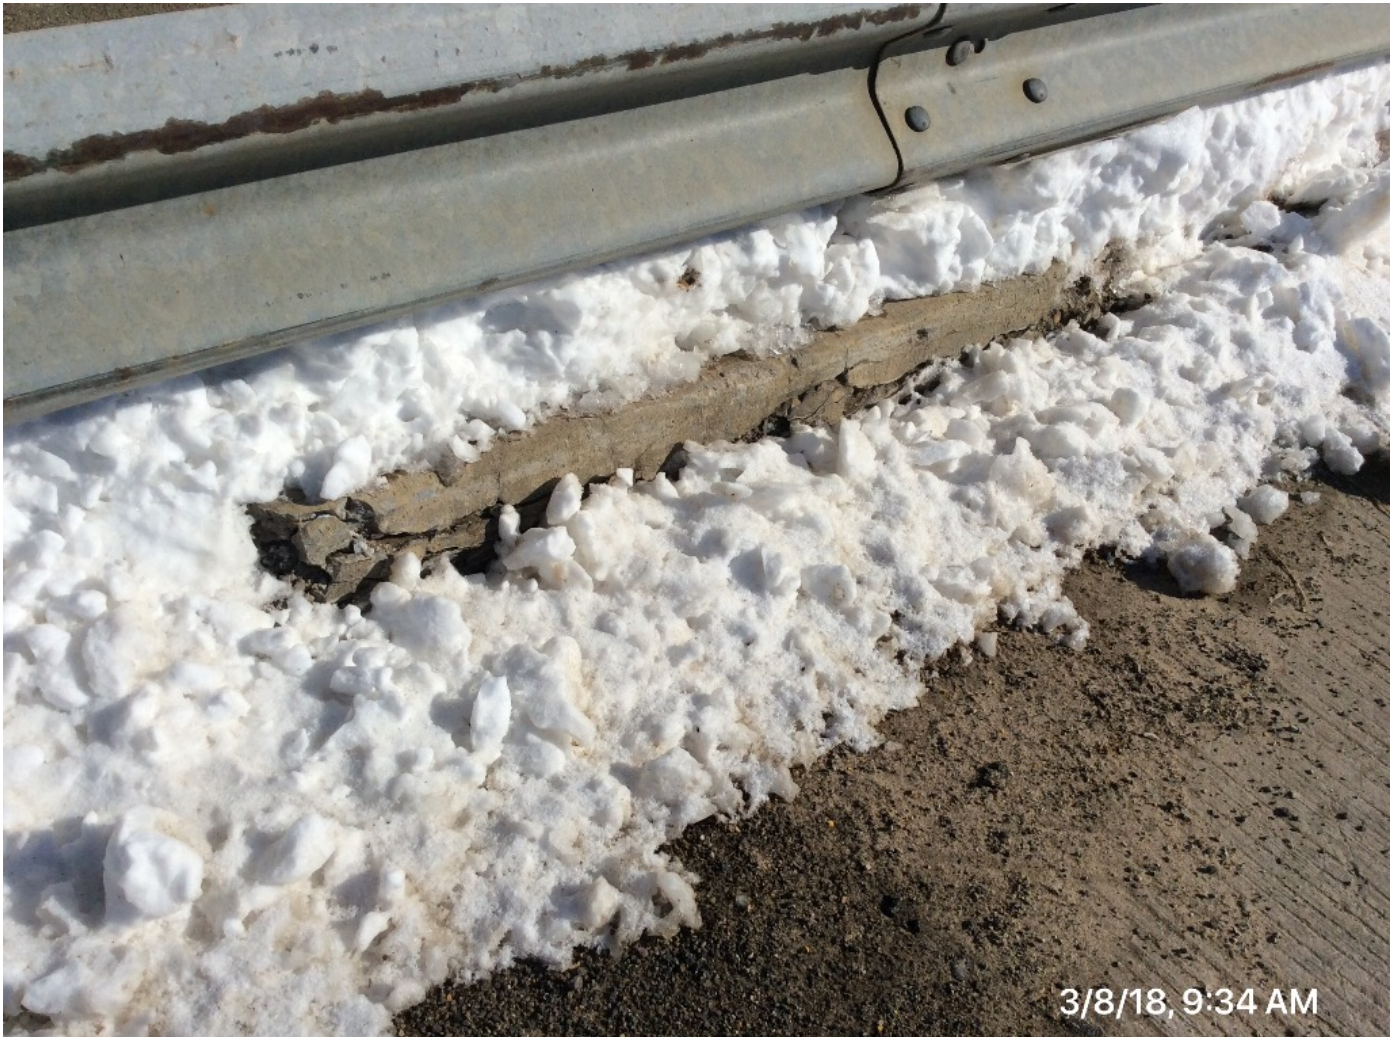
Spalled curb along north parapet.

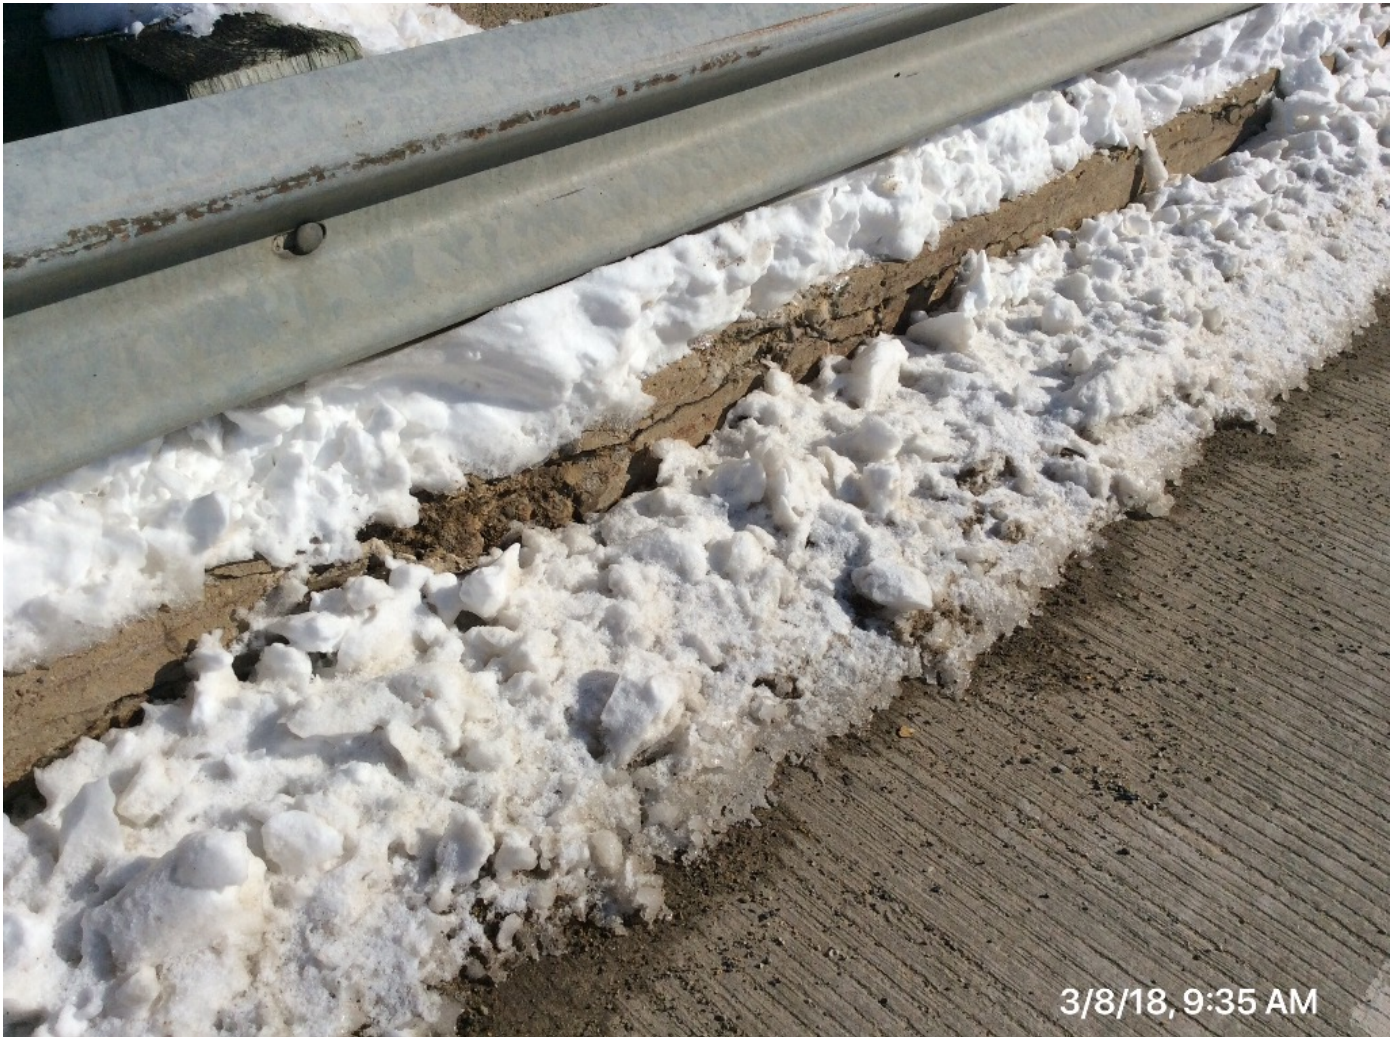
Spalling curb along north parapet

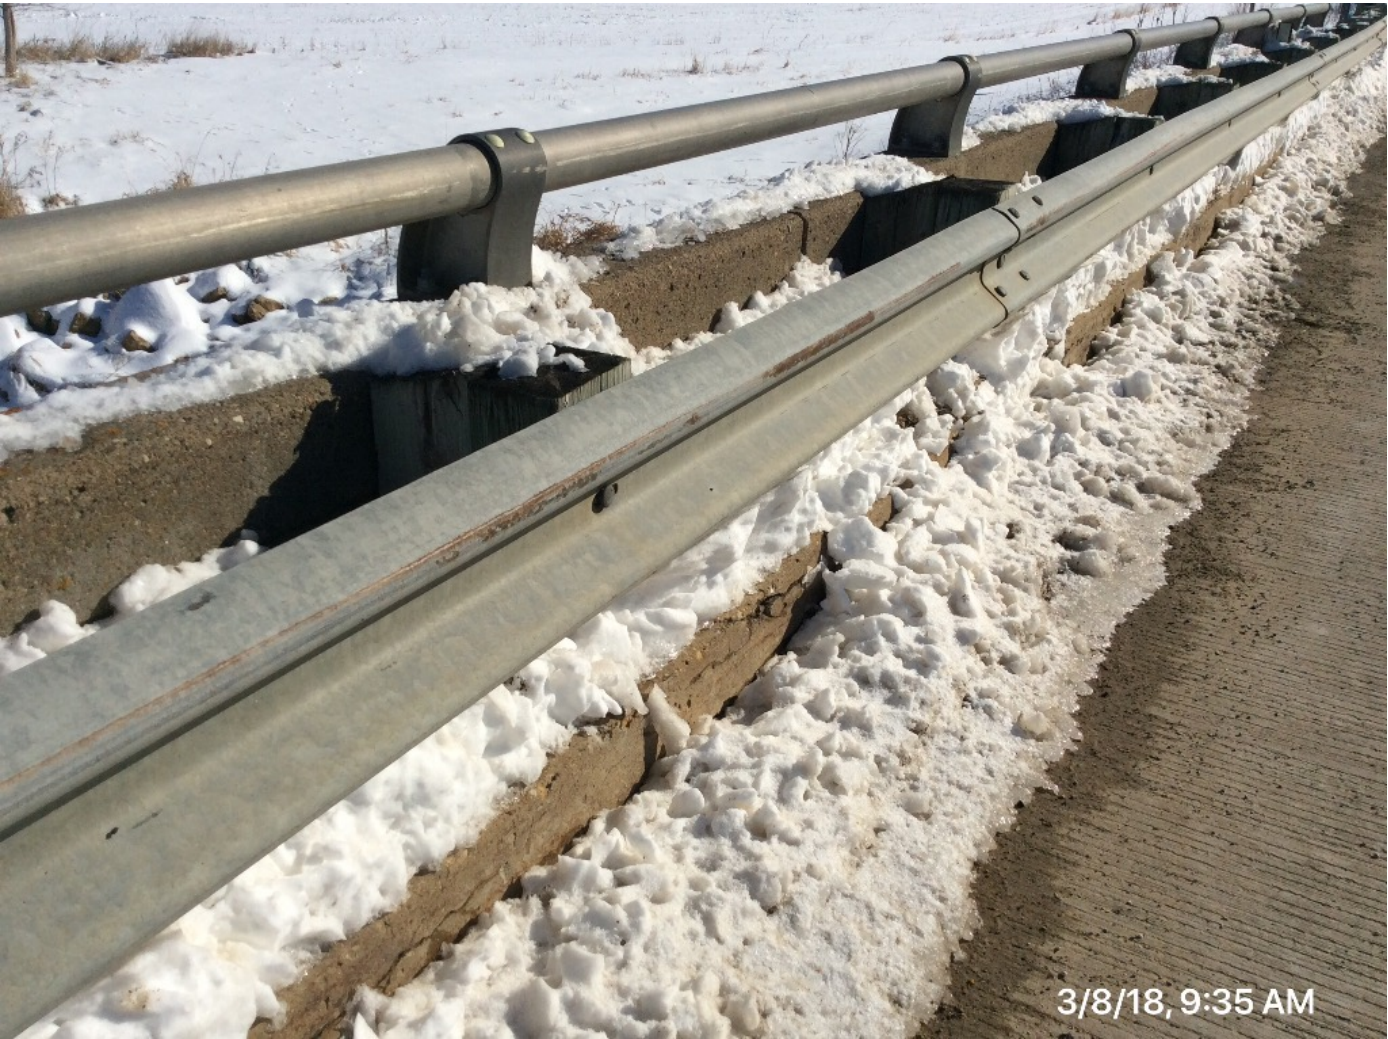
Routine  
Document Comment/Description  
Corrosion on beam guard.

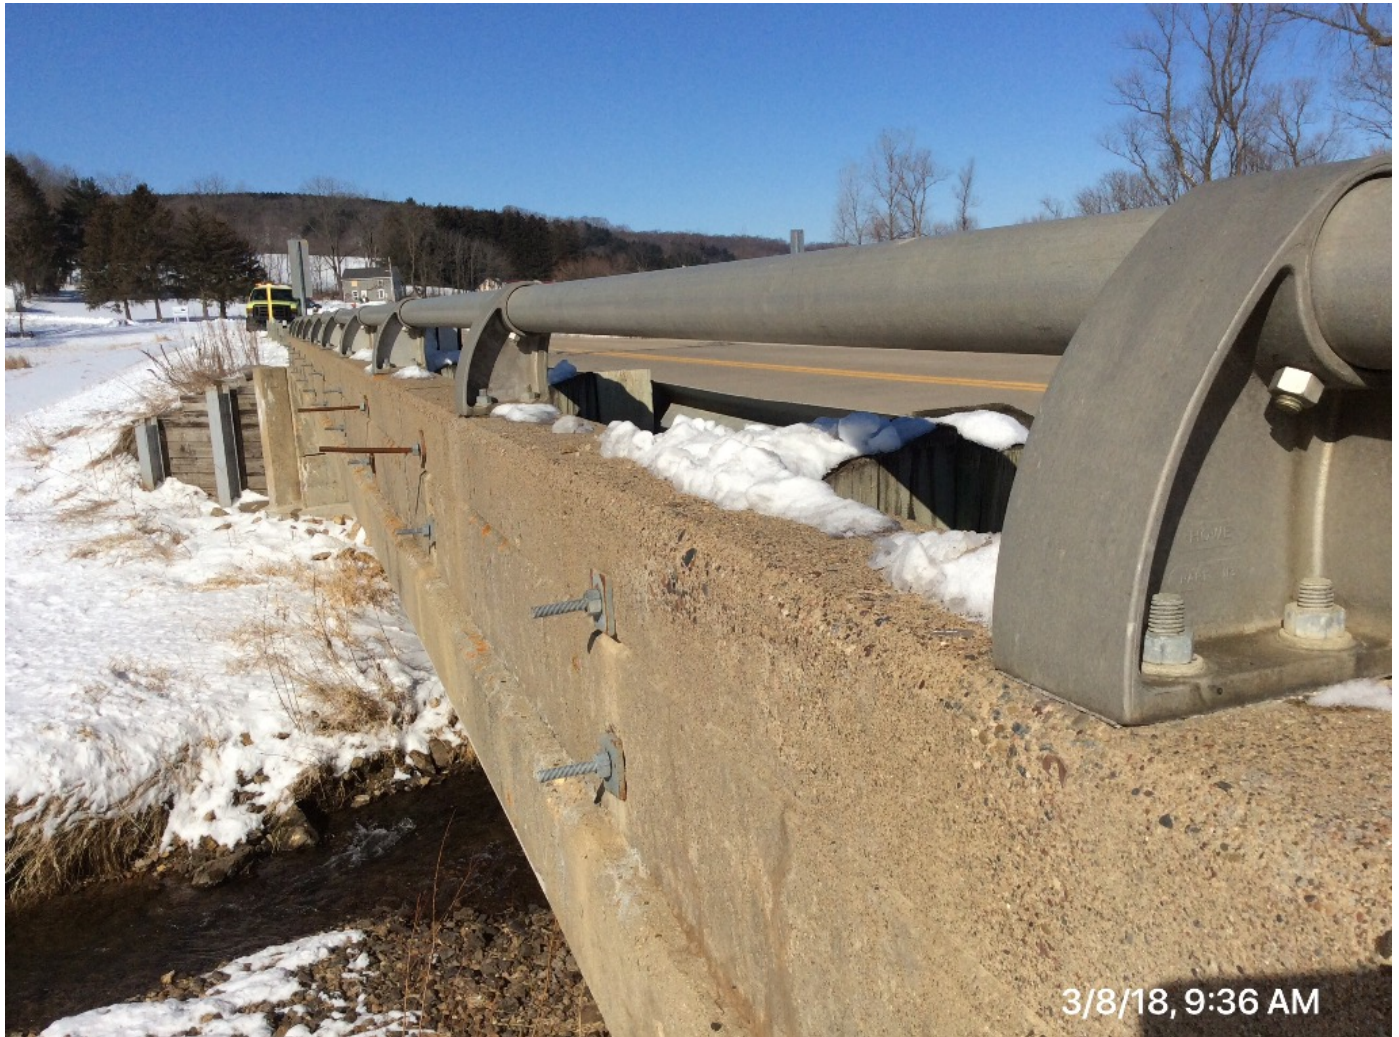
Backside of parapet with bolts fastening steel beam guard to concrete parapet

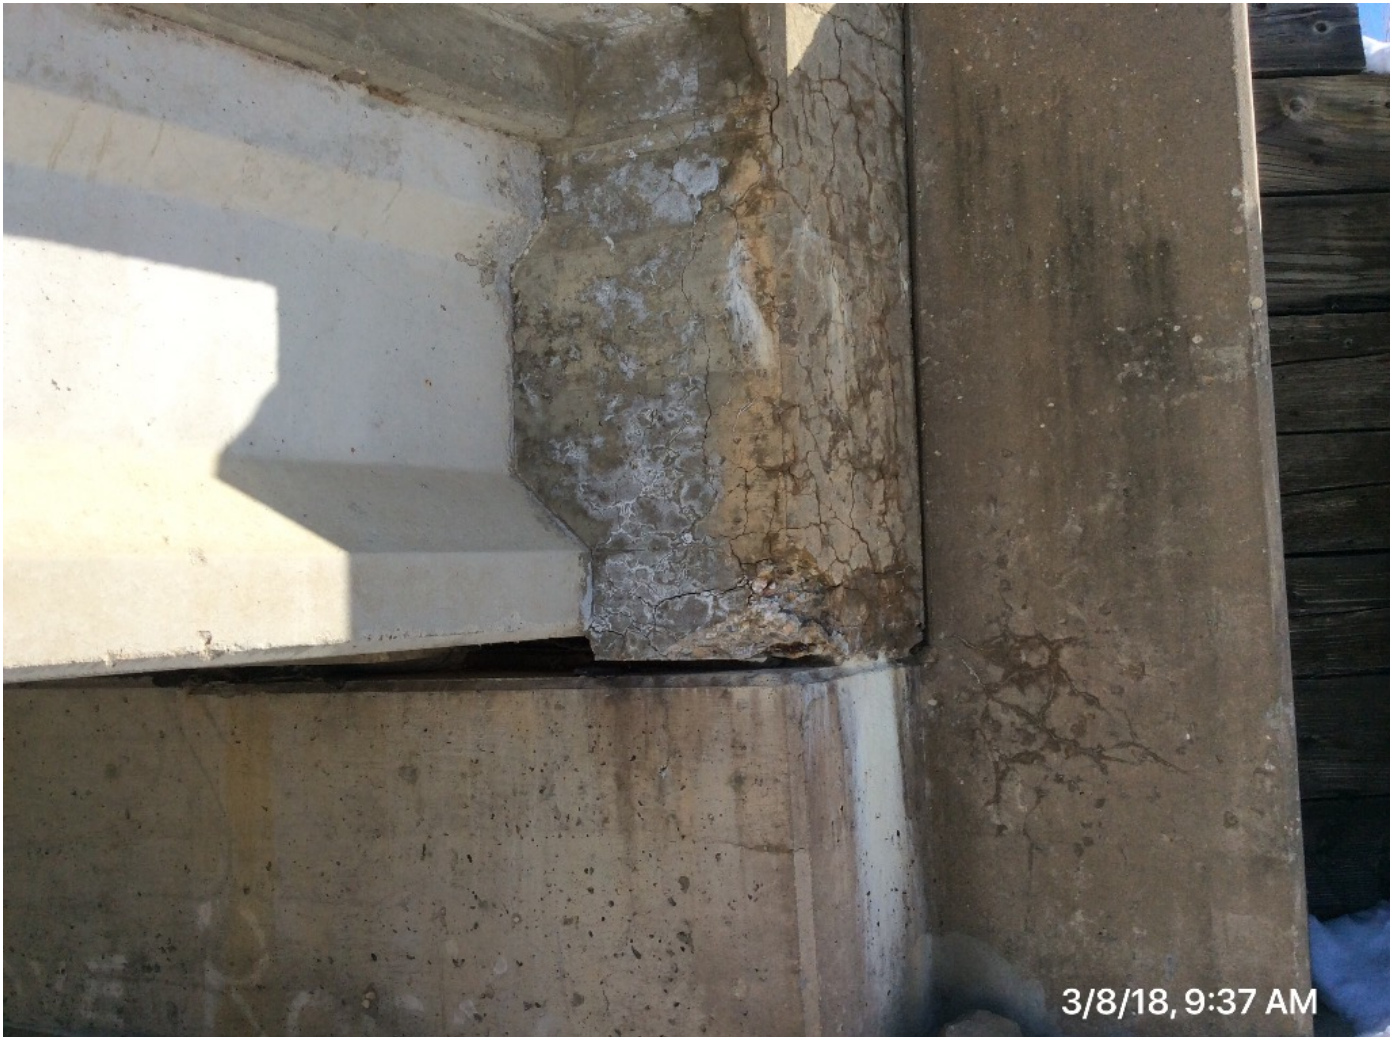
F/T damage in east abutment/concrete cap at south end.

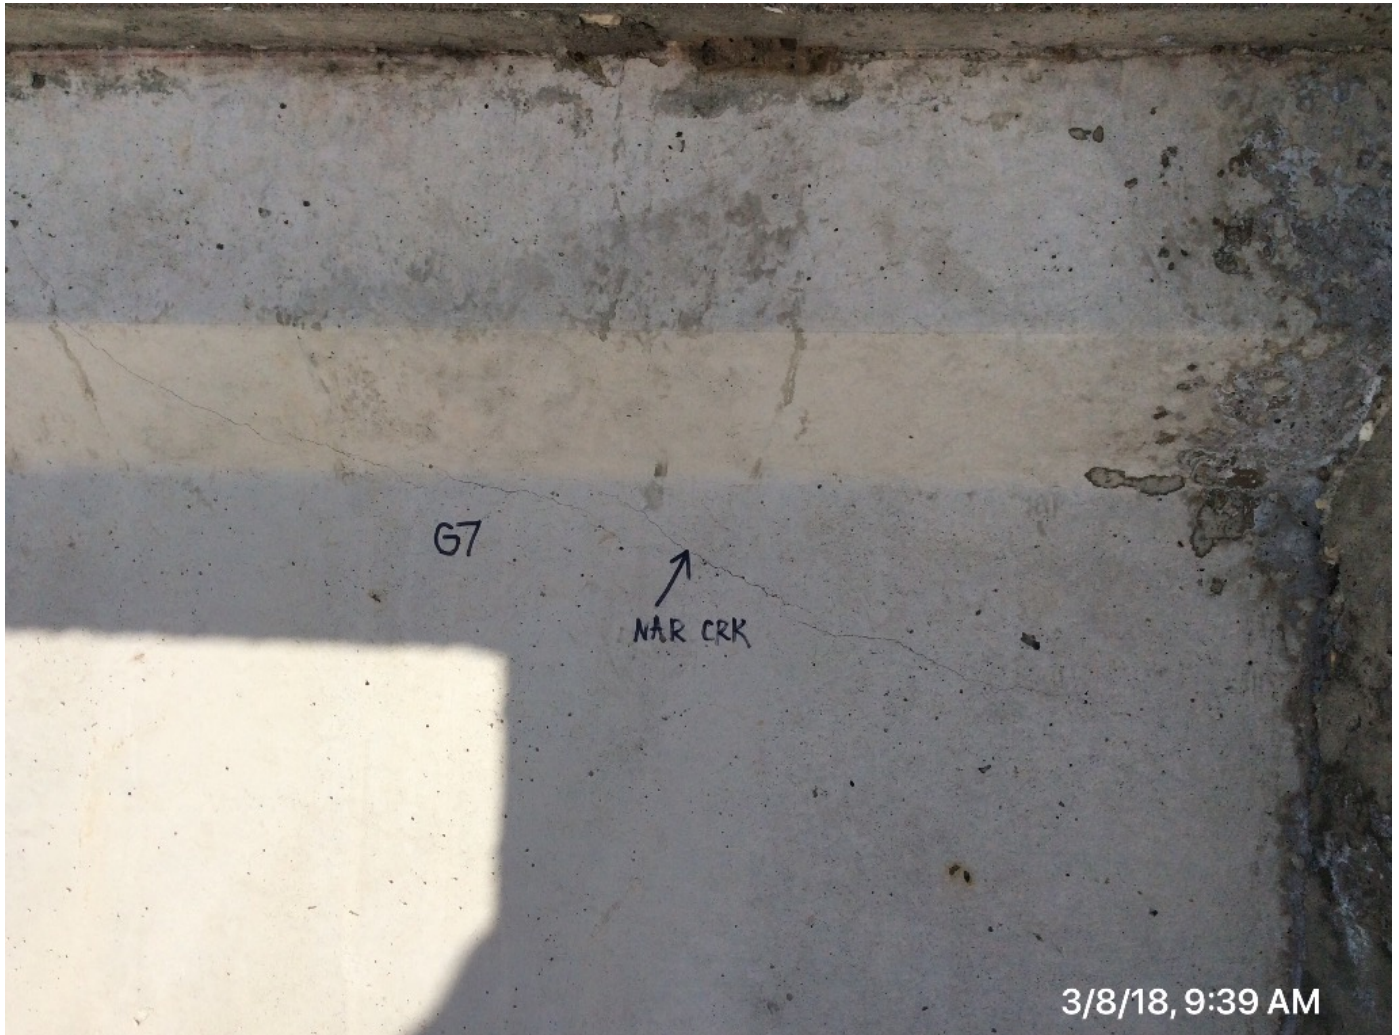
NAR crack in web of G7 at EA

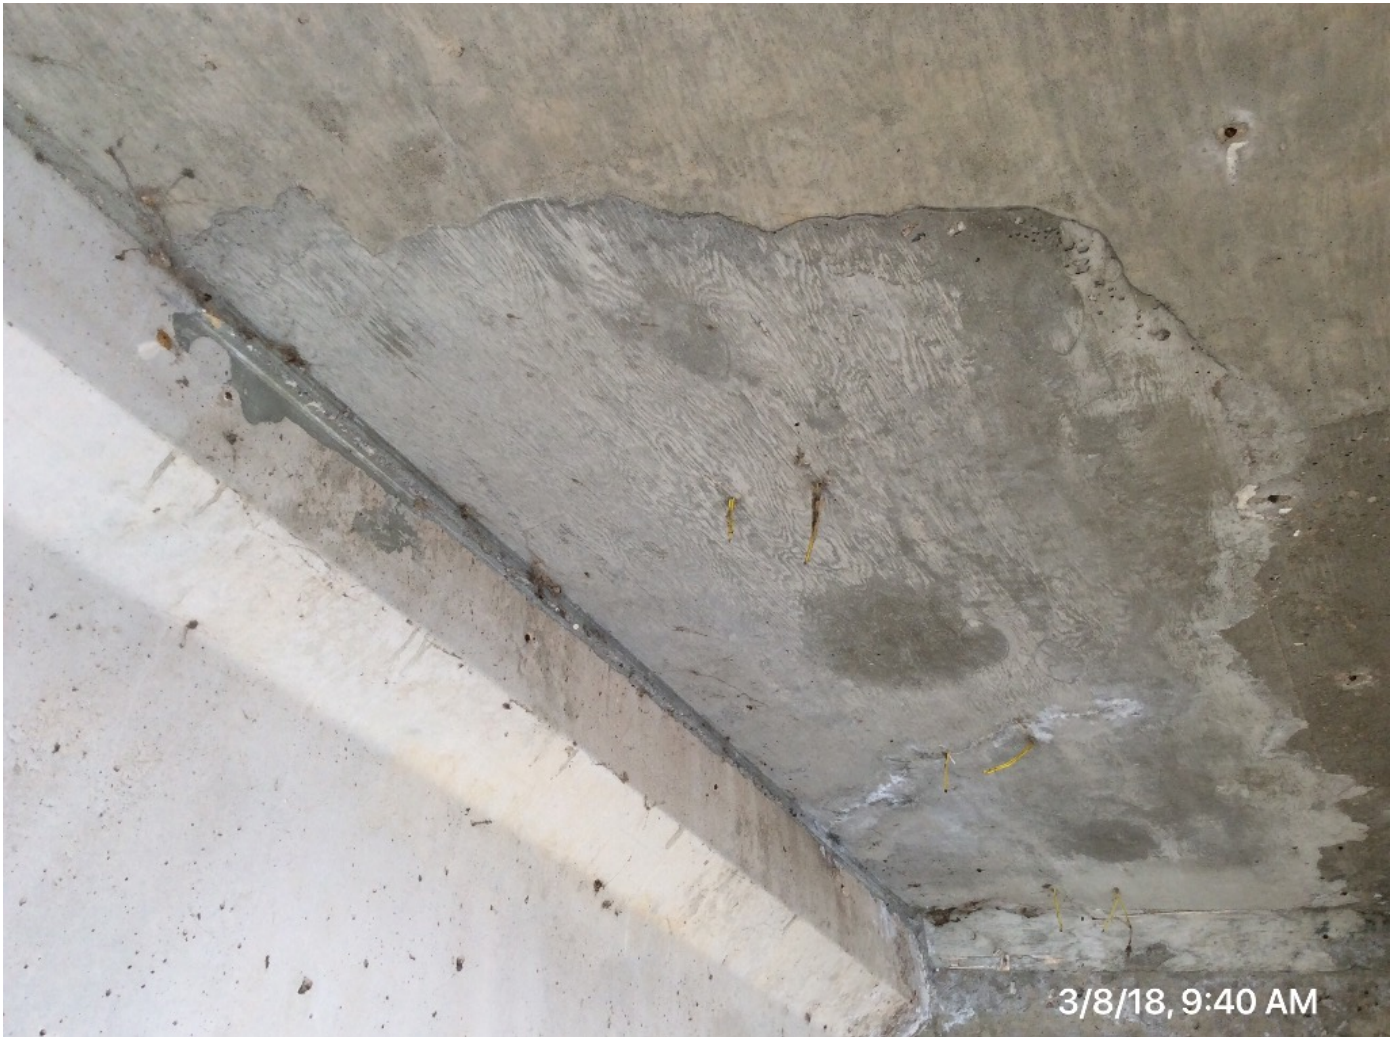
Patch in underside of deck

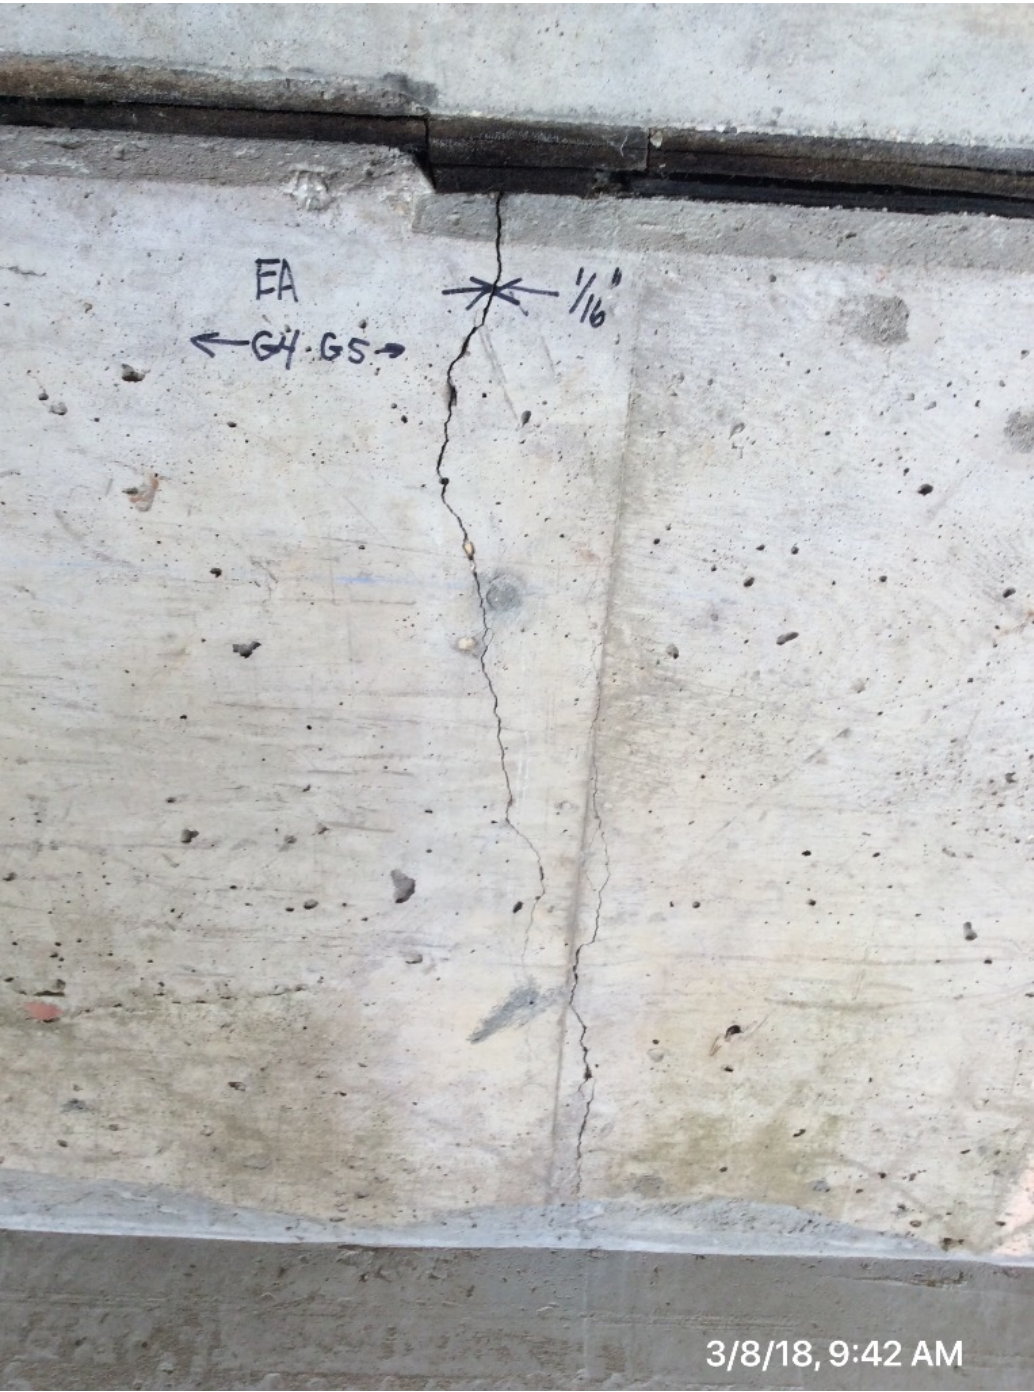
1130	Cracking (RC) WA: F/T cracks with efflorescence on south corner, NAR width horizontal crack at top of abutment diaphragm between G1 & G2 (5 LF). <b>A few NAR vertical cracks in abutment.</b> EA: F/T cracks with efflorescence on north corner (4 LF). <b>1/16" wide vertical crack between G4 and G5.</b>	LF		0	9	4	0

1/16" wide vertical crack in east abutment/cap between G4 and G5

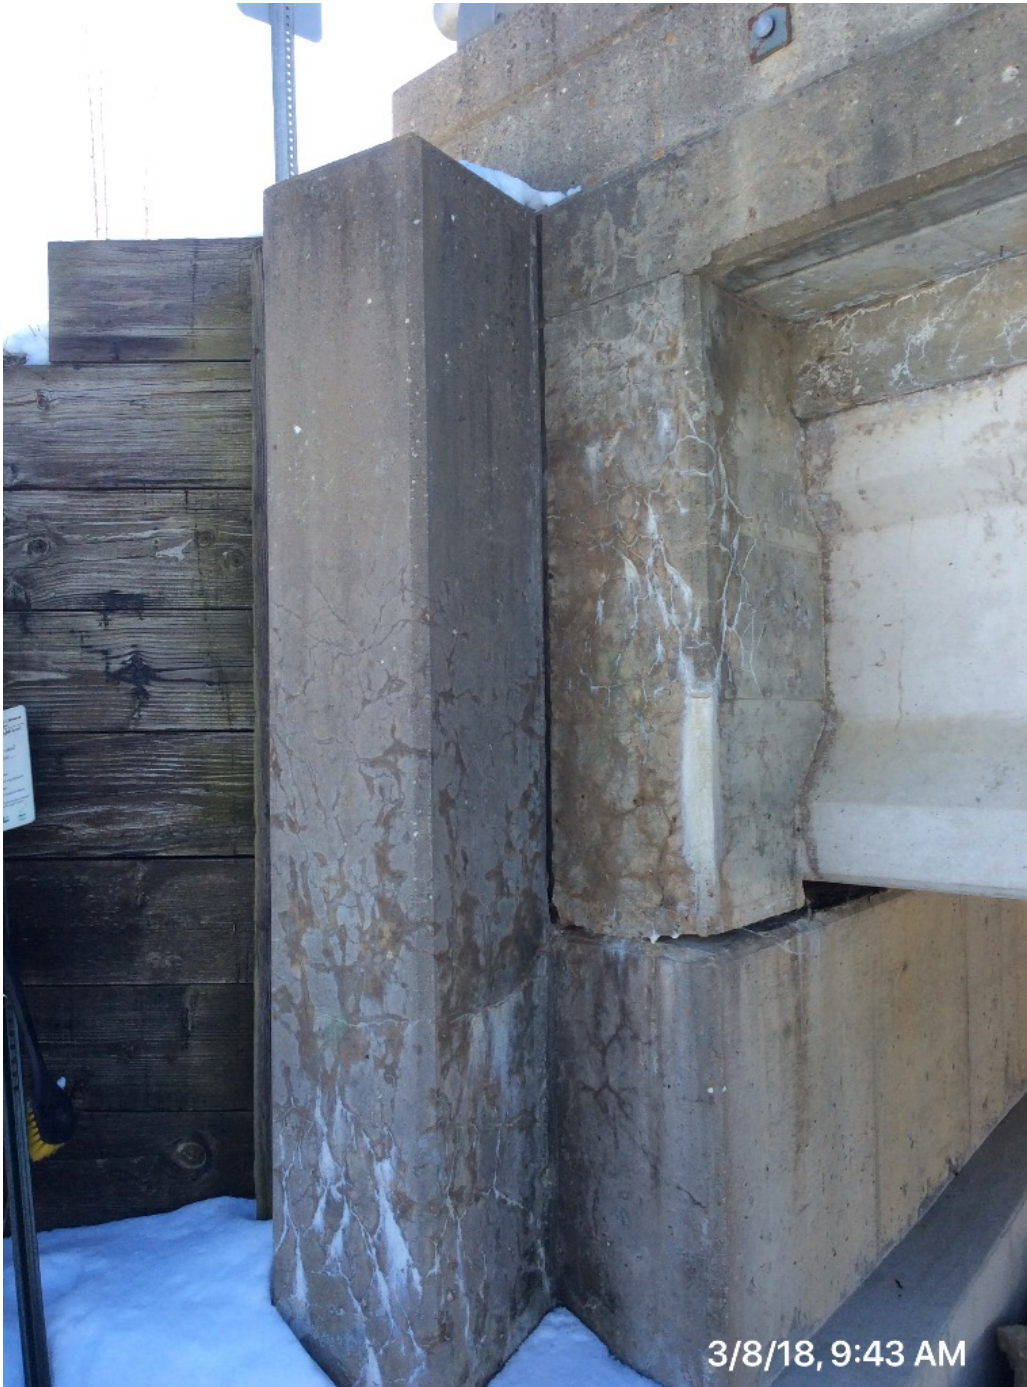
F/T damage in east abutment/concrete cap at north end.

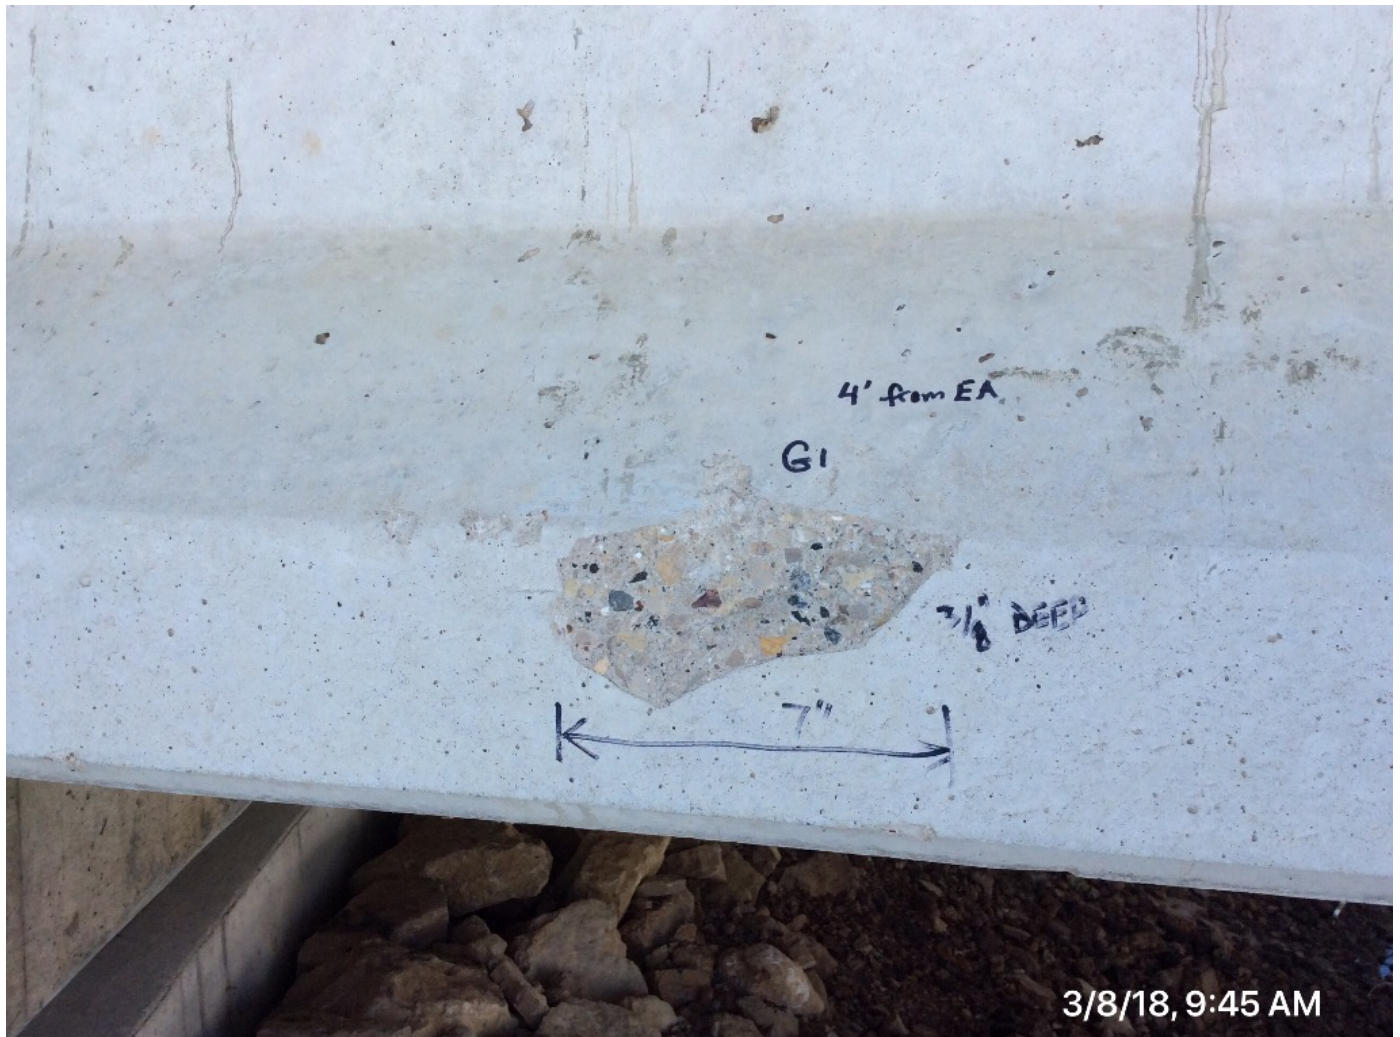
Spall in bottom flange of G1 near EA.

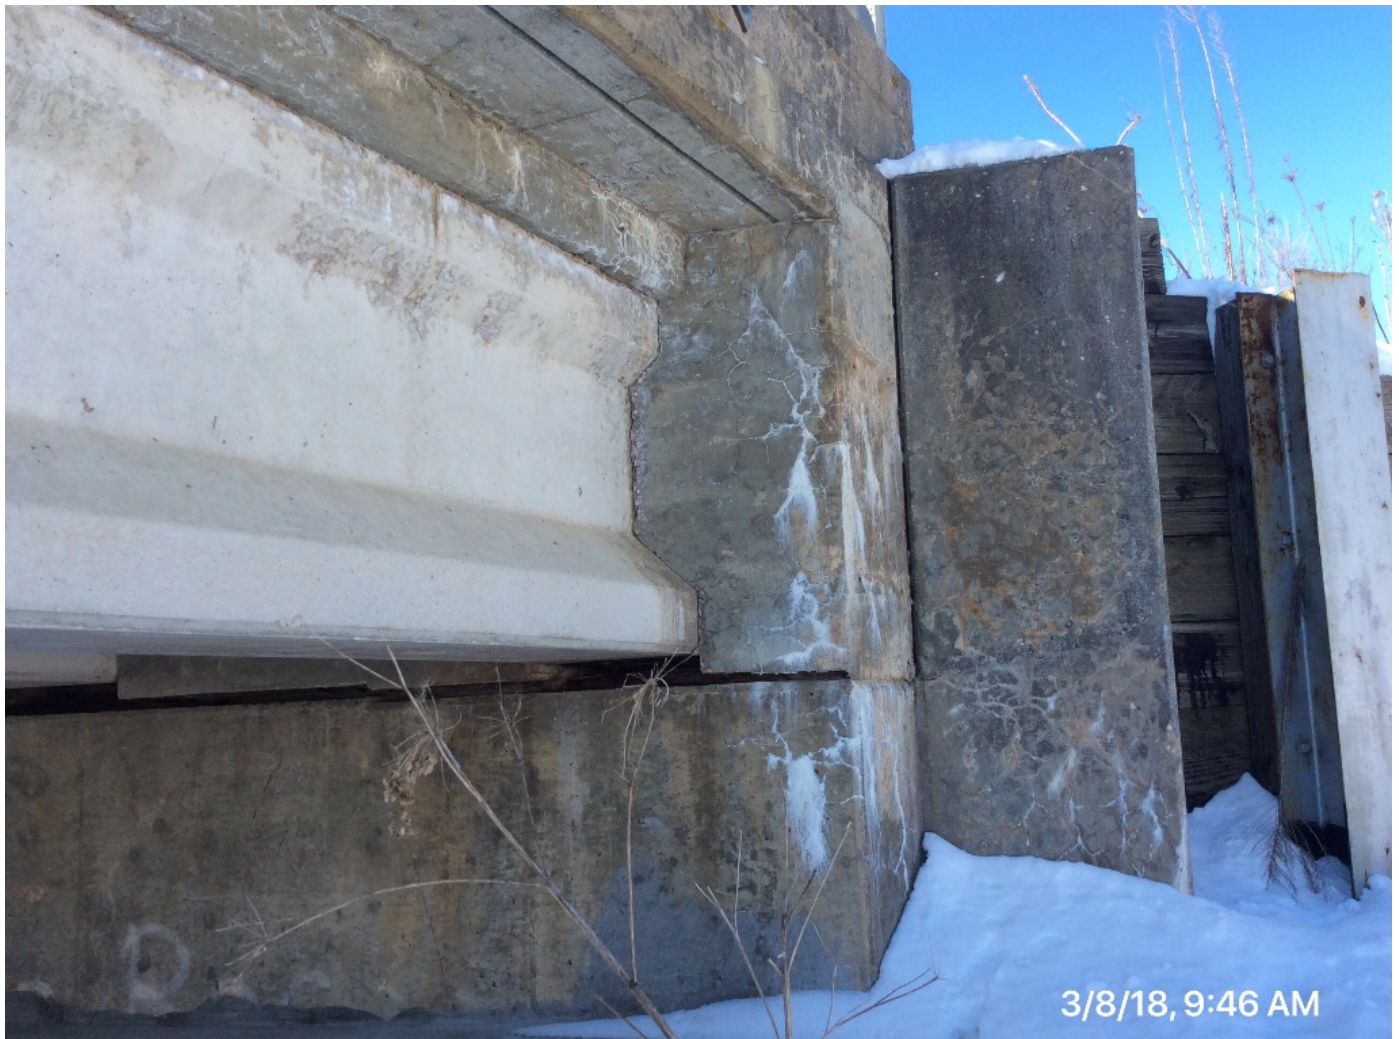
F/T damage in west abutment/concrete cap at north end.

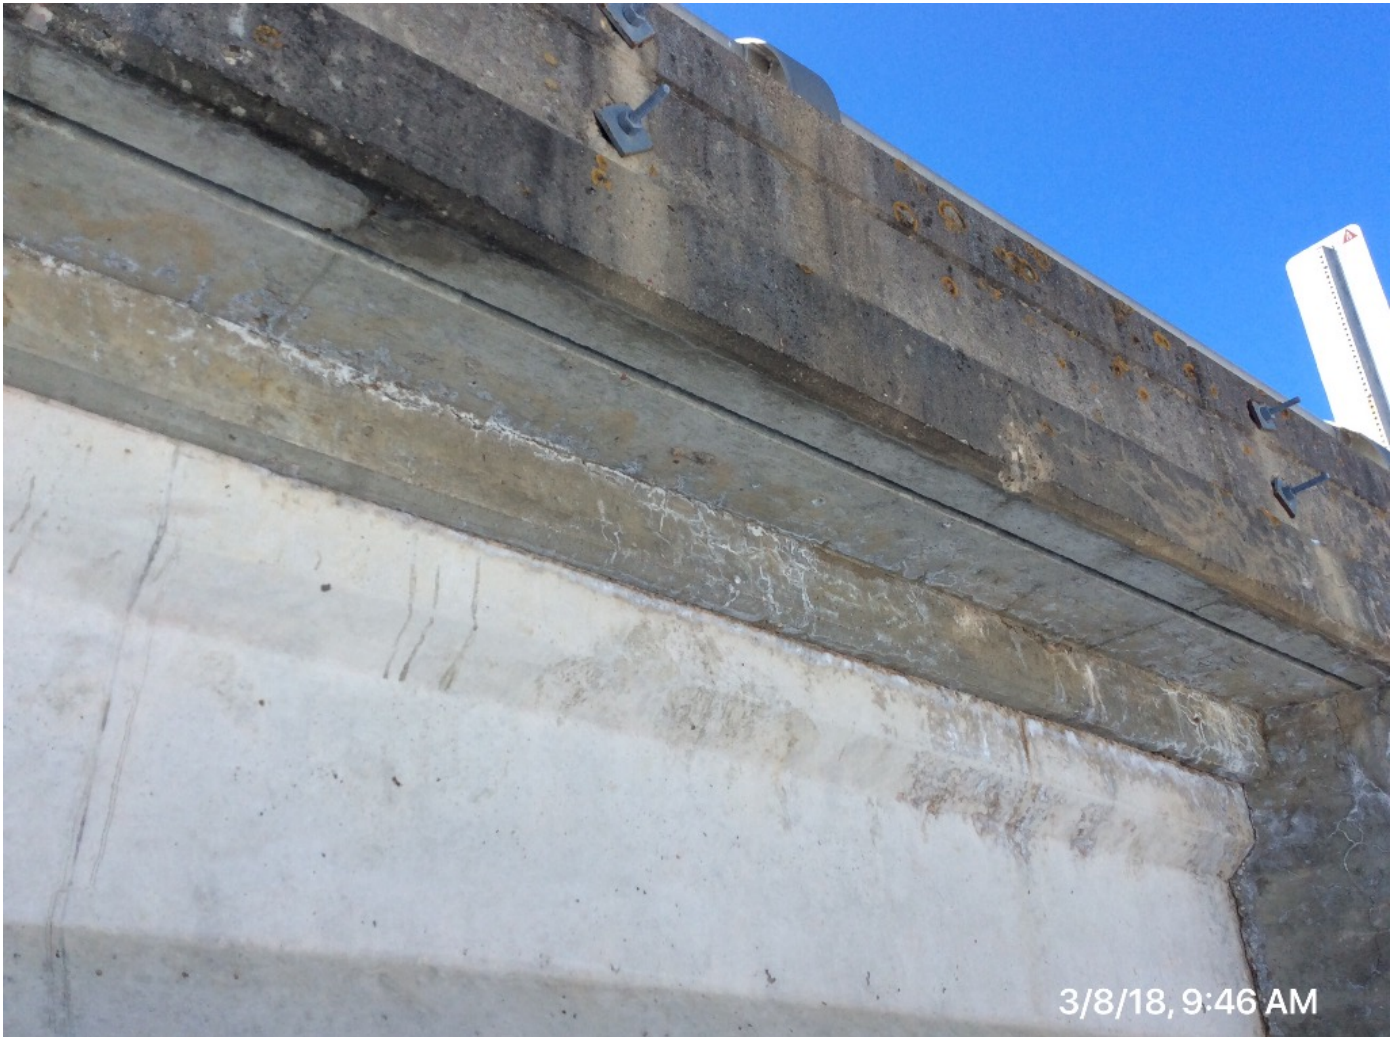
Cracking and efflorescence between deck and ppt at NW corner.

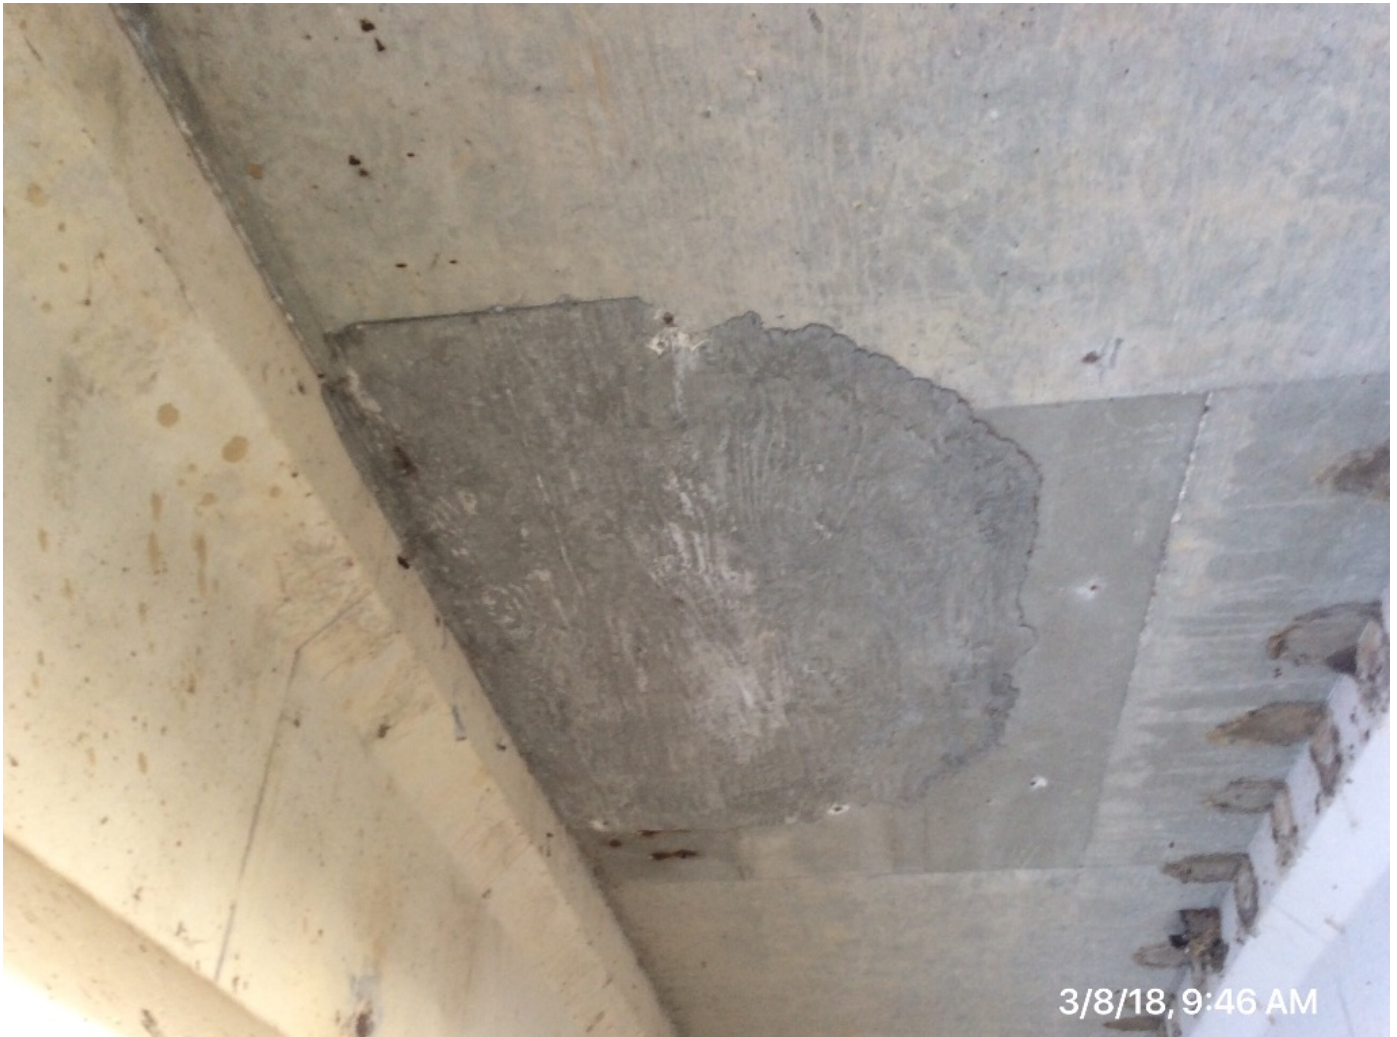
Patched underside of deck at former deck drain.

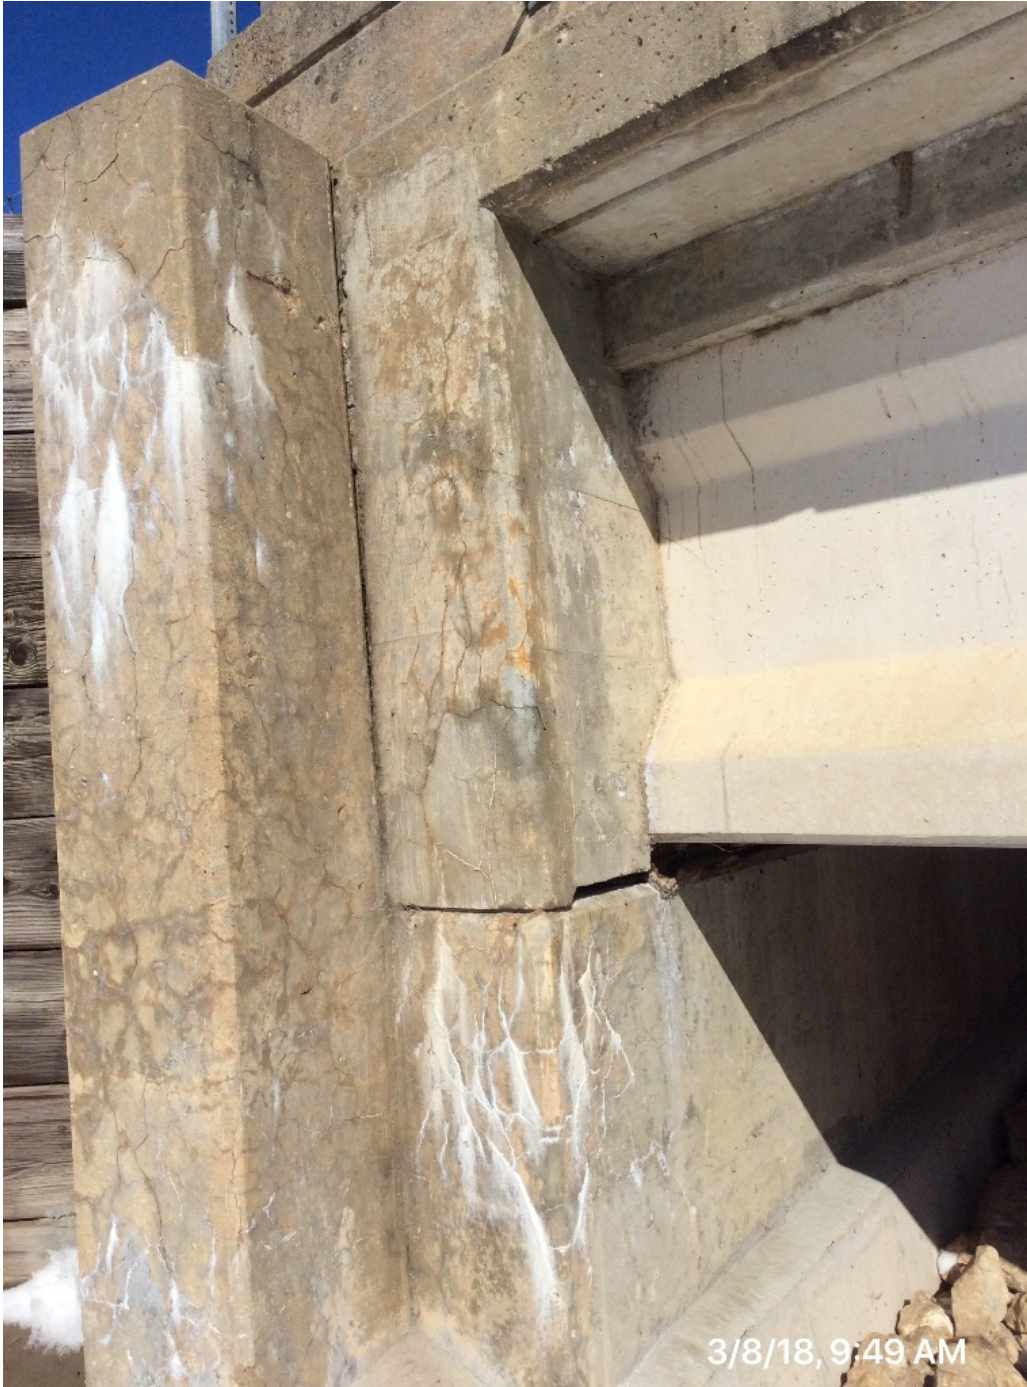
F/T damage in west abutment/concrete cap at south end.

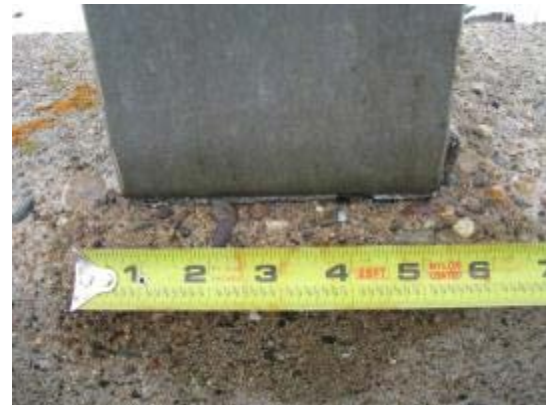
On structure B-52-0035, the gaskets located under the railing attachment plates on the parapet and the caulk located around the bolts in the railing attachment plates tested positive for asbestos greater than 1% and is therefore regulated ACM. The repair of the bridge can proceed as planned. If the ACM will be disturbed, the ACM must be removed prior to any repairs. Standard Special Provision (STSP) 203-005 should be incorporated into the specifications. If the ACM will not be disturbed during the repairs, STSP 107-120 should be included in the specifications.

Gasket under railing attachment

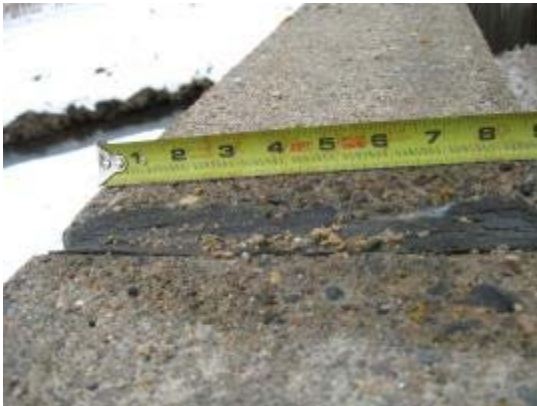
Caulk in parapet expansion joint

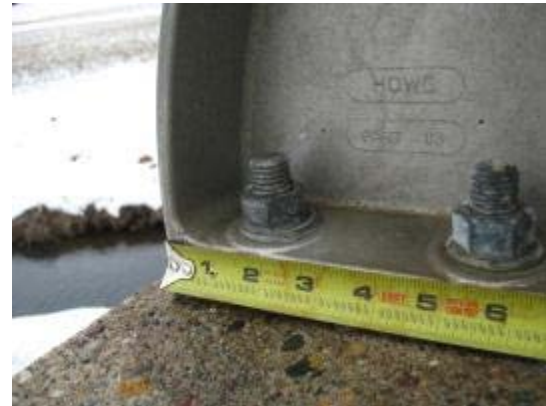
Caulk around bolts in attachment plate

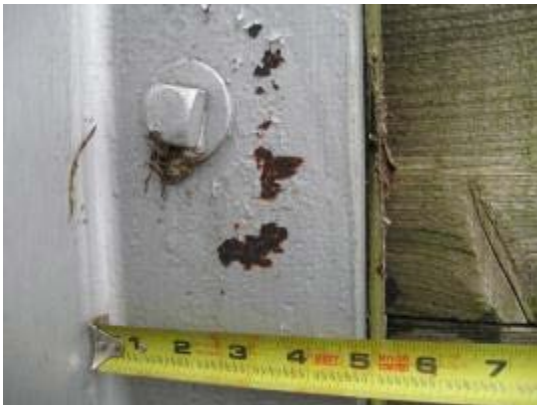
Paint on wingwall supports
