ATTACHMENT C

PHOTOS OF DEFICIENT AREAS

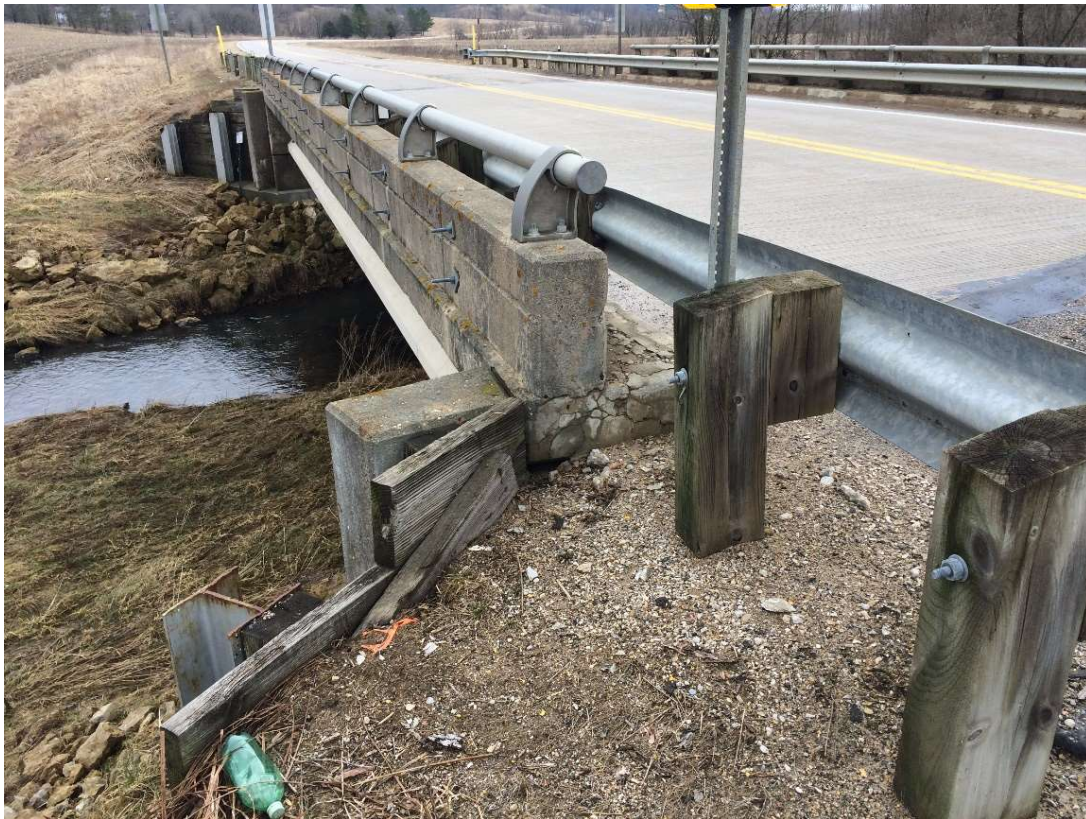
NW Corner - Guardrail to Parapet Connection, Deteriorated curb (Looking East)

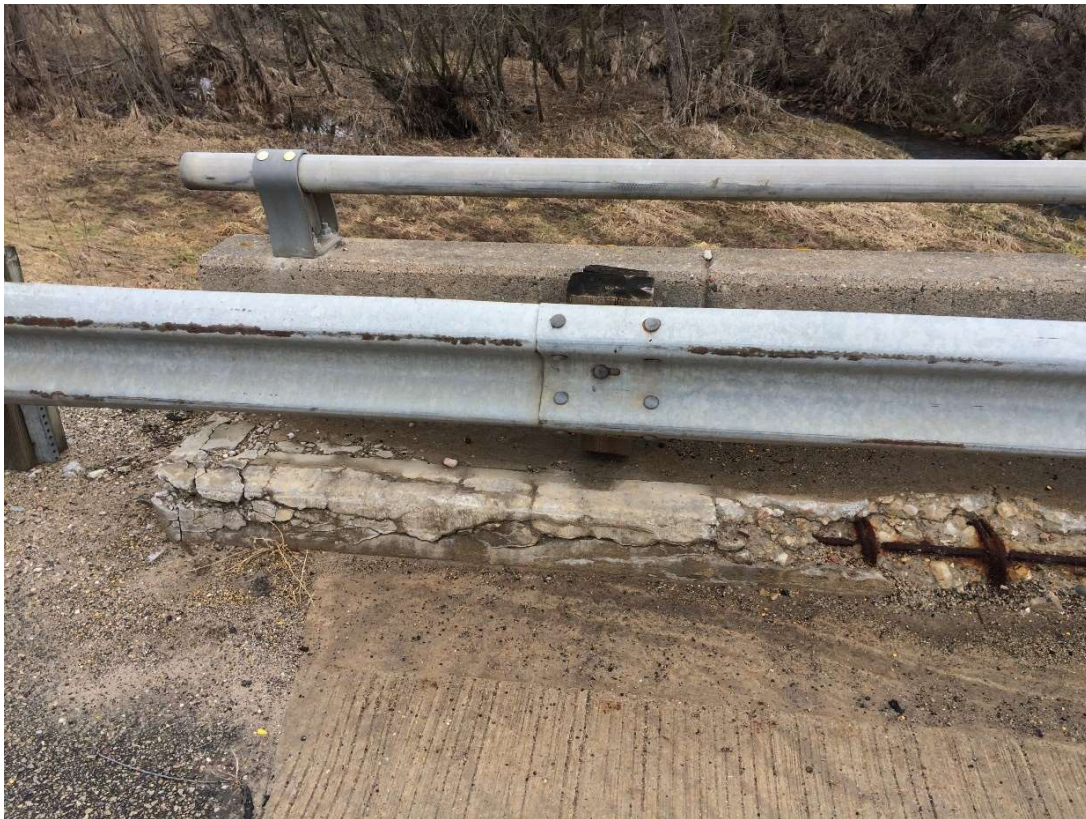
Spalling/Cracking in North Curb

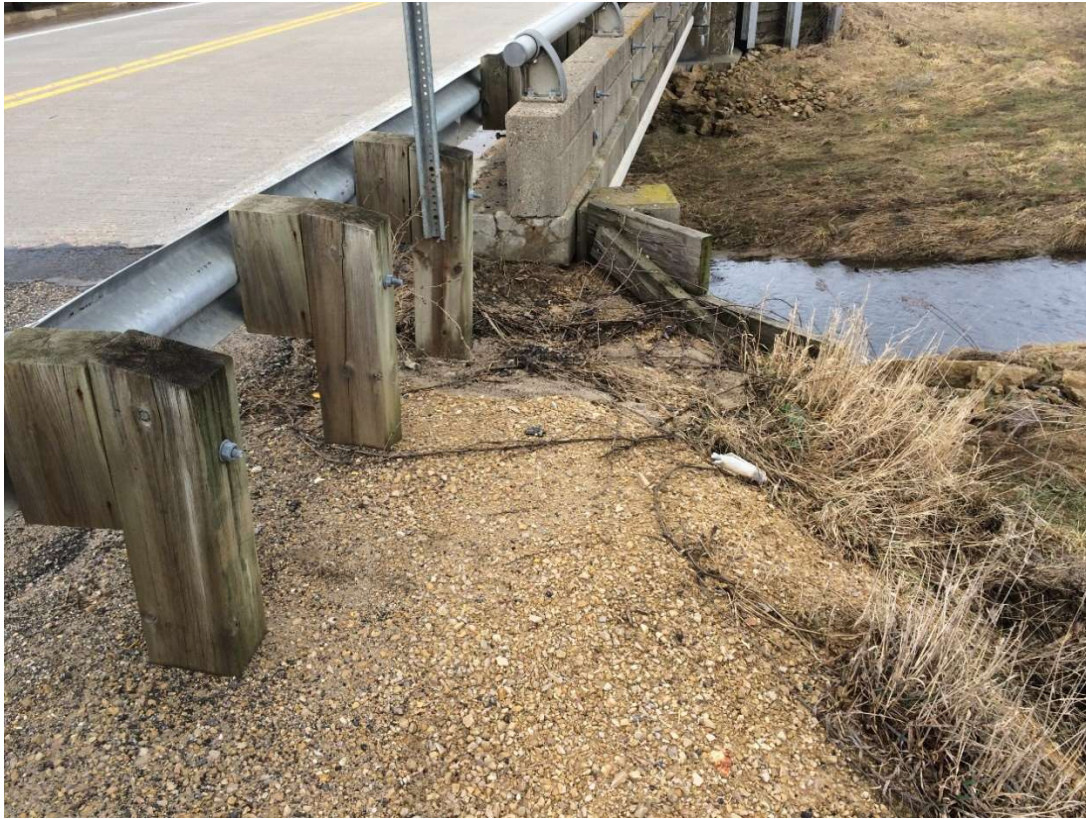
Wing 3 (NE Wing), Shoulder Erosion (Looking West)
