ROUTINE INSPECTION REPORT

Inspection Report for
B-52-084 (BENSON HOLLOW)

STH 56 over UPPER CAMP CREEK
Mar 05,2018

BRIDGE PLAN OF DEFICIENT AREAS

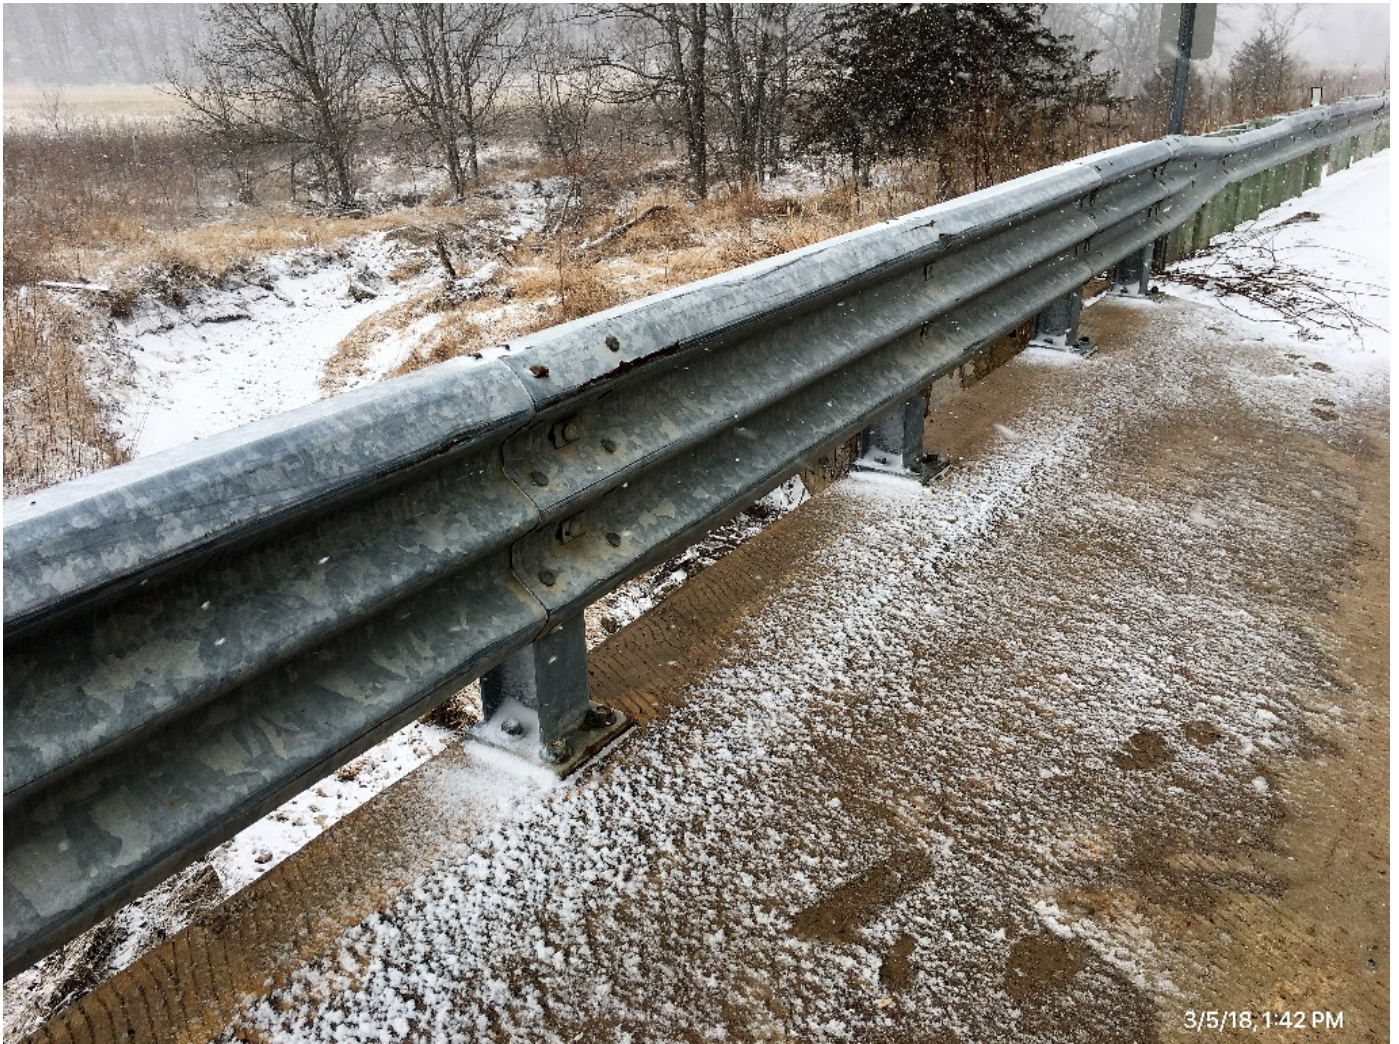
(14) 2 areas of dents from TI. Panels w/ slight waves from snow plow riding rail. South rail has one panel dented from TI. North rail has a small hole at east end from TI.

Typical damage to thrie beam panels - SW corner shown.

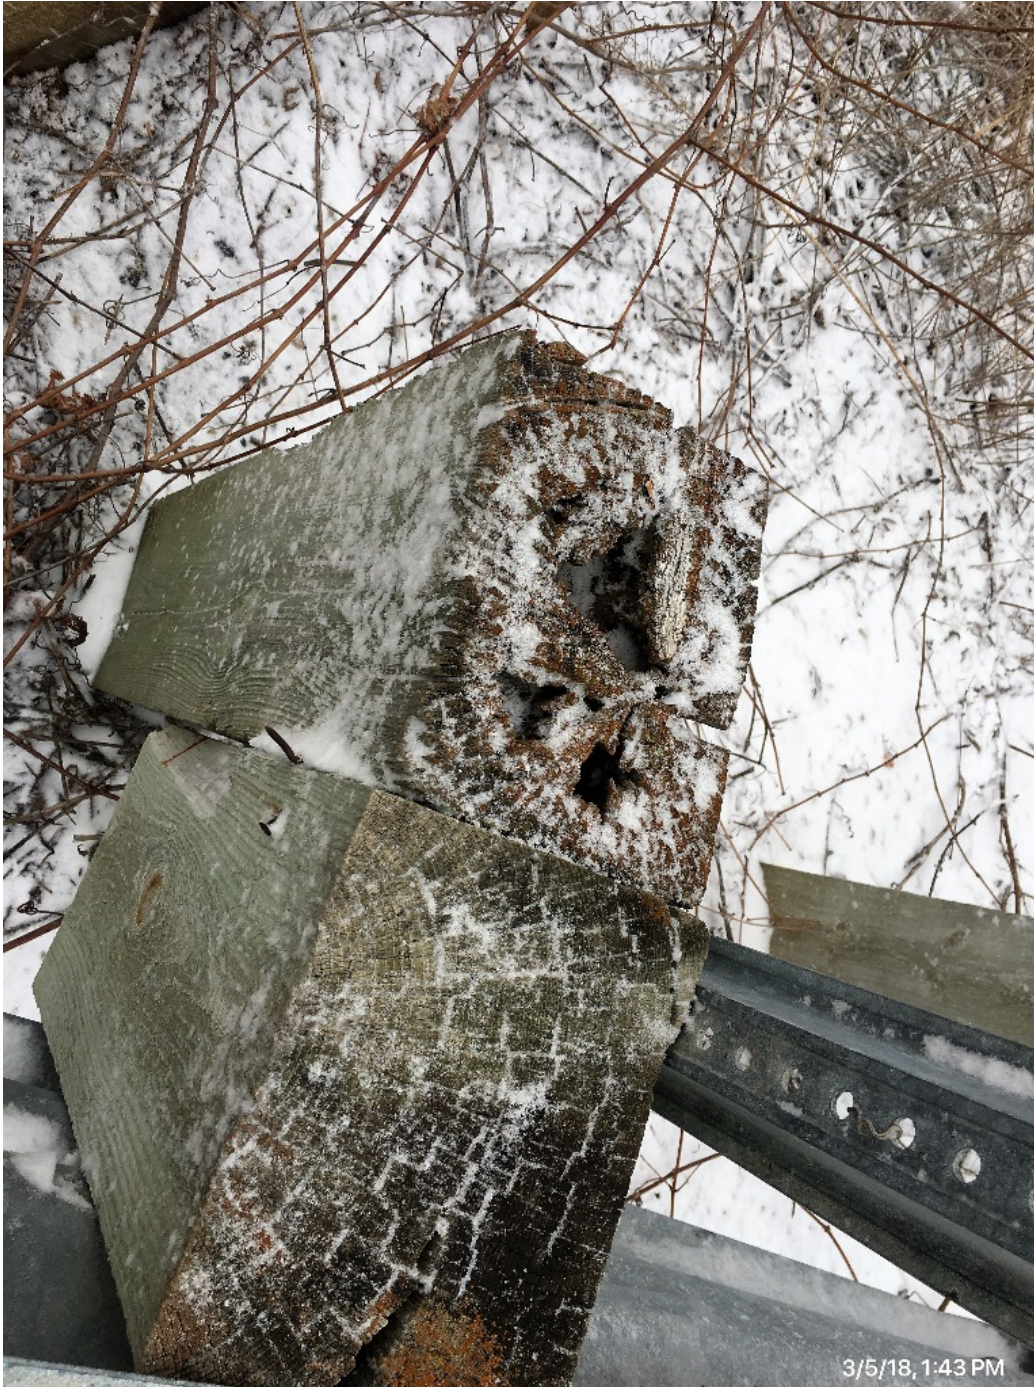
Typical beam guard post rot - post at SW corner shown.

Item	Priority	Recommended by	Status	Status change
Approach - Repair Beam Guard	MEDIUM	Bohnsack, Dave (5015)	IDENTIFIED	03/06/18
Replace rotten beam guard posts on approach.

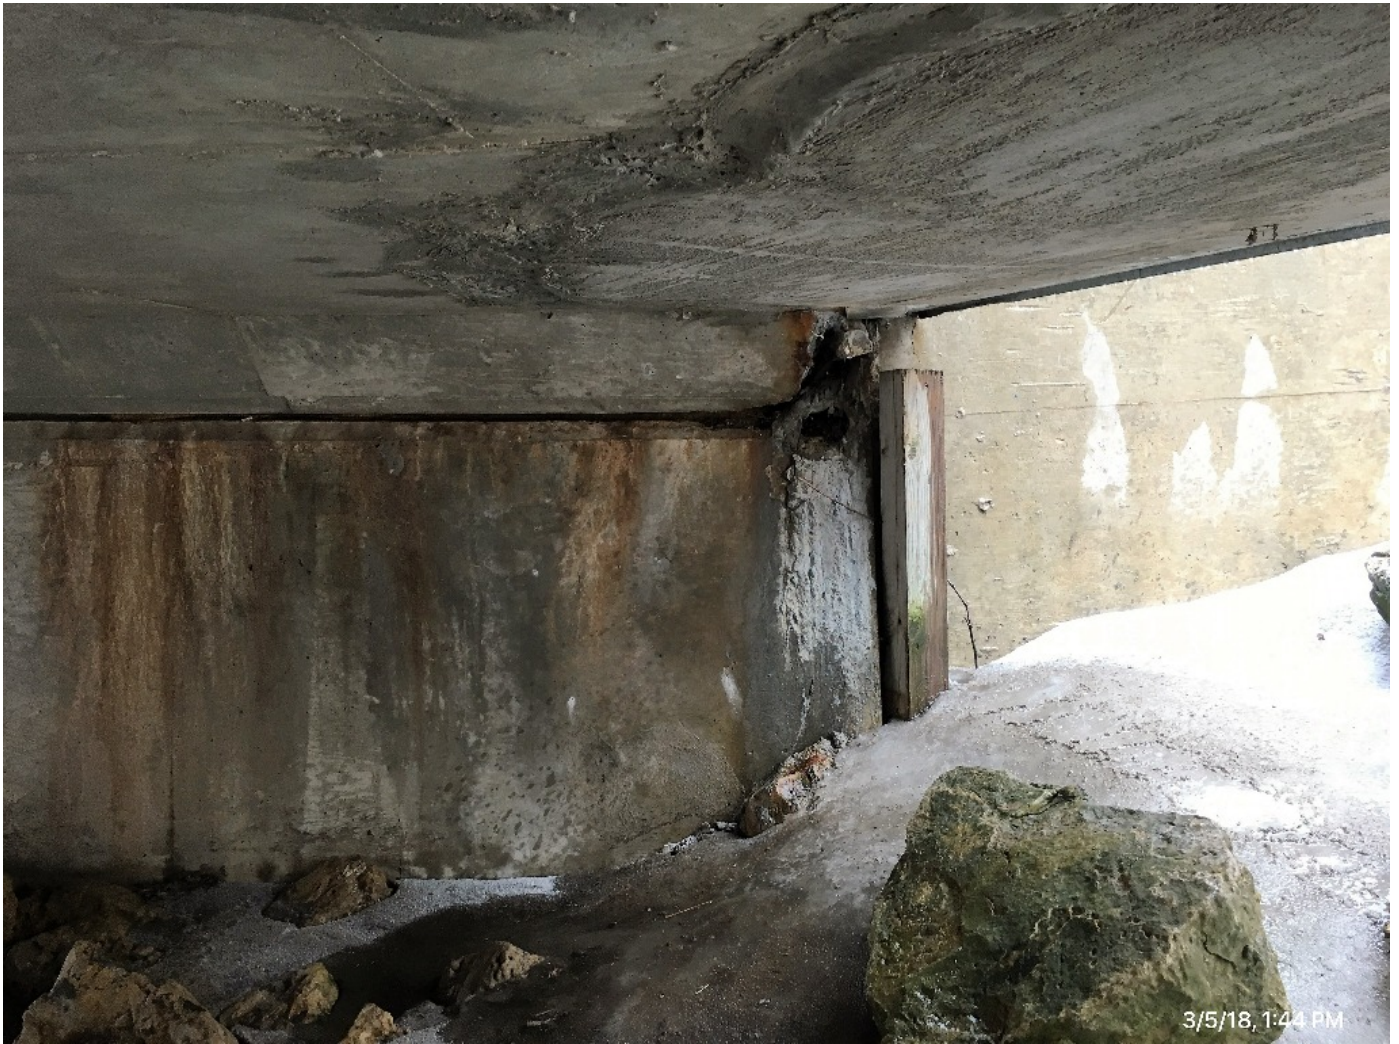
North corner of west abutment.

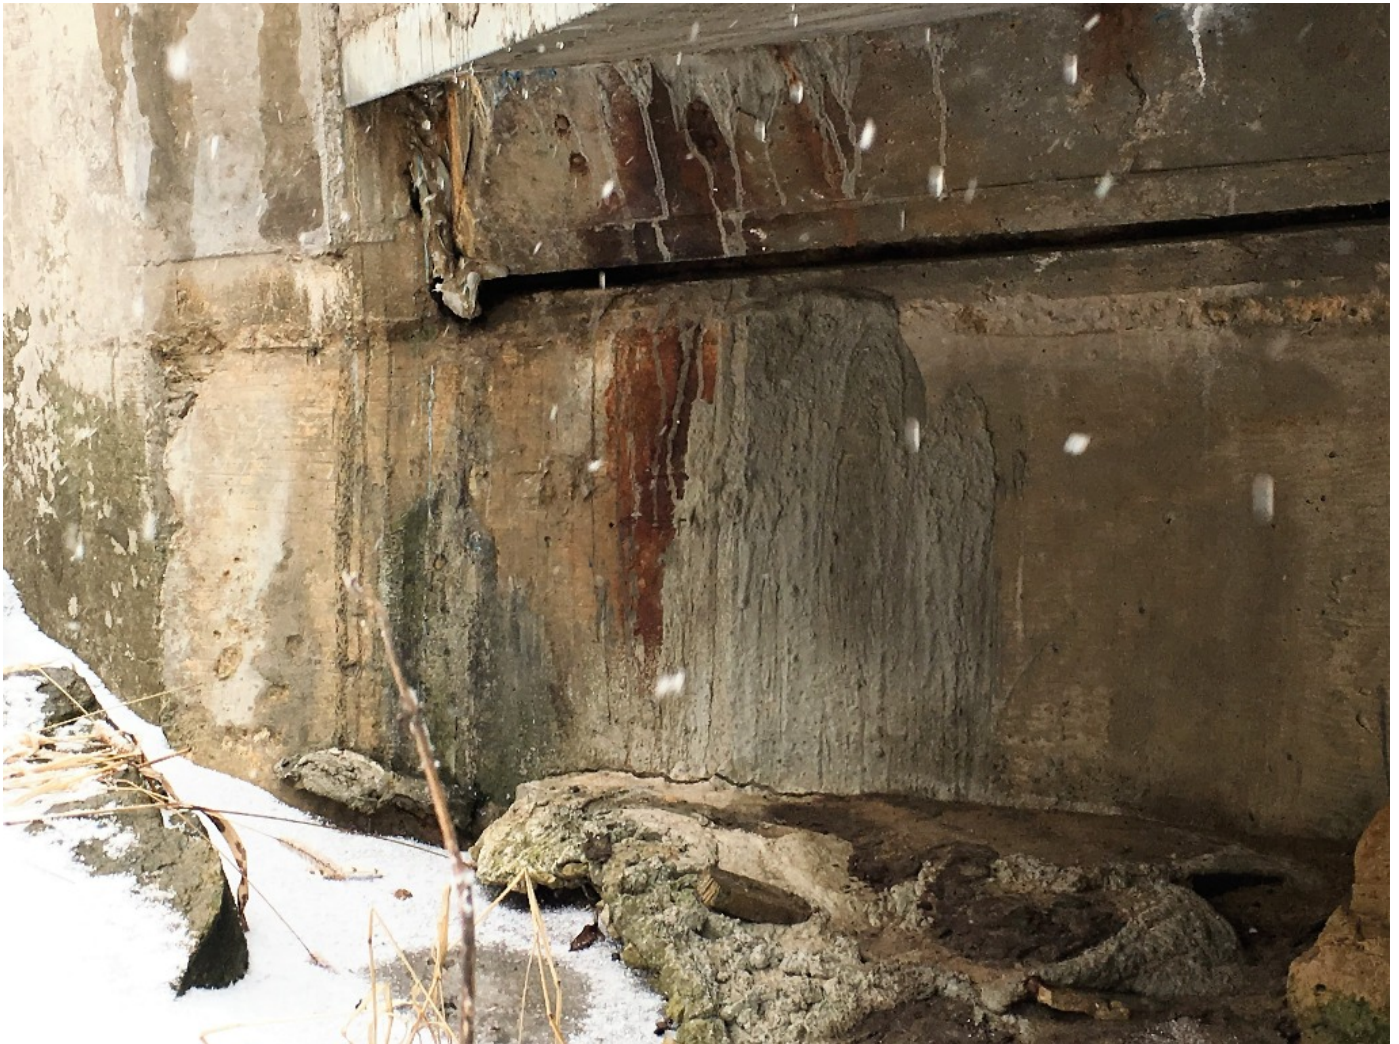
North corner of east abutment.

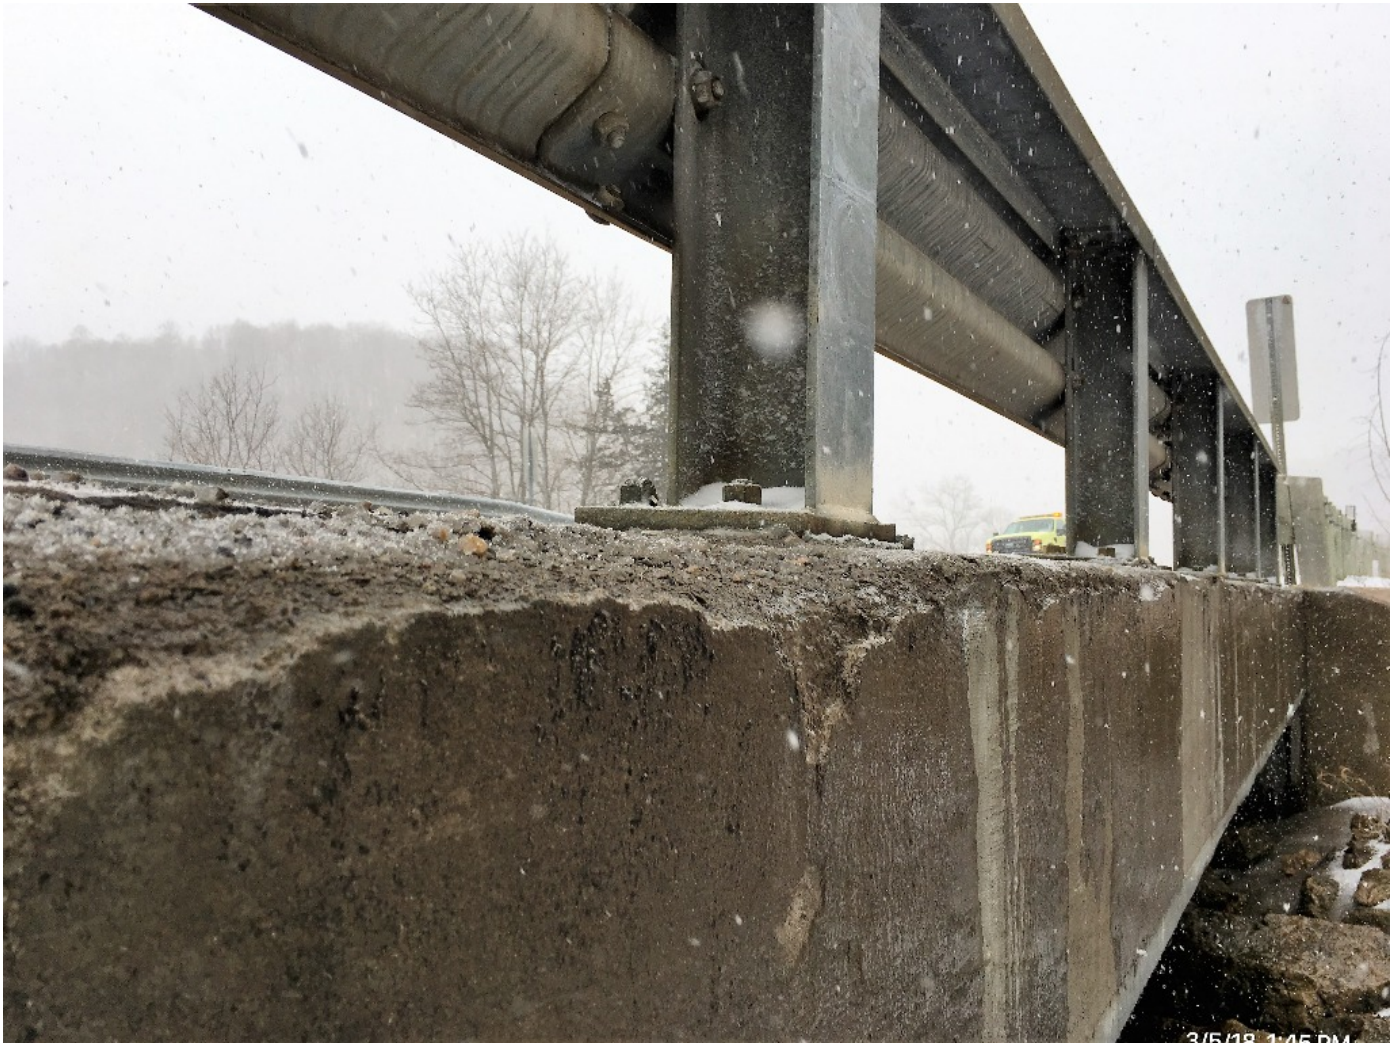
Crumbling edge of north end of deck.

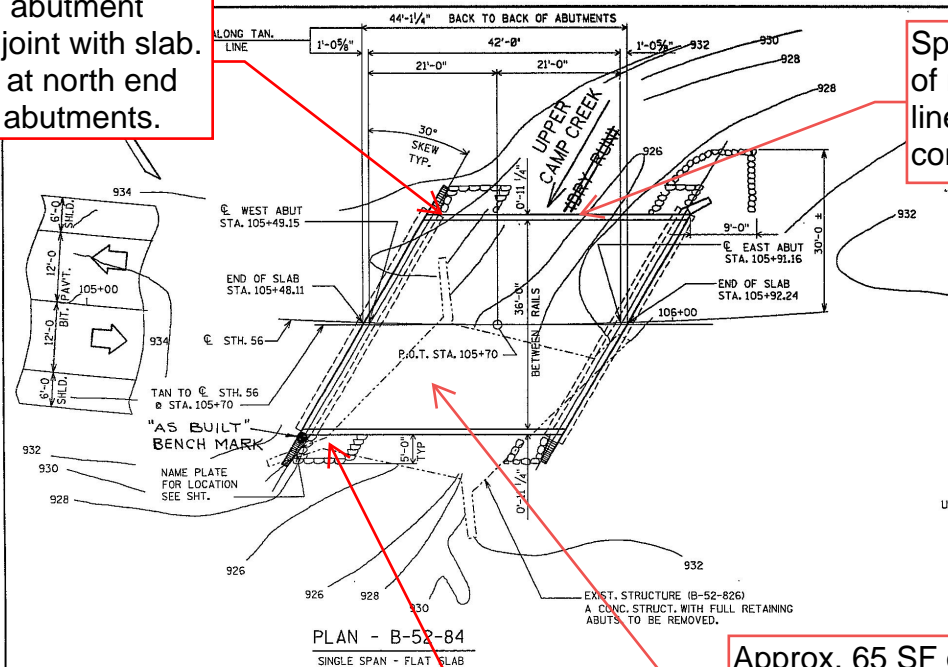
Spall in abutment face at joint with slab. Typical at north end of both abutments.

Spalling concrete at top of north slab edge, along line of surface repair completed in 2015.

Approx. 65 SF of Delamination in deck wearing surface at time of 2016 routine inspection. Most of delamination near C/L and WB lane.

Sediment starting to build up in channel under bridge.

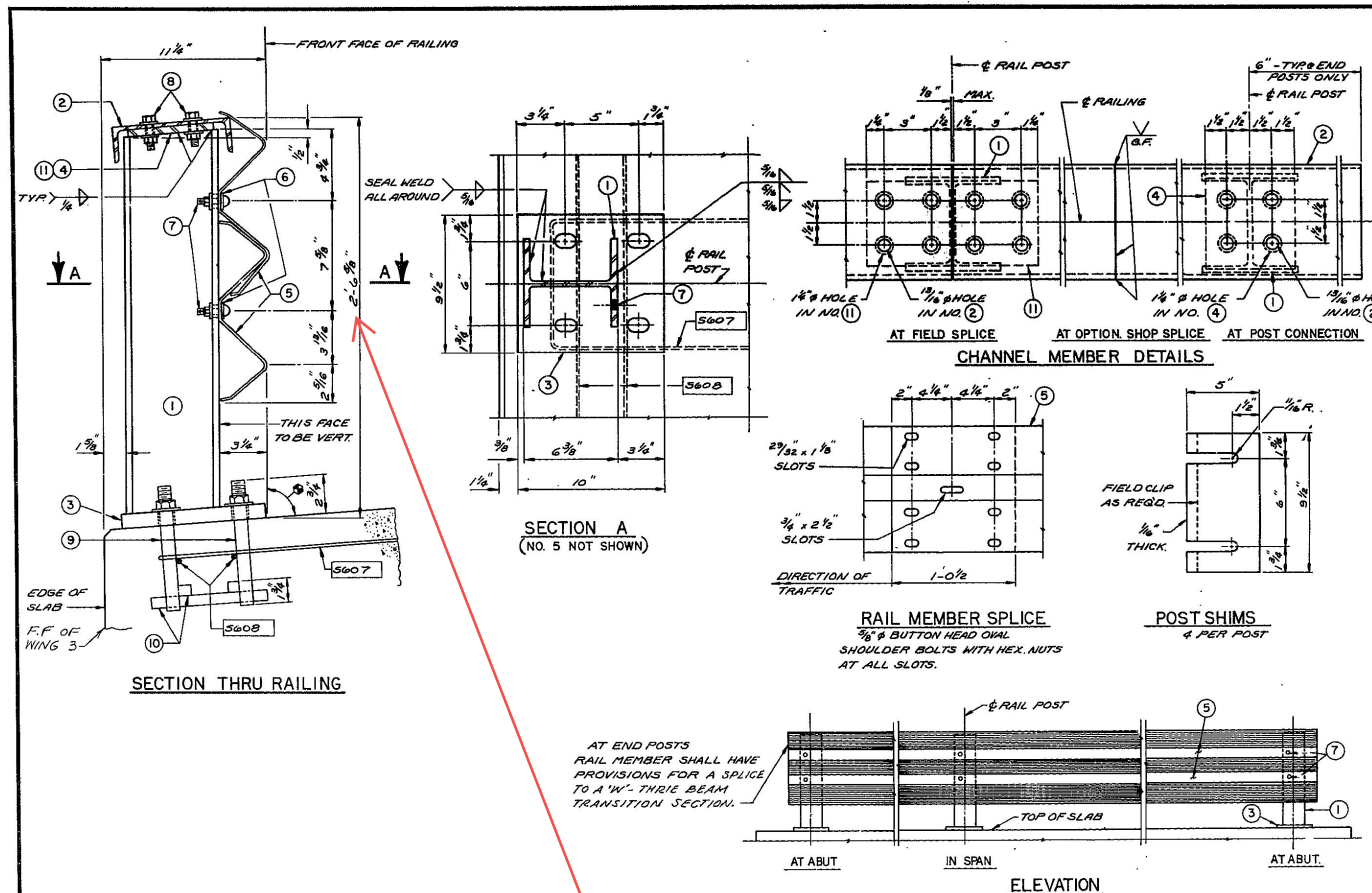
Steel W Rail height does not meet current standards

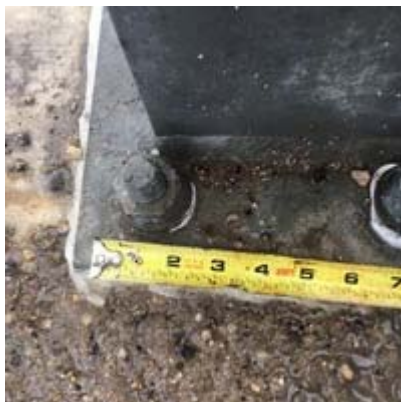
Caulk around railing attachment plate

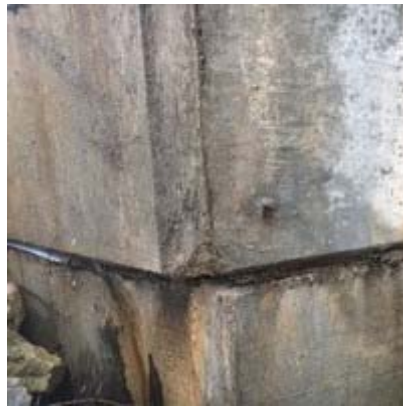
Caulk in abutment joint

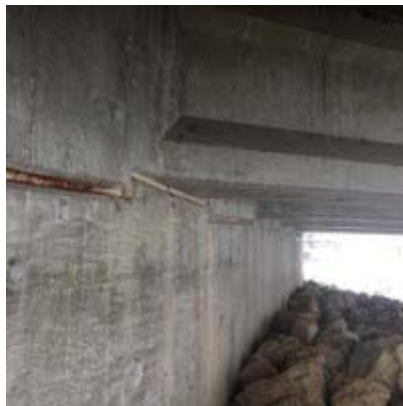
Plastic-like material in abutment joint
