ATTACHMENT C

PHOTOS OF DEFICIENT AREAS

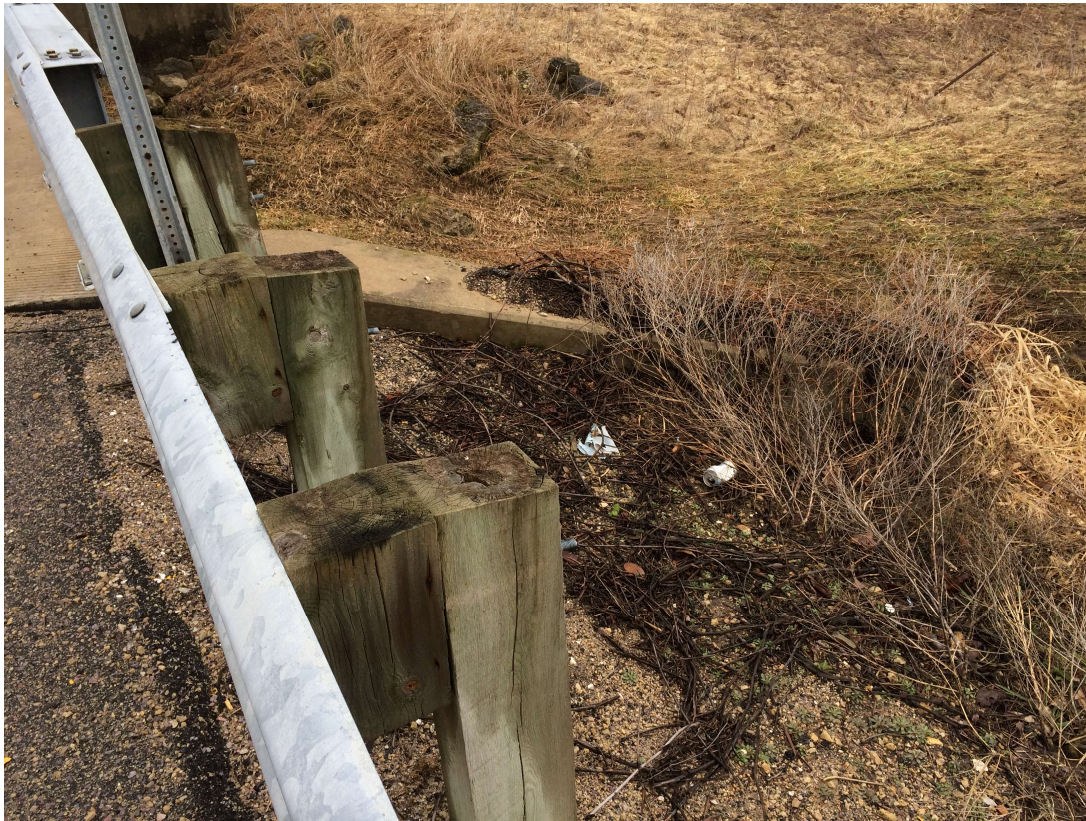
Rotten guardrail posts on bridge approach

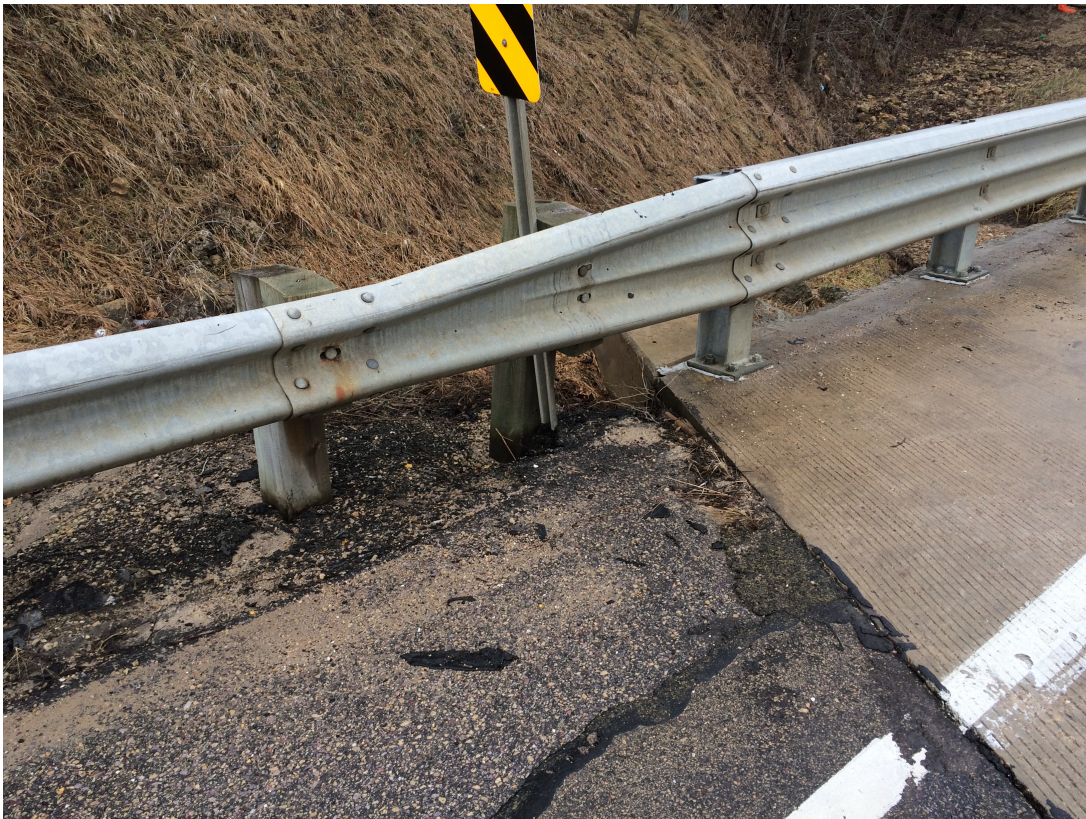
Rusted 'W' Rail

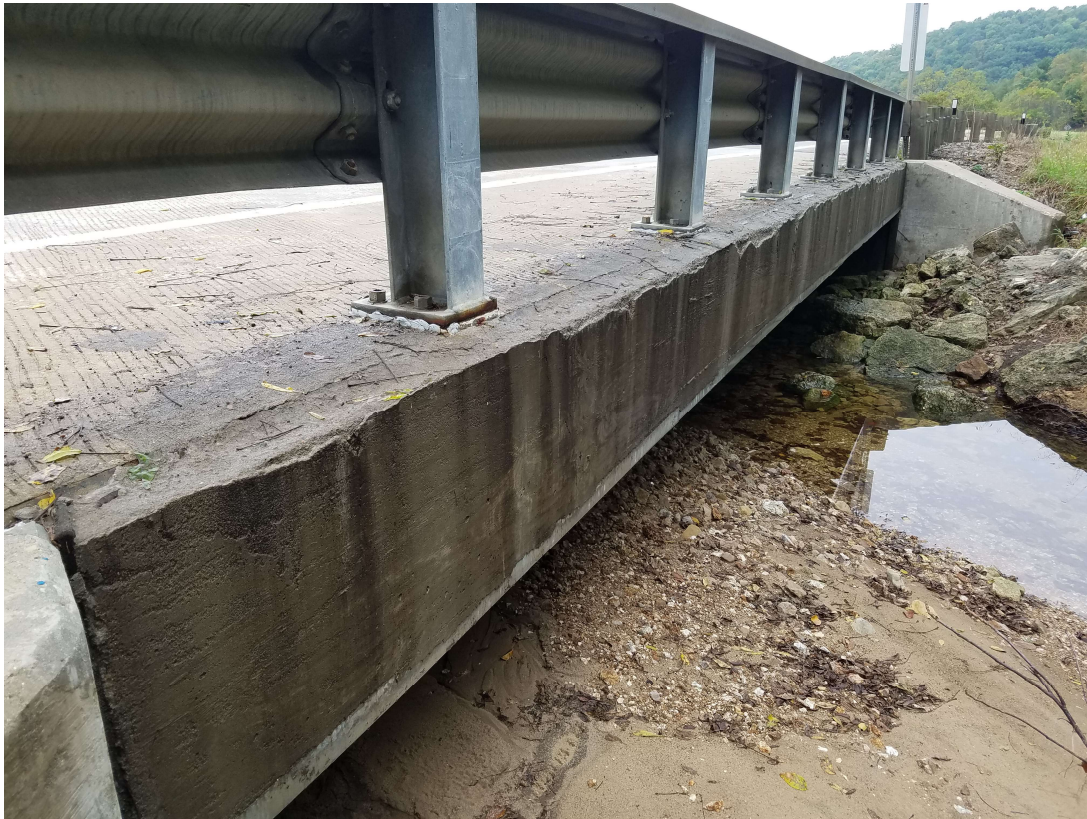
Spalling Concrete along north edge of deck

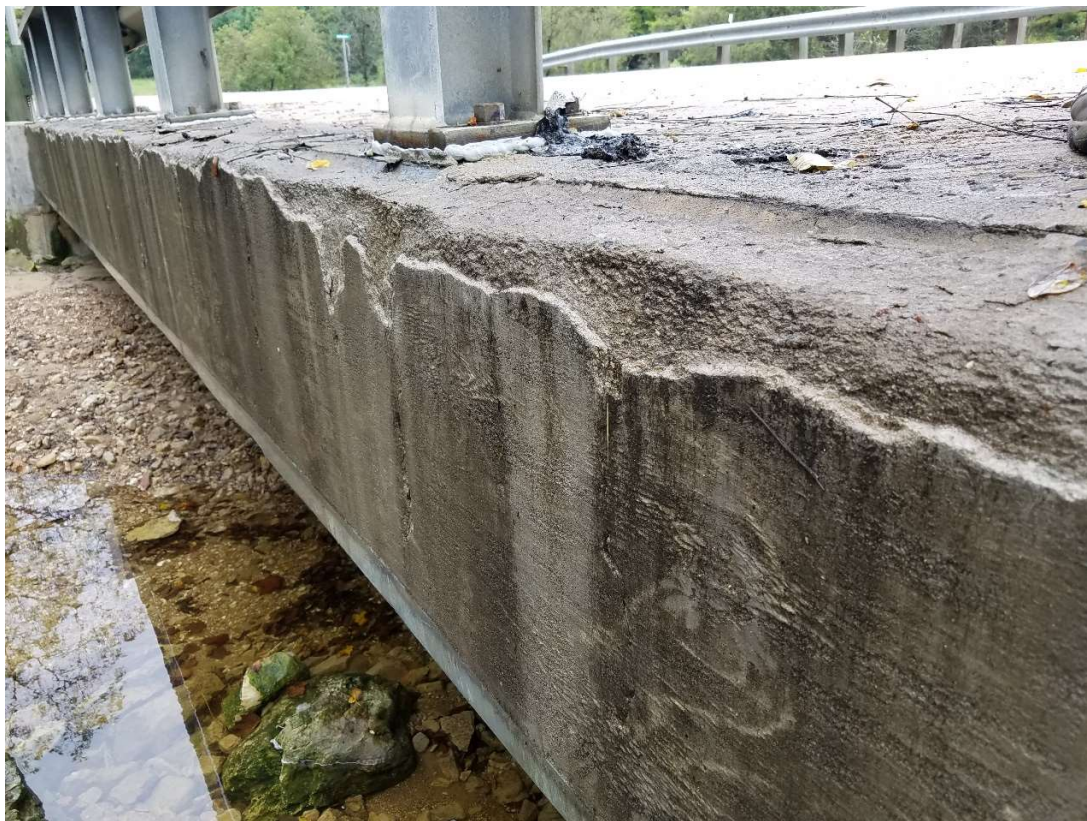
Spalling Concrete along north edge of deck
