**SITE PHOTOGRAPHS  
FOR  
STRUCTURE  
SURVEY REPORT**

**CTH PP Over Sheboygan River  
B-59-48  
CITY OF SHEBOYGAN, WI  
SHEBOYGAN COUNTY**

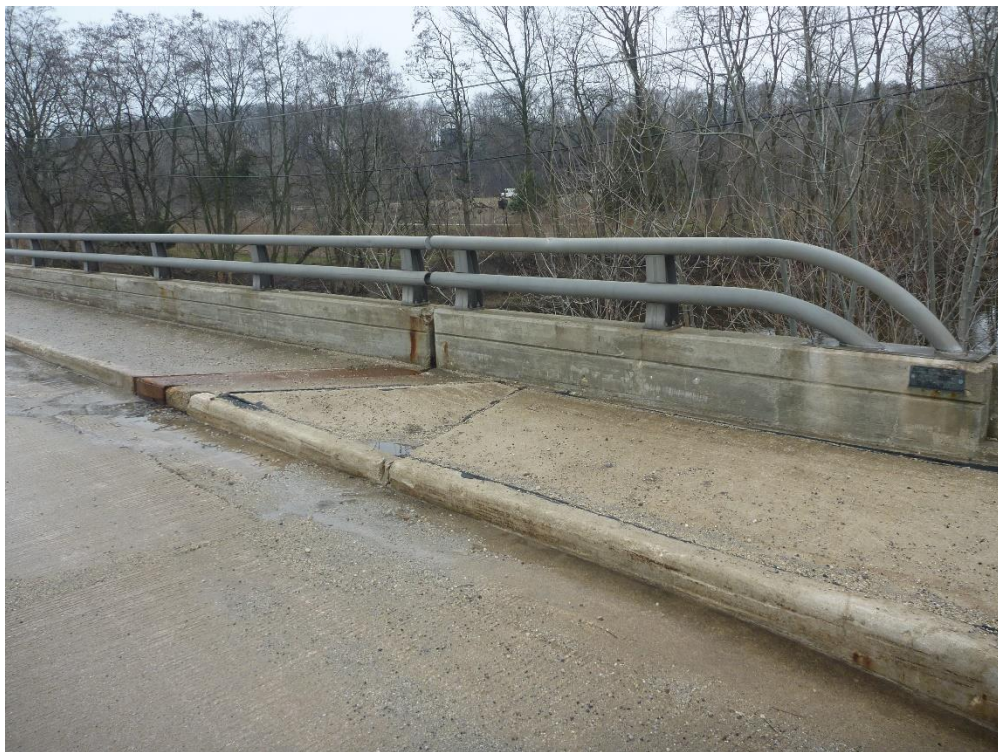
Settled approach sidewalk at southwest wing. Approach to be replaced during rehab.

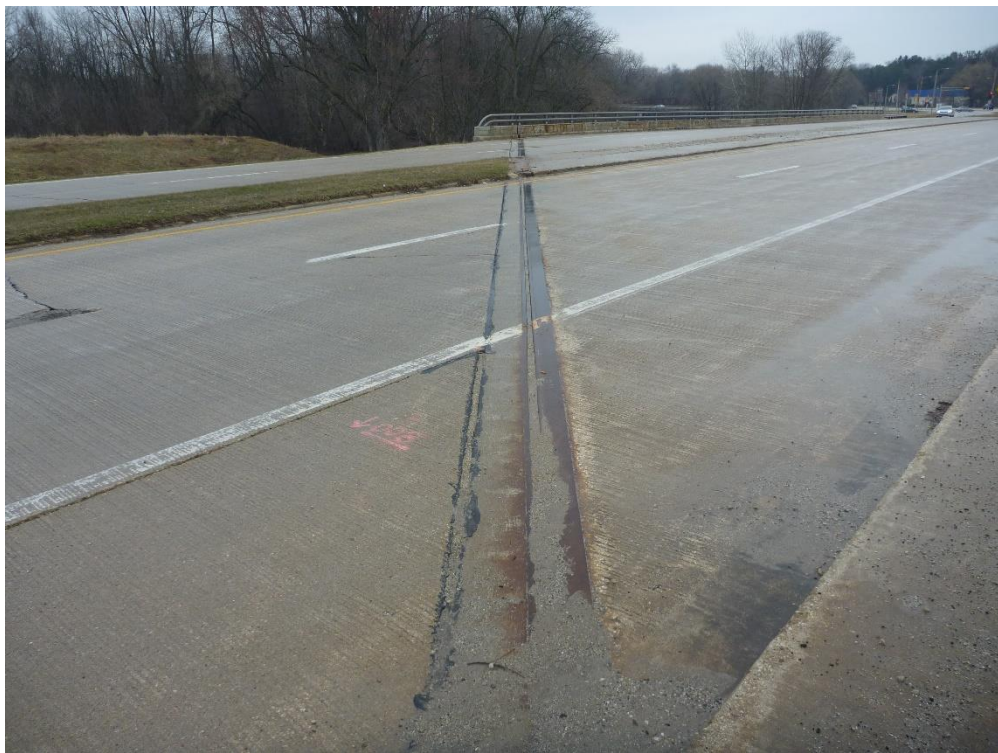
Strip seal expansion joint at west abutment. Strip seal glands at both abutments to be replaced.

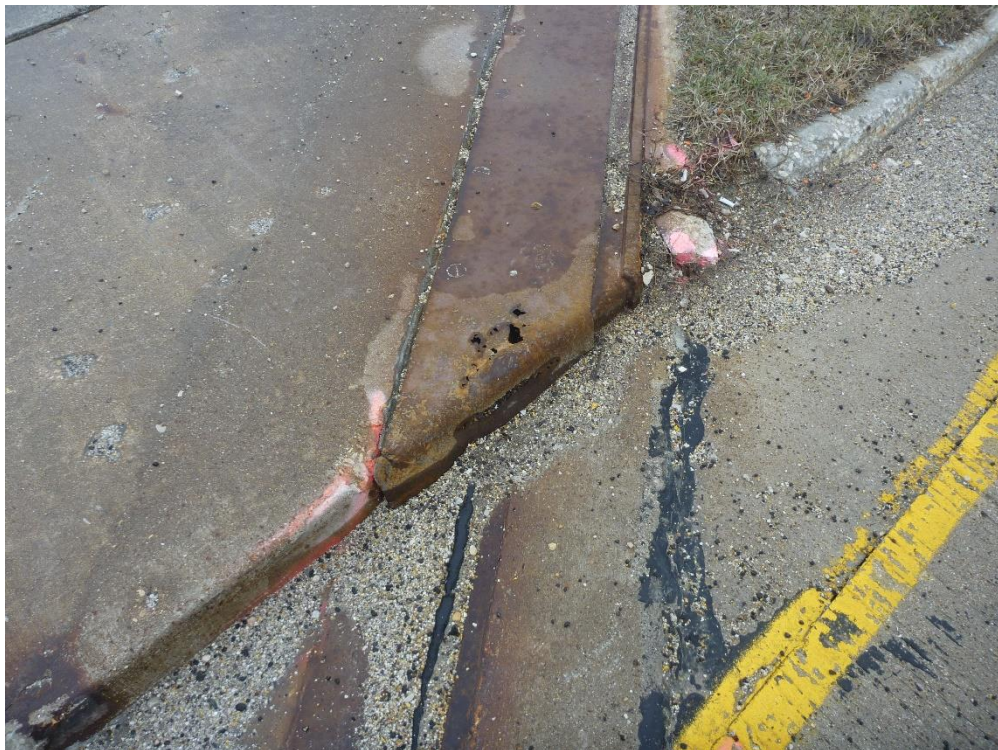
Minor section loss in cover plate of expansion joint at median. Cover plates to be repaired as required.

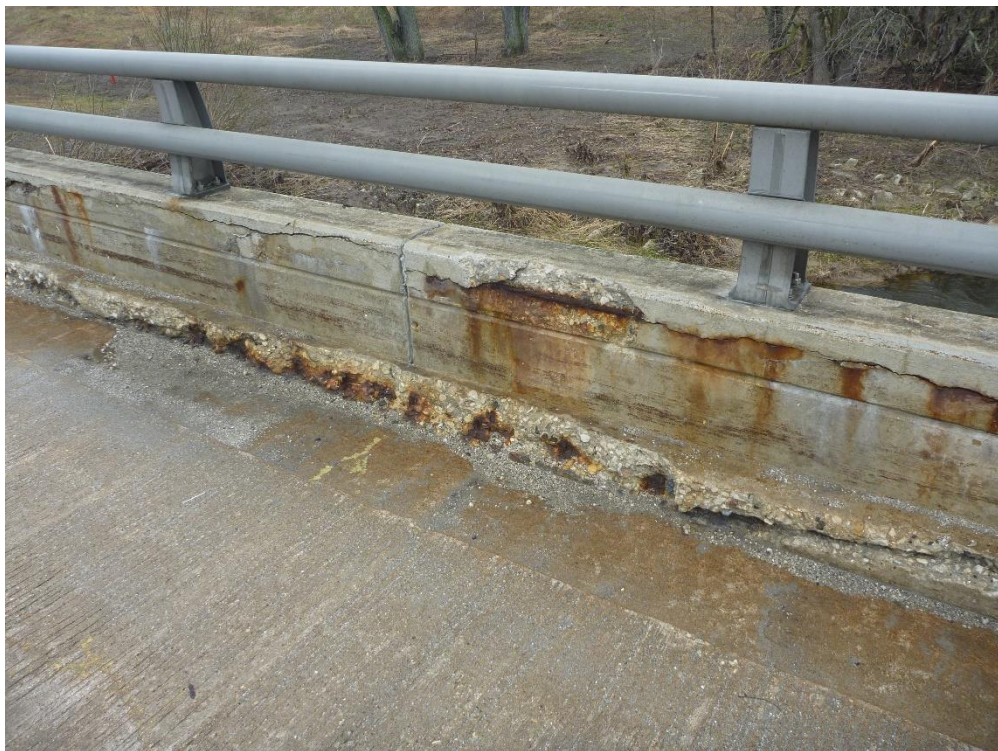
Typical curb and parapet cracking and spalling at north curb and parapet. Concrete surface repair and curb repair to be performed during rehabilitation.

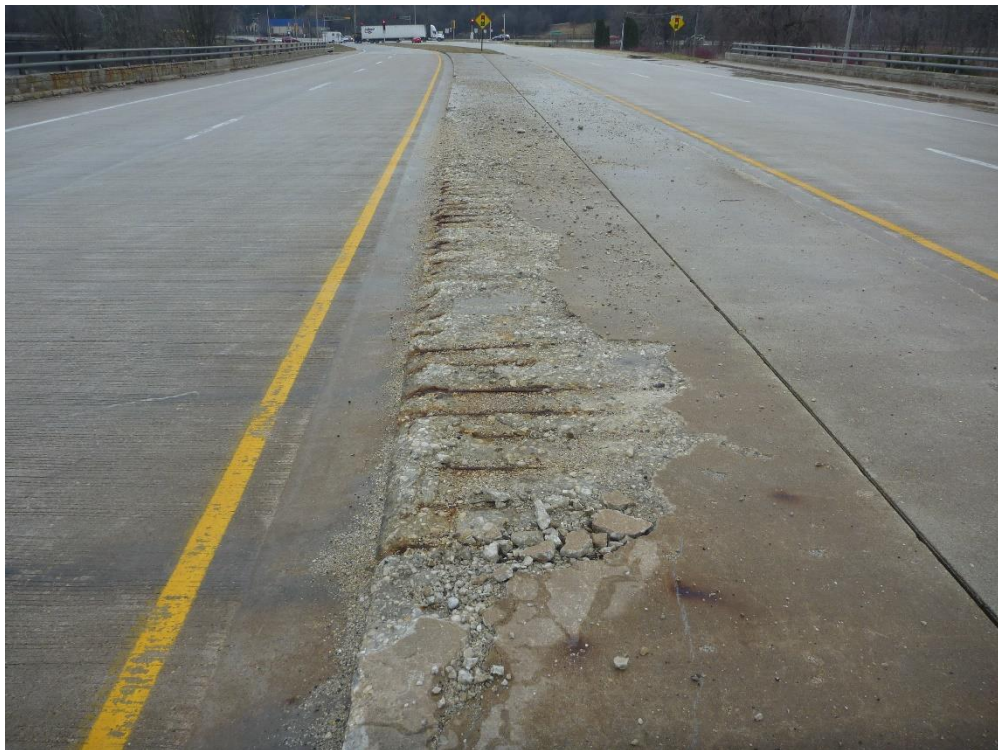
Concrete spalling at median to be repaired during rehabilitation.

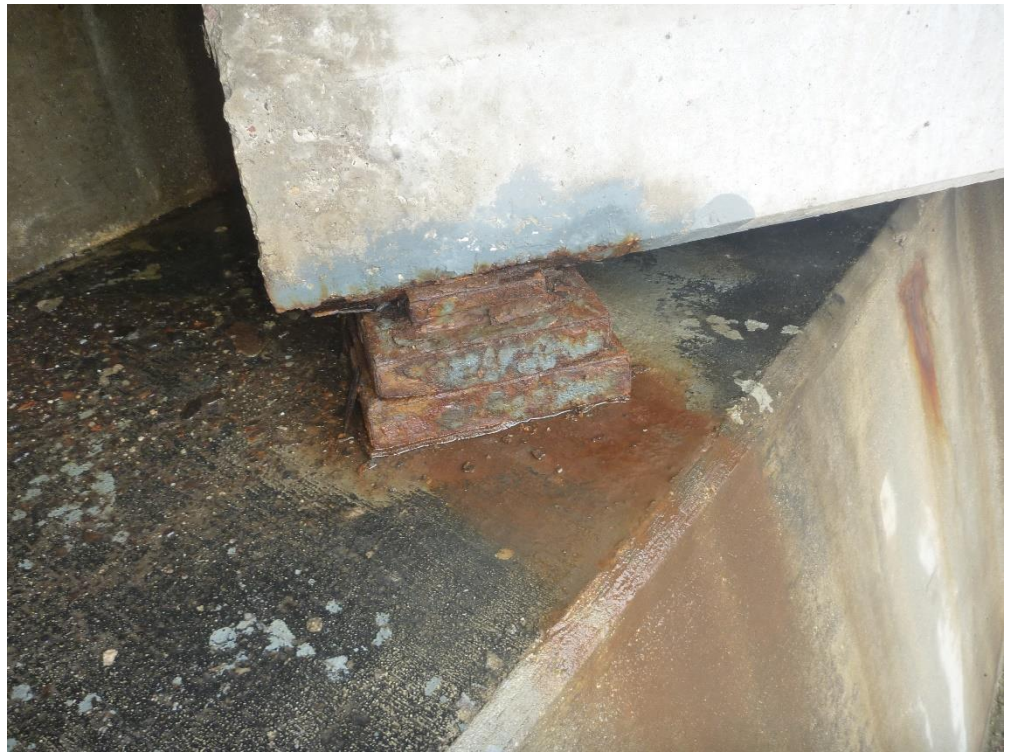
Typical bearing at abutment. Bearings at abutments and piers to be cleaned and repainted.

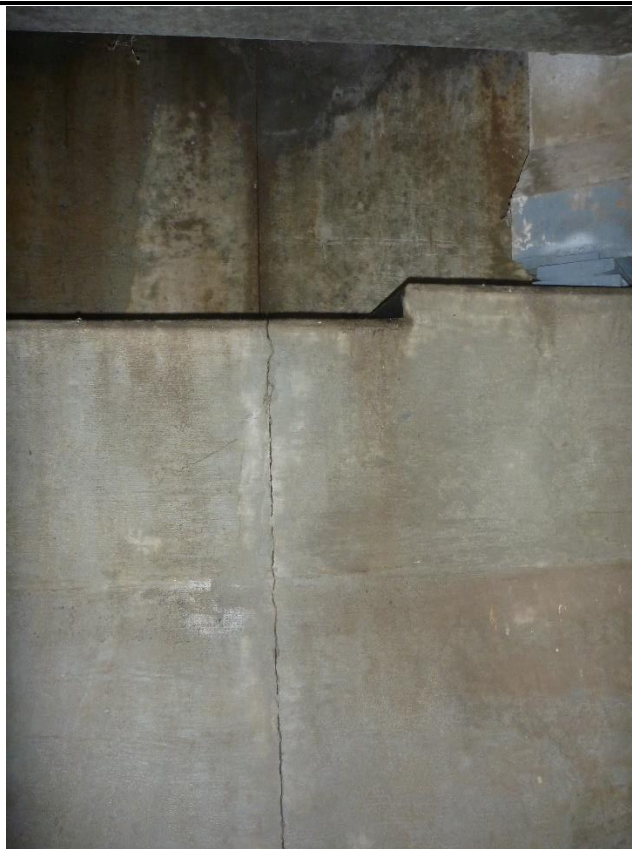
Vertical crack in abutment. All cracks in abutment and abutment backwall to be filled per "Epoxy Crack Sealing" bid item.

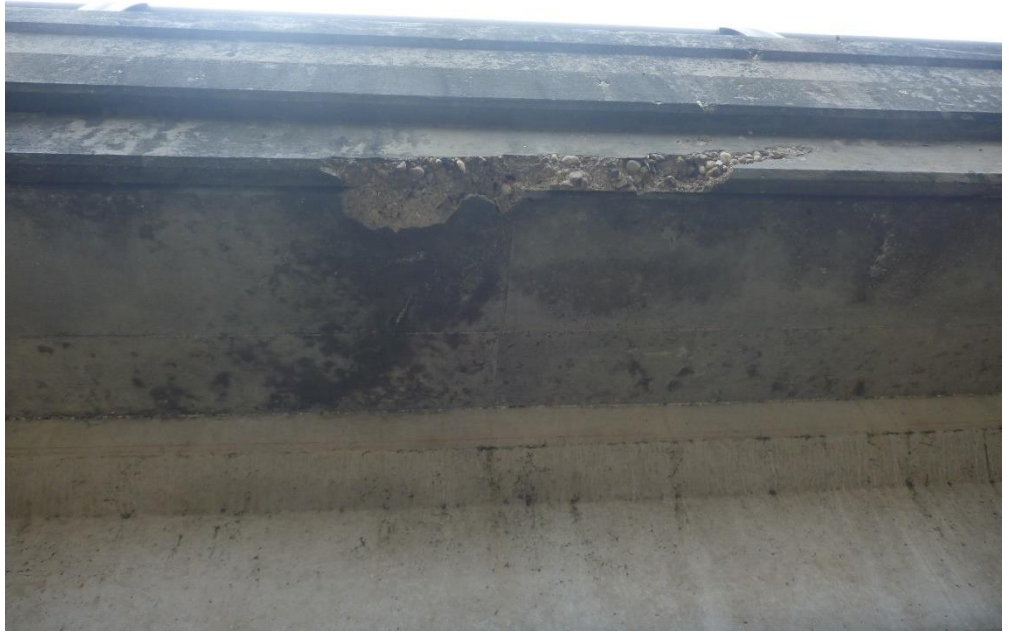
Edge of deck concrete spall to be repaired during rehabilitation.

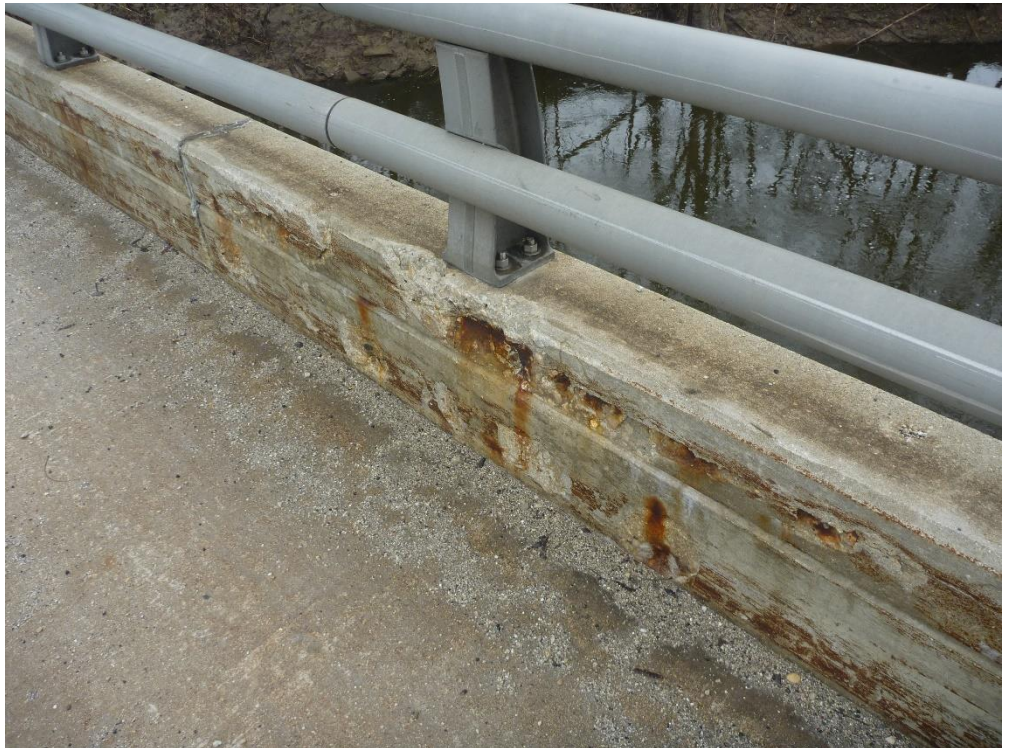
Typical cracking and spalling at south parapet. Concrete surface repair to be performed during rehabilitation.

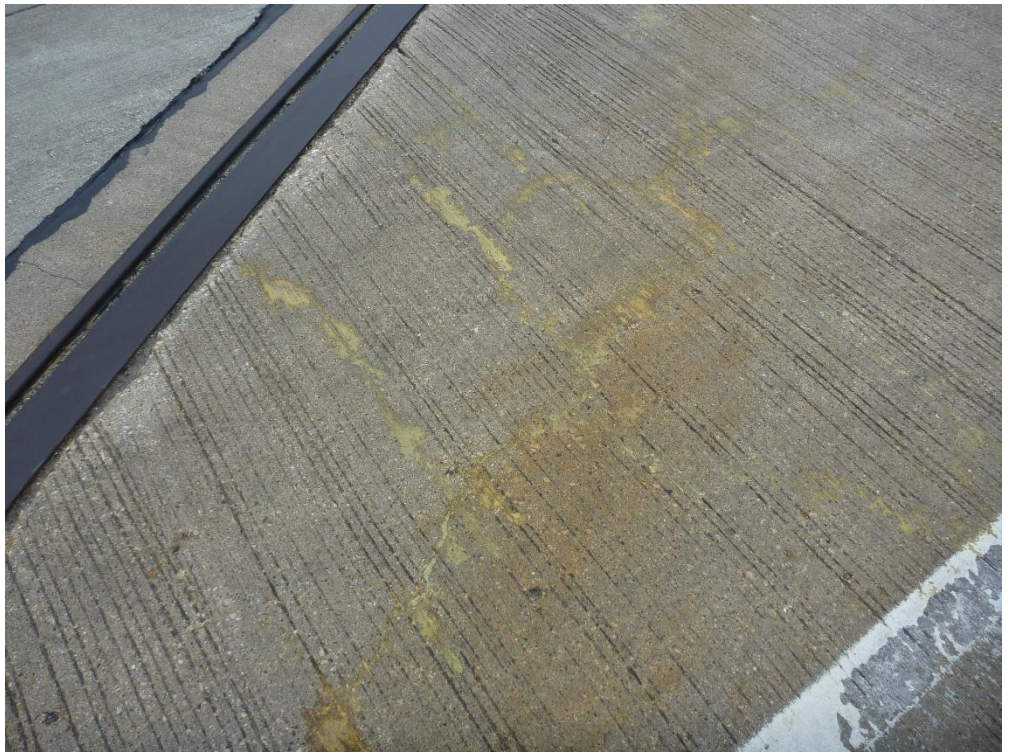
Cracks in concrete overlay to be sealed during rehabilitation.
