Inspection Report for
B-61-059

STH 121 over SPORT VALLEY CREEK
Mar 09,2017

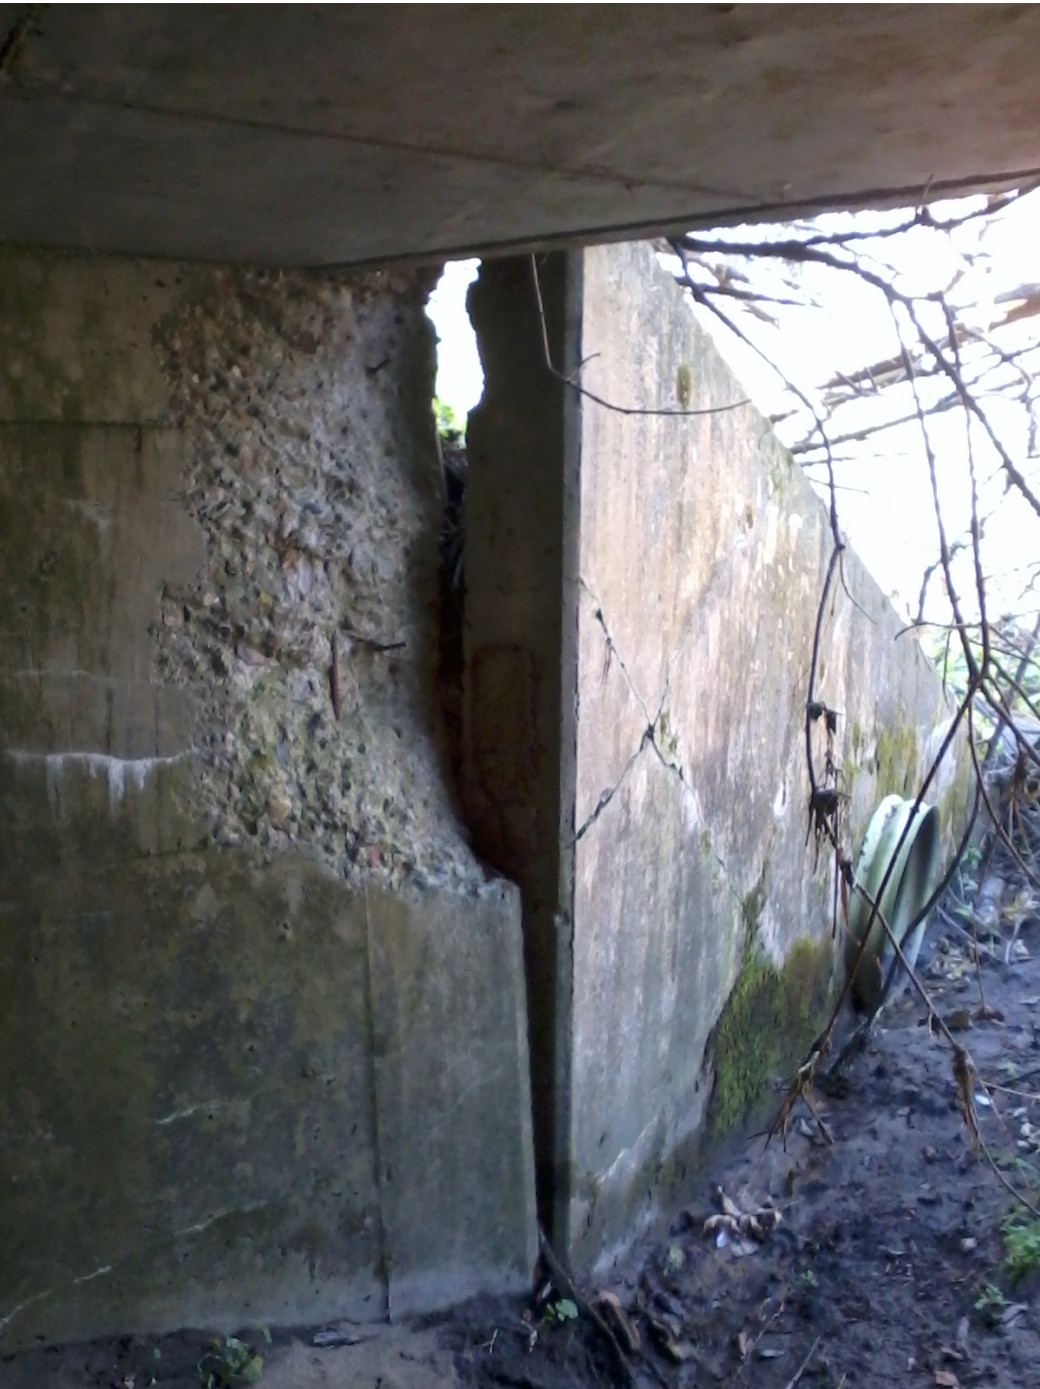
Chk	Element	Defect	Description	UOM	Total	Quantity in Condition State			
						1	2	3	4
X	9248		Culvert End Treatment SW wing heavily spalled & cracked and tipped in. SE wing replaced in 2016.	EA	2	1	0	0	1
X	9325		Roadway Over Structure Rutting and cracking, but the same as the rest of the road.	EA	1	0	1	0	0

Broken & distorted wings appear to have little to no affect on the above rdwy. Repair needed soon - could remove wings and line boxes.
 Monitor wingwalls. Replace wings with any scheduled road work.

Item	Priority	Recommended by	Status	Status change
Misc - Other Work	MEDIUM	Balsiger, Lee (6011)	IDENTIFIED	10/19/16
Replace/Repair SW wing

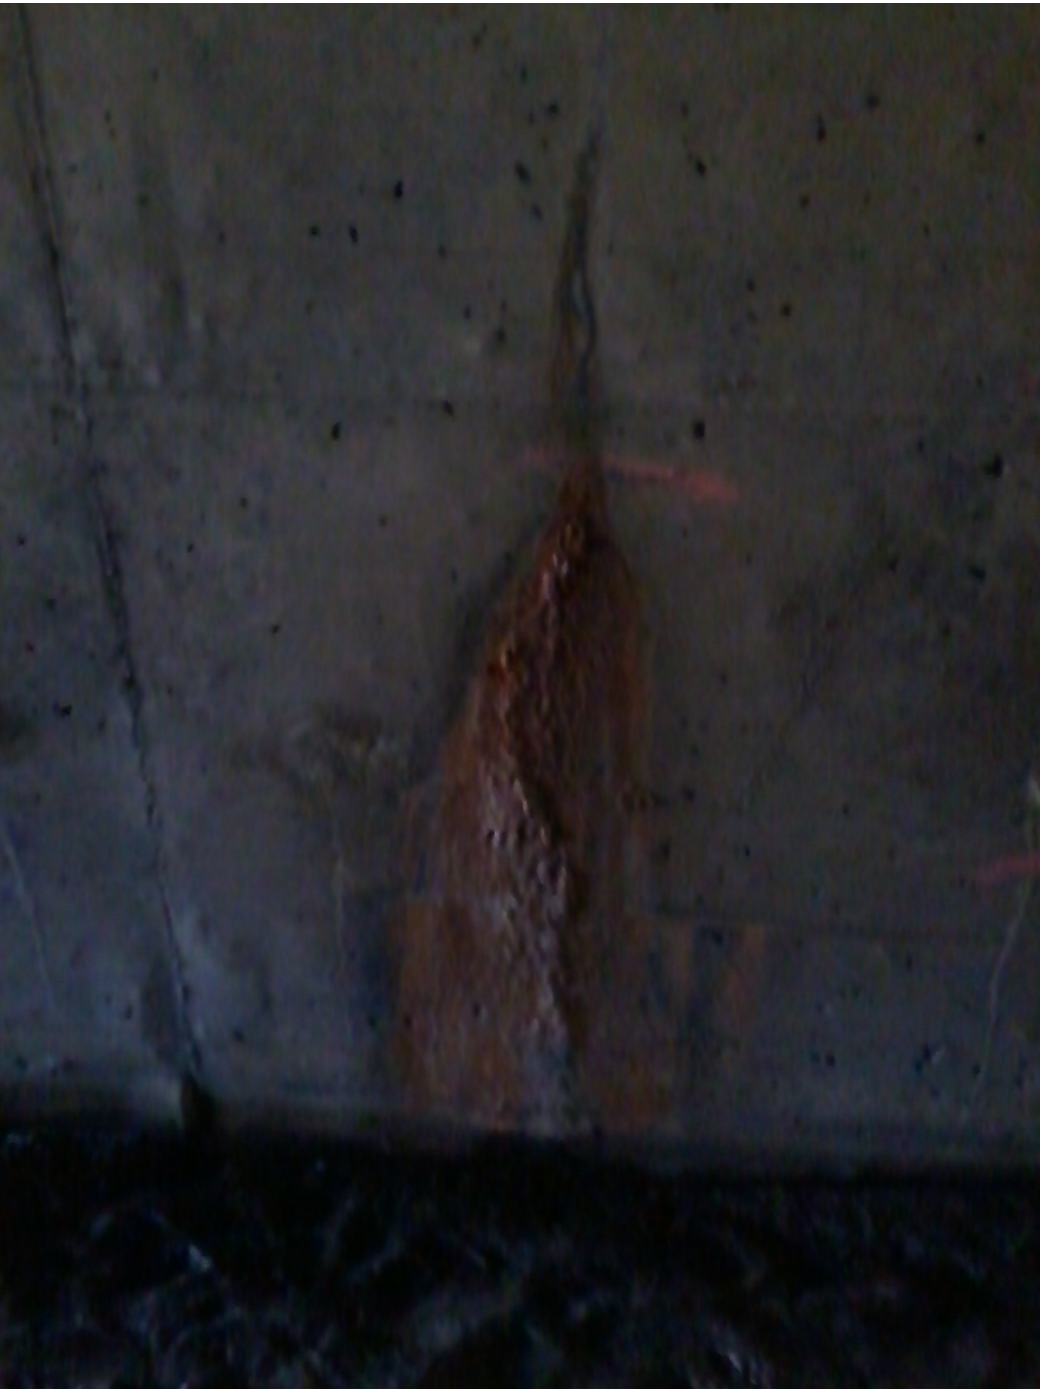
South barrel - middle

Chk	Element	Defect	Description	UOM	Total	Quantity in Condition State			
						1	2	3	4
X	241		Reinforced Concrete Culvert Channel directed to center barrel with 1ft stub walls on apron.	LF	245	193	45	7	0
		1080	Delamination - Spall - Patched Area Spalling at west end in south barrel.	LF		0	0	2	0
		1130	Cracking (RC) NORTH: ~10 transverse cracks CENTER: ~10 transverse cracks, few with EFF. SOUTH: ~15 transverse crack, few with heavy leaching/EFF. ~15ft horizontal crack on south wall near west end of barrel.	LF		0	45	5	0
