Project ID 3839-03-73 USH 12 Bridge Rehabilitation
B-64-22 CTH U over USH 12
Photos of Existing Structure

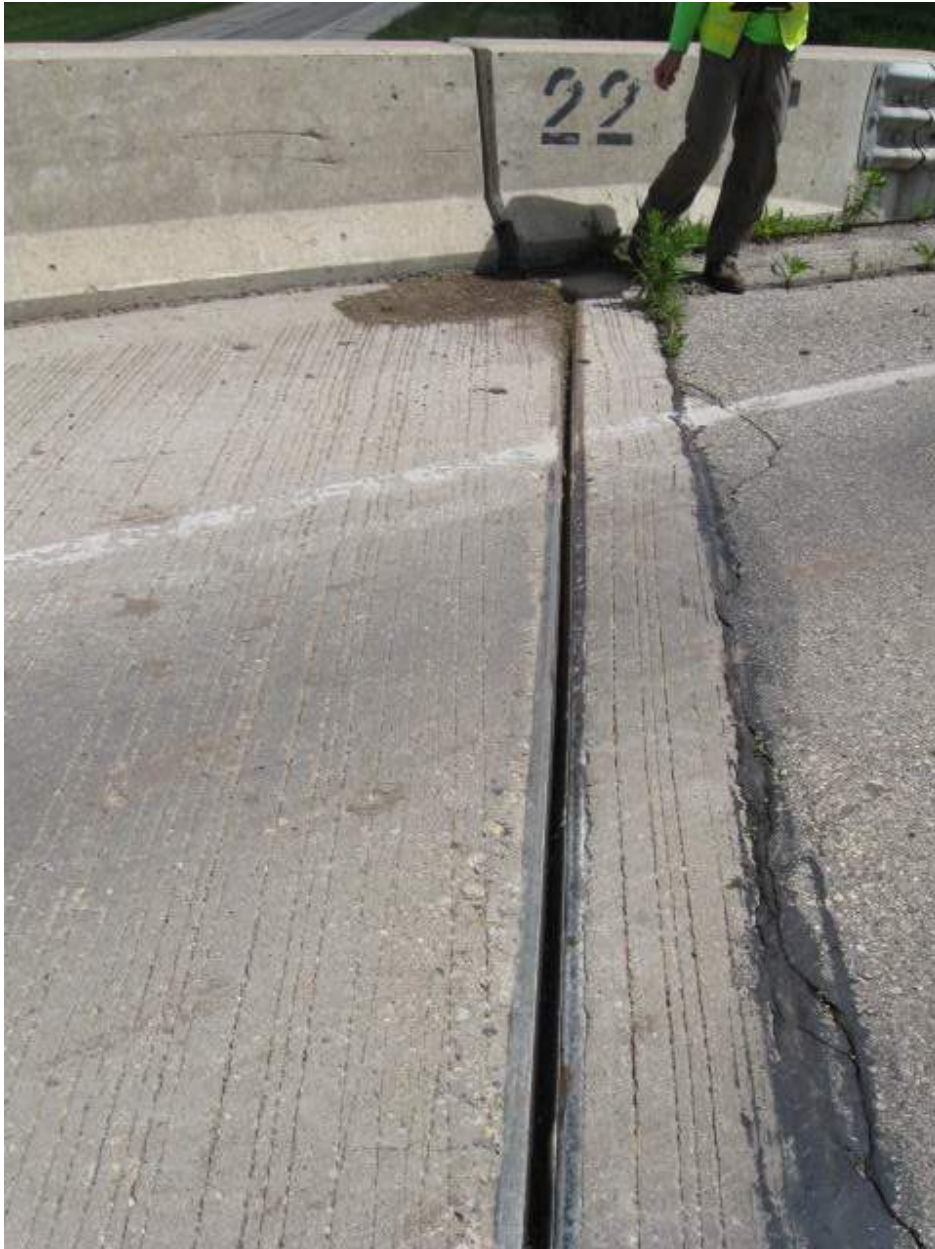
South expansion joint, looking east. Paving block higher than deck slab. Evidence of drainage issues.

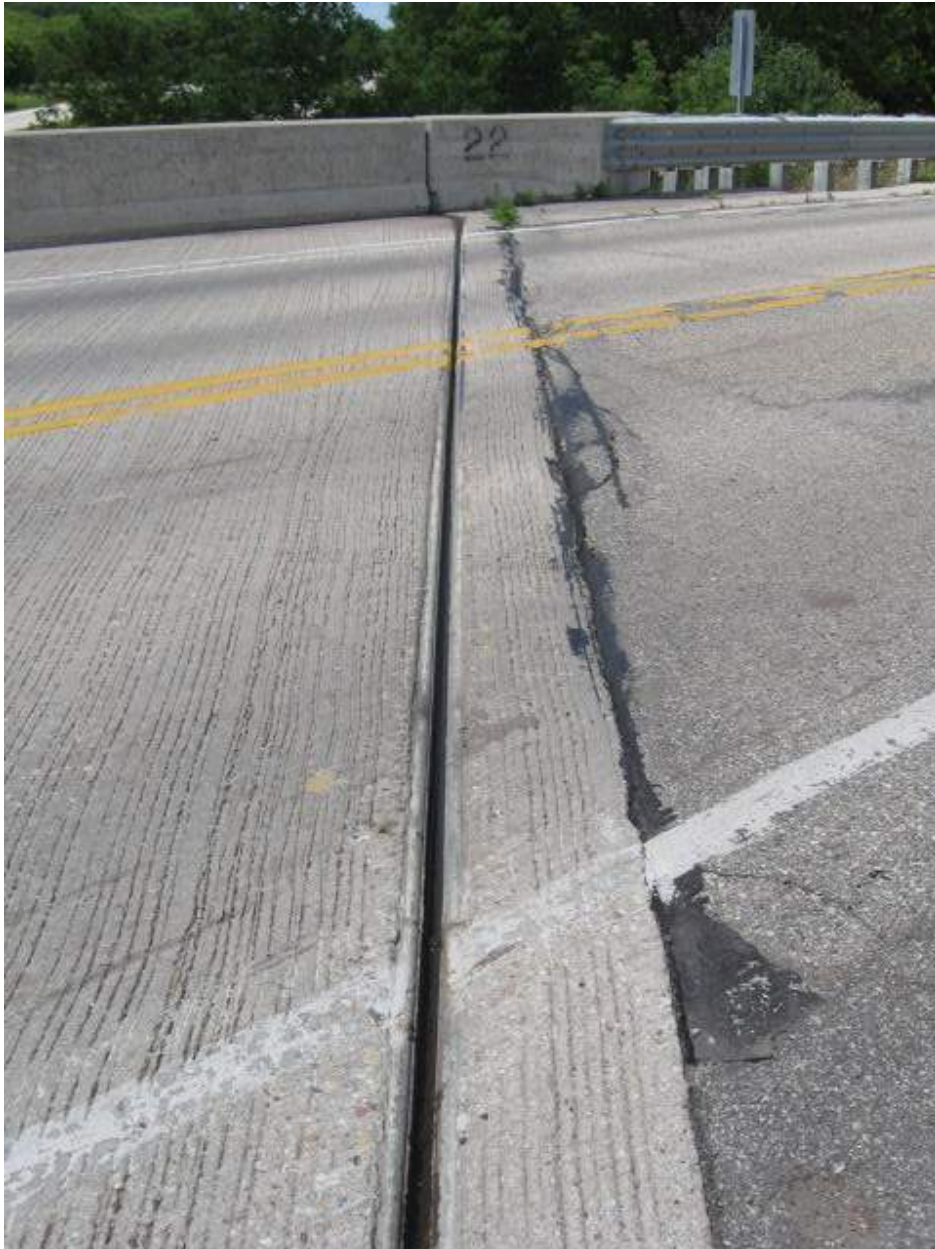
North expansion joint, looking east. Portions of paving block higher than deck.

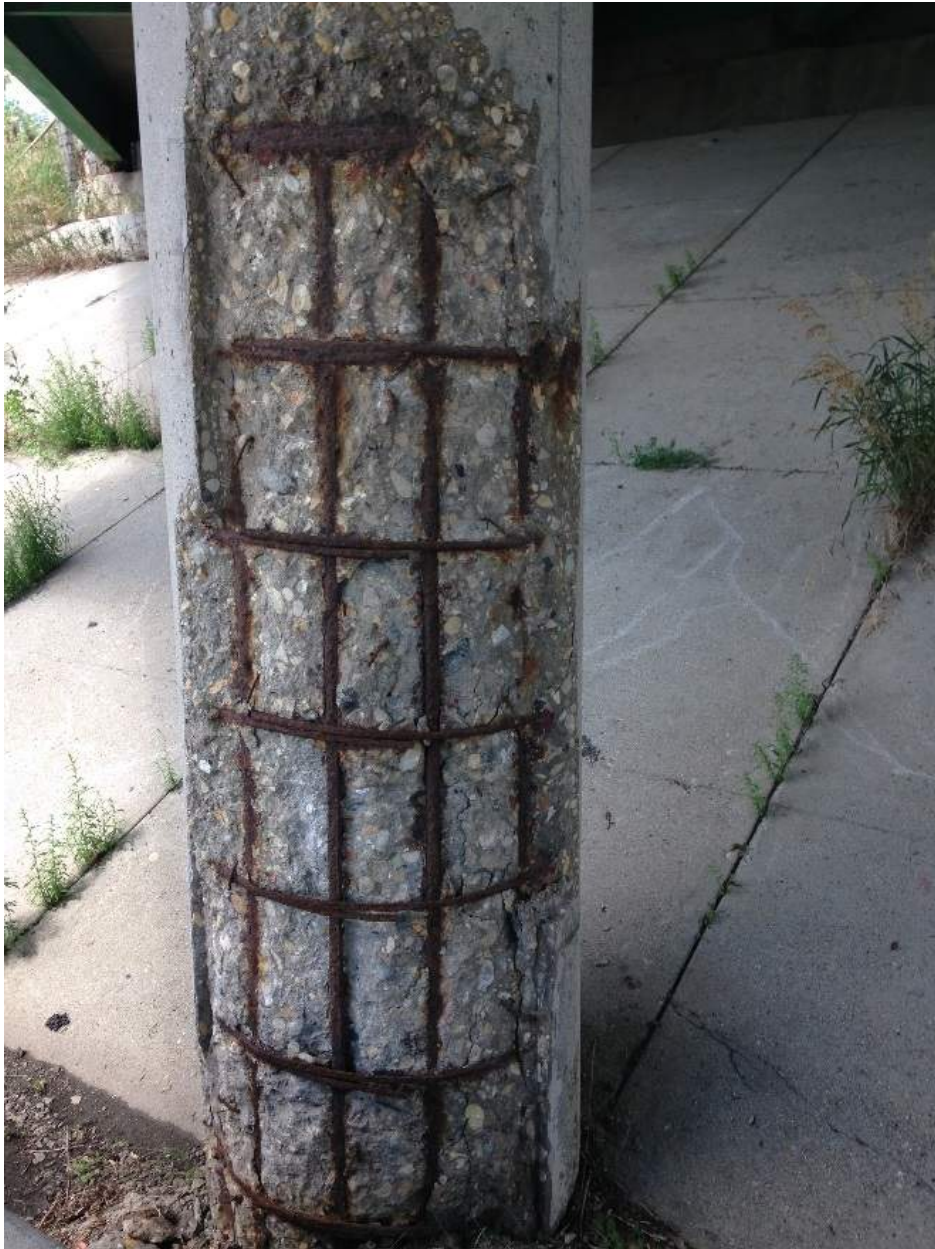
Exposed rebar at failed column repair. Typical several columns at the shoulder piers.

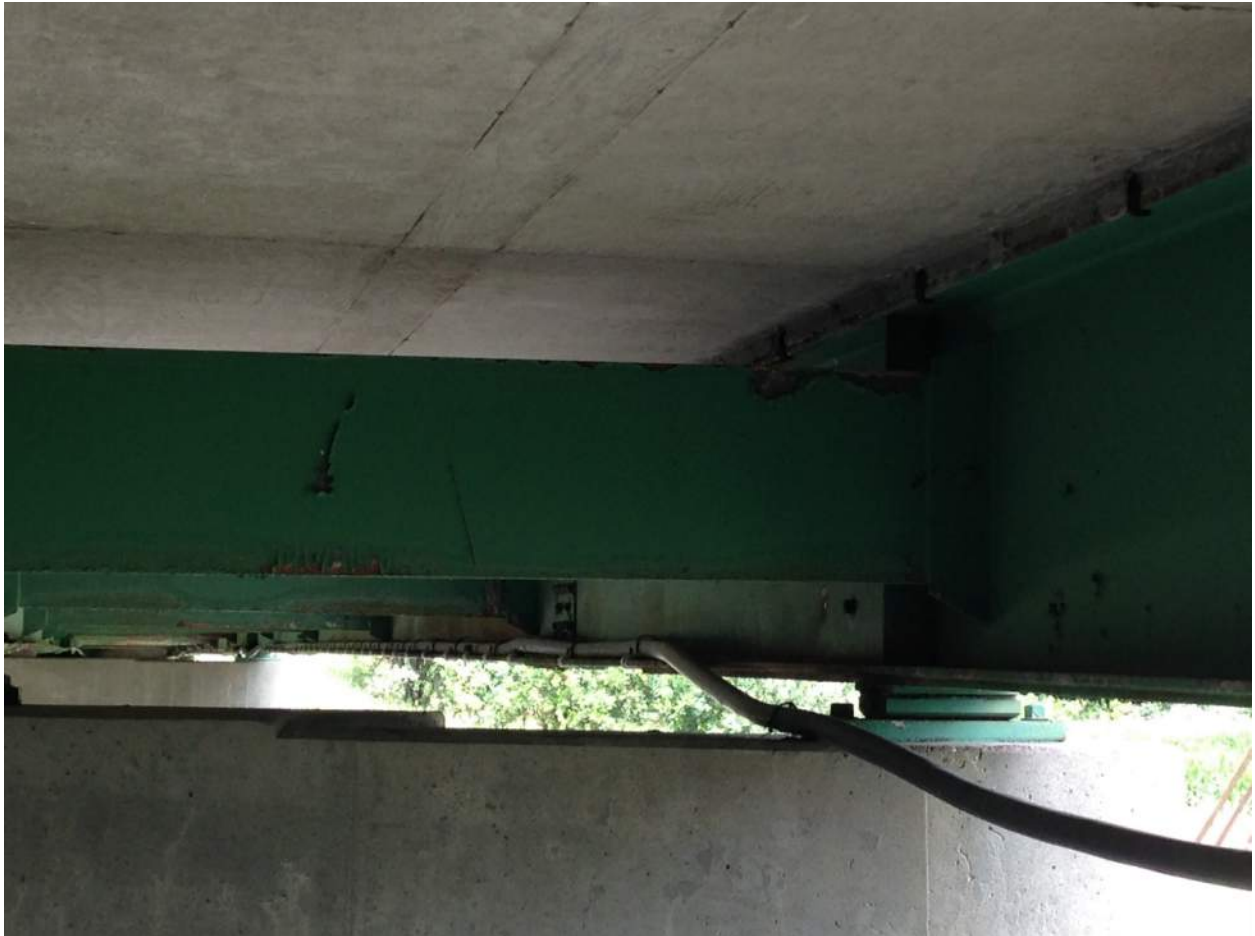
Utility (abandoned?) attached to east girder
