Photos of Existing Structure

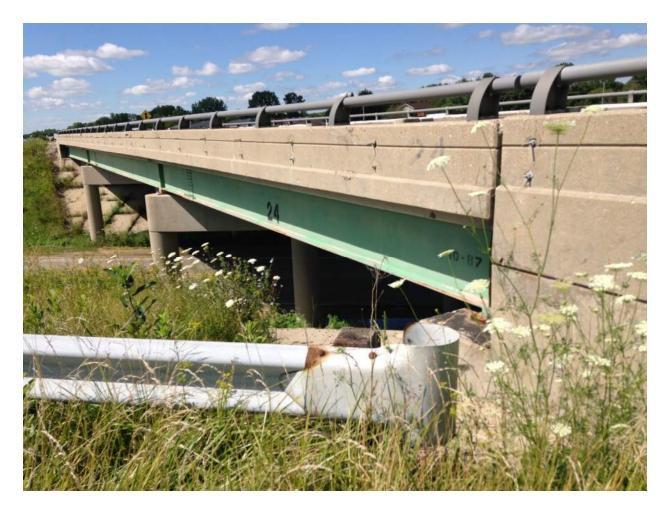
Looking north along west face

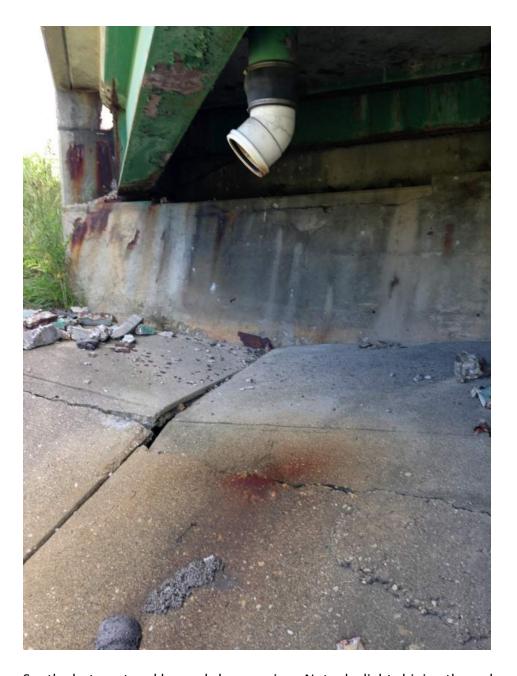
South abutment and heaved slope paving. Note daylight shining through gap in backwall.

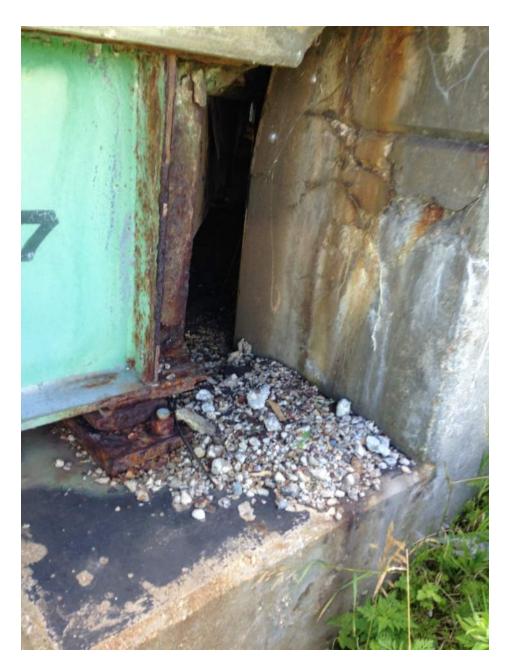
North abutment, east end. Deteriorated backwall, girder and, and bearing.

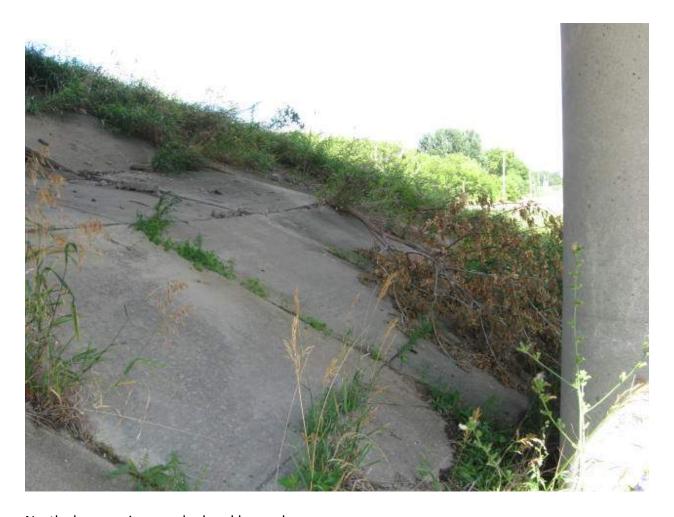
North slope paving, cracked and heaved
