Inspection Report for B-64-064

IH 43 NB over USH 12
Apr 26, 2017

Feature On: IH 43 NB	Section Town Range: S31 T03N R17E	Structure Number: B-64-064
Feature Under: USH 12	County: WALWORTH	
Location 1.9M N JCT STH 67 TO N	Municipality: LA FAYETTE	Structure Name:

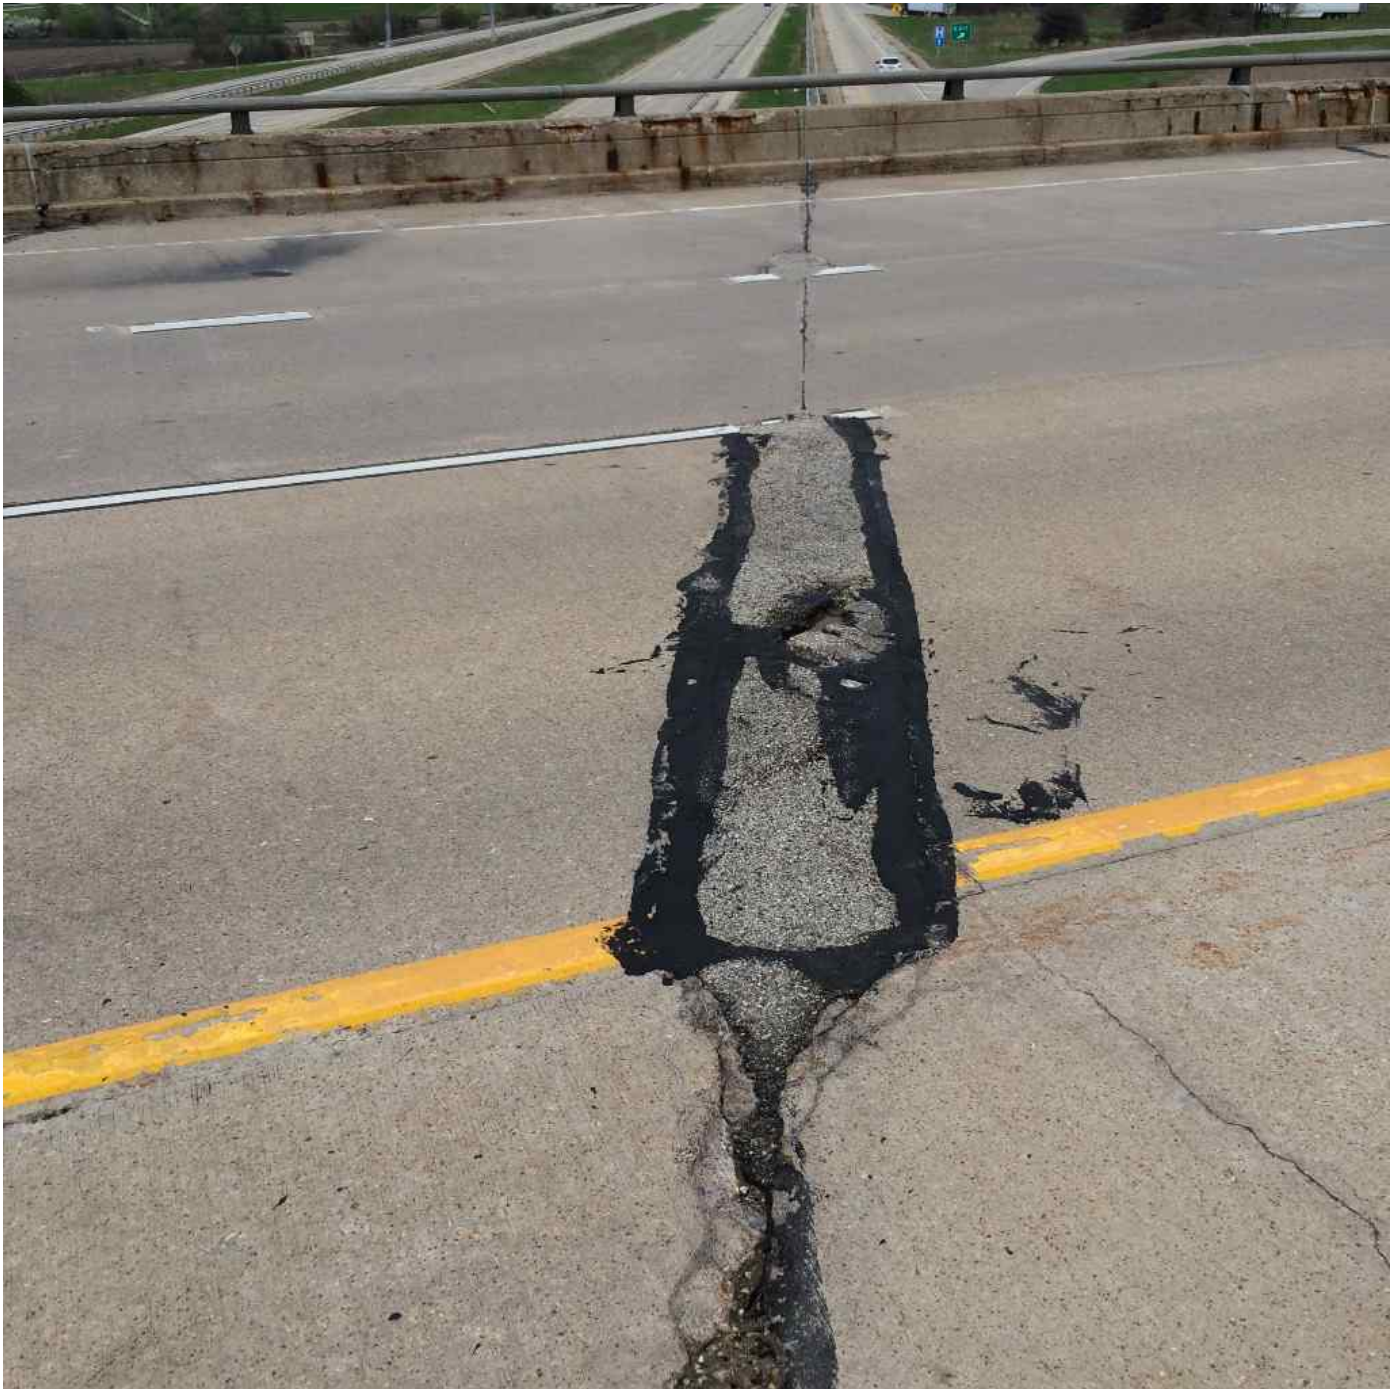
Failing deck patch at Pier 1-Typical.

Item	Priority	Recommended by	Status	Status change
Deck - Patching	HIGH	Brooks, Julie (2017)	IDENTIFIED	01/14/16
Patch spalls and repair/replace failing patches on surface.				
Drainage - Repair/Replace Deck Drains	HIGH	Brooks, Julie (2017)	IDENTIFIED	01/14/16
Repair inlet at SW wing corner: Tuckpoint inlet.				
IMP-Deck Replacement	MEDIUM	Brooks, Julie (2017)	IDENTIFIED	01/14/16
2020 recommended.				
IMP-Paint Structure	MEDIUM	Brooks, Julie (2017)	IDENTIFIED	01/14/16
2020 recommended.				
Misc - Remove/Monitor Loose Concrete	MEDIUM	Brooks, Julie (2017)	IDENTIFIED	01/14/16
Monitor any delams over roadway.				
Approach - Seal Cracks	MEDIUM	Brooks, Julie (2017)	IDENTIFIED	01/14/16
Seal all cracks and joints in approaches.

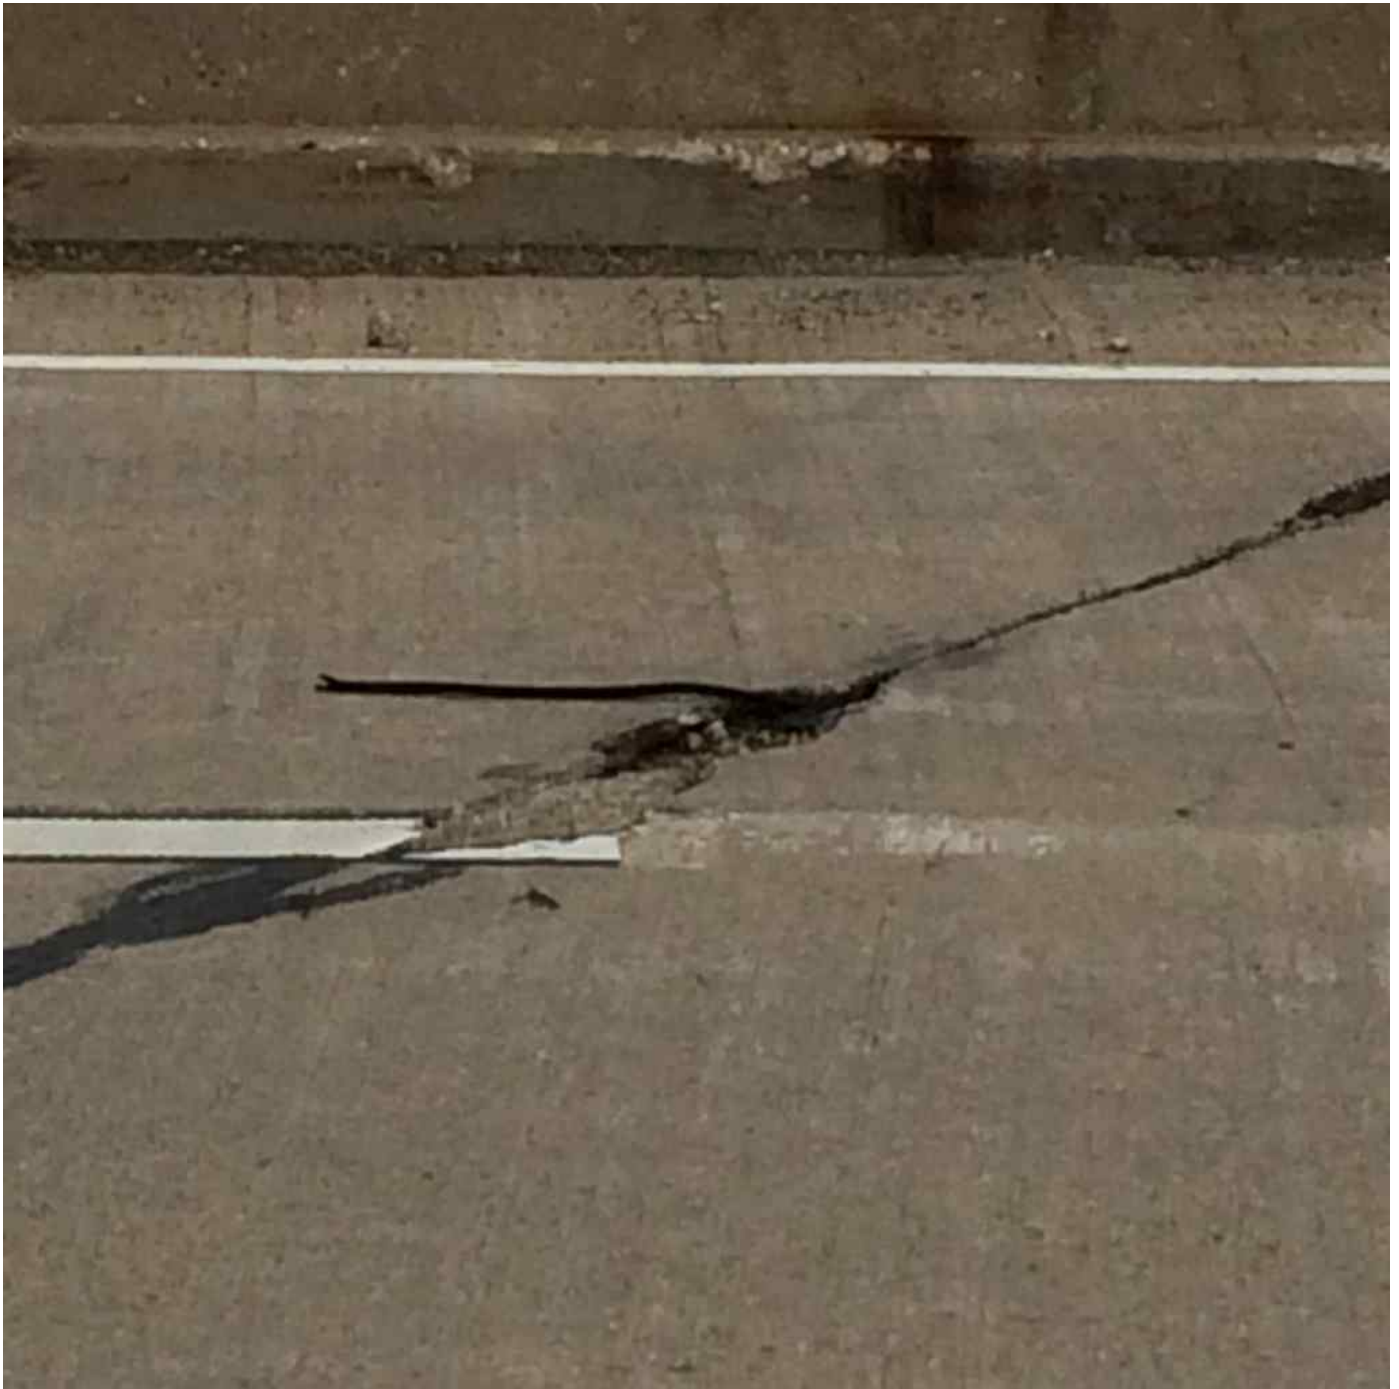
Deck spall at right exit lane at Pier 3.

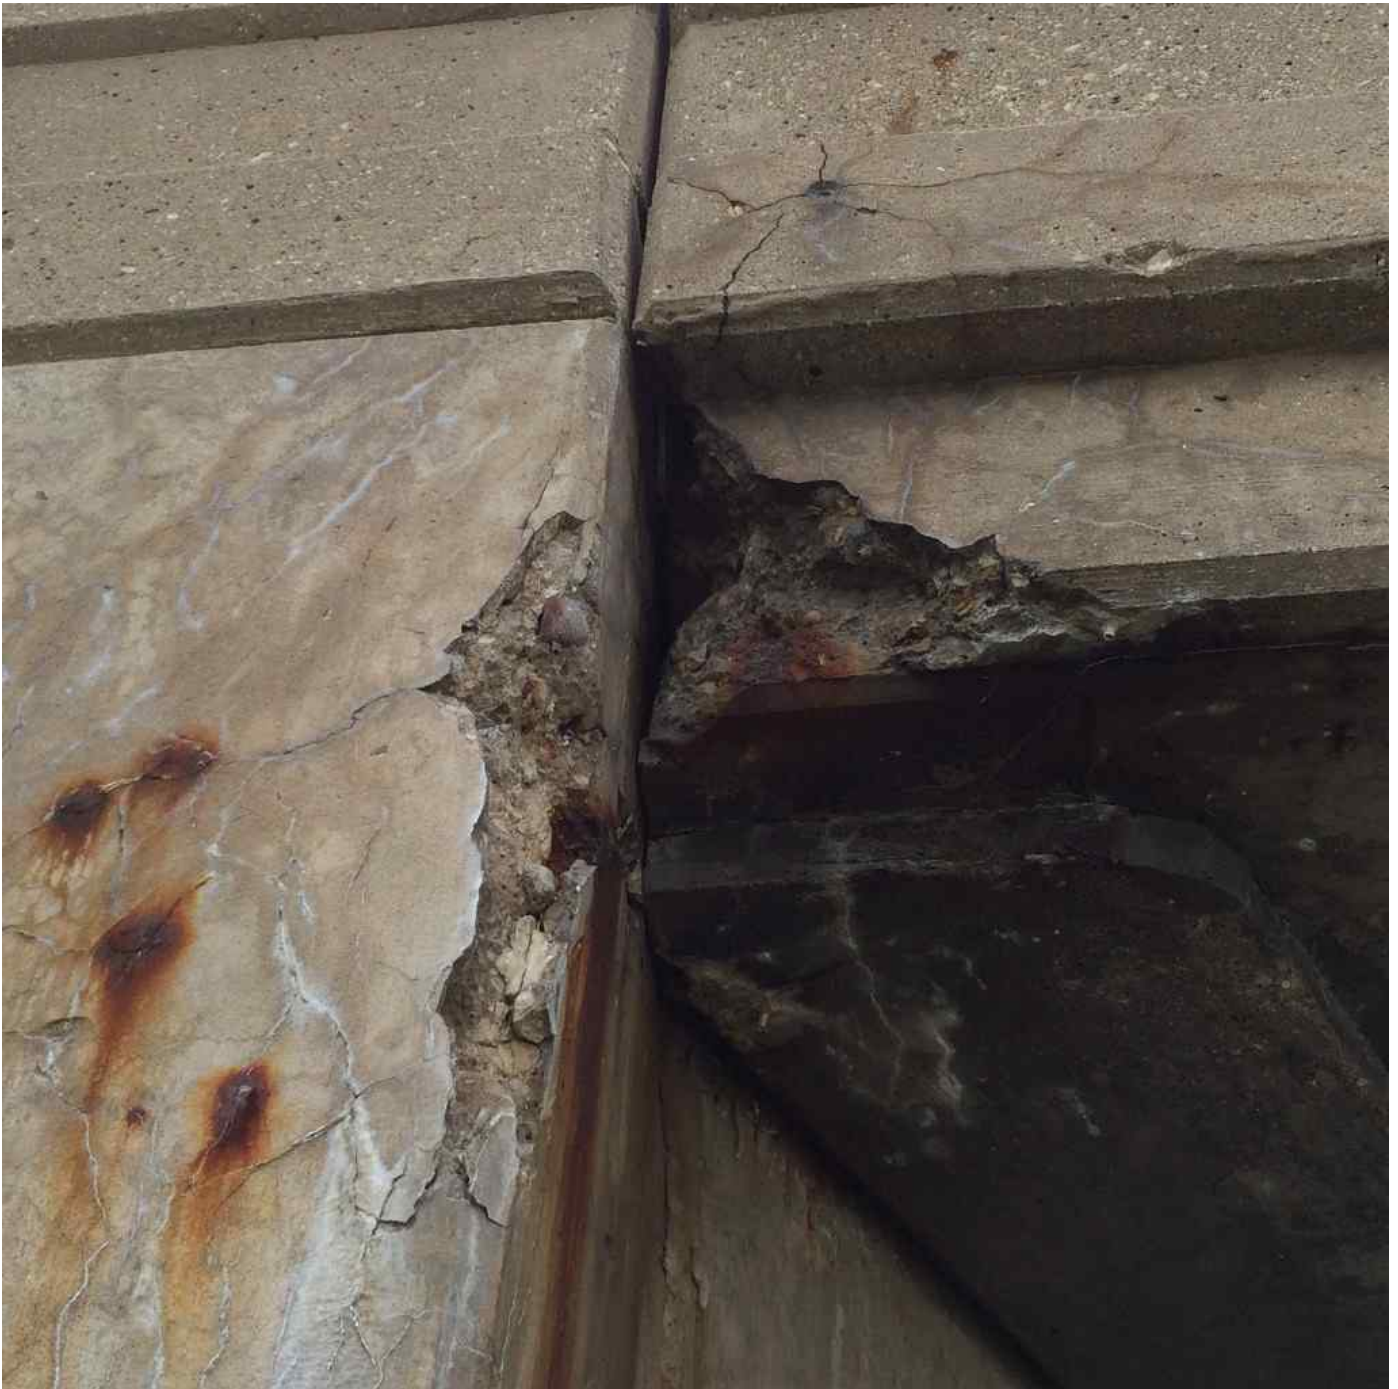
Spall at SW corner deck soffit.

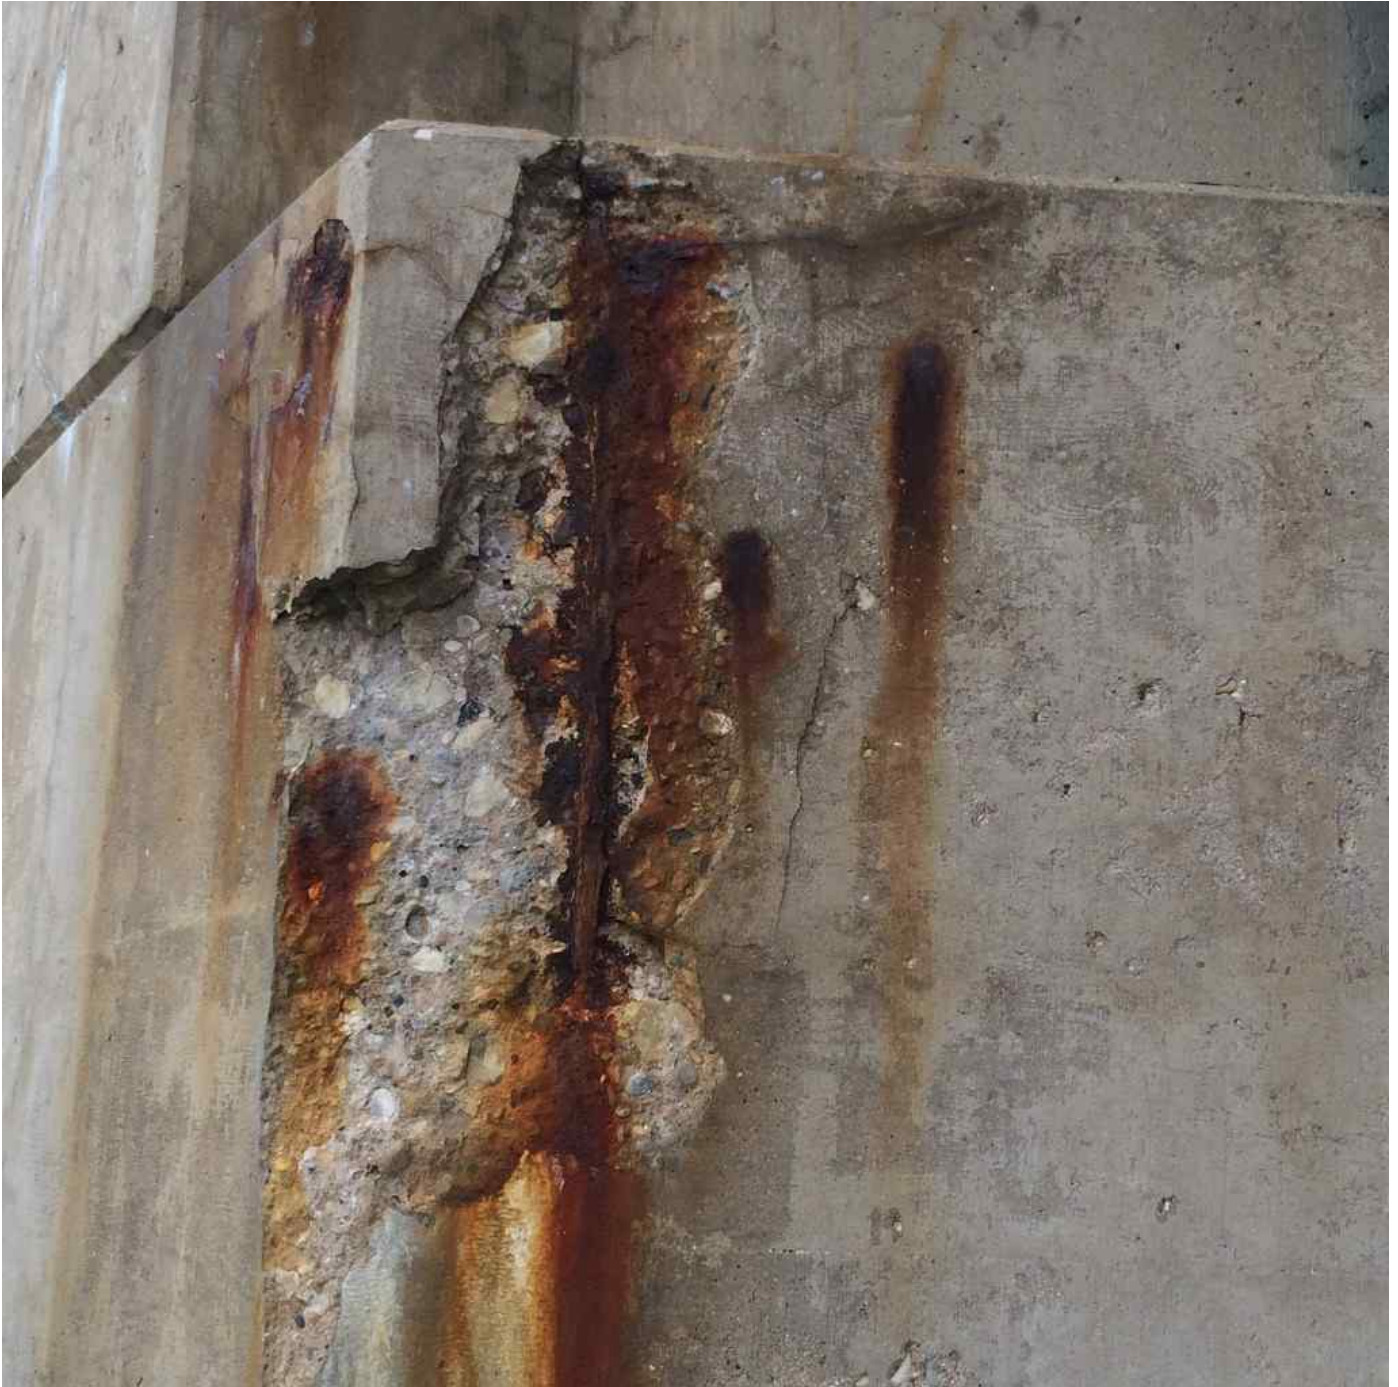
Spall at SW corner south abutment.

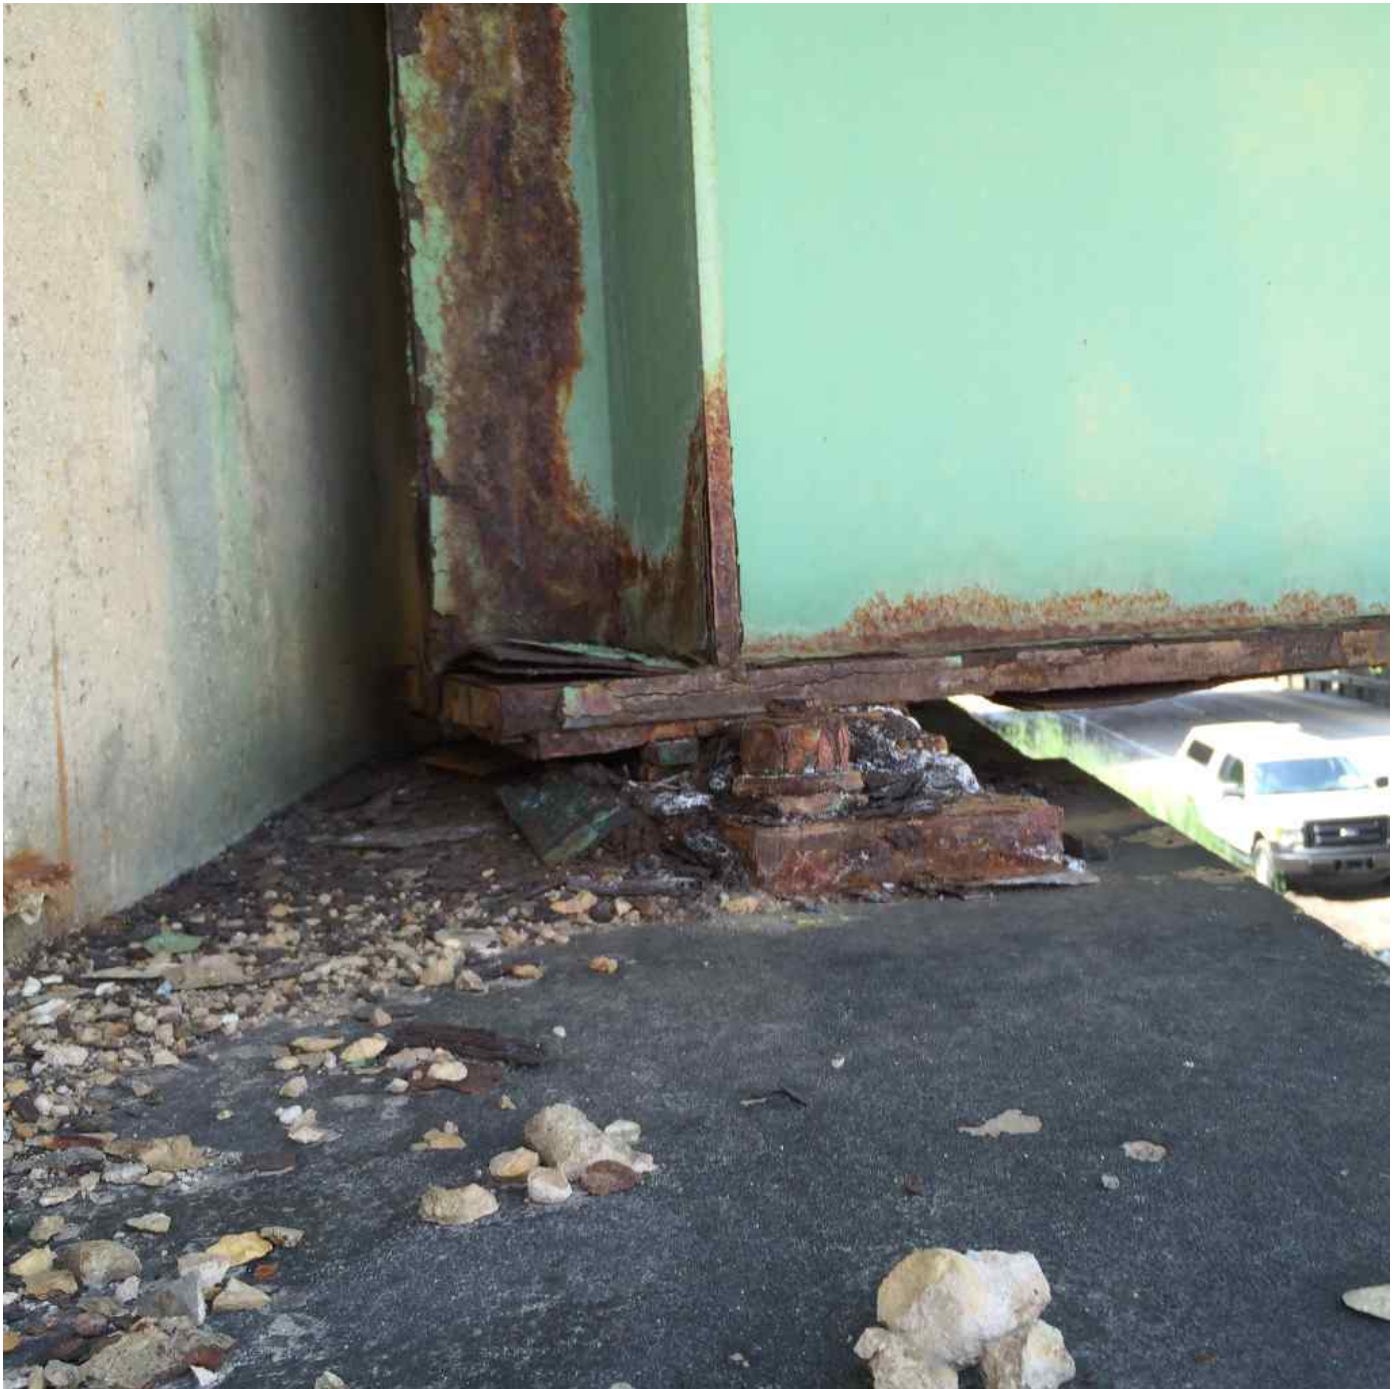
Bearing at girder 5 (SW) west abutment.

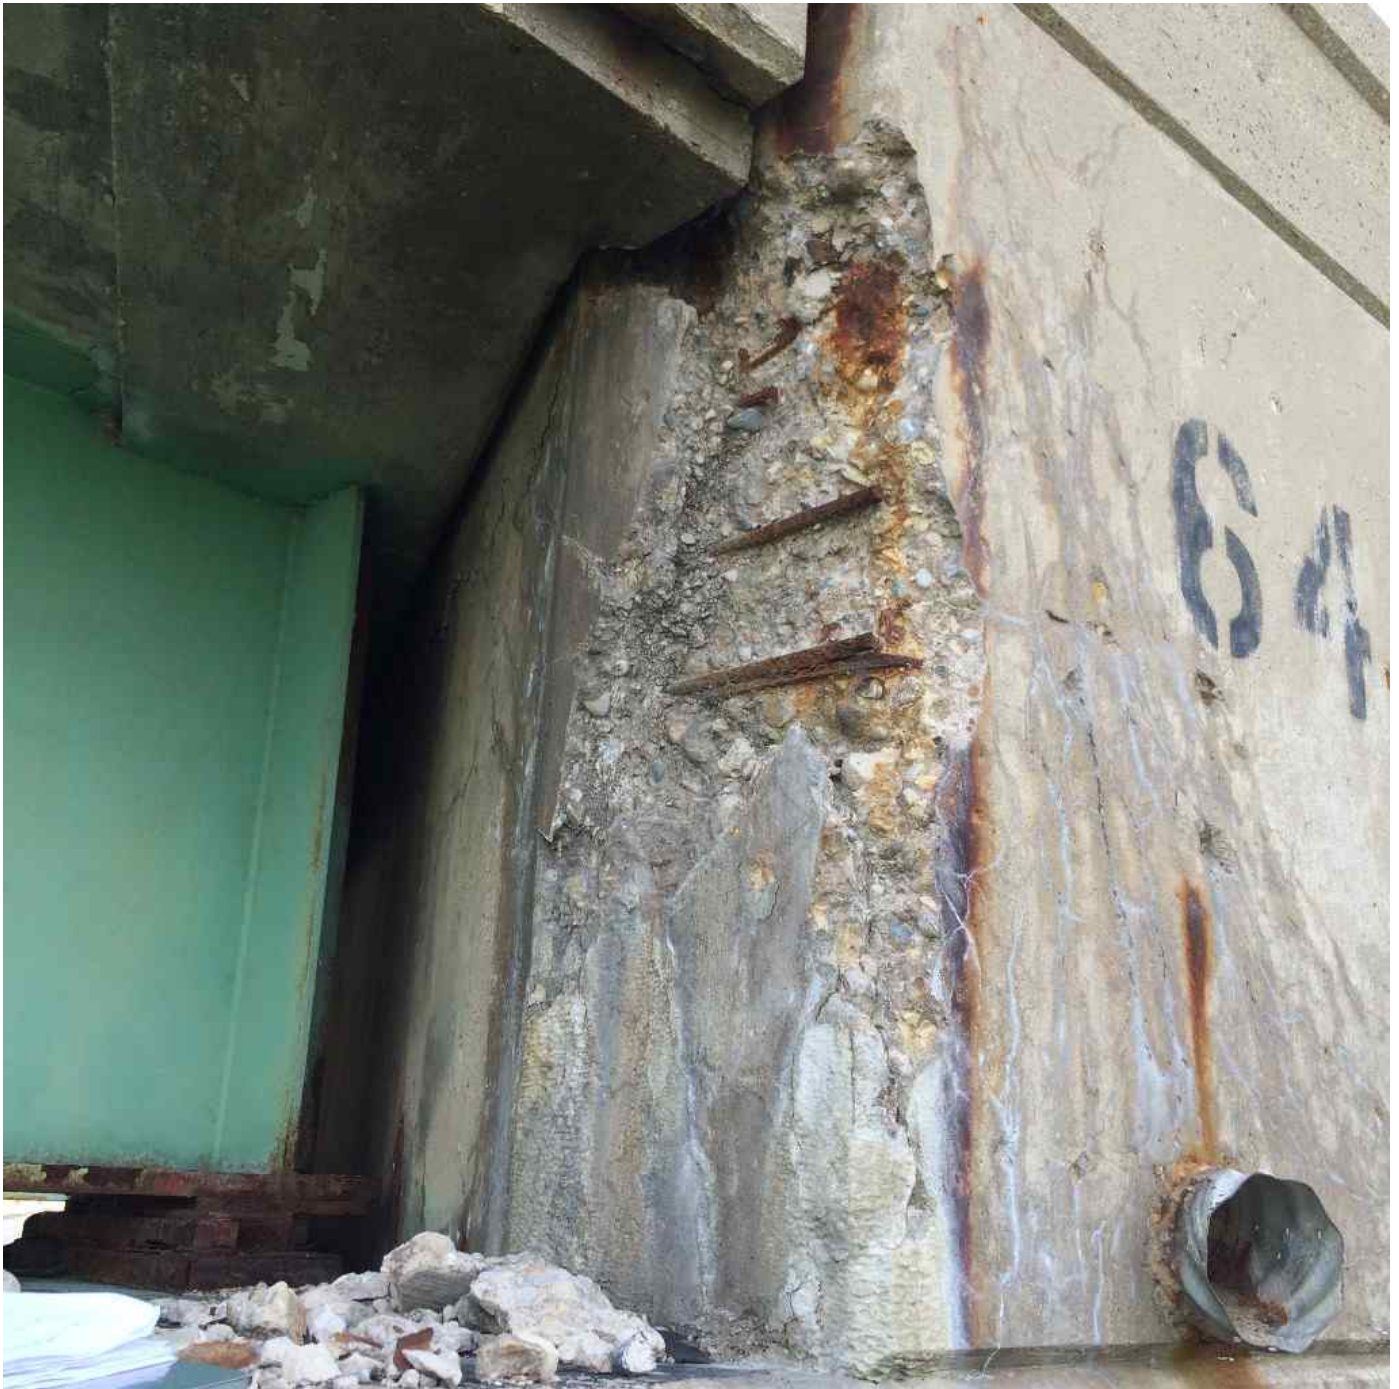
Spall southeast corner backwall at east abutment.

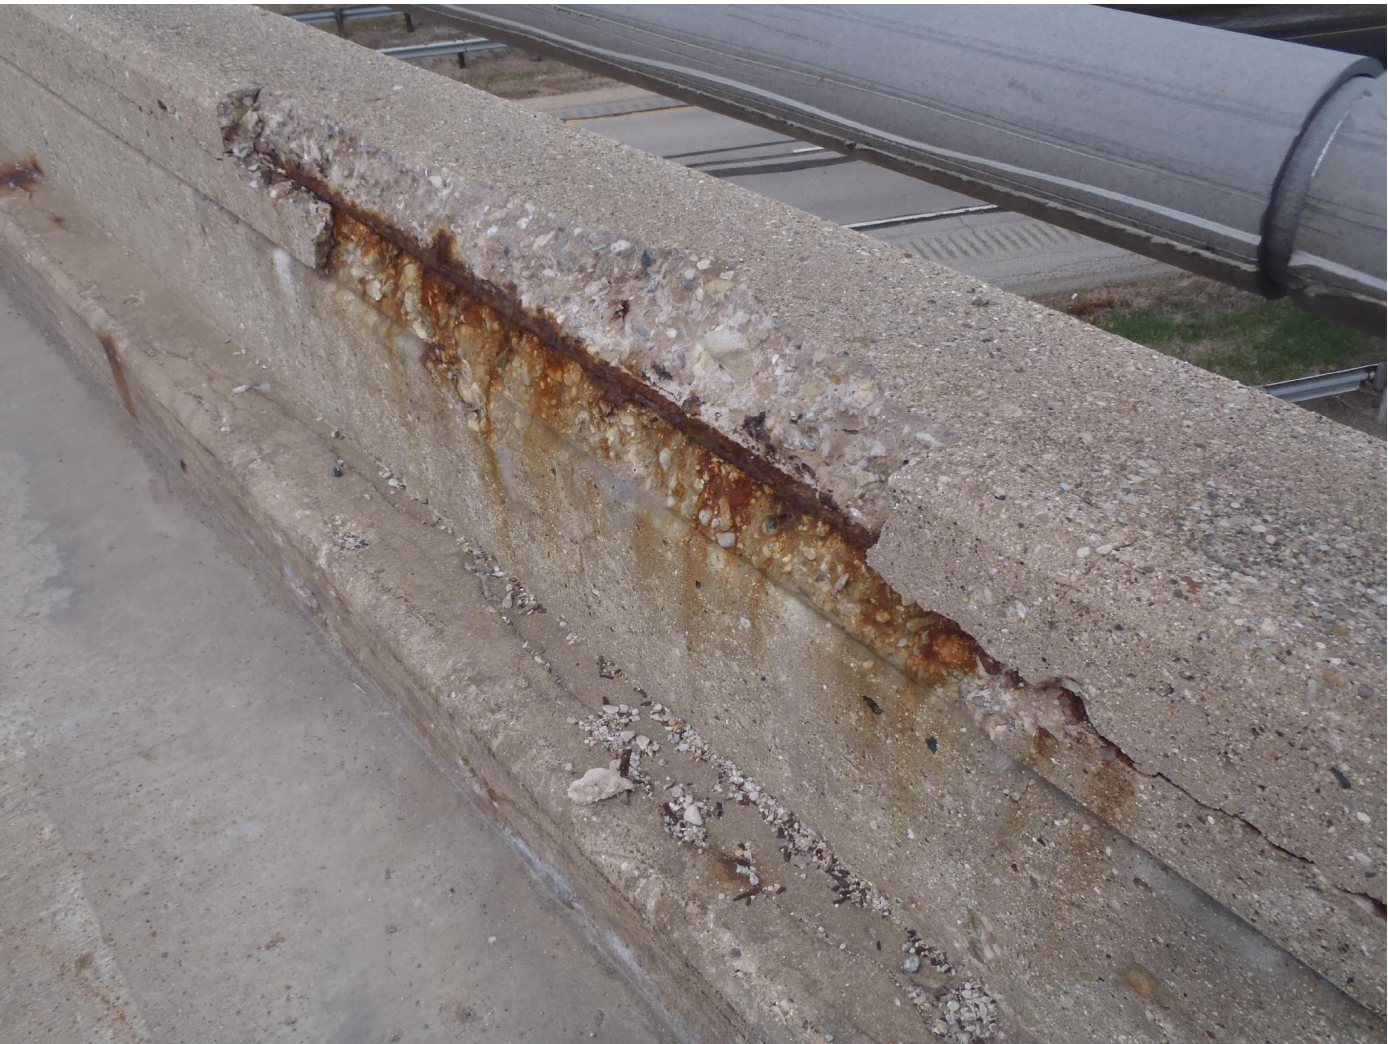
Spall with exposed rebar - North parapet, typical.
Photo copied from previous inspection - no change 2017.

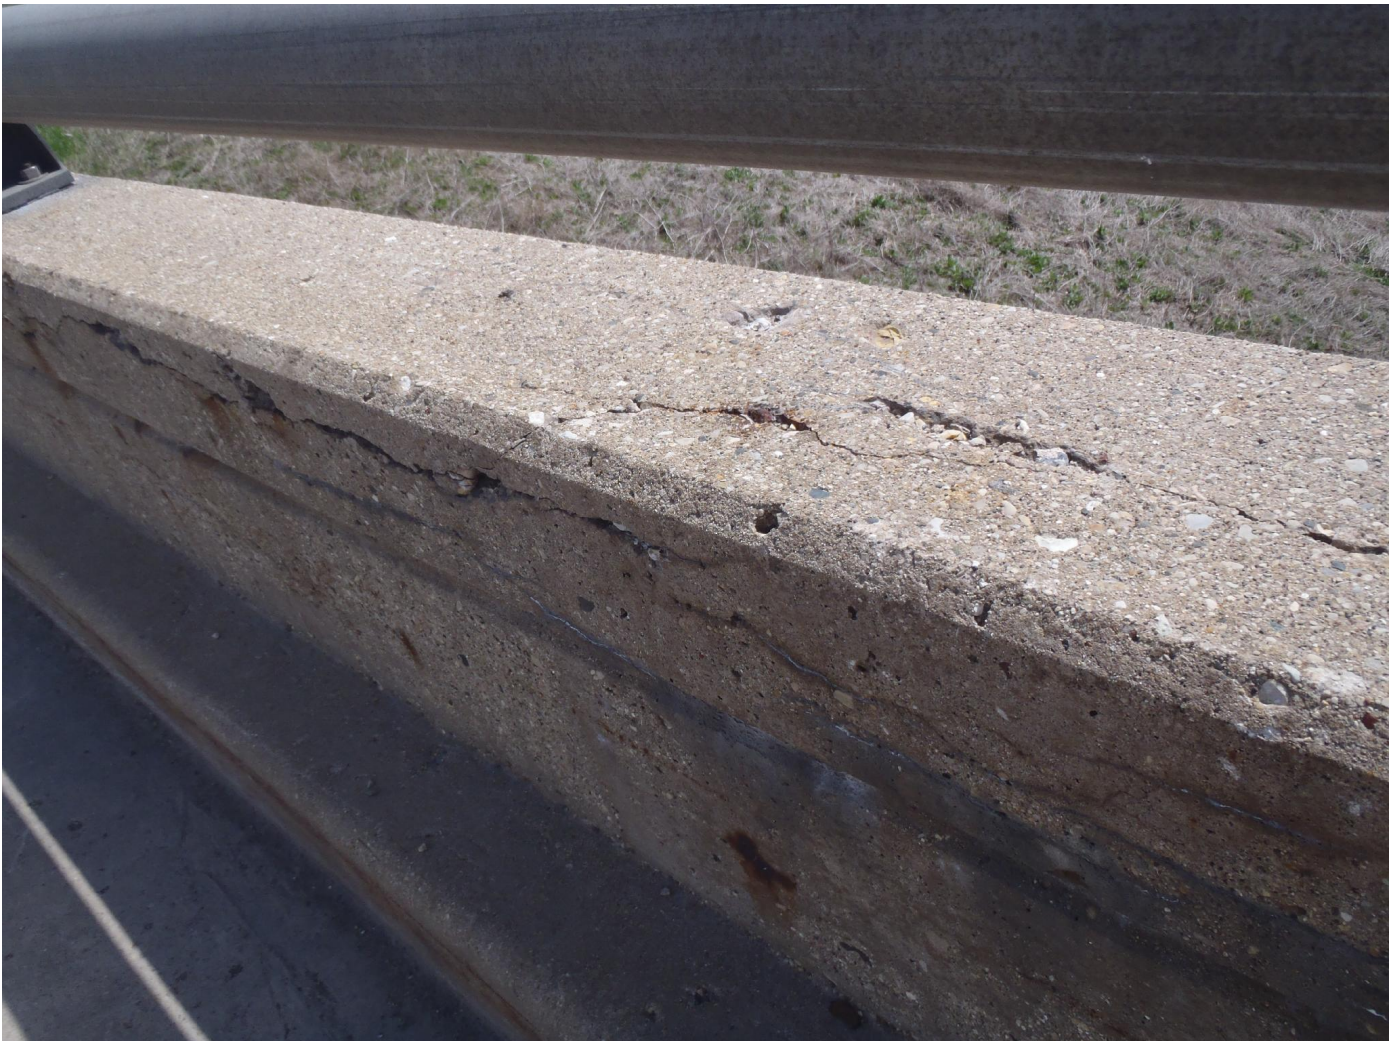
Medium crack and delams - South parapet, typical.
Photo copied from previous inspection - no change 2017.

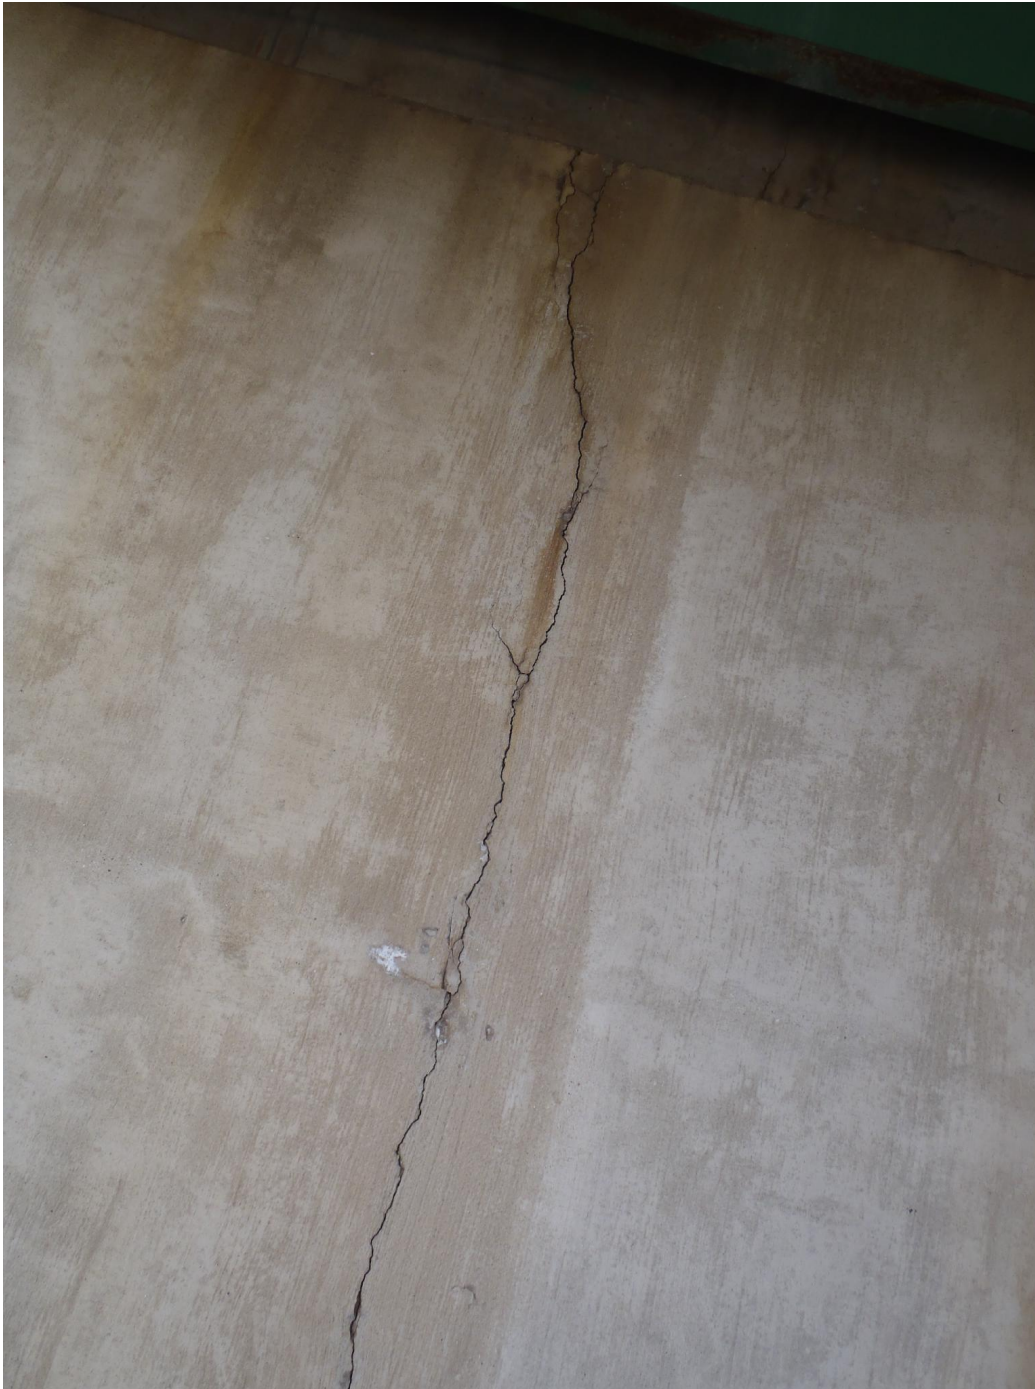
East abutment - Medium crack.
Photo copied from previous inspection - no change 2017.

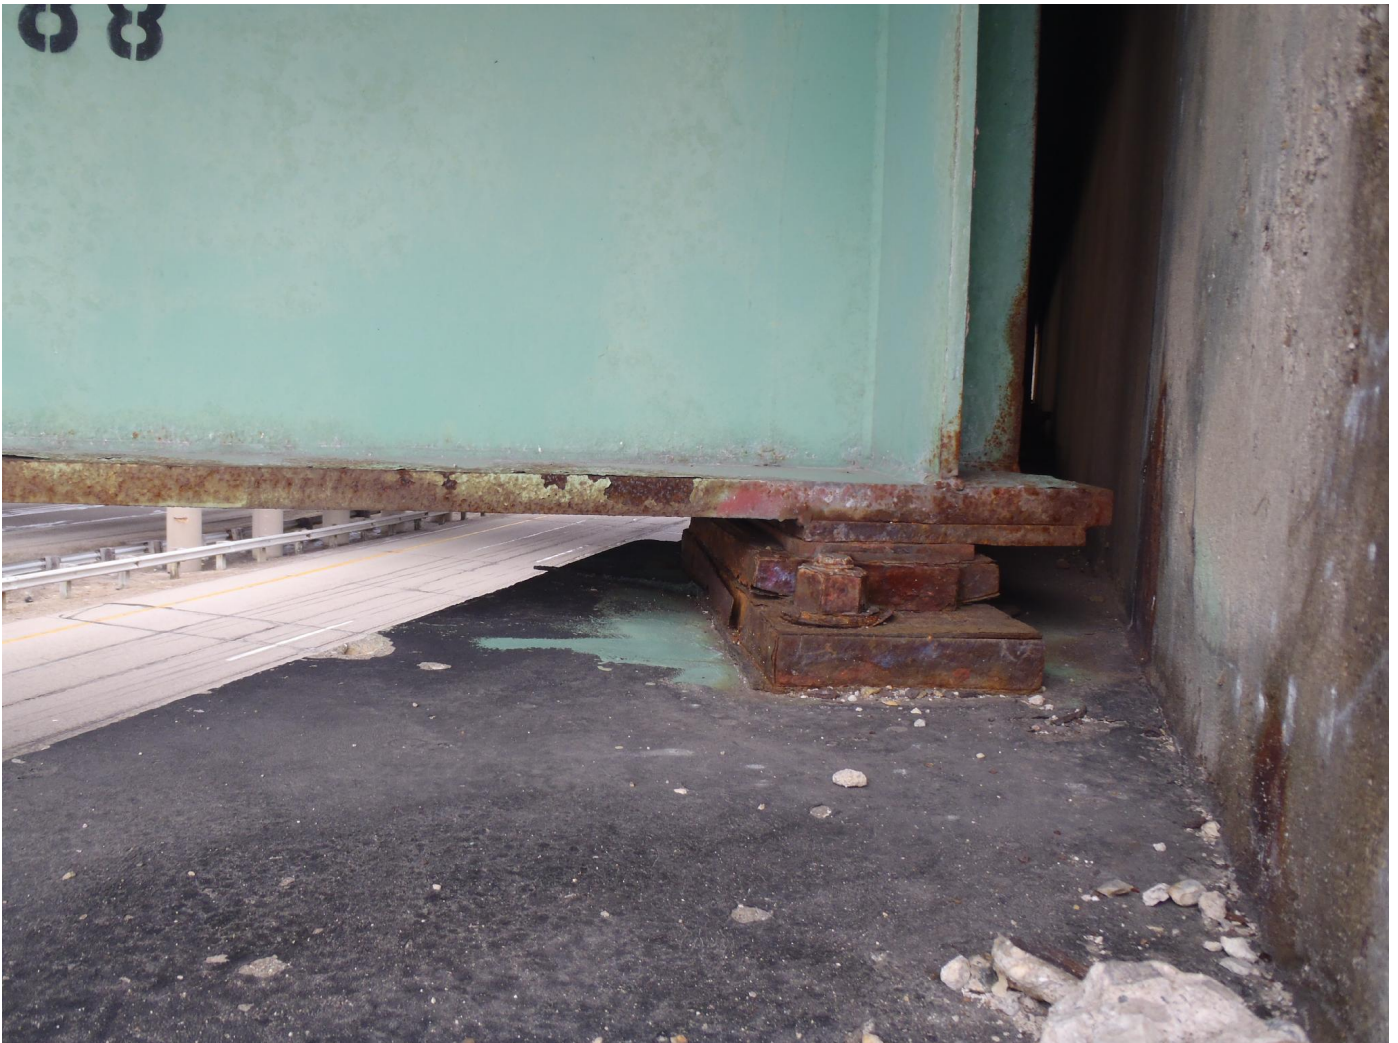
Girder 5 / Bearing at East abutment - Rust and bent keeper bar.
Photo copied from previous inspection - no change 2017.

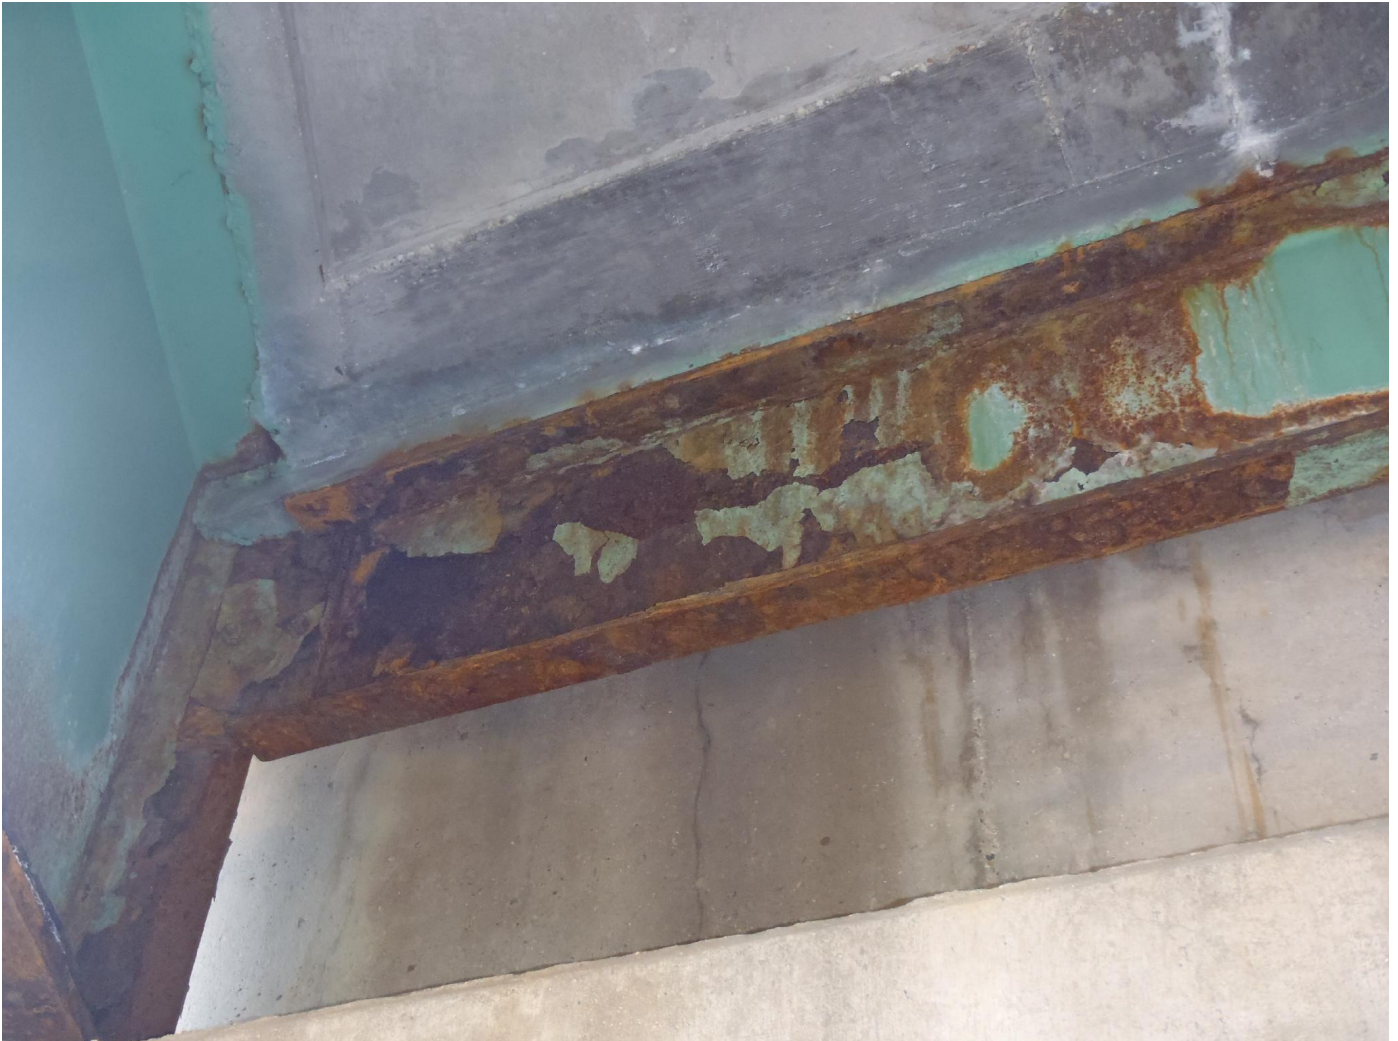
Diaphragm with laminate rust at West Abutment, typical.
Photo copied from previous inspection - no change 2017.

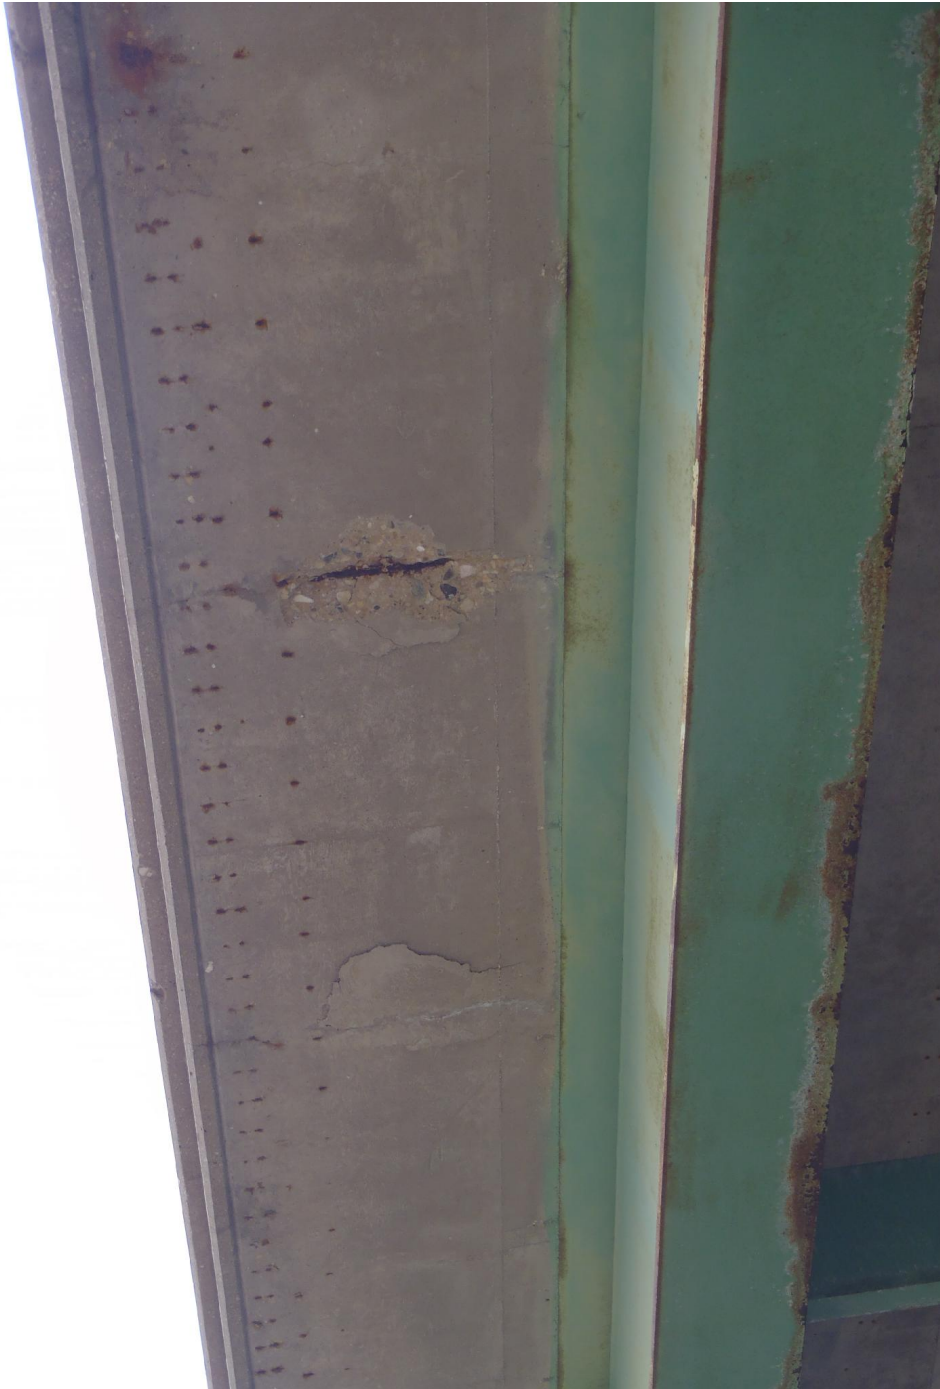
Deck spall and delam - South soffit, near pier.
Photo copied from previous inspection - no change 2017.

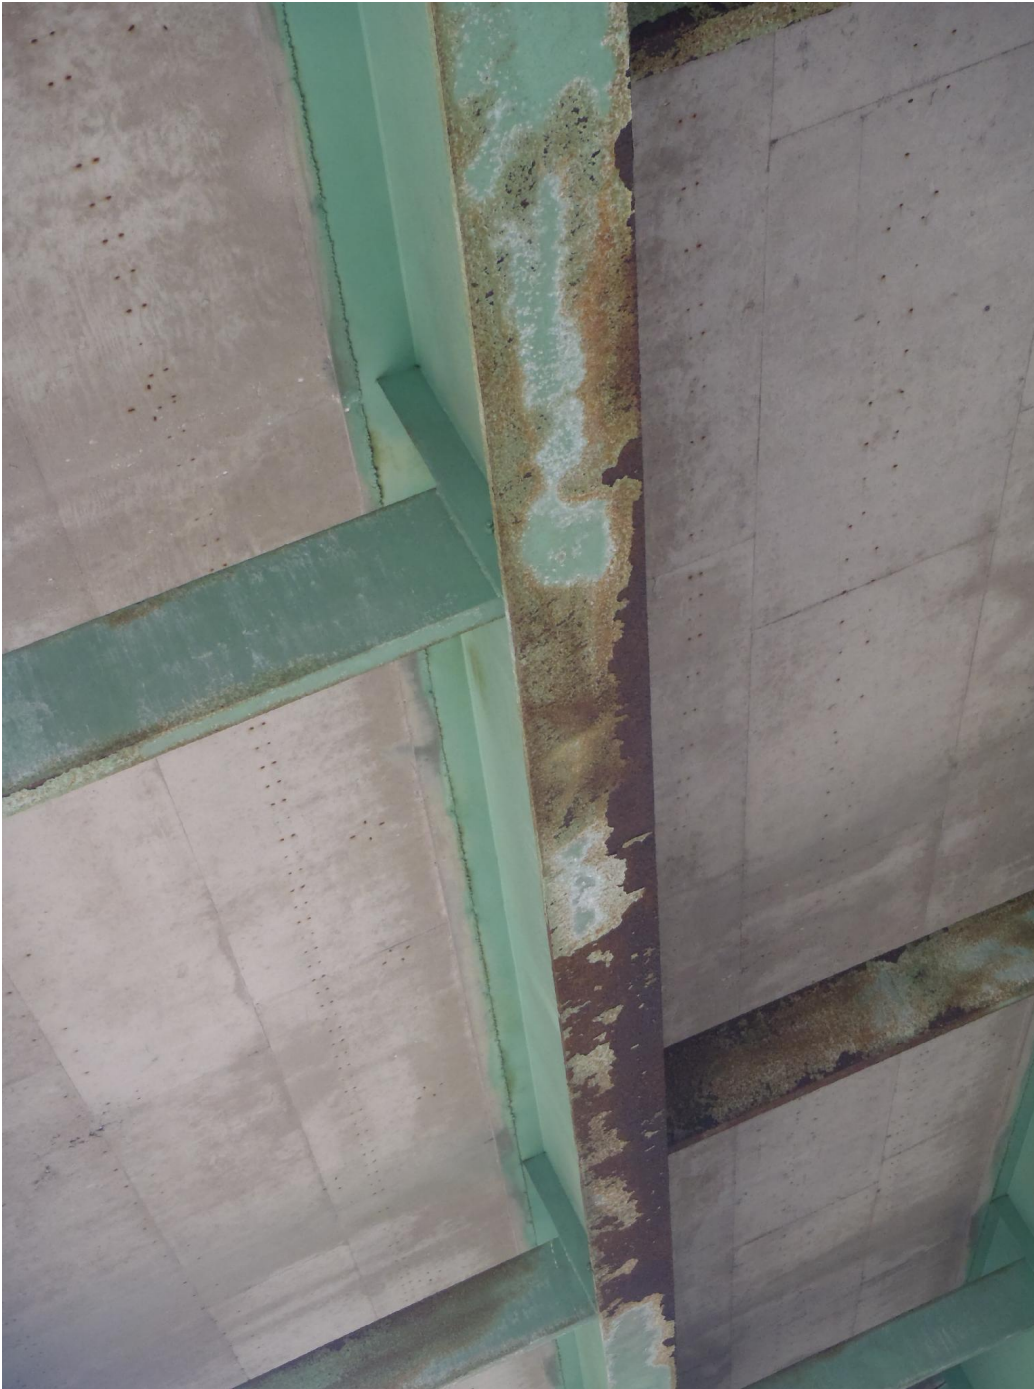
8516	Painted Steel Painted 1988.	SF	23,429	0	15,932	5,857	1,640
		3440	Effectiveness (Steel Protective Coatings) Paint no longer effective in areas of rust; peeling paint on btm flgs. at ends, piers and over roadways; Fading and chalking throughout. CS 3 est at 25%; CS 4 est at 7%	SF		0	15,932	5,857	1,640

Typical girder rust and failing paint.
Photo copied from previous inspection - no change 2017.
