Inspection Report for B-64-064

IH 43 NB over USH 12
Apr 26, 2017

Feature On: IH 43 NB	Section Town Range: S31 T03N R17E	Structure Number: B-64-064
Feature Under: USH 12	County: WALWORTH	
Location 1.9M N JCT STH 67 TO N	Municipality: LA FAYETTE	Structure Name:

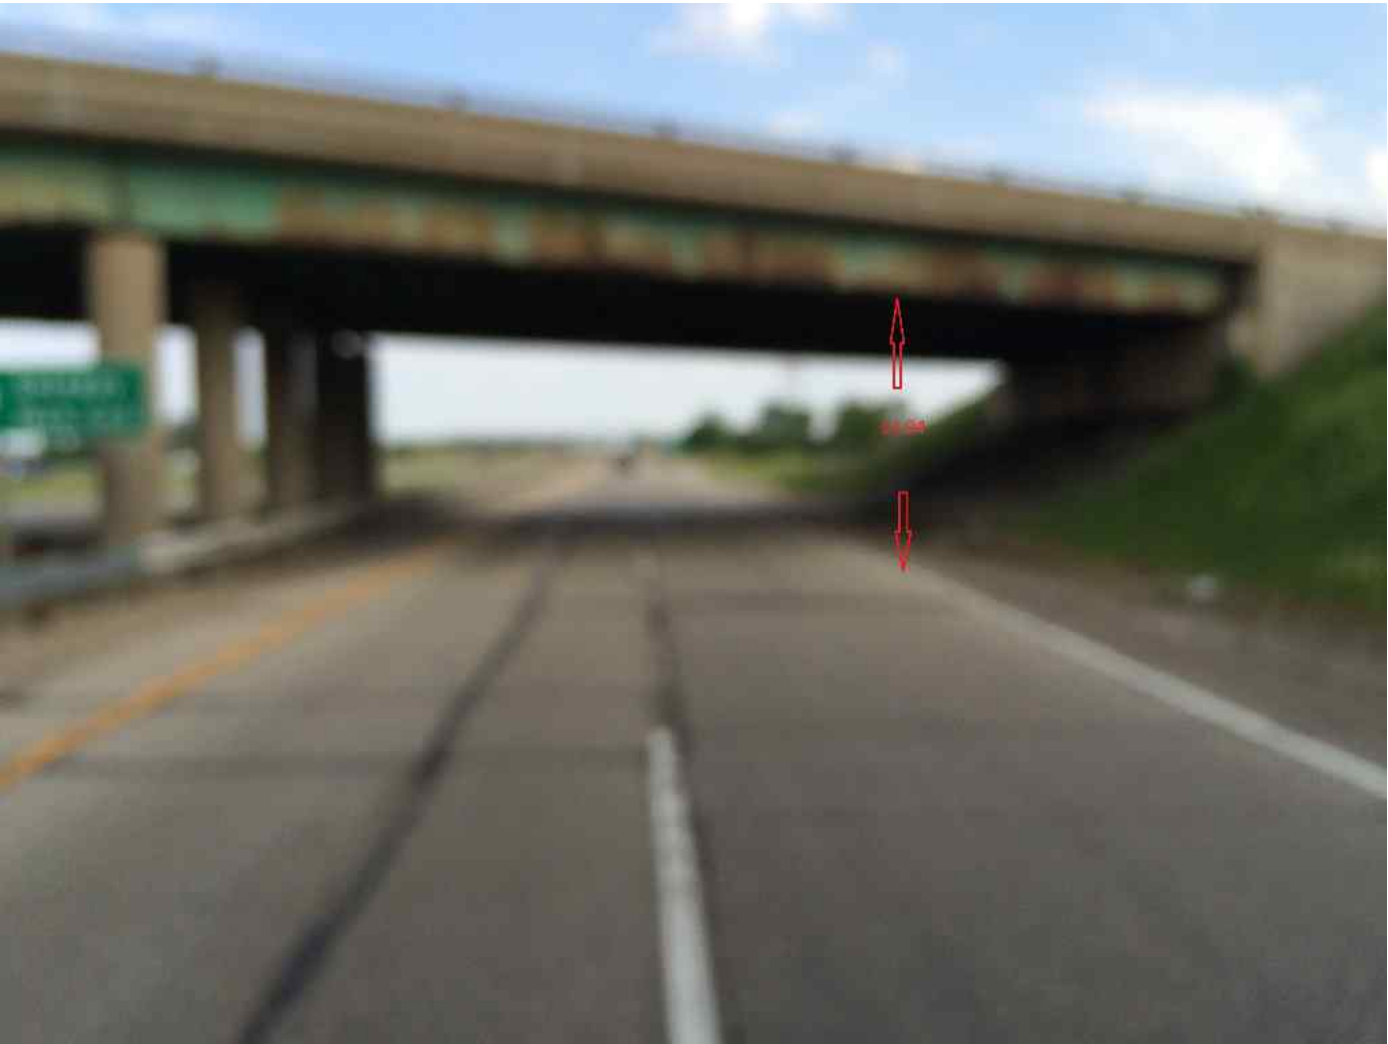
Minimum vertical clearance at eastbound CD ramp 14.94'

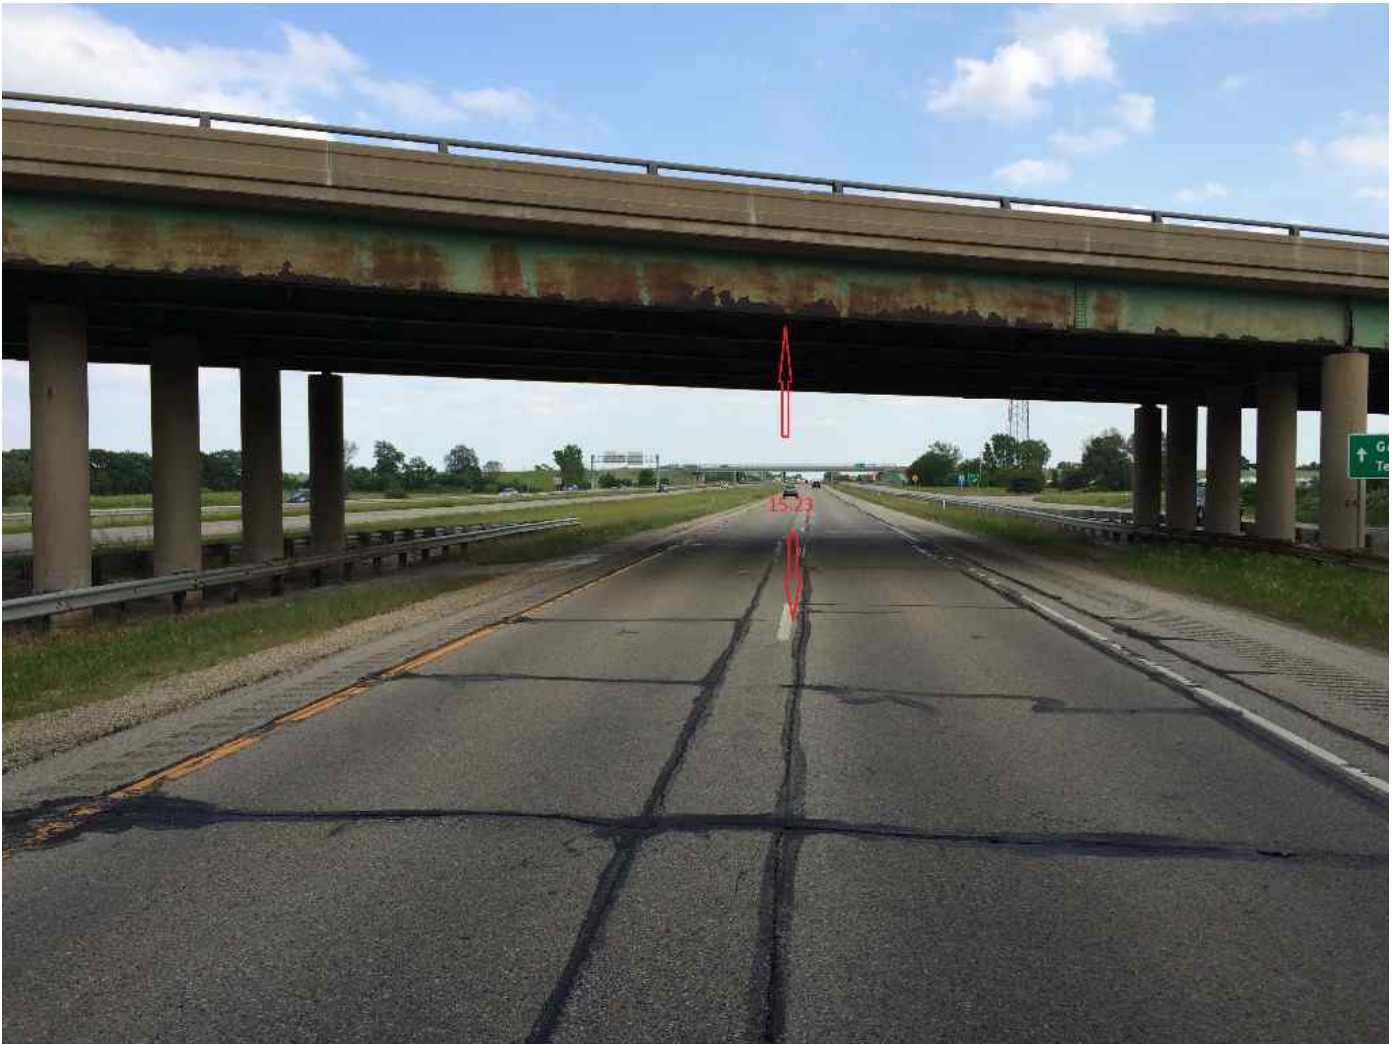
Minimum vertical clearance at eastbound US12 15.23'

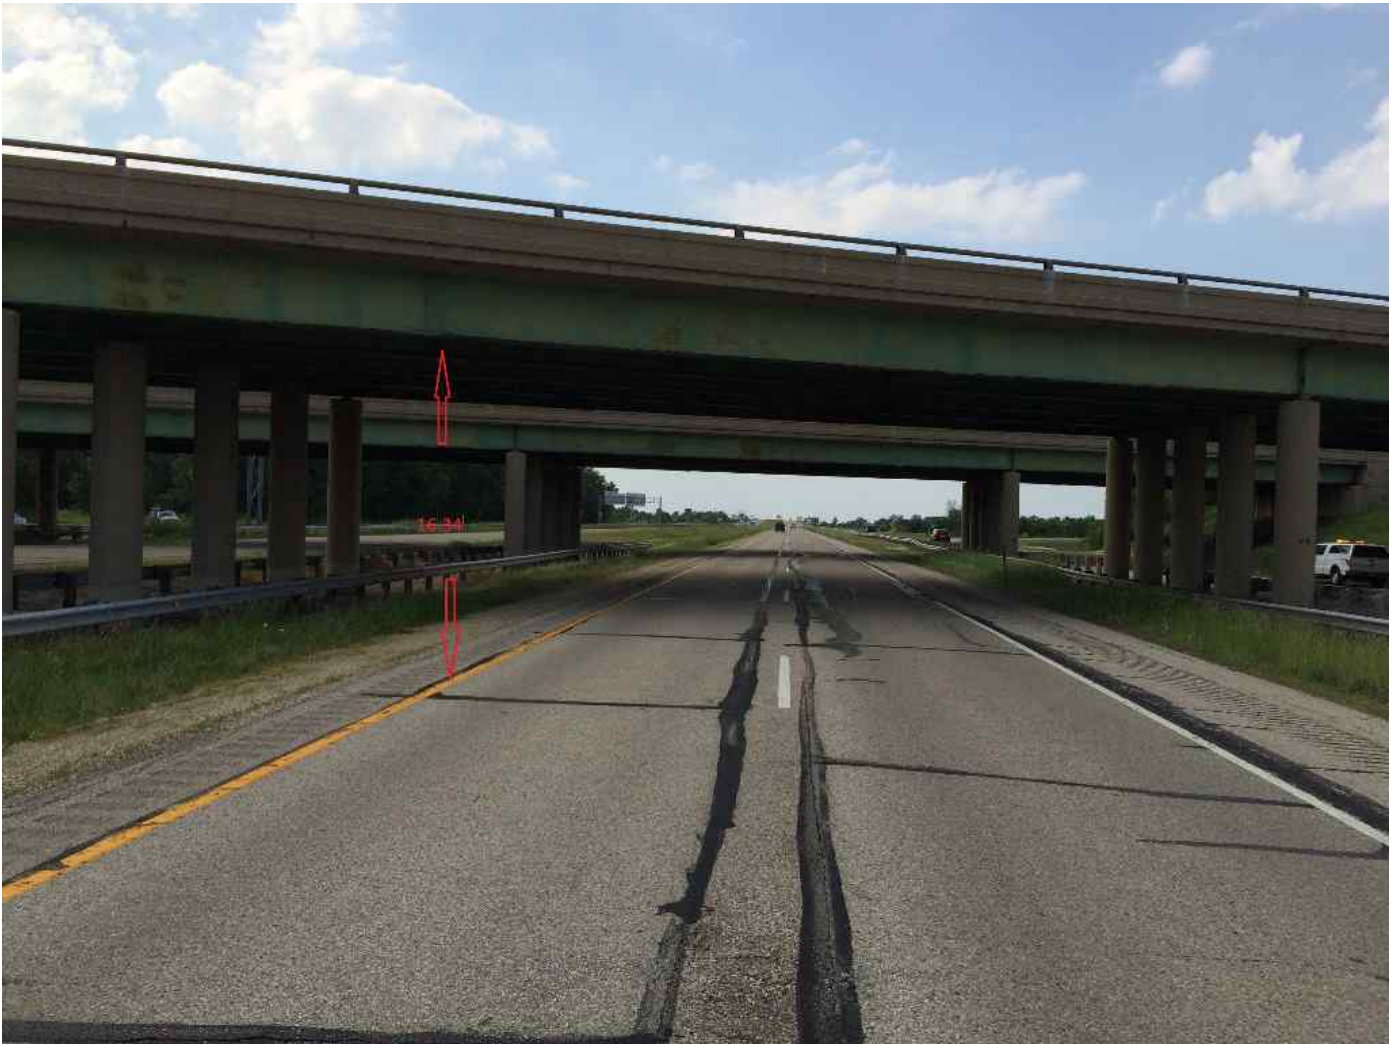
Minimum vertical clearance at westbound US12 16.34'

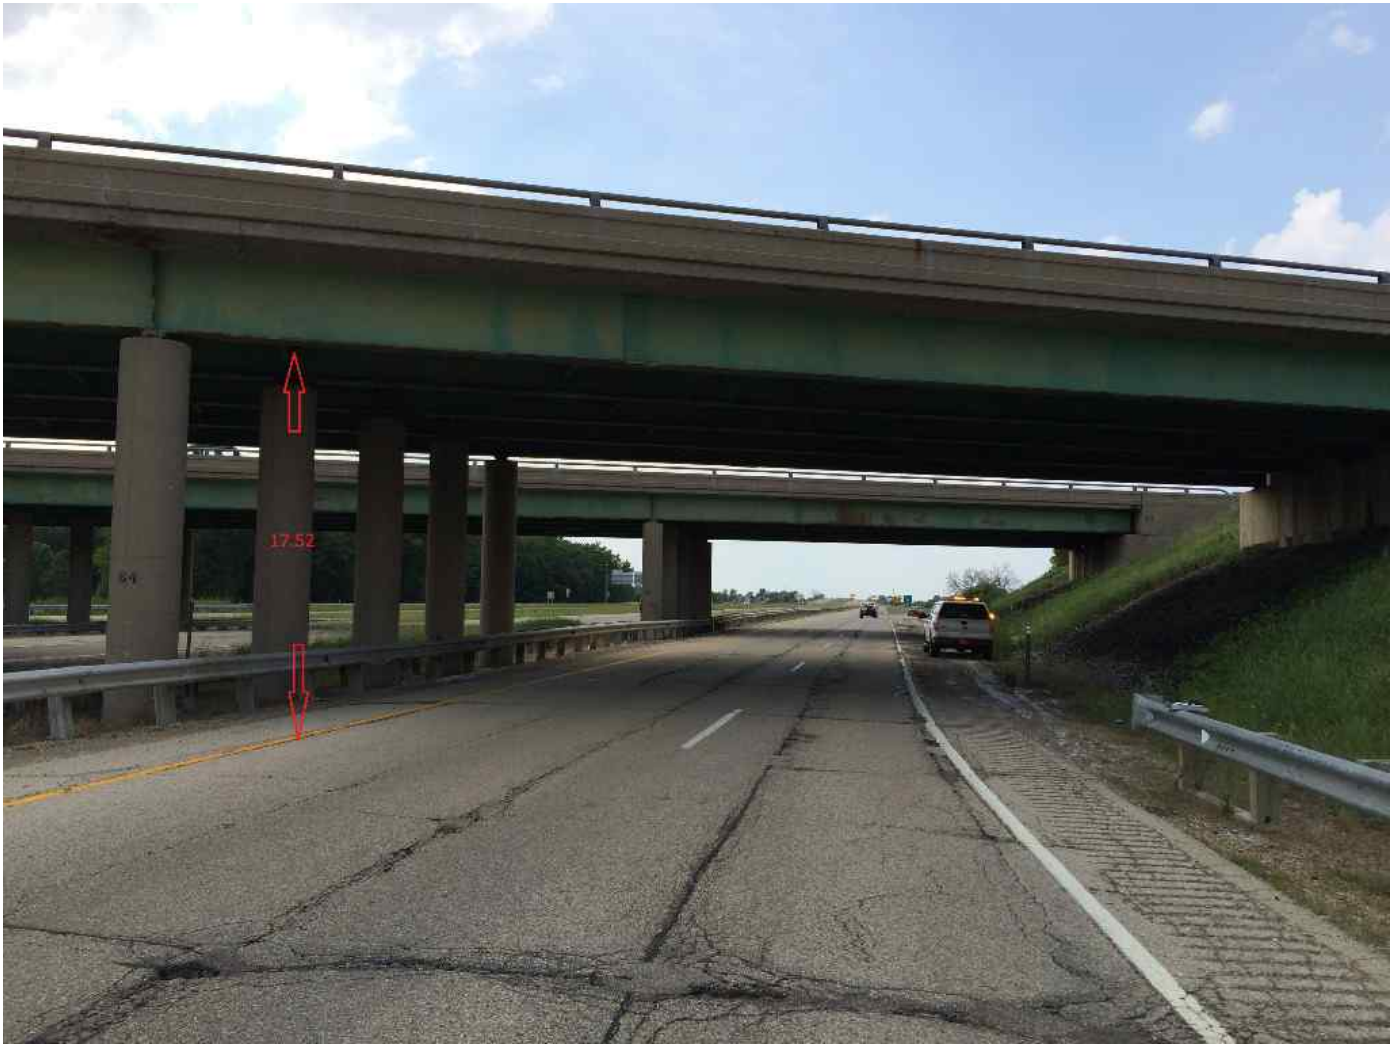
Minimum vertical clearance at westbound CD ramp 17.52'

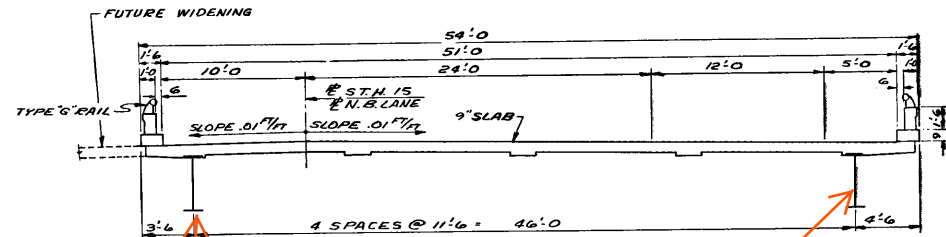
CROSS SECTION THRU ROADWAY

STEEL MEMBERS
ARE BEGINNING
TO CORRODE

REPLACE
BEARINGS
