STATE OF WISCONSIN
DEPARTMENT OF TRANSPORTATION

Inspection Report for
B-66-110

STH 144 over IH 41
Jul 26, 2018

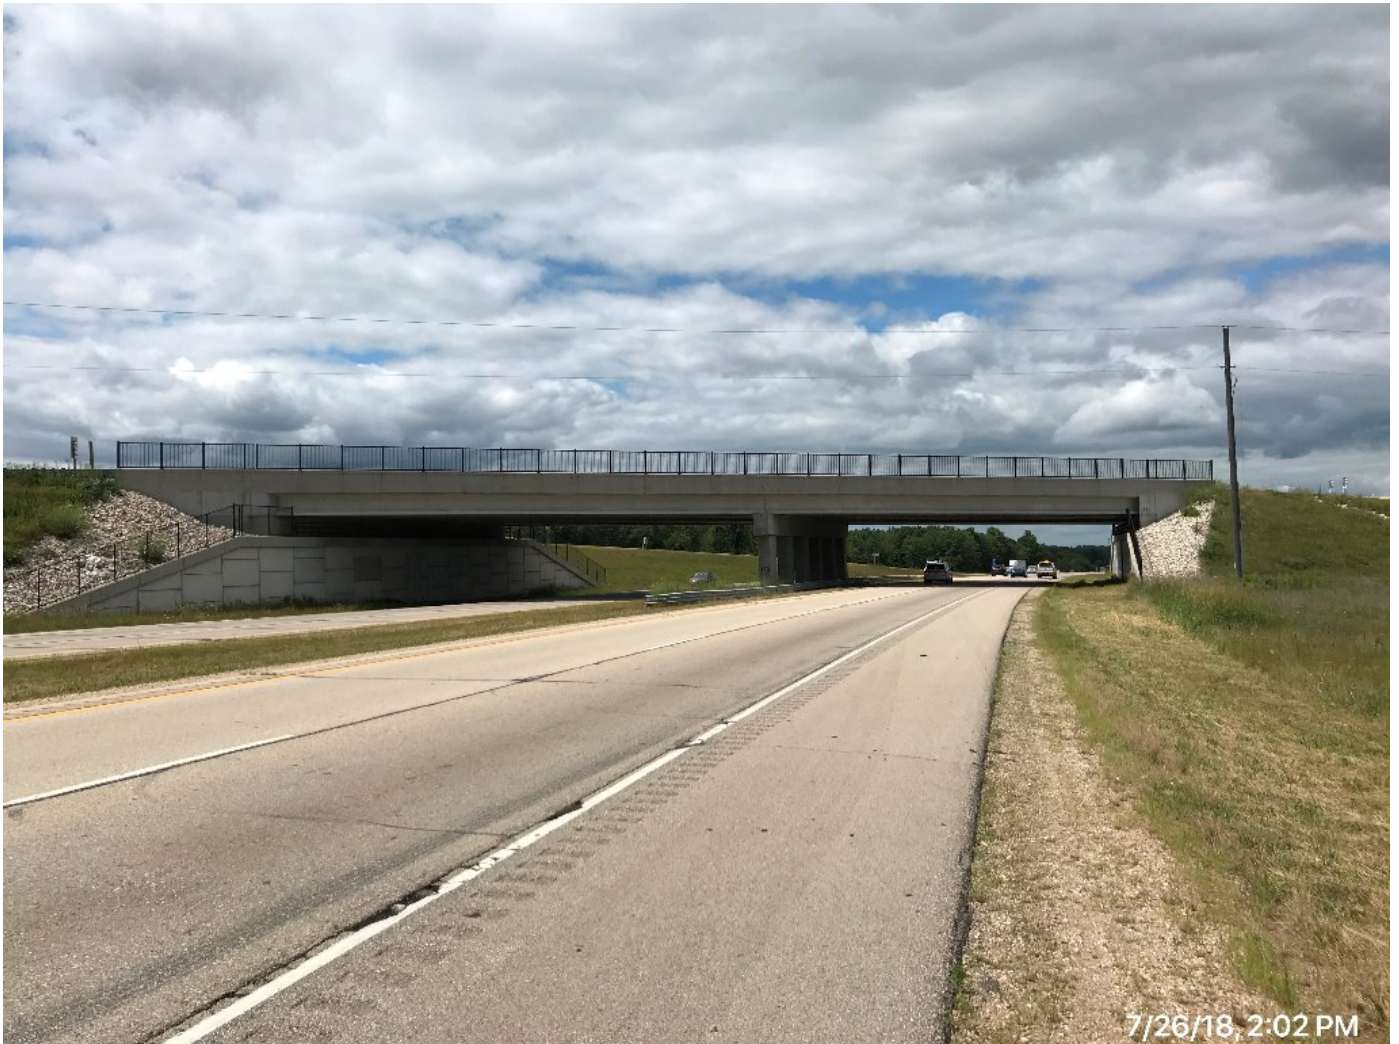
East elevation view looking NW along NB 41.

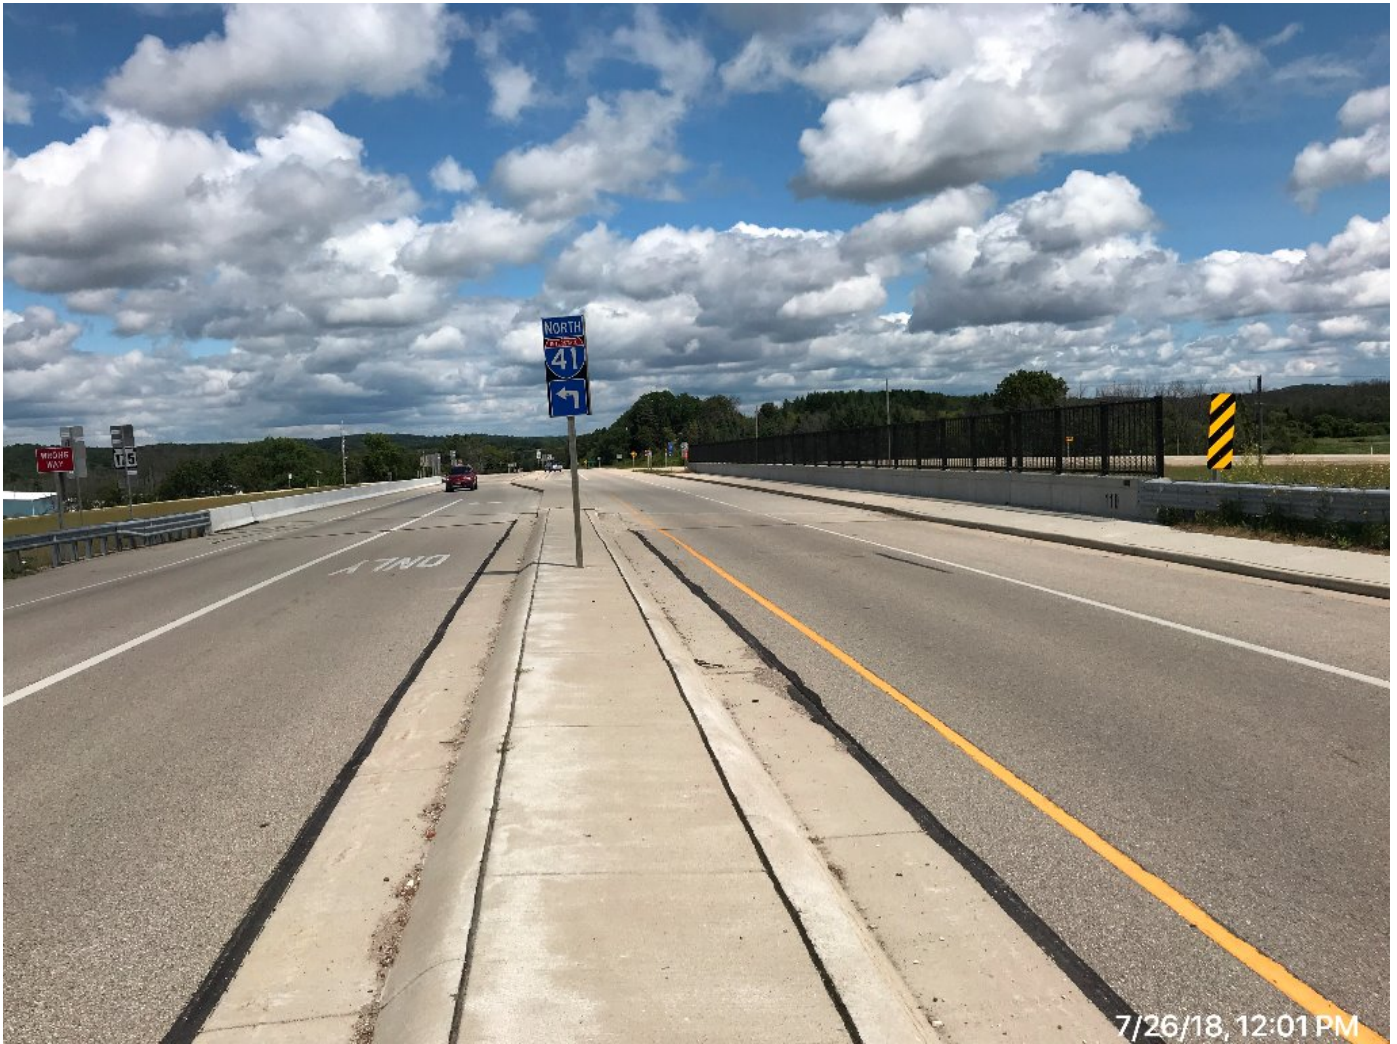
Roadway looking north.

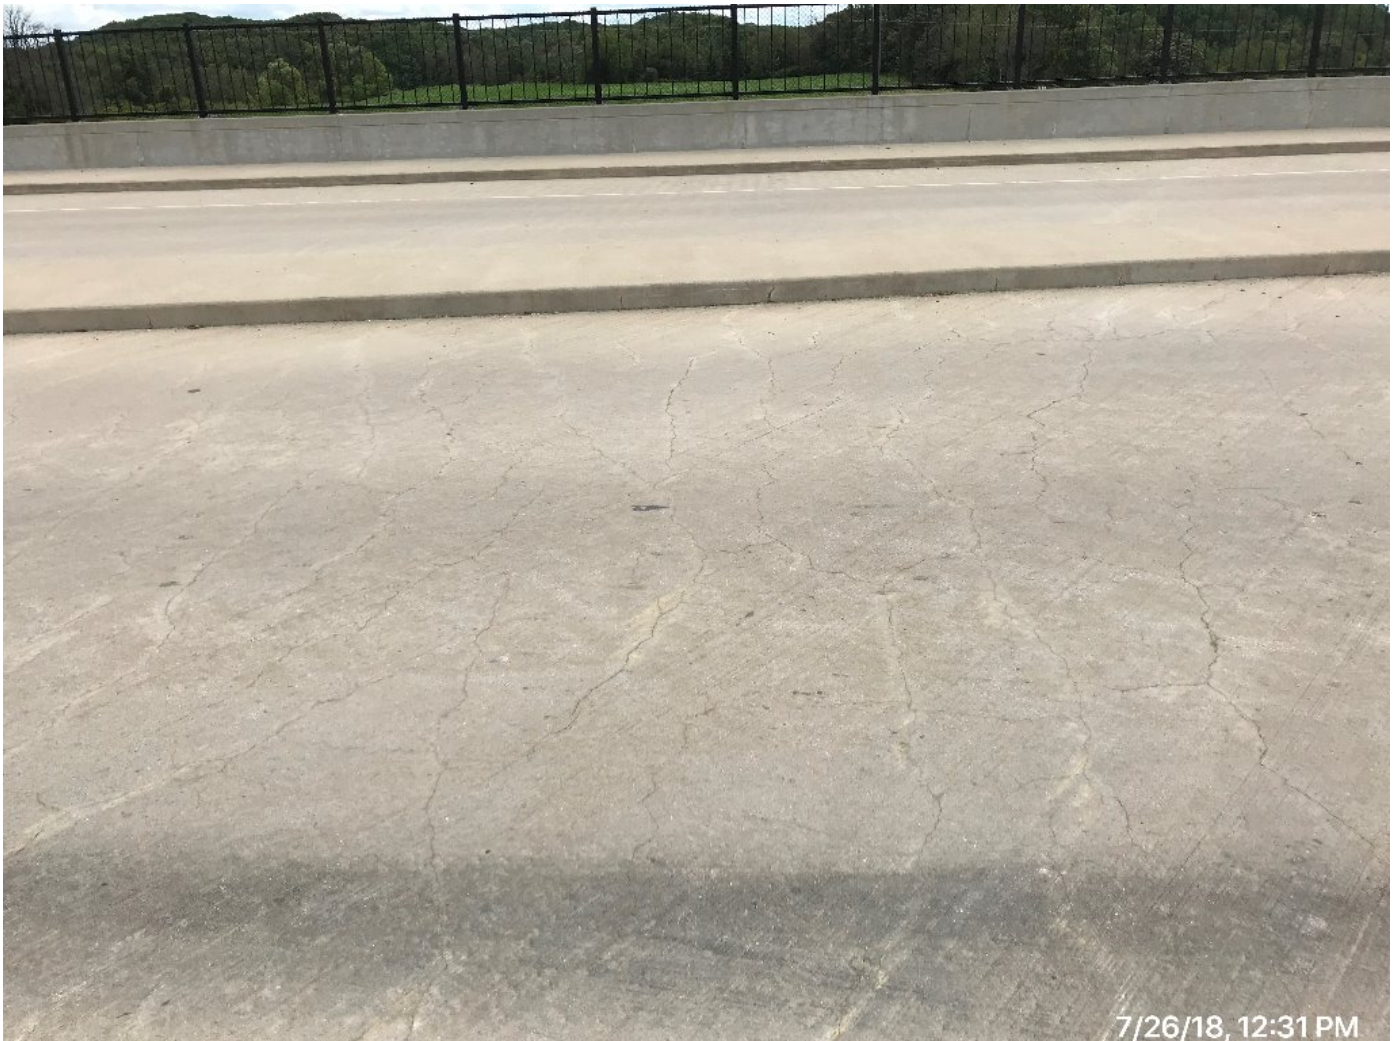
Extensive HL transverse cracking, with some longit. and diagonal cracks near deck ends. Many cracks sealed with epoxy. Pictured at SB lanes over pier.

Item	Priority	Recommended by	Status	Status change
IMP-Thin Epoxy Overlay	HIGH	Zemke, Jason (2016)	IDENTIFIED	01/26/17
2022- Recommend thin polymer overlay prior to 2024. Fairly extensive cracking in deck after 2 years.				
Drainage - Repair Washouts / Erosion	HIGH	Zemke, Jason (2016)	IDENTIFIED	01/26/17
Fill in undermining at SE corner and grade to top of pavement. Also - repair erosion ruts beyond flume in RT shoulder at NE wing. Pave with HMA or place compacted millings.				
IMP-Concrete Overlay	LOW	Zemke, Jason (2016)	IDENTIFIED	01/26/17
2039- Recommend concrete OL				
Slope Protection - Reseal Slope Paving	LOW	Zemke, Jason (2016)	IDENTIFIED	07/31/18
Recommend re-sealing the concrete slope paving above the retaining wall.				
Approach - Seal Approach to Paving Block	LOW	Zemke, Jason (2016)	IDENTIFIED	08/30/18
Re-seal deck joints.

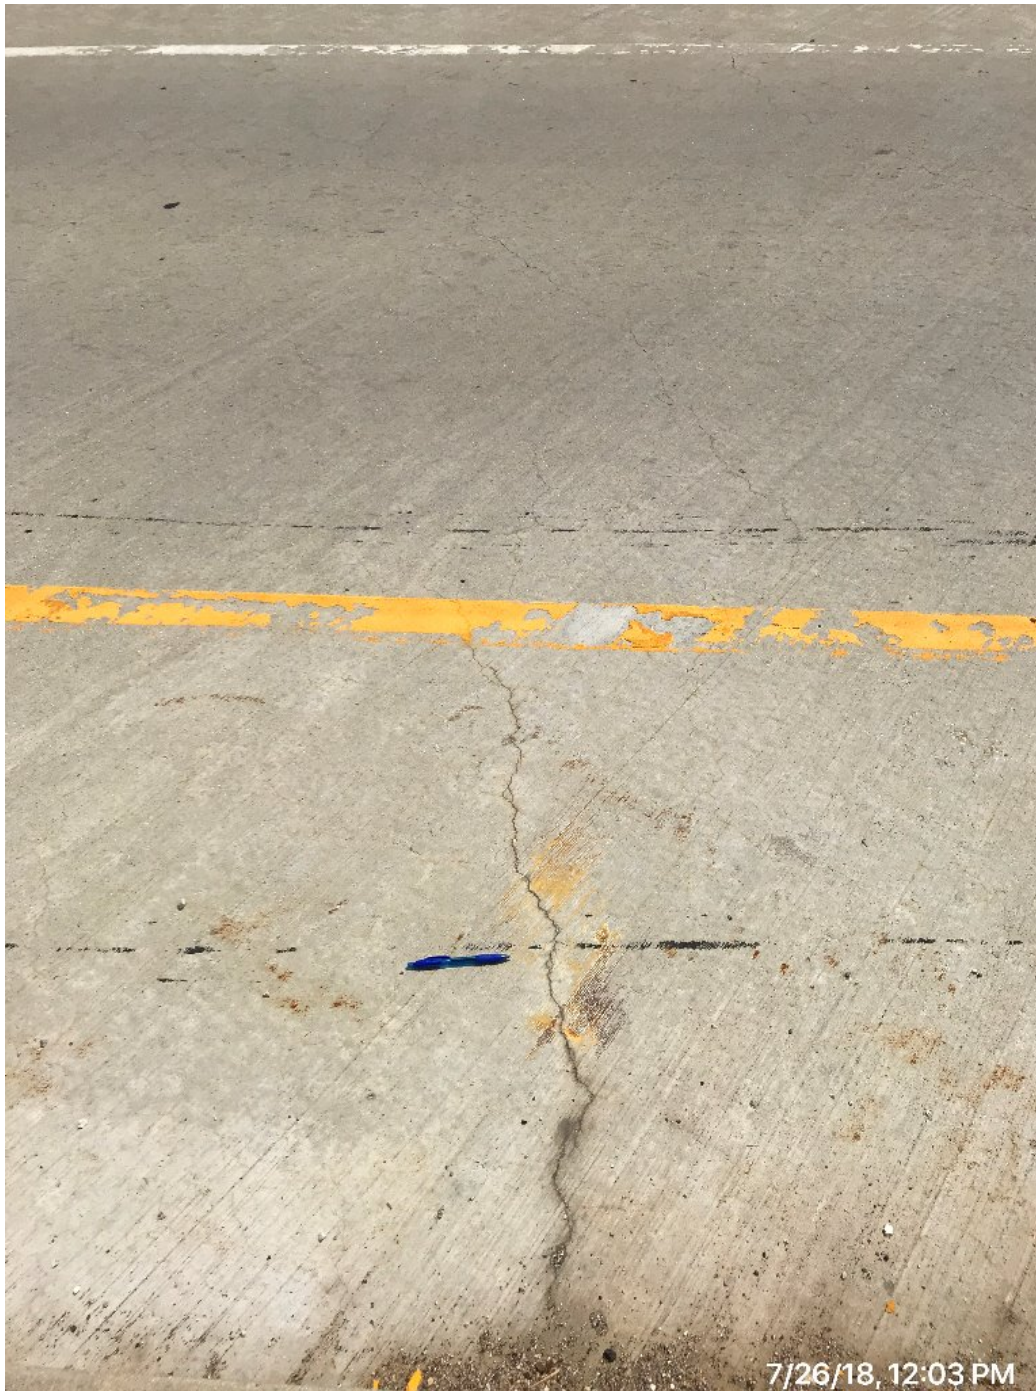
Typical medium transverse crack in wearing surface at pier. Medium diagonal crks also near ends of deck.

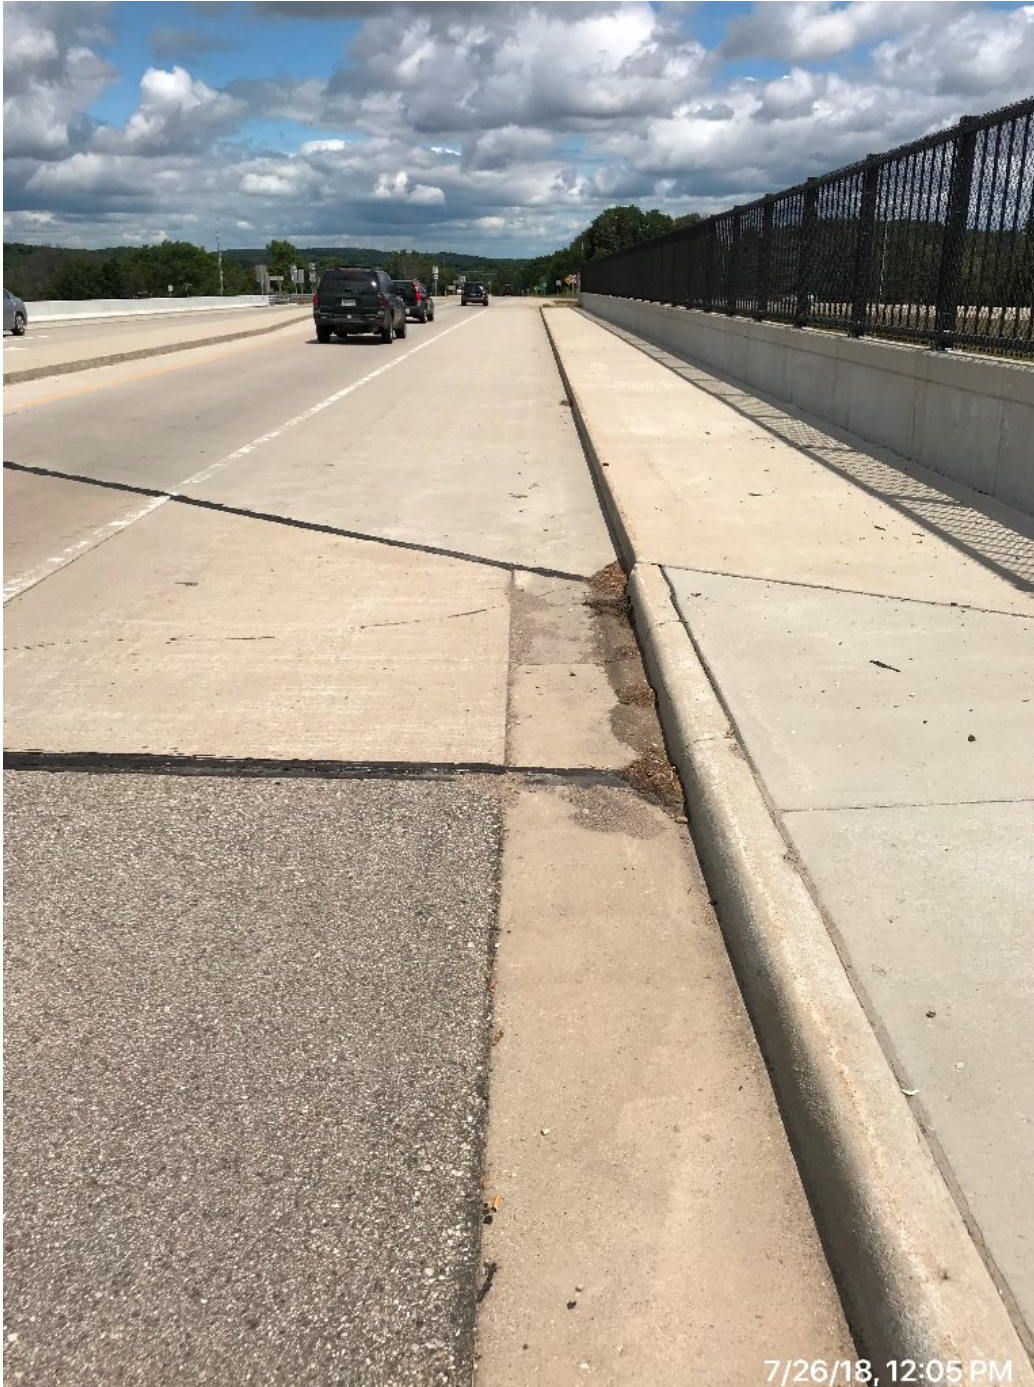
Ponding at curb line at SE approach.

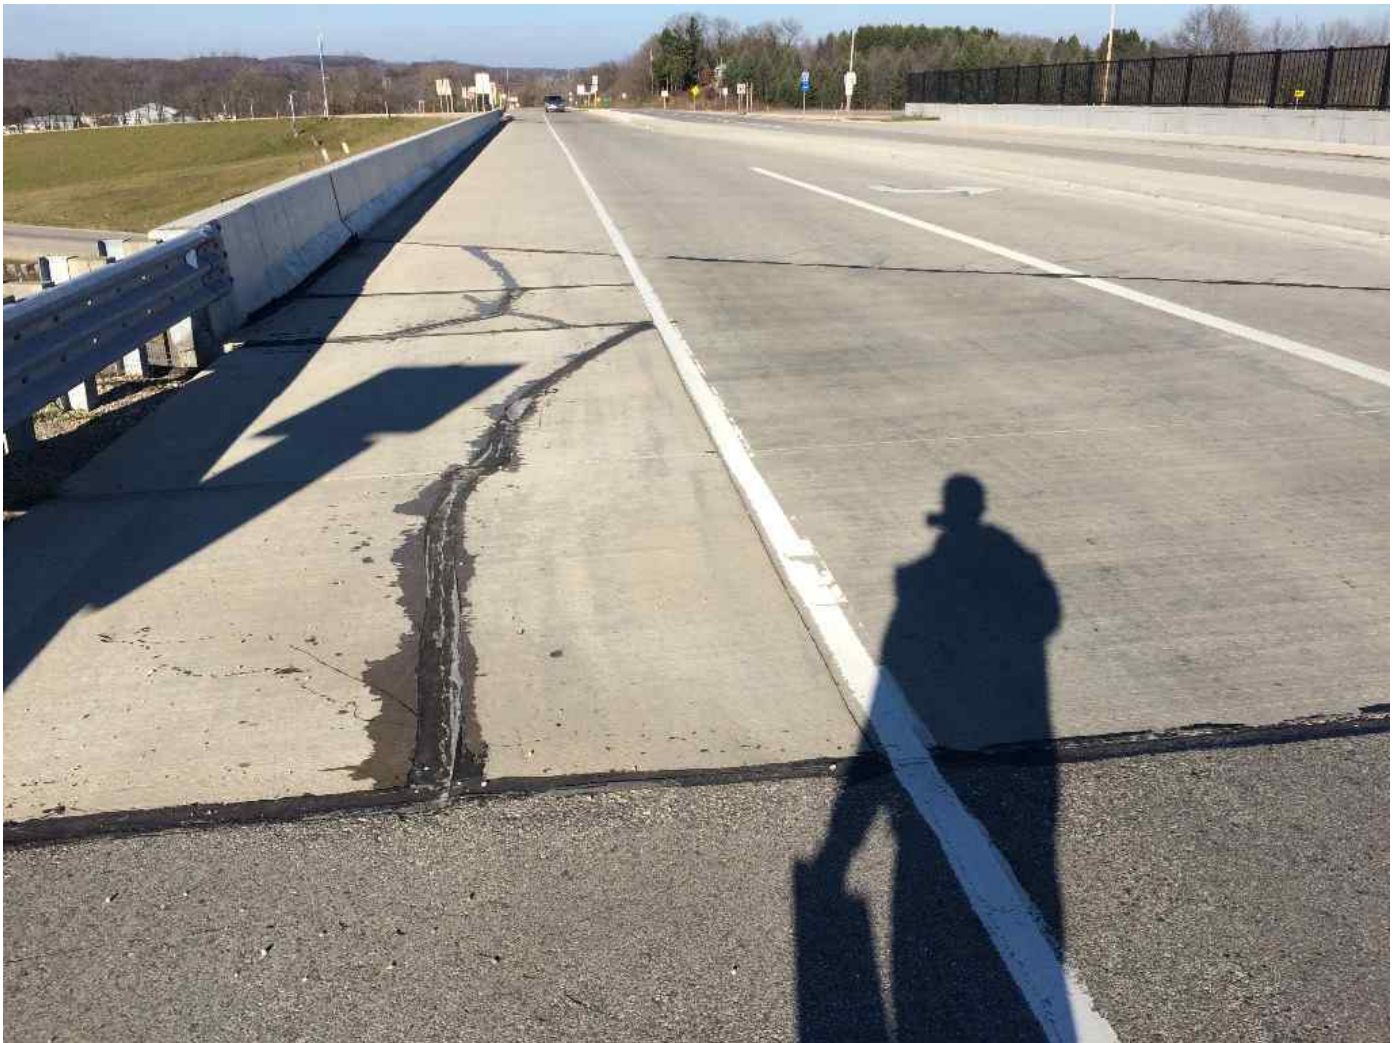
SW approach - RT shoulder has several longit./diag. cracks sealed with epoxy and tar. (Unchanged 2018)

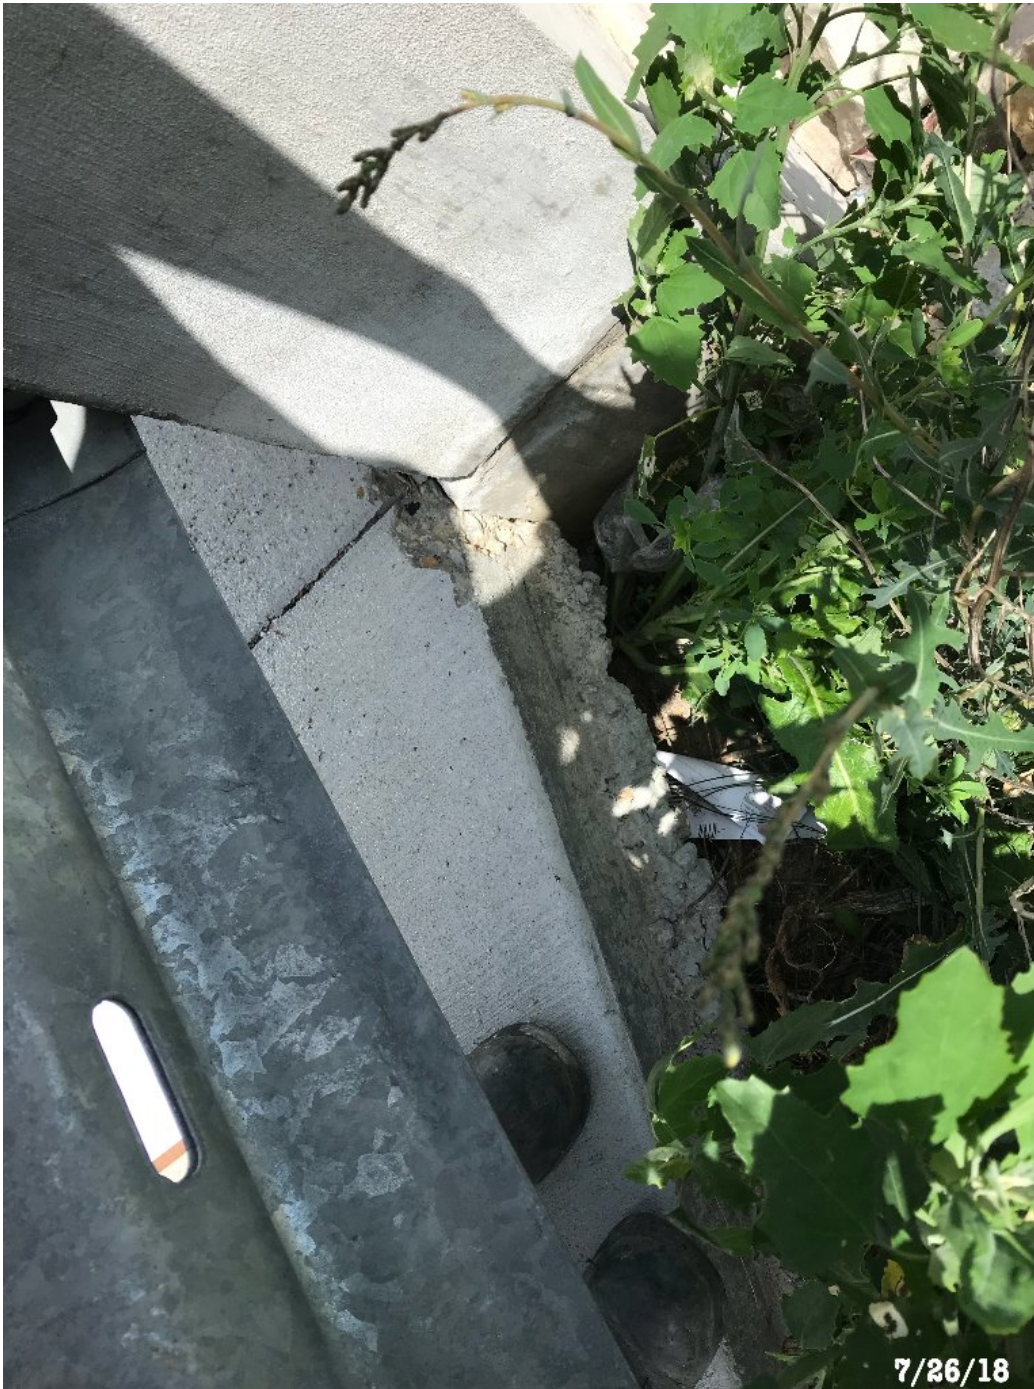
SE corner undermining of sidewalk slab.

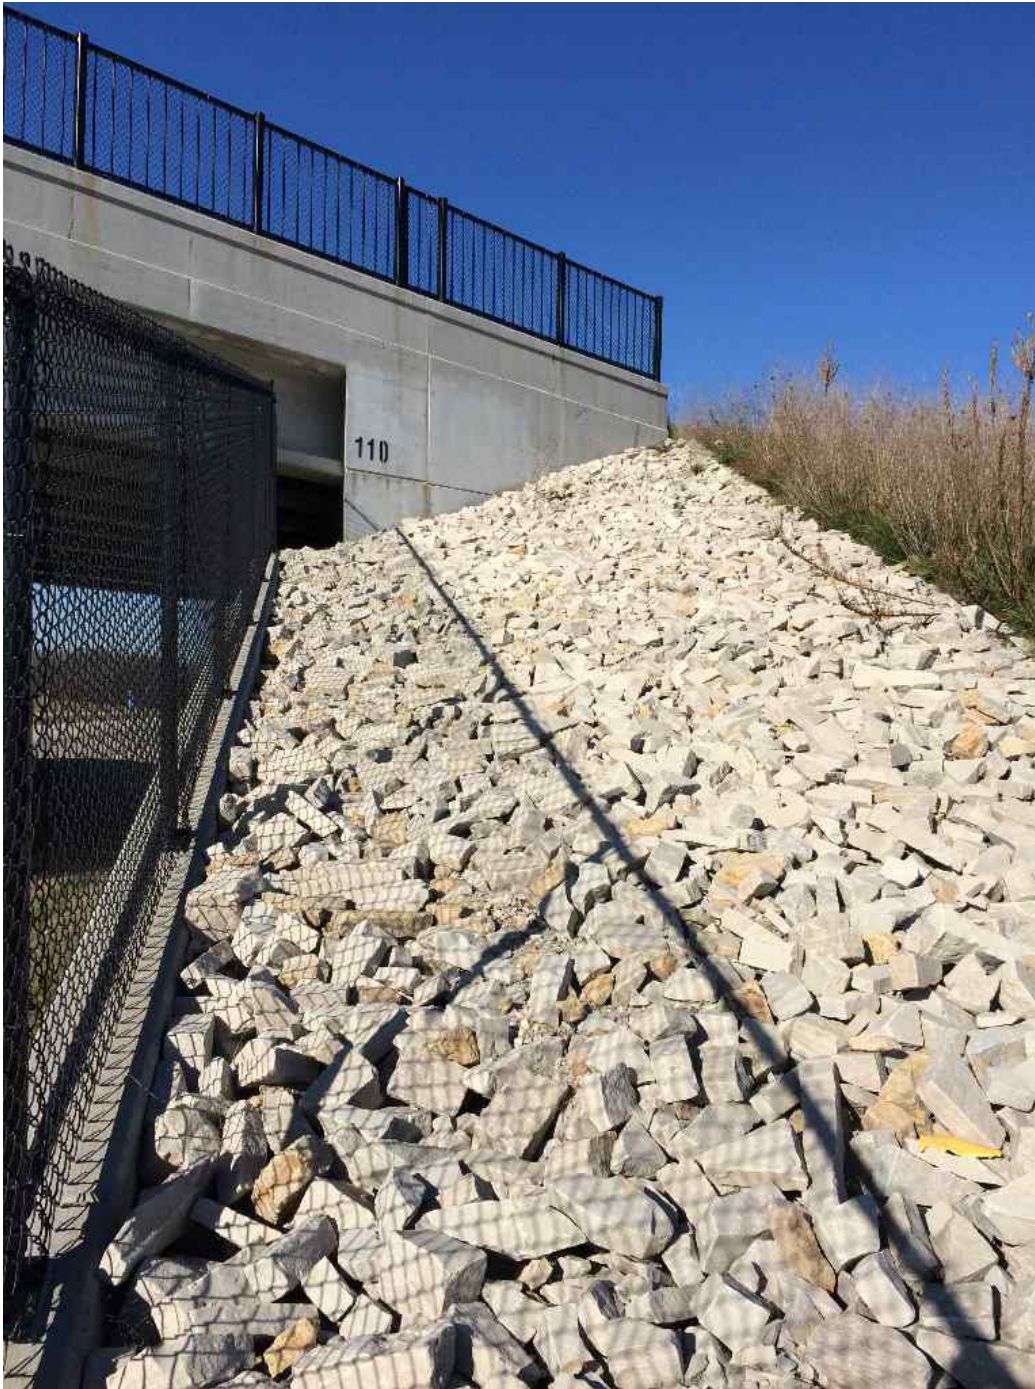
Typical riprap treatment behind all 4 wings along abutment retaining walls. Pic at NE wing.
(Unchanged 2018)

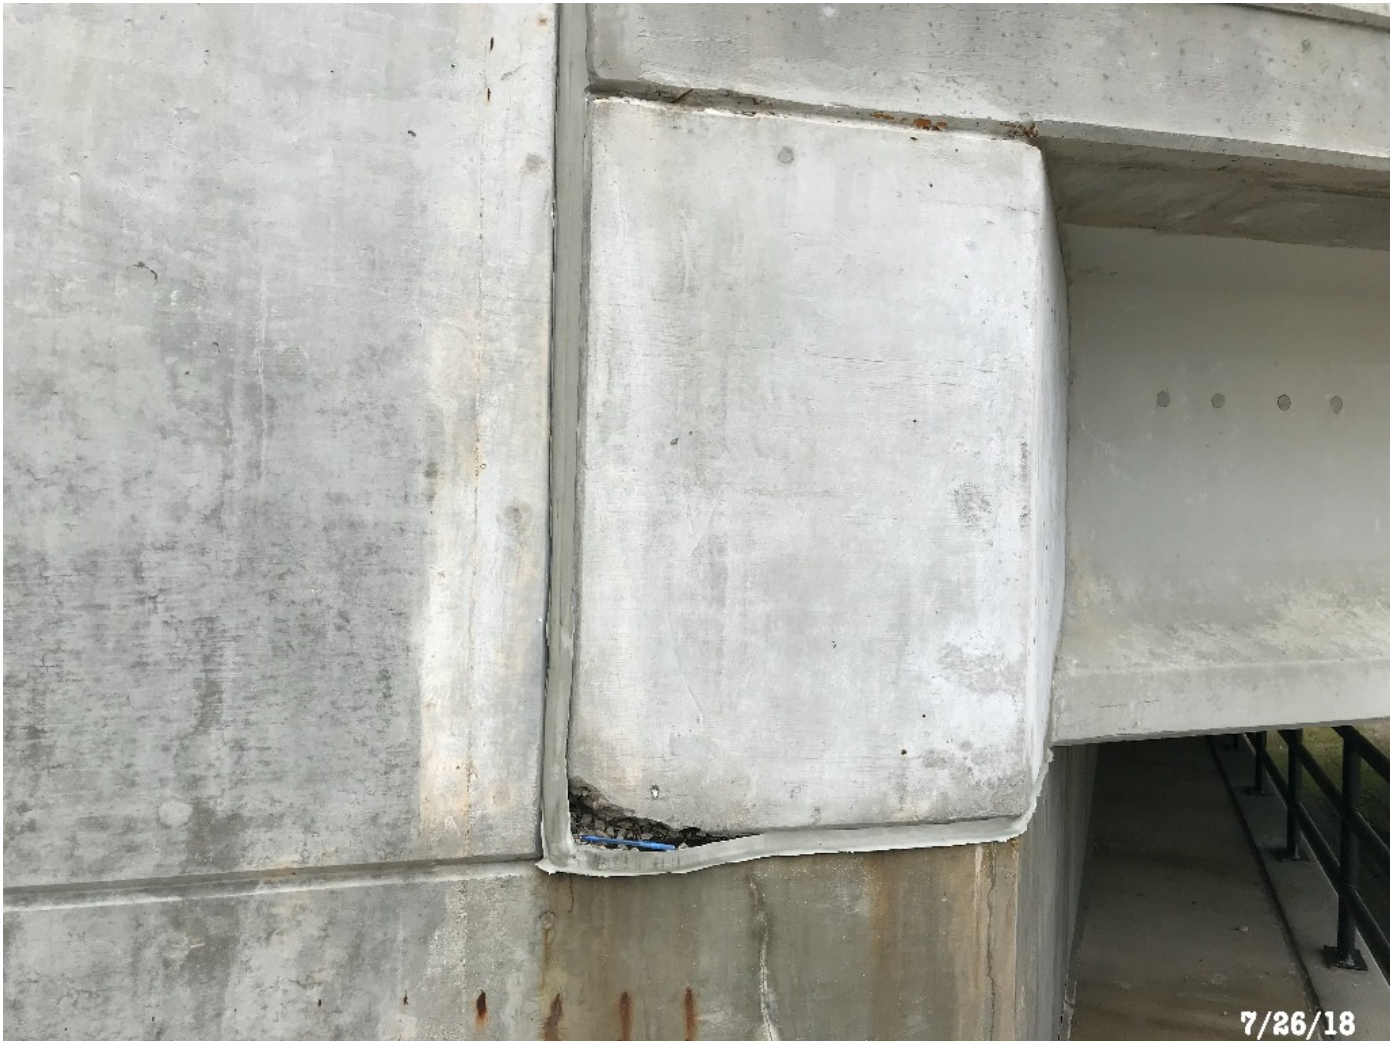
Small spall at N abut at west end.

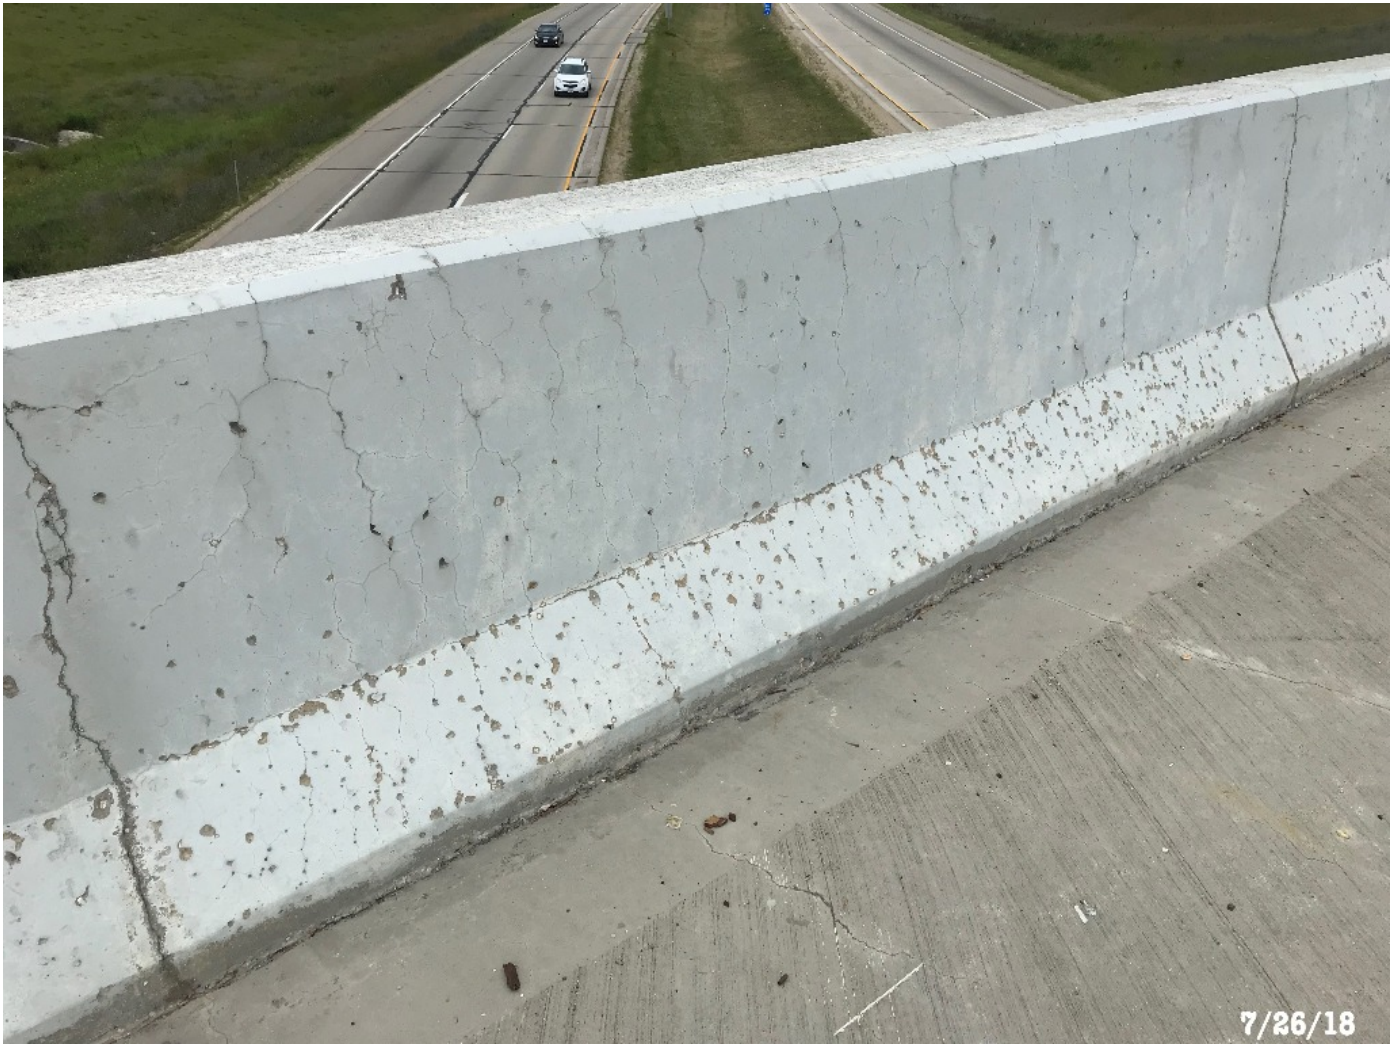
1080	Delamination - Spall - Patched Area	LF		0	2	0	0
			E: Small delams at face of barrier at middle of bridge expansion joint, small delam under fence post connection plate near middle of bridge.						
		1130	Cracking (RC)	LF		250	68	0	0
			W Rail: HL Vertical Cracks entire rail, scattered NRW vertical cracks. E Rail: HL & Narrow Vertical Cracks.						
X	8400		Integral Wingwall	EA	4	4	0	0	0
			No defects noted at all 4 wings

Typical condition of West rail.

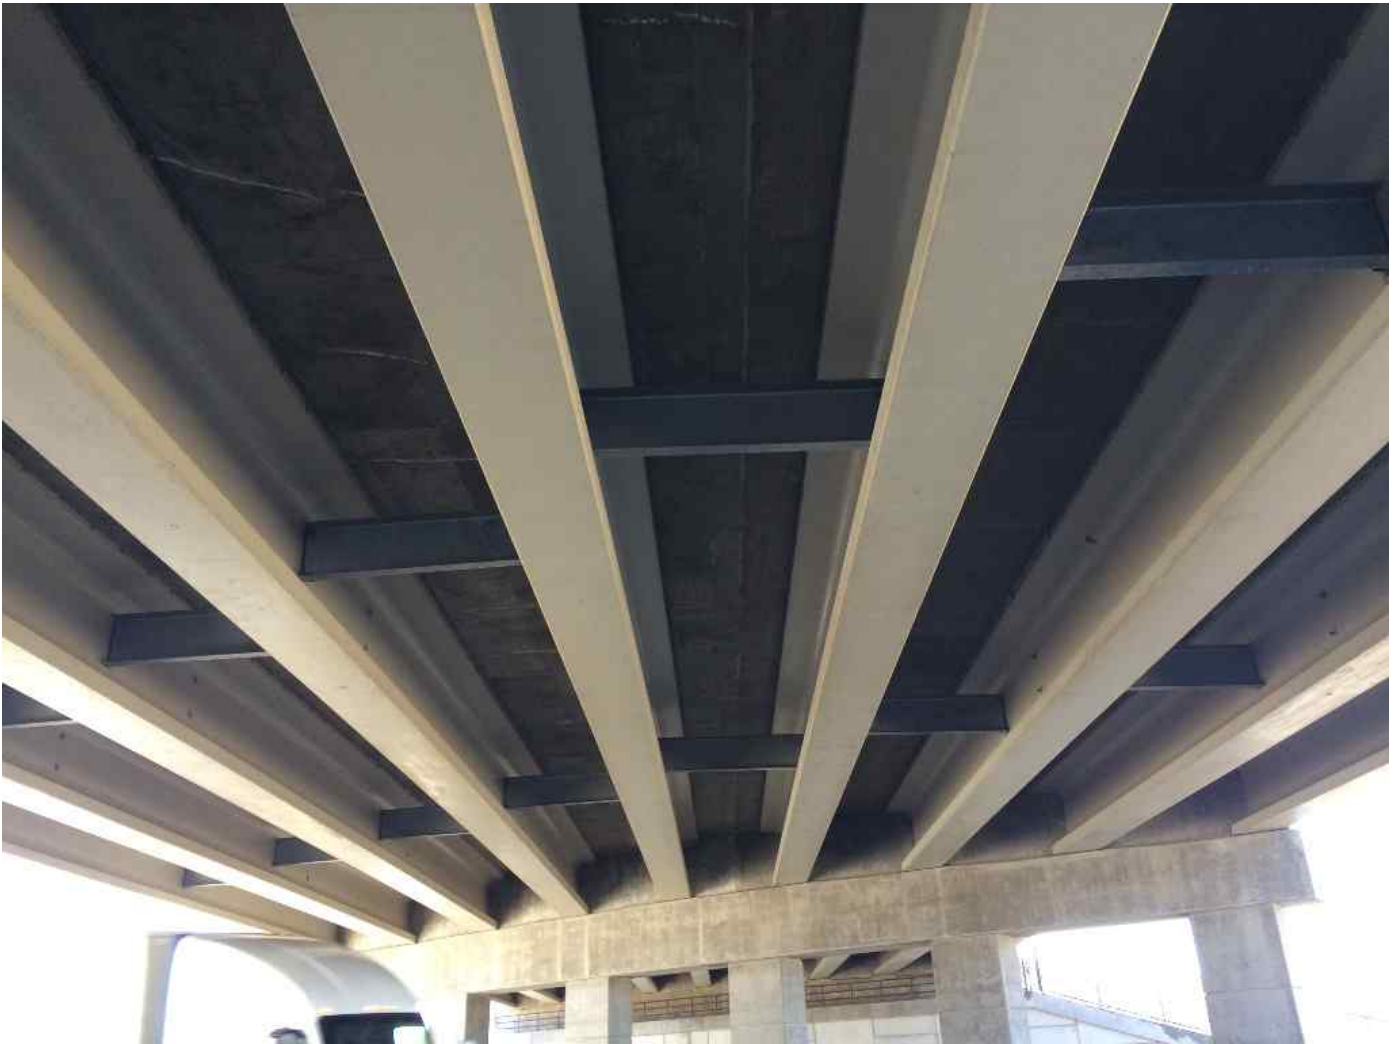
North span (span 2) girders and soffit. (Unchanged 2018)

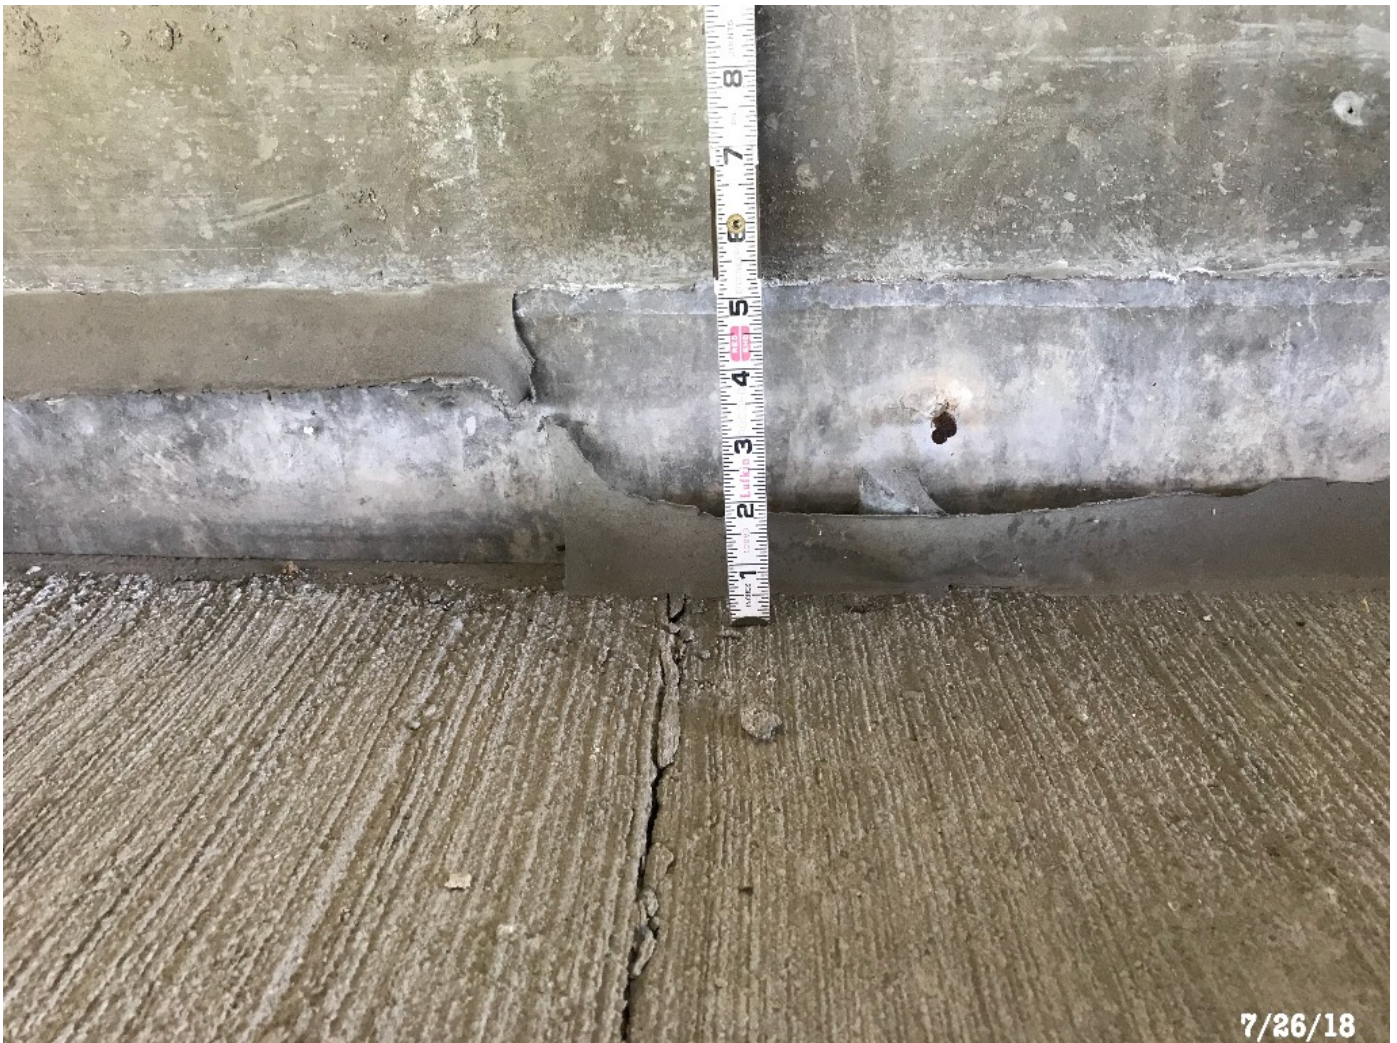
X	9042		Slope Protection- Concrete	EA	2	0	2	0	0
			N-dip at bay 2 from S - has settled 4" with a NRW crack at the low point. S- 1 1/2" settlement at the East end of the abutment, med size crack 1" East from middle joint of the slope paving, east side of crack starting to settle.

N. Slope paving, looking at North abutment. Settled 5 inches.

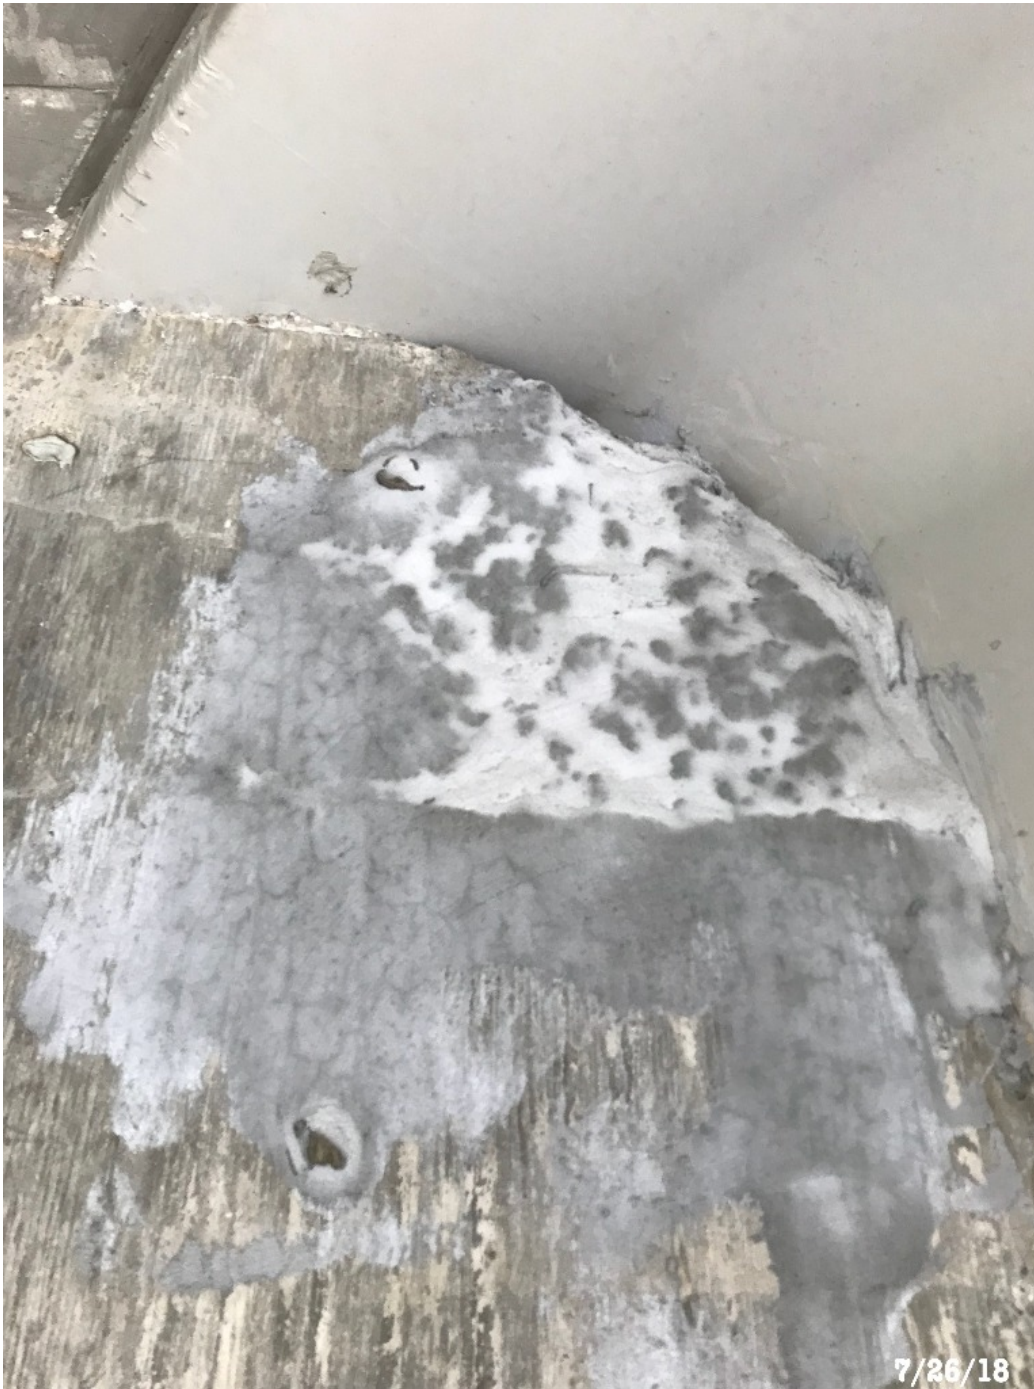
Typical mortar rub at abutment diaphragms.

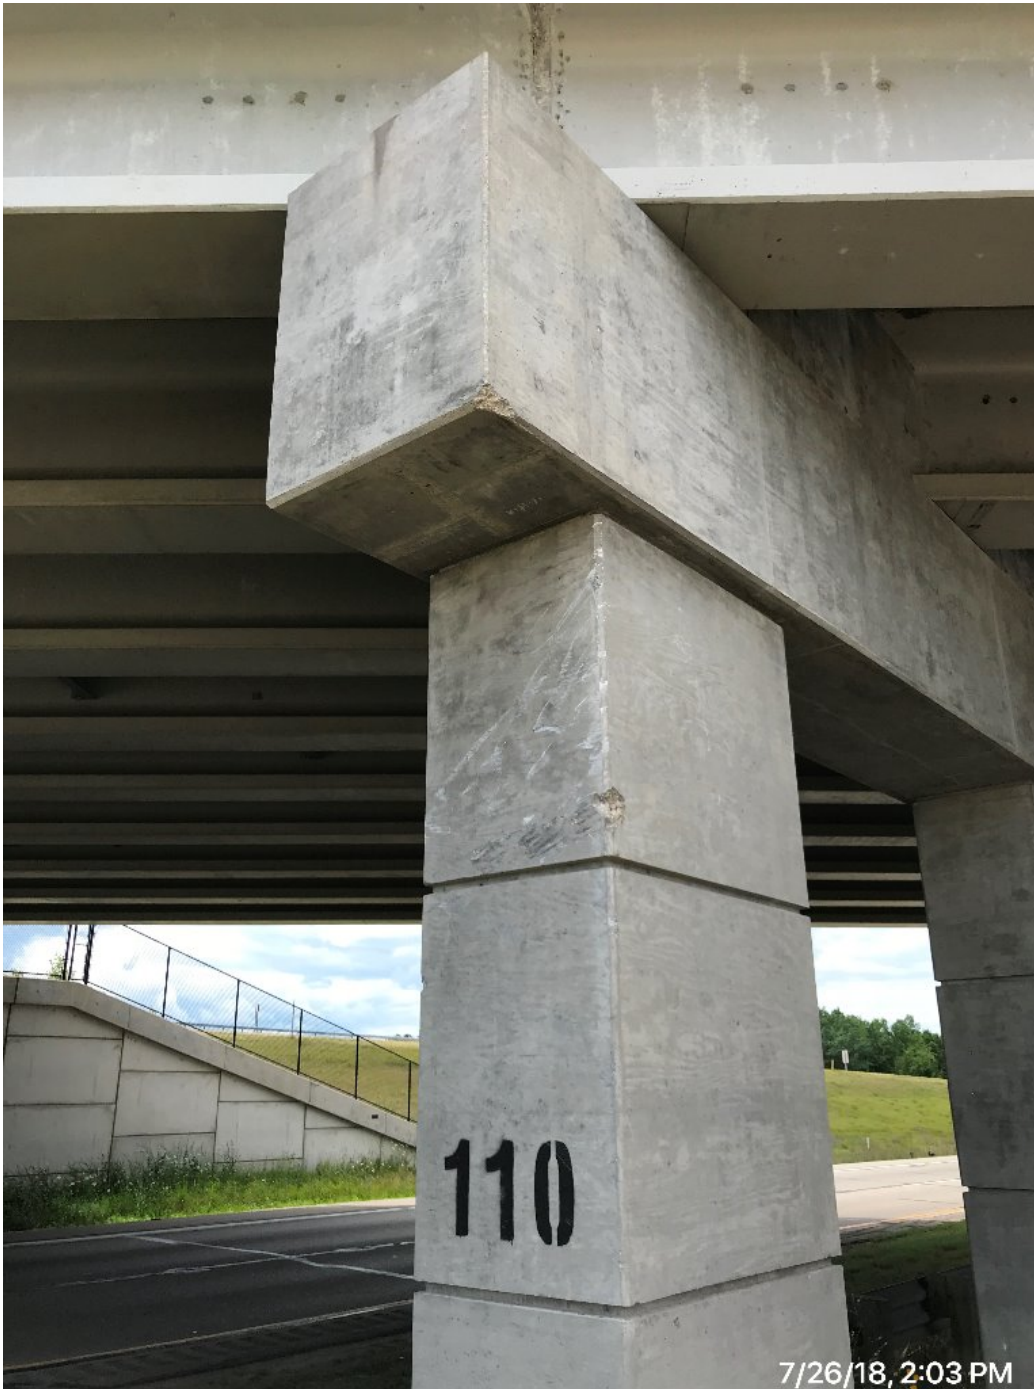
Small spalls at east column and east end of pier cap from 2017 traffic impact.

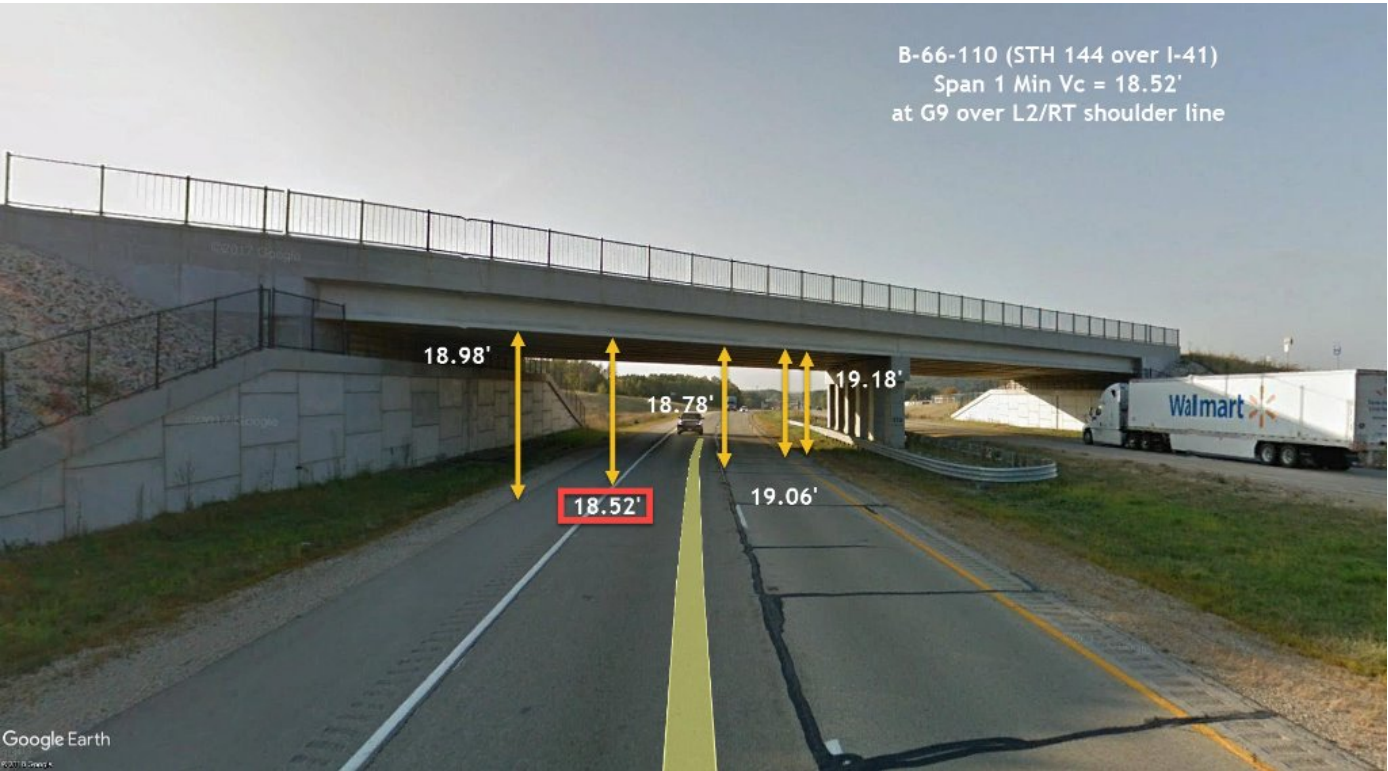
NonCardinal Min Vc (SB 41) = 18.52' at G9 over RT edge L2.

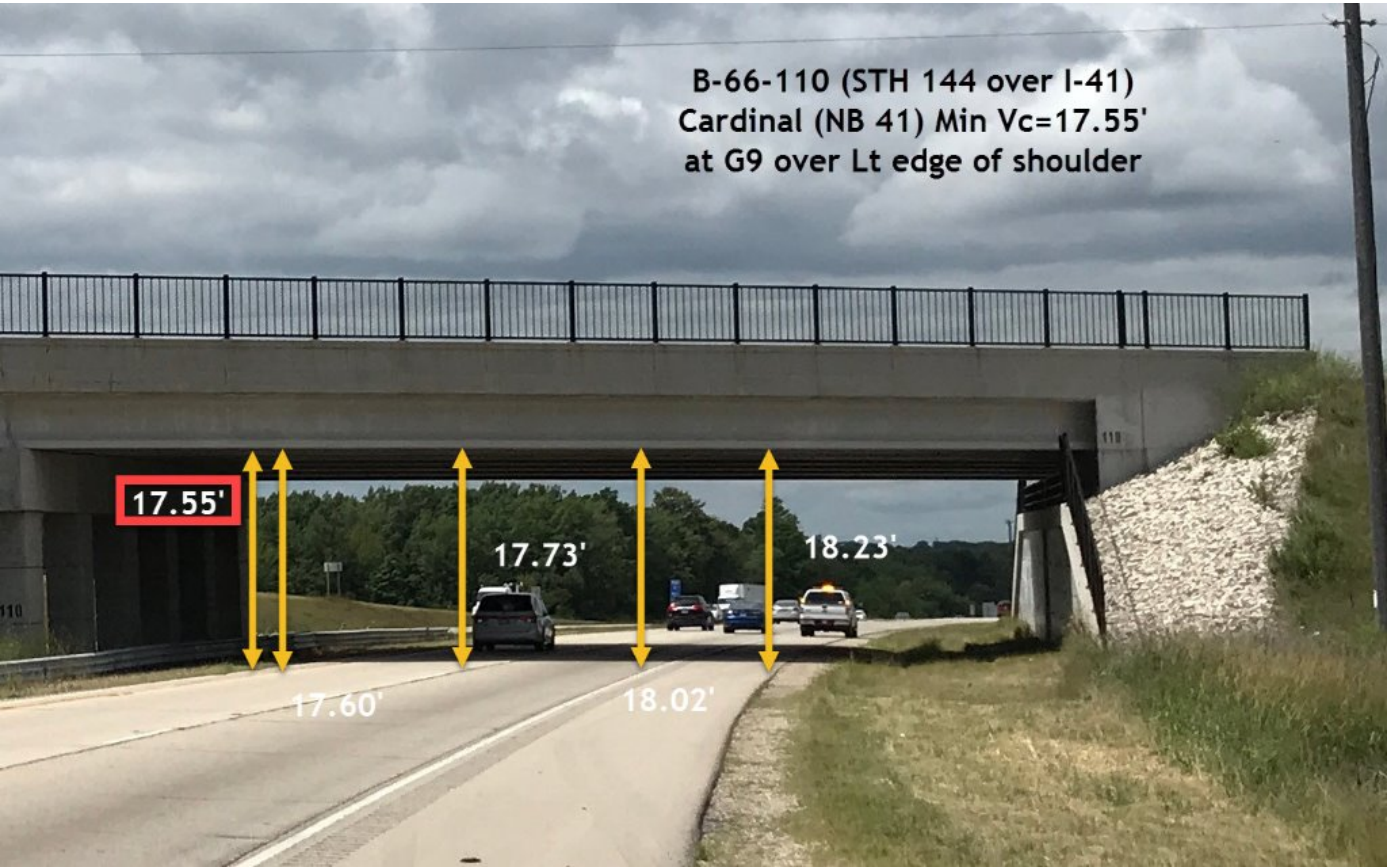
Cardinal Min Vc (NB 41) = 17.55' at G9 over LT edge LT shoulder.
