**WisDOT Project ID 1090-35-00 / 1090-35-70**  
**Existing Bridge B-67-111 – IH 43 SB over Martin Rd**  
Photos of Existing Conditions

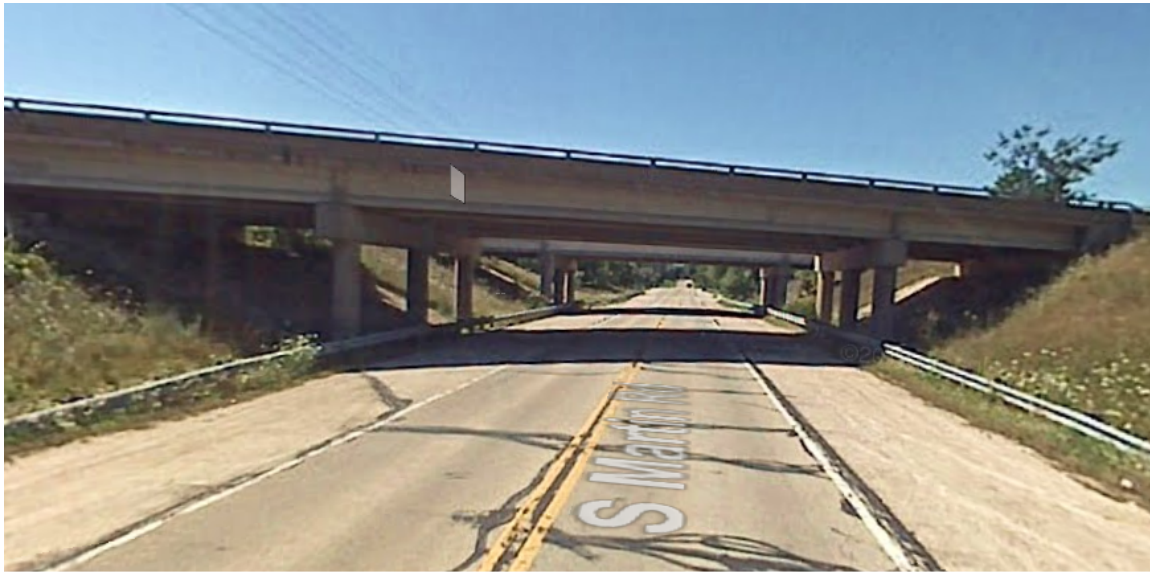
North elevation, looking south. Taken from Google Earth.

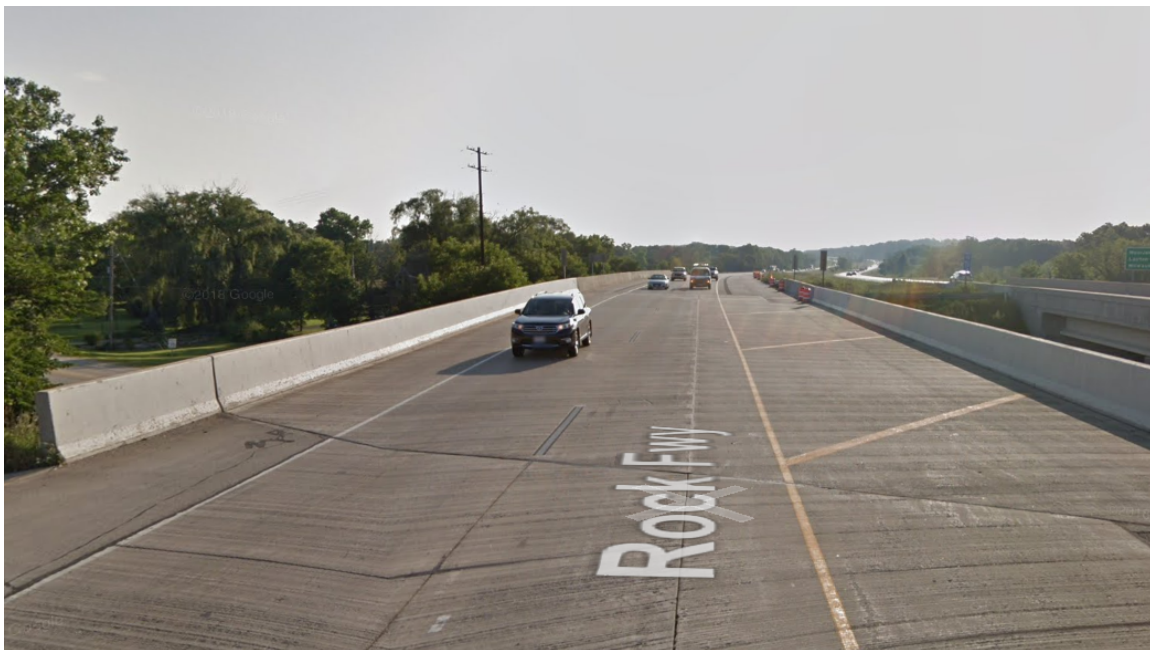
Overview of top of deck, looking east. Taken from Google Earth.

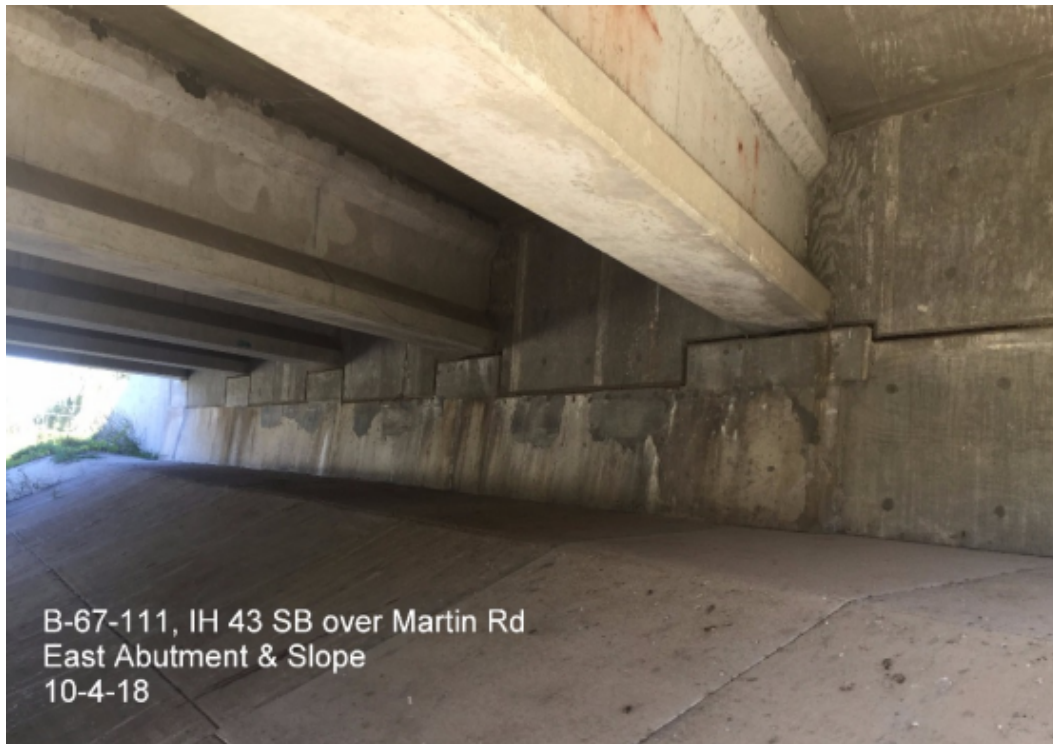
East Abutment & Slope. Photo from WisDOT inspection report.

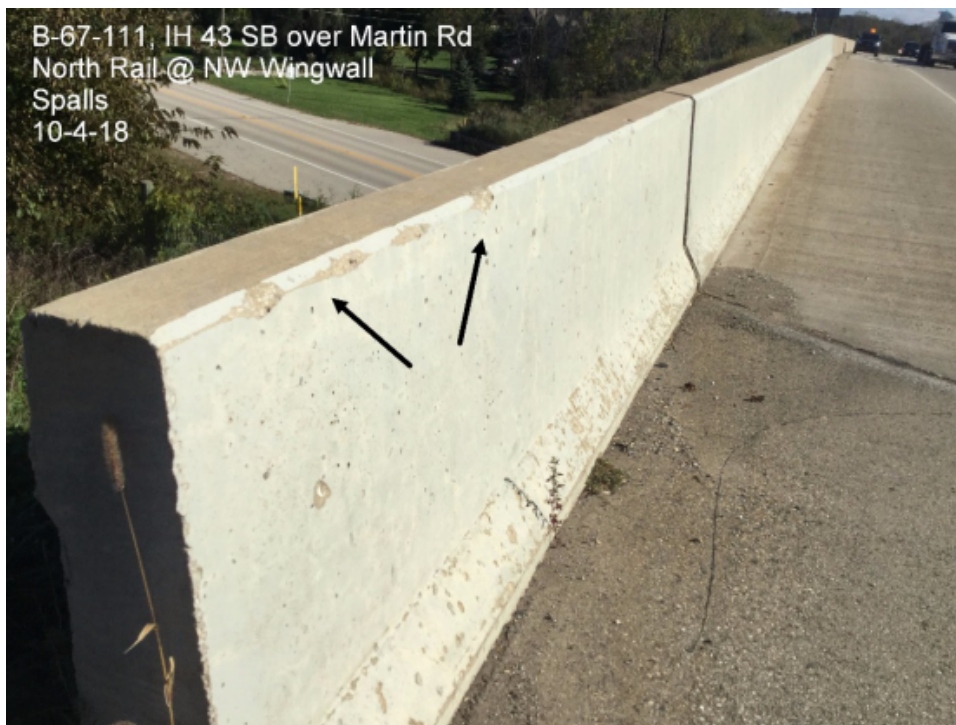
North Rail at NW Wingwall, Spalls. Photo from WisDOT inspection report.

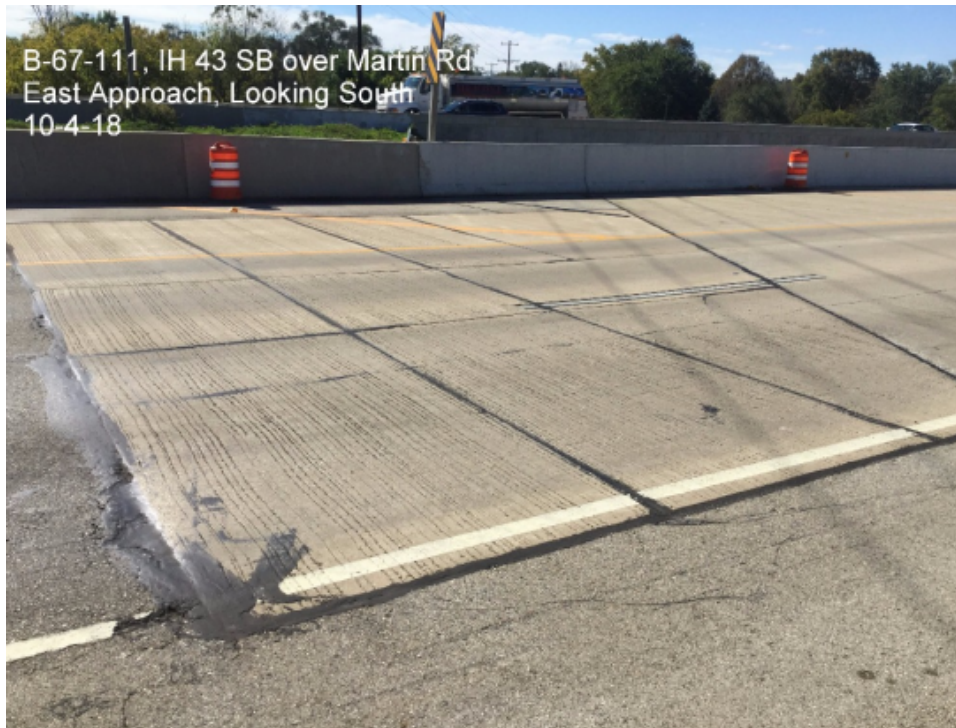
East approach, Looking south and east side of deck. Photo from WisDOT inspection report.

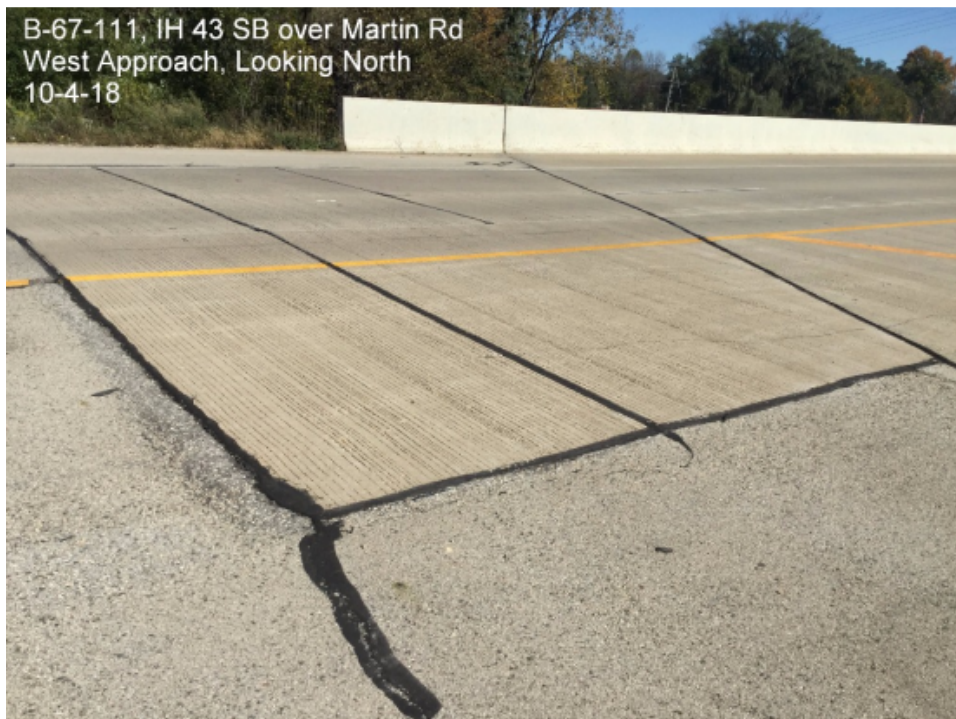
West approach, looking north and west side of deck. Photo from WisDOT inspection report.

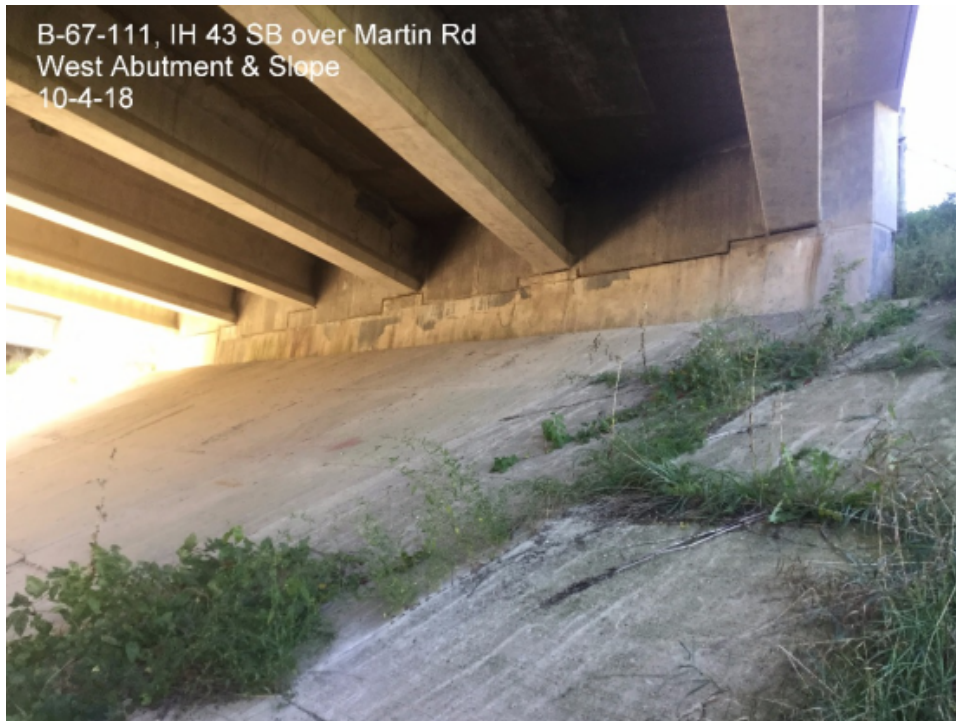
West abutment & slope. Photo from WisDOT inspection report.

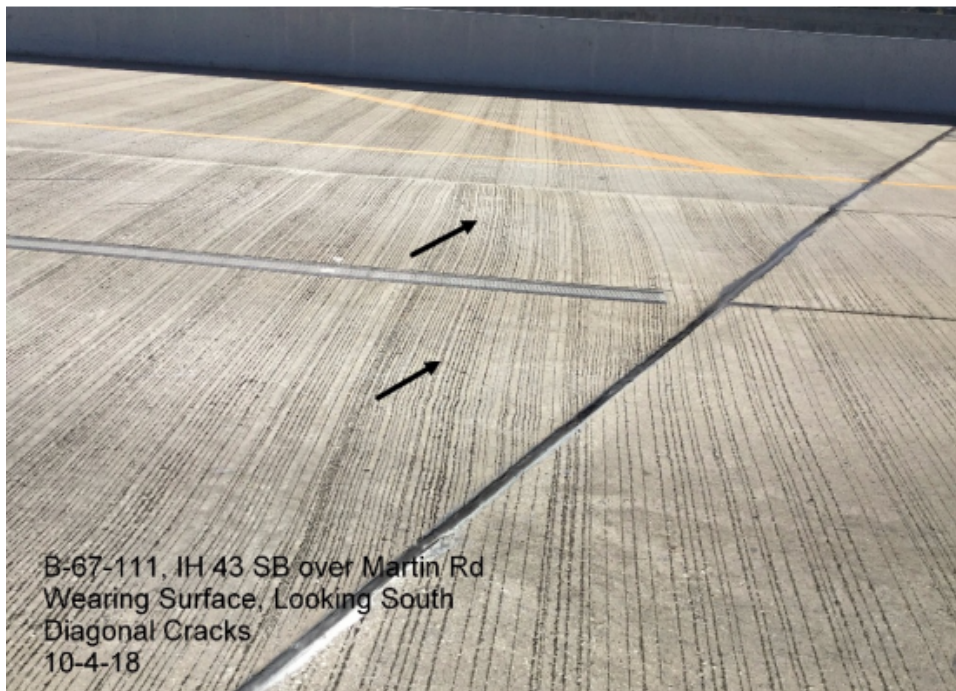
Wearing surface, looking south. Diagonal Cracks. Photo from WisDOT inspection report.

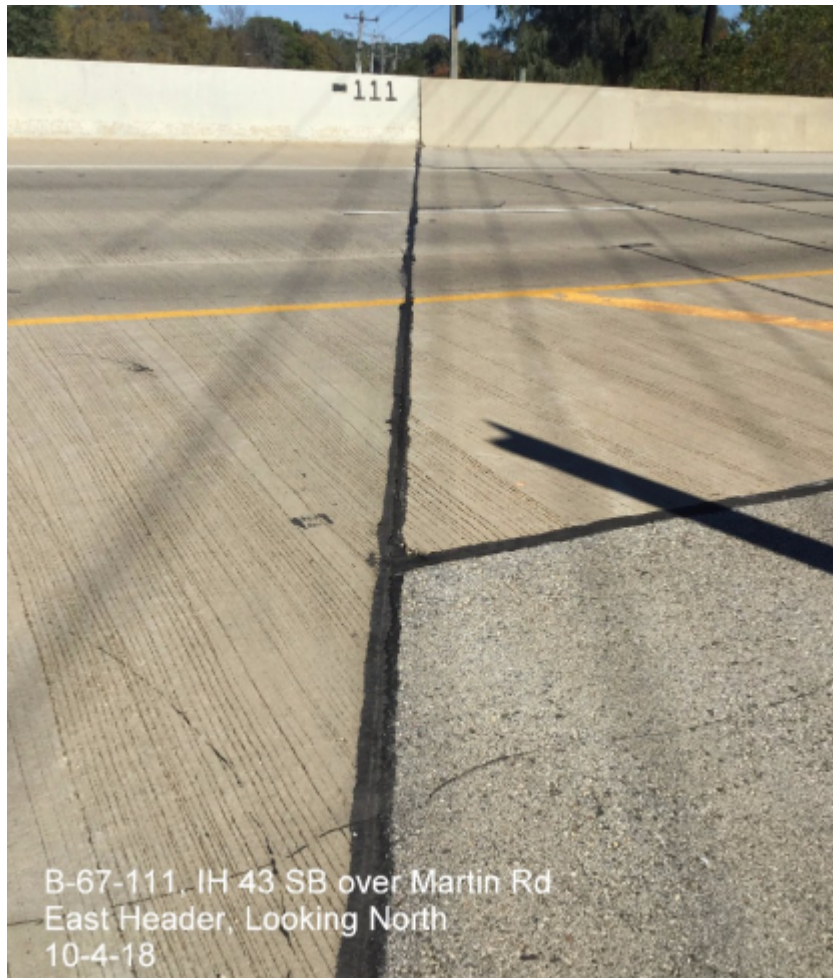
East header, looking north. Photo from WisDOT inspection report.
