## **Bridge Asbestos Inspection Report**

WisDOT Project ID: 1090-35-00 Structure Number: B-67-0113 Structure Name: CTH Y over IH 43

## Inspection Report for B-67-113

## CTH Y (RACINE AVE) over IH 43 Sep 04,2018

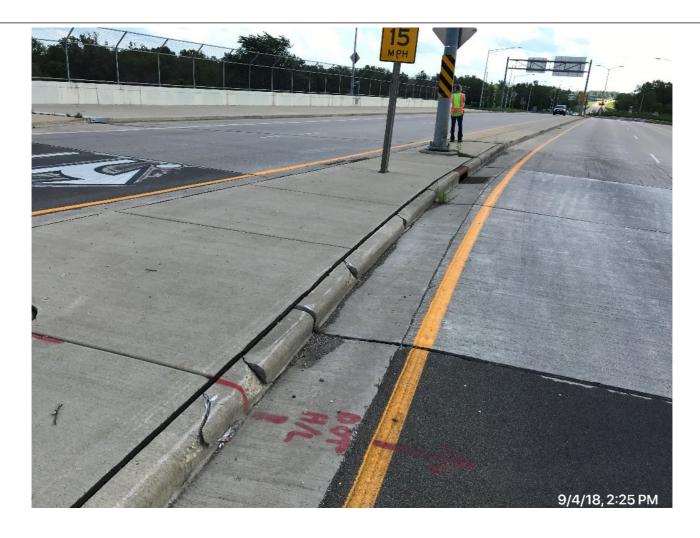
SB at N approach median - curb with several spalls.

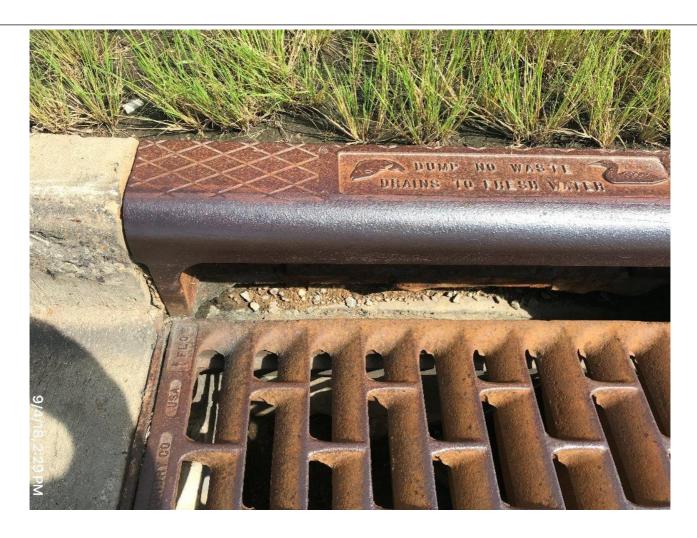
Inlet at NE quad - CABC visible below casting - tuckpoint needed.

Item	Priority	Recommended by	Status	Status change
Drainage - Repair/Replace Deck Drains	HIGH	Zemke, Jason (2016)	IDENTIFIED	01/04/19
Inlet at NE corner at outside shoulder (not deck dalso tuckpoint outside inlet at SE quad.	rain) - tuckpoint	below casting at adjustment rings.	Roadway base co	ourse visible;
Substructure - Other Work	MEDIUM	Zemke, Jason (2016)	IDENTIFIED	10/09/18
Recommend sealing vertical medium and wide cr	acks at both ab	utments.		
Misc - Other Work	MEDIUM	Zemke, Jason (2016)	IDENTIFIED	10/09/18
Recommend monitoring cracking in top cap of pie	r for growth or	widening.		
Approach - Seal Joint along Parapet/Wing	MEDIUM	Zemke, Jason (2016)	IDENTIFIED	01/04/19
Clean and seal parapet/sidewalk joints at NE and	SE quadrants.			
Expansion Joints - Clean	LOW	Zippel, William J (9605)	IDENTIFIED	01/07/16
Clean out expansion joints.				
IMP-Concrete Overlay	LOW	Zippel, William J (9605)	IDENTIFIED	01/07/16

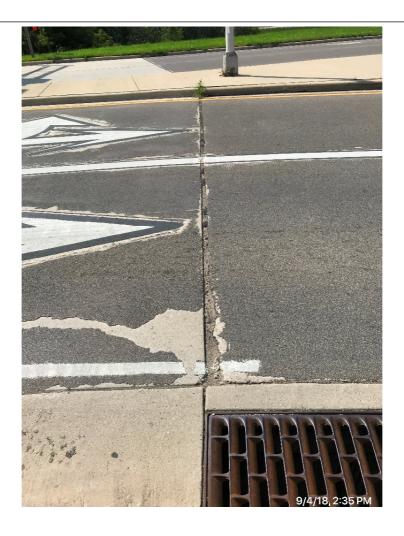
NE approach - typical unsealed transverse joints.

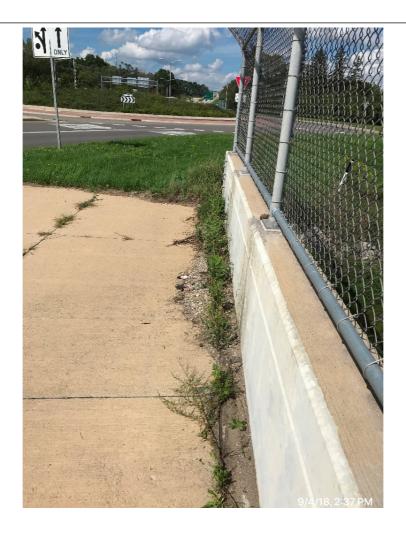
NE- wing/sidewalk joint full of weeds and needs to be sealed.

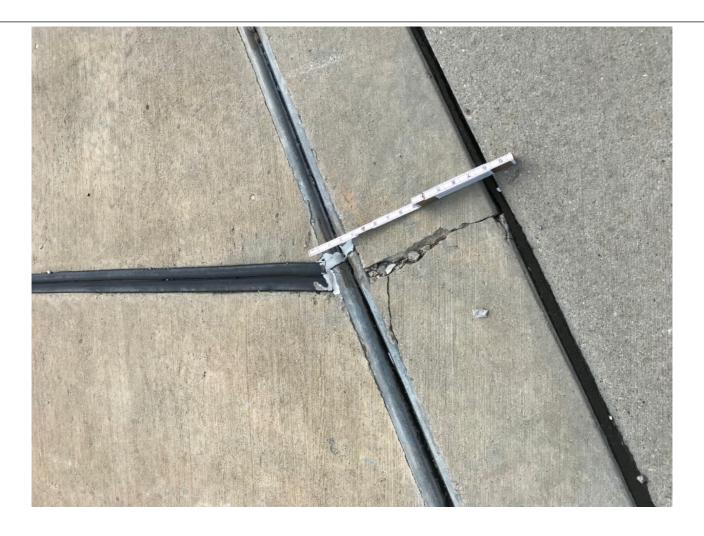
Strip Seal Exp Jt - CS3 spall in S header at compression seal.

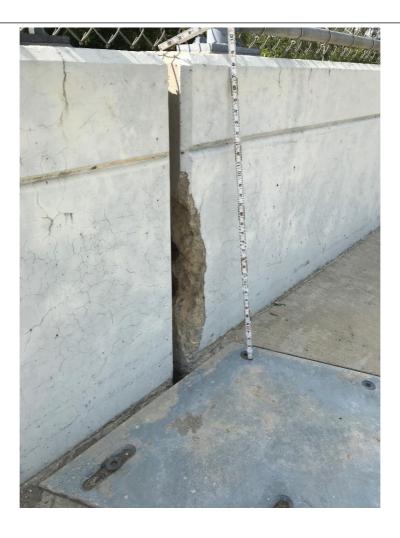
West Rail: Large vertical spall at N expansion joint.

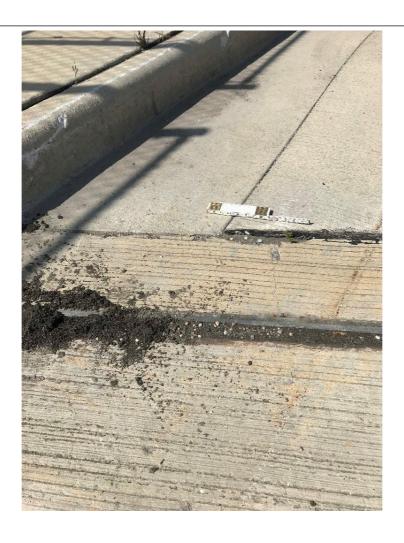
Routine
Document Comment/Description
Typical small spall in header.

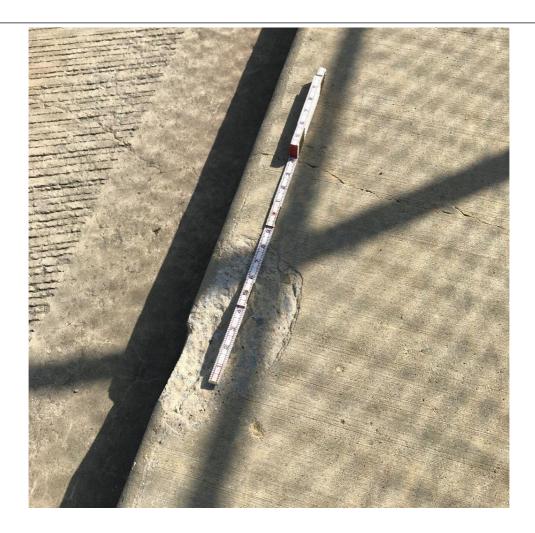
West sidewalk - spall near middle of bridge

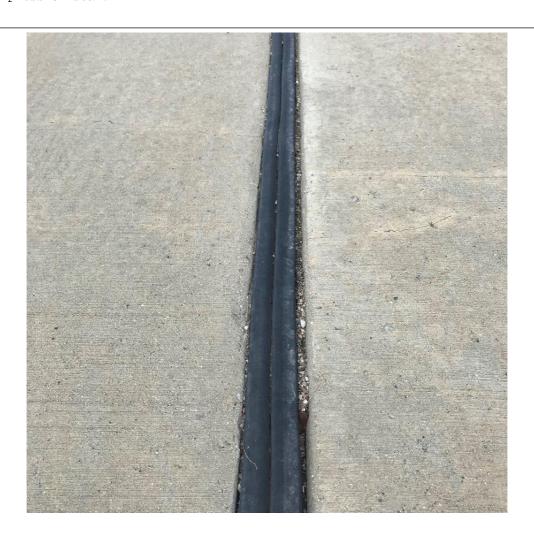
# Routine Document Comment/Description Debris in compression seal.

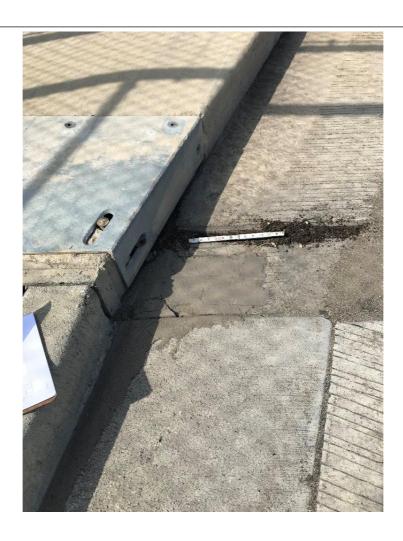
## Routine Document Comment/Description Failed patch in S header.

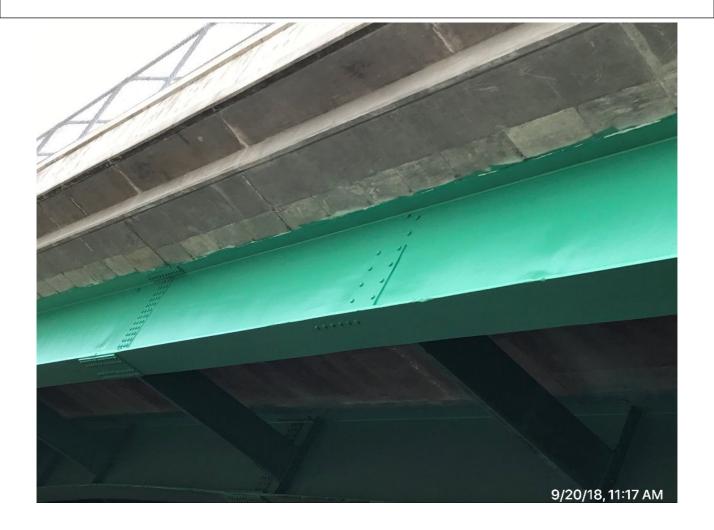
12/15/17: Empty dump truck traveling full freeway speeds on I-43 NB with box up hit G1 over L2 resulting in significant damage. Repairs were completed by Zenith Tech with International Straightening Inc. as the heat straightening sub in early May 2018.

G1 span 1 previous distortion heat straightened. Note some minor distortion still present but within tolerances.

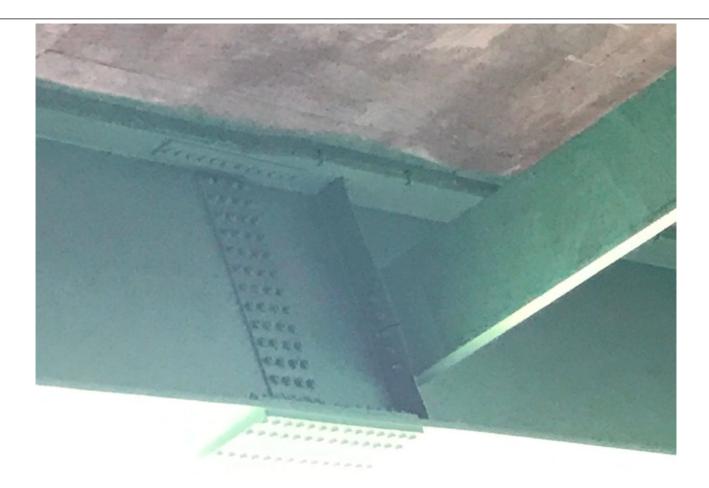
E face G1 in span 1 at intermediate diaph connection 4 - crack in stiffener drilled out but not fully arrested due to clearance issue between web and drill.

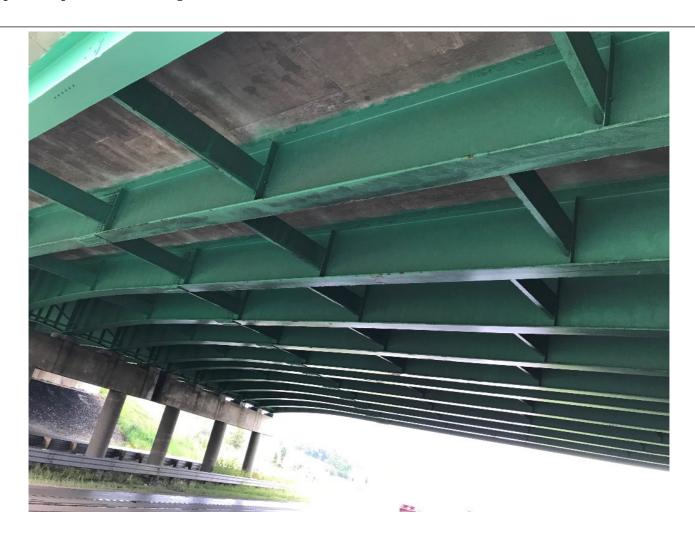
Span 1 superstructure in good condition.

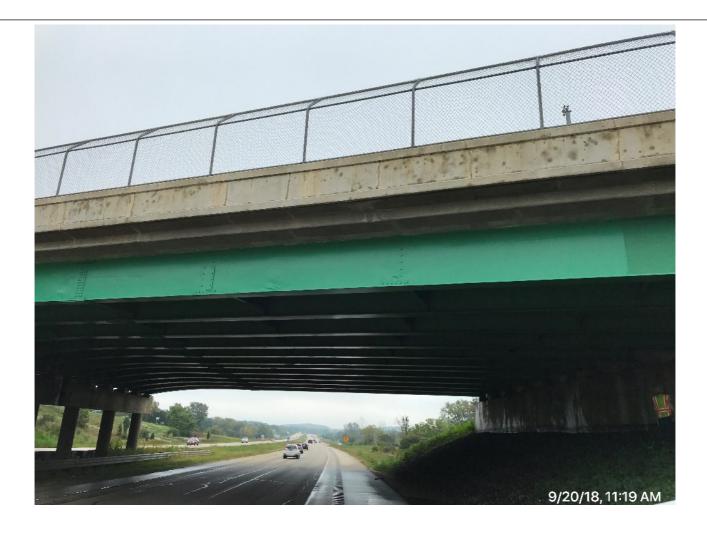
Routine
Document Comment/Description
G1 in span 1 repainted after heat straightening.

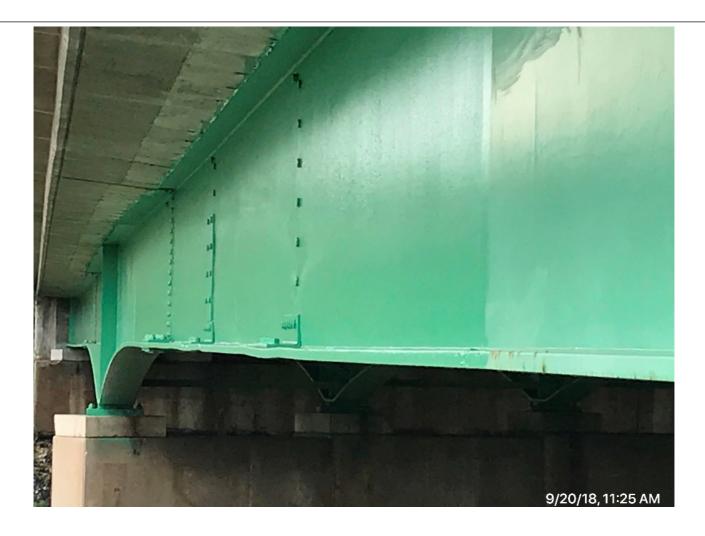
Routine
Document Comment/Description
G1 span 1 - some minor distortion still visible.

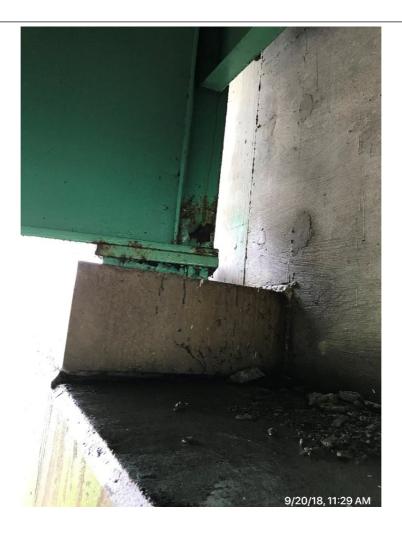
Typ light rust at girder - picture at G12 at S abut.

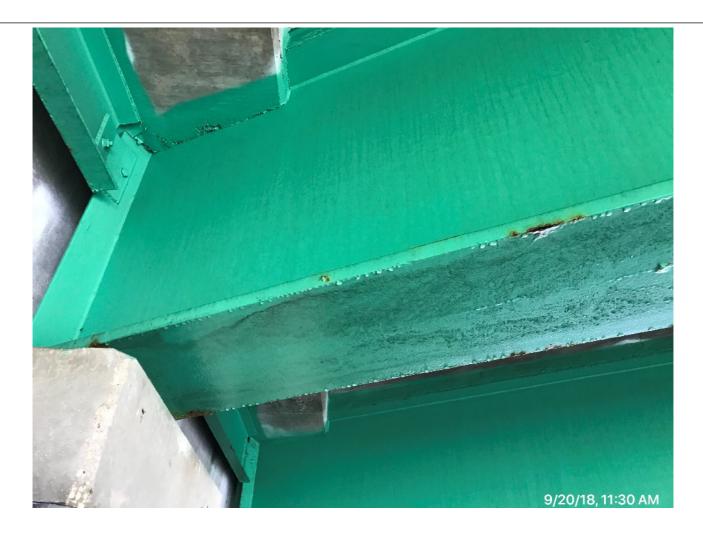
Example of condensation at bottom flanges at south abutment girder ends.

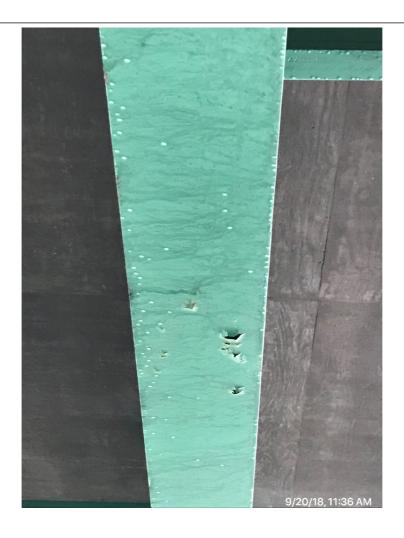
Scattered peeling paint in bottom flange with light rust.

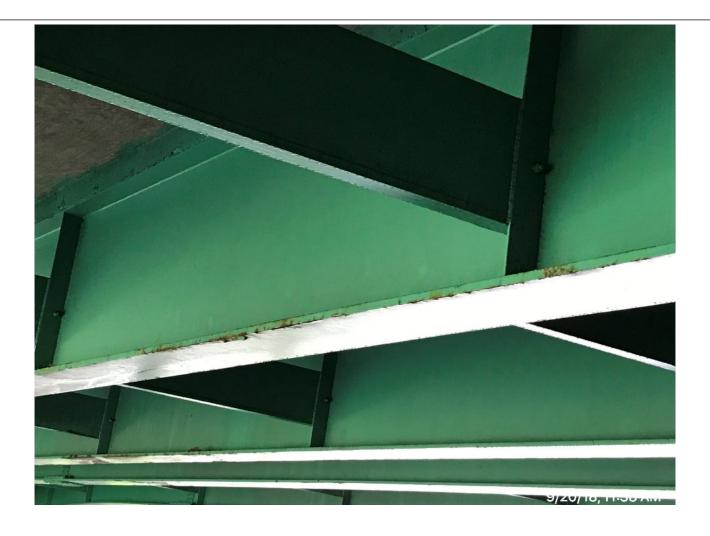
Span 1 girders - typical edge rust on bottom rust.

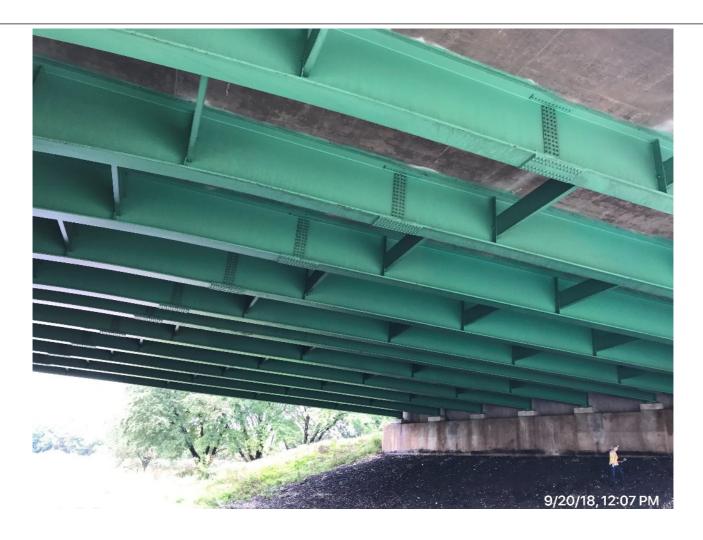
Routine
Document Comment/Description
Typical condition superstructure span 2.

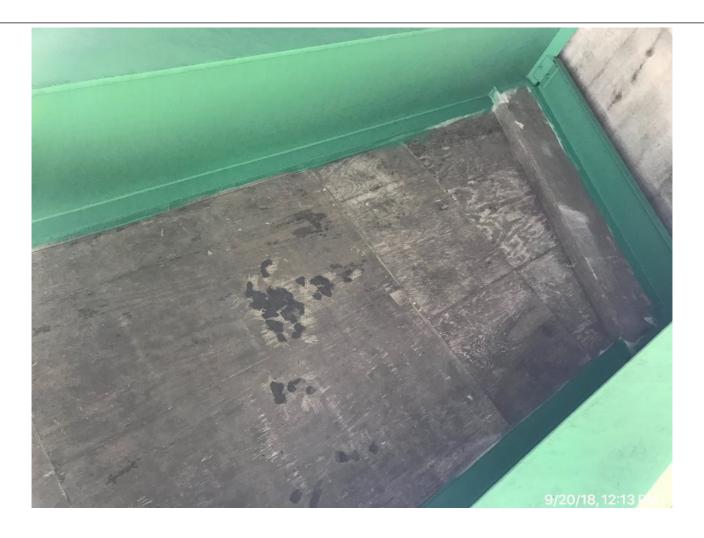
Bay 1 at north abutment - mortar rubs in soffit.

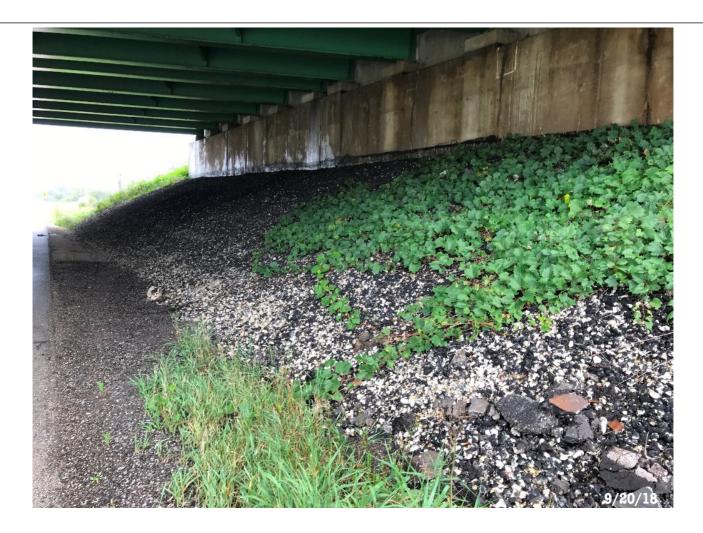
# Routine Document Comment/Description Vine growth at south slope.

2034-Recommend concrete overlay.				
Approach - Seal Approach to Paving Block	LOW	Zippel, William J (9605)	IDENTIFIED	01/07/16
Reseal approaches at headers.				
Misc - Remove Vegetation (Spray)	LOW	Zemke, Jason (2016)	IDENTIFIED	10/09/18
Spray slope paving to remove vines, particularly a	t W end of S sl	ope. Also kill weed overgrowth at ri	prap flumes at all	4 quadrants.

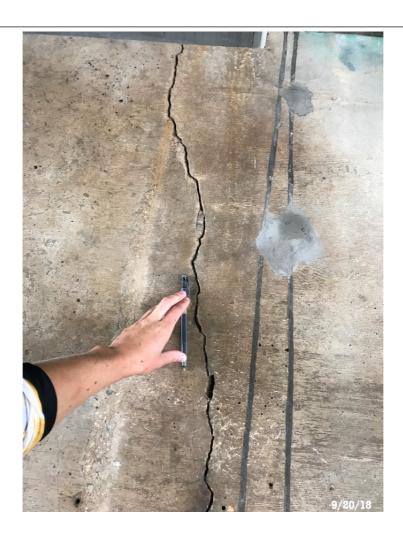
RC Abut - Wide crack at Girder 4 at N abutment.

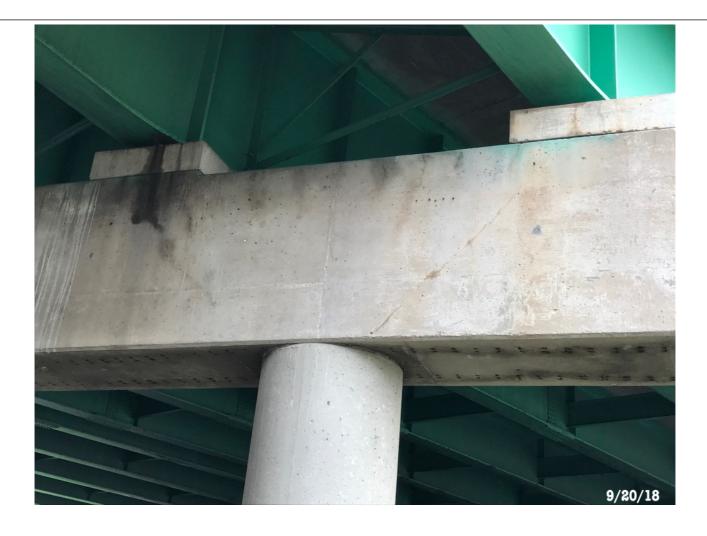
Need to monitor cracking in Pier Cap: No apparent change 2017 **or 2018.**The bridge was stationed south to north and the girders were labeled west to east. The diaphragm numbering increased fr**om south** to north.

RC Cap - Typical HL load induced cracks in cap. Photo shows north side of pier at west end.

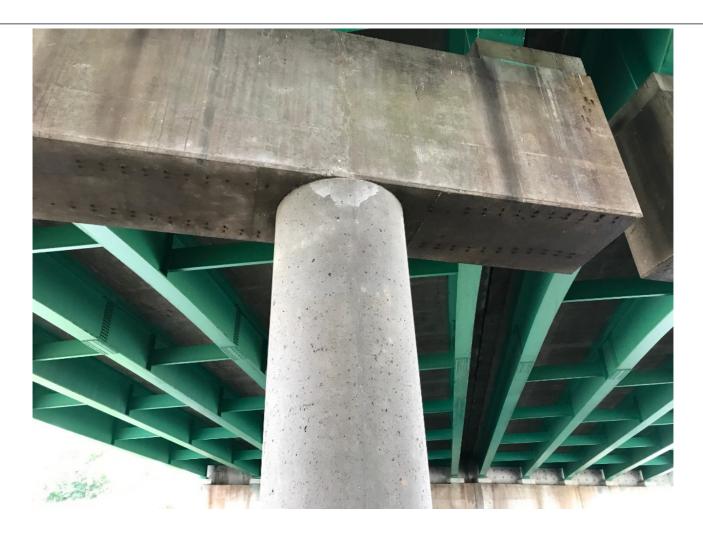
# Routine Document Comment/Description CS3 delam on C4.

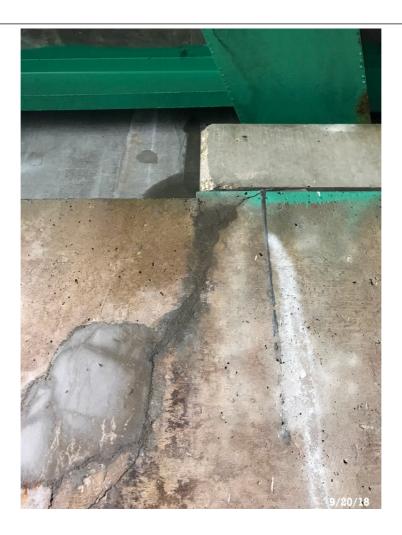
Routine
Document Comment/Description
Typical medium cracking at abutment.

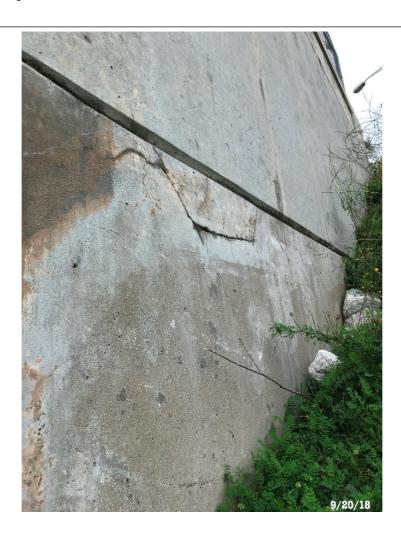
Routine
Document Comment/Description
SW wing - patch with adjacent cracks.

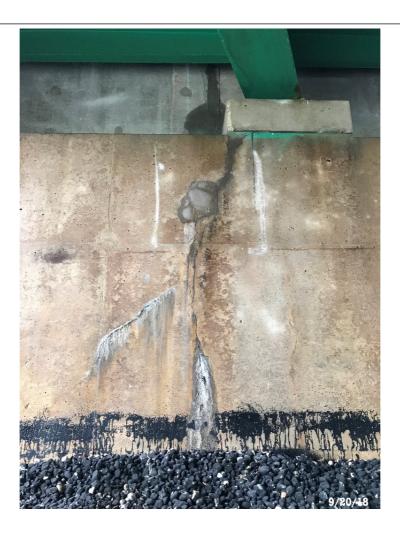
Routine
Document Comment/Description
S abut - crack with effl and patch.

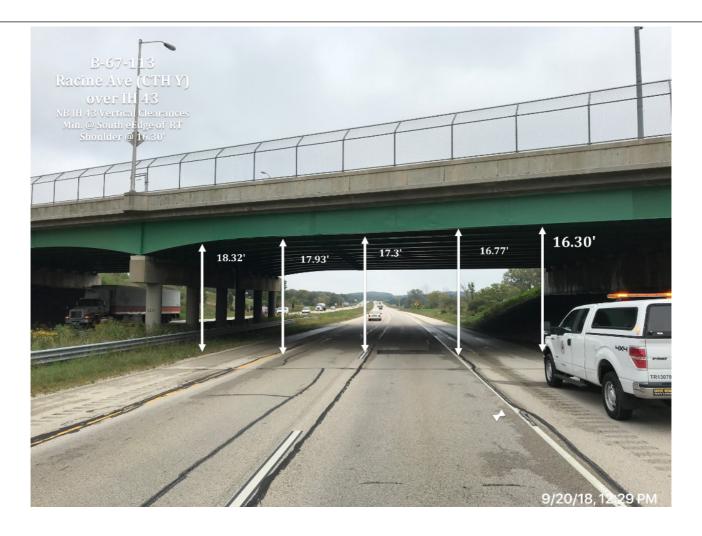
Span 1 min. VC at edge of NB right shoulder, 16.30'

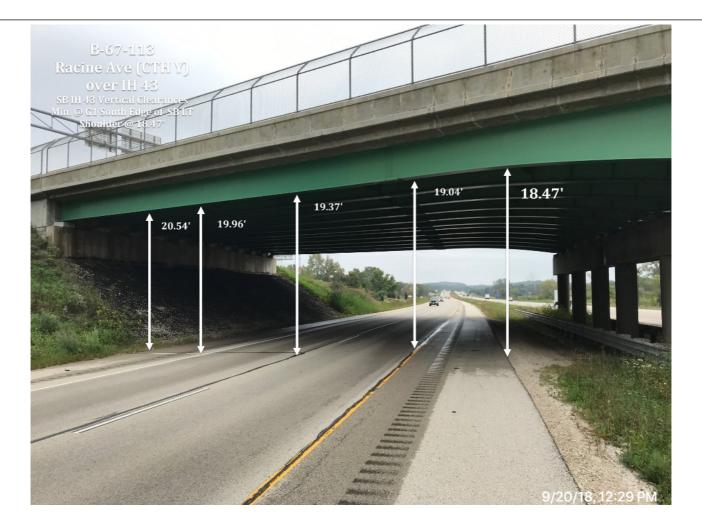
Span 2 Min. VC at SB left shoulder, 18.47'
