ATTACHMENT C
PHOTOS OF DEFICIENT AREAS

1050-01-11
Chippewa Falls – Abbotsford
Stillson Creek to Cardinal Ave
STH 29
Chippewa and Clark Counties
Structure Photos

B-09-175

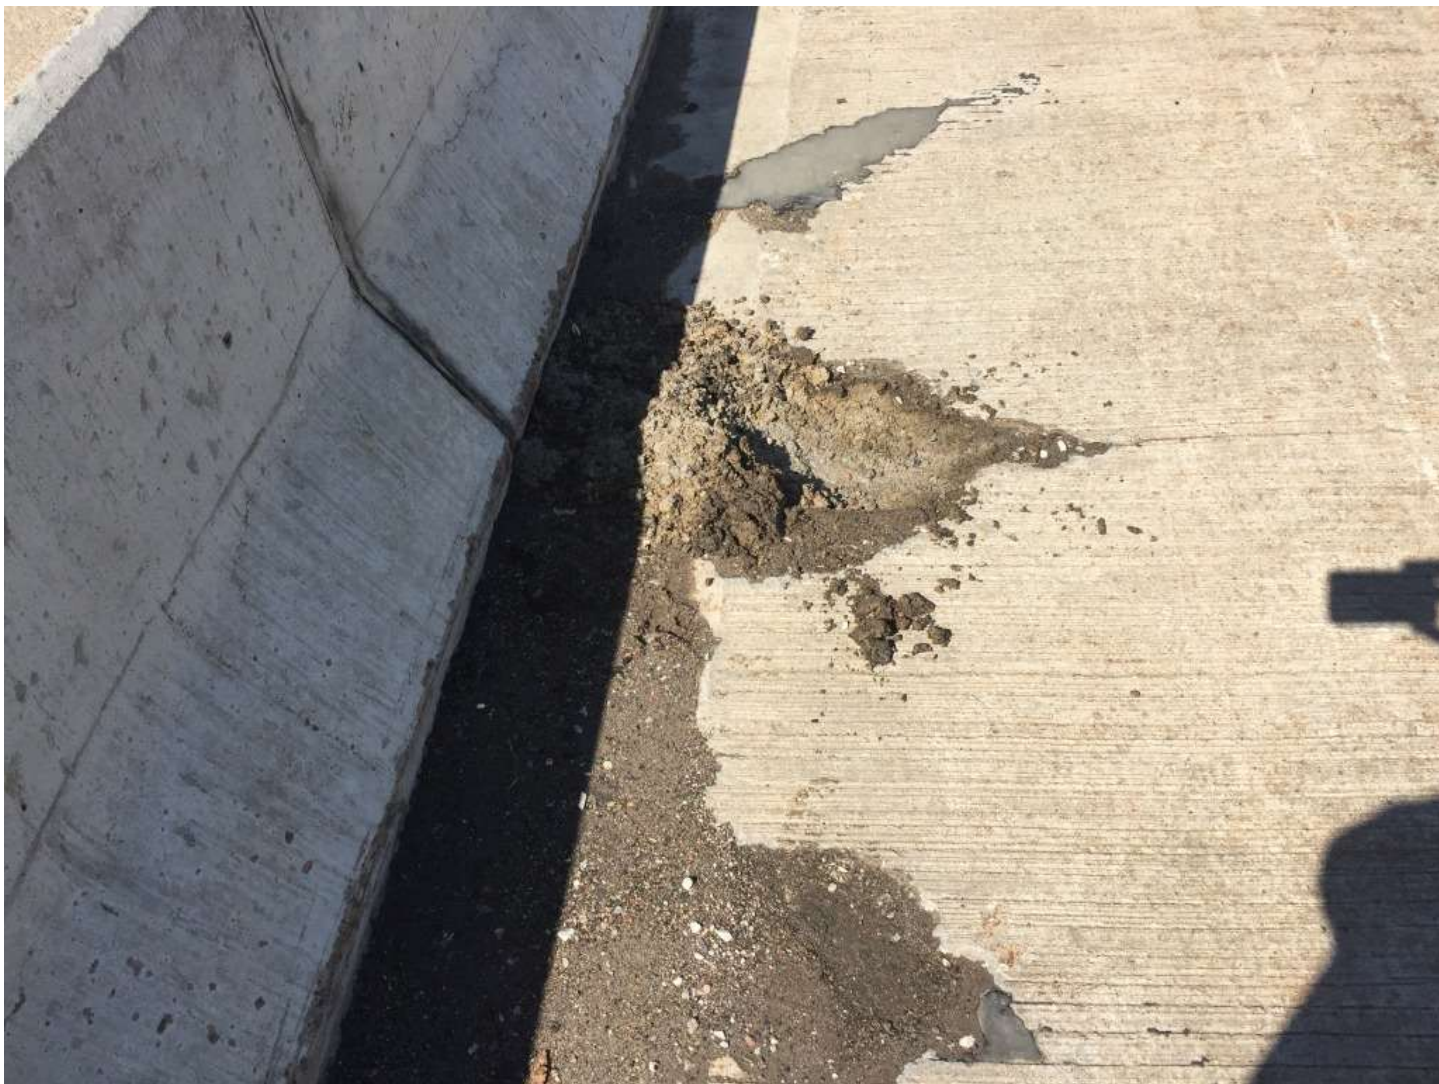
Top of deck near south rail over pier 2 - Spalling

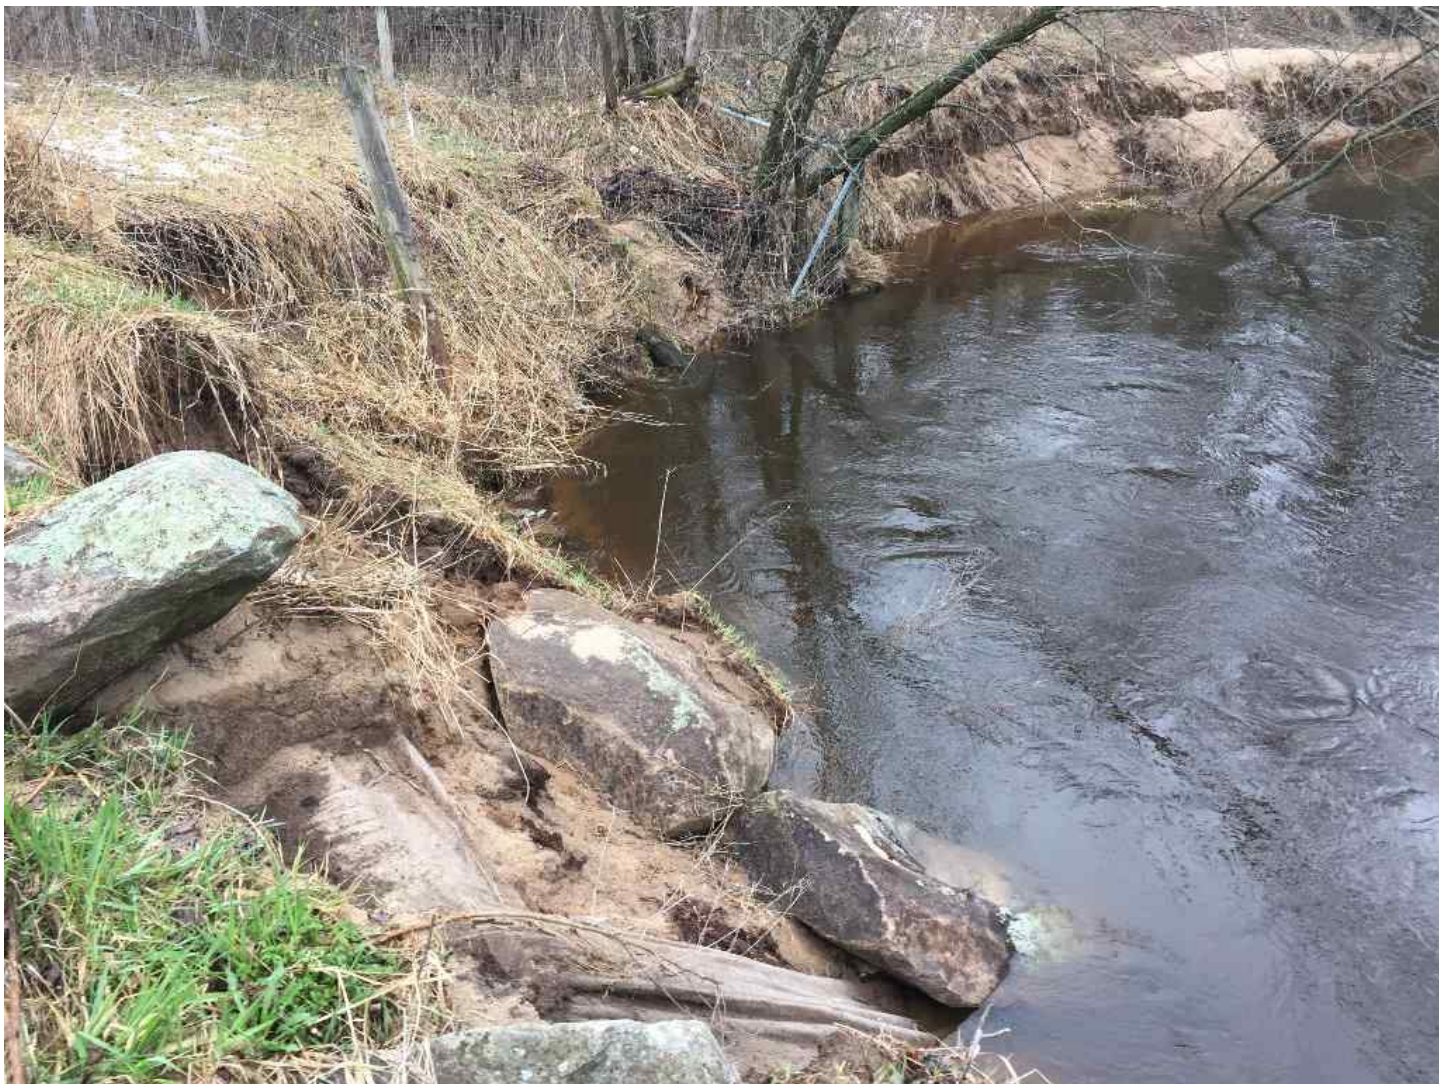
SE Corner of Structure – Streambank Erosion

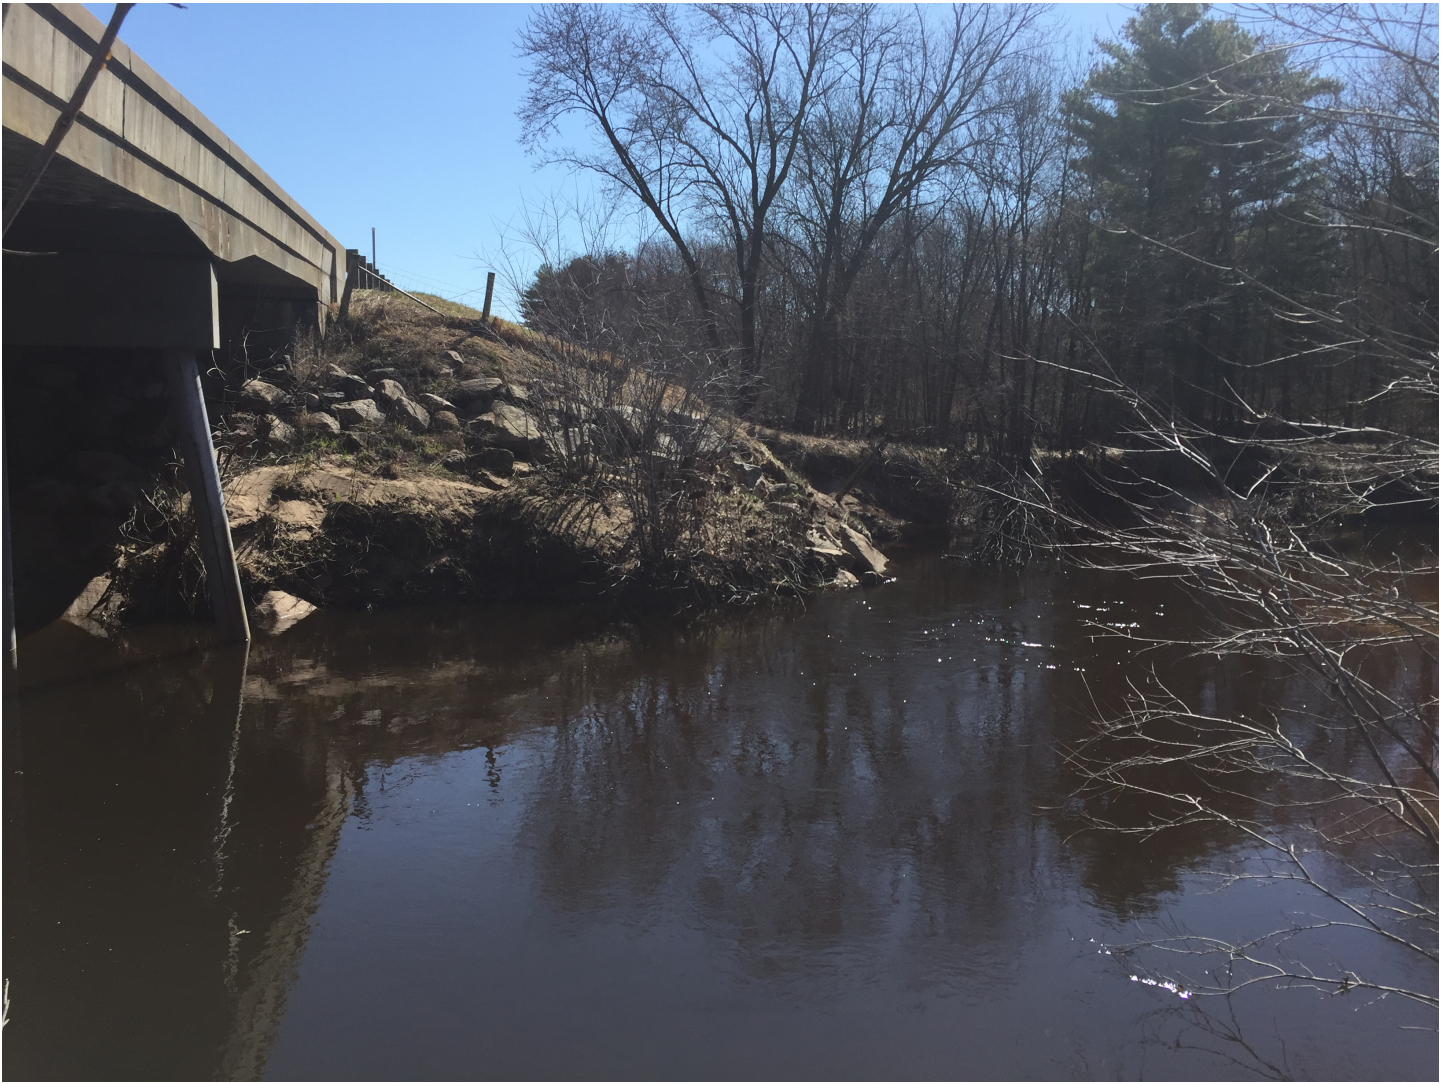
SE Corner of Structure – Streambank Erosion

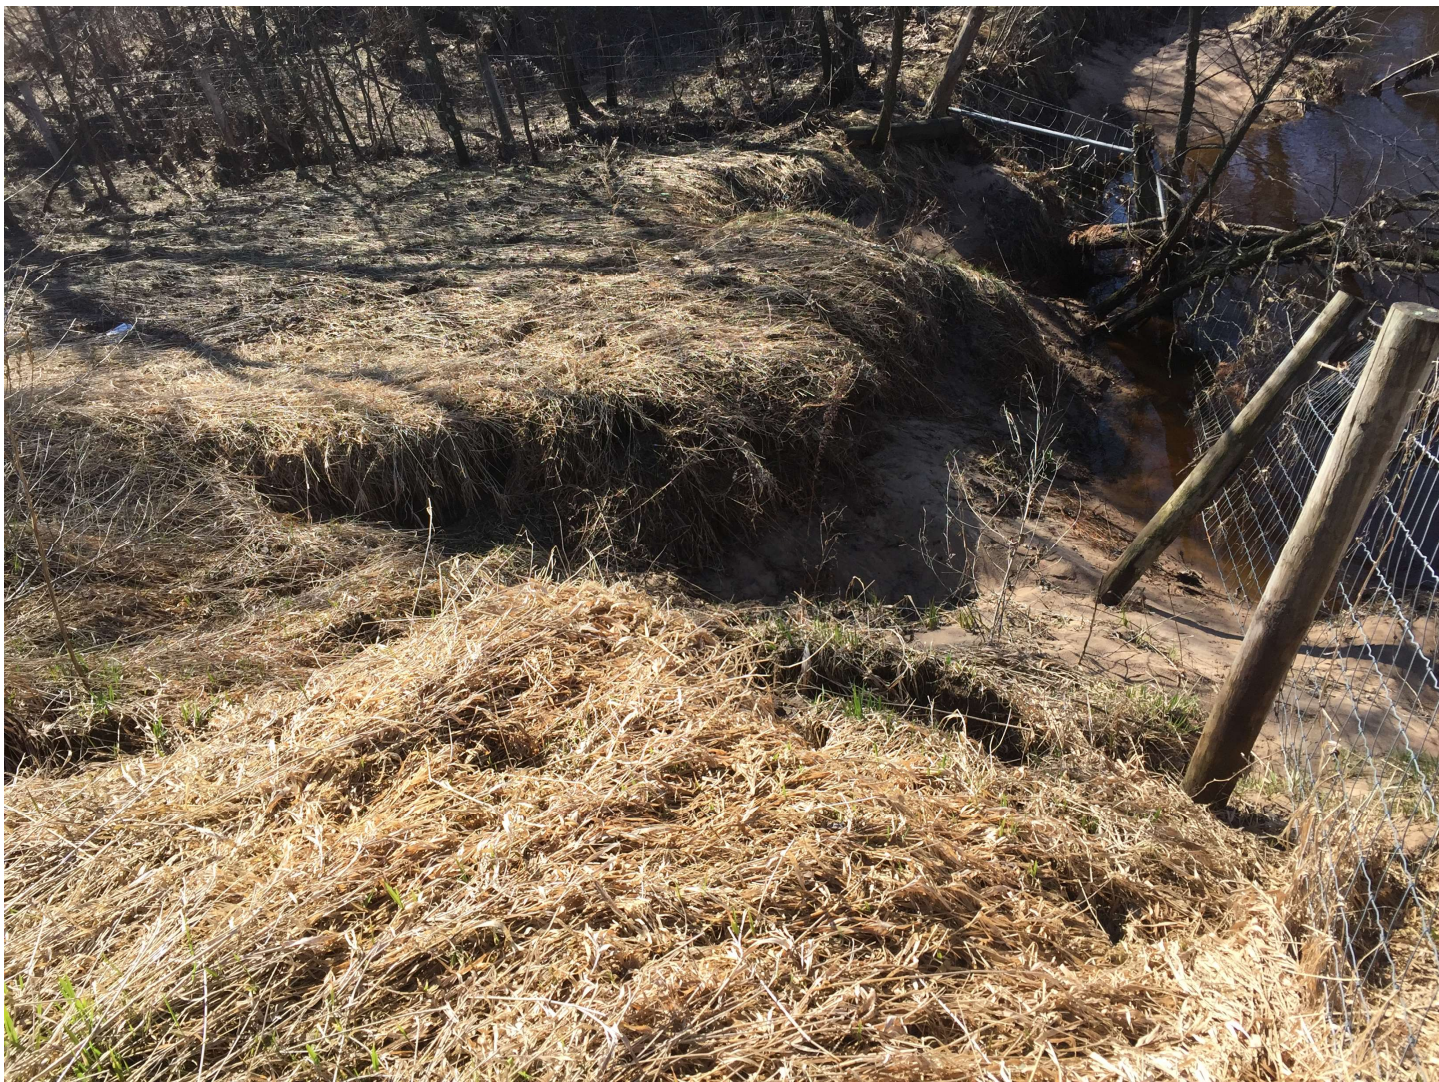
SE Corner of Structure – Streambank Erosion

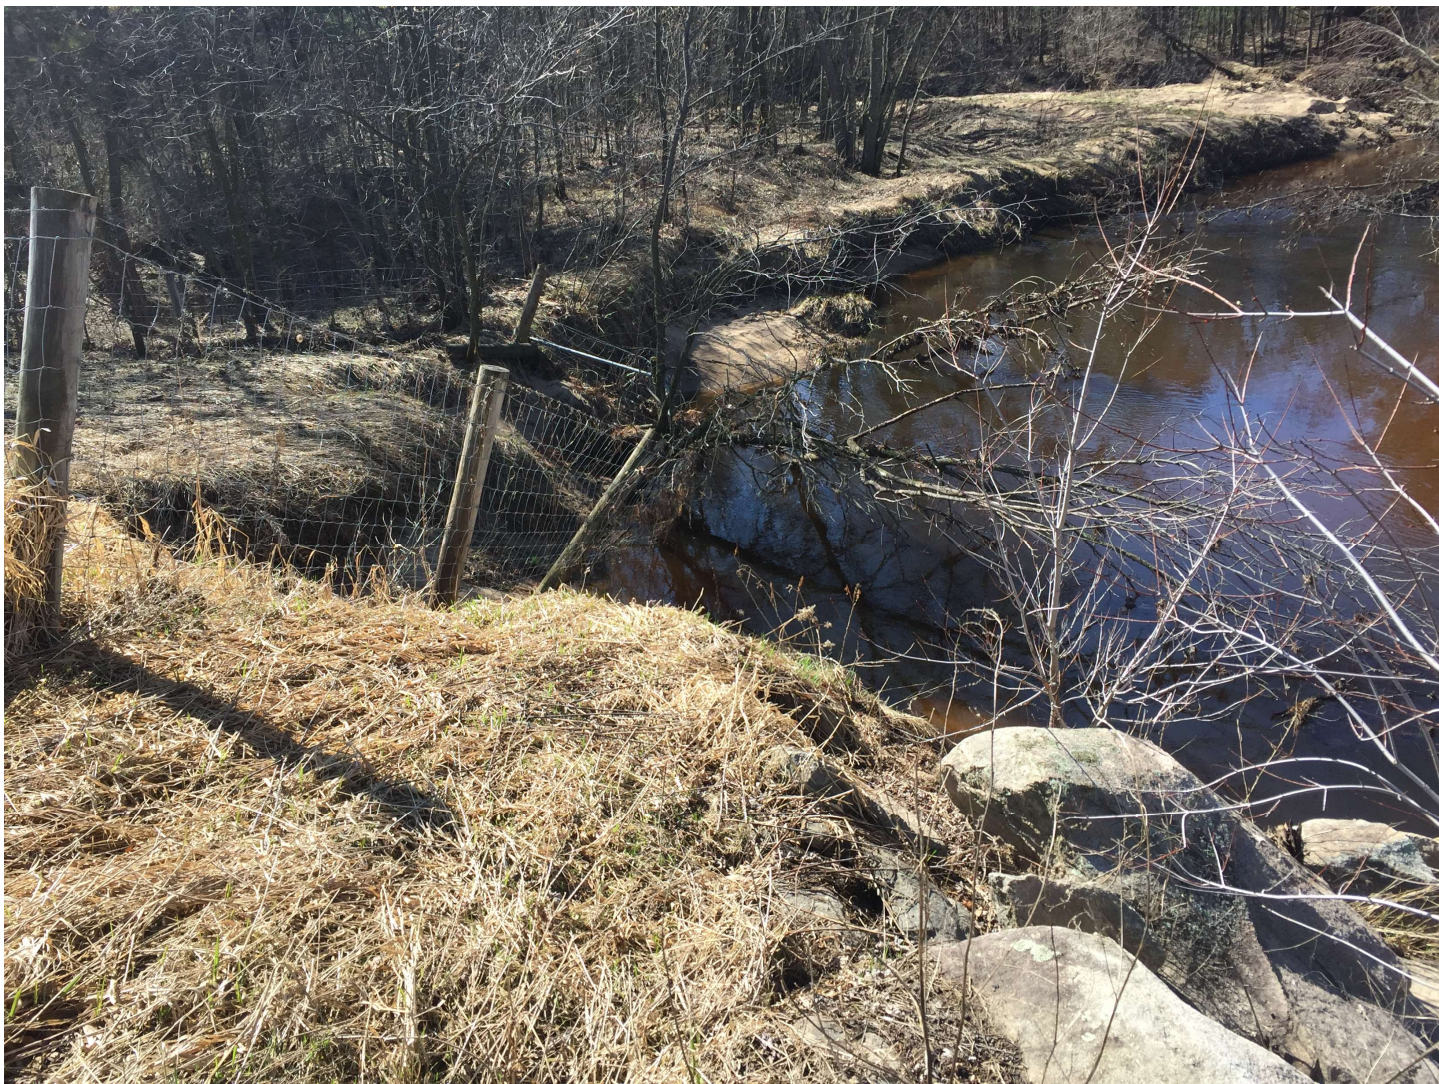
SE Corner of Structure – Streambank Erosion
