Inspection Report for C-19-001

STH 139 over Long Lake Outlet Aug 29,2016

BRIDGE INSPECTION REPORT Wisconsin Department of Transportation DT2007 2003 s.84.17 Wis. Stats.

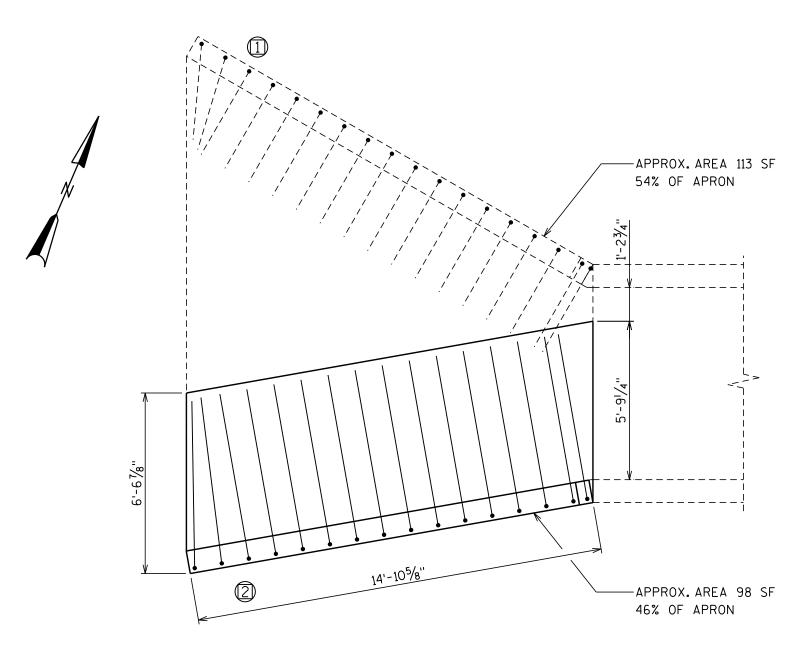
C-19-1 APRON WING REPLACEMENT

Quantity in Co	ondition State	
Chk	Element	Defect	Description	UOM	Total	1	2	3	4
			Signs - Object Markers	EA	2	0	0	0	2
Х	9030		culvert markers missing	·		•			
			Slope Protection- Riprap	EA	2	0	2	0	0
Х	X 9045								
			Culvert End Treatment	EA	2	1	0	1	0
Χ	9248		Concrete aprons w/wings. SW wing replaced v	ith riprap	, NW wing	tipped 1 in	ch		
		Roadway Over Structure	EA	1	1	0	0	0	
Χ	9325		Asphalt			•
