STATE OF WISCONSIN  
DEPARTMENT OF TRANSPORTATION

# Inspection Report for B-37-360-0002 ( NB 51 TUB GIRDER )

51NB TO29WB over USH51  
Jun 06,2016

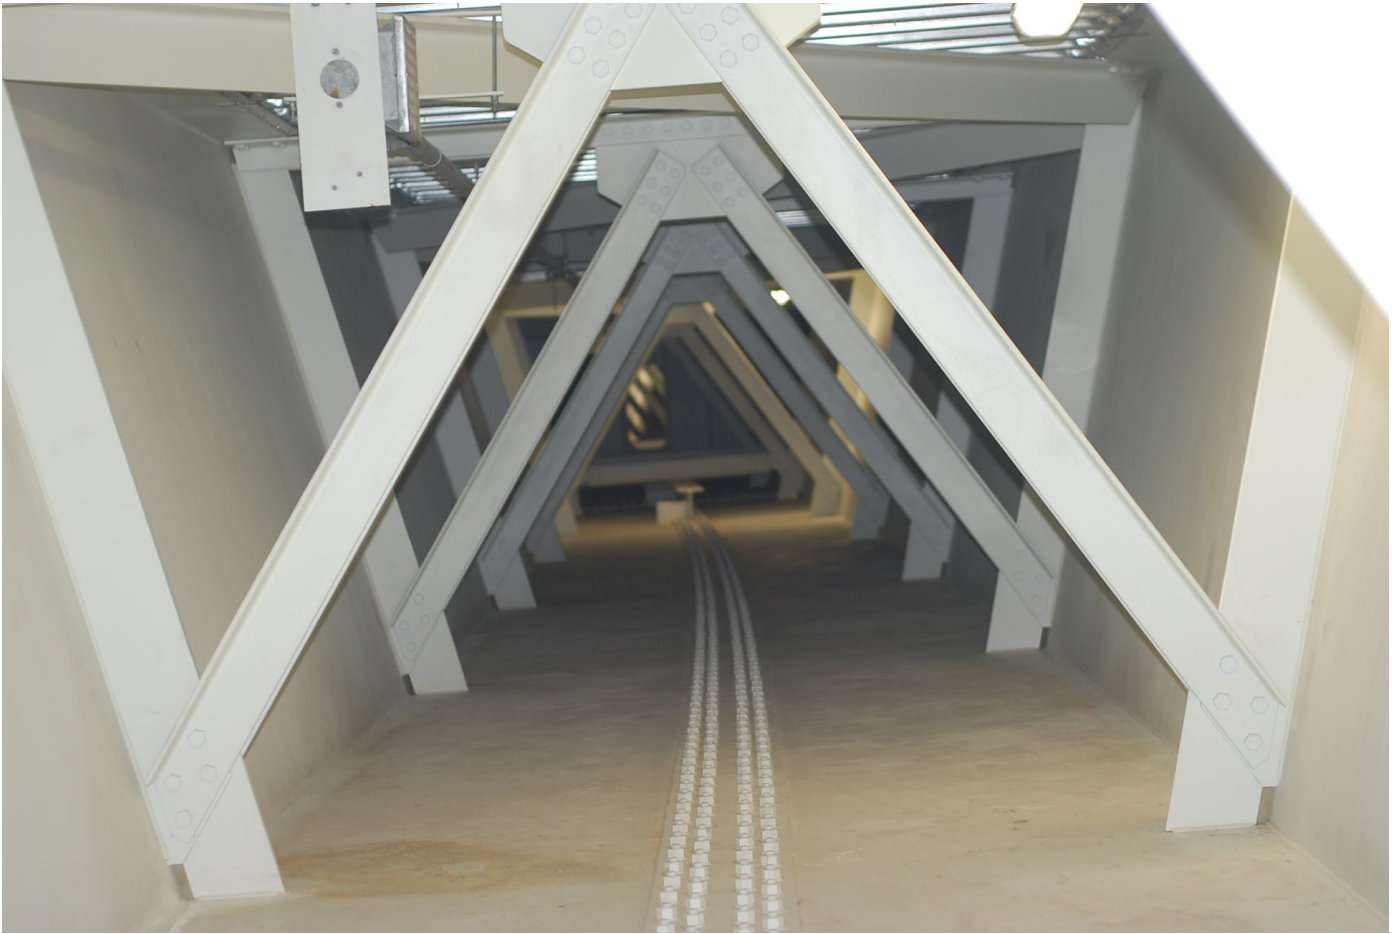
TYPICAL: INTERIOR OF TUB GIRDER SHOWING K FRAMES AND "ZIPPER" SEAM.

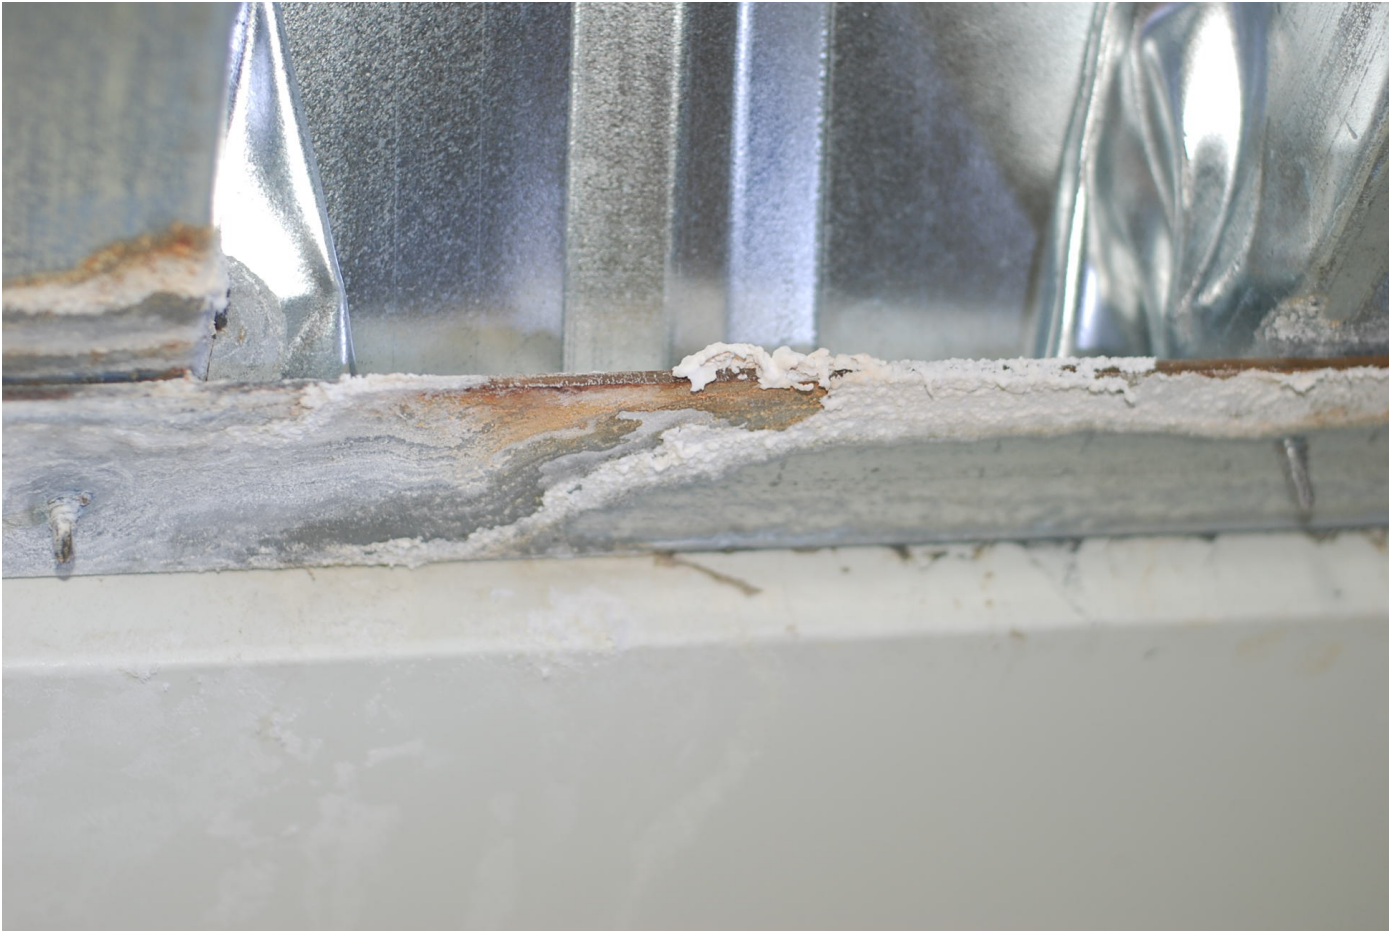
TYPICAL CORROSION OCCURRING ALONG TOP FLANGES BETWEEN GALVINIZED DECK PANELS AND GIRDER TOP FLANGE .

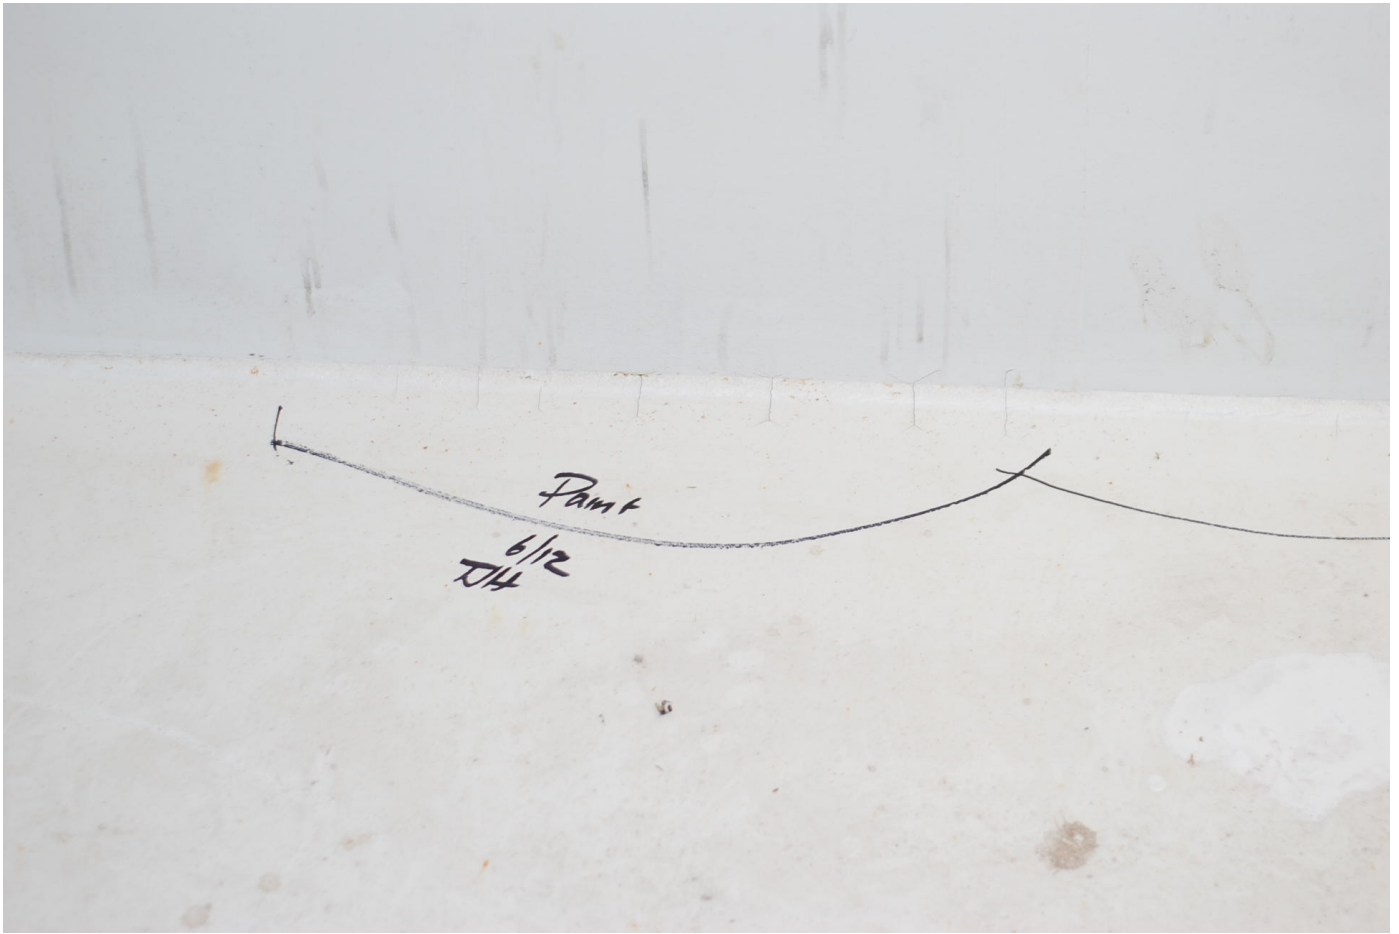
| Chk | Element | Defect | Description | UOM | Total | Quantity in Condition State | | | |
|---|---|---|---|---|---|---|---|---|---|
| | | | <b>SEE SUPPLEMENTAL INSPECTION NOTES. SUMMARY CONDITION 2: SPAN 9: 900 SF; SPAN 8: 1150 SF; SPAN 7: 1300 SF; SPAN 6: 1750 SF; TOTAL = 5100 SF.</b> | | | | | | |

TYPICAL PAINT FAILURES INTERIOR OF TUBS.

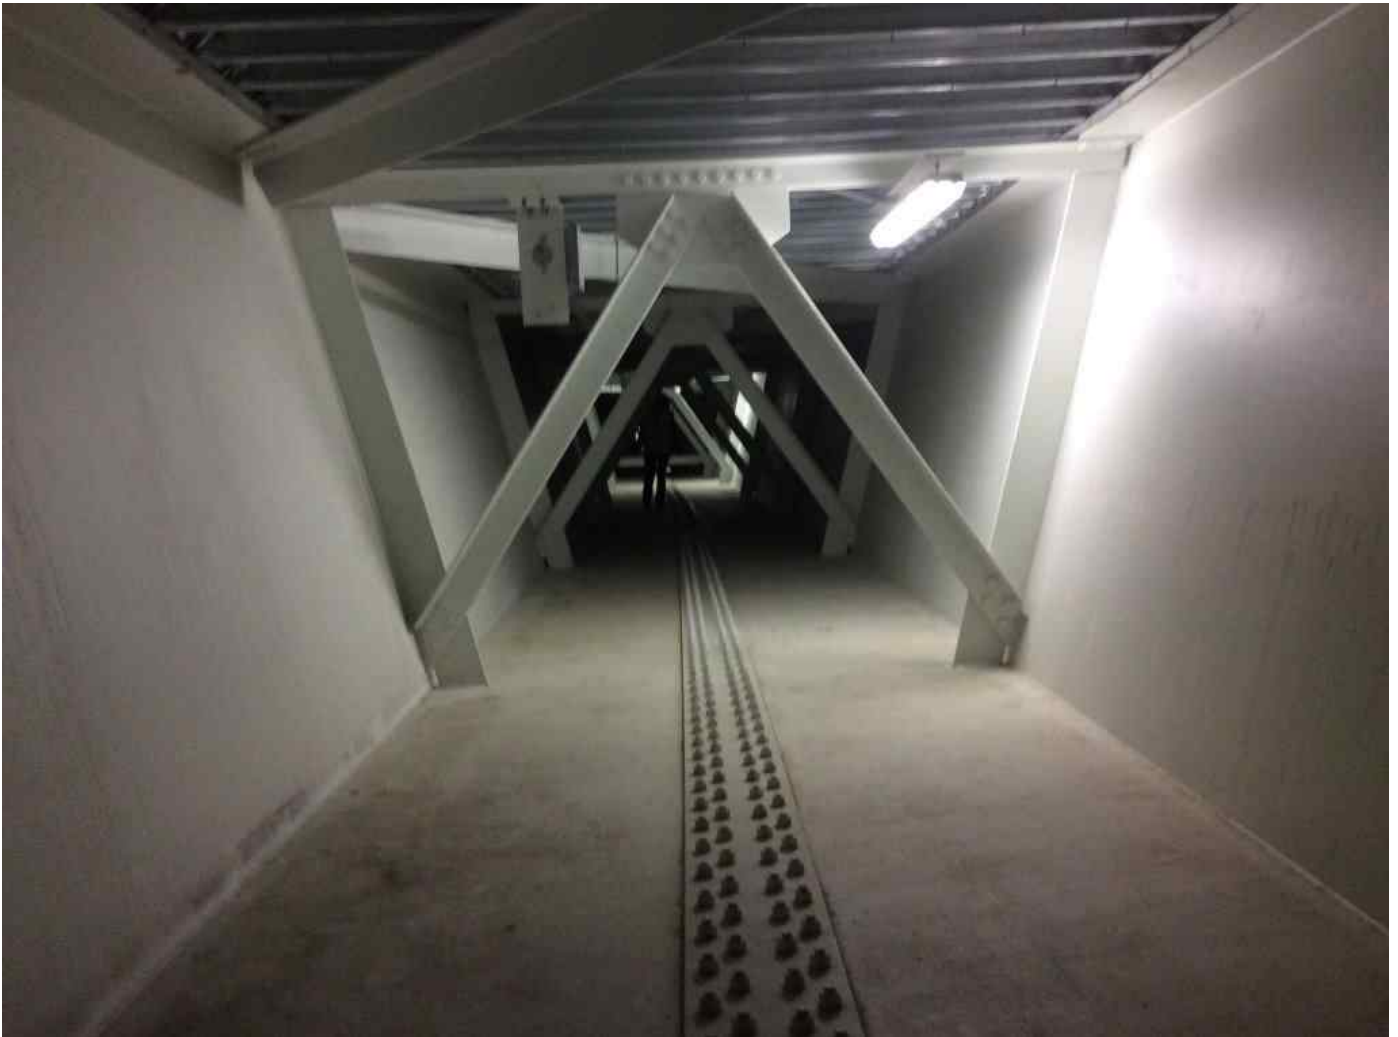
TYPICAL INTERIOR VIEW W SIPPER PLATE. 2016

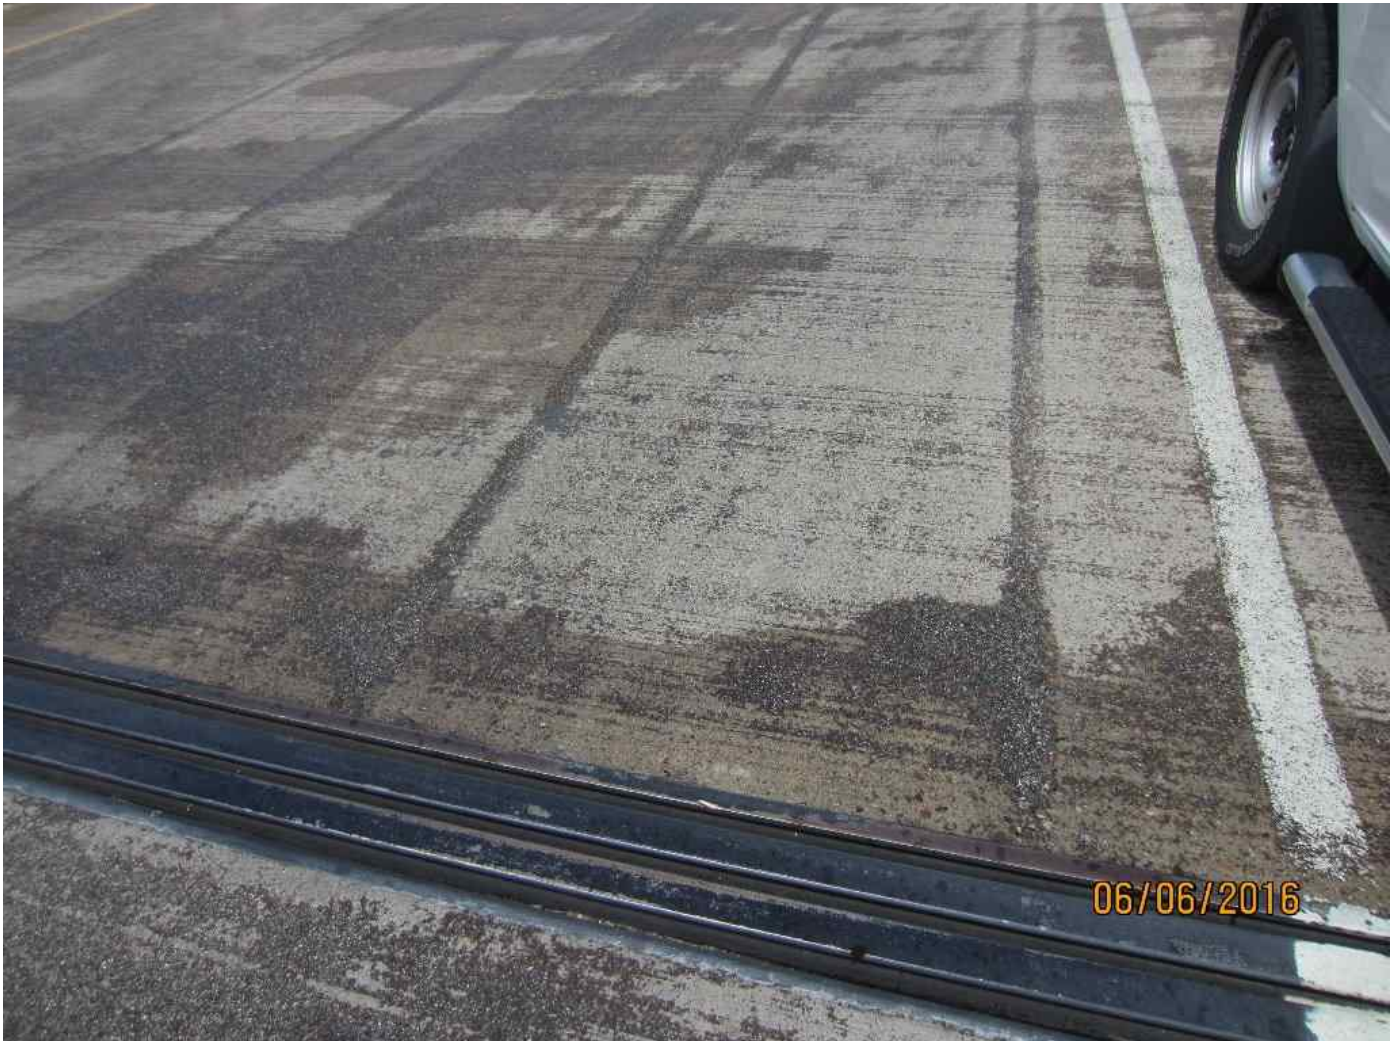
| | | | <b>PIERS 5 AND 9. FILLED PARTIALLY W/ DIRT.</b> | | | | | |

MODULAR JOINT. 2016

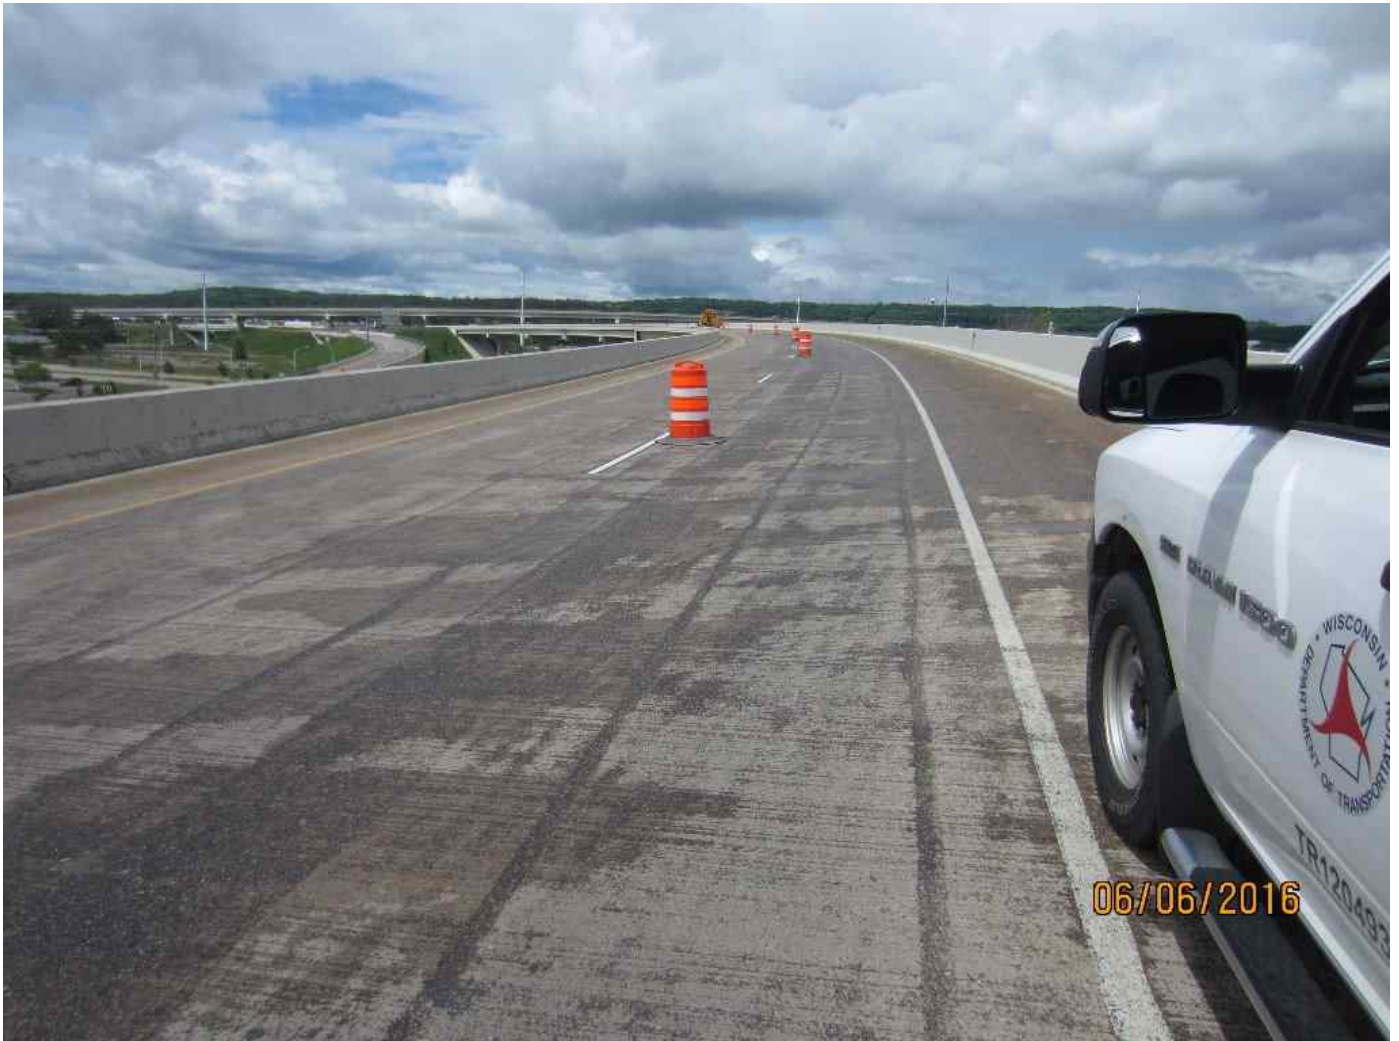
| Component | Year | Work Performed | Note |
|---|---|---|---|
| EPOXY OVERLAY - POLY-CARB MARK-163 FLEXOGRID | 2008 | OVERLAY - EPOXY | 2008 EPOXY OVERLAY - 1 LAYER POLYCARB. HEAVY LOSS OF OVERLAY STONE OCCURRING. |

POLYMER OVERLAY - TYPICAL. EST. 75% LOSS OF MATERIAL. 2016

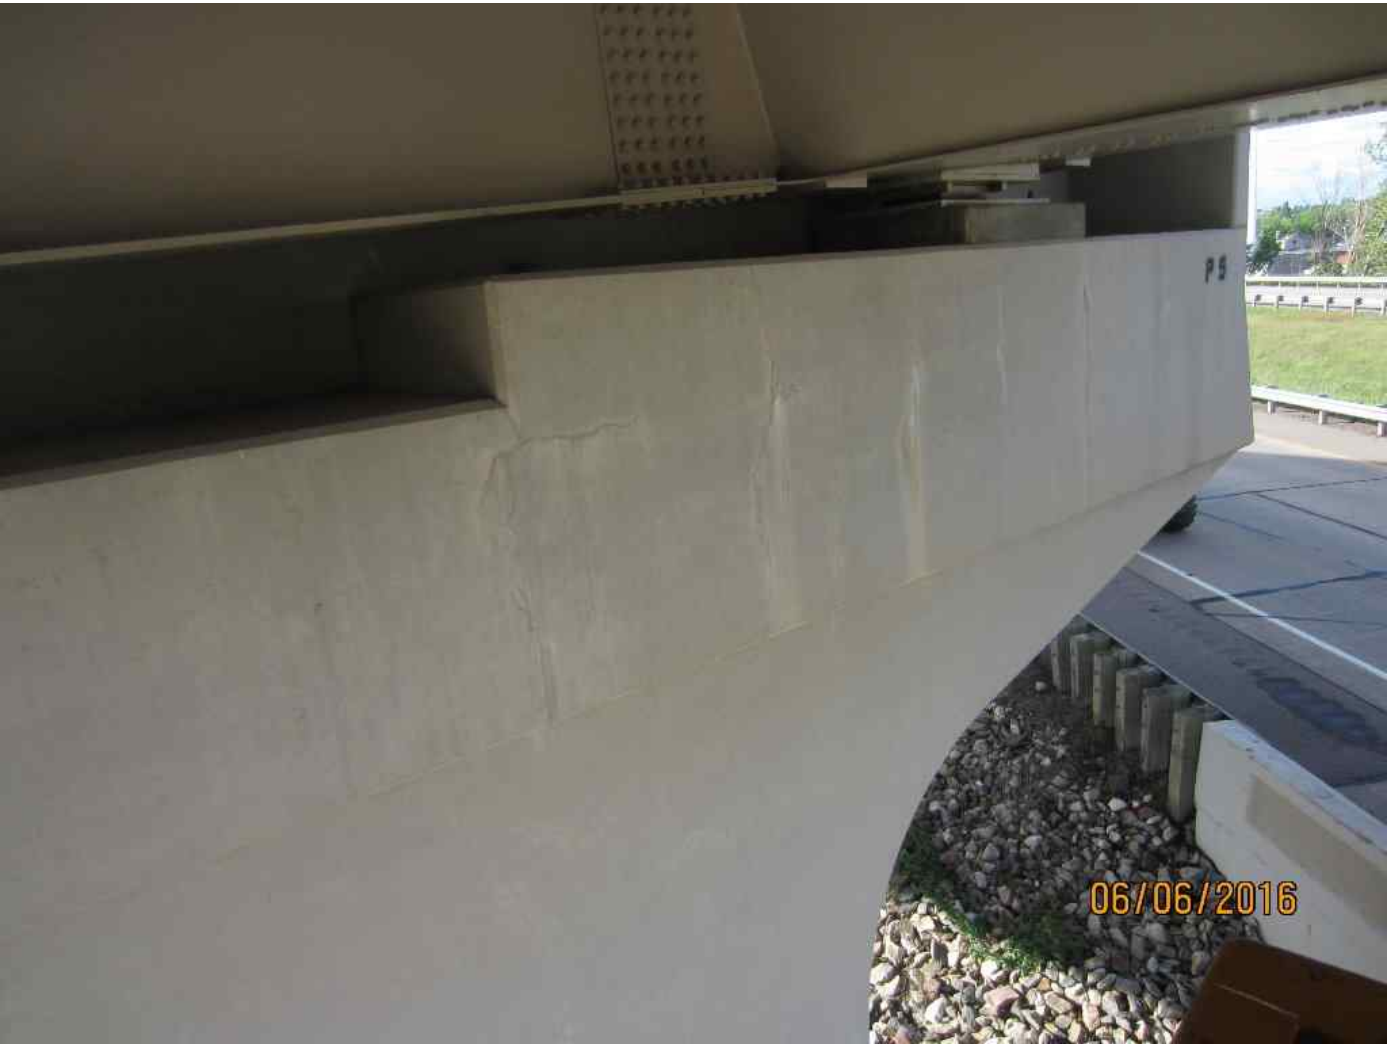
PIER 5 - CAP CRACKING. 2016

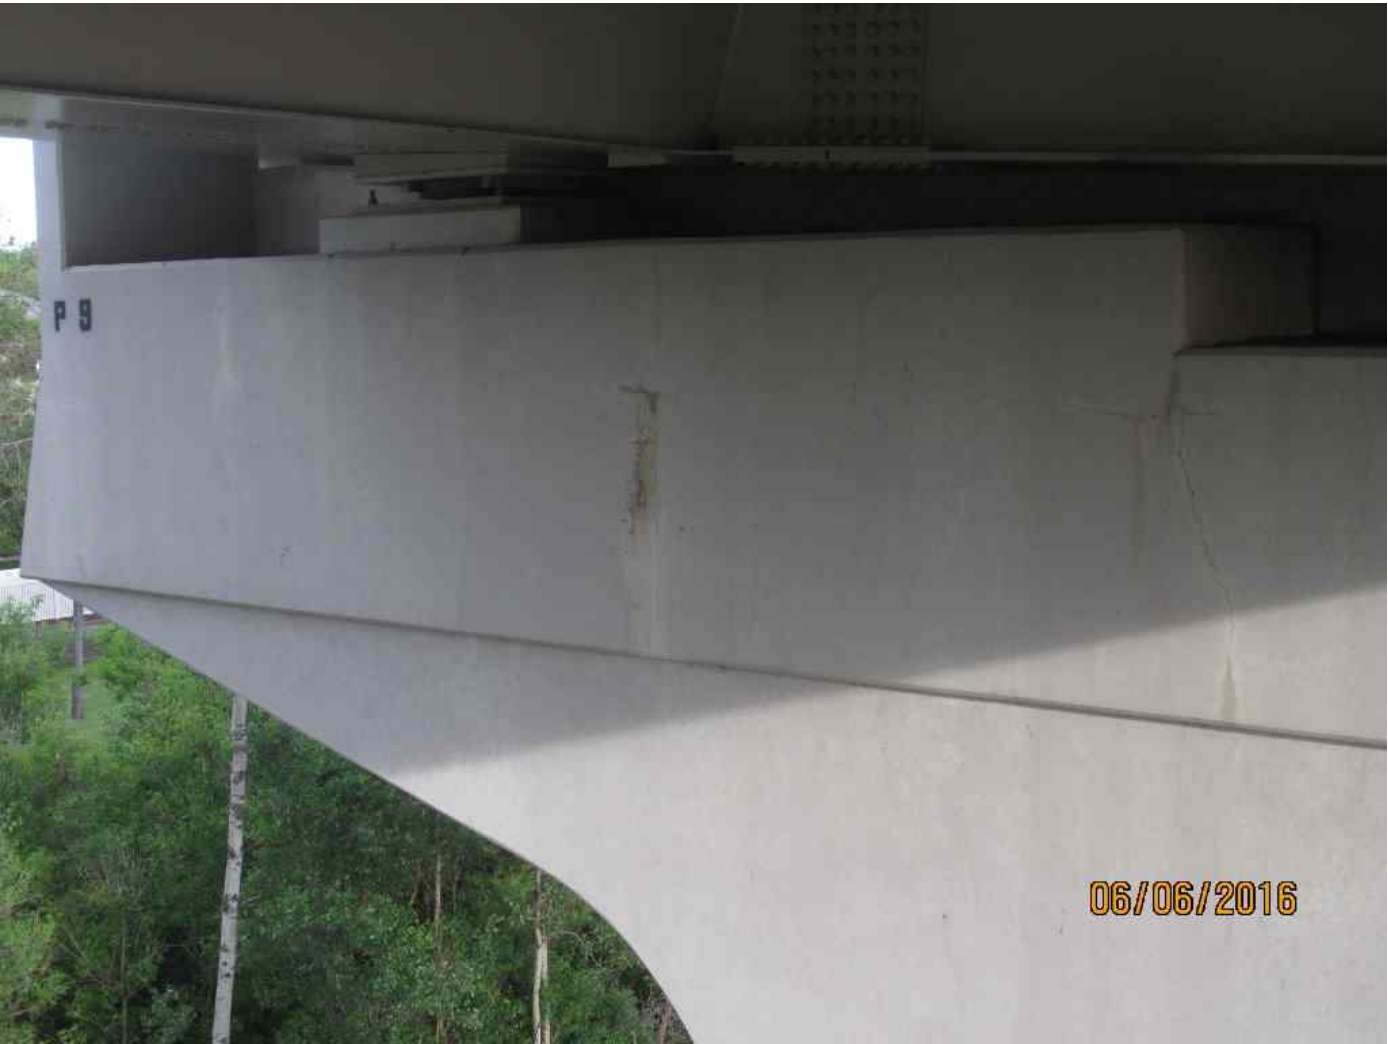
PIER 9 - CAP CRACKING. 2016

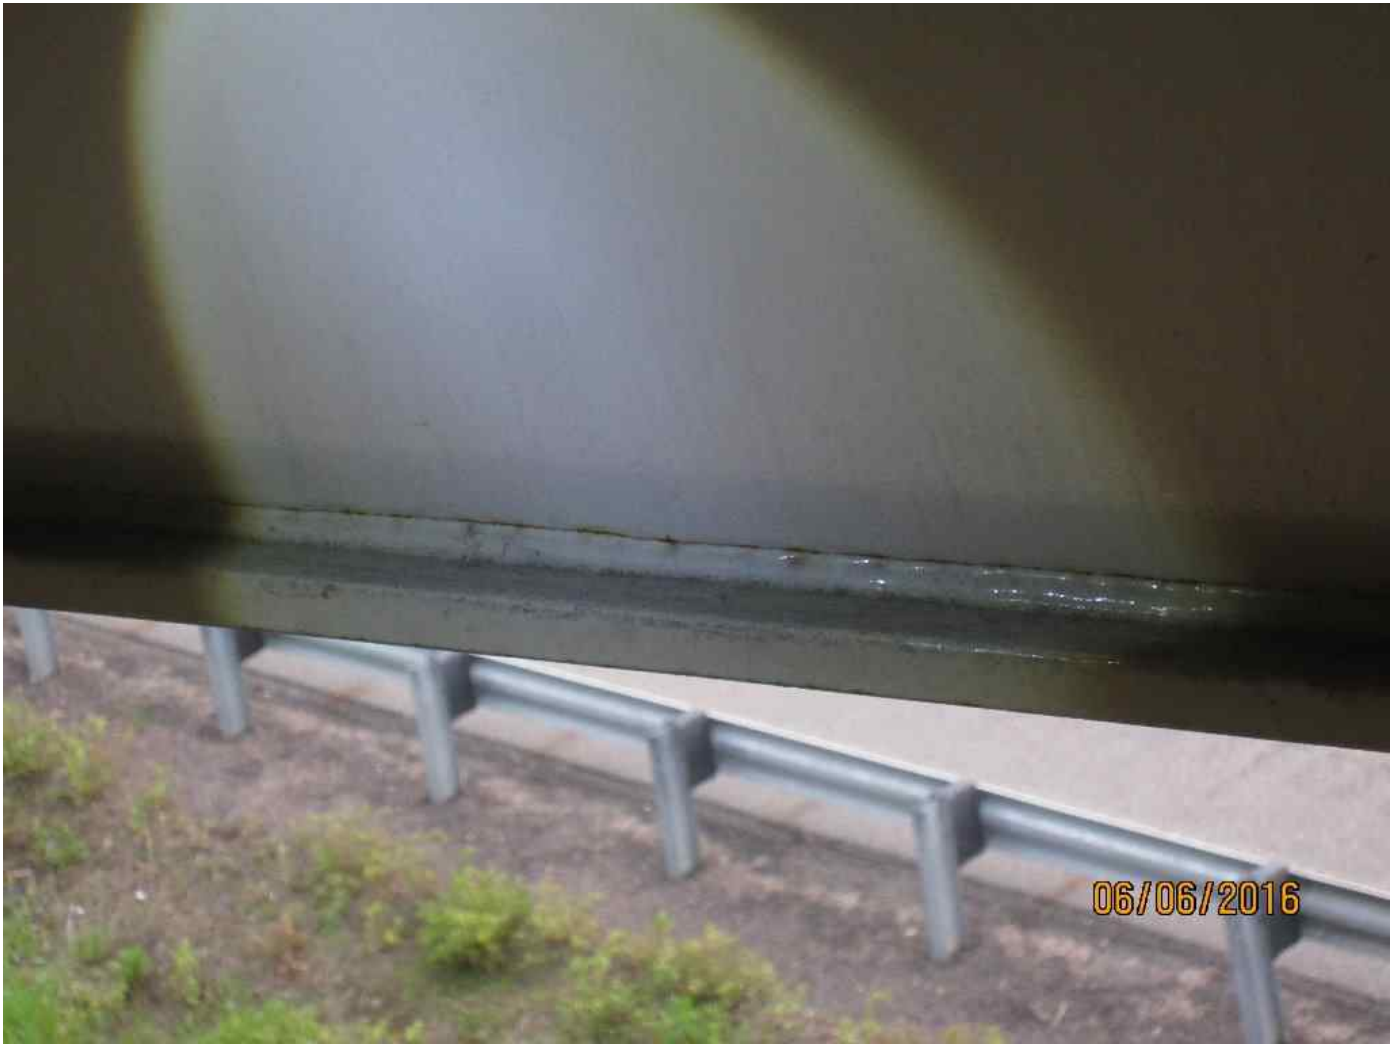
RUST LINE FORMING, SPAN 8 BOTTOM FLANGE. 2016

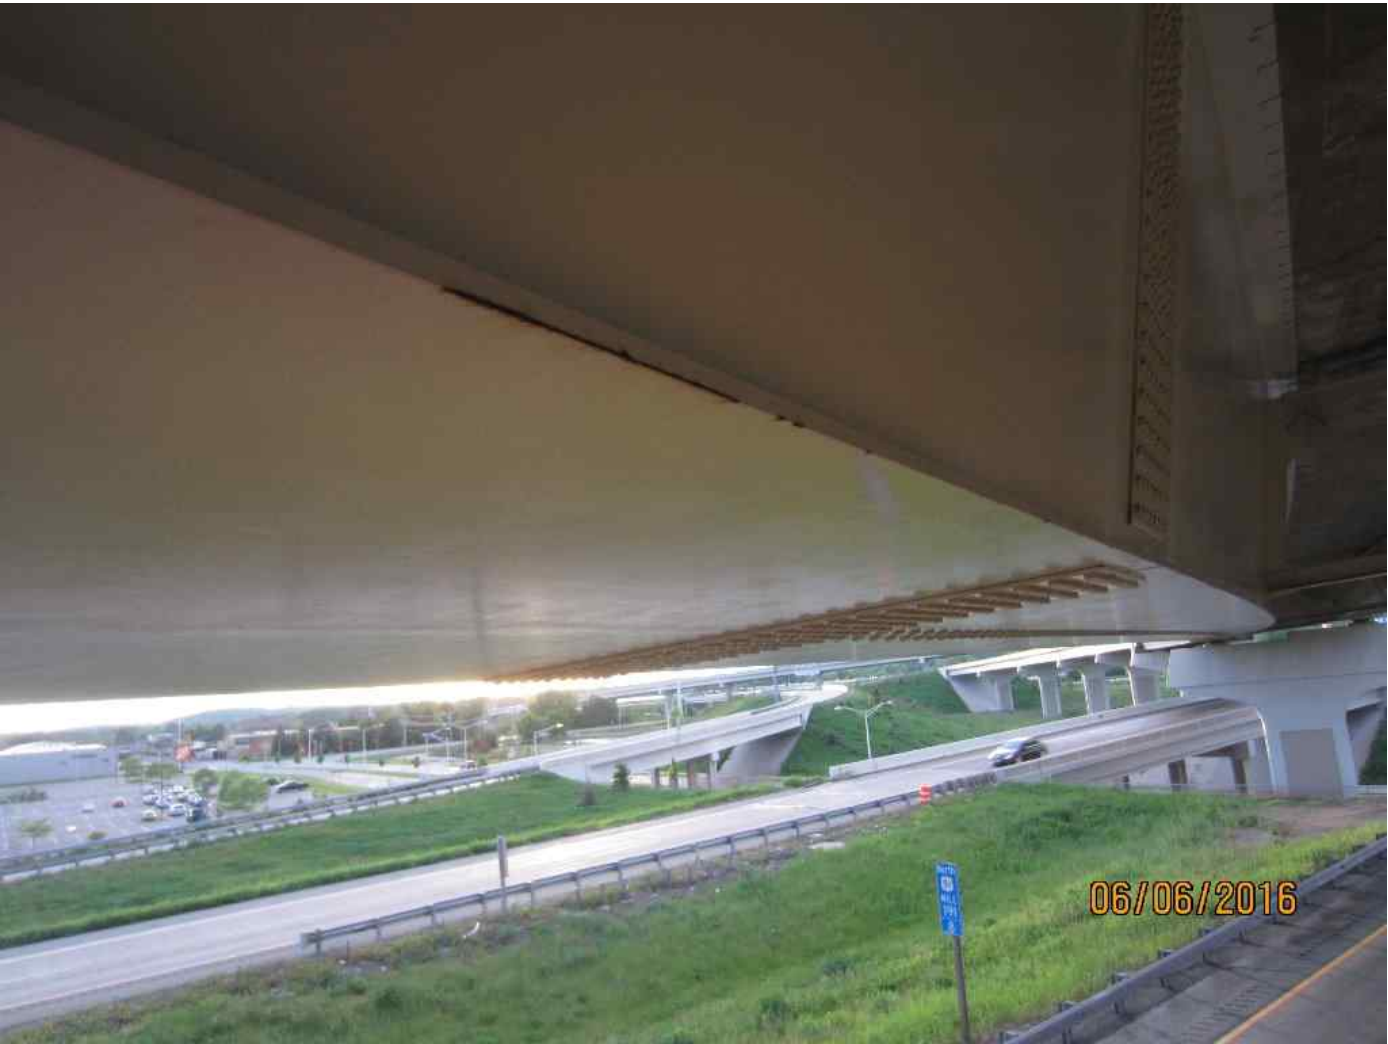
TYPICAL BOTTOM FLANGE CORNER RUST, SPAN 8. 2016.

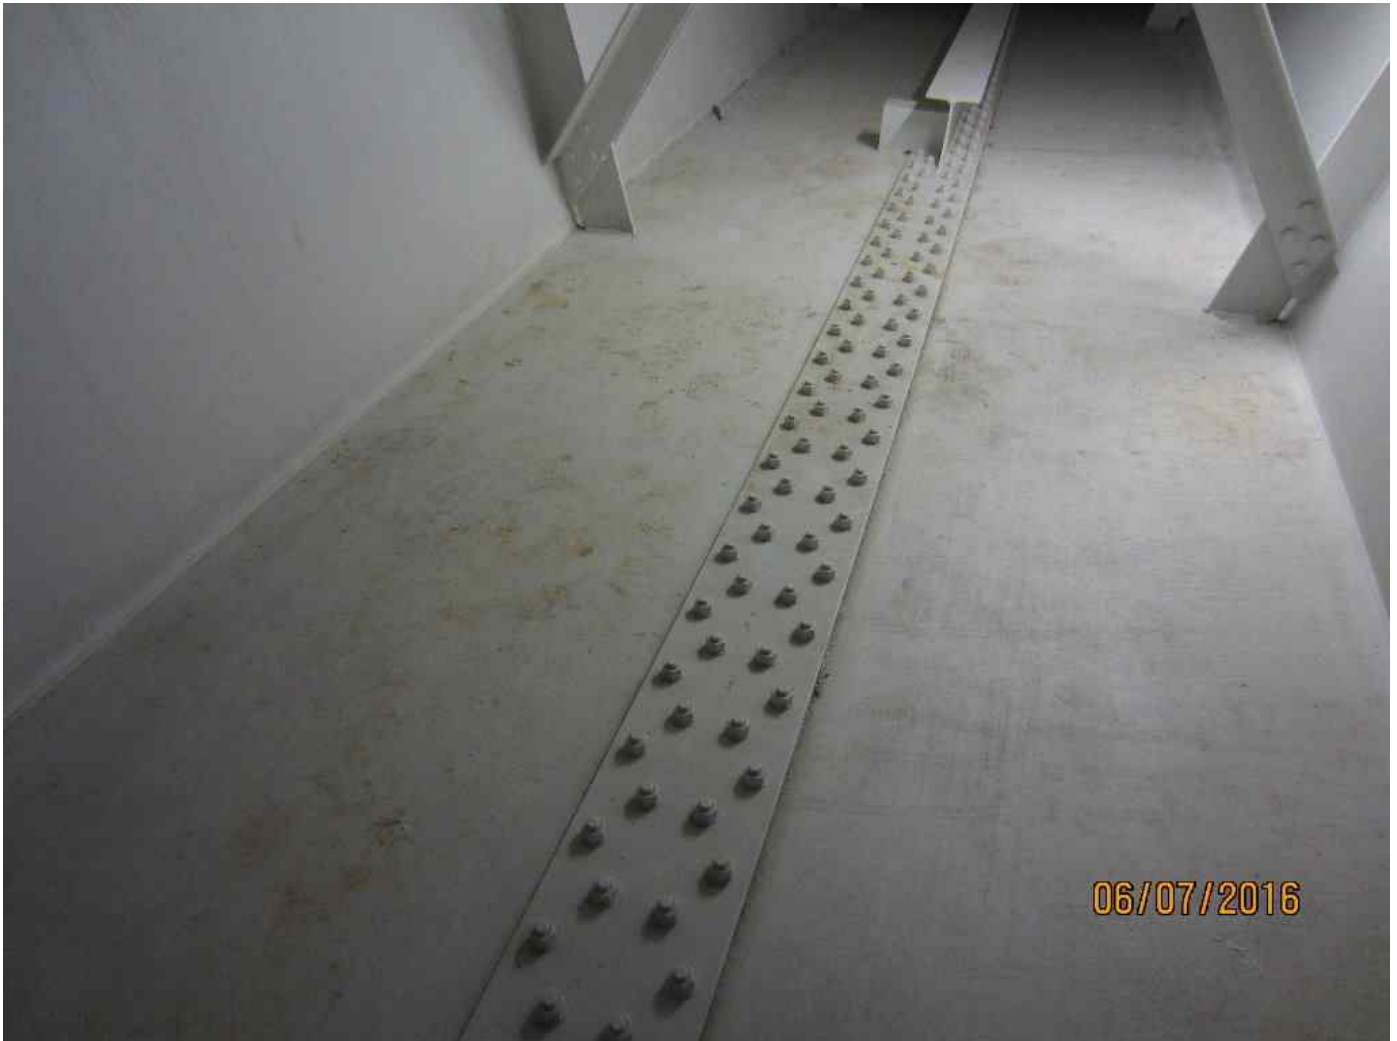
TYPICAL INTERIOR CONDITION W ZIPPER PLATE. 2016

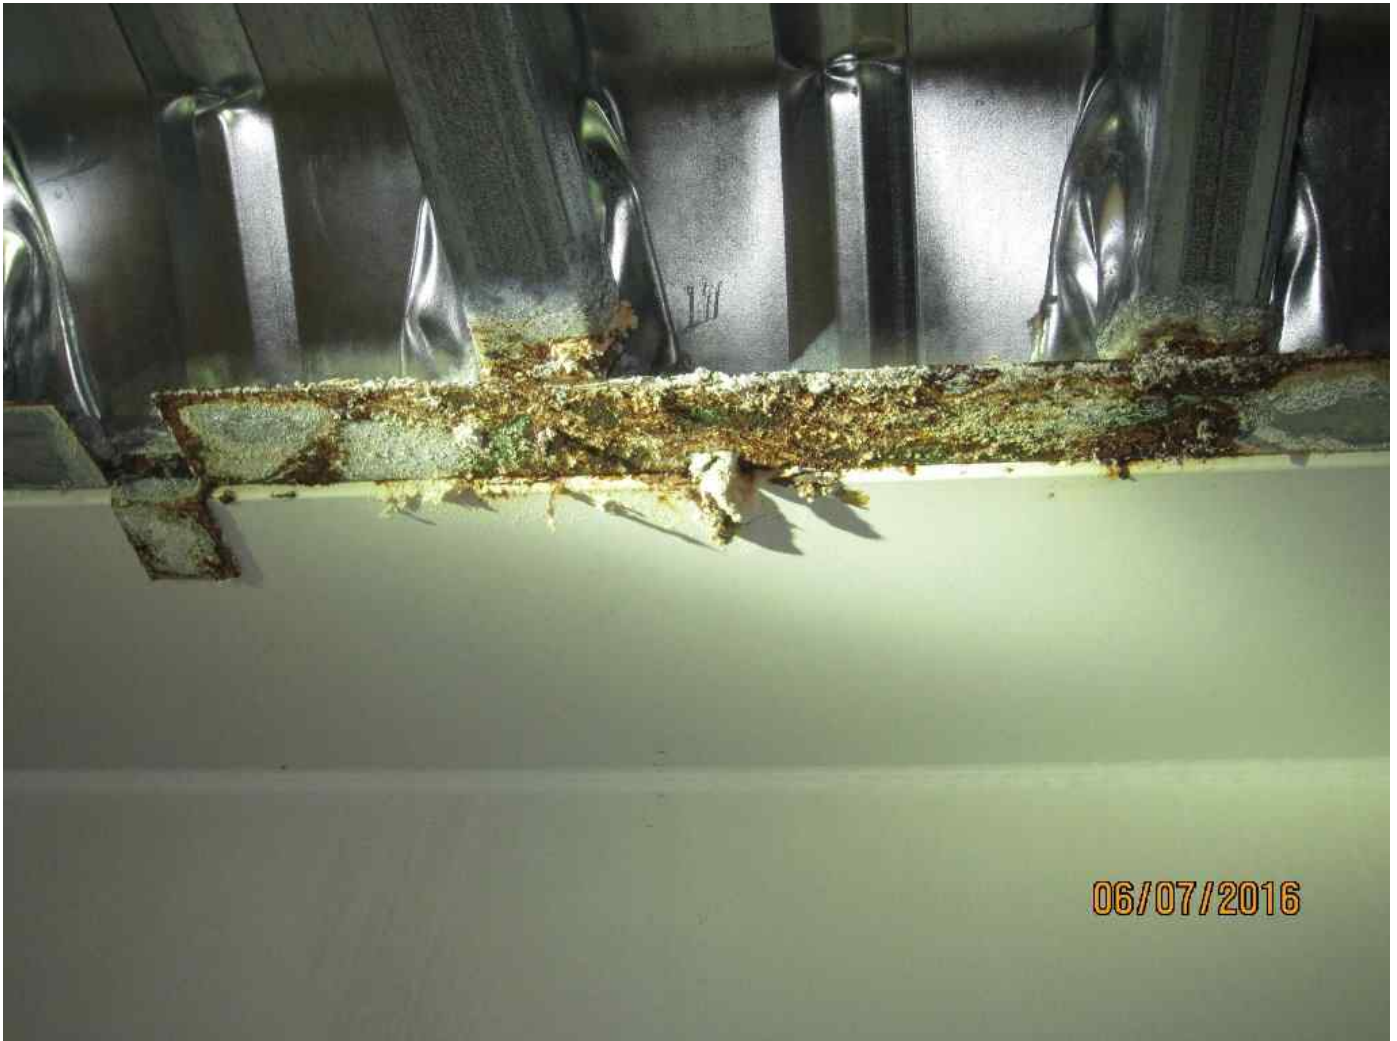
TYPICAL TOP FLANGE-TO-DECK PANEL CORROSION. INTERIOR. 2016.

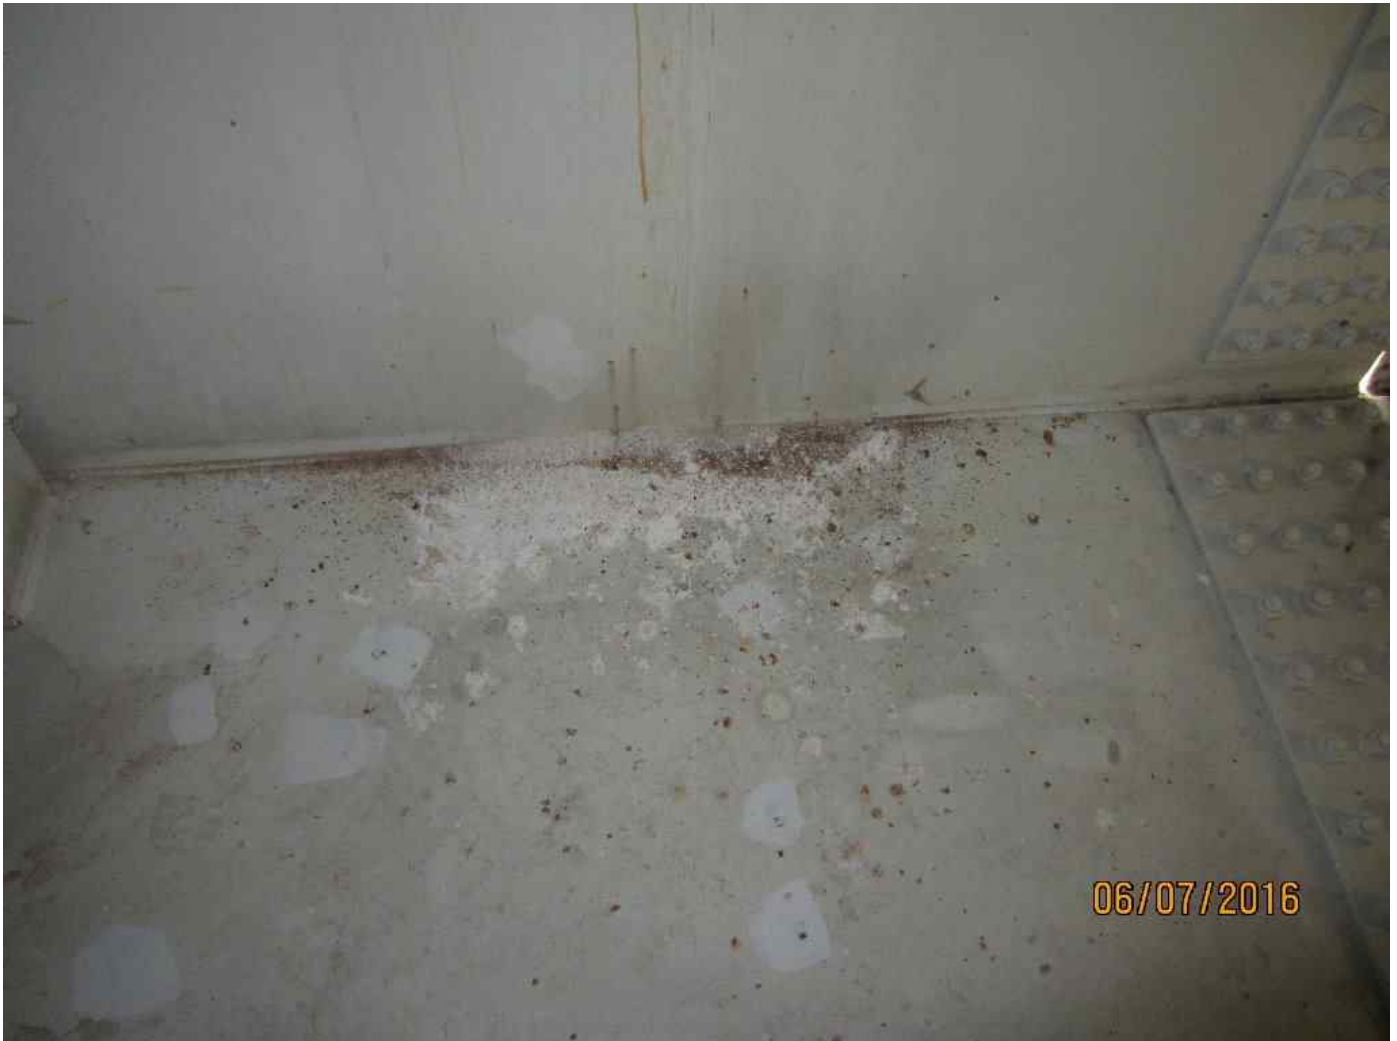
TYPICAL BOTTOM FLANGE (FLOOR)CONDITION UNDER TOP FLANGE CORROSION LOCATIONS.

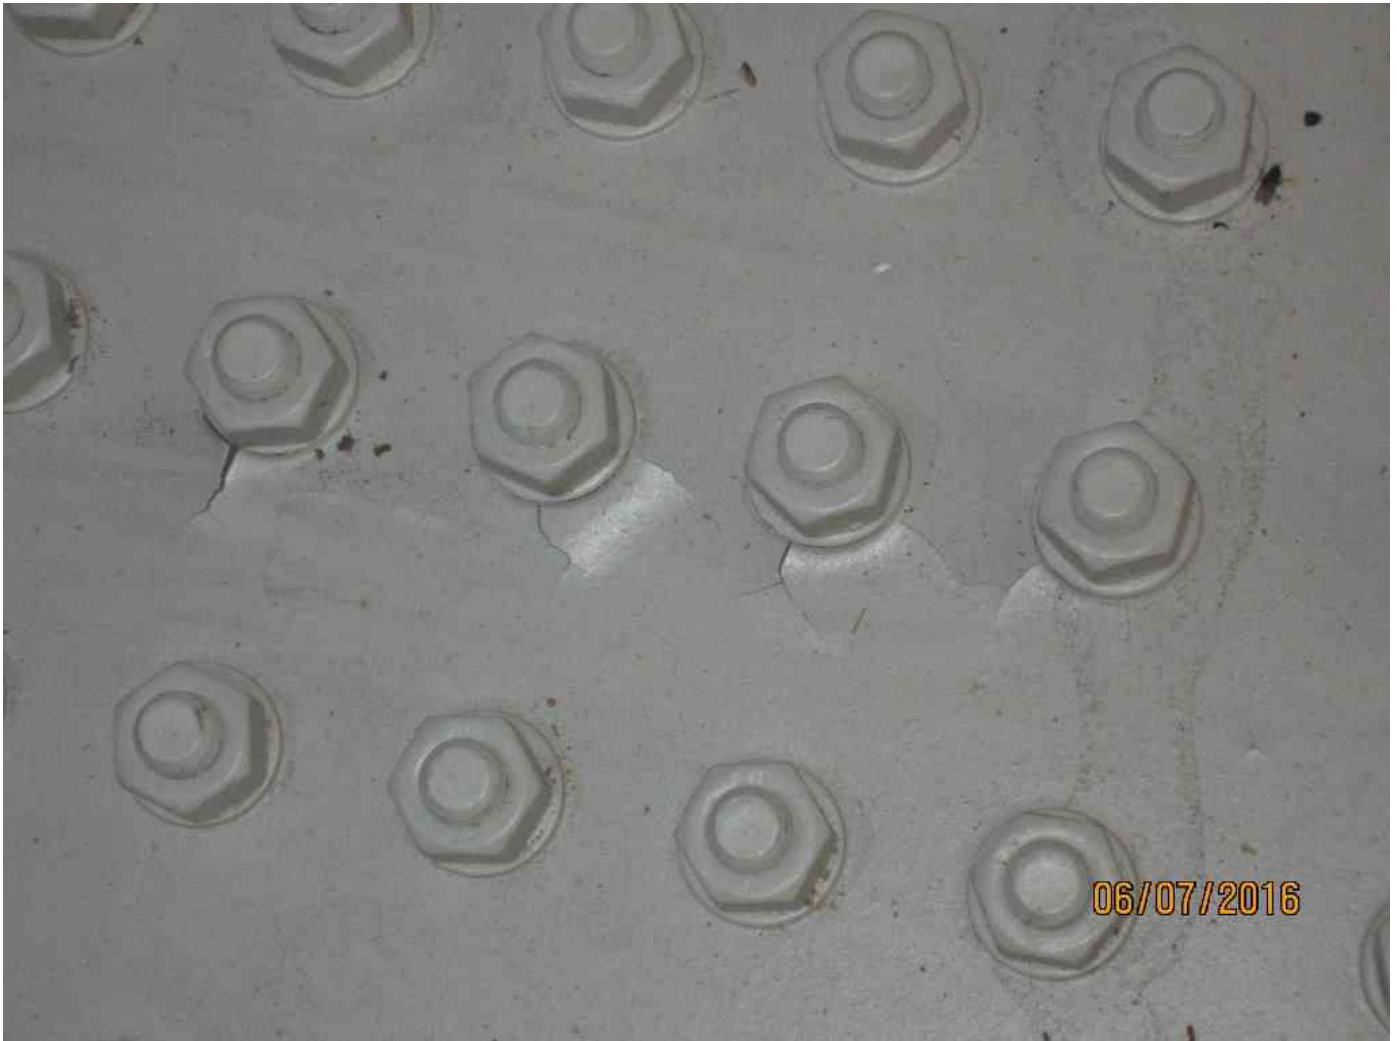
INTERIOR: FIELD SPLICE IN SPAN 7. 2016.

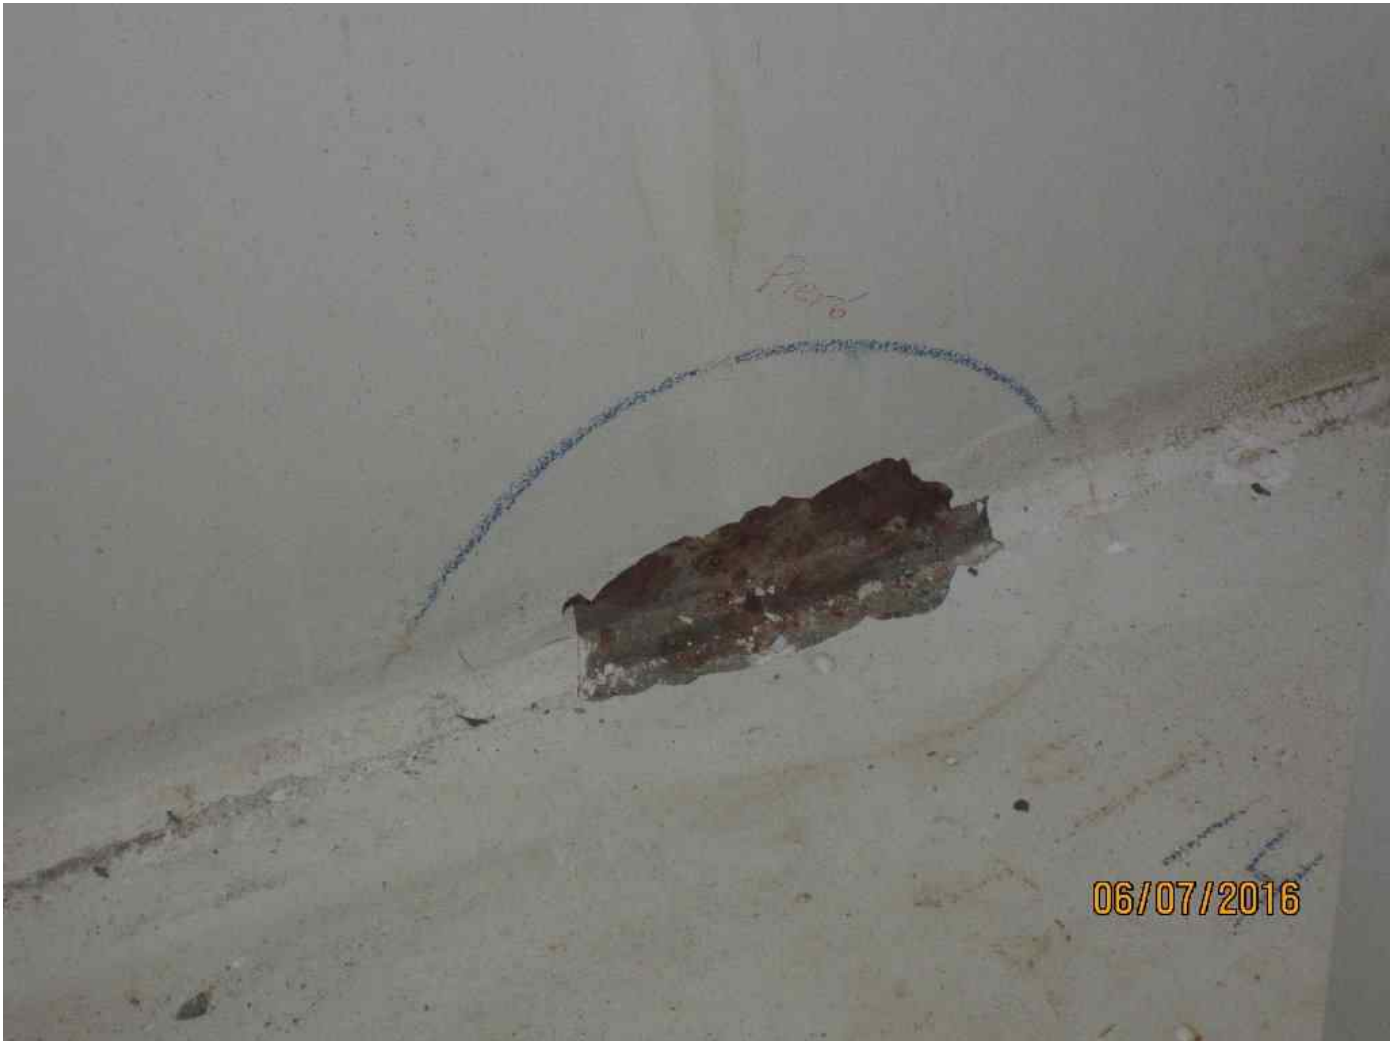
TYPICAL BOTTOM-FLANGE-TO-WEB PAINT PEEING THRUOUT. 2016

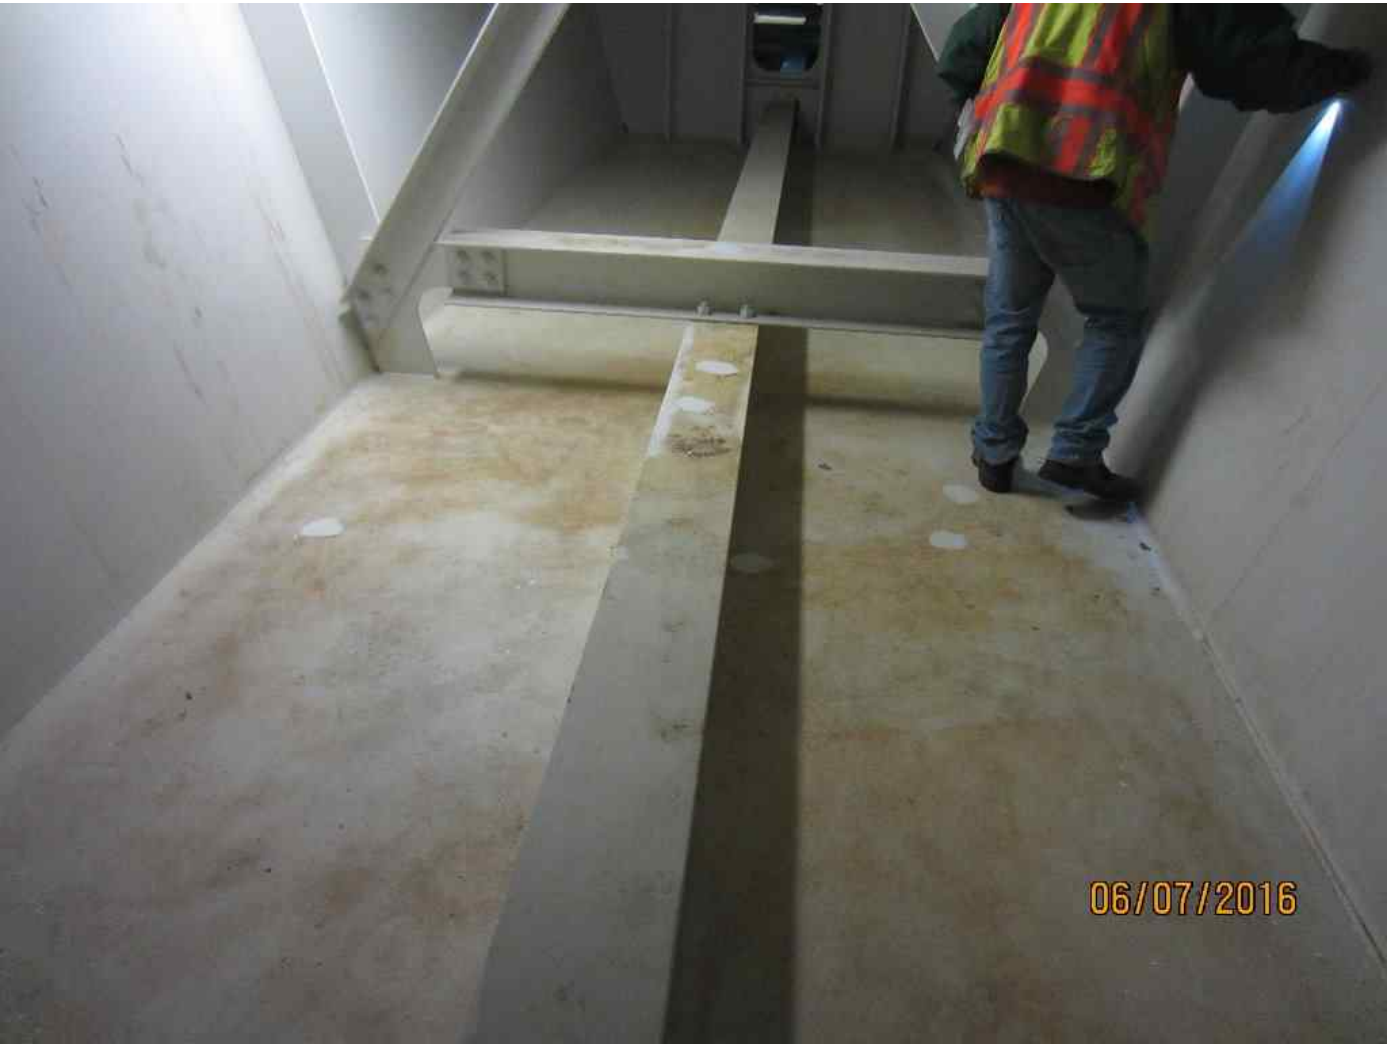
TYPICAL INTERIOR CONDITION. 2016.
