STATE OF WISCONSIN  
DEPARTMENT OF TRANSPORTATION

# Inspection Report for B-37-360-0002 ( NB 51 TUB GIRDER )

51NB TO29WB over USH51  
Jun 06,2016

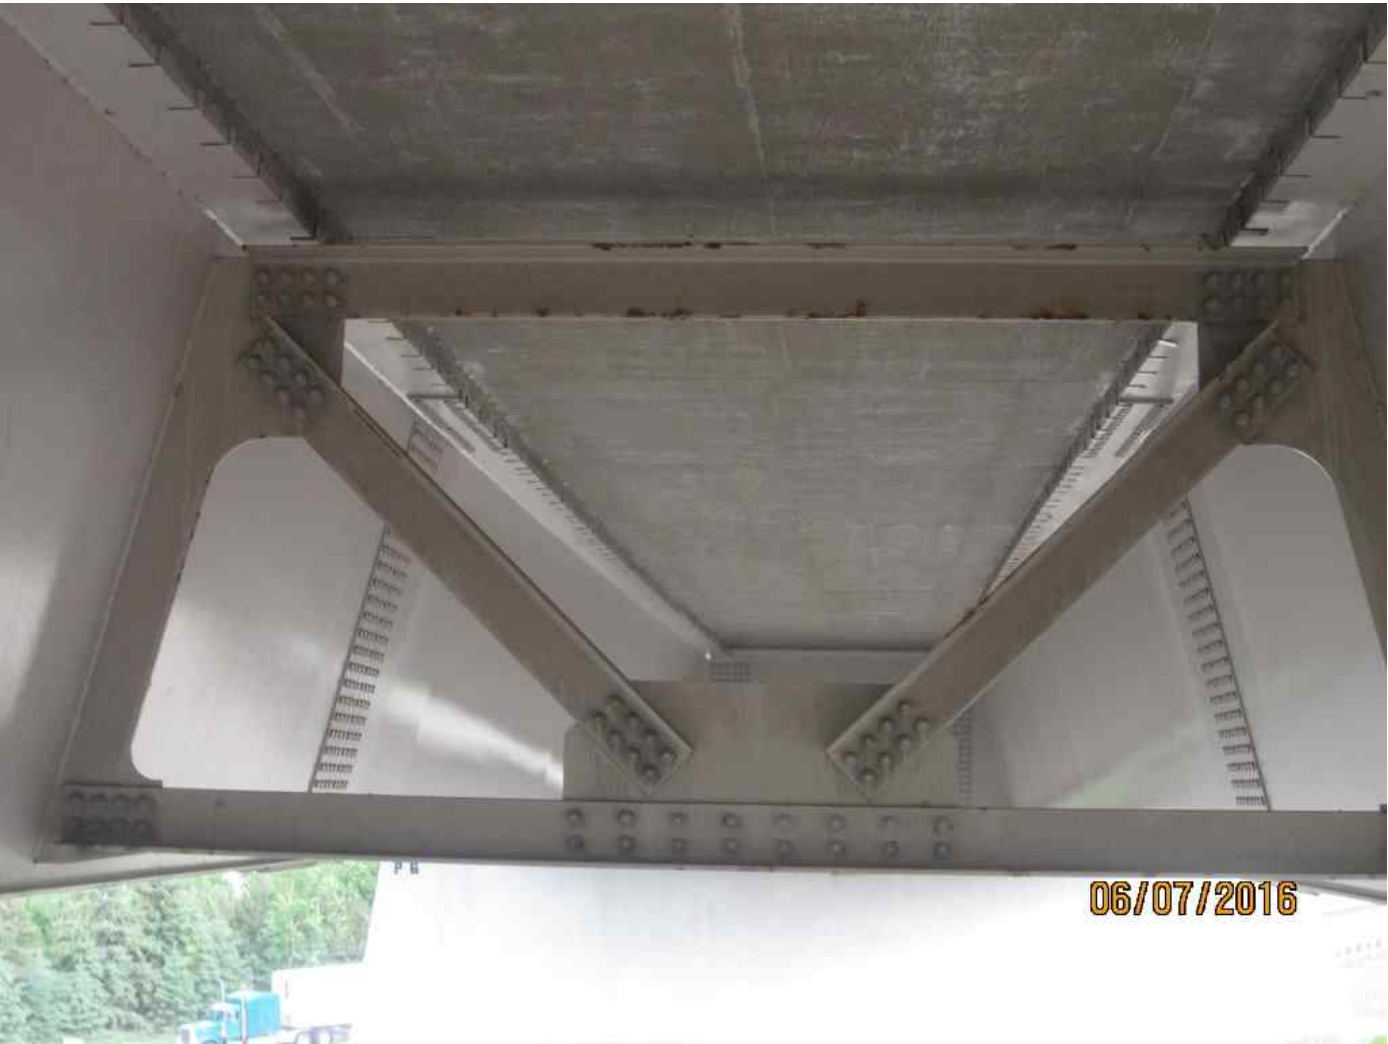
TYPICAL EXTERIOR DIAPHRAM RUST CONDITION. 2016

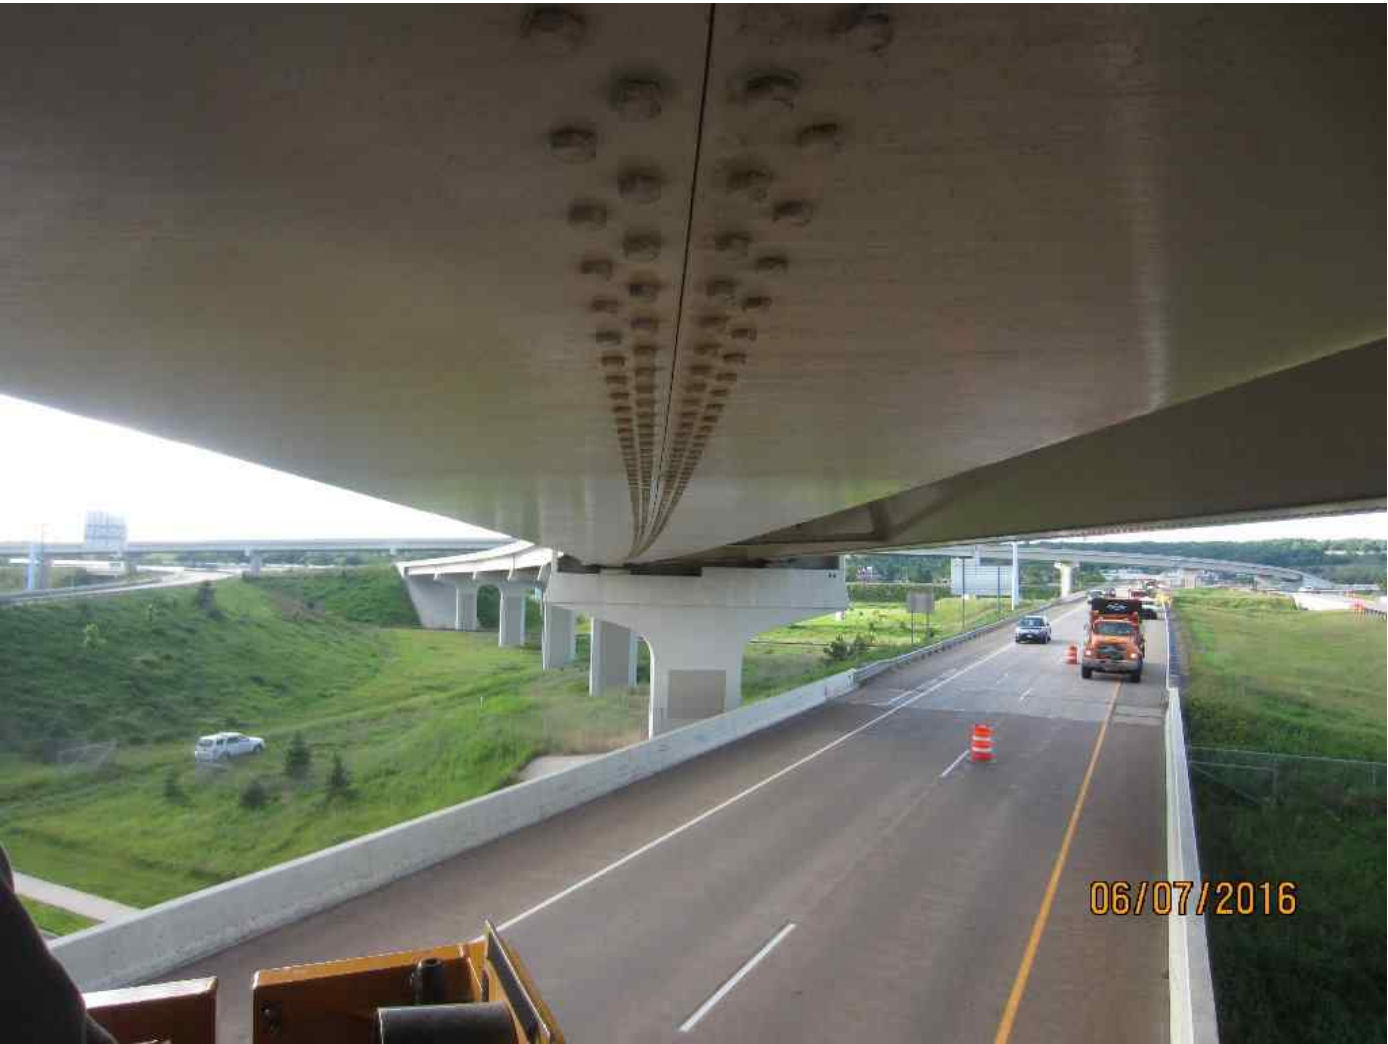
TYPICAL ZIPPER PLATE CONDITION - EXTERIOR. 2016

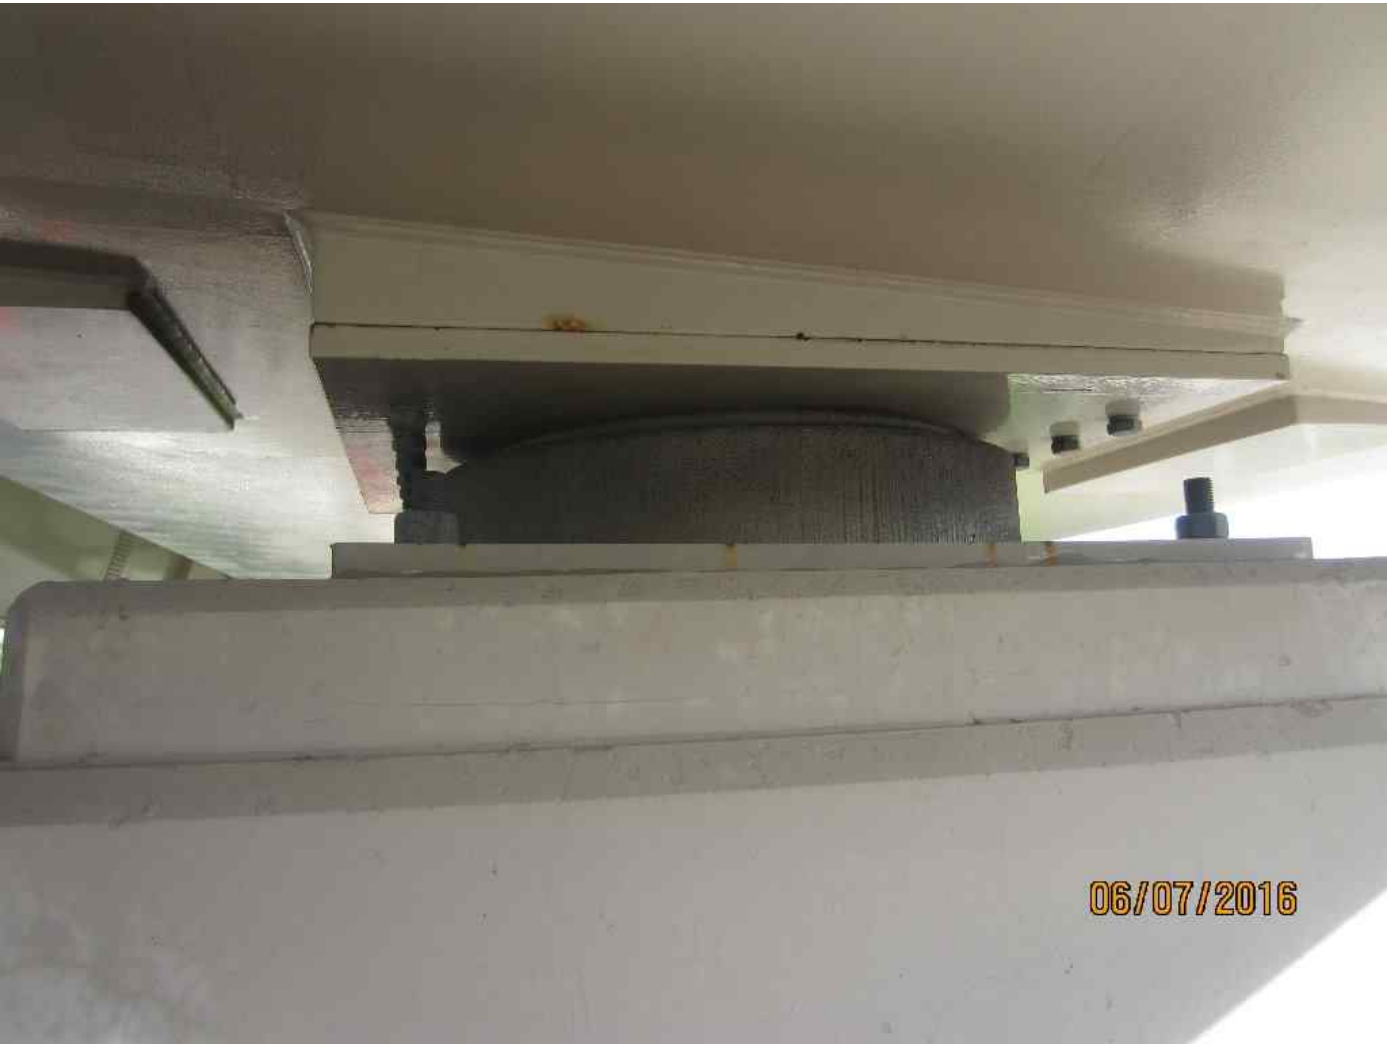
TYPICAL PIER POT BEARING. 2016.

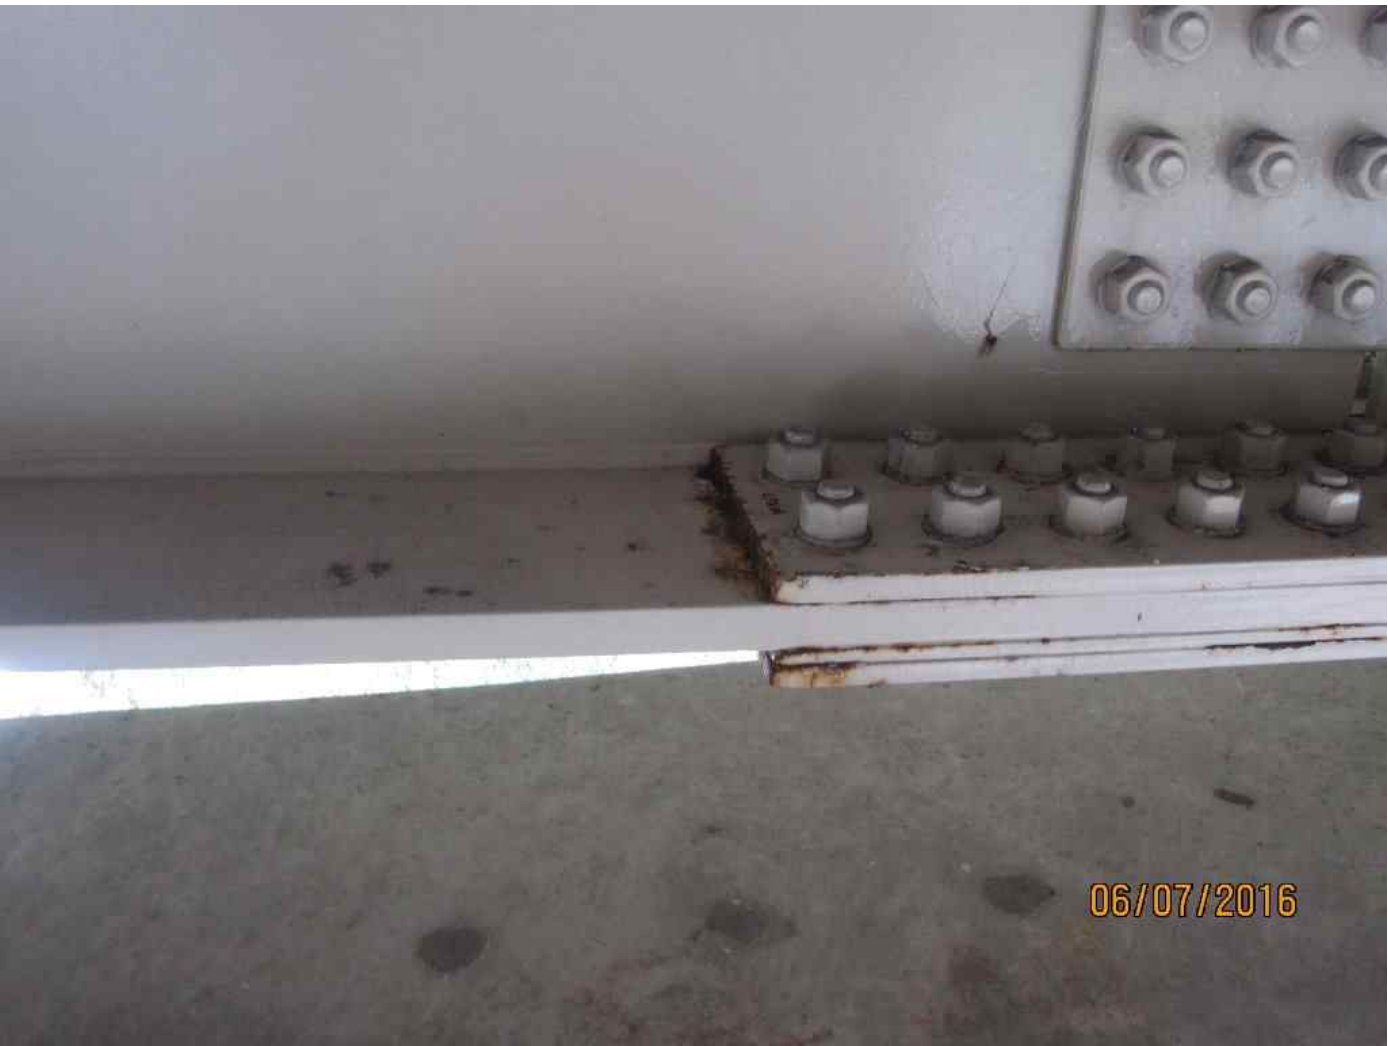
TYPICAL PIER DIAPHRAM CONNECTION. 2016

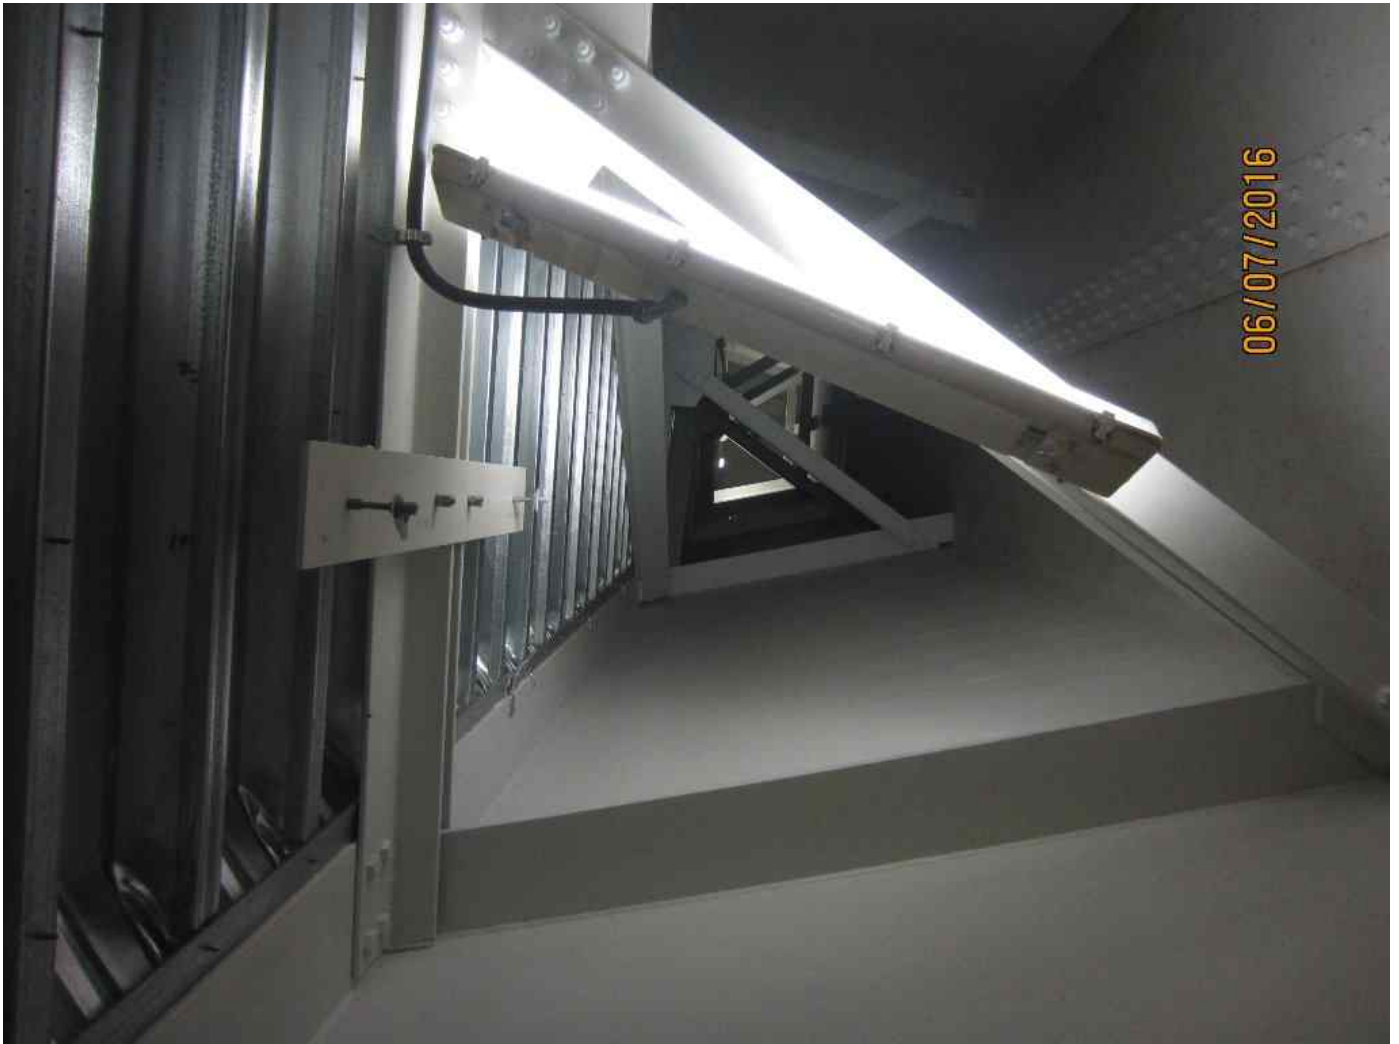
LITE IN SPAN 8 BROKE OFF MOUNTS. 2016.

| Item | Priority | Recommended by | Status | Status change |
|---|---|---|---|---|
| REPAIR INTERIOR LITE IN TUB. USE STATE ELECTRIAN POSSIBLY. SPAN 8. | | | | |
