Inspection Report for B-29-038 (COLFAX ST. MAUSTON)

STH 58 over IH 90-IH 94
May 11,2017

BRIDGE INSPECTION REPORT
Wisconsin Department of Transportation
DT2007 2003 s.84.17 Wis. Stats.

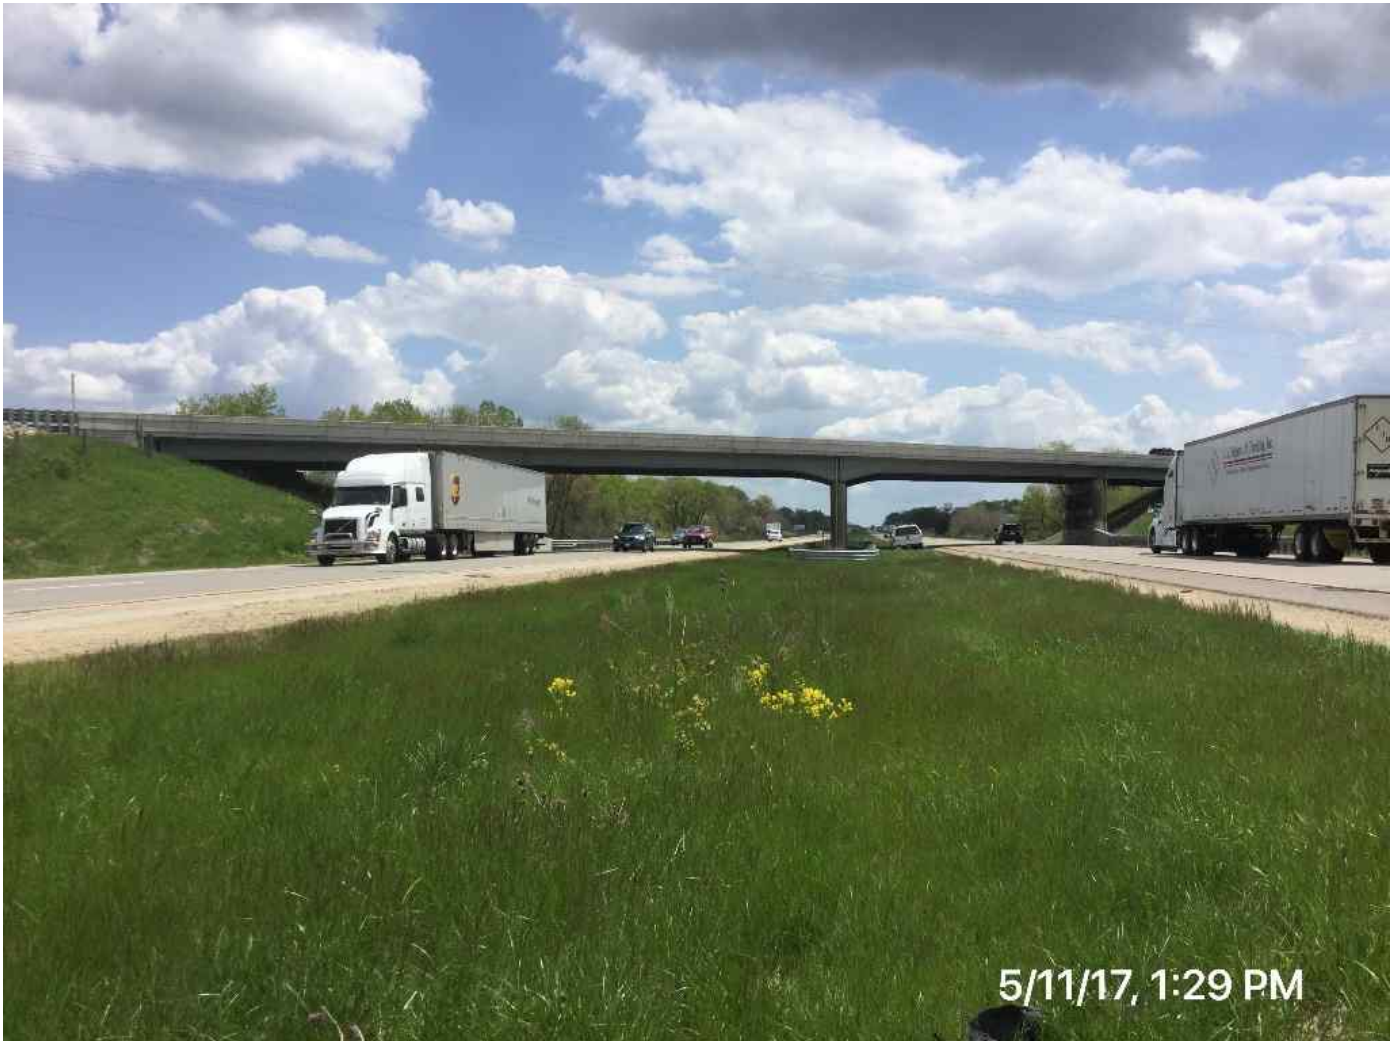
Elevation view looking east.

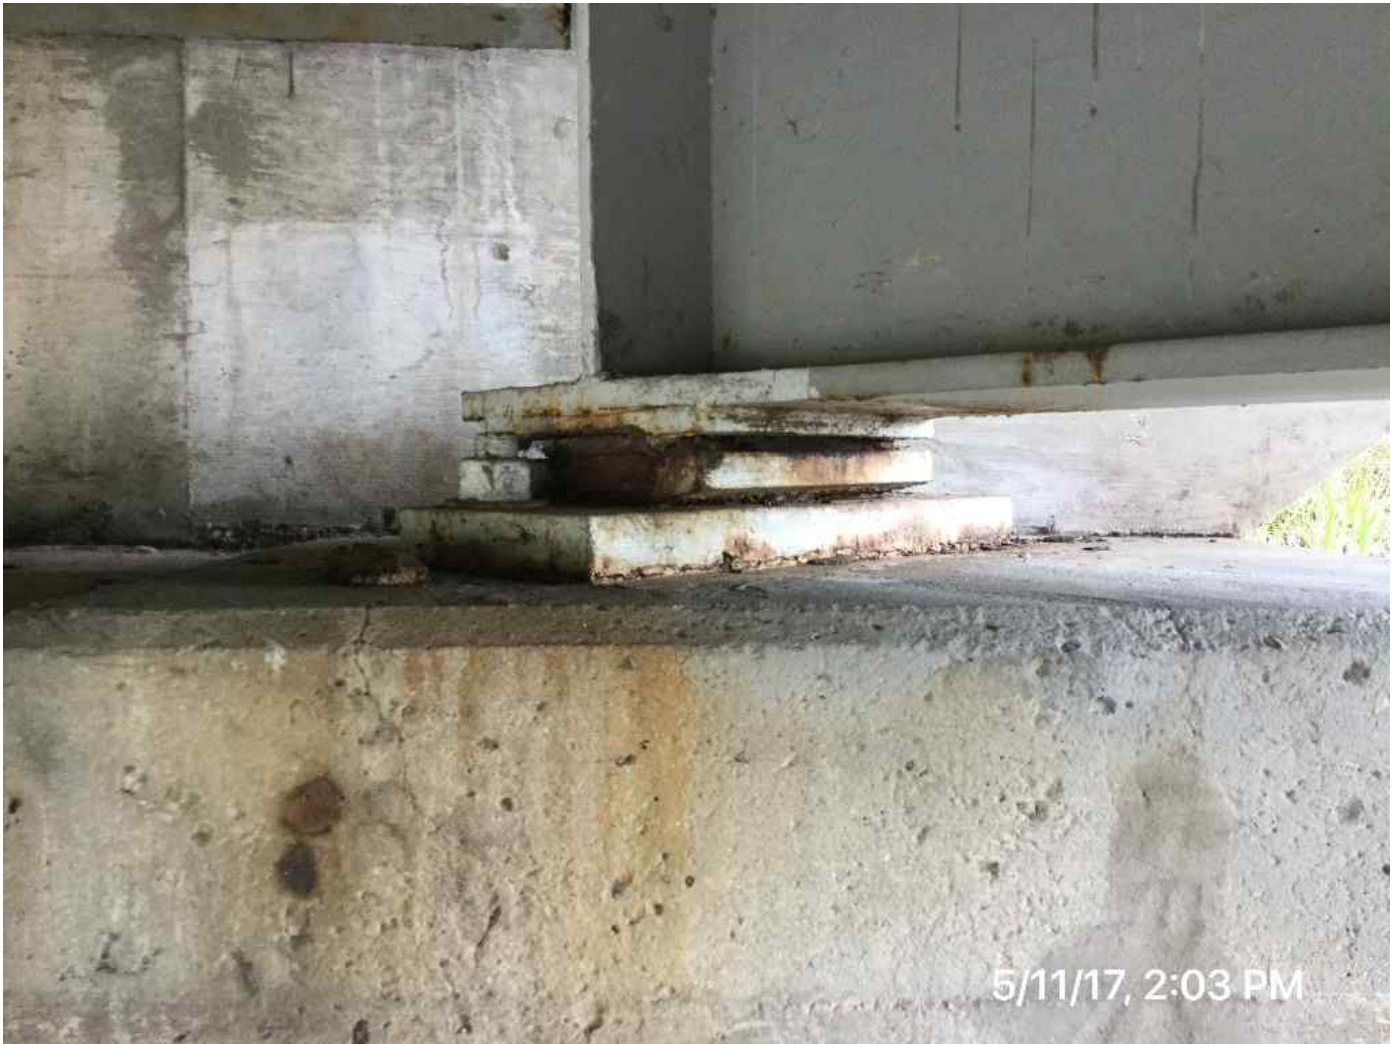
Typical of bearings with active corrosion.

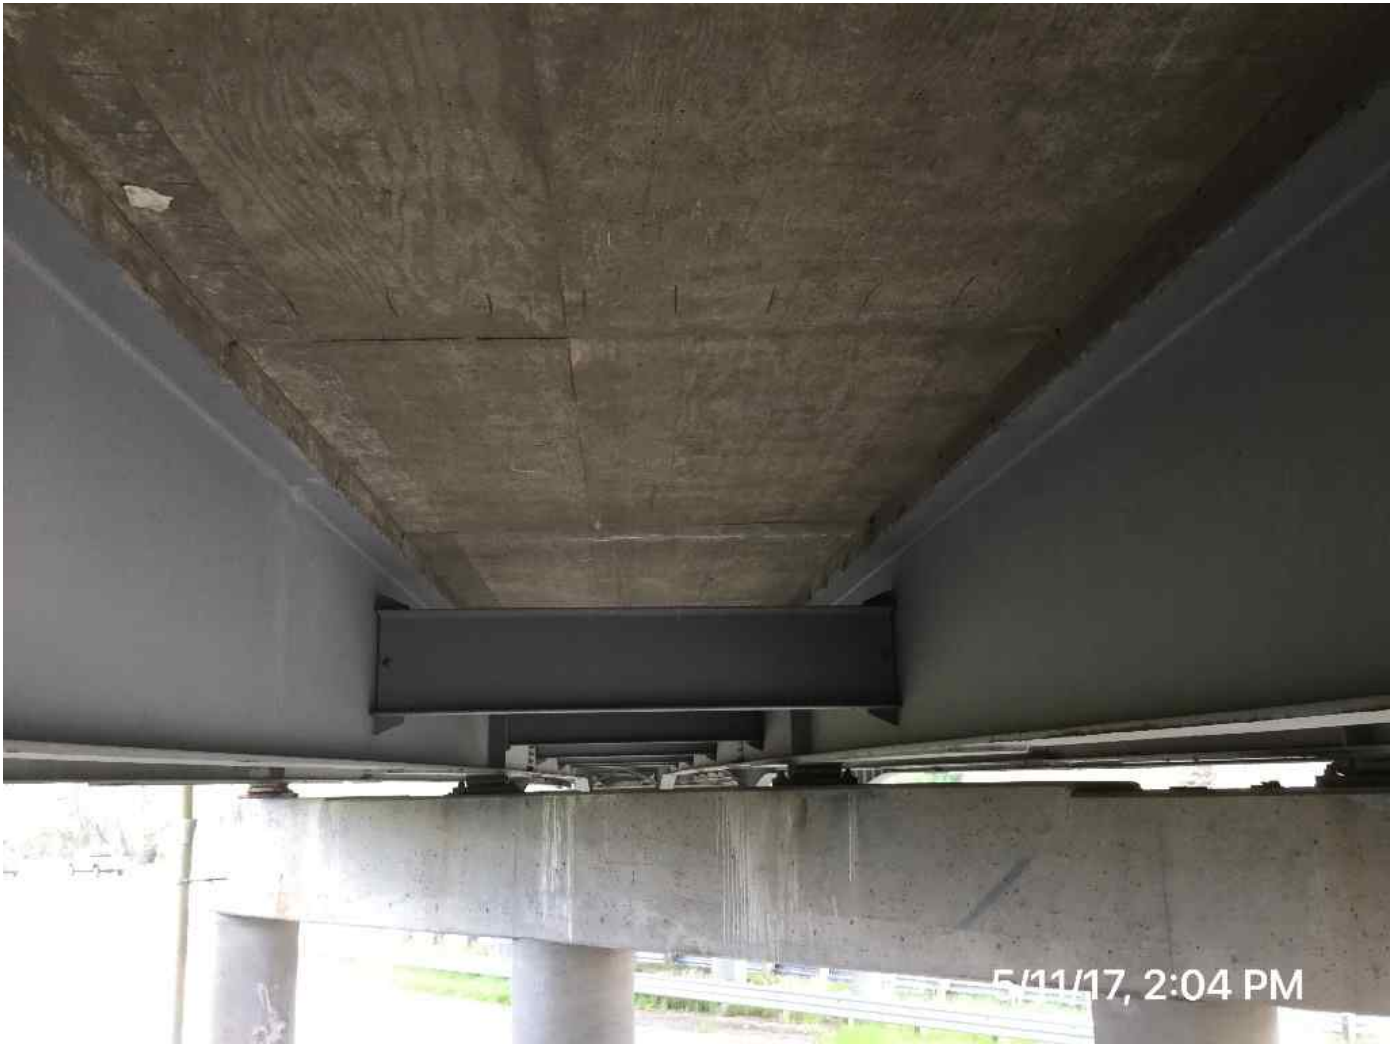
Typical of the underside of deck and girders in spans one and four.

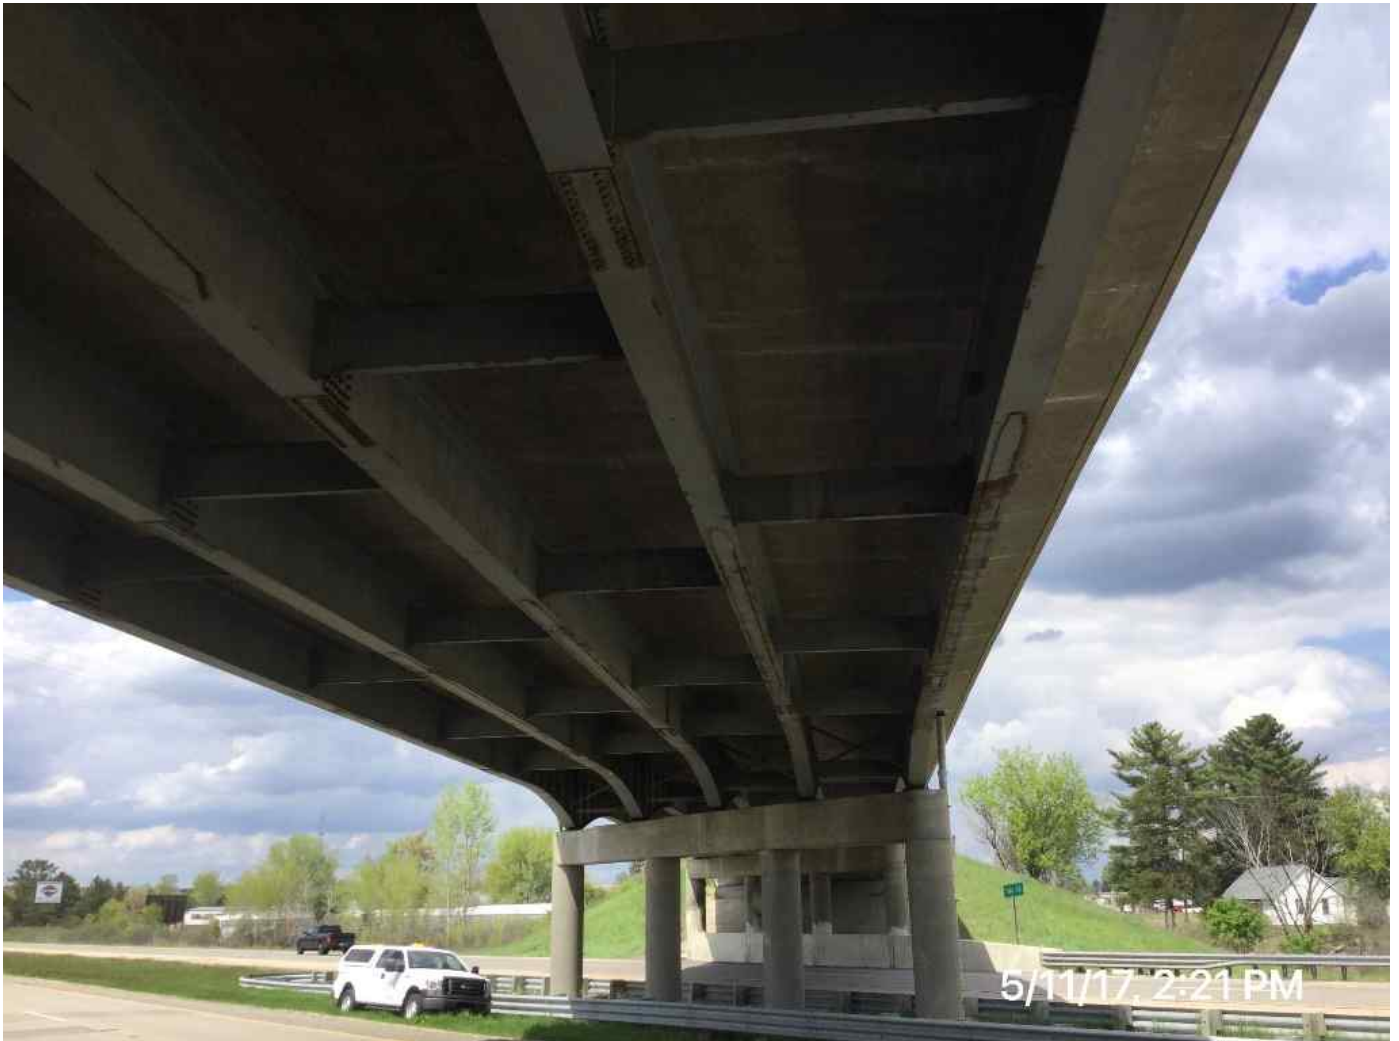
Typical of underside and girders in spans two and three.

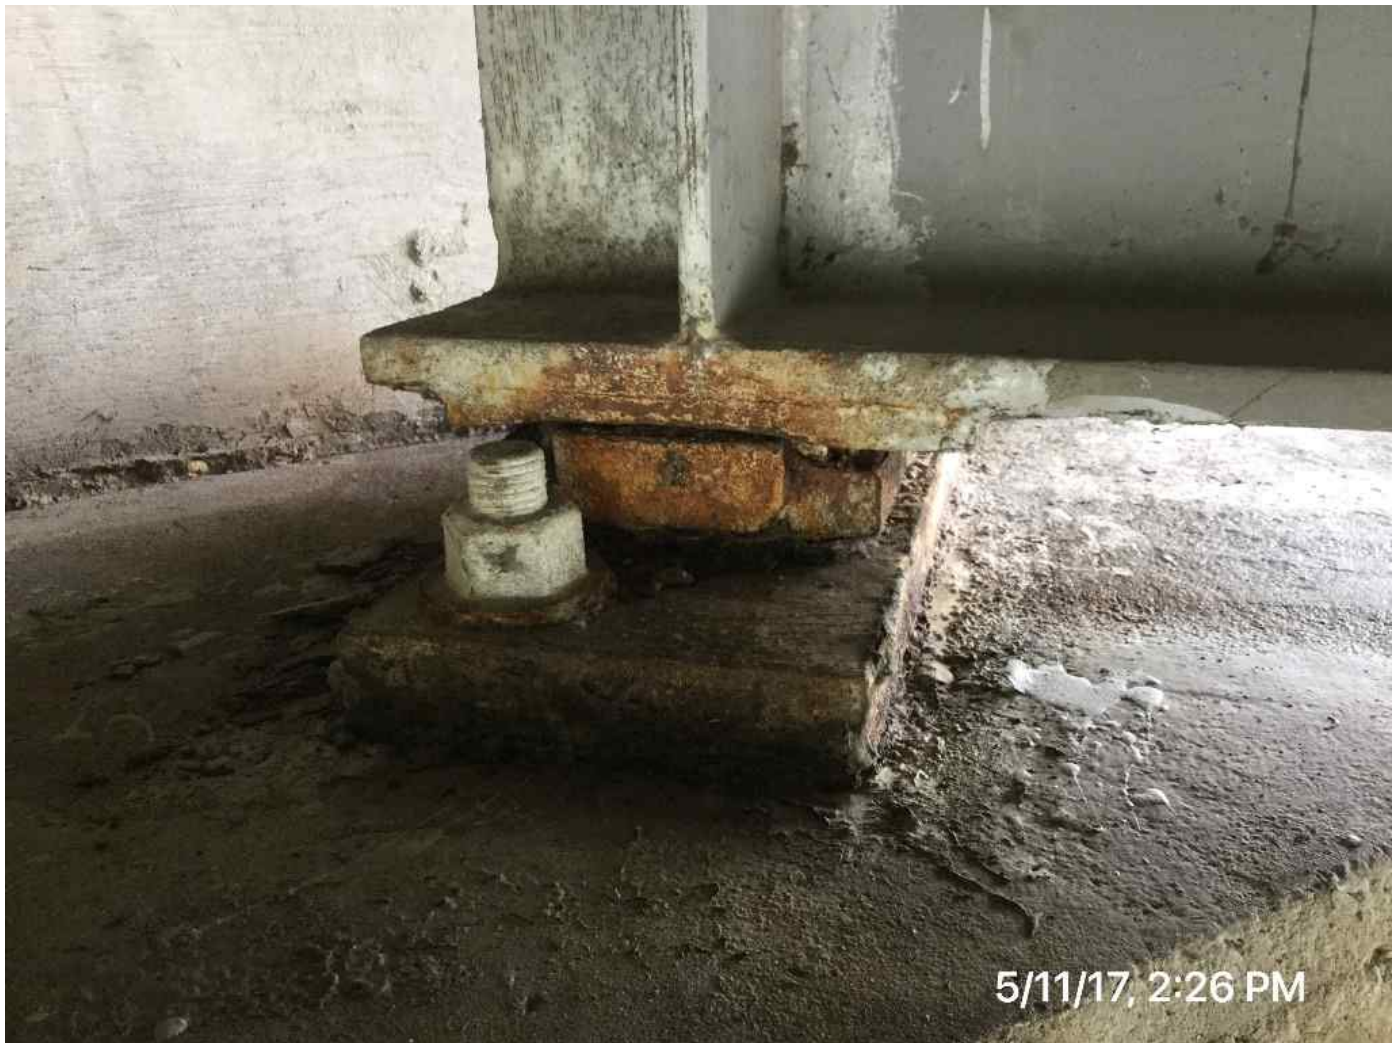
Cupped sole plate on pairing one N. abutment.

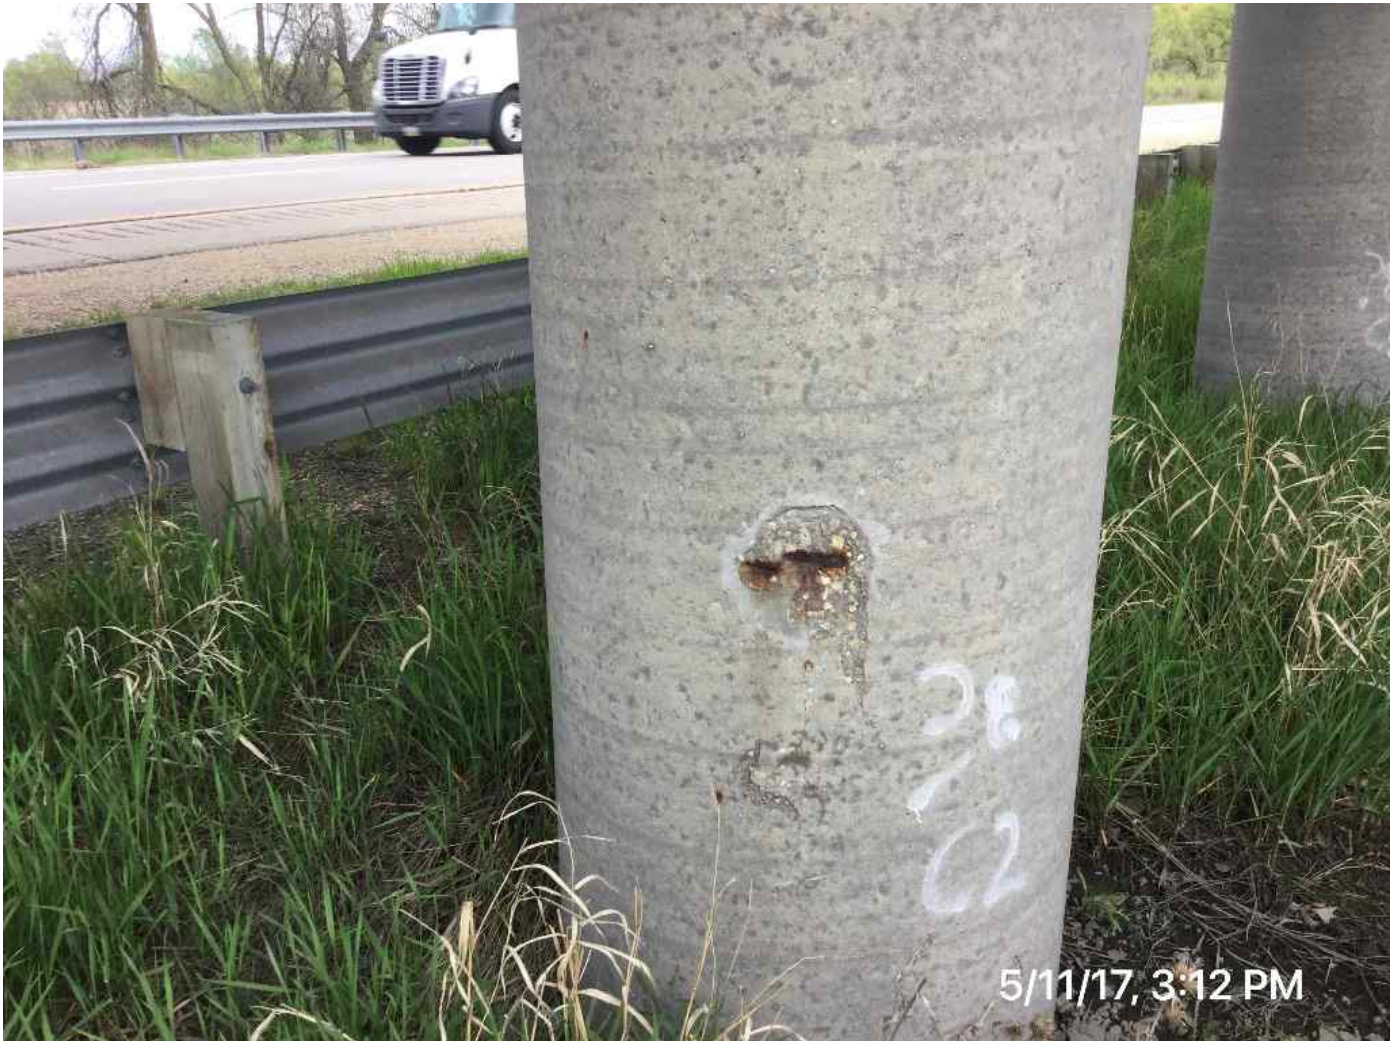
Spall with exposed rebar in P2C2.

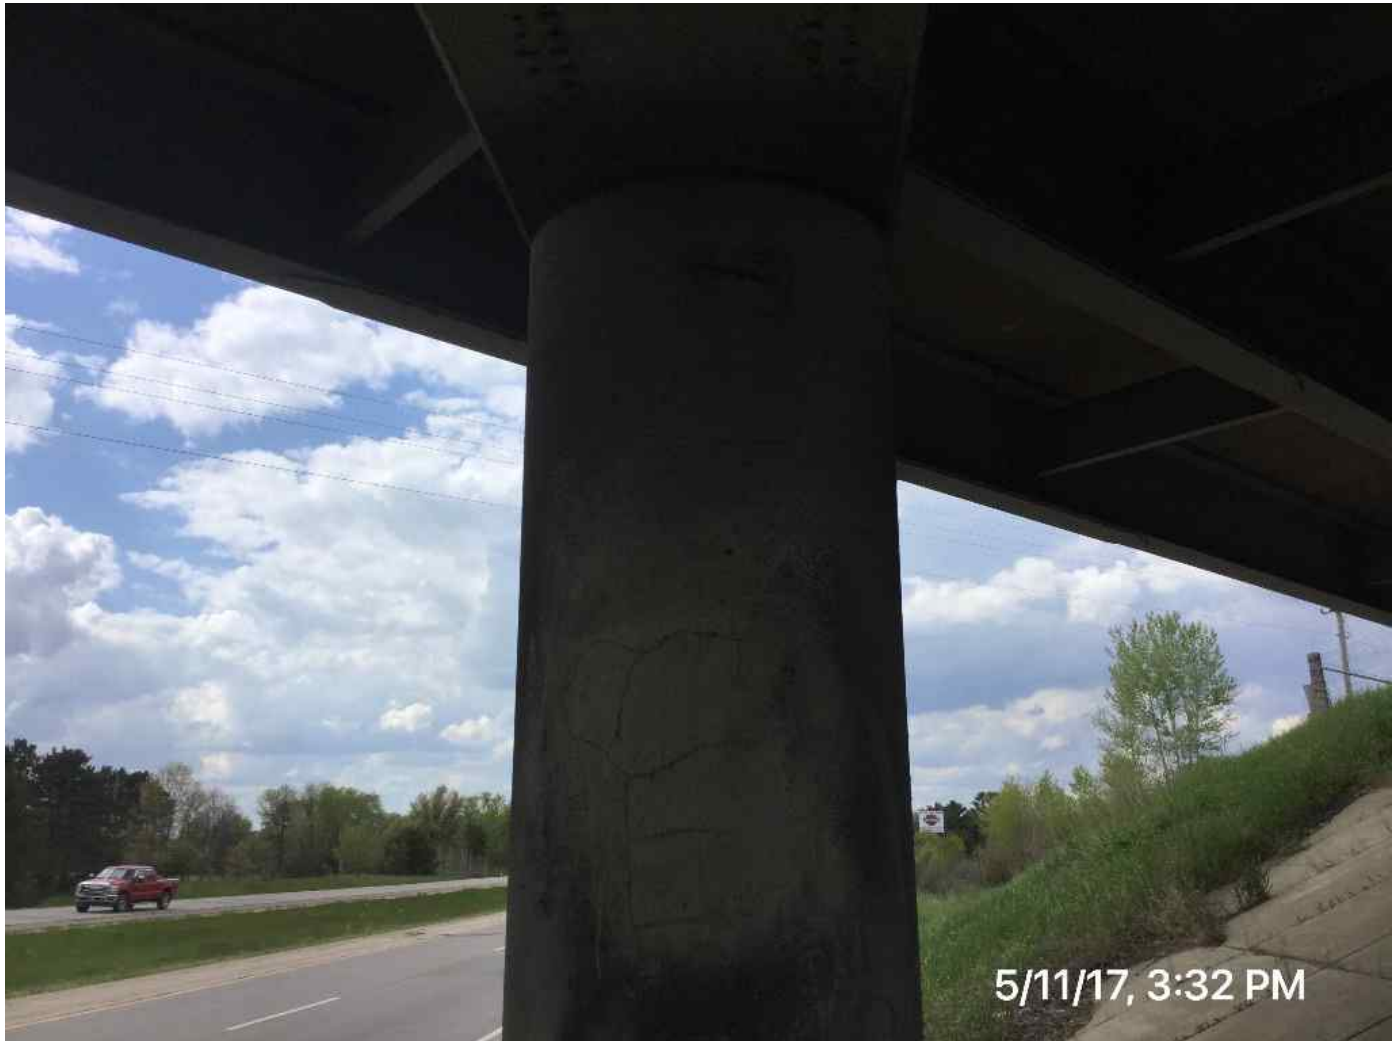
Spall with exposed rebar in P3C2.

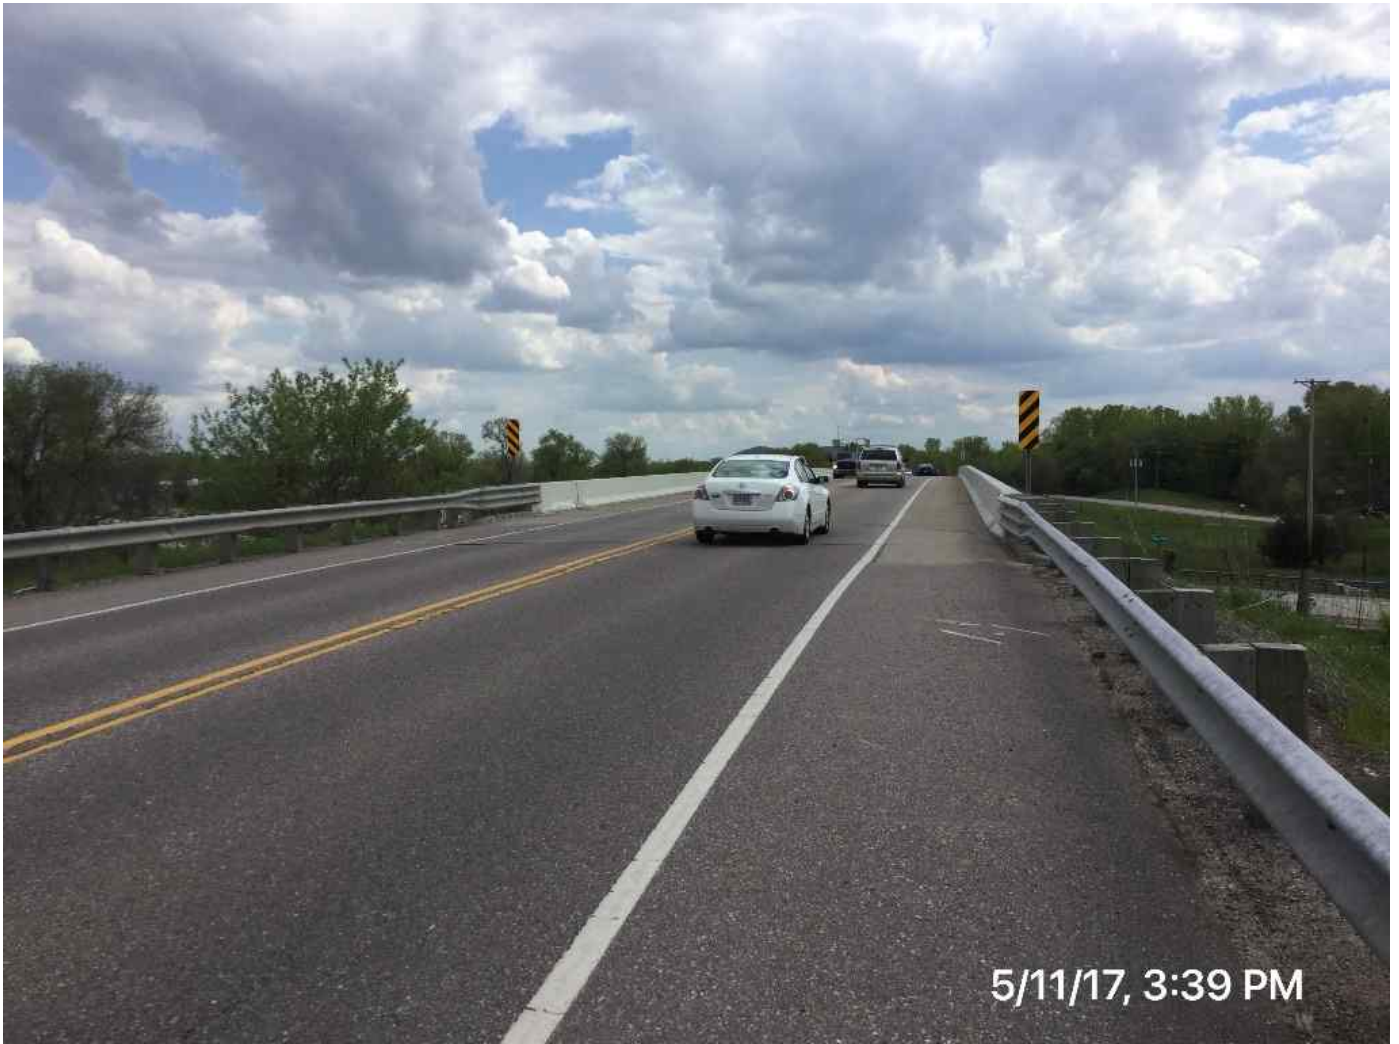
Roadway view looking south.
