Inspection Report for
B-29-089 (OLD CTH Q)

STH 58 over LITTLE YELLOW RIVER
May 22,2017

Feature On: STH 58	Section Town Range: S25 T17N R03E	Structure Number: B-29-089
Feature Under: LITTLE YELLOW RIVER	County: JUNEAU	
Location 0.8M N JCT CTH A	Municipality: CLEARFIELD	Structure Name: OLD CTH Q

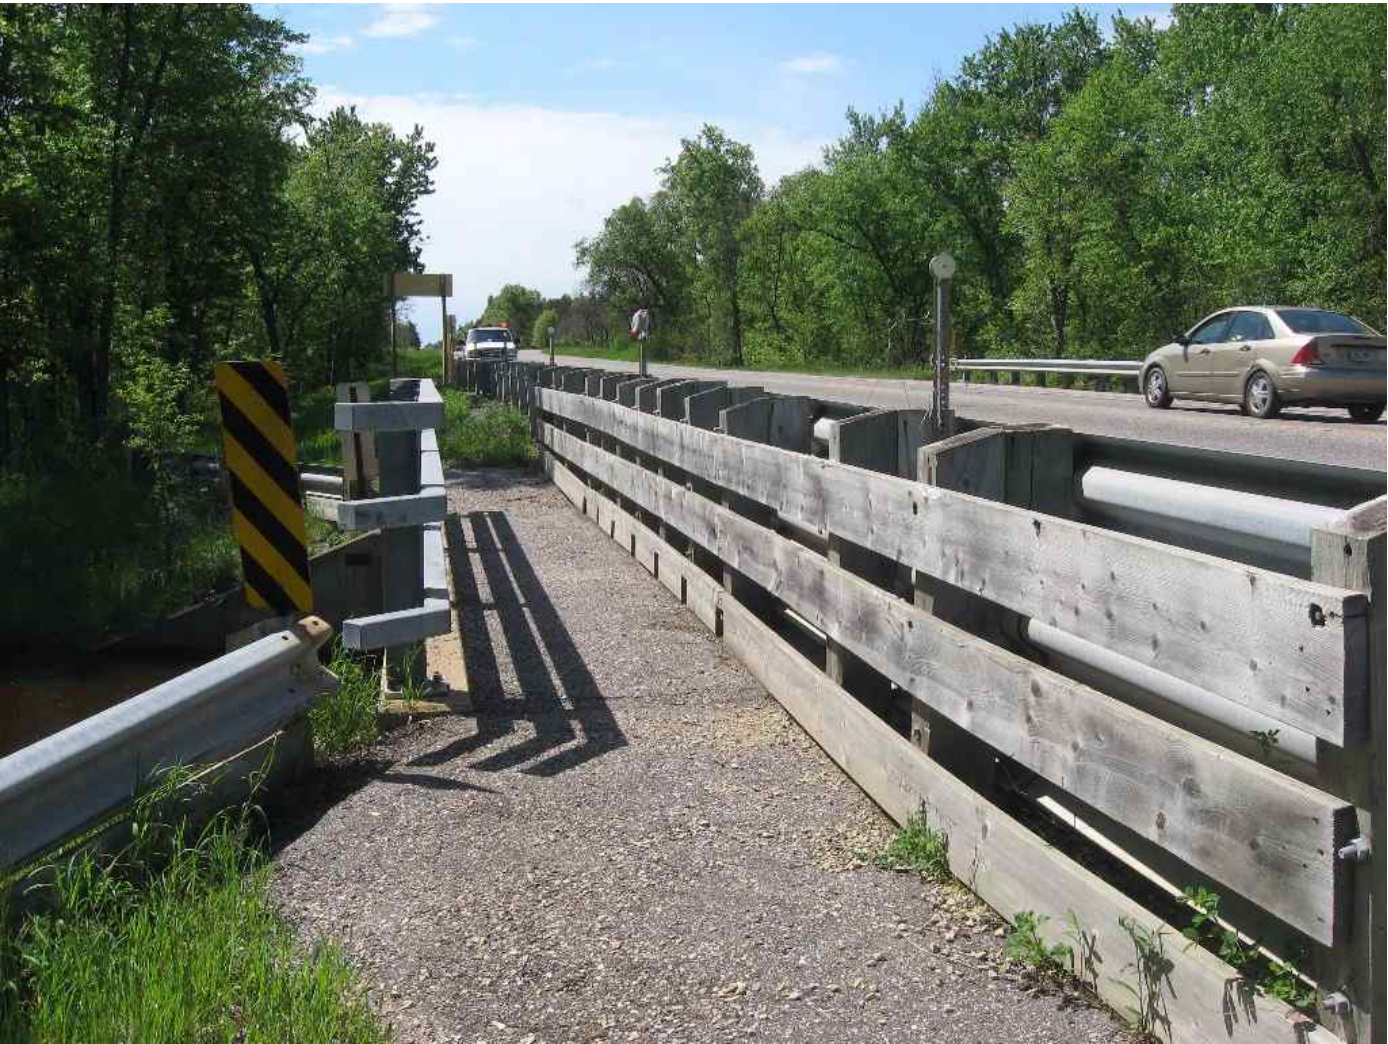
Snowmobiles don't use trail as designed - too narrow.

Snow mobile trail looking south not used too narrow
