Bridge Asbestos Inspection Report

WisDOT Project ID: 5783-03-00 Structure Number: B-12-618

Structure Name: STH 131 over Dellamater Hollow Creek

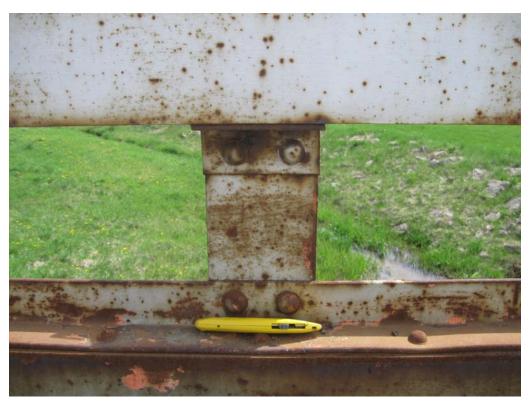
Paint on guardrail (6" long x 1" wide utility knife)
