Wisconsin Department of Transportation Salt Shed Facilities Asset Management Condition Inspection Report

| Region: | <u>Northwest</u> |
|---|---|
| Site ID: | <u>6-18-1-1</u> |
| Site Address: | 2000 Spooner Ave., Altoona |
| Date: | <u>February 23, 2016</u> |

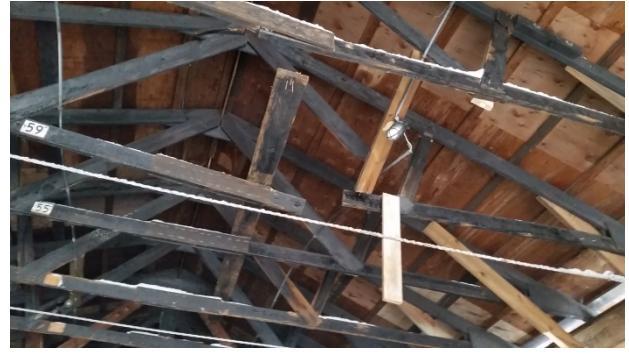
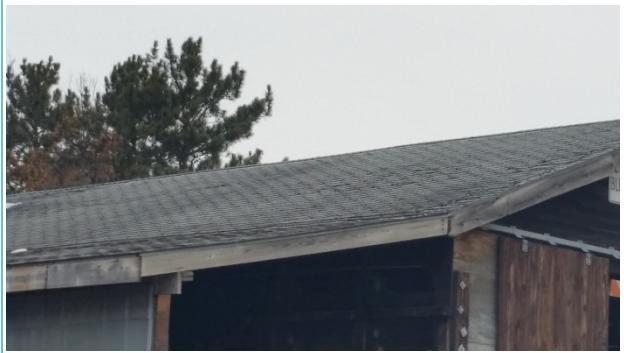
| Asset | Comments | 1 – Excellent | 2 - Good | 3 – Okay | 4 – Poor | 5 - Bad |
|---|---|---|---|---|---|---|
| Ceiling and Roof | Ceiling trusses are damaged and unrepaired. Shingles are very weathered. | | | | х | |

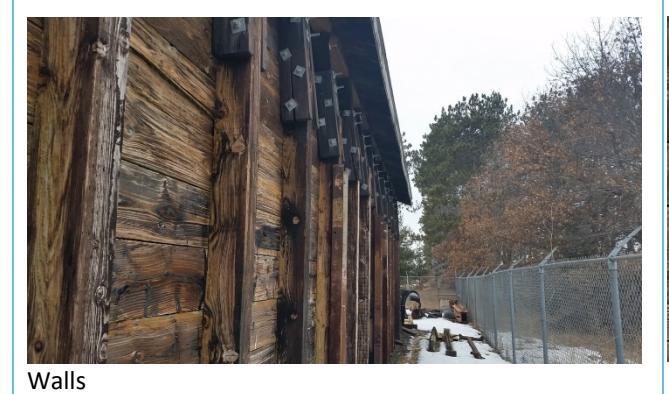
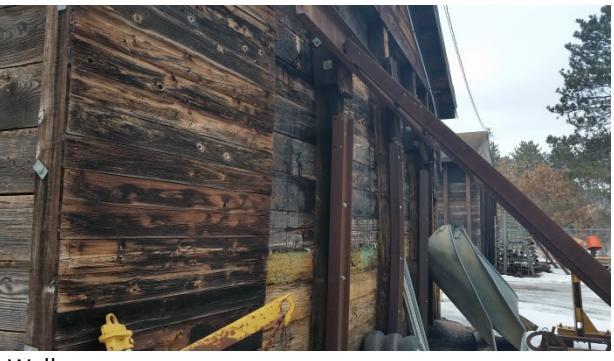
| Asset | Comments | 1 – Excellent | 2 - Good | 3 – Okay | 4 – Poor | 5 - Bad |
|---|---|---|---|---|---|---|
| Walls | Walls are moderately bowed out. Salt is seeping through the weathered wood. | | | | х | |
