Subject: Asbestos Survey

Structure Name/Location: USH 12 over Como Creek, Walworth County Structure Number: B-64-34 WisDOT ID Number: 1080-12-00

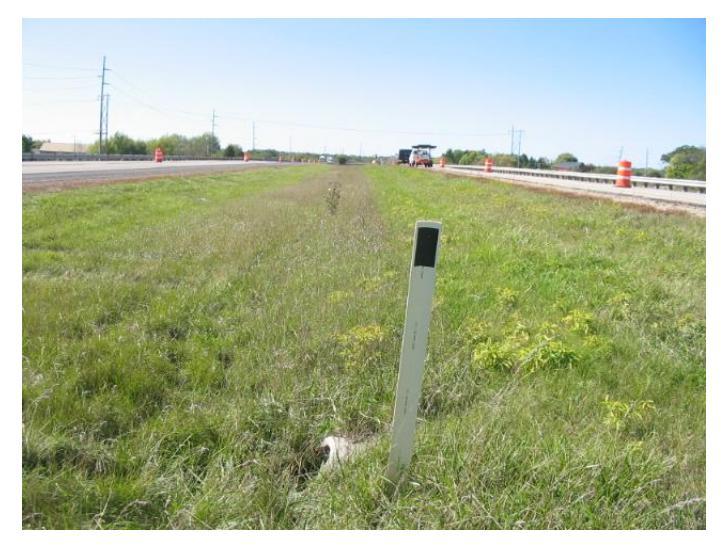
B-64-34

A visual walkover of the surface and underside of the bridge was performed, at which time no potentially asbestos-containing materials were identified. Since no material was identified as potentially contained asbestos, no samples were collected.
