REHABILITATION STRUCTURE SURVEY REPORT

EAU CLAIRE - CHIPPEWA FALLS

Inspection Report for B-18-038

Bridge Asbestos Inspection Report

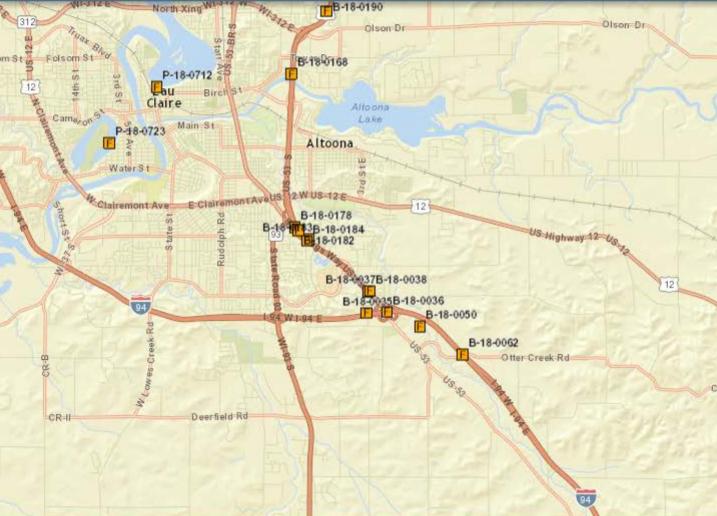
B-18-0038

On both of the bridges, the gaskets located under the railing attachment plates on the parapet tested positive for asbestos greater than 1% and is therefore regulated ACM. If the ACM will be disturbed during the planned overlays, the ACM must be removed prior to any work. Standard Special Provision (STSP) 203-005 should be incorporated into the specifications. If the ACM will not be disturbed during the planned overlays, STSP 107-120 should be included in the specifications.

Gasket under railing attachment plate
