Bridge Asbestos Inspection Report

WisDOT Project ID: 8680-00-04

Structure Number: B-16-0038 (center span section ID)

Structure Name: Bong Bridge (USH 2) over St. Louis River

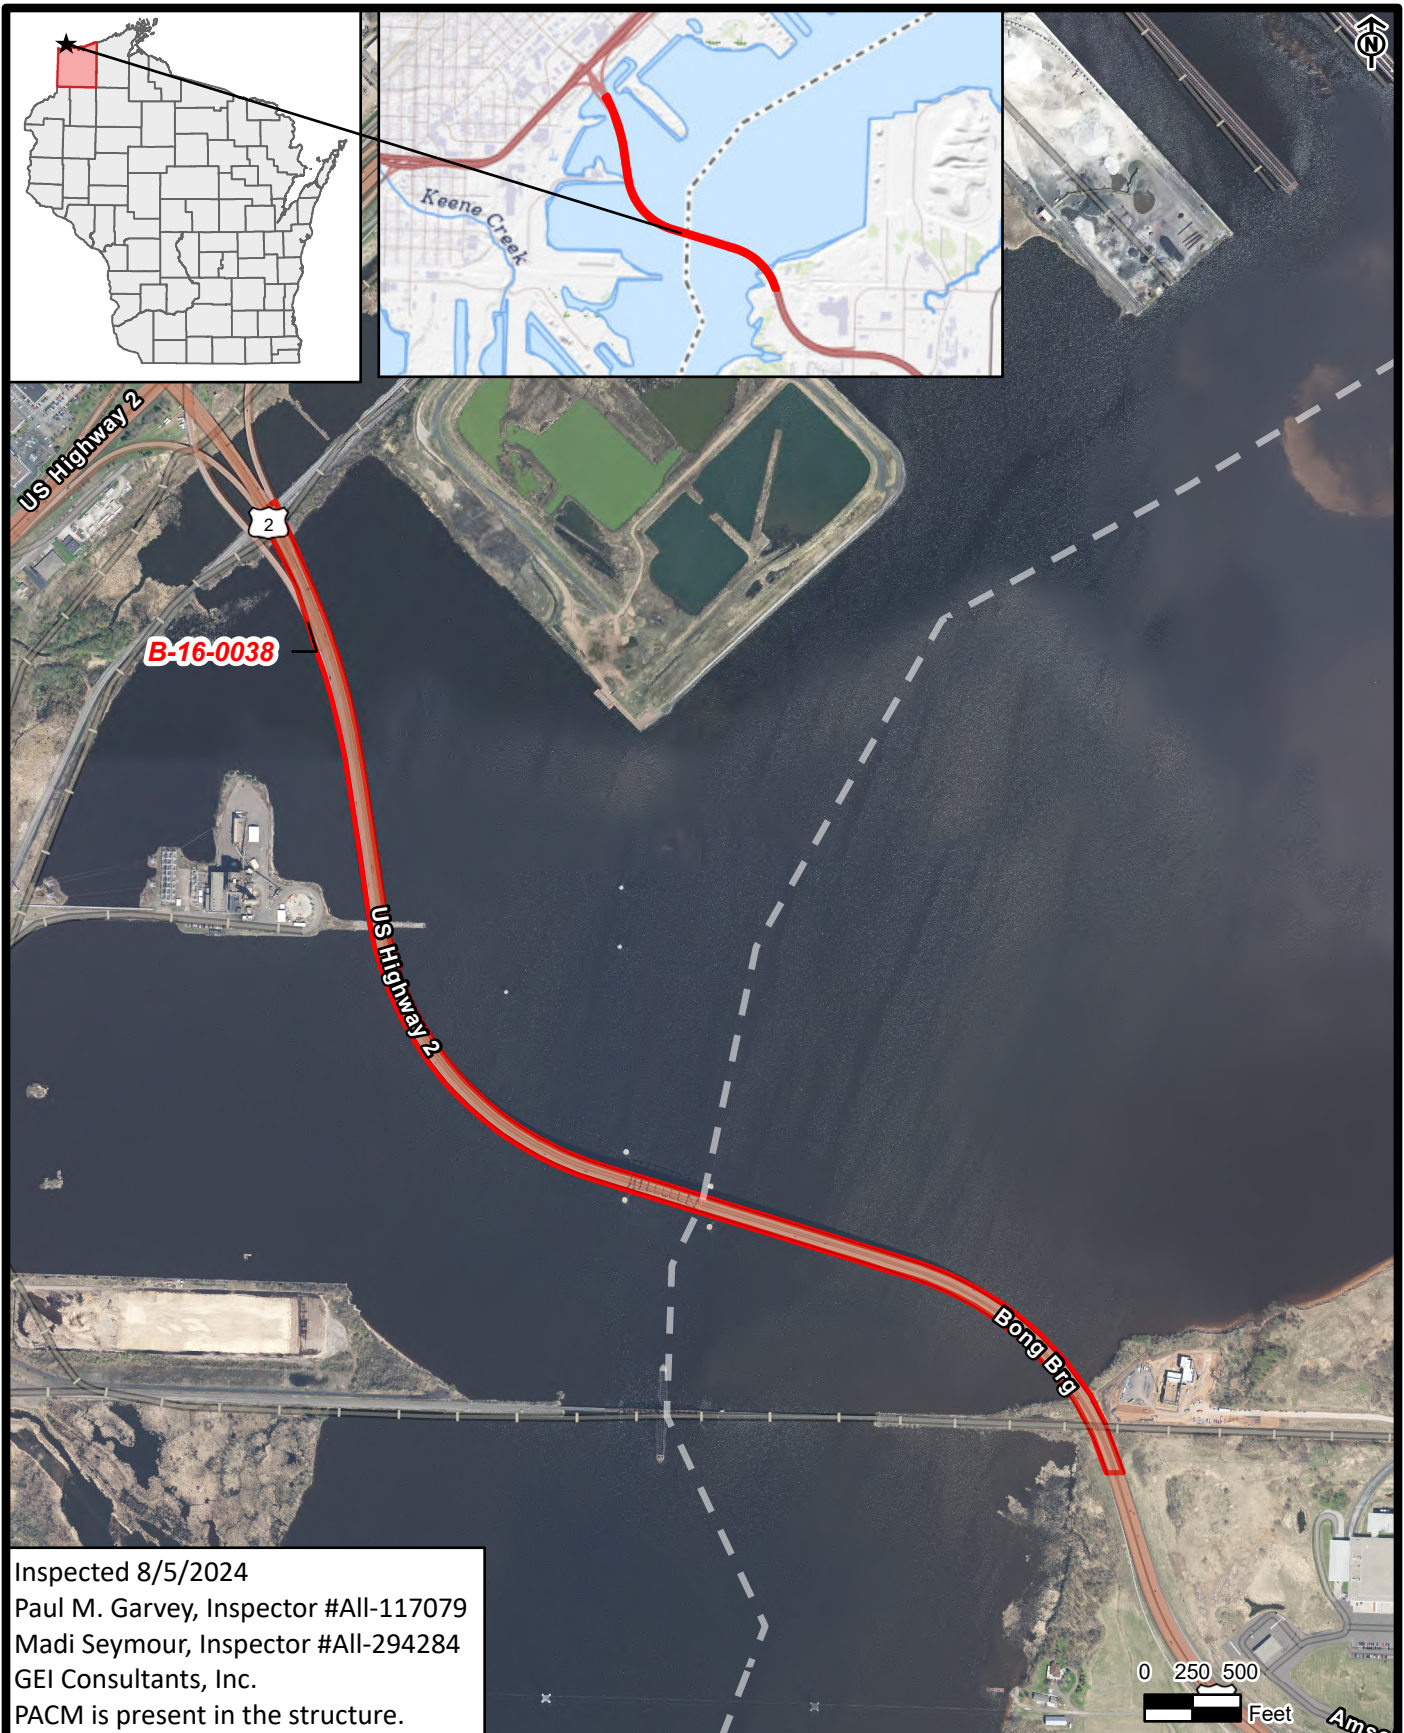
Designed:	JLH	8/12/2024
Checked:	PMG	8/12/2024
Drawn:	JLH	8/12/2024
Figure No.	B-16-0038

Inspected 8/5/2024
Paul M. Garvey, Inspector #All-117079
Madi Seymour, Inspector #All-294284
GEI Consultants, Inc.
PACM is present in the structure.

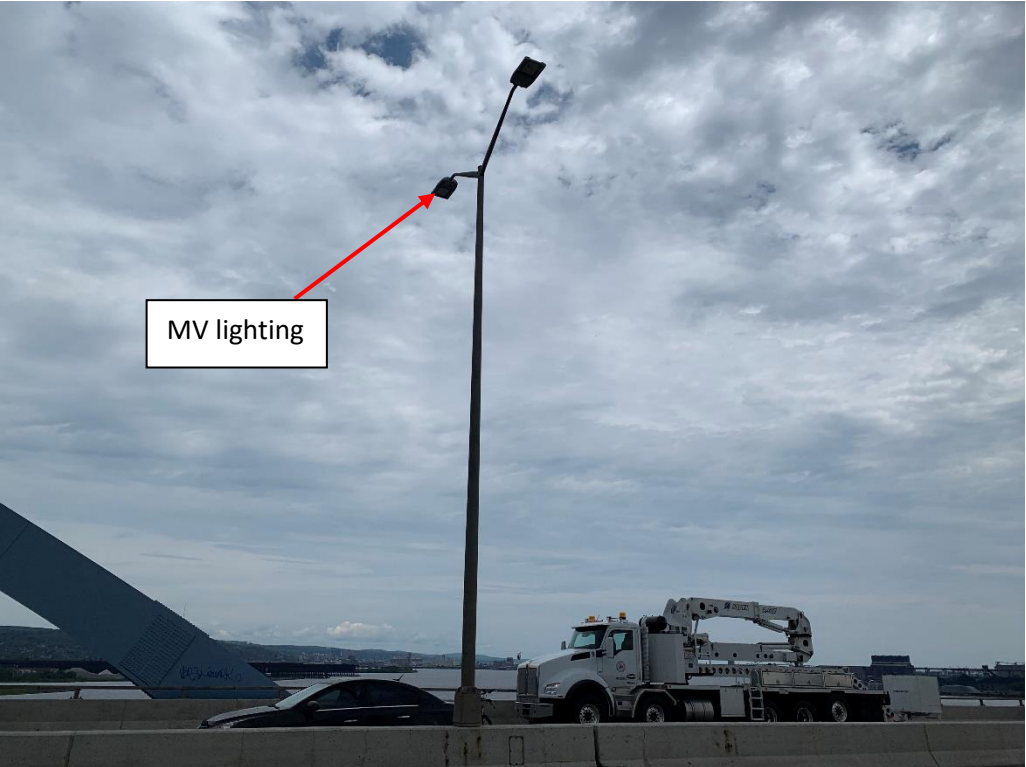
<p>PHOTOGRAPH NO: 4</p>

<p>DIRECTION: N</p>	
<p>DESCRIPTION:</p> <p>Looking at the mercury vapor lighting system on the poles mounted to the center parapet wall of the Structure. The lighting system is energized and could not be sampled. The lamps, ballasts and electrical boxes are presumed asbestos containing materials (PACM).</p>

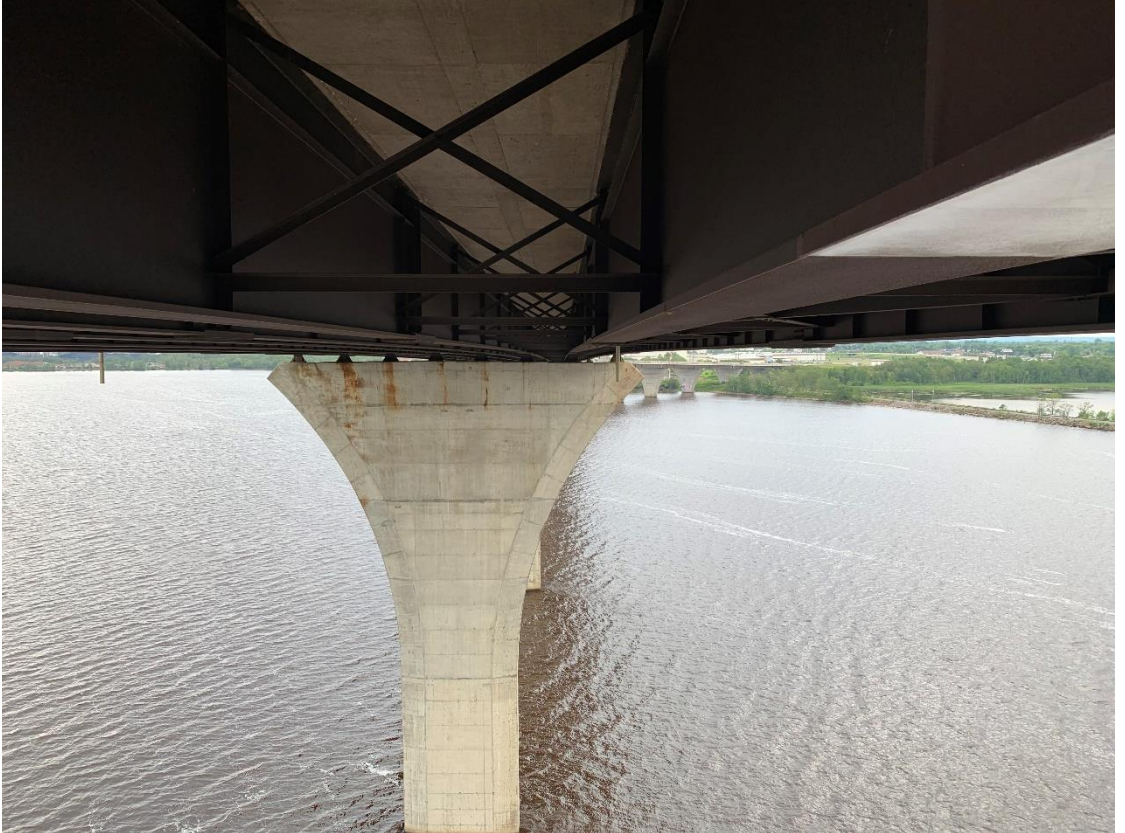
<p>PHOTOGRAPH NO: 5</p>

<p>DIRECTION: E</p>	
<p>DESCRIPTION:</p> <p>Looking east under the Wisconsin side of the structure showing the brown paint system on the underside girders.</p>

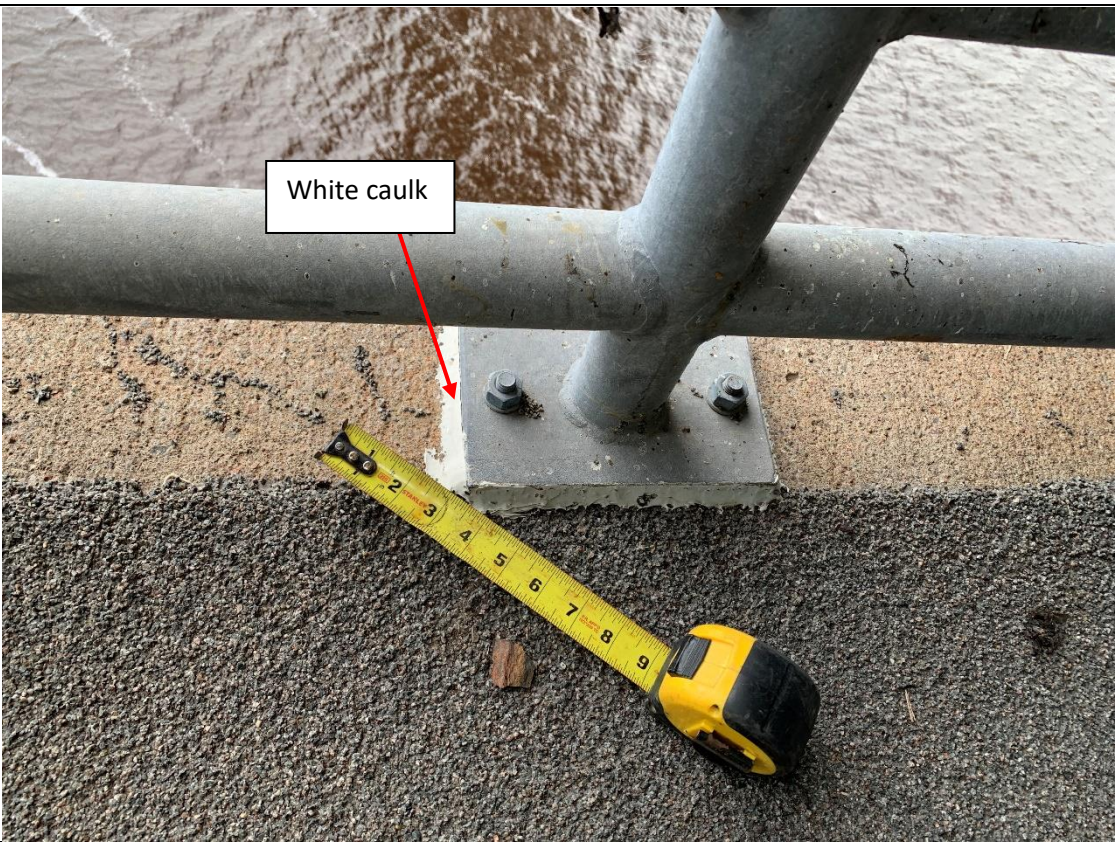
PHOTOGRAPH NO: 9

DIRECTION: Down	
DESCRIPTION: Looking at the white caulk on the guardrail base plates. The caulk is not ACM.

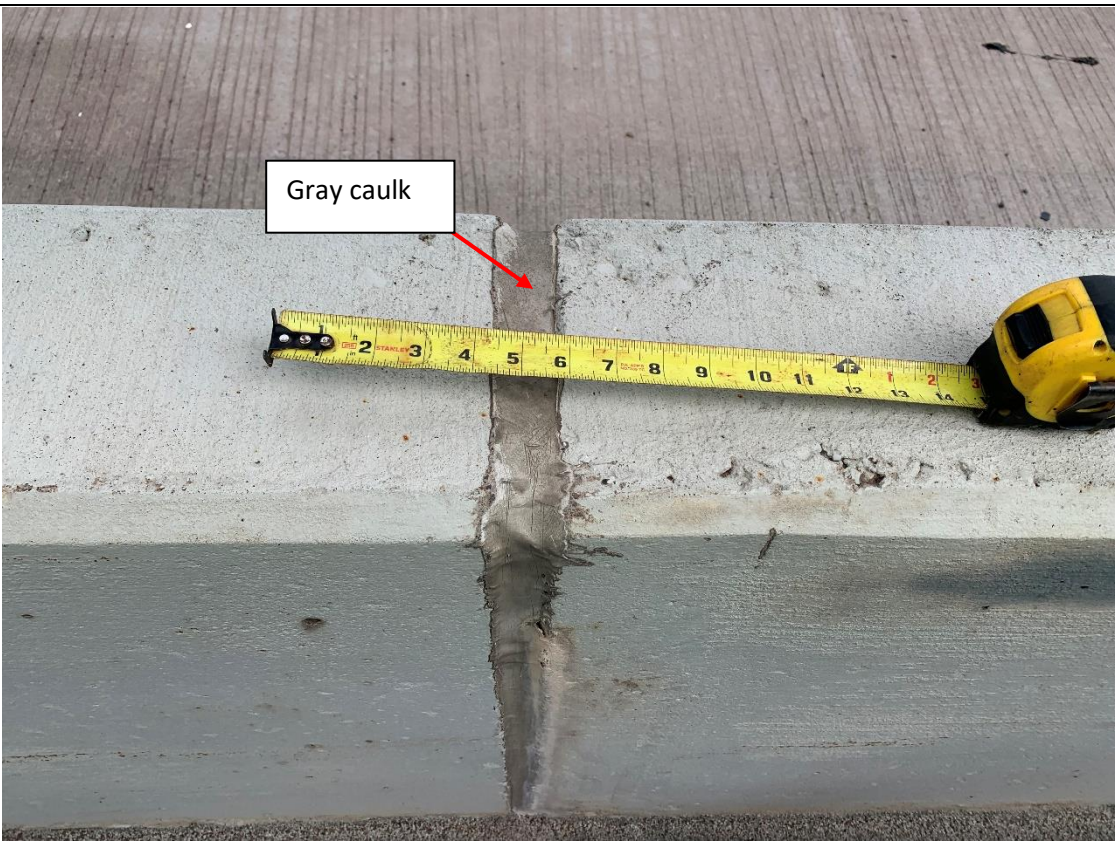
PHOTOGRAPH NO: 10

DIRECTION: N/Down	
DESCRIPTION: Looking at the gray caulk on the parapet wall joints and non-walkway (north side) guardrail base plates (Photo 2). The caulk is not ACM.

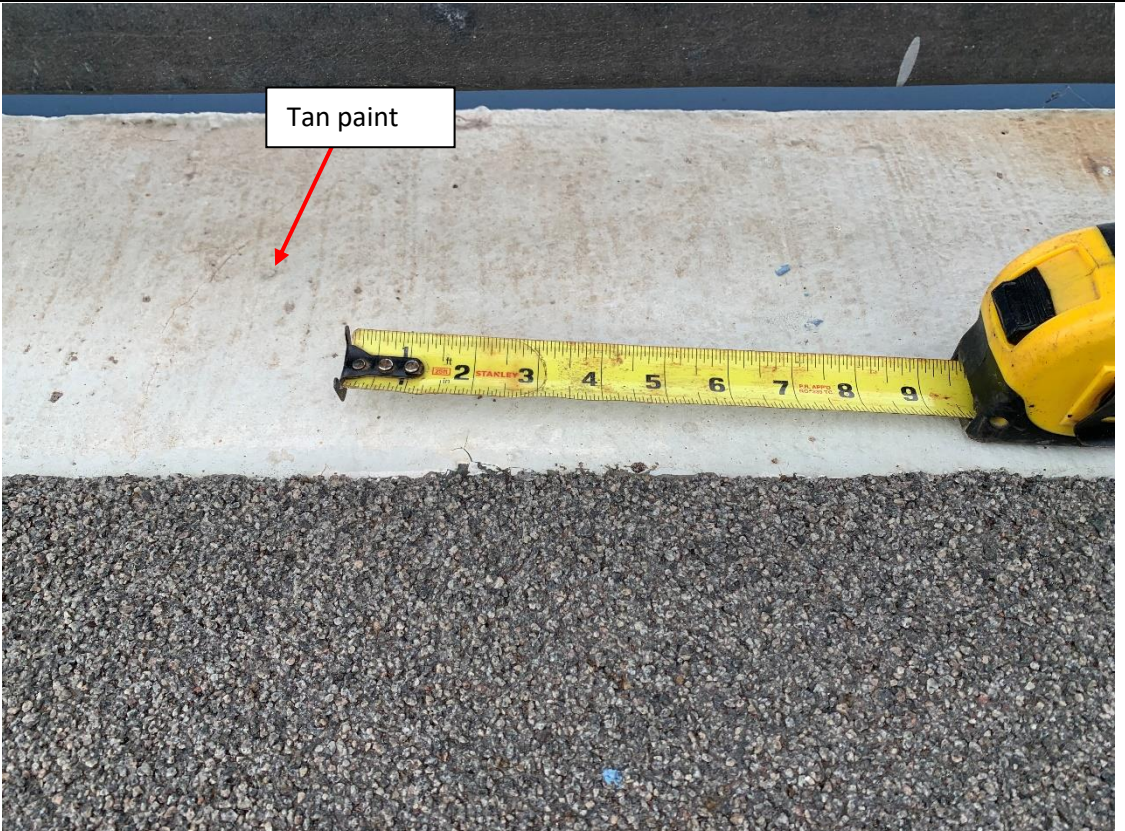
PHOTOGRAPH NO: 12

DIRECTION: NW	
DESCRIPTION: Looking at the tan paint on the walkway deck and parapet walls. The paint is not ACM.
