## Bridge Asbestos Inspection Report

**Structure Number:** B-03-014

# Inspection Report for B-03-014

USH 53 SB over CARLSON SCHOOL DRIVE  
Jun 08,2017

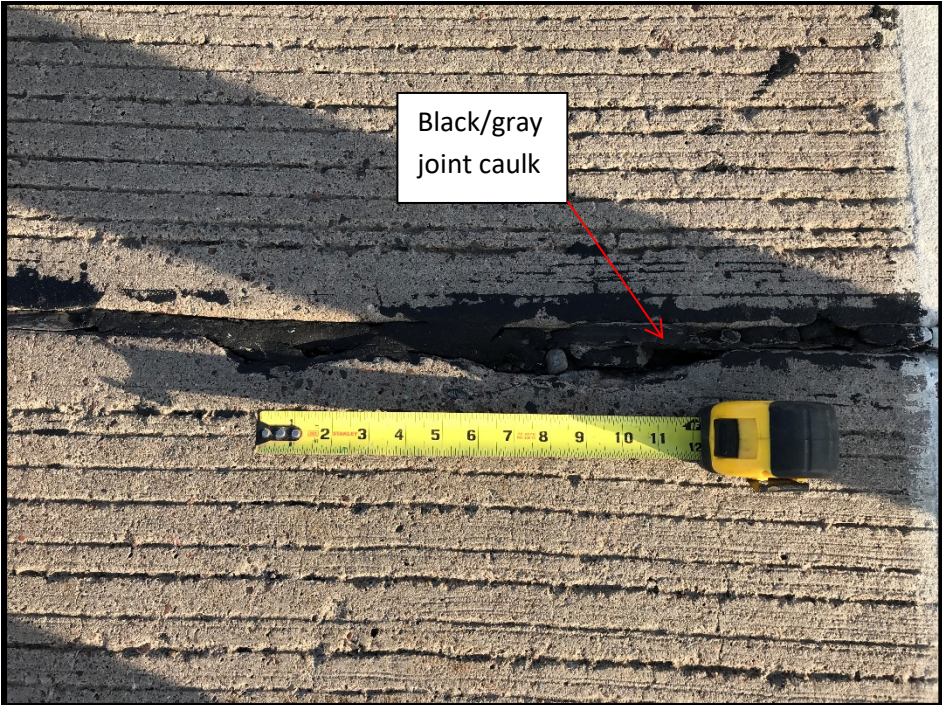
<b>PHOTOGRAPH NO: 4</b>

<b>DIRECTION: Down</b>	
<b>DESCRIPTION:</b>  View of the black/gray joint caulk on the bridge deck. The black/gray joint caulk is not ACM.

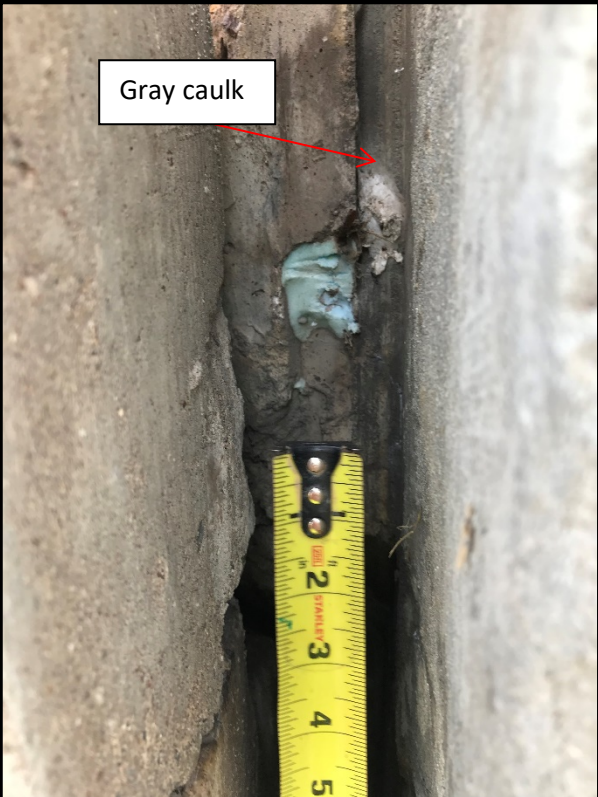
<p><b>PHOTOGRAPH NO: 5</b></p>

<p><b>DIRECTION: SE</b></p>	
<p><b>DESCRIPTION:</b></p> <p>View of the gray caulk on the bridge wall joints and abutment joints. The gray caulk is not ACM.</p>

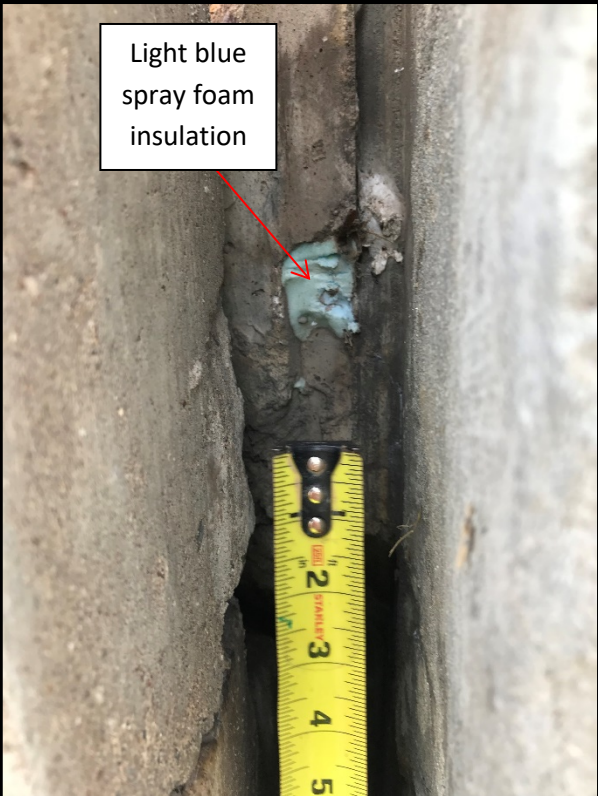
<b>PHOTOGRAPH NO: 7</b>

<b>DIRECTION: E</b>			
<b>DESCRIPTION:</b>  View of the light blue spray foam insulation between the bridge deck and abutment joints. The light blue spray foam insulation is not ACM.

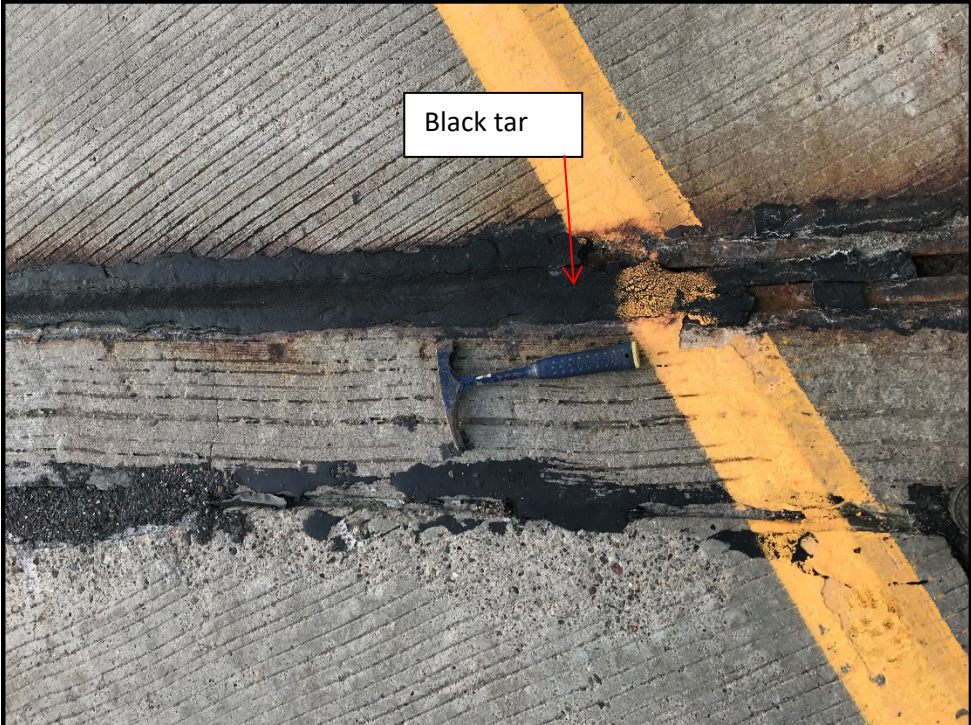
<b>PHOTOGRAPH NO: 8</b>

<b>DIRECTION: Down</b>			
<b>DESCRIPTION:</b>  View of the black tar on the southern bridge deck joints. The black tar is not ACM.
