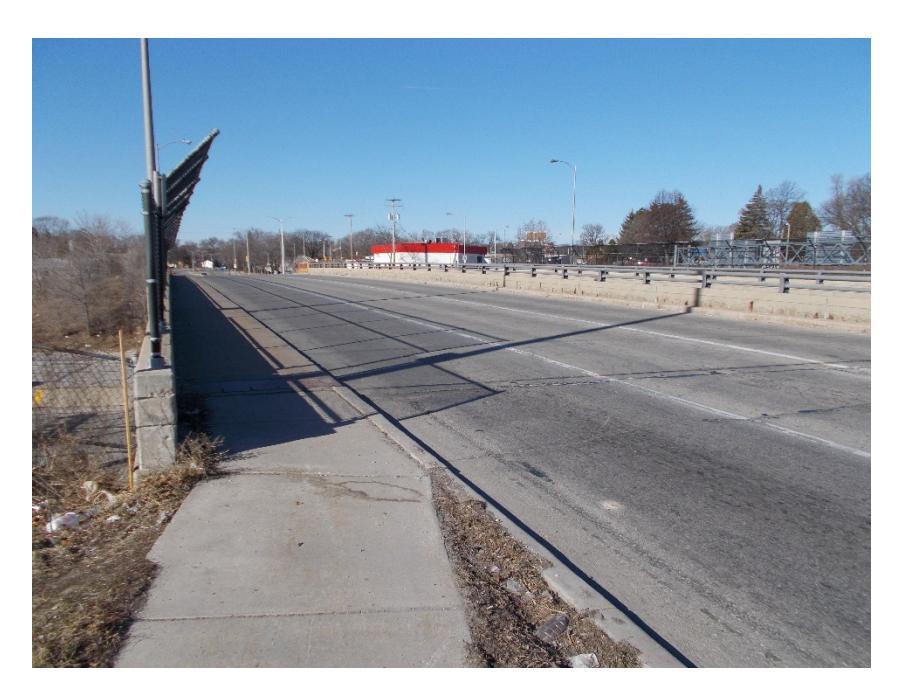
1) Top of deck looking west

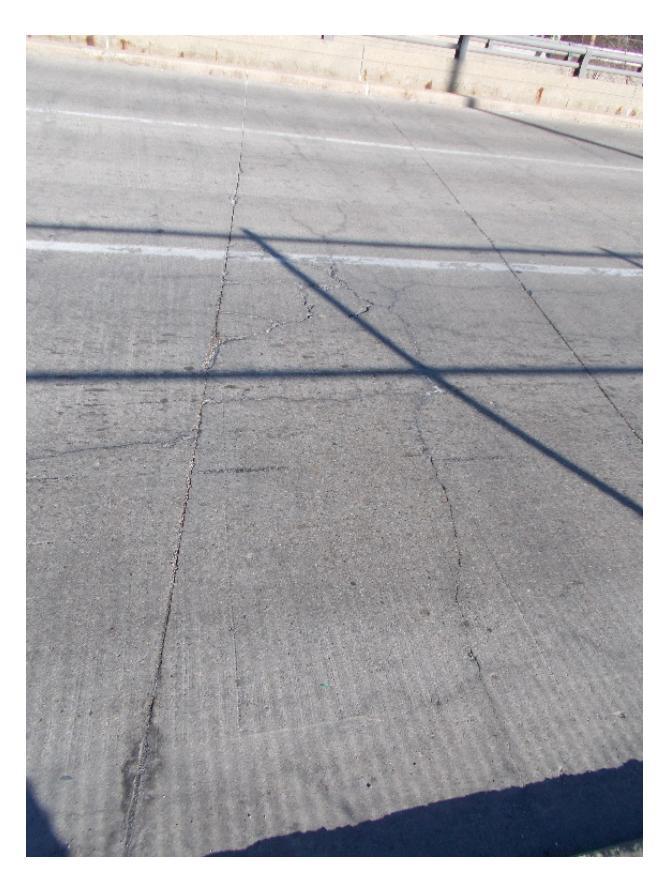
2) Top of deck condition looking north

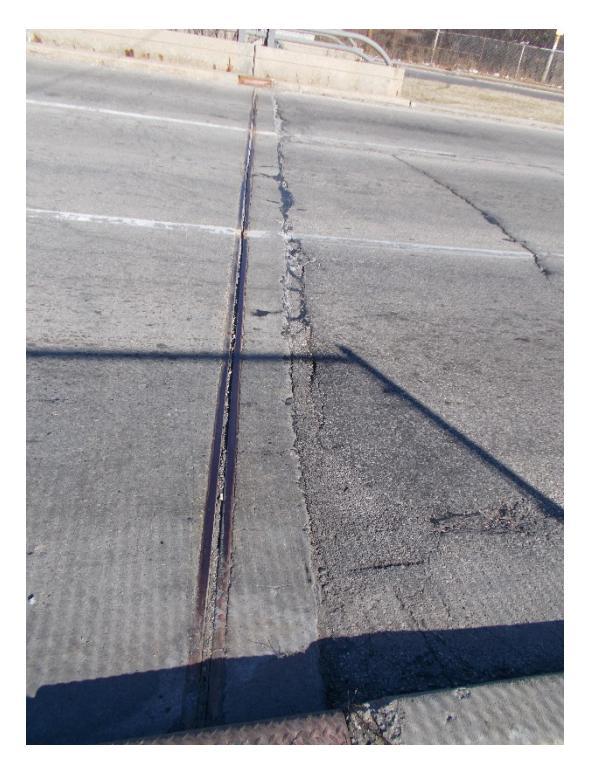
3) Expansion device at east abutment, joint is nearly closed

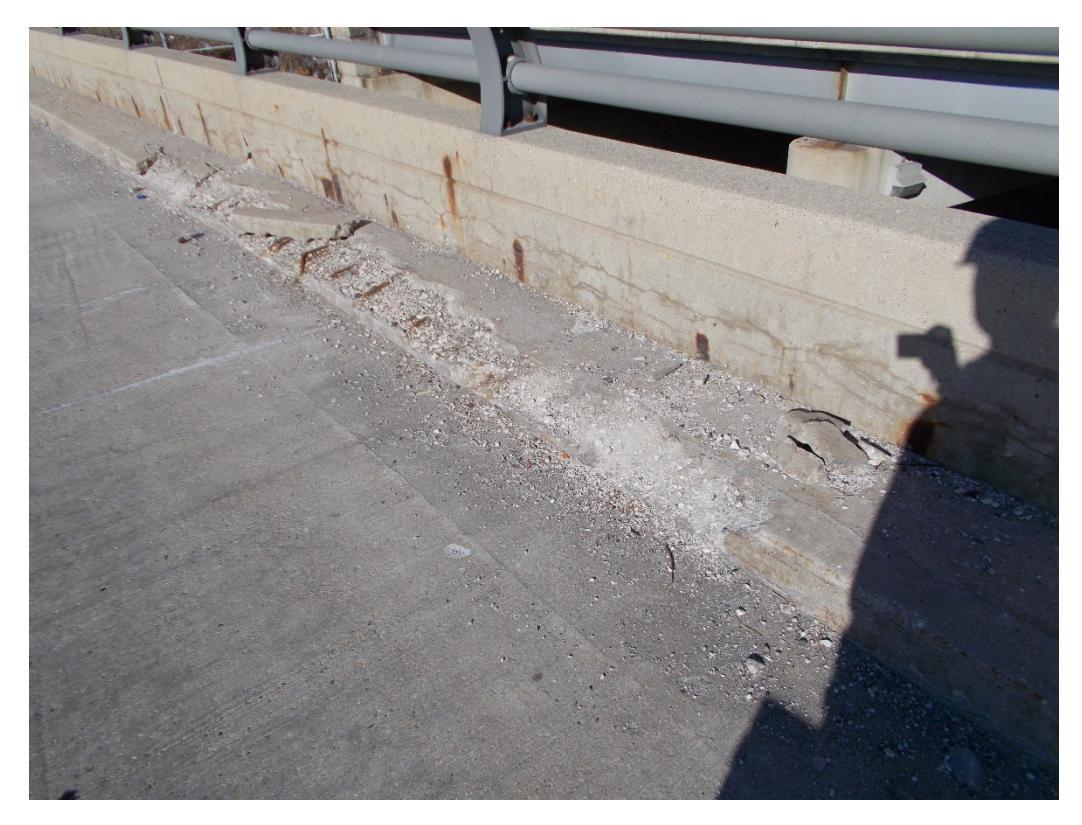
4) Curb spalling at north barrier

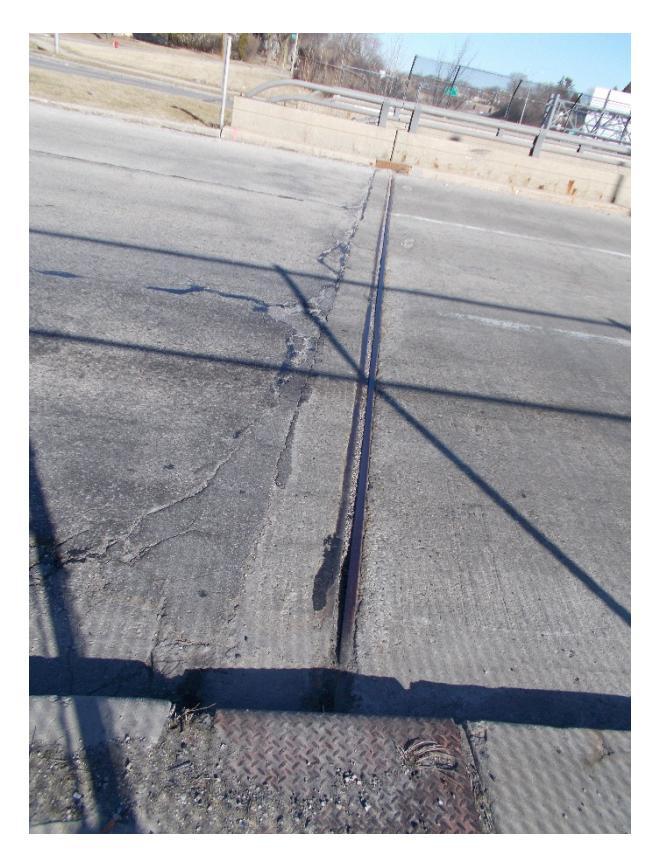
5) Expansion device at west abutment

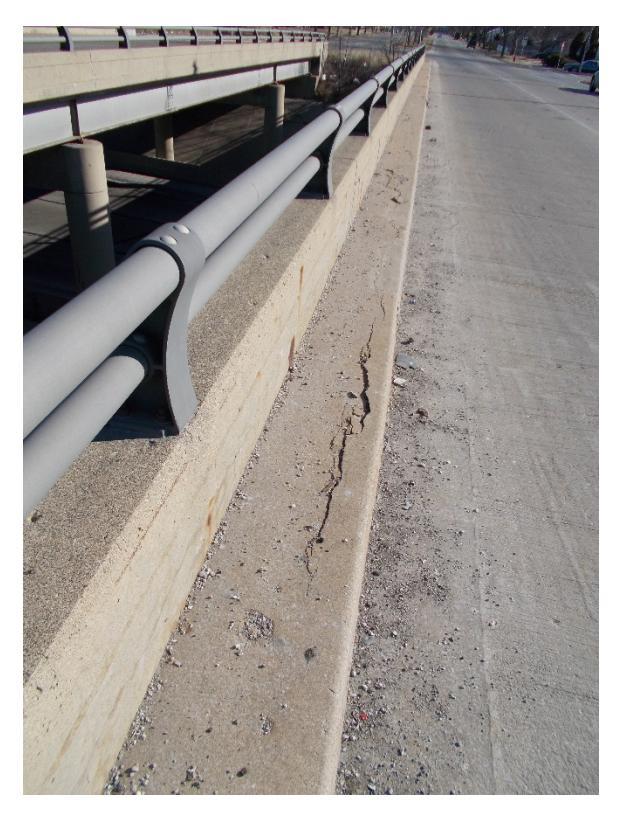
6) Curb deterioration at north side of structure

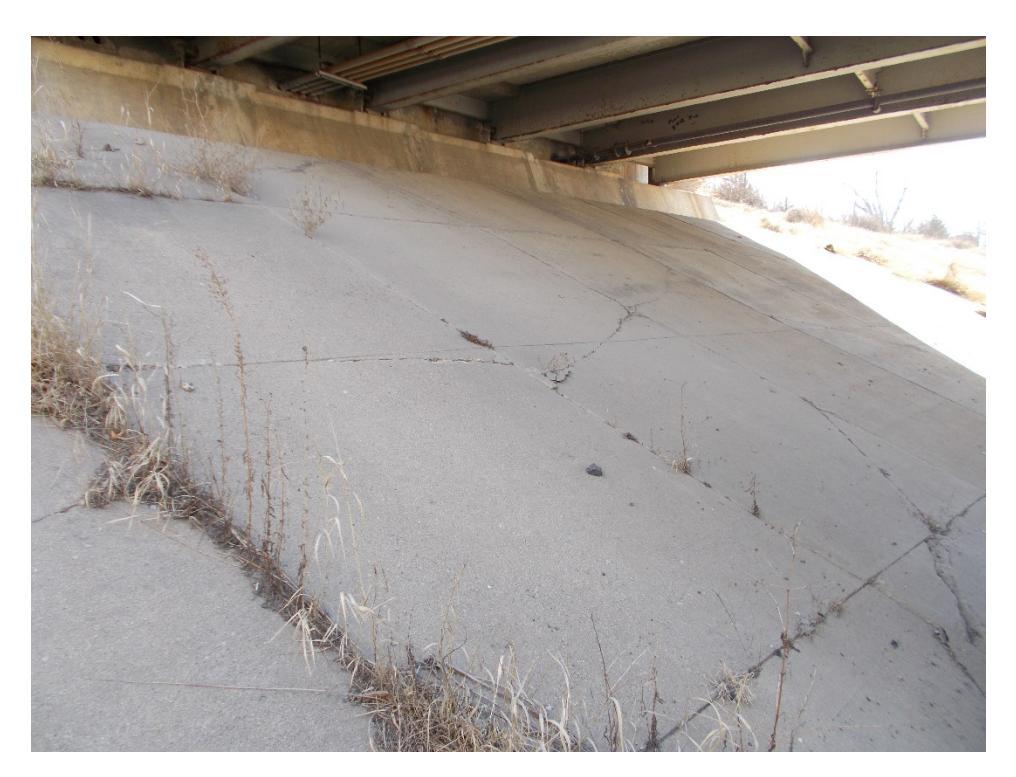
7) Slope paving in front of east abutment

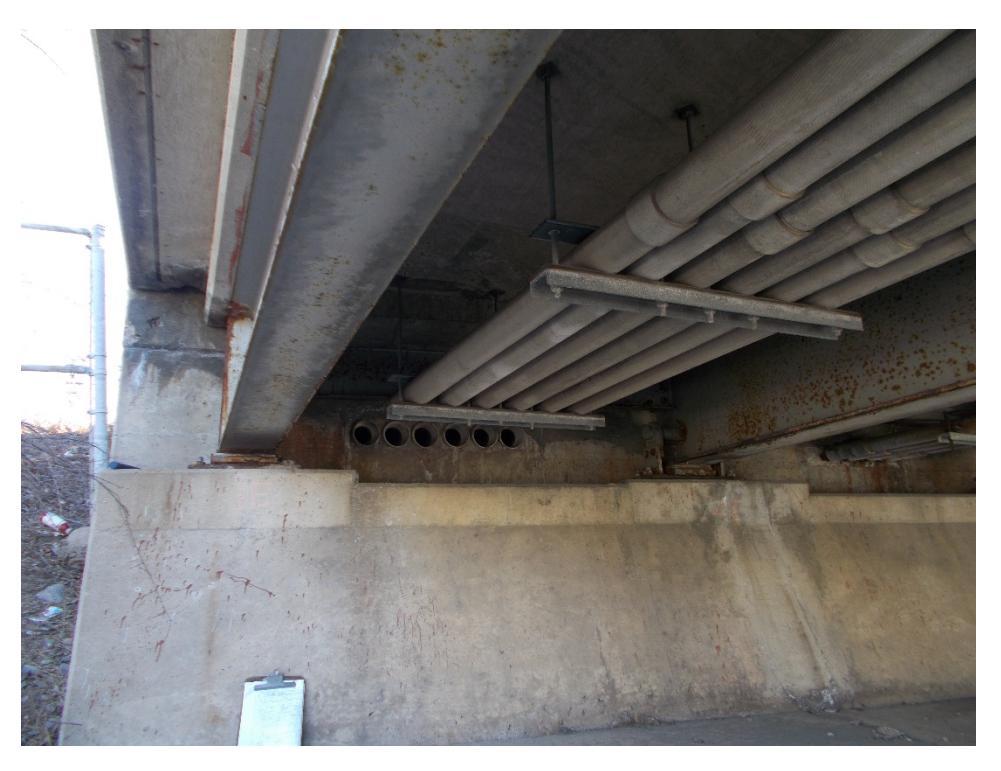
8) Disconnected conduit at east abutment between girders 1 & 2 (WIS ELECTRIC POWER CO ducts per original structure plans)

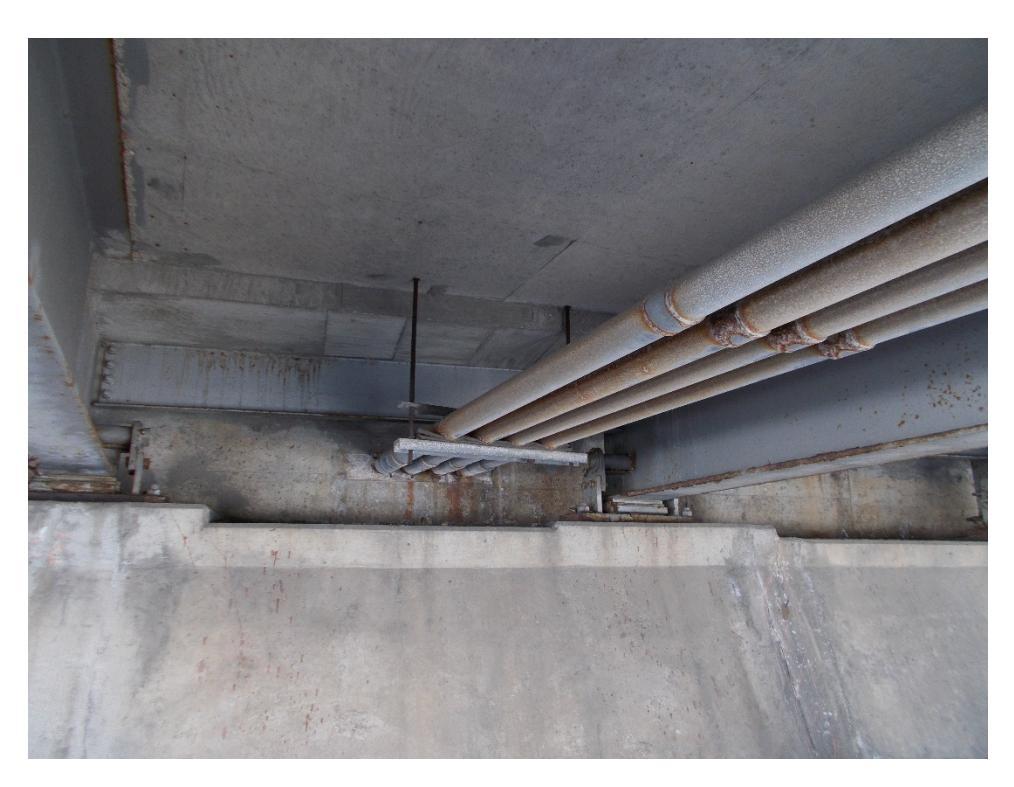
9) Conduit at east abutment between girders 2 & 3 (FIRE, POLICE & TRAFFIC CONTROL DUCTS per original structure plans)

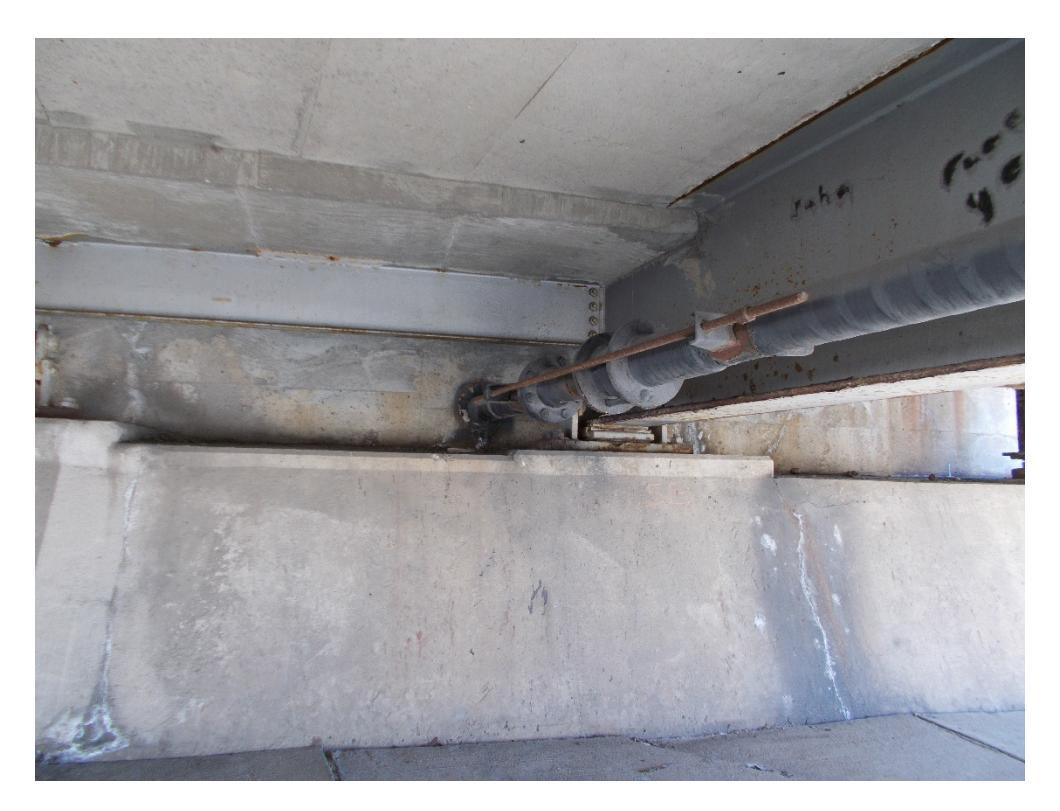
10) Gas main between girders 4 & 5 at east abutment

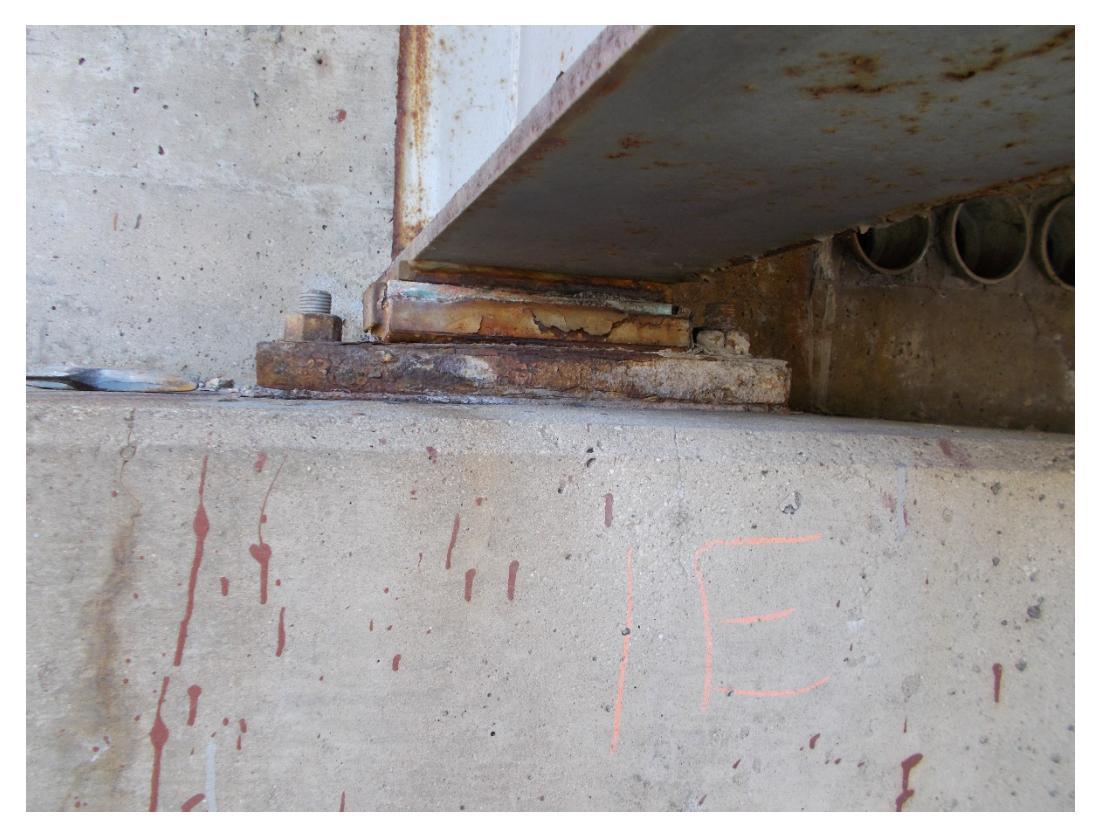
11) Girder 1 east abutment bearing condition

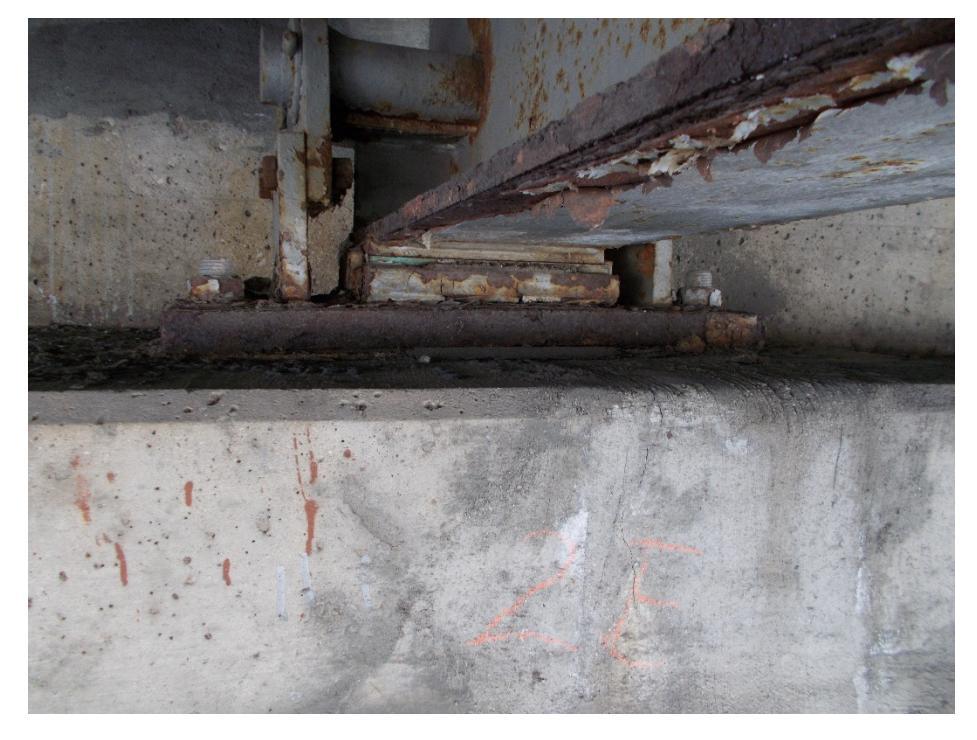
12) Girder 2 east abutment bearing condition

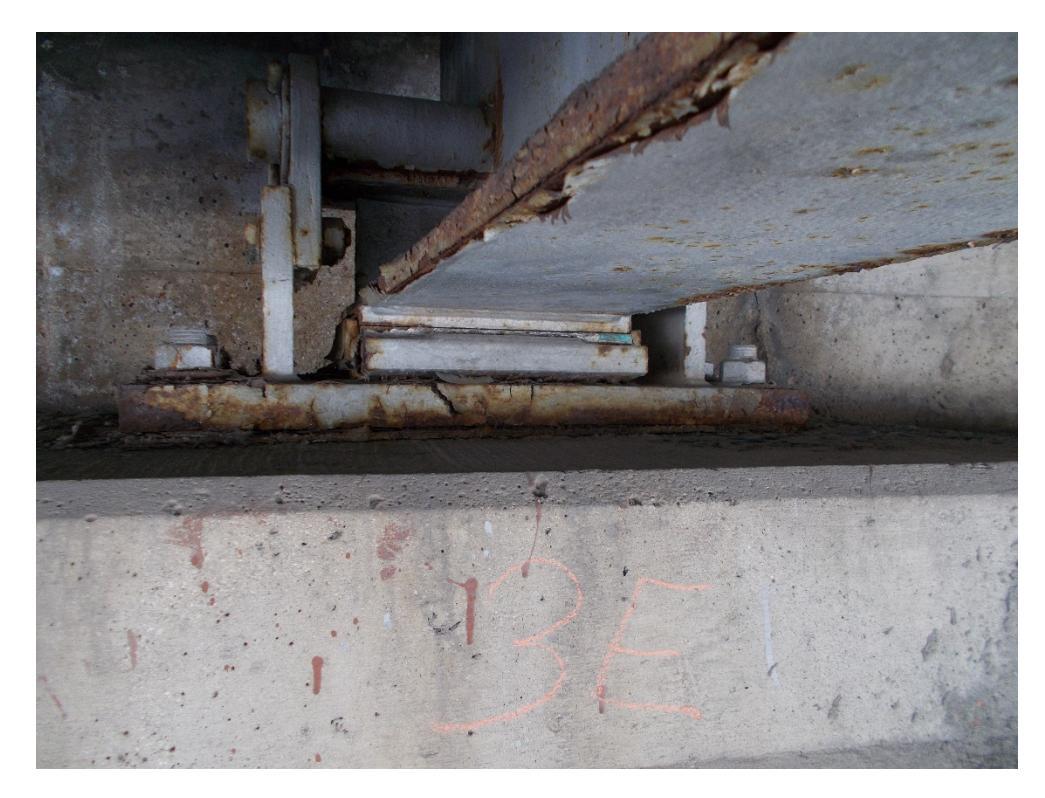
13) Girder 3 east abutment bearing condition

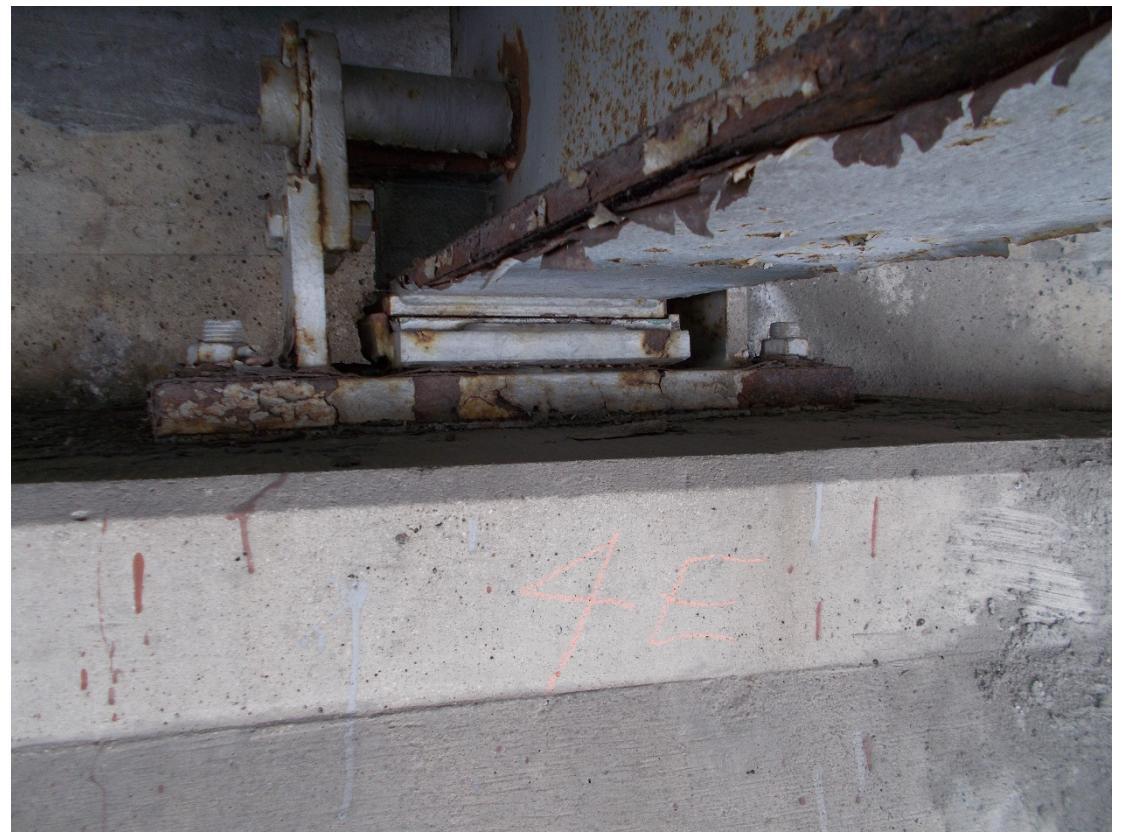
14) Girder 4 east abutment bearing condition

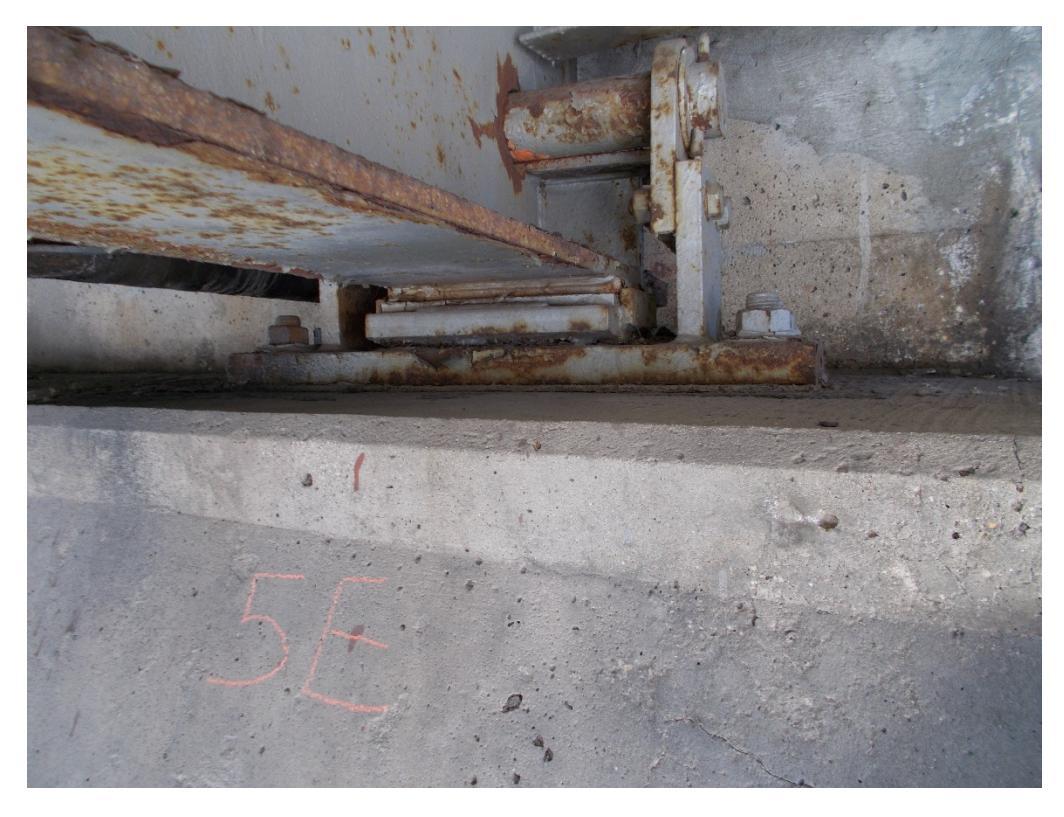
15) Girder 5 east abutment bearing condition

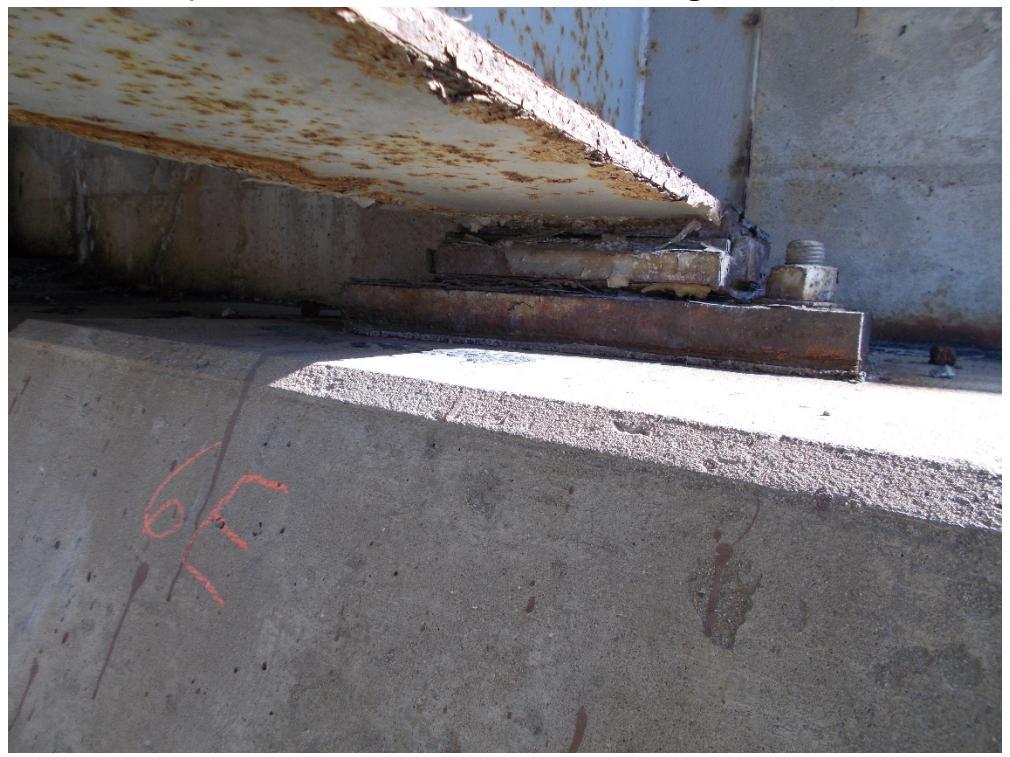
16) Girder 6 east abutment bearing condition

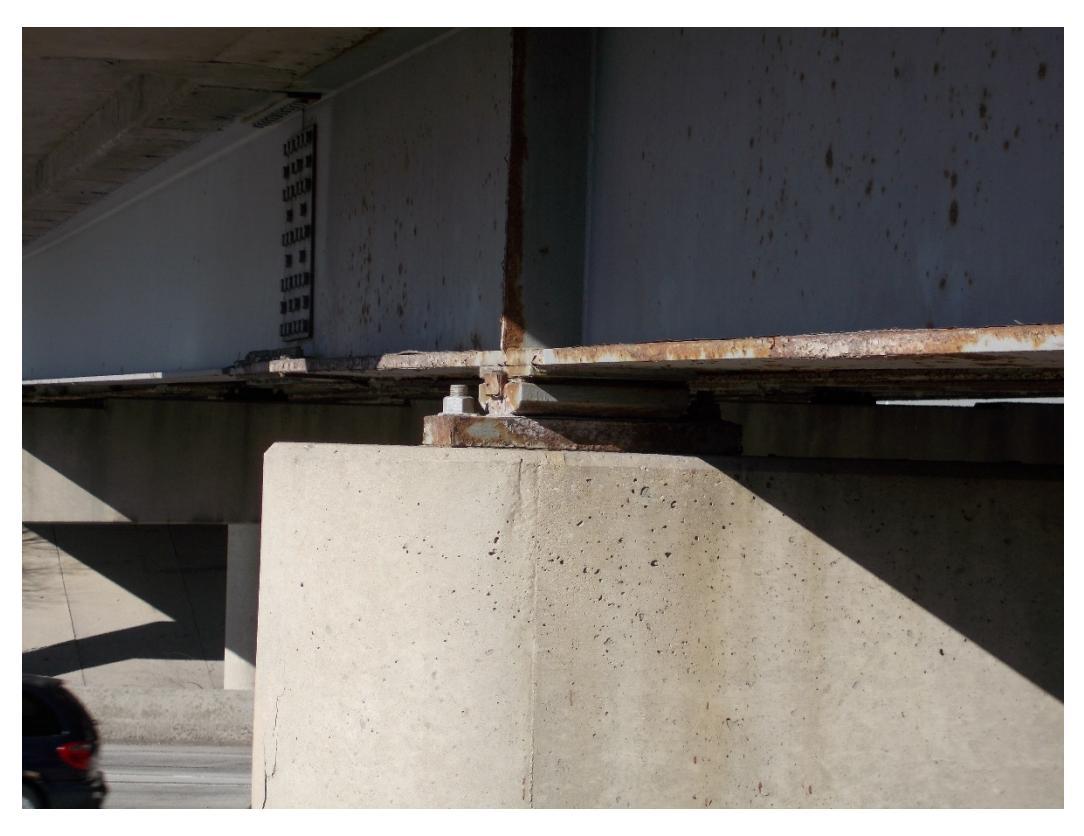
17) Girder 6 pier 3 bearing condition

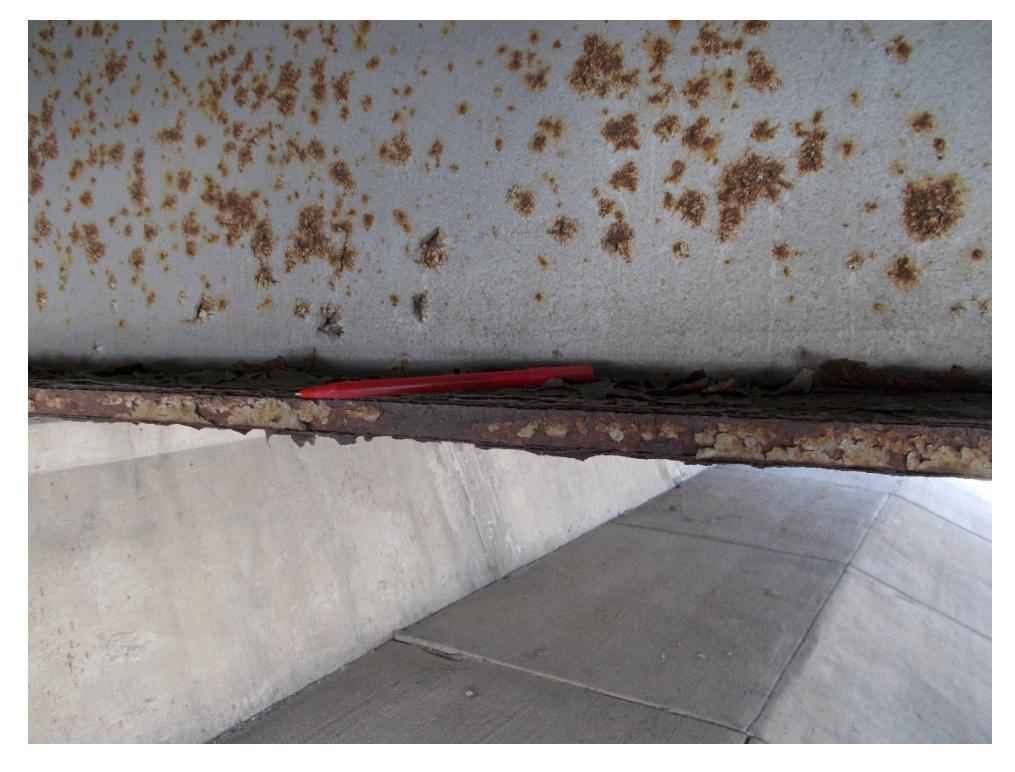
18) Paint system condition at east abutment

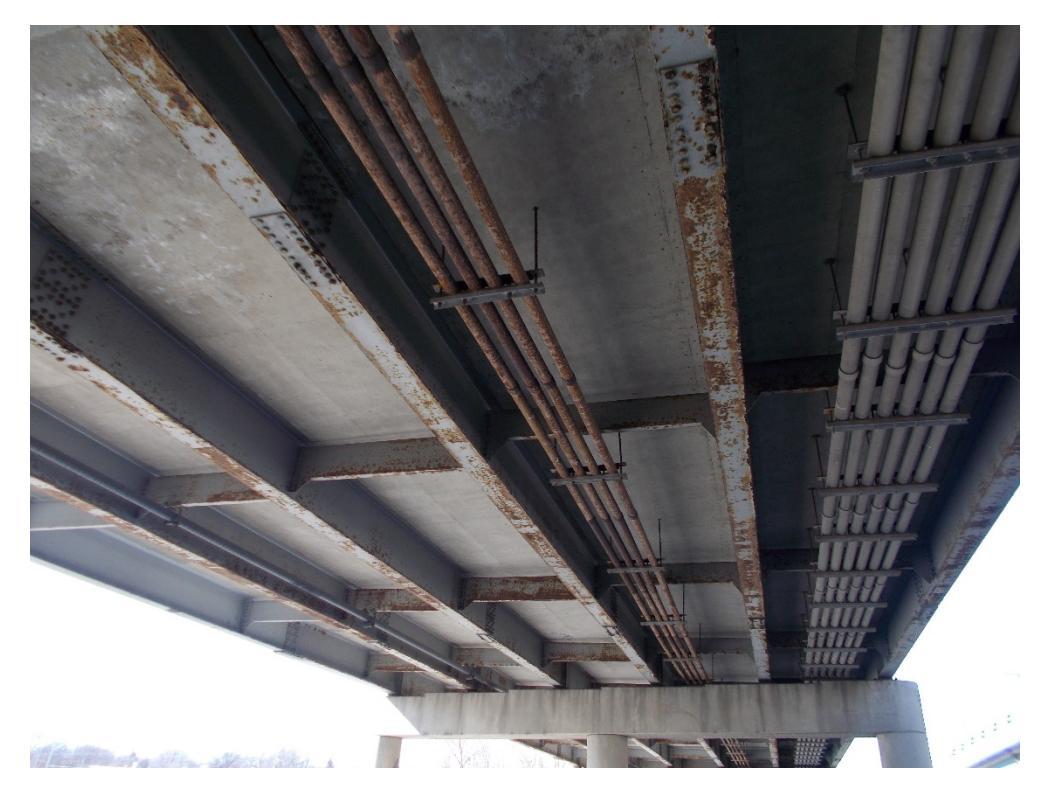
19) Paint system condition at span 3 looking west

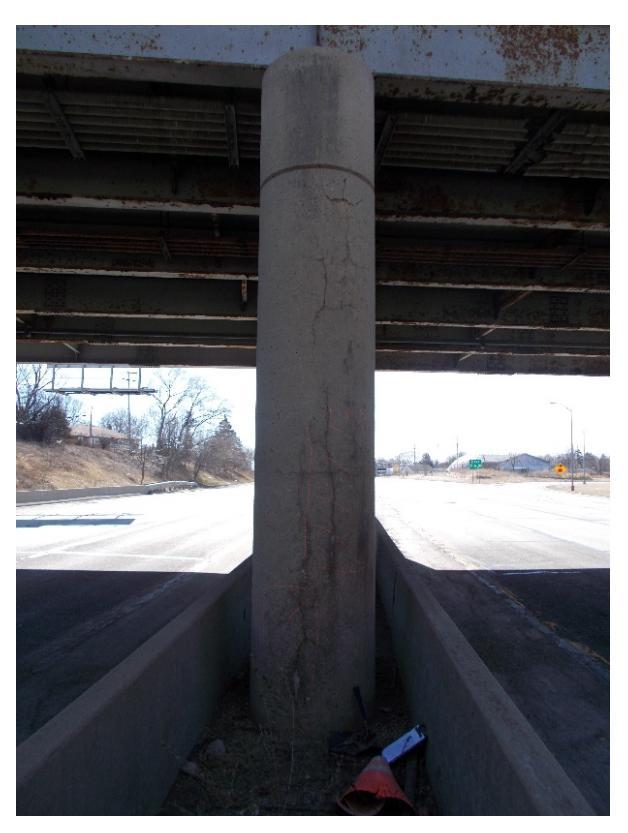
20) Delams at pier 2 column 1 north face

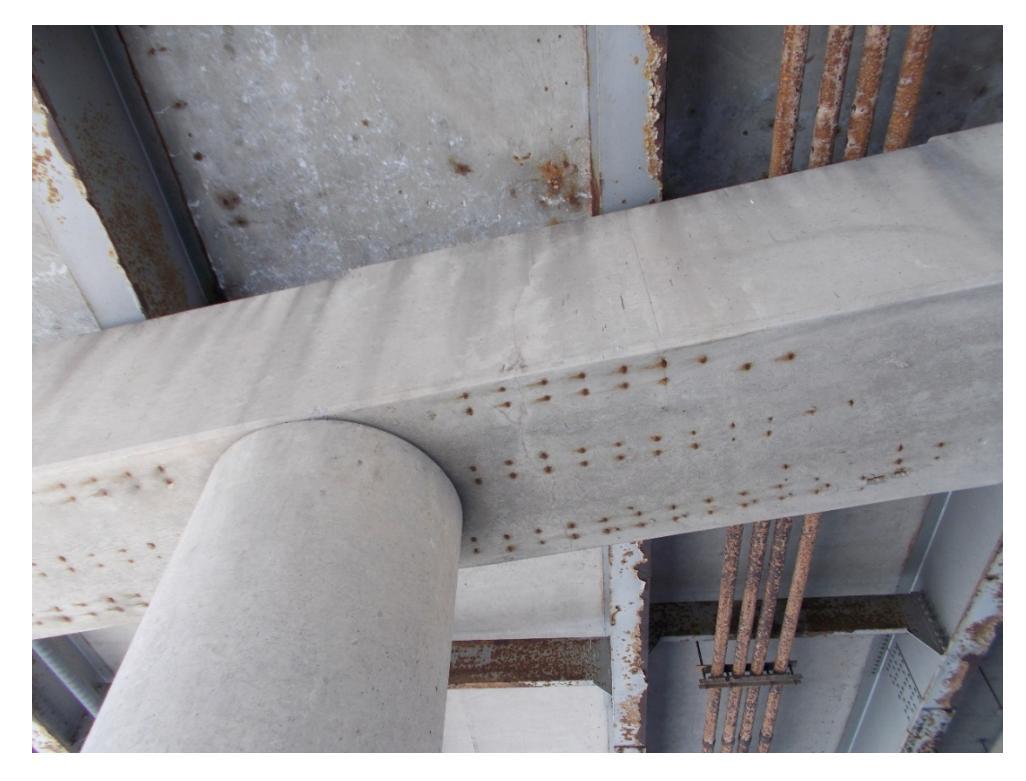
21) Vertical shear crack at pier 2 north of column 2 looking west

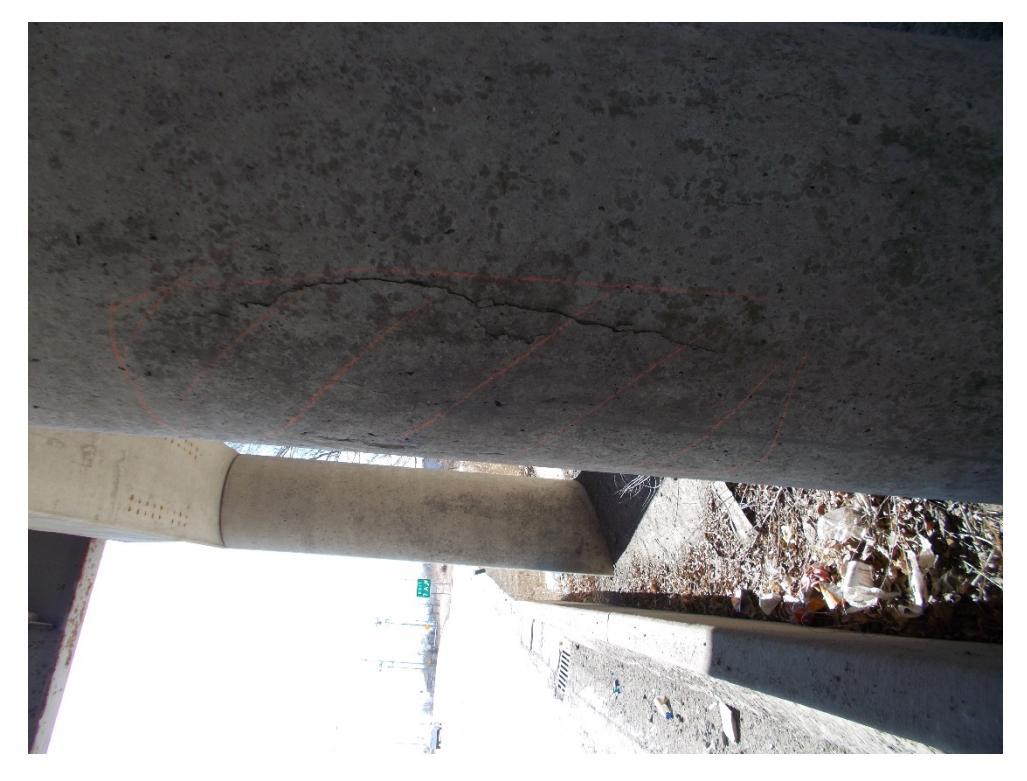
22) Delam at pier 1 column 2

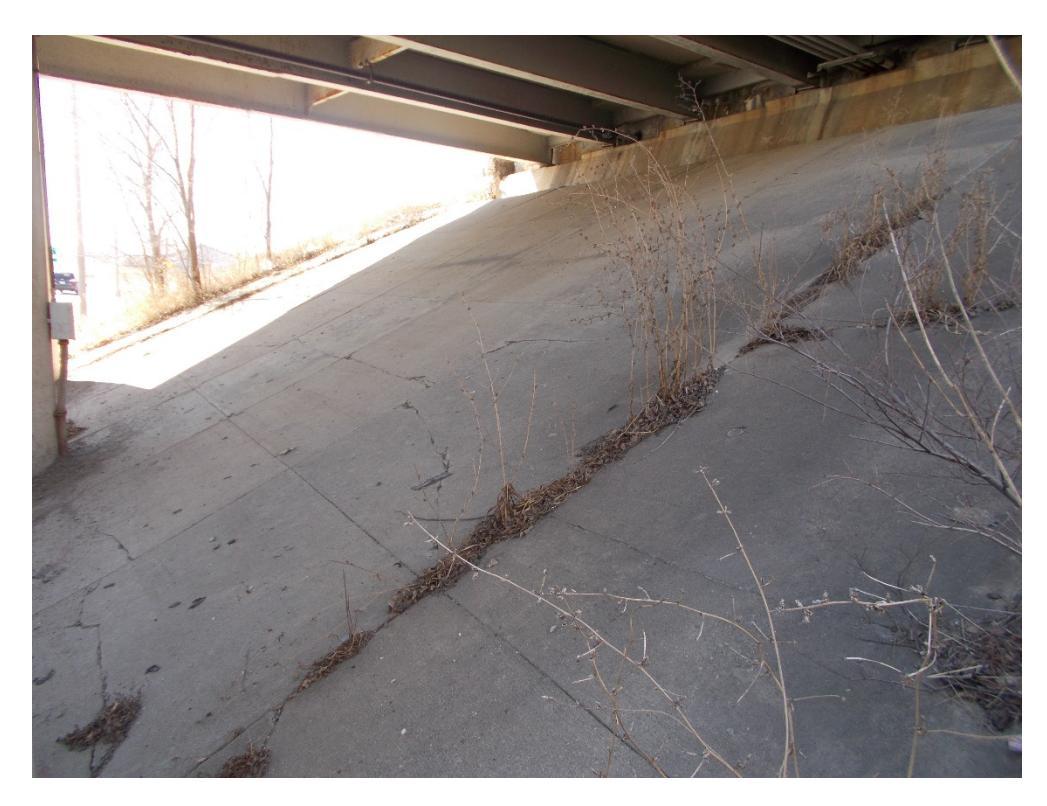
23) Slope paving in front of west abutment

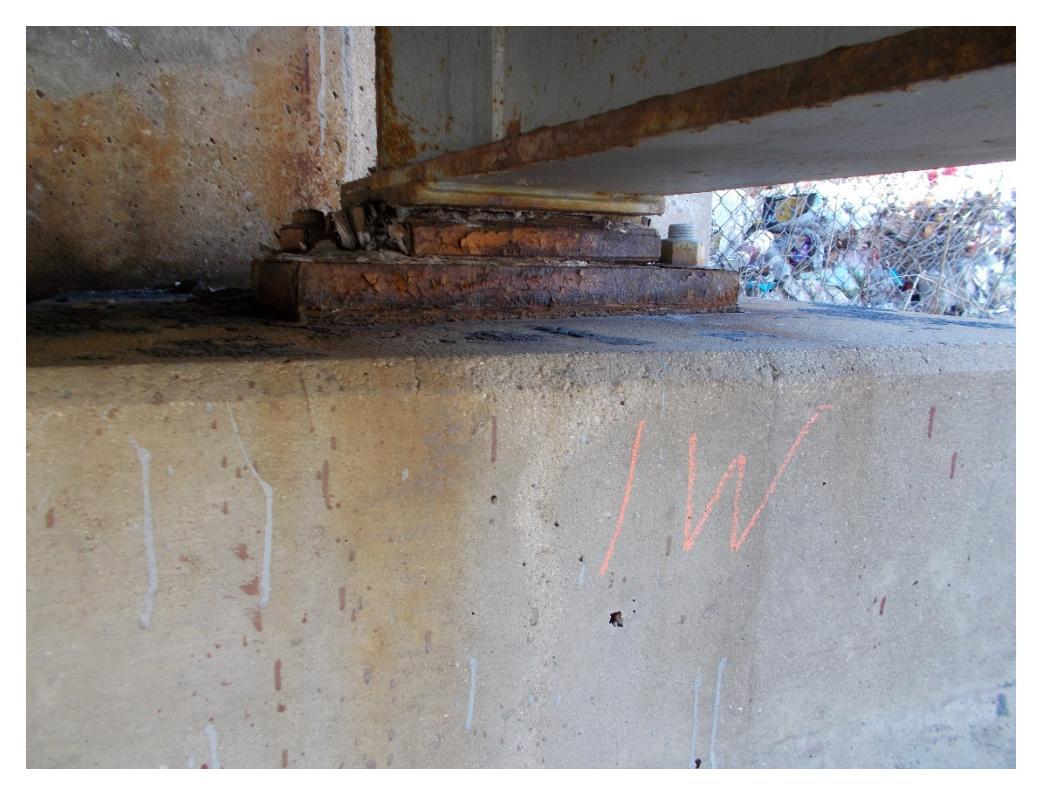
24) Girder 1 west abutment bearing condition

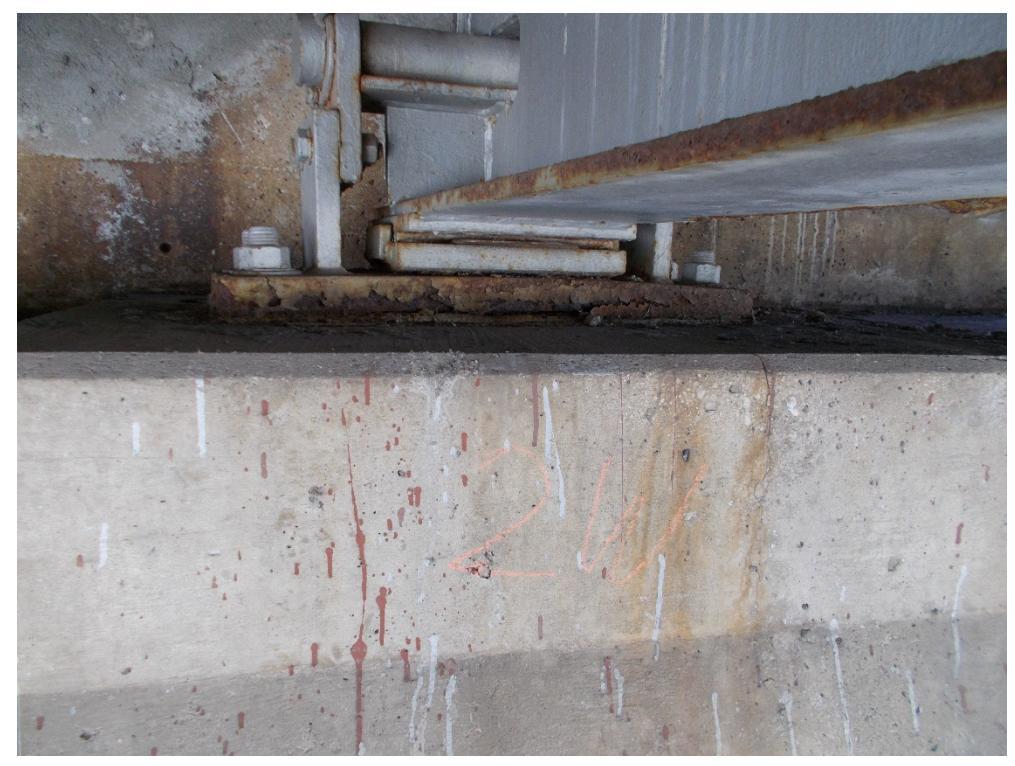
25) Girder 2 west abutment bearing condition. Noticeable concave distortion of masonry plate.

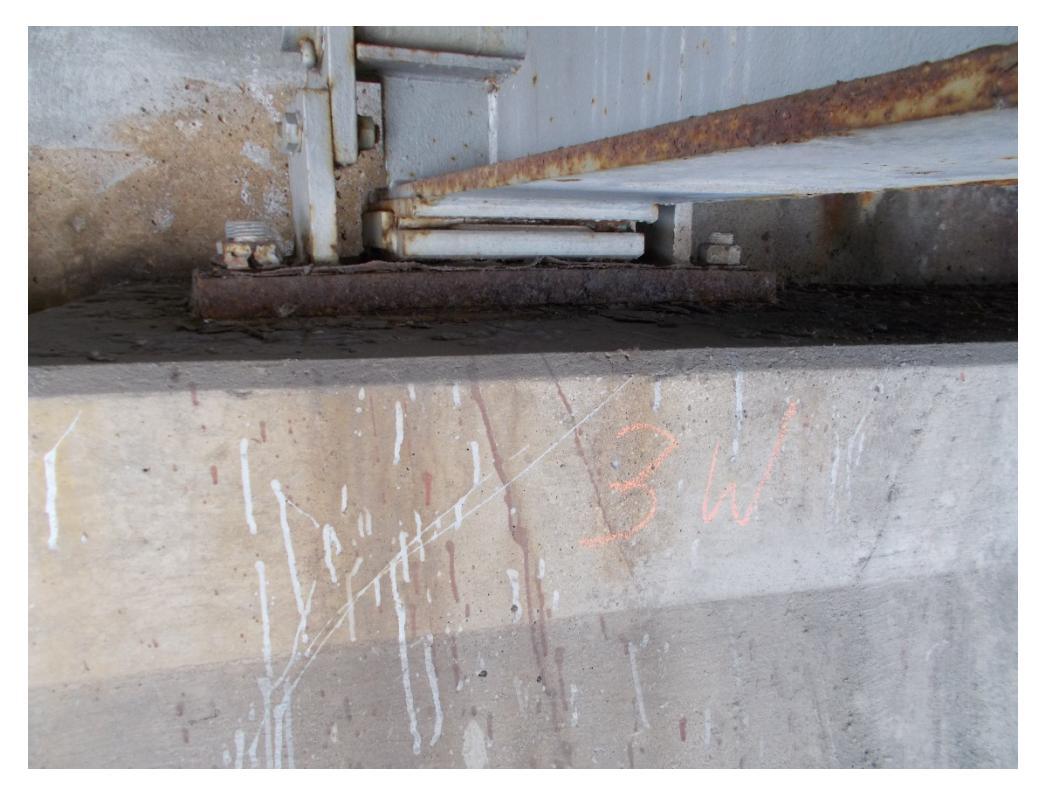
26) Girder 3 west abutment bearing condition

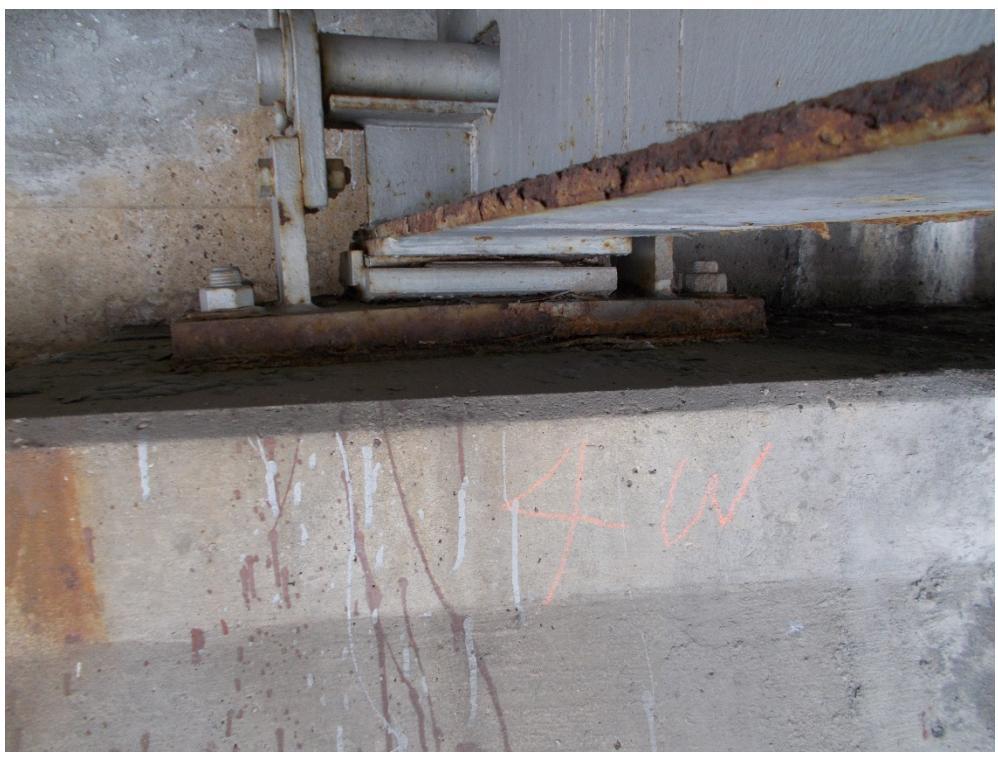
27) Girder 4 west abutment bearing condition.

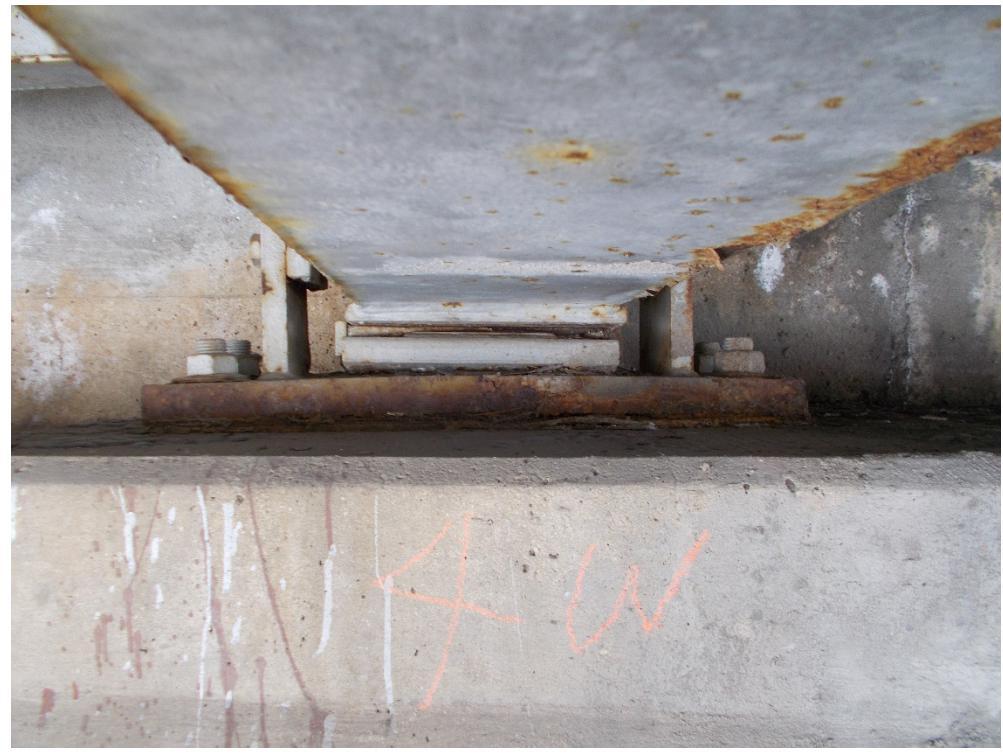
28) Girder 4 west abutment bearing. Noticeable concave distortion of masonry plate.

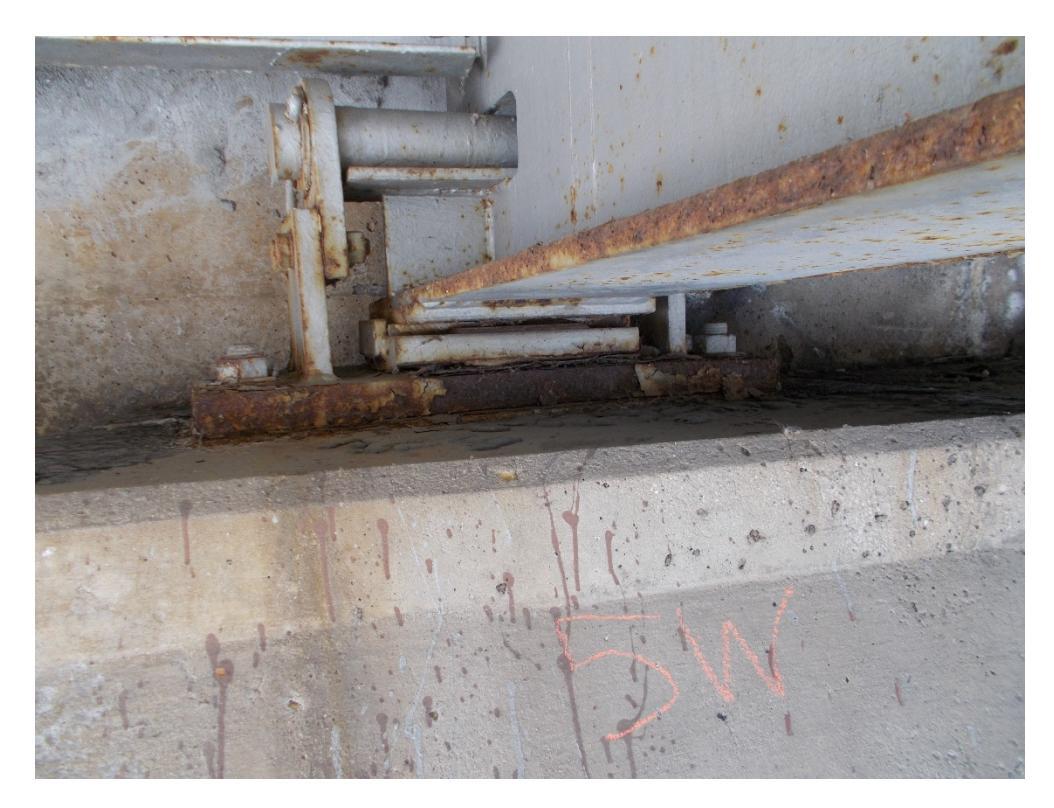
29) Girder 5 west abutment bearing condition

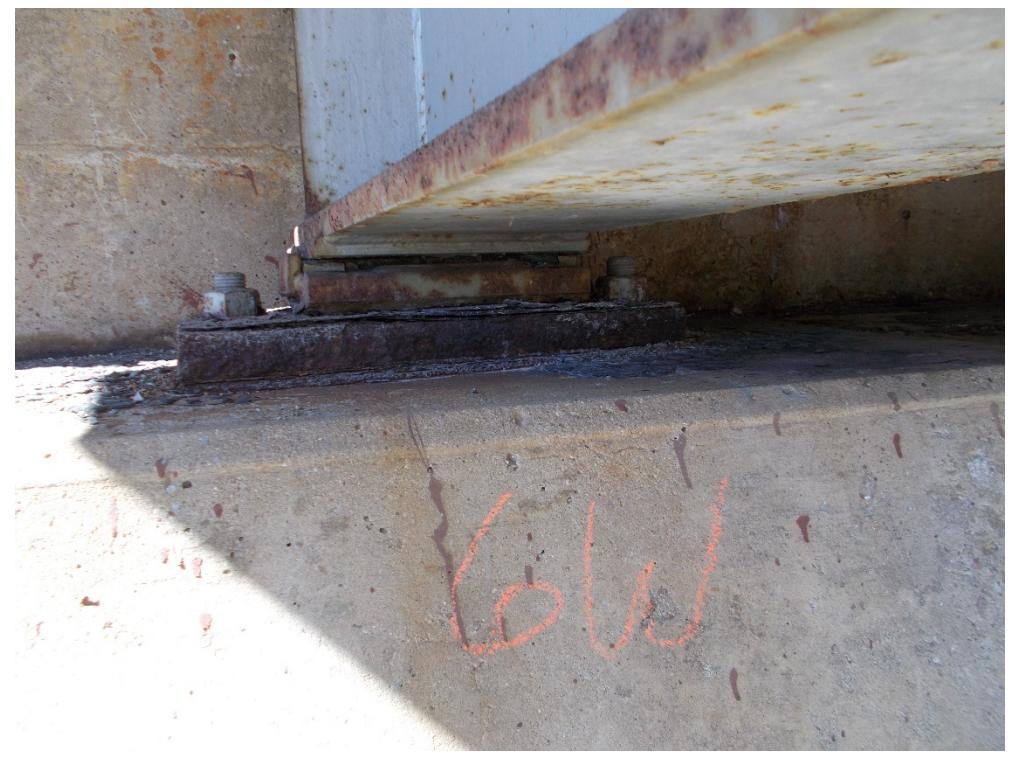
30) Girder 6 west abutment bearing condition
