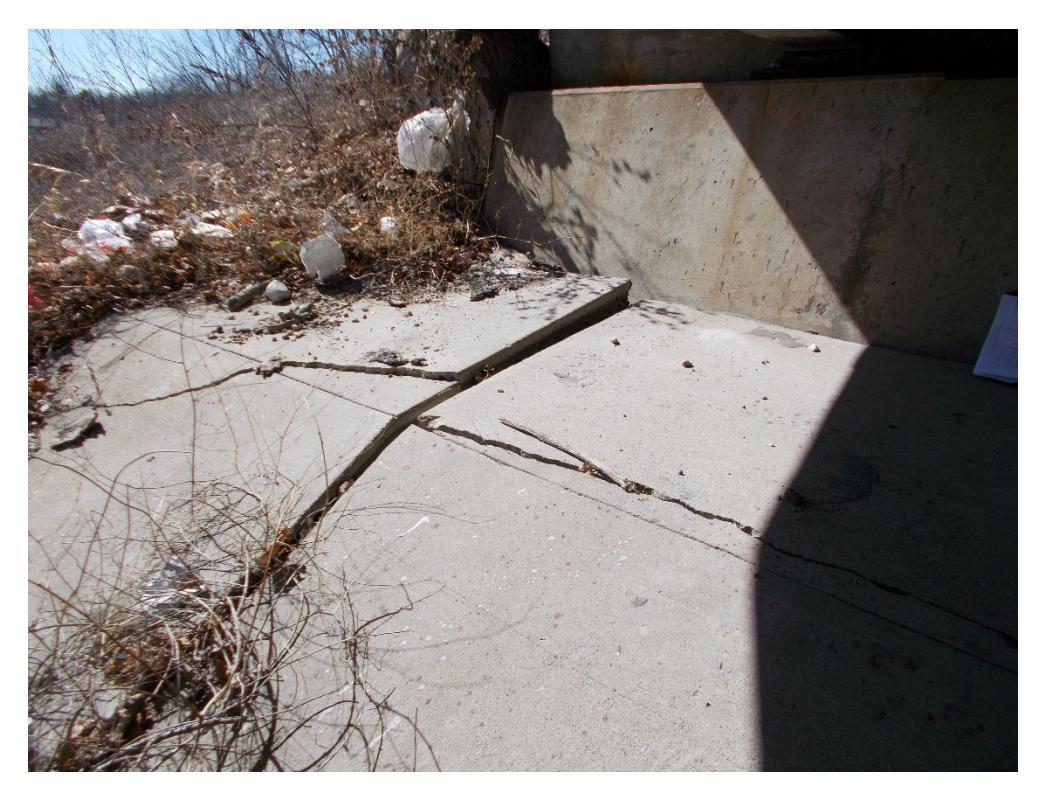
31) Slope paving in front of west abutment looking southwest

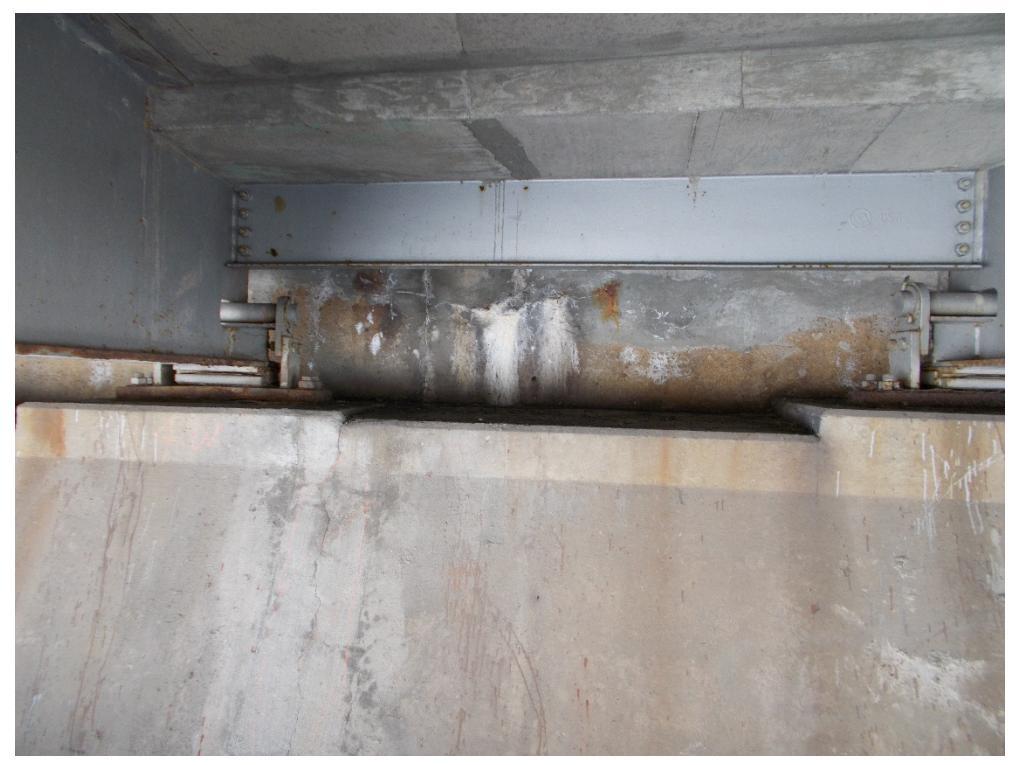
32) West abutment backwall condition

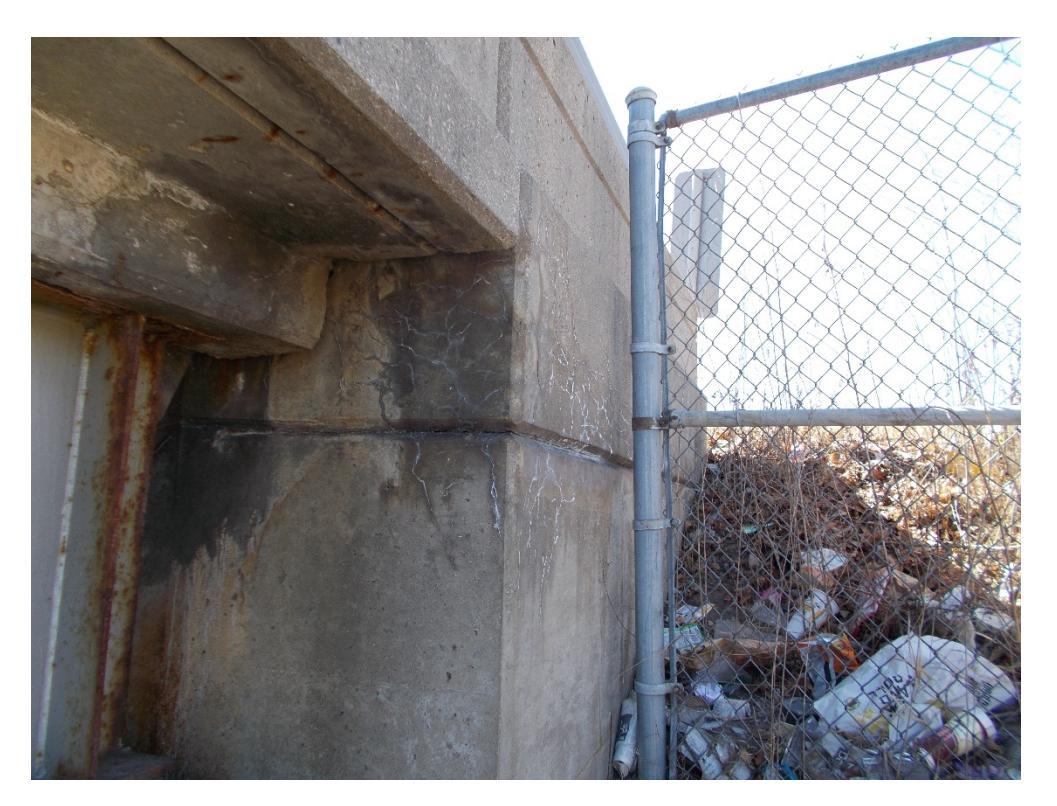
33) Leaching map cracks at northwest wingwall
