## **Bridge Asbestos Inspection Report**

WisDOT Project ID: 5783-03-00 Structure Number: B-12-618 Structure Name: STH 131 over Dellamater Hollow Creek City/County: Crawford County RMT Project Number: 10944.75 Date Inspected: April 19, 2010 Inspected By/License Number: John Roelke, All-119523

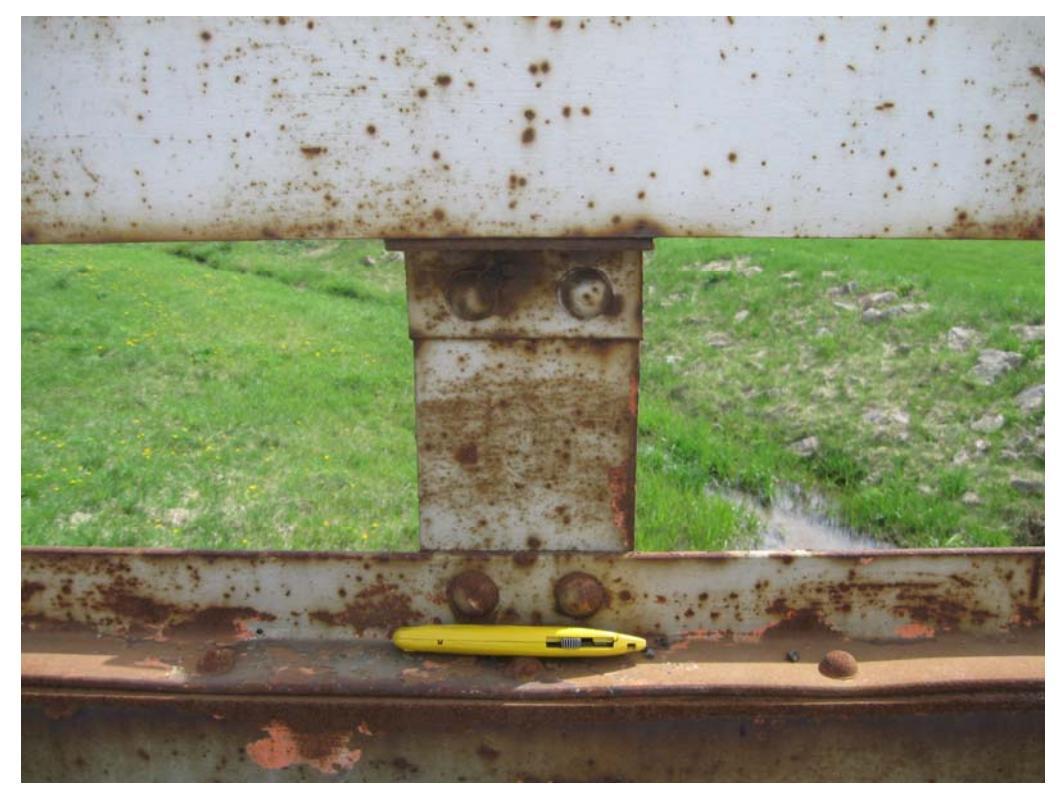
Paint on guardrail (6" long x 1" wide utility knife)
