Wisconsin Department of Transportation
Salt Shed Facilities Asset Management Condition Inspection Report

Region: Southwest
County: Dodge
Site ID: 1-14-33-1
Facility Type: Shed
Site Address: 271 West Lehman, Neosho
Date: March 15, 2016
Inspector: Phil Eagan

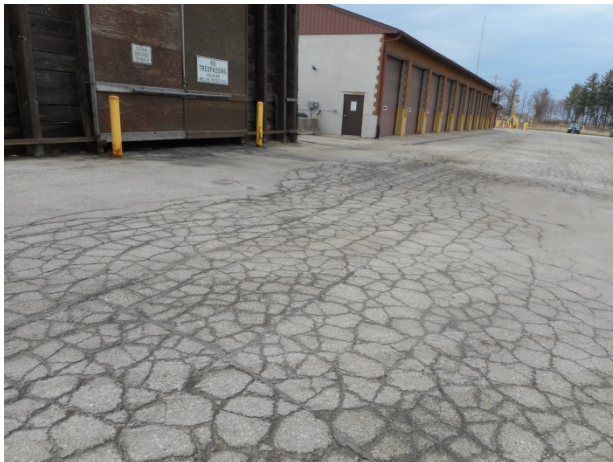
Asset	Comments	1 – Excellent	2 - Good	3 – Okay	4 – Poor	5 - Bad
Apron and Pad	Apron has approximately 80% alligator patterned cracking.					X
Ceiling and Roof	None		X			
Walls	Back wall bowed out.				X	
Doors	None		X
