Wisconsin Department of Transportation
Salt Shed Facilities Asset Management Condition Inspection Report

Region: Northeast
County: Manitowoc
Site ID: 3-36-22-5
Facility Type: Shed
Site Address: 318 W. Main St./CTH C, St. Nazianz
Date: March 23, 2016
Inspector: Marcus Hopkins

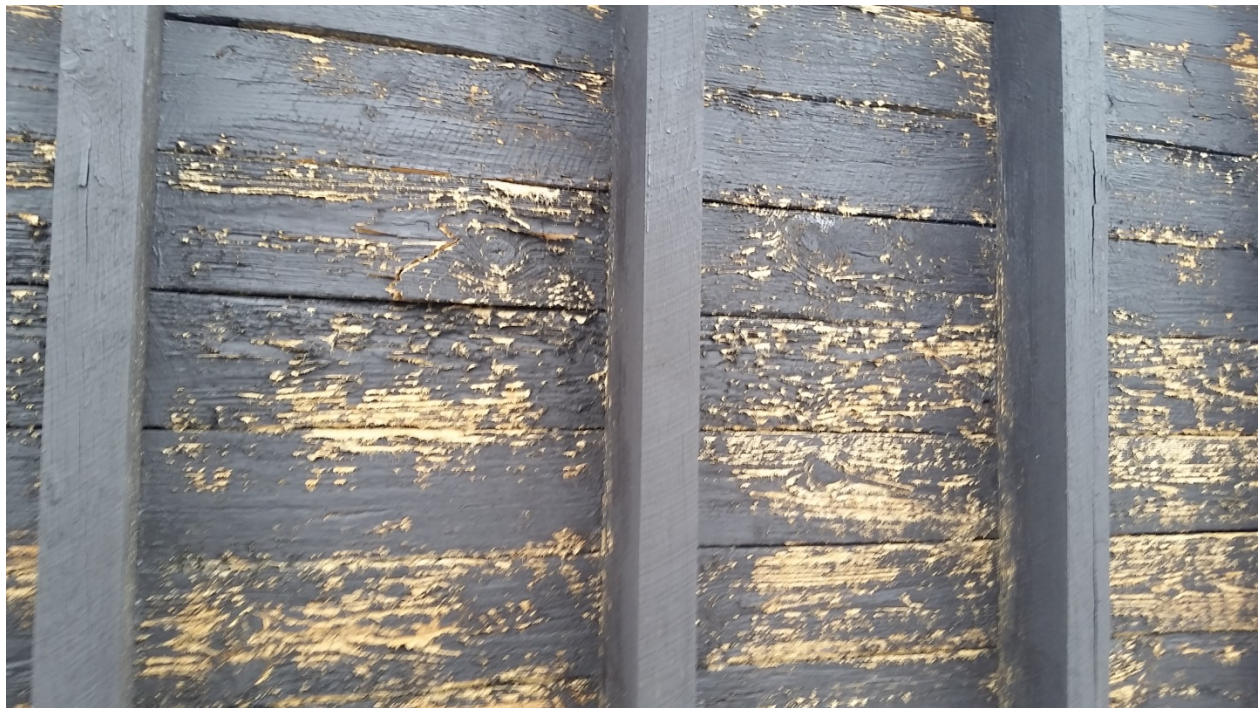
Asset	Comments	1 – Excellent	2 - Good	3 – Okay	4 – Poor	5 - Bad
Apron and Pad	None	X				
Ceiling and Roof	None		X			
Walls	Wood siding is beginning to crack and splinter. A section of the wood siding is soft to the touch, and can be pulled apart.			X		
Doors	None		X
