Wisconsin Department of Transportation  
Salt Shed Facilities Asset Management Condition Inspection Report

Region: North Central  
County: Menominee  
Site ID: 3-73-85-1  
Facility Type: Dome  
Site Address: W2703 Chief Carron Rd., Keshena  
Date: February 18, 2016  
Inspector: Todd Laska

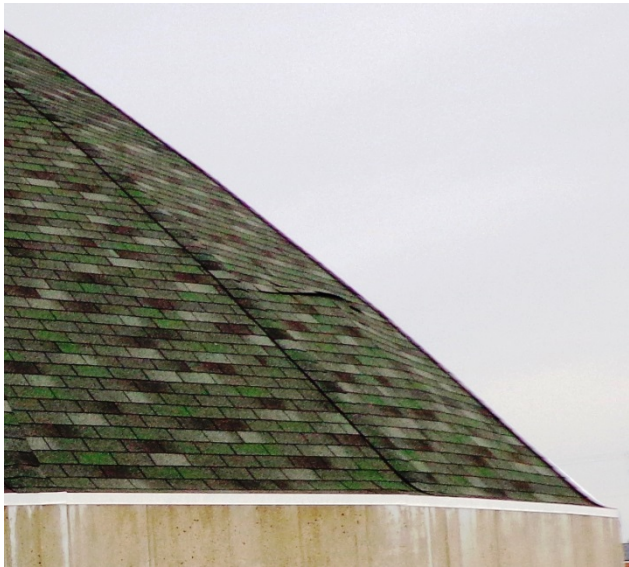
Asset	Comments	1 – Excellent	2 - Good	3 – Okay	4 – Poor	5 - Bad
Apron and Pad	None		X			
Ceiling and Roof	Small indentation in roof where loader likely hit.			X		
Walls	None		X			
Doors	Door needs to be replaced, not operating correctly according to Jeremy Weso. Door header damaged.				X
