Rest Area Inspection Guidebook

Instructions

The assets are broken down into 5 different categories, exterior, landscaping, equipment/systems, interior, and restrooms. Each asset will be given a condition rating.

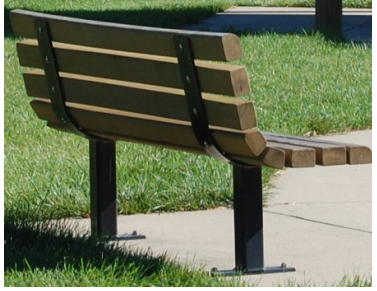
Rating	Condition/ Action	Description	Example
1	Excellent	Benches are functioning as they were intended and are in good condition.

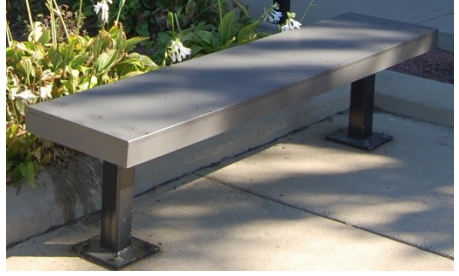
Review in 10 years		
2	Good	Bench is functioning as it should, it is structurally sound, if metal, it may have some small areas of rust, if wood, it may have small cracks that do not affect the structural stability.

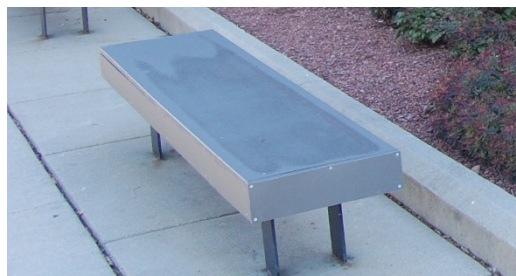
Review in 5 years		
3	Okay	Bench is functioning, it may contain some small areas of graffiti, or it may have sharp edges. If wood, it may need to be stained, if metal, it may have areas of rust.

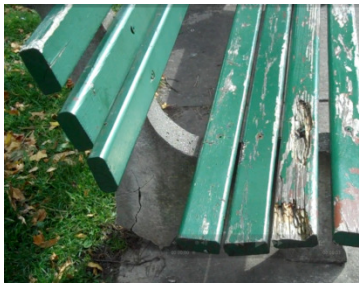
Review in 1 year		
4	Poor	Bench is functioning, but it has rough or sharp edges. If wood, it may be uncomfortable due to rotted wood or it needs to be stained. If metal it may have large areas of rust, or be rusted through in some small areas.

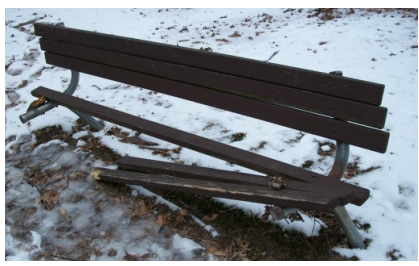
Schedule for Repair		
5	Bad	Bench is broken and is no longer functional.

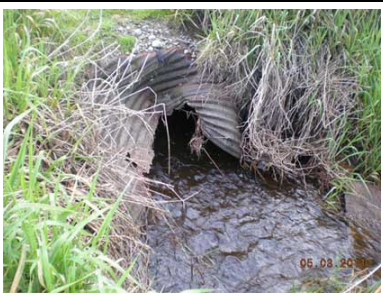
Review in 1 year		
4	Poor	Culvert bottom does not allow for proper drainage. Concrete culvert may have large cracks or large pieces broken off. Metal culvert may have large dents, be bent in a way that slows water flow, or have small holes.

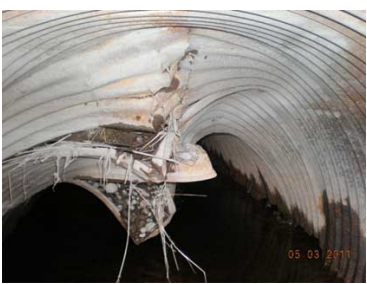
Schedule for Repair		
5	Bad	Culvert has collapsed in on itself or no longer allows water to flow through it.

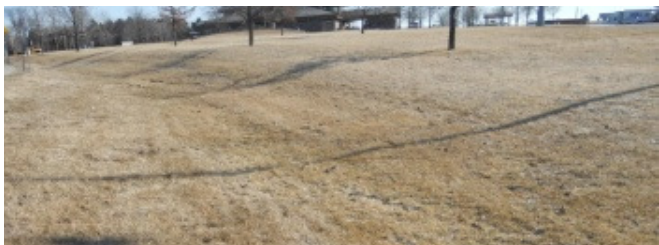
Rating	Condition/ Action	Description	Example
1	Excellent	Ditch is functioning as originally intended and is in good condition.

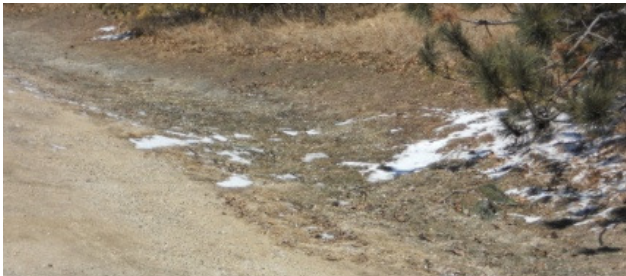
Review in 10 years		
2	Good	Ditch functions as it should but there may be a small amount of debris, rocks, litter or large plants, that slow the flow of water.

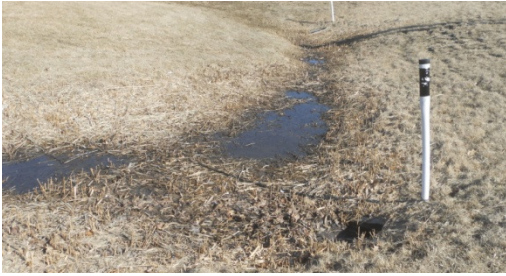
Review in 5 years		
3	Okay	Ditch functions for the majority of the time, but there is debris that slows the flow of water, occasionally debris is built up that could cause flooding, or some small areas do not drain properly.

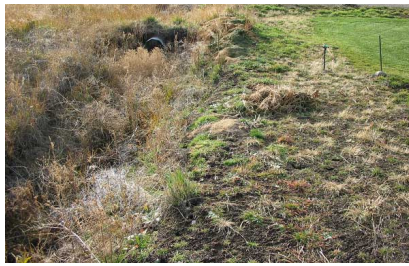
Review in 1 year		
4	Poor	Ditch is blocked by debris such as large rocks, large plants or litter and sometimes flooding occurs.

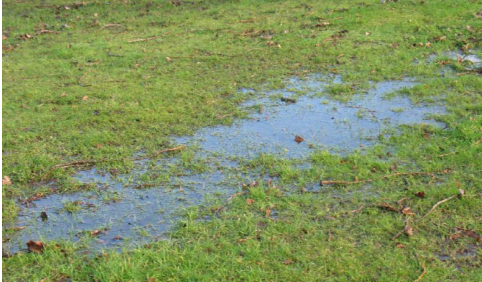
Remove Debris/ Restore Flow		
5	Bad	Ditch has been filled in, no longer drains, is too shallow and causes flooding easily, or is obsolete.

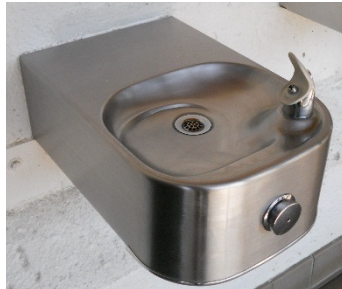
Rating	Condition/ Action	Description	Example
1	Excellent	Drinking fountains are functioning as originally intended and are in good condition.

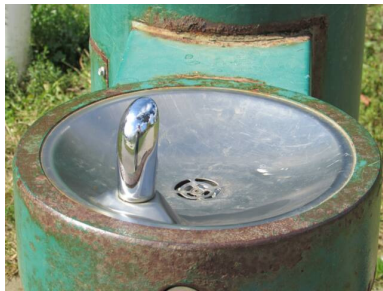
Review in 1 year		
4	Poor	Drinking fountain has minimal water pressure, contains large amounts of corrosion or rust, is not secure to the wall, or handle is difficult to use.

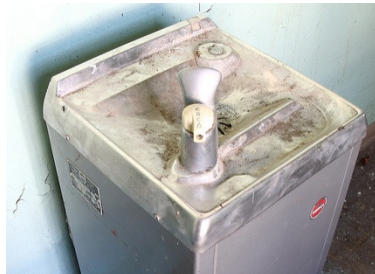
Schedule for Repair		
5	Bad	Drinking fountain is no longer working, has large amounts of rust or corrosion that affect the condition of the water, or is not secure in place.

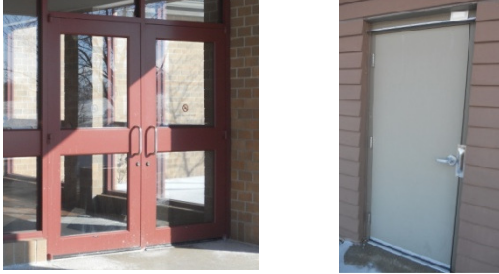
Rating	Condition/ Action	Description	Example
1	Excellent	Exterior doors are functioning as originally intended and are in good condition.

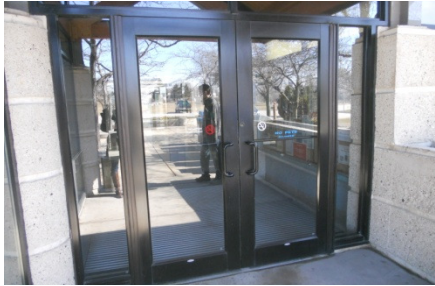
Review in 10 years		
2	Good	Exterior doors function as they should but may have small areas of chipping paint or rust.

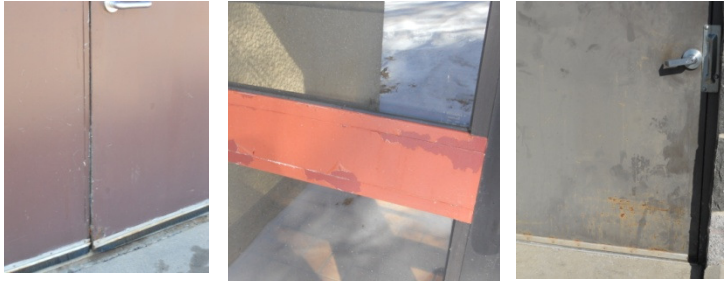
Review in 5 years		
3	Okay	Exterior doors may have dents, areas of chipping paint, areas of rust, may not fully close properly, or the handle may be difficult to use.

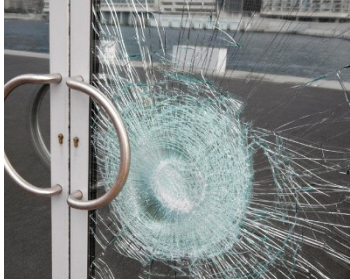
Review in 1 year		
4	Poor	Exterior door handle or lock is broken, the hinges may not hold the door secure in place, there are large areas of chipping paint or rust, or glass is cracked or broken.

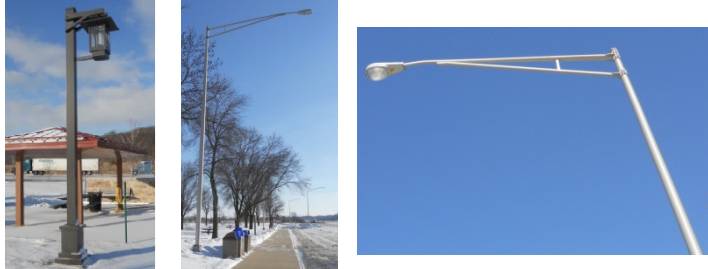
Rating	Condition/ Action	Description	Example
1	Excellent	Exterior lighting is functioning as originally intended and is in good condition.

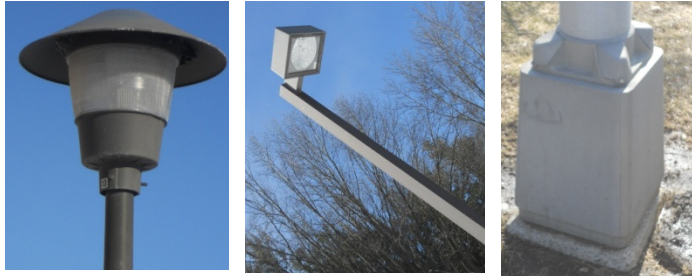
Review in 10 years		
2	Good	Exterior lighting usually functions as it should, there may be small areas of rust or light covers may be a little unclear.

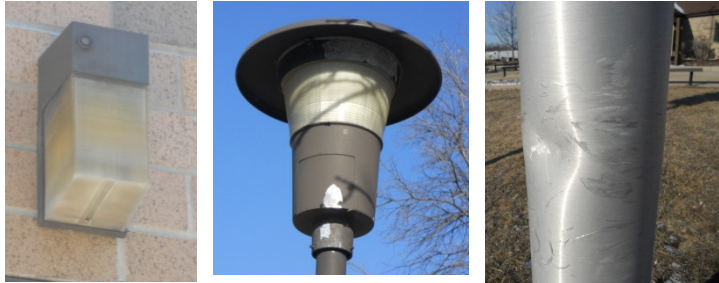
Review in 5 years		
3	Okay	Exterior lighting does not always work properly, it may contain rust, small dents or cracks, or light covers may be unclear

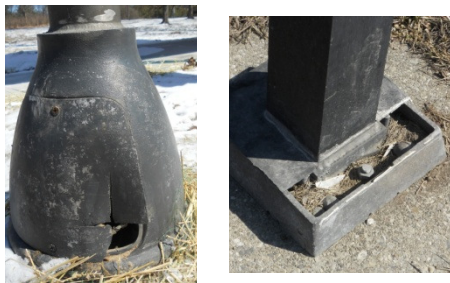
Review in 2 years		
4	Poor	Exterior lighting is no longer functioning properly, it contains rust, dents or cracks, it is not fully secure in place, the access panel is missing or there are exposed wires.

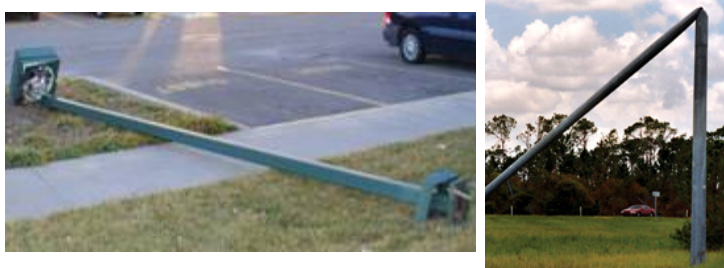
Schedule for Repair		
5	Bad	Exterior lighting is not secure in place, has fallen over, or is no longer in a safe working condition and requires major repair or replacement.

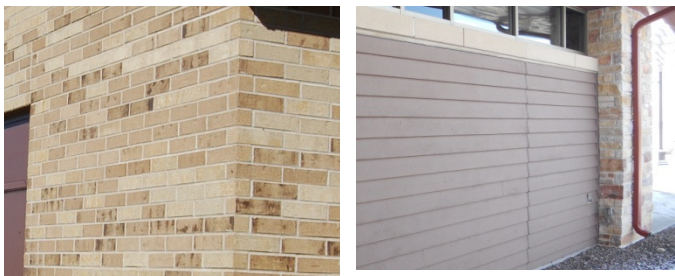
Rating	Condition/ Action	Description	Example
1	Excellent	Exterior walls are functioning as originally intended and are in good condition.

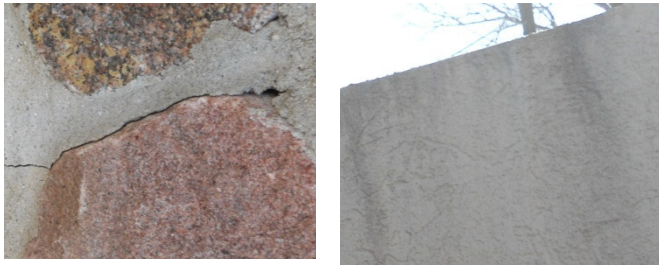
Review in 10 years		
2	Good	Exterior walls are functioning as they should but, siding may be slightly faded or have small dents, small areas of paint may be chipping or brick walls may have small cracks in grout.

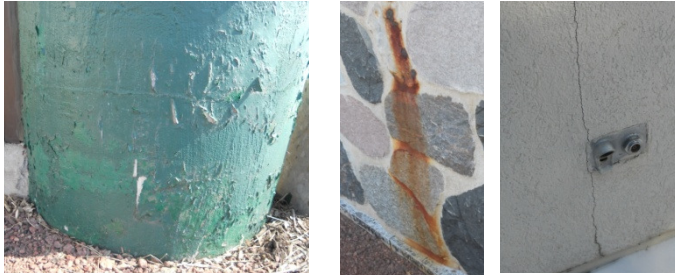
Review in 5 years		
3	Okay	Siding on exterior walls may have some cracks, paint may be faded or is significantly chipping, or bricks may have some cracks or deteriorating grout, or there may be some water damage.

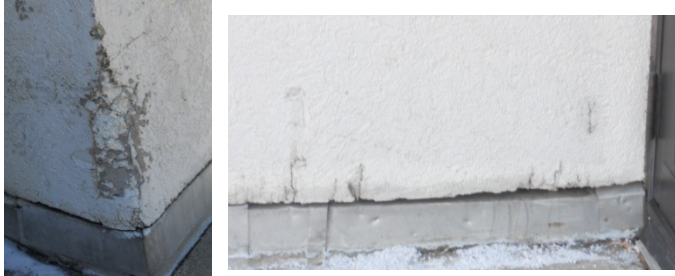
Review in 1 year		
4	Poor	There are missing pieces of siding, large areas of paint are chipped off, large areas of grout are missing, or there are large areas with water damage.

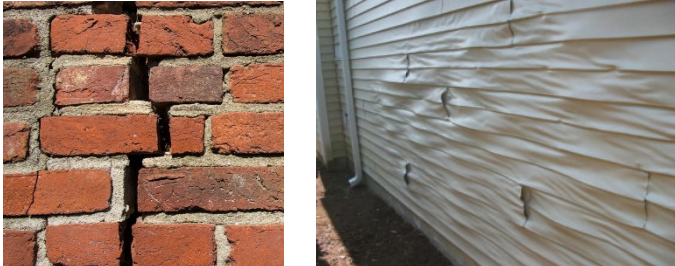
Schedule for Repair		
5	Bad	Large amounts of siding or brick are missing or severely cracked or damaged, or the wall is no longer structurally sound.

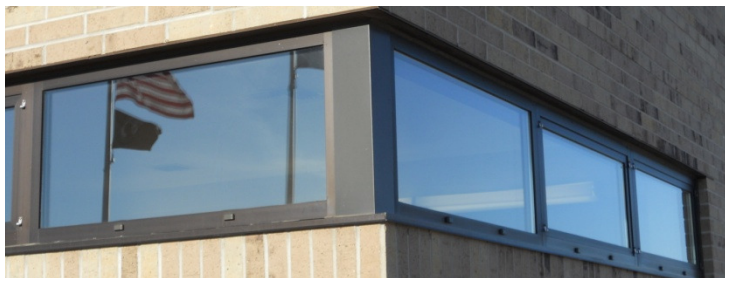
Rating	Condition/ Action	Description	Example
1	Excellent	Windows are functioning as originally intended and are in good condition.

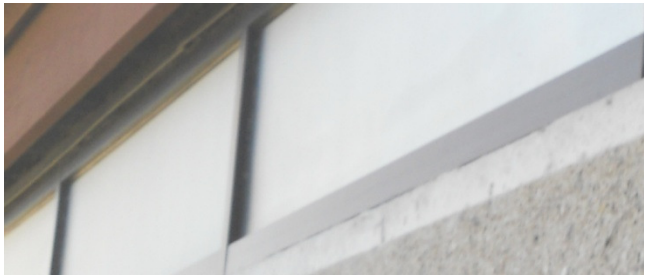
Review in 10 years		
2	Good	Windows are functioning as they should but some caulking may be beginning to deteriorate around the edges of the window.

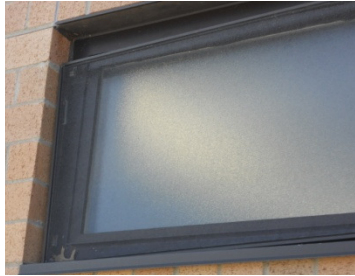
Review in 5 years		
3	Okay	Window trim may be rusting, there are minor cracks in one of the panes, or there is some evidence of water in between the panes.

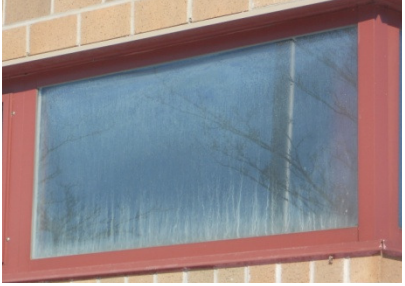
Review in 1 year		
4	Poor	Windows contains cracks, caulking is missing or there is water damage between the panes.

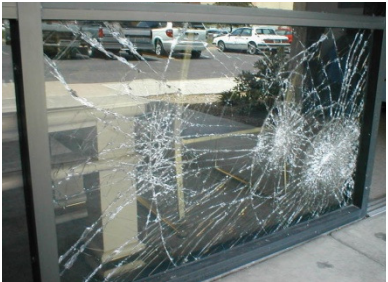
Schedule for Repair		
5	Bad	Window glass is broken or missing or window casing is damaged beyond repair.

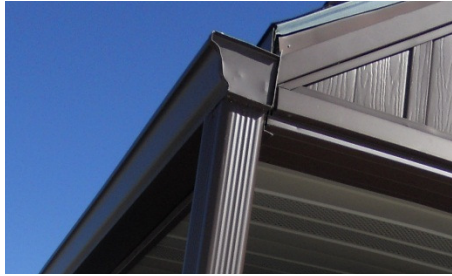
Rating	Condition/ Action	Description	Example
1	Excellent	Gutters and downspouts are functioning as originally intended and are in good condition.

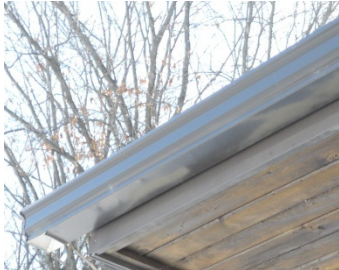
Review in 10 years		
2	Good	Gutters and downspouts are functioning but have some small areas with rust, peeling paint, or small dents.

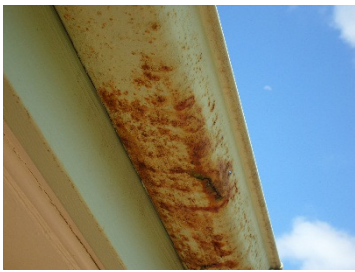
Review in 1 year		
4	Poor	Gutters and downspouts are not secure to the building, are leaking, or have large areas of rust or peeling paint.

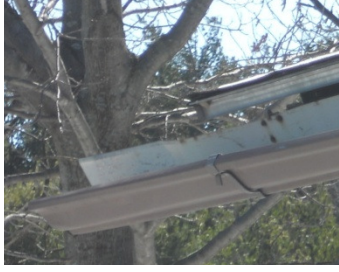
Schedule for Repair		
5	Bad	Gutters and downspouts are not secure to the building or are rusted through and severely leaking.

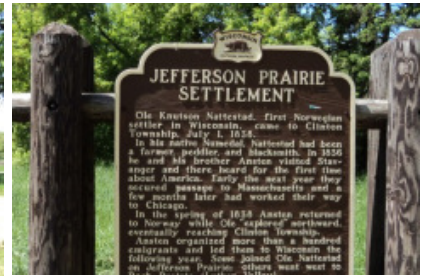
Review in 10 years		
2	Good	There is minor fading or chipping on the sign.

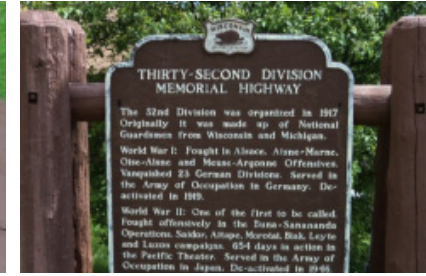
Review in 5 years	The supports may be faded and painting is needed.	
3	Okay	The sign is faded or chipped but it is still legible.

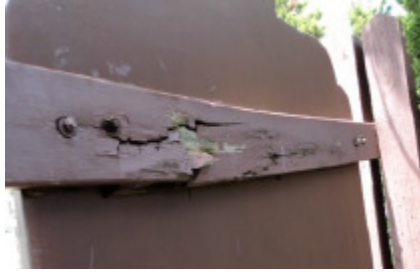
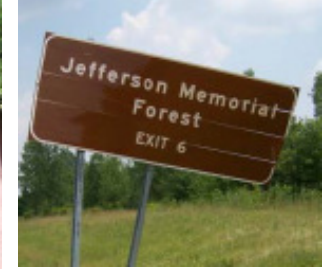
Schedule for Repair	The support is damaged and structural support is limited.	
5	Bad	The sign is damaged beyond repair.

Remove and Replace	The support is damaged and may fail suddenly.

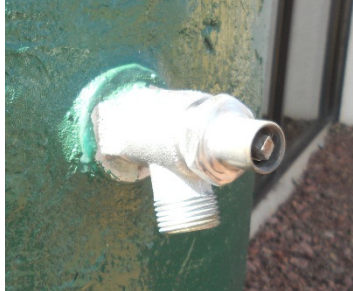
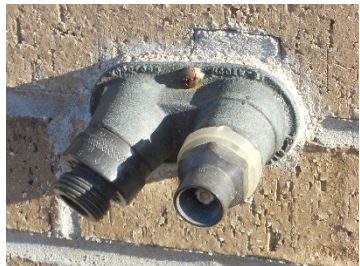
Rating	Condition/ Action	Description	Example
1	Excellent	The hose bibb is functioning as originally intended and is in good condition.

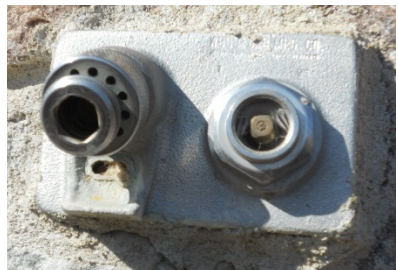
Review in 10 years		
2	Good	Hose bibb functions as it should, it may contain some minor areas of rust.

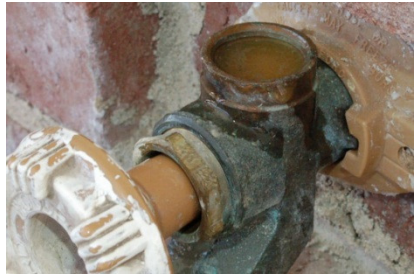
Review in 5 years		
3	Okay	Hose bibb functions as it should, it may leak slightly when turned on, may contain some areas of rust, or may be slightly corroded,

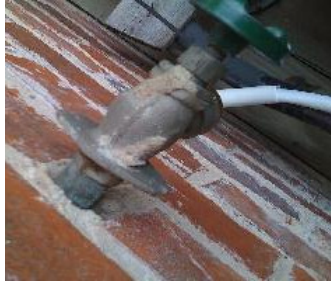
Review in 1 year		
4	Poor	Hose bibb functions poorly, it is constantly leaking even when not turned on, or it is not properly attached to the building.

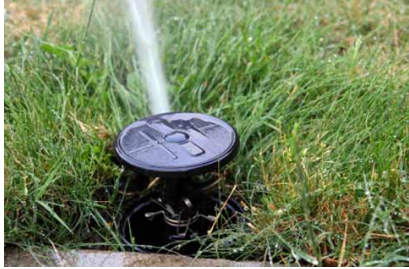
Rating	Condition/ Action	Description	Example
1	Excellent	In ground sprinkler system is functioning as originally intended and is in good condition.

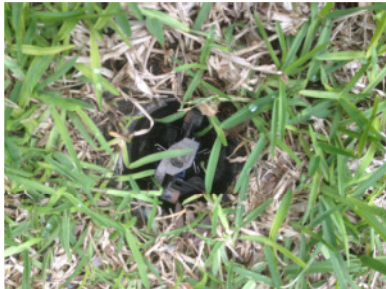
Review in 10 years		
2	Good	In ground sprinkler system functions as it should but sprinkler heads may have some minor dents.

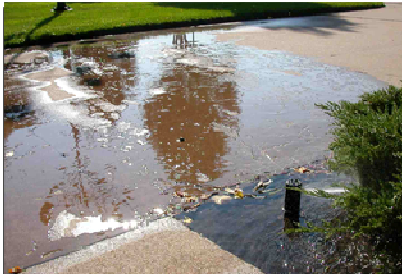
Review in 1 year		
4	Poor	In ground sprinkler system does not function well, some sprinkler heads do not work, there is low water pressure, sprinkler heads are obstructed, or causes flooding.

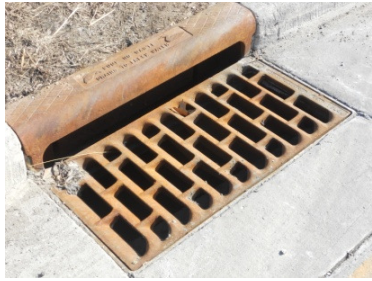
Rating	Condition/ Action	Description	Example
1	Excellent	Inlets are functioning as originally intended and are in good condition.

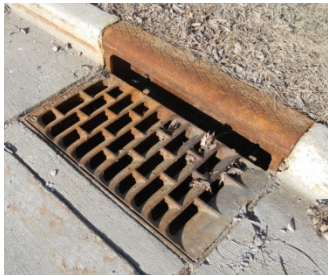
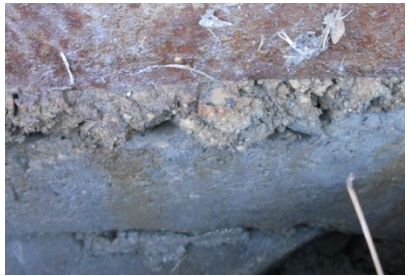
Review in 10 years		
2	Good	Inlet is functioning but there may be some small cracks or signs of deterioration in the catch basin walls.

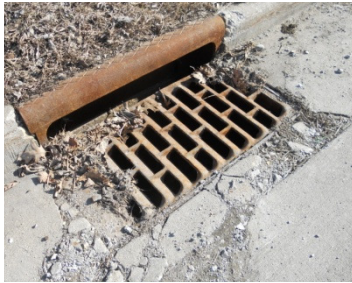
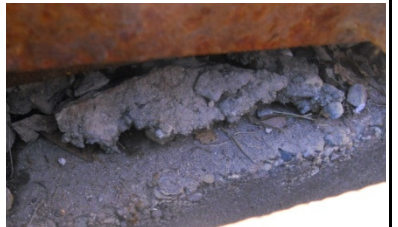
Review in 5 years		
3	Okay	There are some cracks in the catch basin walls or the subgrade may be beginning to deteriorate.

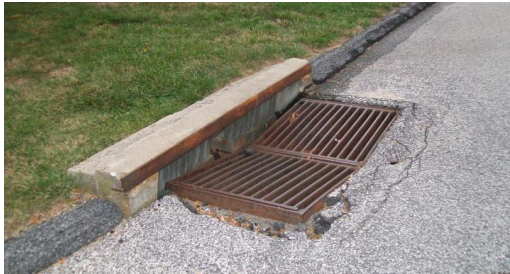
Review in 1 year		
4	Poor	The inlet is not secure in place, or the catch basin walls have large cracks or are deteriorating.

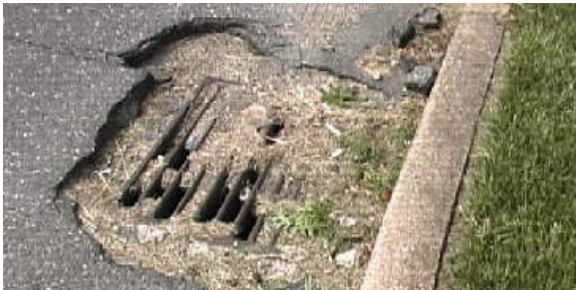
Schedule for Repair		
5	Bad	Inlet is no longer properly draining or the catch basin walls are in danger of collapsing due to deterioration or cracks.

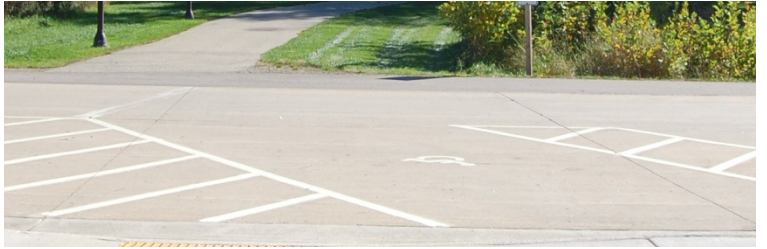
Rating	Condition/ Action	Description	Example
1	Excellent	Parking lots and ramps are functioning as originally intended and are in good condition.

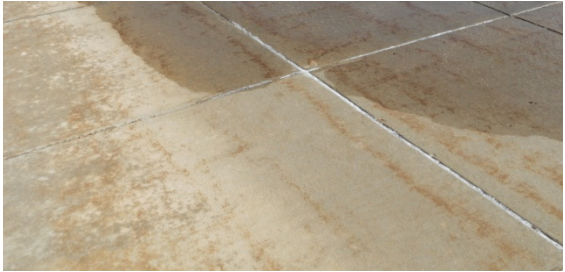
Review in 10 years		
2	Good	Parking lots and ramps are functioning as they should, they only contain some minor cracks or stains.

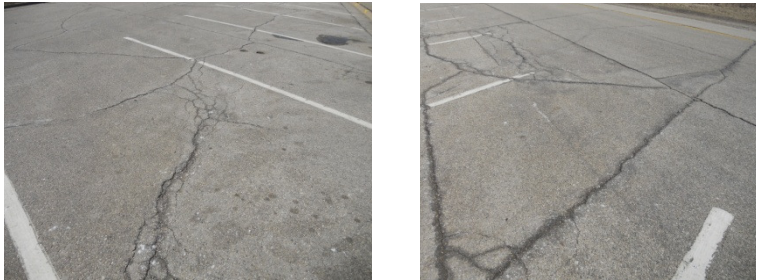
Review in 5 years		
3	Okay	Parking lots and ramps have some cracks and a few small potholes, or paint markings may be slightly fading.

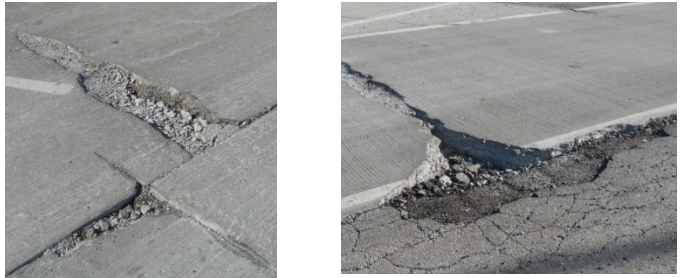
Review in 1 year		
4	Poor	Parking lots and ramps have large cracks and/or potholes that affect the driving condition, or paint markings are not visible.

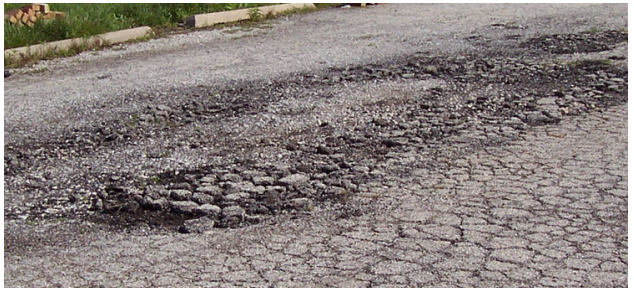
Schedule for Repair		
5	Bad	Parking lots and ramps have a large number of large cracks and potholes, or the subgrade is visible in multiple places.

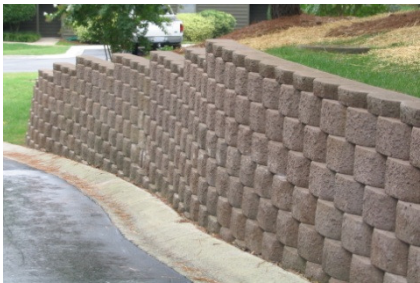
Rating	Condition/ Action	Description	Example
1	Excellent	Retaining walls are functioning as originally intended and are in good condition.

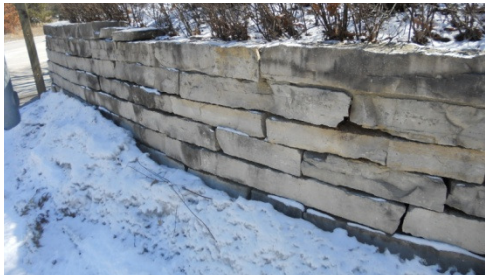
Review in 10 years		
2	Good	Retaining wall is functioning as it should but it may have a few sharp edges.

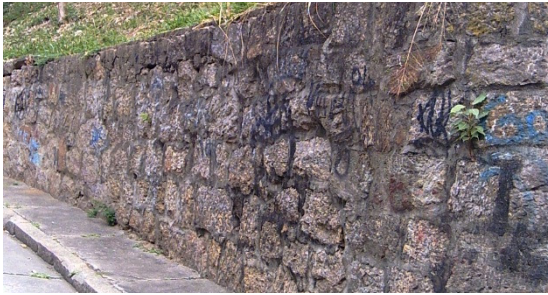
Review in 5 years		
3	Okay	Retaining wall may have some sharp edges or cracks, or bricks may be slightly loose.

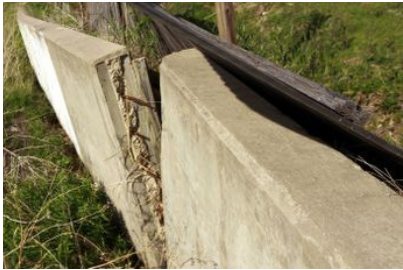
Schedule for Repair		
5	Bad	Retaining wall shows severe structural deterioration or damage and is no longer safe.

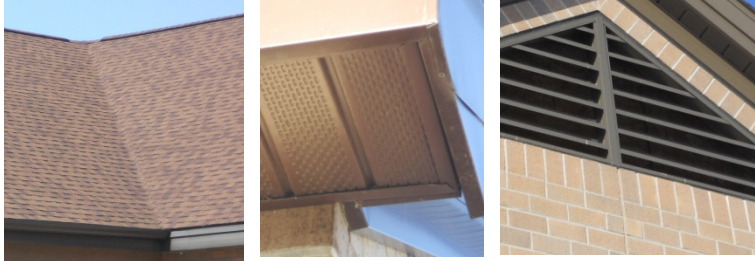
Rating	Condition/ Action	Description	Example
1	Excellent	Roof, soffits and venting are functioning as originally intended and are in good condition.

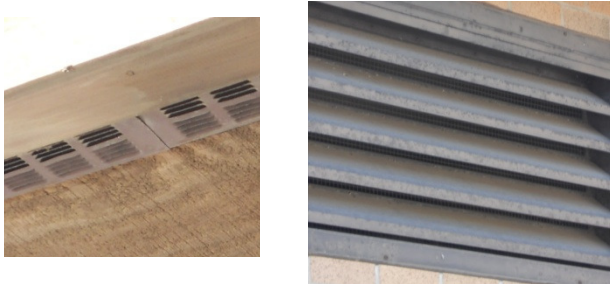
Review in 10 years		
2	Good	Roof, soffits, and venting are functioning as they should, soffits and venting may contain some dirt or small areas of rust.

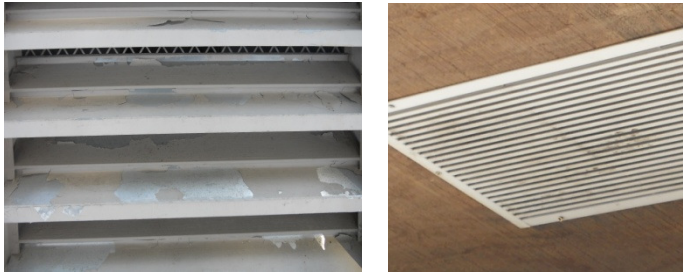
Review in 5 years		
3	Okay	Roof may have some damaged roof tiles, soffits and venting contain dirt, small cracks or rust.

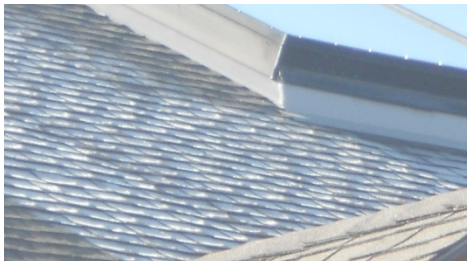
Review in 1 year		
4	Poor	Roof has some damaged or missing roof tiles, soffits and venting have large amounts of dirt, cracks, peeling paint or rust.

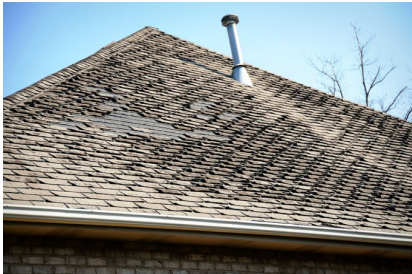
Schedule for Repair		
5	Bad	A large amount of roof tiles are missing or damaged, soffits and venting are missing or have large cracks or holes.

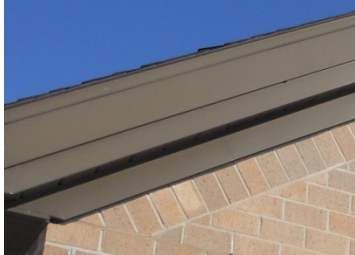
Rating	Condition/ Action	Description	Example
1	Excellent	Trim is functioning as originally intended and is in good condition.

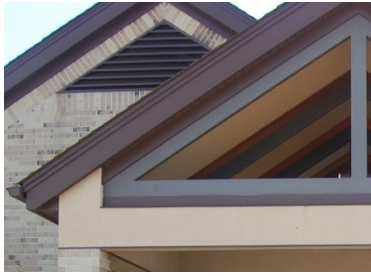
Review in 10 years		
2	Good	Trim has some small areas of chipping paint .

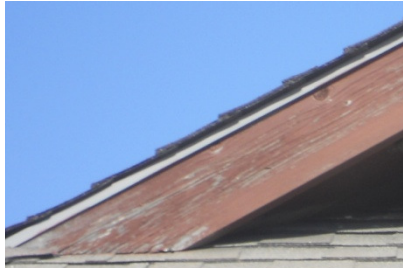
Review in 5 years		
3	Okay	Trim contains large areas of chipping paint, it is slightly damaged, or small areas need to be stained.

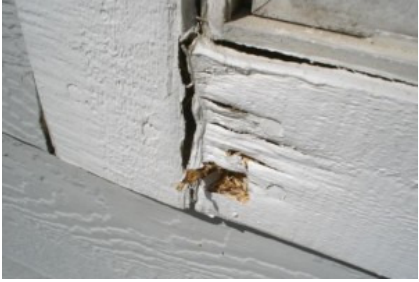
Review in 1 year		
4	Poor	Trim is not fully secure in place, there are some spots that are rotted or where there is major damage, paint is chipping in a majority of the areas, and caulking is missing in areas.

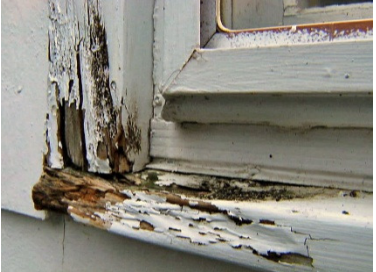
Schedule for Repair		
5	Bad	Trim is rotted or is not fully secure in place.

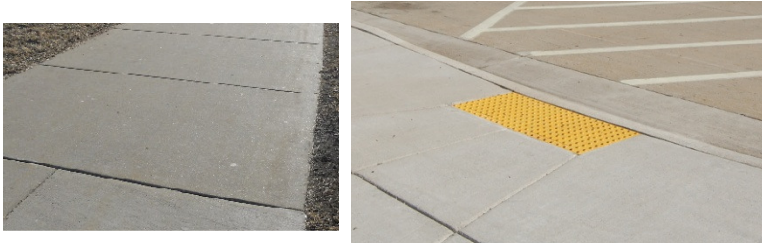
Rating	Condition/ Action	Description	Example
1	Excellent	Walkways are functioning as originally intended and are in good condition. Meets all ADA requirements.

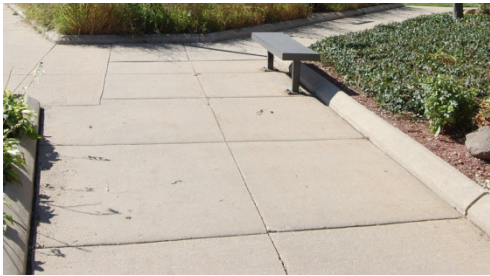
Review in 10 years		
2	Good	Walkways have only a few minor cracks.

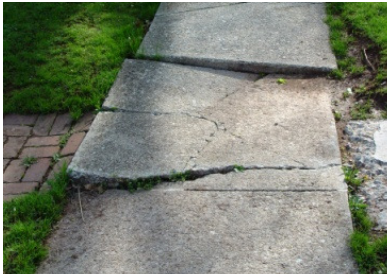
Schedule for Repair *		
5	Bad	Walkways contain major cracks, have large drainage issues, and have high raised edges that are a tripping hazard and can not be ground down.

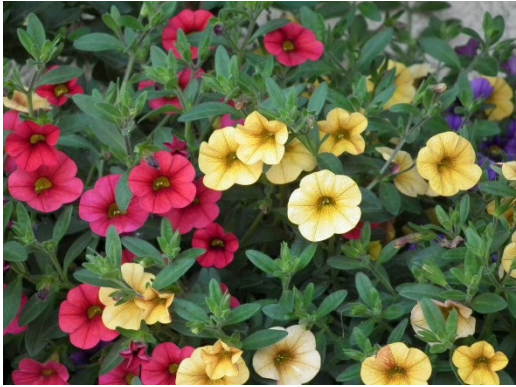
Rating	Condition/ Action	Description	Example
1	Excellent	Annuals are in good condition, they are healthy and properly trimmed.

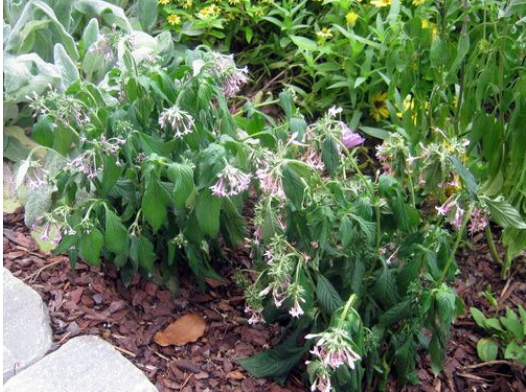
No action necessary		
2	NA	NA	NA
3	Okay	Annuals are in decent condition, most of them are healthy, but a few are showing signs of declining health, a lack of pruning or trimming, or they are not receiving proper water or fertilizer.

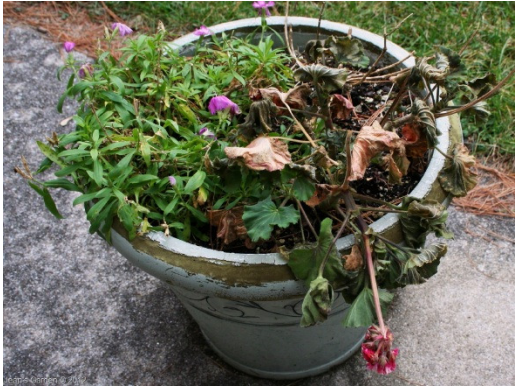
Schedule for treatment		
4	NA	NA	NA
5	Bad	Annuals are dead, in severe decline, or removed plantings are not replaced.

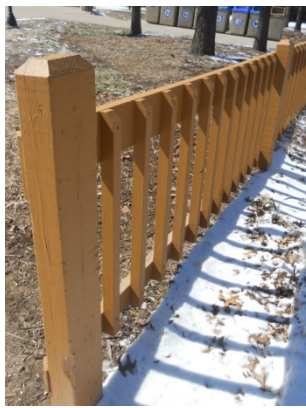
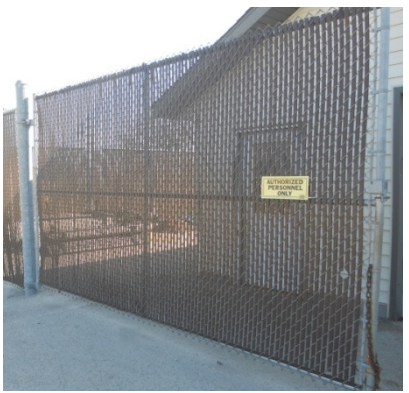
Rating	Condition/ Action	Description	Example
1	Excellent	Fencing is functioning as it was intended, only requires preventative maintenance, is in sound structural condition and is in place where necessary.

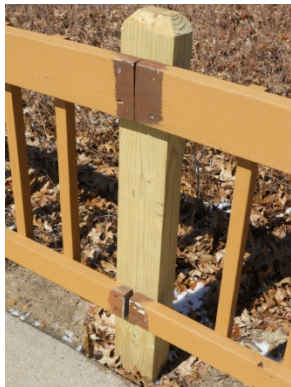
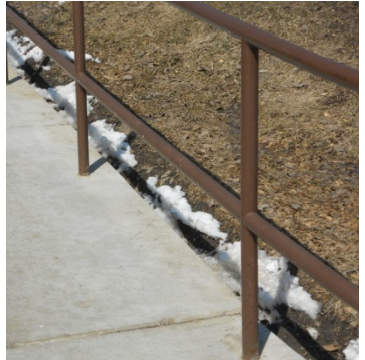
Review in 5 years		
2	NA	NA	NA
3	Okay	Fencing needs some minor repairs and infrequent large repairs. Fences show some structural deterioration or lean slightly. A wood fence may have some chipped paint or an aluminum fence may have some rust.

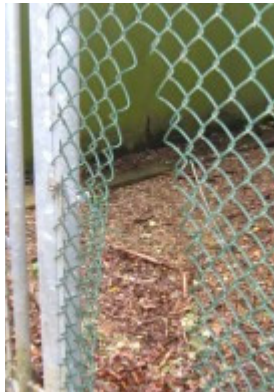
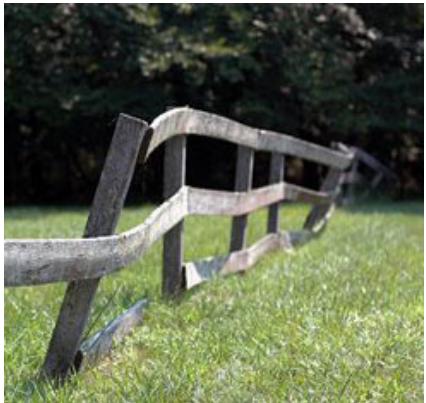
Review in 2 years		
4	NA	NA	NA
5	Bad	Fences are unsafe and require major repair or replacement, they are not in place where necessary or show severe structural deterioration or damage.

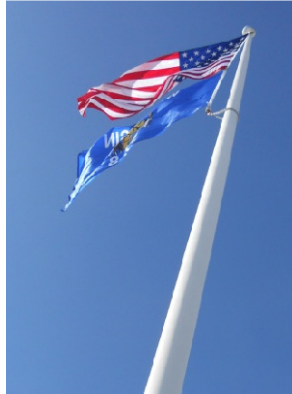
Rating	Condition/ Action	Description	Example
1	Excellent	Flag poles are functioning as intended, are in good condition, and only require preventative maintenance.

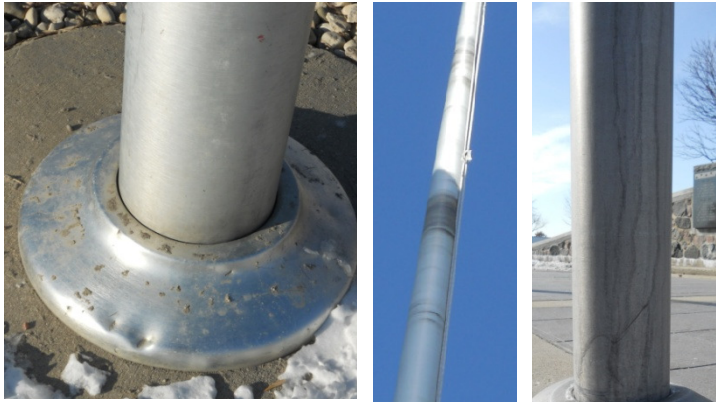
Review in 10 years		
2	NA	NA	NA
3	Okay	Flag poles need some minor repairs or maintenance and infrequent large repairs. There may be small areas of rust or water damage, or small cracks or dents.

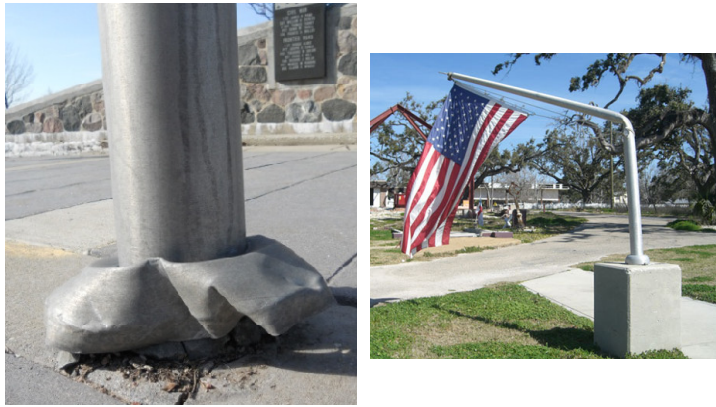
Review in 1 year		
4	NA	NA	NA
5	Bad	Flag pole is in an unsafe condition and requires major repair or replacement. It is no longer standing upright, it is not secure in the ground, or it contains rust or cracks that affect the structural integrity.

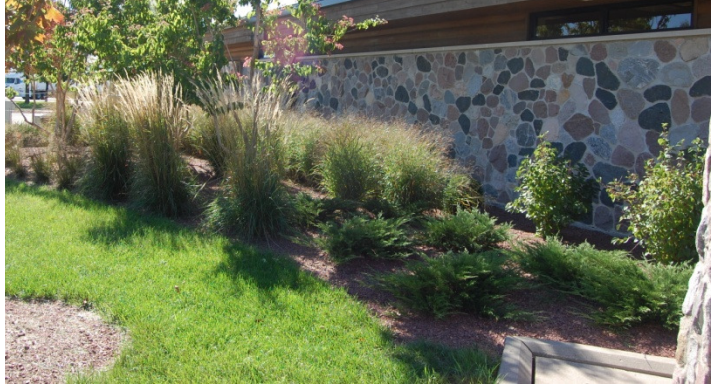
Rating	Condition/ Action	Description	Example
1	Excellent	Plants are in good condition, they are healthy and properly trimmed, and mulch or rocks cover any portion of landscape bed not covered by plants.

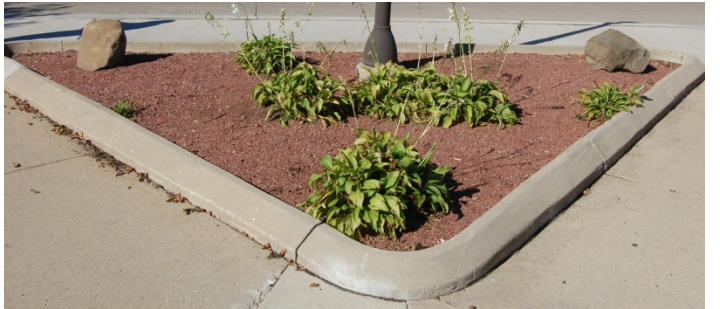
Review in 2 years		
2	NA	NA	NA
3	Okay	Plants are in decent condition, most of them are healthy, but a few show signs of declining health, a lack of pruning or trimming, or they are not receiving proper water or fertilizer. There are a few bare spots that need mulch or rocks.

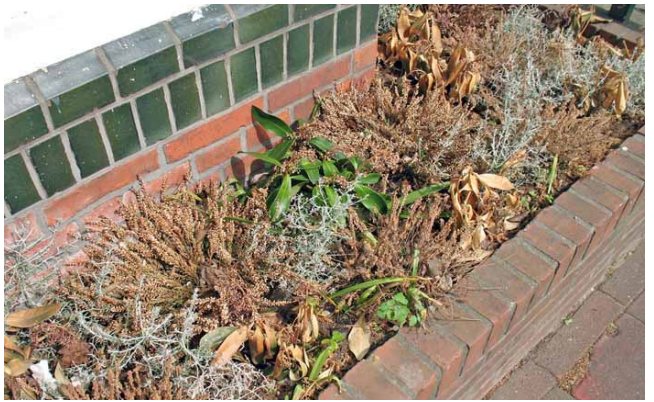
Review in 1 year		
4	NA	NA	NA
5	Bad	Plants are dead, in severe decline, or removed plantings are not replaced. Area surrounding plants is dirt.

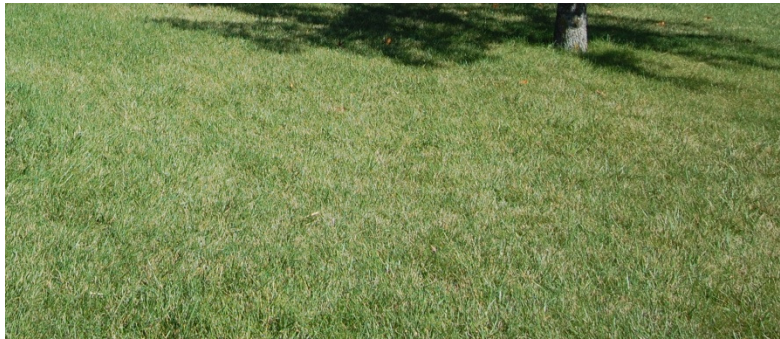
Rating	Condition/ Action	Description	Example
1	Excellent	Lawn is in good condition, turf is strong, grass is less than 4" in height, there are few weeds and no bare spots.

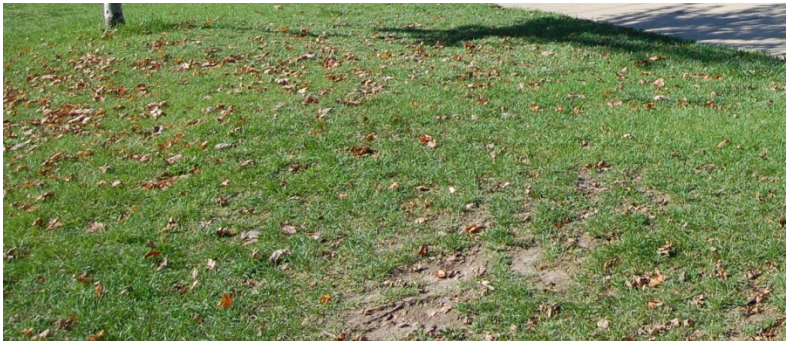
Review in 2 years		
2	NA	NA	NA
3	Okay	Lawn/turf is in decent condition, the grass is less than 8" in height, there are some weeds, and/or occasional bare patches or paths.

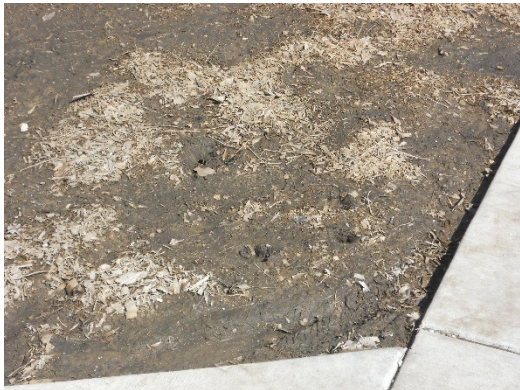
Review in 1 year		
4	NA	NA	NA
5	Bad	Lawn is in poor condition, turf is unhealthy, grass is taller than 8", infested with weeds or pests, or there are significant worn areas.

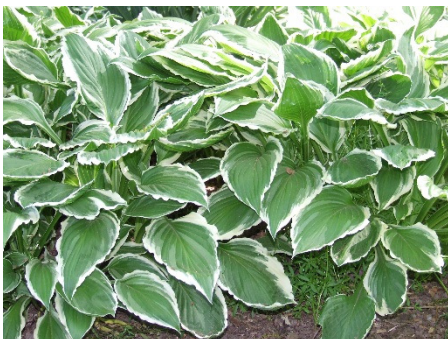
Rating	Condition/ Action	Description	Example
1	Excellent	Perennials are in good condition, they are healthy and properly trimmed.

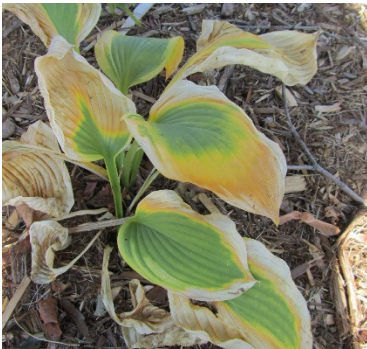
<p>Please see next pages for a list and pictures of appropriate rest area perennial plant species.</p>
	Review in 1 year		
2	NA	NA	NA
3	Okay	Perennials are in decent condition, most of them are healthy, but a few are showing signs of declining health, a lack of pruning or trimming, or they are not receiving proper water or fertilizer.

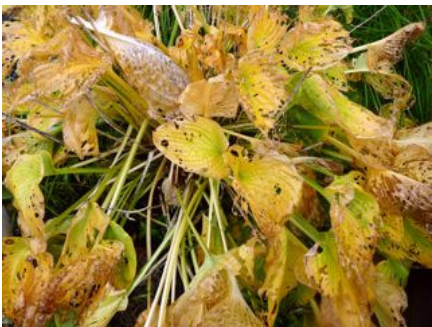
<p>Please see next pages for a list and pictures of appropriate rest area perennial plant species.</p>
	Schedule for treatment		
4	NA	NA	NA
5	Bad	Perennials are dead, in severe decline, or removed plantings are not replaced.

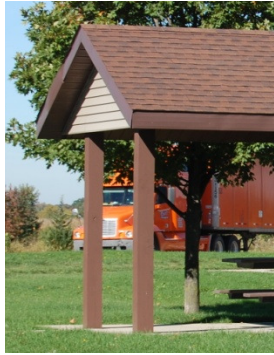
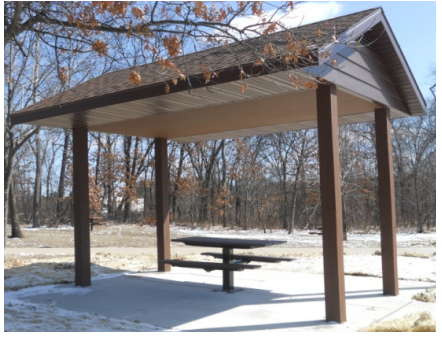
Rating	Condition/ Action	Description	Example
1	Excellent	Picnic shelters are functioning as they were intended and only require preventative maintenance.

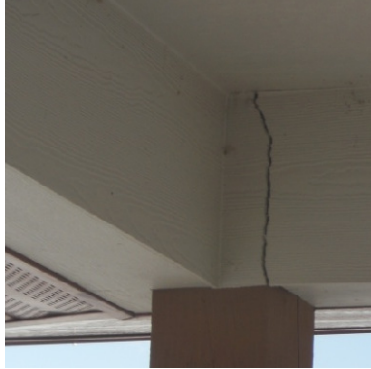
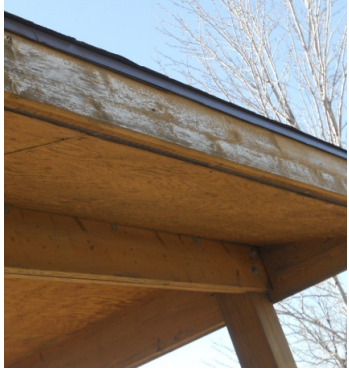
Review in 5 years		
2	NA	NA	NA
3	Okay	Picnic shelters need some minor repairs or maintenance. There may be areas of graffiti, faded or peeling paint or stain, supports may be damaged but still structurally sound, or there could be small cracks in the structure.

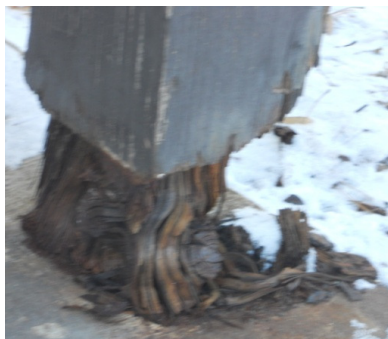
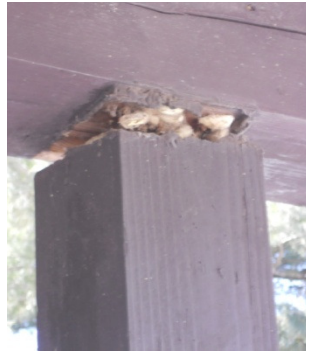
Review in 2 years		
4	NA	NA	NA
5	Bad	Picnic shelter is in an unsafe condition and requires major repair or replacement. It is no longer structurally sound or structural support is limited.

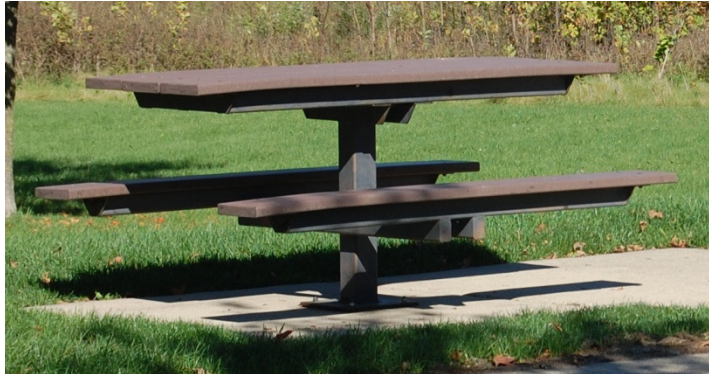
Rating	Condition/ Action	Description	Example
1	Excellent	Picnic tables are functioning as they were intended, they are painted and in sound structural condition, and surfaces are smooth.

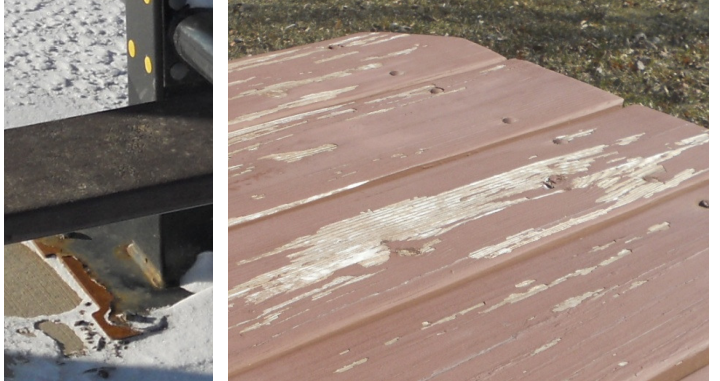
Review in 5 years		
2	NA	NA	NA
3	Okay	Picnic tables need some minor repairs or maintenance and infrequent large repairs. There is some minor paint wear, the surface could have some minor irregularities, or graffiti, or there could be support damage that is not affecting the structural support of the table.

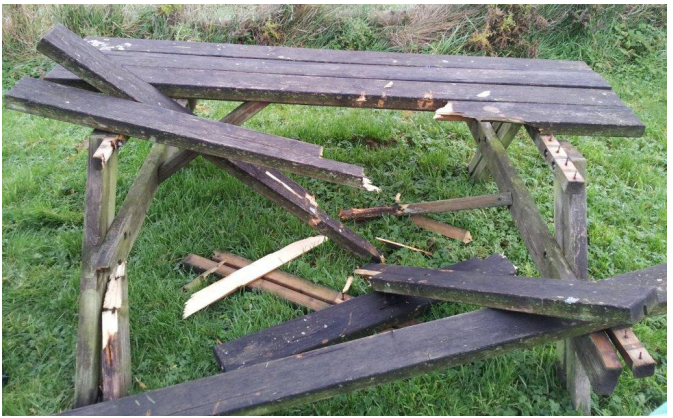
Review in 2 years		
4	NA	NA	NA
5	Bad	Picnic tables are unsafe to use or require major repair or replacement. Structural supports are no longer sound, there are sharp edges, or broken or missing boards.

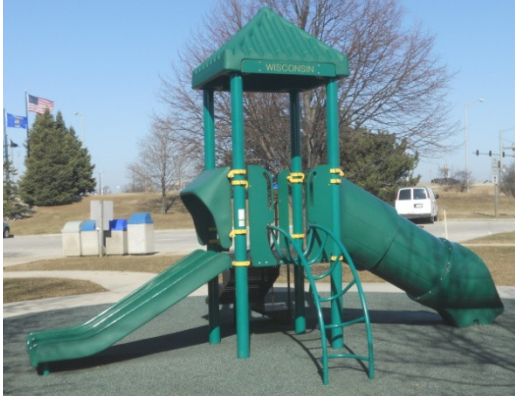
Rating	Condition/ Action	Description	Example
1	Excellent	Play areas are in excellent condition, functioning as they were intended and only require preventative maintenance.

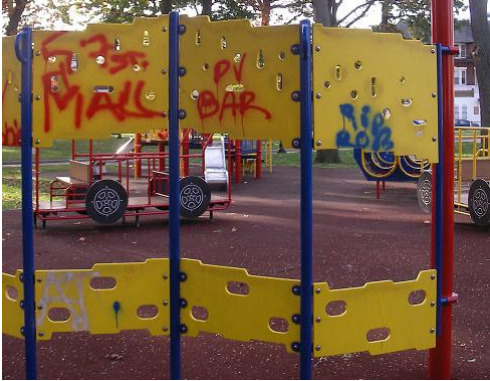
Review in 5 years		
2	NA	NA	NA
3	Okay	Play areas show some sign of wear and tear, may contain some rust, there may be some small dents or graffiti, chipping paint or it requires some minor repairs and infrequent large repairs.

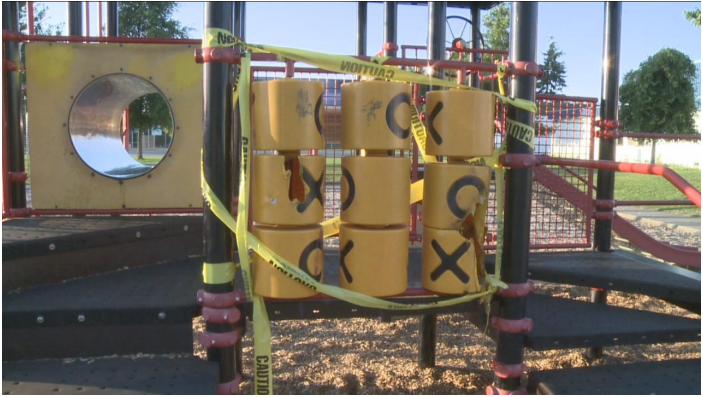
Review in 2 year		
4	NA	NA	NA
5	Bad	The play area is unsafe to use and requires major repair or replacement. Structural supports are in danger of failing, or there are large cracks in the equipment.

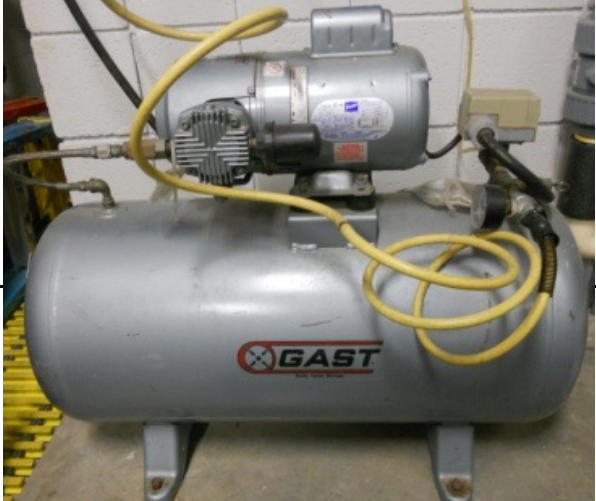
Rating	Condition/ Action	Description	Example
1	Excellent	Air compressor is functioning as originally intended and is in good condition. Inspection report is good.

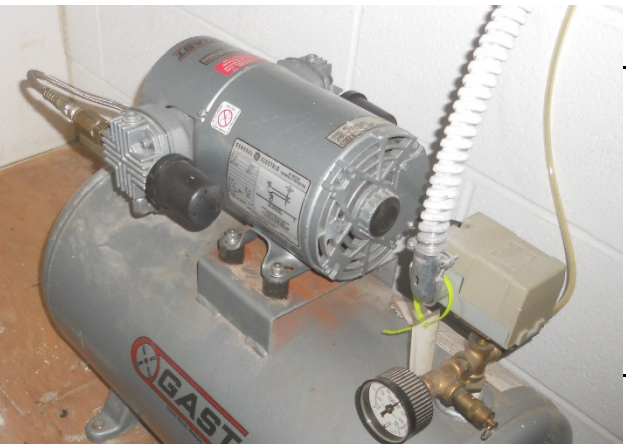
Review in 3 years		
2	Good	Air compressor usually functions as it should and only requires some minor repairs. Inspection report is good.

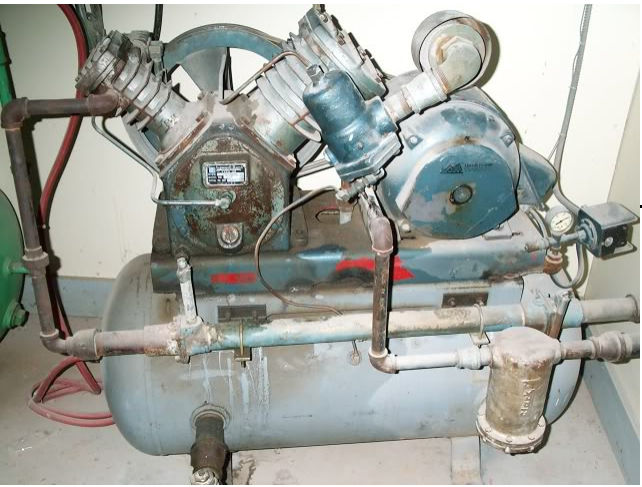
Review in 2 years		
3	Okay	Air compressor inspection results are either poor, over a year old, or missing. Air compressor has some rust, it usually functions as it should, it may need some minor repairs or maintenance.
