Rest Area Inspection Guidebook

Instructions

The assets are broken down into 5 different categories, exterior, landscaping, equipment/systems, interior, and restrooms. Each asset will be given a condition rating.

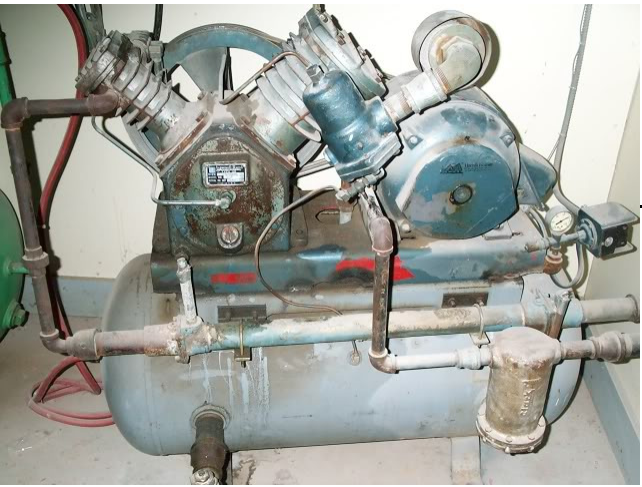
Review in 1 year		
4	Poor	Air compressor requires significant repair, is obsolete or is not fully functional.

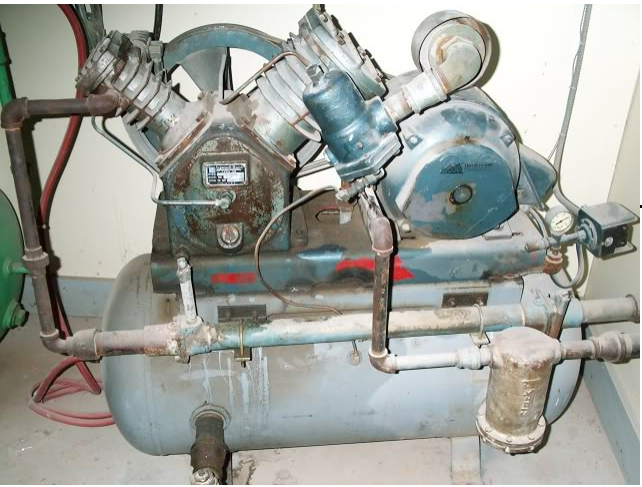
Schedule for Repair		
5	Bad	Air compressor inspection results indicate replacement is needed, it is no longer safe to use, or it requires major repair.

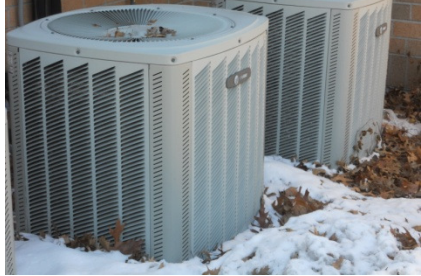
Rating	Condition/ Action	Description	Example
1	Excellent	Air conditioner is functioning as originally intended and is in good condition. Inspection report is good.

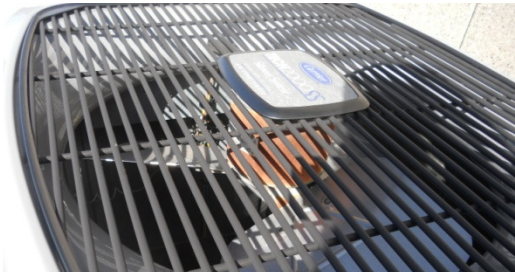
Review in 5 years		
2	Good	Air conditioner usually functions as it should and only requires some minor repairs. It may contain some rust.

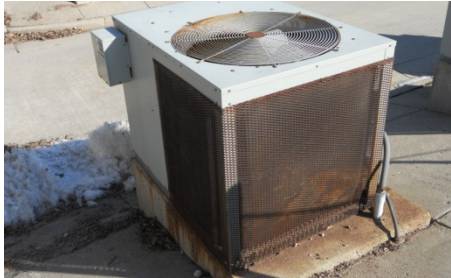
Review in 3 years		
3	Okay	Air conditioner inspection results are either poor, over a year old, or missing. Air conditioner contains rust, the insulation on the refrigerant lines may be damaged, or some minor repairs may be needed.

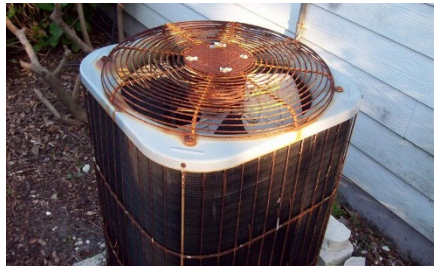
Review in 1 year		
4	Poor	Air conditioner requires significant repair, is obsolete, or is not fully functional. Inspection report indicates repairs are needed.

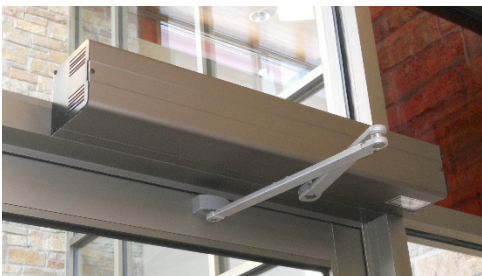
Rating	Condition/ Action	Description	Example
1	Excellent	Auto door control is functioning as originally intended and is in good condition.

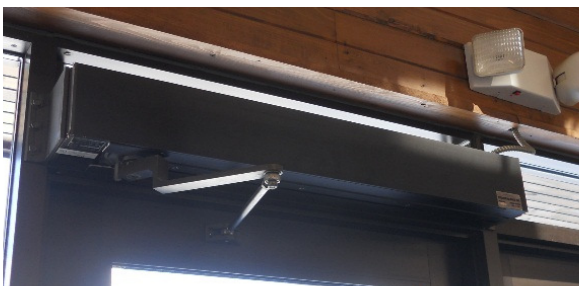
Review in 5 years		
2	Good	Auto door control usually functions as it should and only requires some minor repairs. It may contain some rust.

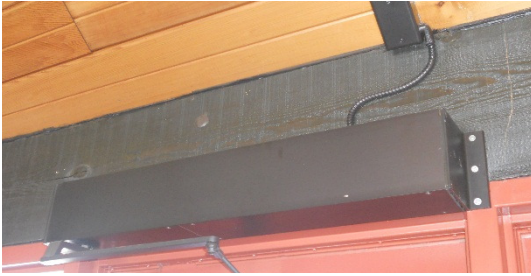
Review in 3 years		
3	Okay	Auto door control contains rust, some minor repairs may be needed.

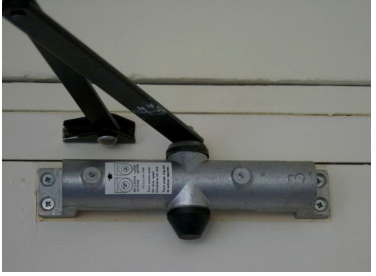
Review in 1 year		
4	Poor	Auto door control requires significant repair, is not fully functional, or is not properly attached to the wall or door.

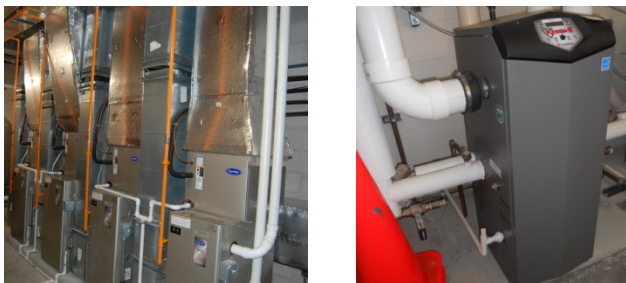
Rating	Condition/ Action	Description	Example
1	Excellent	Boiler or furnace is functioning as originally intended and is in good condition. Inspection report is good.

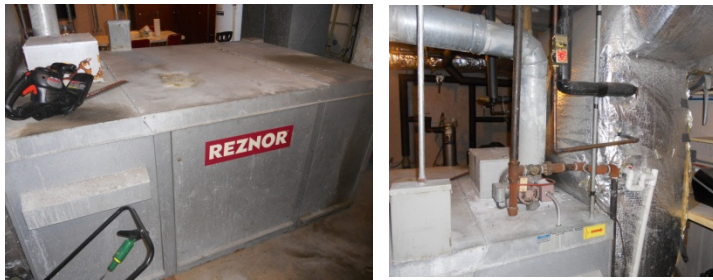
Review in 2 years		
3	Okay	Boiler or furnace inspection results are either poor, over a year old, or missing. Boiler or furnace may contain some rust, some pipe connections may be loose or some minor repairs may be needed.

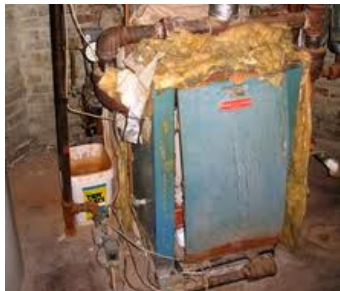
Schedule for Repair		
5	Bad	Boiler or furnace inspection results indicate replacement is needed, it is no longer safe to use, or it requires major repair.

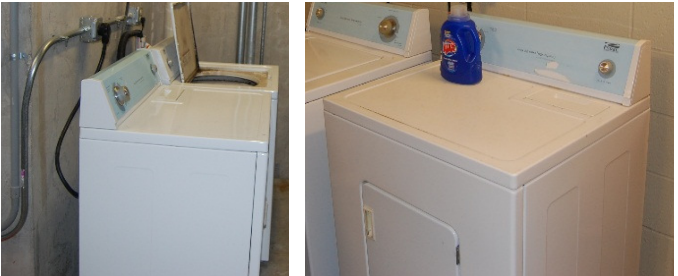
Review in 5 years		
2	Good	Clothes dryer usually functions as it should and only requires some minor repairs. It may contain some rust.

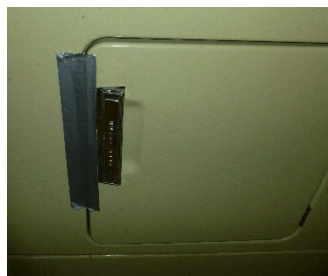
Review in 3 years		
3	Okay	Clothes dryer may contain some rust, some minor repairs may be needed or it may be inefficient.

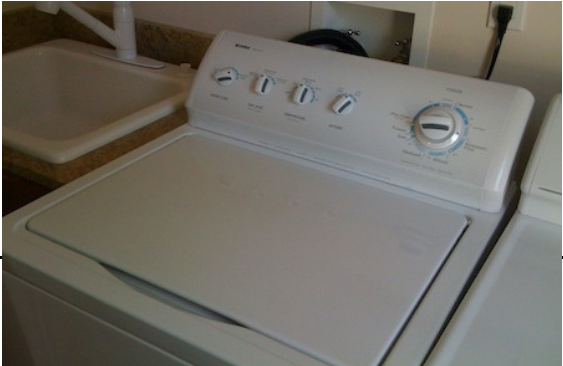
Rating	Condition/ Action	Description	Example
1	Excellent	Clothes washer is functioning as originally intended and is in good condition.

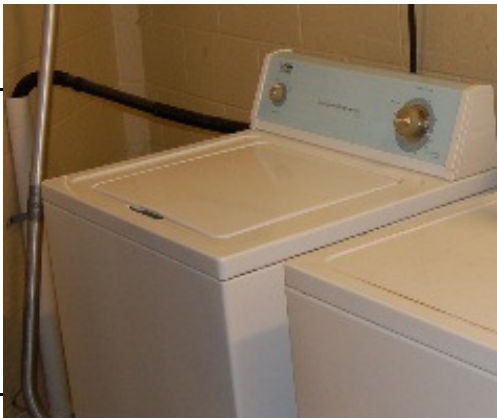
Review in 5 years		
2	Good	Clothes washer usually functions as it should and only requires some minor repairs. It may contain some rust.

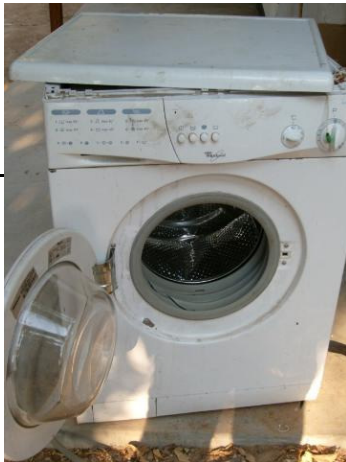
Review in 1 year		
4	Poor	Clothes washer requires significant repair, pipes may not be properly attached to the washer, pipes may be leaking or rusted, or it may be very inefficient.

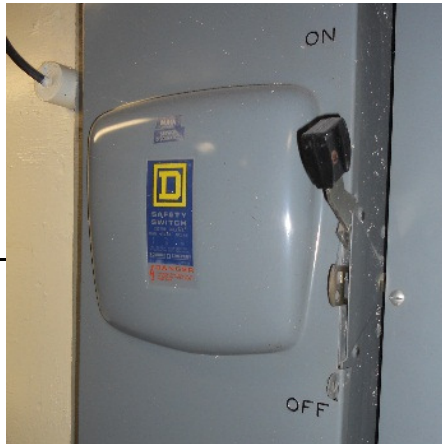
Rating	Condition/ Action	Description	Example
1	Excellent	Electrical breakers are functioning as originally intended and are in good condition. Inspection report is good.

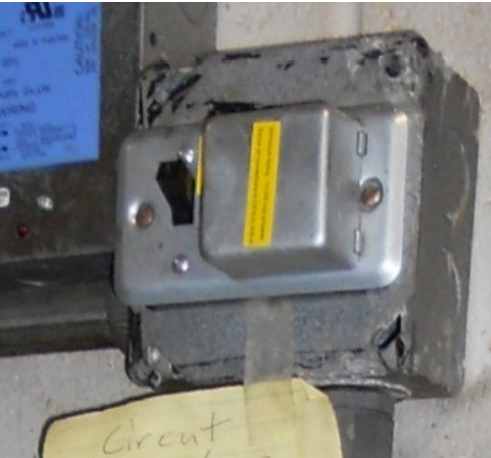
Review in 5 years		
2	Good	Electrical breakers function as they should and only require routine maintenance. Inspection report is good.

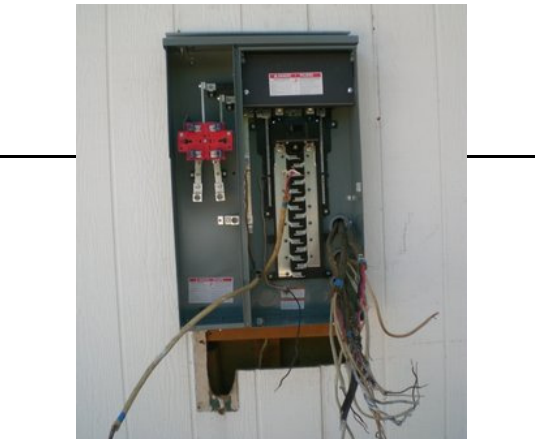
Review in 3 years		
3	Okay	Electrical breakers inspection results are either poor, over a year old, or missing. There may be some minor rust on the breakers or some minor repairs may be needed.

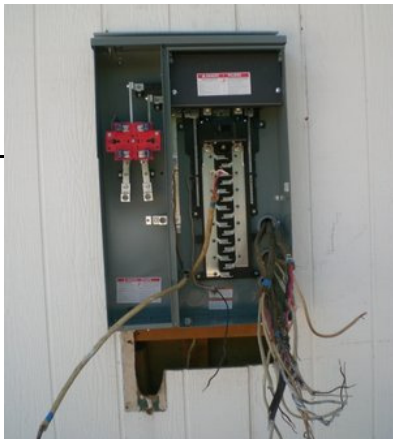
Review in 1 year		
4	Poor	Electrical breakers require significant repair, are unsafe, or are not fully functional. Inspection results are not good.

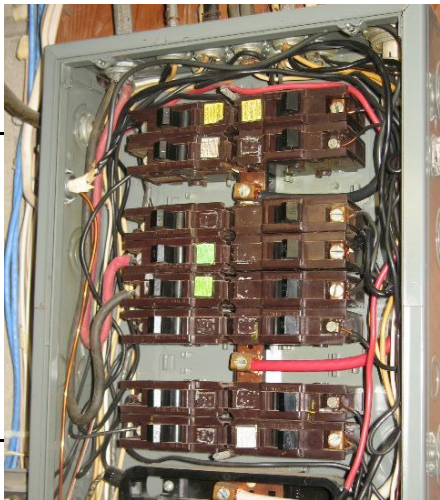
Review in 10 years		
2	Good	Electrical panel functions as it should and only requires routine maintenance. Inspection report is good.

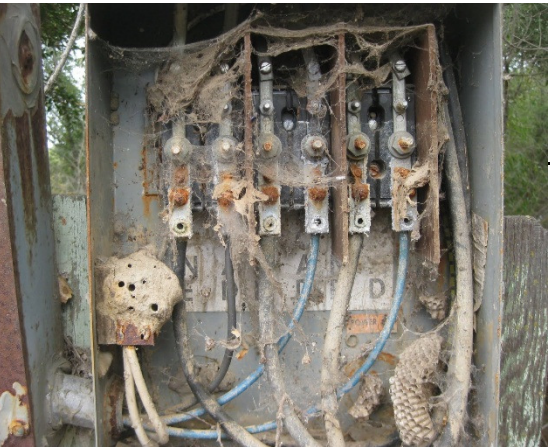
Review in 5 years		
3	Okay	Electrical panel inspection results are either poor, over a year old, or missing. There may be some minor rust on the panel or busbar, some small areas of corrosion, or some minor repairs may be needed.

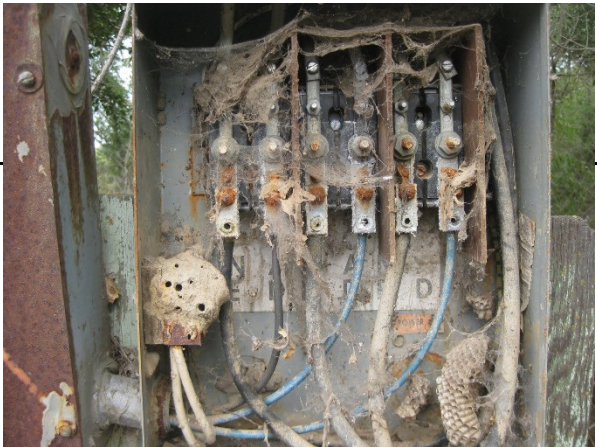
Review in 1 year		
4	Poor	Electrical panel requires significant repair, is unsafe, or is not fully functional. The panel is rusted or corroded or the busbar may have burn marks. Inspection results are not good.

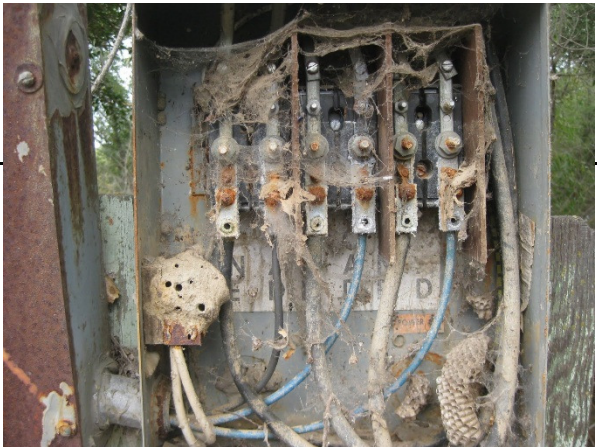
Schedule for Repair		
5	Bad	Electrical panel inspection results indicate replacement is needed, it is no longer safe to use, no longer operable, or requires major repair.

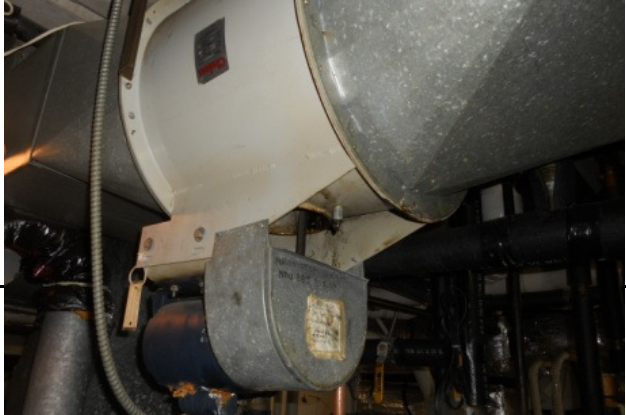
Rating	Condition/ Action	Description	Example
1	Excellent	Exhaust fans are functioning as originally intended and are in good condition. Inspection report is good.

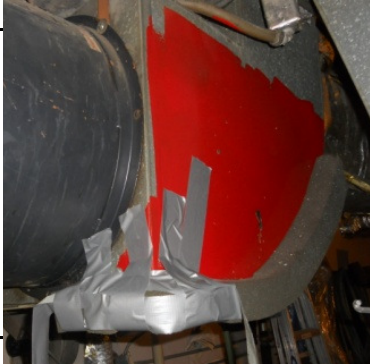
Review in 3 years		
3	Okay	Exhaust fan inspection results are either poor, over a year old, or missing. Exhaust fan may be noisy, contain rust, run slowly, or some minor repairs may be needed.

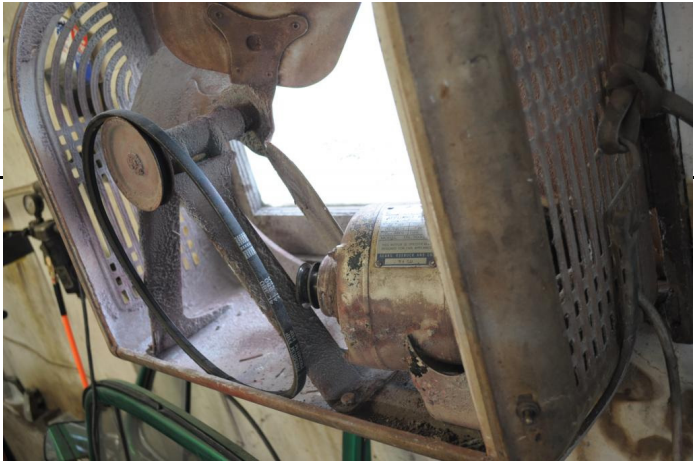
Review in 1 year		
4	Poor	Exhaust fan requires significant repair, is obsolete or is not fully functional. Inspection report is not good.

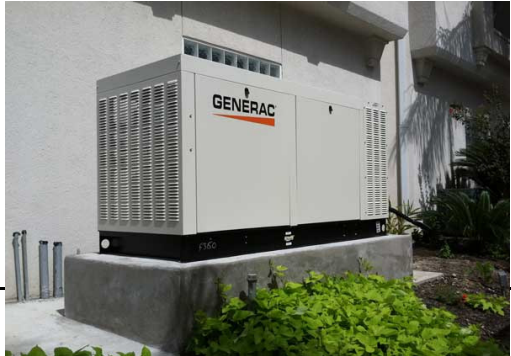
Rating	Condition/ Action	Description	Example
1	Excellent	Generator is functioning as originally intended and is in good condition. Inspection report is good.

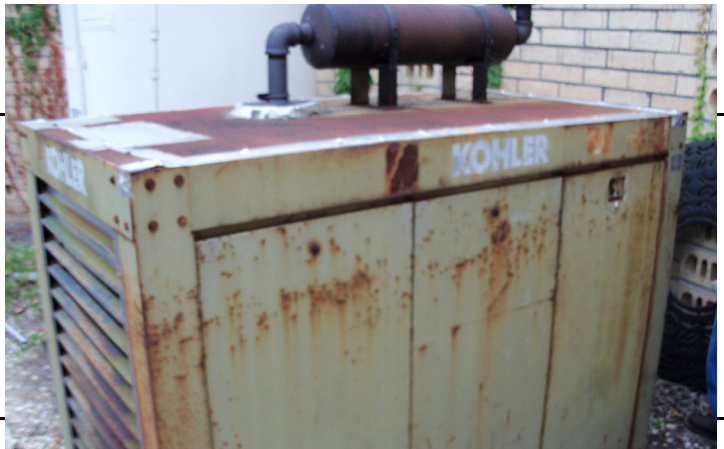
Review in 3 years		
2	Good	Generators usually functions as it should, and only requires some minor repairs. Inspection report is good.

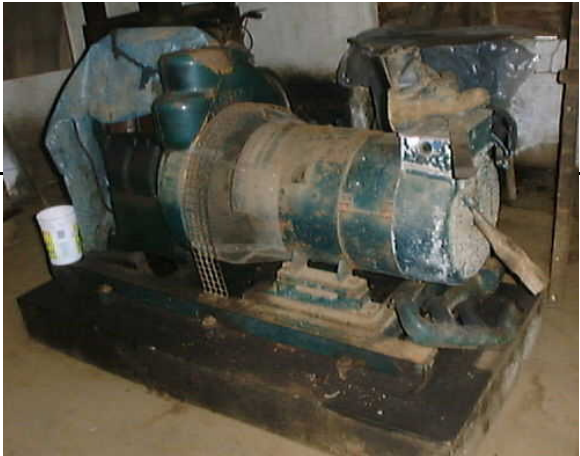
Review in 2 years		
3	Okay	Generator inspection results are either poor, over a year old, or missing. Generator may contain rust, show signs of wear and tear, or it may need some minor repairs.

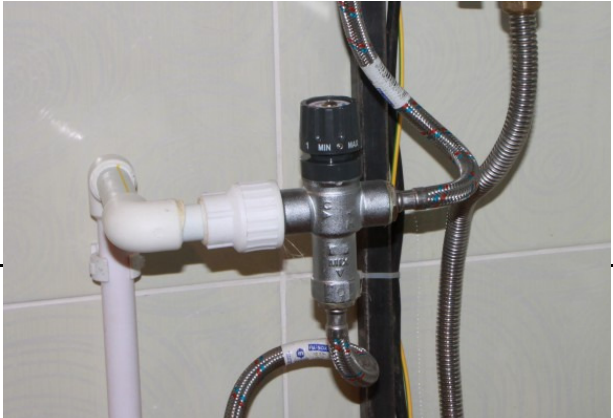
Rating	Condition/ Action	Description	Example
1	Excellent	Mixing valve is functioning as originally intended and is in good condition.

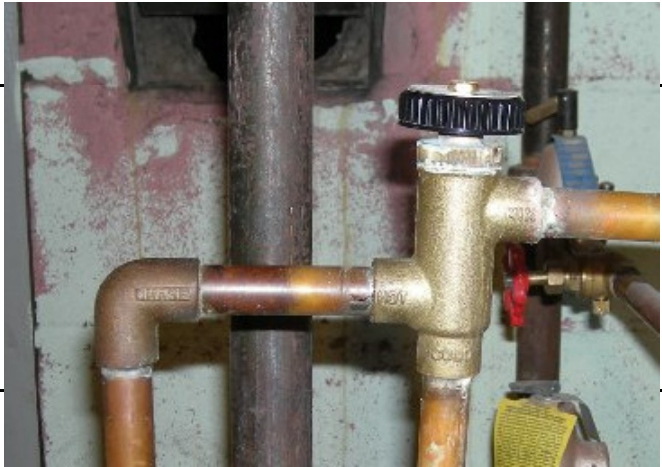
Review in 5 years		
2	Good	Mixing valve usually functions as it should, and only requires some minor repairs. There may be some minor areas of rust.

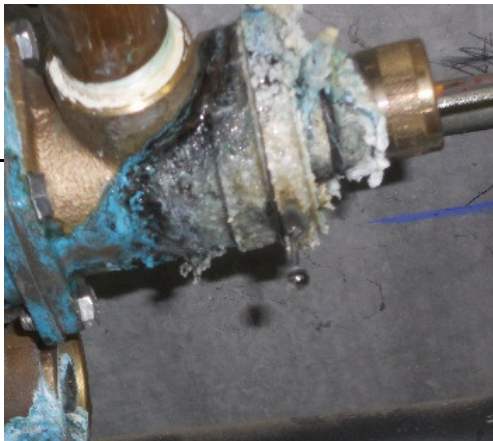
Review in 3 years		
3	Okay	Mixing valve or pipes connecting to valve may contain some areas of rust or corrosion, or other minor repairs are needed.

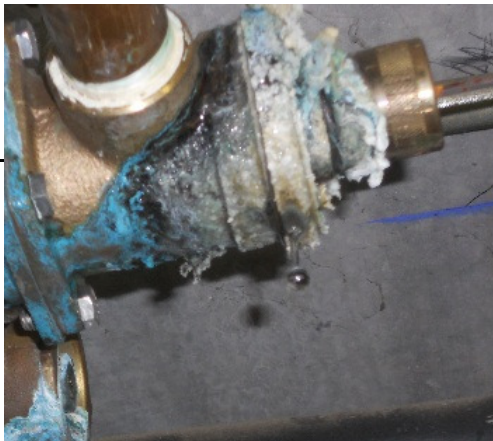
Review in 1 year		
4	Poor	Mixing valve has a small leak, valve or pipes have some corrosion, or there is a large amount of rust.

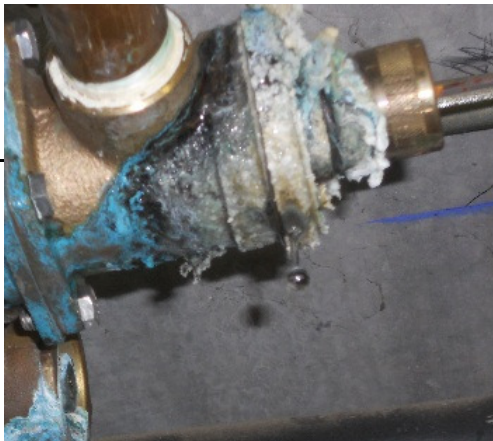
Schedule for Repair		
5	Bad	Mixing valve is no longer safe to use, it is constantly leaking, or it contains a large amount of corrosion.

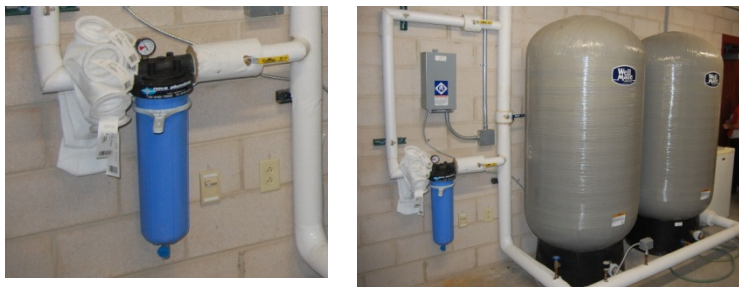
Rating	Condition/ Action	Description	Example
1	Excellent	Pressure tank is functioning as originally intended and is in good condition. Inspection report is good.

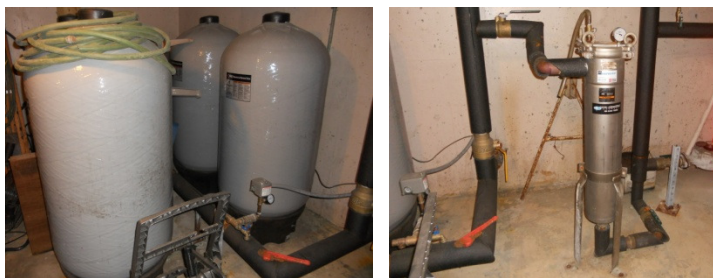
Review in 5 years		
2	Good	Pressure tank usually functions as it should, and only requires some minor repairs. Inspection report is good.

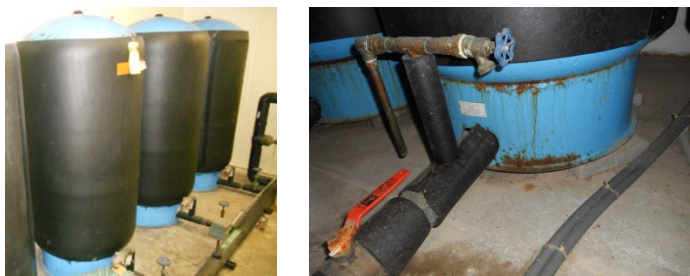
Review in 3 years		
3	Okay	Pressure tank inspection results are either poor, over a year old, or missing. Pressure tank or pipes may have some rust, needs some minor repairs or maintenance and infrequent large repairs.

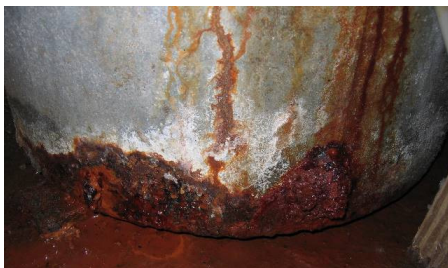
Review in 1 year		
4	Poor	Pressure tank requires significant repair, is obsolete or is not fully functional. Inspection report is not good.

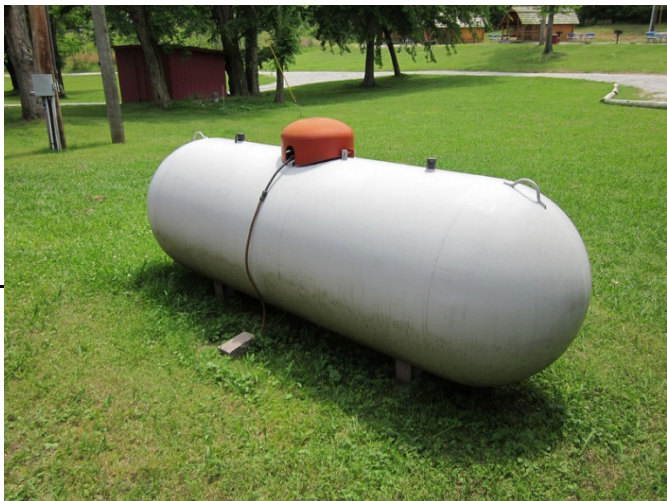
Rating	Condition/ Action	Description	Example
1	Excellent	Propane tank is functioning as originally intended and is in good condition. Inspection report is good.

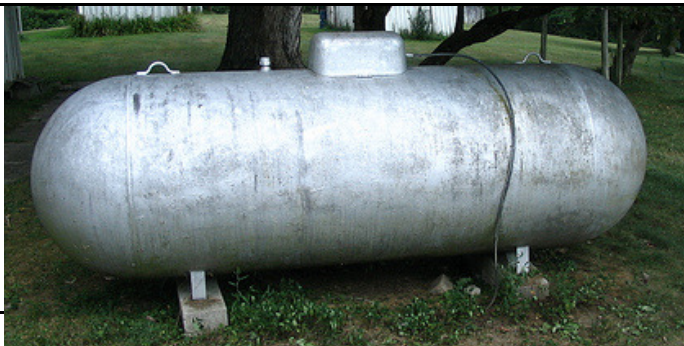
Review in 3 years		
3	Okay	Propane tank inspection results are either poor, over a year old, or missing. Propane tank may have some rust, needs some minor repairs or maintenance and infrequent large repairs.

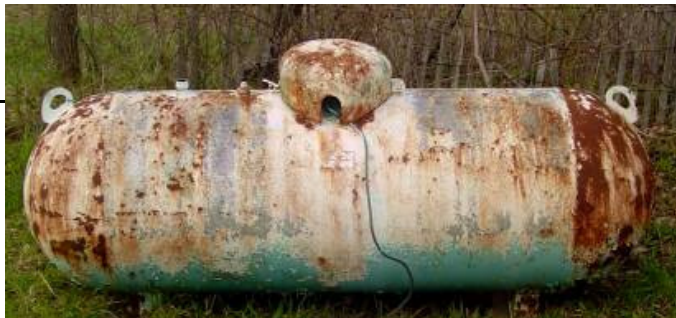
Review in 1 year		
4	Poor	Propane tank requires significant repair, is obsolete or is not fully functional. Inspection report is not good.

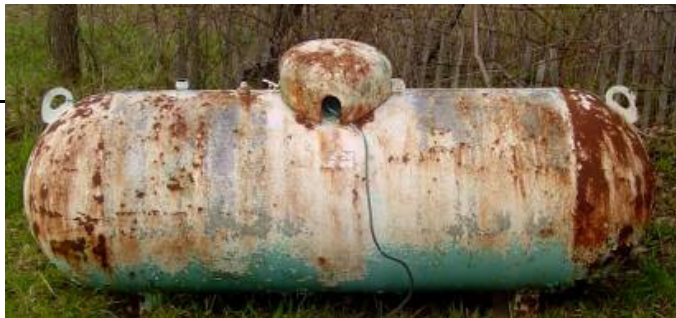
Schedule for Repair		
5	Bad	Propane tank inspection results indicate replacement is needed, it is no longer safe to use, or it requires major repair. Or propane tank is cracked.

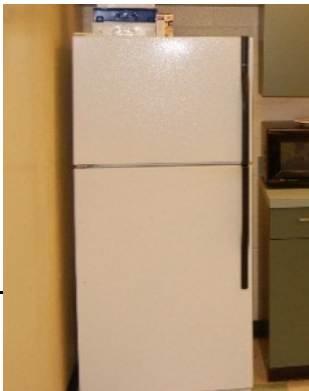
Rating	Condition/ Action	Description	Example
1	Excellent	Refrigerator is functioning as originally intended and is in good condition.

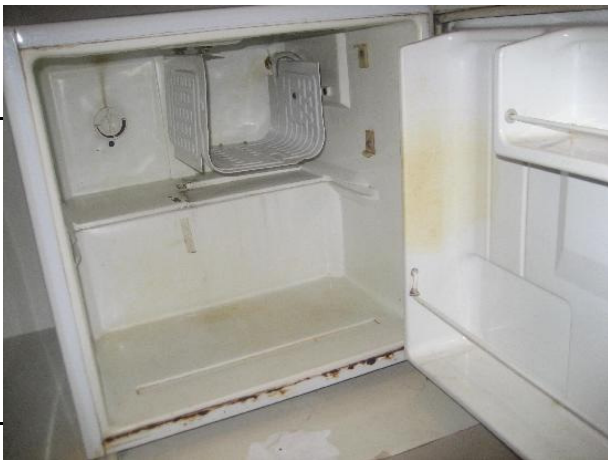
Review in 3 years		
3	Okay	Refrigerator may contain rust, some minor repairs may be needed, condenser coils may be slightly damaged but still in working condition, the door may not properly close or it may be inefficient.

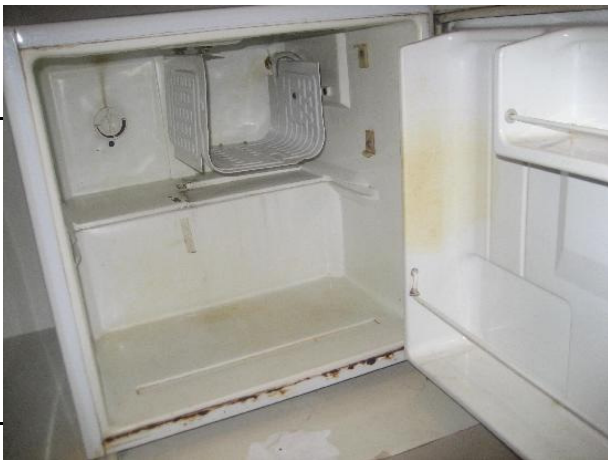
Review in 1 year		
4	Poor	Refrigerator requires significant repair, it may be very inefficient, condenser coils may be damaged or not in proper working condition, or the door may not be properly attached.

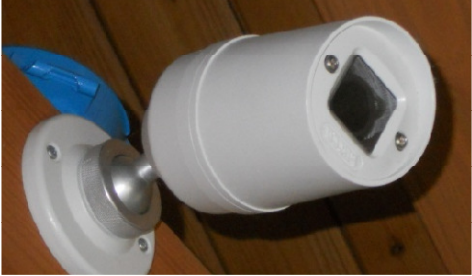
Rating	Condition/ Action	Description	Example
1	Excellent	Security camera is functioning as originally intended and is in good condition. Inspection report is good.

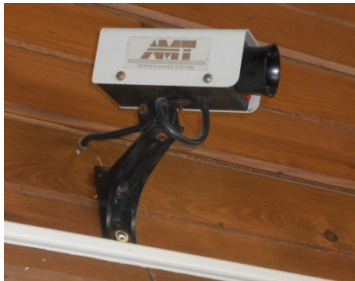
Review in 5 years		
2	Good	Security camera usually functions as it should, and only requires some minor repairs. Inspection report is good.

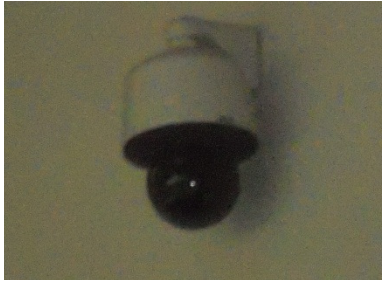
Review in 3 years		
3	Okay	Security camera inspection results are either poor, over a year old, or missing. Security camera needs some minor repairs or maintenance and infrequent large repairs. Security cameras may contain rust.

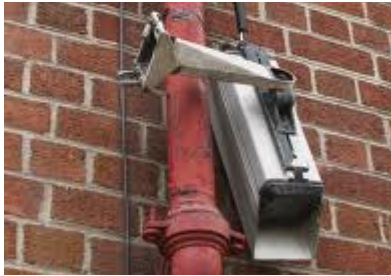
Schedule for Repair		
5	Bad	Security camera inspection results indicate replacement is needed, it is no longer functioning, or it requires major repair. Security camera is no longer secure to the building, or the glass is broken.

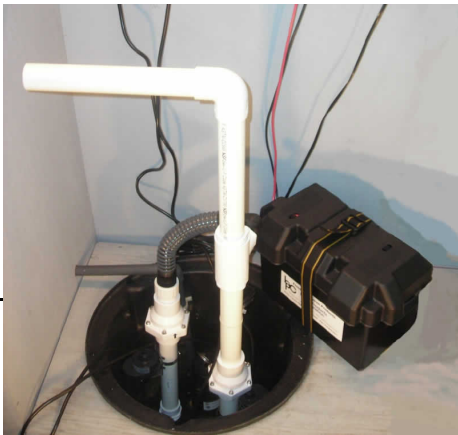
Rating	Condition/ Action	Description	Example
1	Excellent	Sump pump is functioning as originally intended and is in good condition. Inspection report is good.

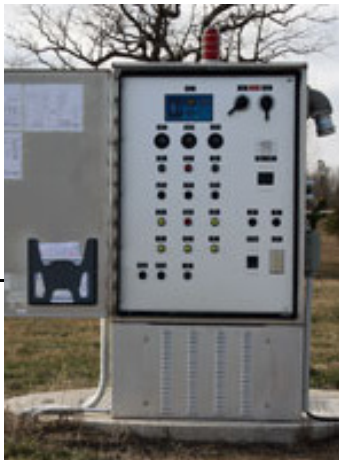
Rating	Condition/ Action	Description	Example
1	Excellent	Wastewater control panel is functioning as originally intended and is in good condition. Inspection report is good.

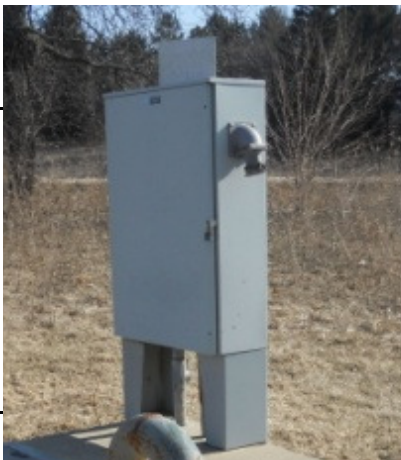
Review in 5 years		
2	Good	Wastewater control panel functions as it should, and only requires some minor repairs. Inspection report is good.

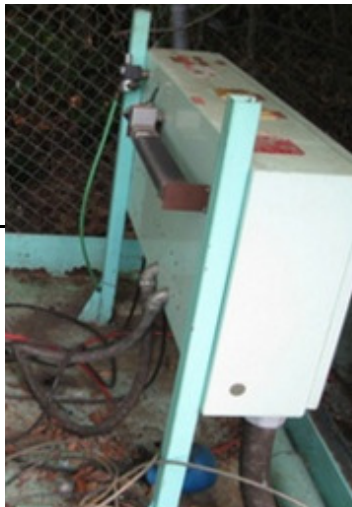
Review in 1 year		
4	Poor	Wastewater control panel requires significant repair or is not fully functional. It may contain large areas of rust or corrosion or it may be unsafe to operate.

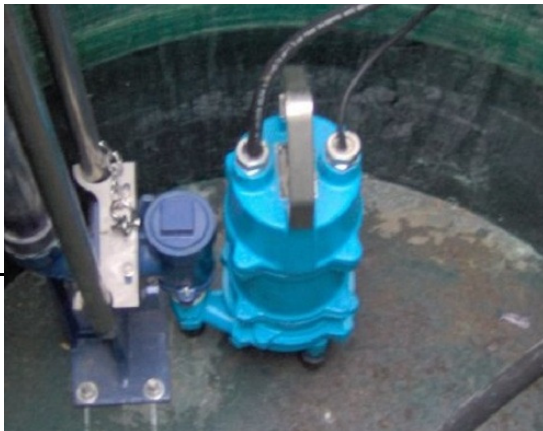
Rating	Condition/ Action	Description	Example
1	Excellent	Wastewater grinder is functioning as originally intended and is in good condition. Inspection report is good.

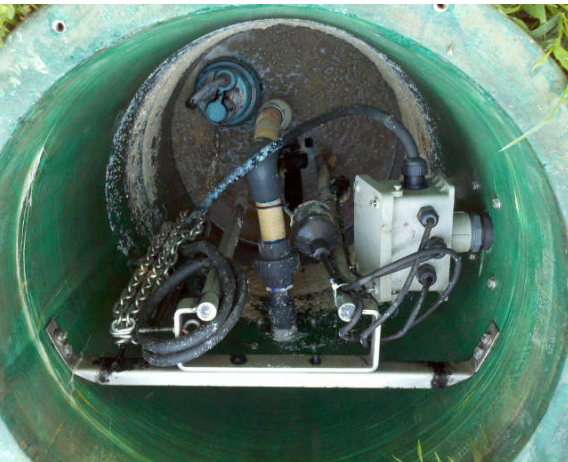
Review in 5 years		
2	Good	Wastewater grinder usually functions as it should, and only requires some minor repairs. Inspection report is good.

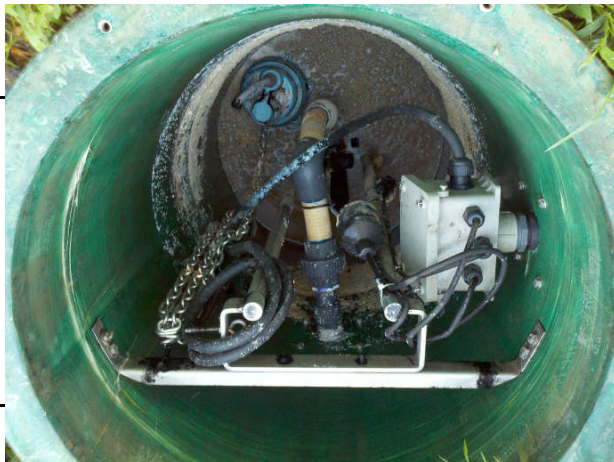
Review in 3 years		
3	Okay	Wastewater grinder inspection results are either poor, over a year old, or missing. Grinder needs some minor repairs or maintenance and infrequent large repairs.

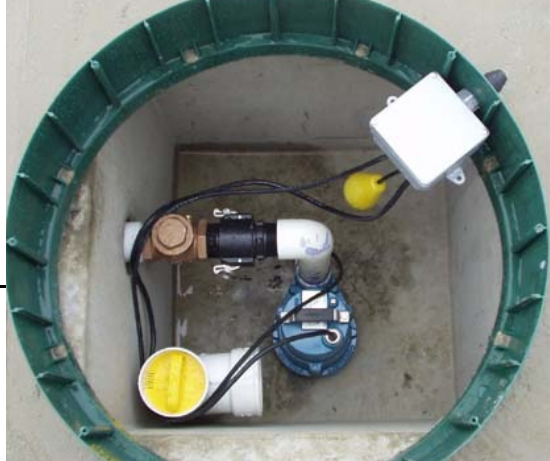
Rating	Condition/ Action	Description	Example
1	Excellent	Wastewater pump is functioning as originally intended and is in good condition. Inspection report is good.

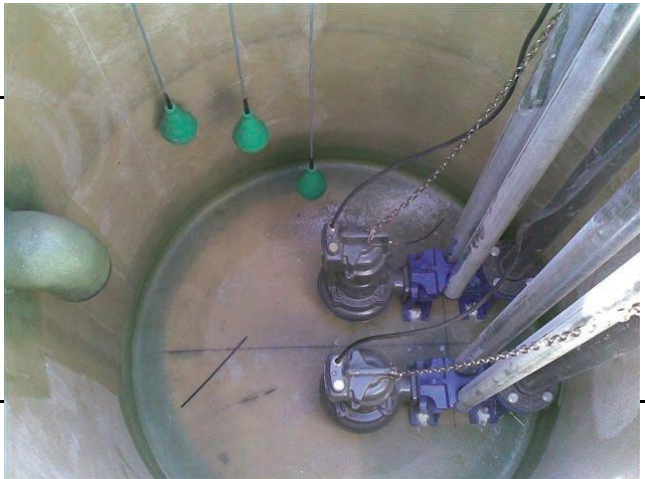
Review in 5 years		
2	Good	Wastewater pump usually functions as it should, and only requires some minor repairs. Inspection report is good.

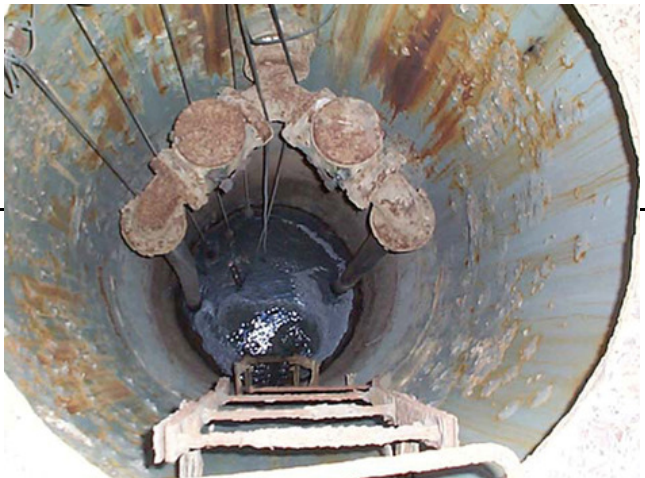
Review in 3 years		
3	Okay	Wastewater pump inspection results are either poor, over a year old, or missing. Pump needs some minor repairs or maintenance and infrequent large repairs.

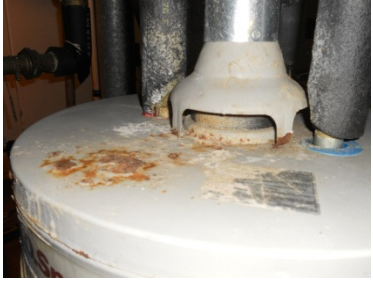
Review in 3 years		
3	Okay	Water heater inspection results are either poor, over a year old, or missing. Water heater or pipes may contain some areas of rust or corrosion, or other minor repairs are needed.

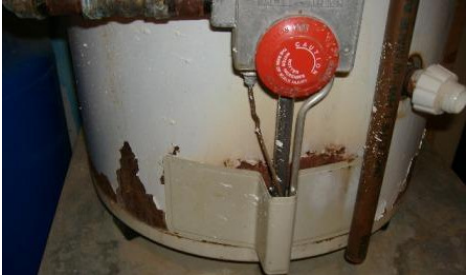
Review in 1 year		
4	Poor	Water heater requires significant repair, is obsolete or is not fully functional. Water heater is leaking, pipes are significantly corroded, or there is a large amount of rust.

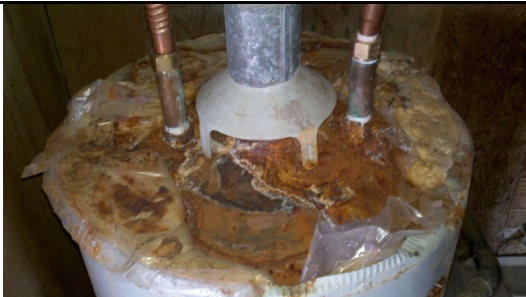
Schedule for Repair		
5	Bad	Water heater inspection results indicate replacement is needed, it is no longer functioning, has a major leak, or it requires major repair.

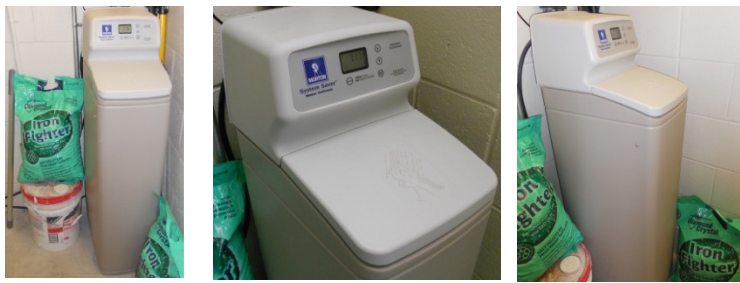
Rating	Condition/ Action	Description	Example
1	Excellent	Water softener is functioning as originally intended and is in good condition. Inspection report is good.

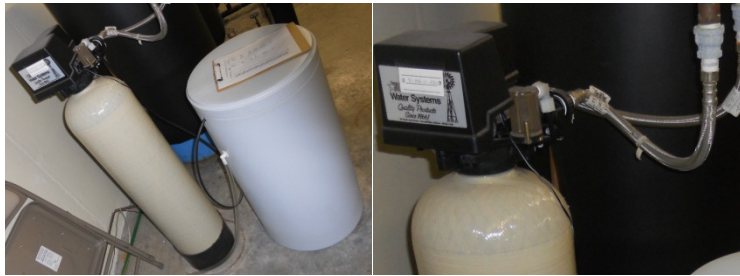
Review in 5 years		
2	Good	Water softener usually functions as it should, and only requires some minor repairs. Inspection report is good.

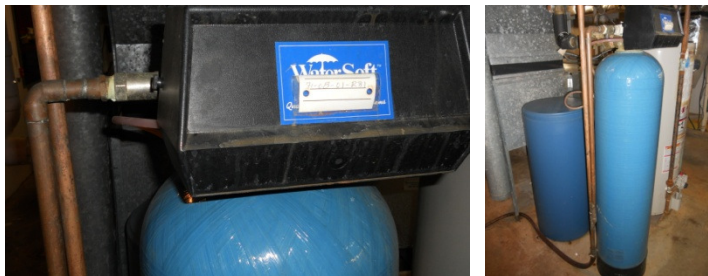
Review in 3 years		
3	Okay	Water softener inspection results are either poor, over a year old, or missing. Water softener water pipes may contain some areas of rust, there may be a small leak, or minor repairs are needed.

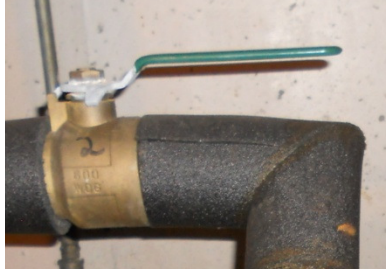
Rating	Condition/ Action	Description	Example
1	Excellent	Water valves are functioning as originally intended and are in good condition.

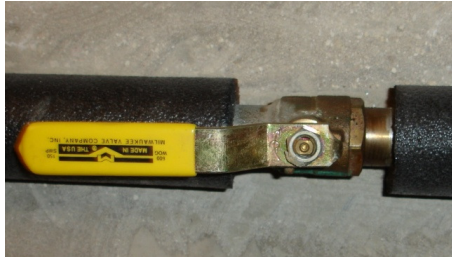
Review in 10 years		
2	Good	Water valve is functioning as it should, but it may be difficult to access, or it may contain small amounts of rust.

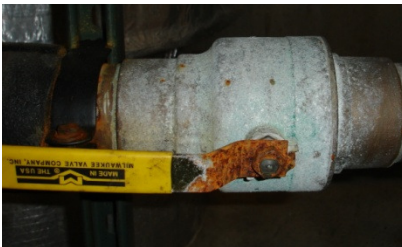
Review in 1 year		
4	Poor	Water valve is leaking, it contains a large amount of corrosion or rust, or the handle is difficult to use.

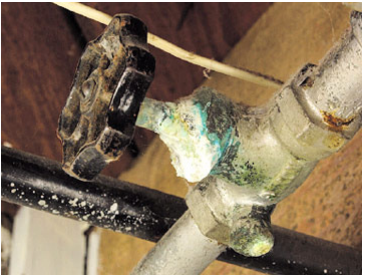
Schedule for Repair		
5	Bad	Water valve is no longer working, is completely rusted through, or is leaking heavily.

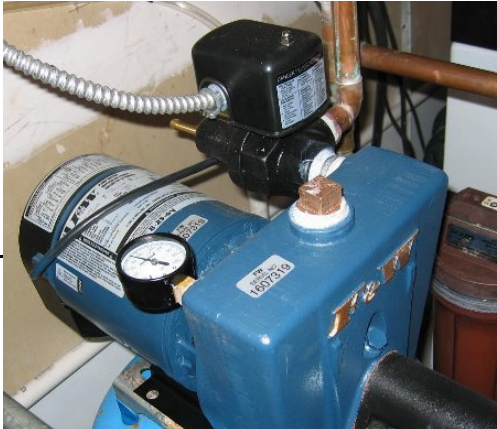
Rating	Condition/ Action	Description	Example
1	Excellent	Well pump is functioning as originally intended and is in good condition. Inspection report is good.

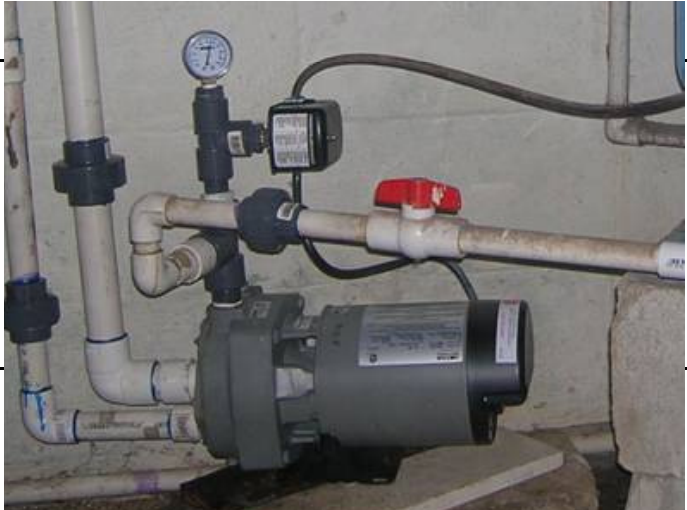
Review in 3 years		
3	Okay	Well pump inspection results are either poor, over a year old, or missing. Well pump needs some minor repairs or maintenance and infrequent large repairs.

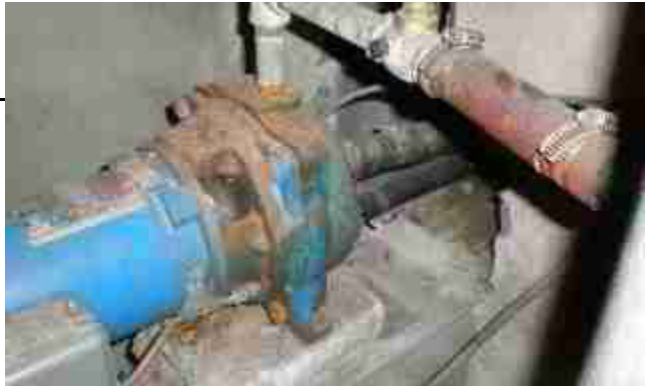
Schedule for Repair		
5	Bad	Well pump inspection results indicate replacement is needed, it is no longer safe to use, or it requires major repair.

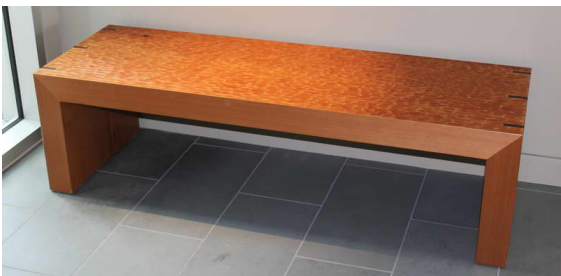
Rating	Condition/ Action	Description	Example
1	Excellent	Benches are functioning as they were intended and are in good condition.

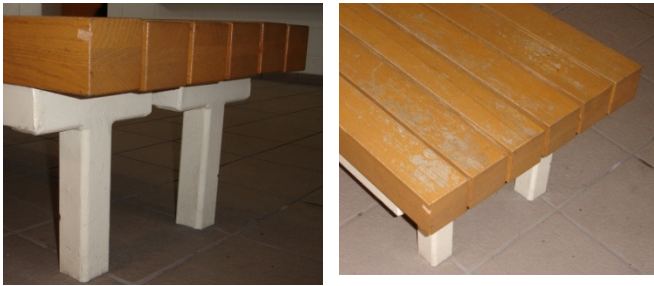
Review in 10 years		
2	Good	Bench is functioning as it should, it is structurally sound, if metal, it may have some small areas of rust, if wood, it may have small cracks that do not affect the structural stability.

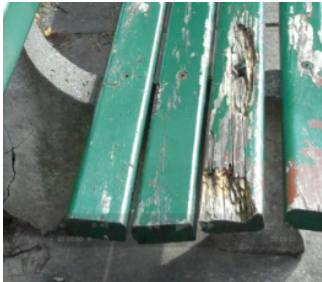
Review in 1 year		
4	Poor	Bench is functioning, but it has rough or sharp edges. If wood, it may have rotted wood or it needs to be stained. If metal it may have large areas of rust, or be rusted through in some small areas.

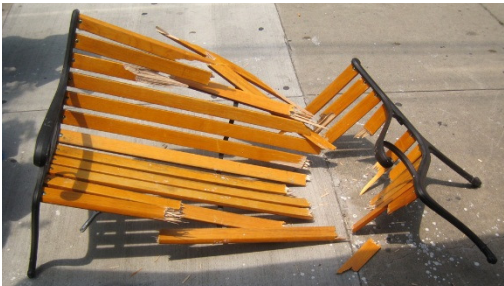
Schedule for Repair		
5	Bad	Bench is broken and is no longer functional.

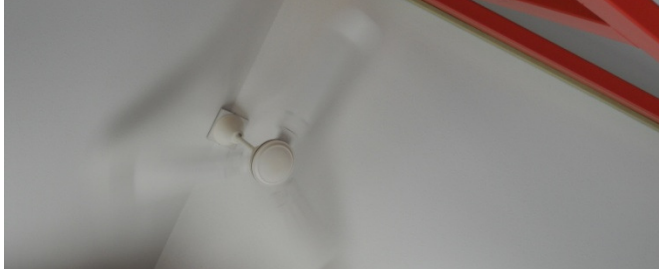
Rating	Condition/ Action	Description	Example
1	Excellent	Ceiling is functioning as originally intended and is in good condition.

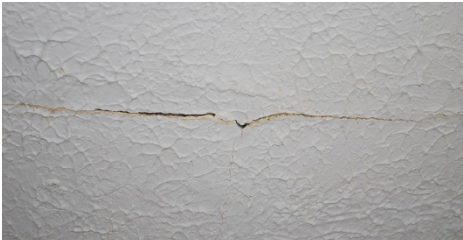
Review in 10 years		
2	Good	Ceiling is functioning as it should but it may contain a few minor cracks.

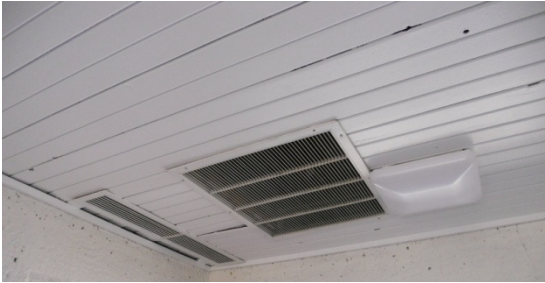
Review in 5 years		
3	Okay	Ceiling is functioning but may contain a few minor cracks, small holes or the paint may be peeling in small areas.

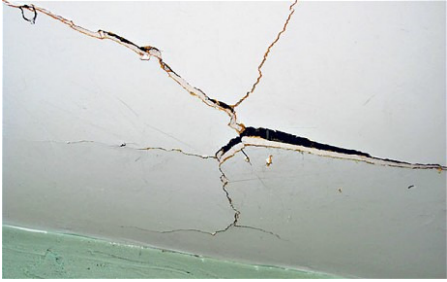
Review in 1 year		
4	Poor	Ceiling shows signs of water damage, cracks, or small holes, or the paint is peeling.

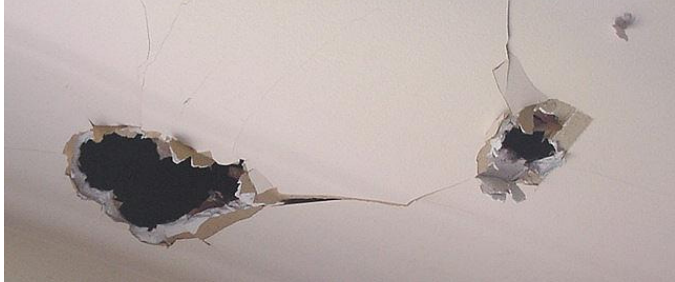
Schedule for Repair		
5	Bad	Ceiling has large holes, large cracks, or has major water damage.

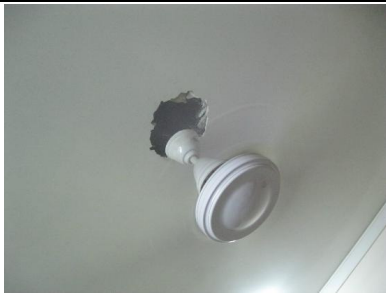
Review in 1 year		
4	Poor	Ceiling fans are not fully secure in place, they do not function well, they are noisy, or they are missing blades.

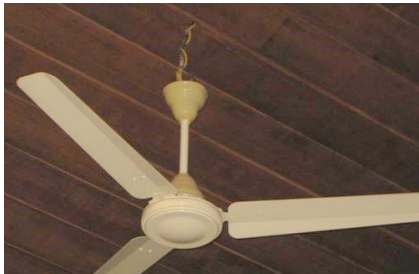
Schedule for Repair		
5	Bad	Ceiling fans no longer function, are unsafe to operate, or require major repair or replacement.

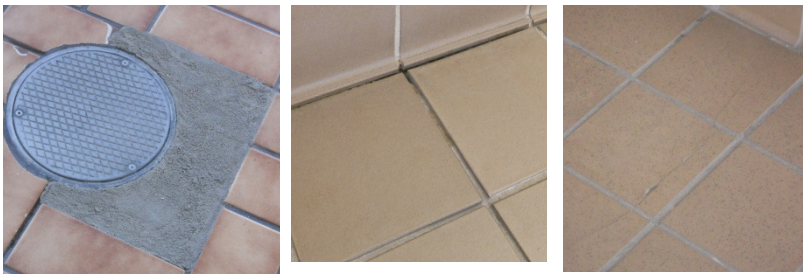
Review in 20 years		
2	Good	Floor functions as it should, but shows some signs of age.	 
	Review in 10 years		
3	Okay	Floor has a few minor cracks, missing tiles, or caulking is deteriorated in a few places.

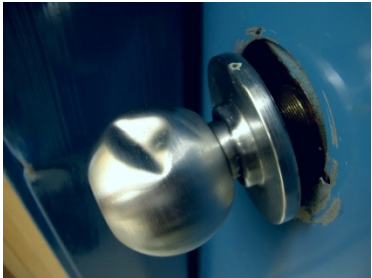
Review in 1 year		
4	Poor	Door handle or lock is broken, the hinges may not hold the door secure in place, or there are large areas of chipping paint or rust.

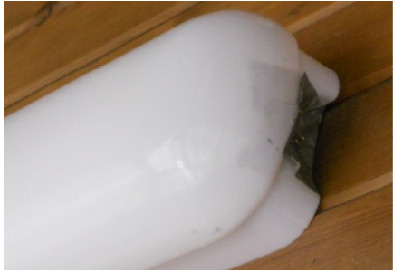
Review in 5 years		
3	Okay	Light covers are discolored, contain a small amount of rust, or contain small cracks.

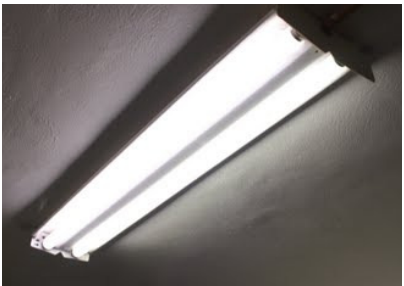
Review in 1 year		
4	Poor	Light fixtures are not fully secure in place and are in danger of falling, or they contain large amounts of rust. Light cover is discolored, missing or has a large crack.

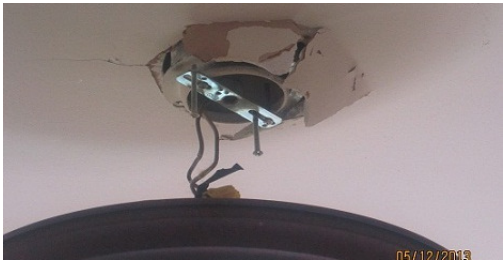
Schedule for Repair		
5	Bad	Lighting is no longer functioning or is no longer able to be safely secured to the wall or ceiling.

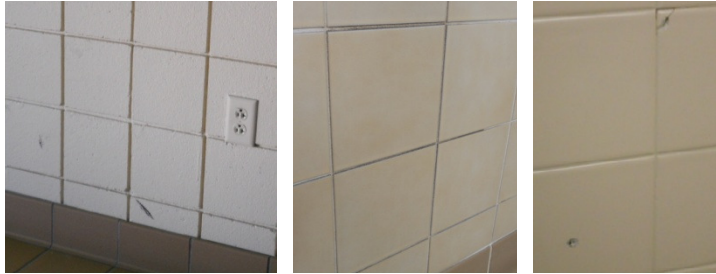
Review in 5 years		
3	Okay	Walls may have small areas of chipping paint, be faded, or there may be small cracks or holes, a few wall tiles may be broken or missing, grout may be beginning to deteriorate.

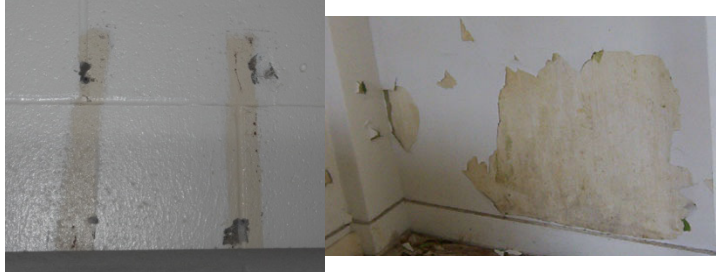
Review in 1 year		
4	Poor	Paint is chipping in many areas or is very faded, there are cracks, or a large amount of wall tiles are cracked or missing.

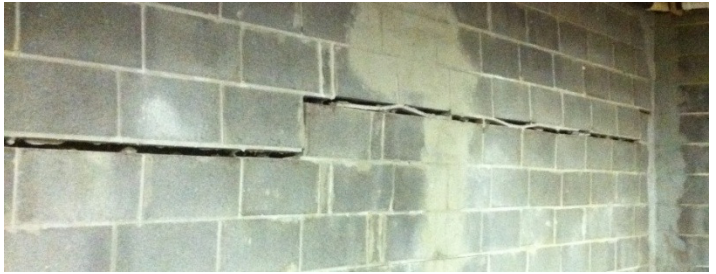
Schedule for Repair		
5	Bad	There are large cracks in the walls that affect the structural support of the building.

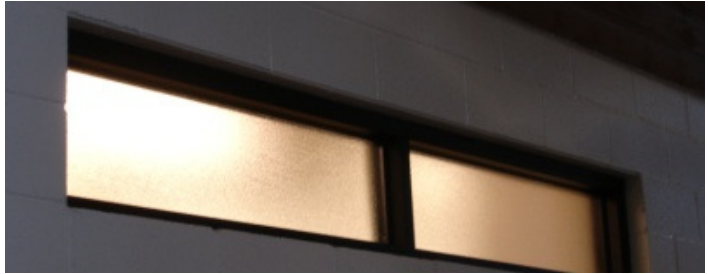
Review in 10 years		
2	Good	Windows are functioning as they should but some caulking may be beginning to deteriorate around the edges of the window.

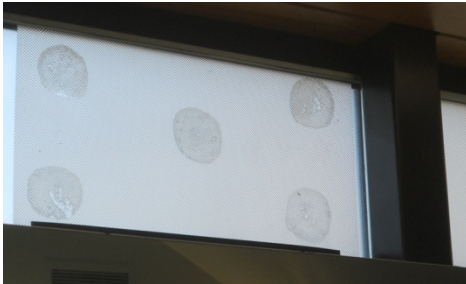
Review in 1 year		
4	Poor	Windows contains cracks, caulking is missing or there is water damage between the panes.

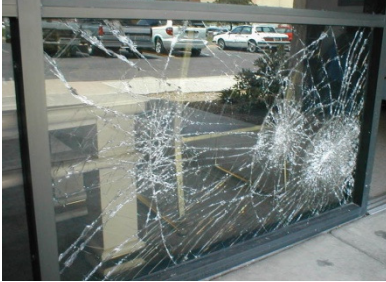
Schedule for Repair		
5	Bad	Window glass is broken or missing or window casing is damaged beyond repair.

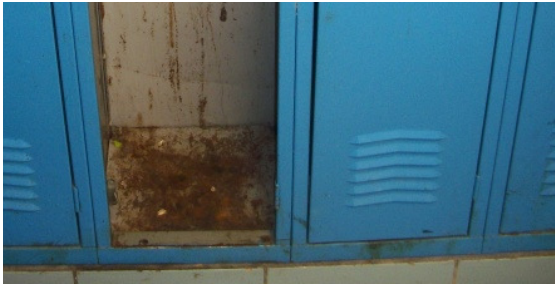
Review in 5 years		
3	Okay	Lockers are functioning but they may contain some areas of graffiti, chipped paint, or rust, have a few sharp edges, or have some dents.
