Rest Area Inspection Guidebook

Instructions

The assets are broken down into 5 different categories, exterior, landscaping, equipment/systems, interior, and restrooms. Each asset will be given a condition rating.

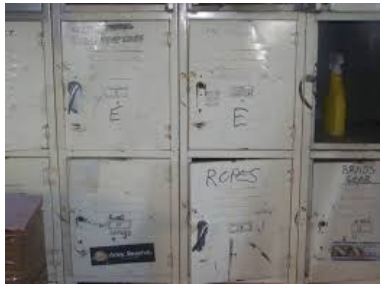
Review in 1 year		
4	Poor	Some lockers are not functioning as originally intended, they are not secure to the wall or stable, they have large dents or areas of rust, or large sharp edges.

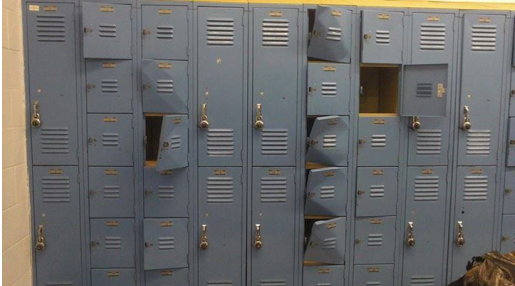
Schedule for Repair		
5	Bad	Lockers are no longer functional, they are rusted through, cannot stand on their own, or are no longer safe to use.

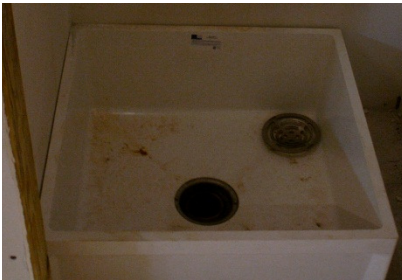
Review in 5 years		
3	Okay	Mop sink is functioning but it may contain some areas of rust, have a few sharp edges, have dents, or, if plastic, it may have some small cracks that do not cause a leak.

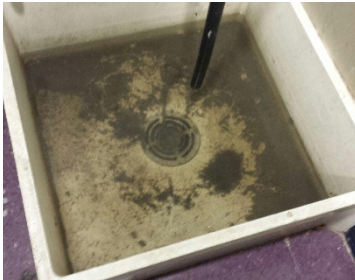
Review in 1 year		
4	Poor	Mop sink has large dents areas of rust, or cracks. It may have large sharp edges, be a hazard for those who use it, have a small leak, or it may not drain properly.

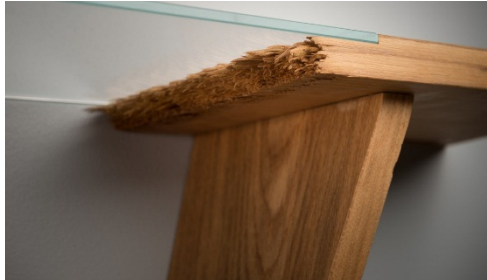
Review in 5 years		
3	Okay	Shelving is functioning but it may contain some areas of chipped paint, or rust, have a few sharp edges, shelves may be slightly bowed, or it may be a little unstable.

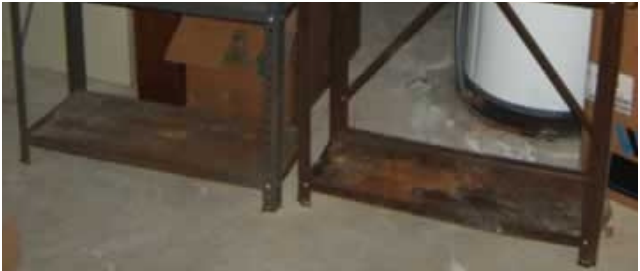
Review in 1 year		
4	Poor	Shelving is not stable, it has large dents or areas of rust or chipping paint. It may have large sharp edges or be a hazard for those who use it.

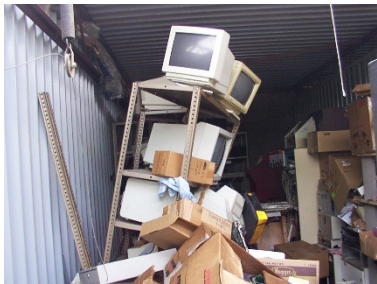
Schedule for Repair		
5	Bad	Shelving is no longer functional, it is rusted through, cannot stand on its own, cannot hold any items, or is no longer safe to use.

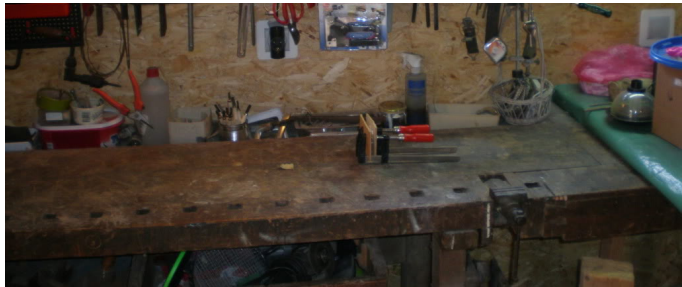
Review in 5 years		
3	Okay	Workbench is functioning but it may contain some areas of chipped paint, or rust, have a few sharp edges, or it may be a little unstable.

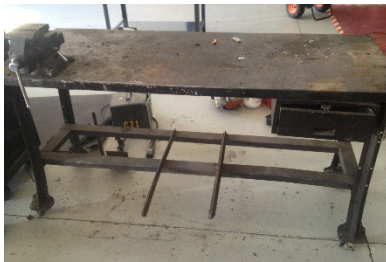
Review in 1 year		
4	Poor	Workbench is not stable, it has large dents or areas of rust or chipping paint. It may have large sharp edges or be a hazard for those who use it.

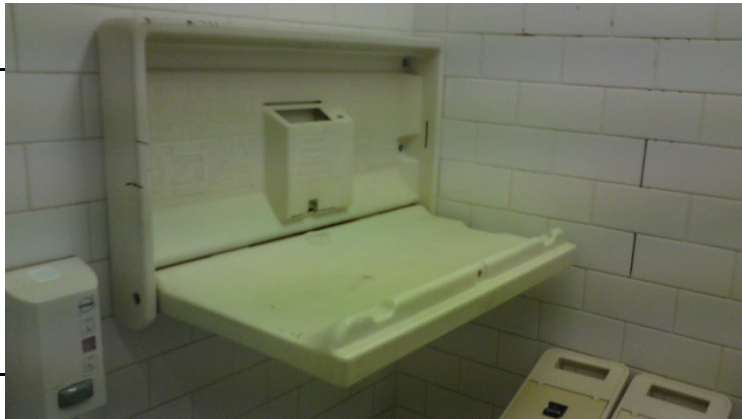
Review in 5 years		
3	Okay	Baby changing stations contain large areas of graffiti, have slightly sharp edges, are missing straps, or have some minor cracks.

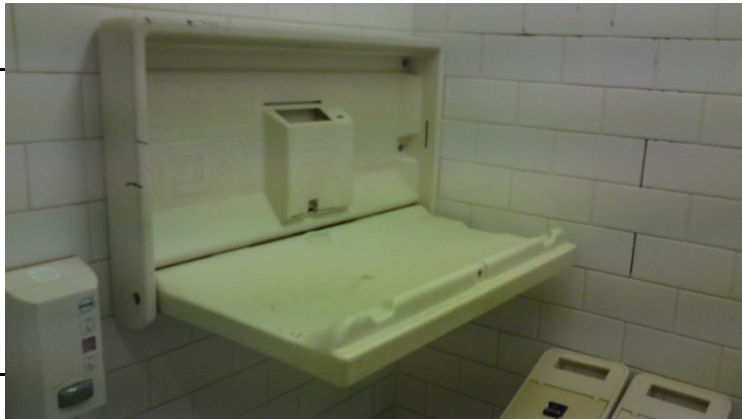
Review in 1 year		
4	Poor	Baby changing stations are not fully secured to the wall, contain sharp edges, contain large amounts of graffiti or have cracks.

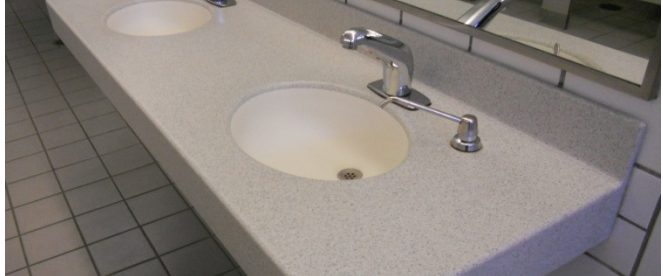
Rating	Condition/ Action	Description	Example
1	Excellent	Counter tops are functioning as originally intended and are in good condition.

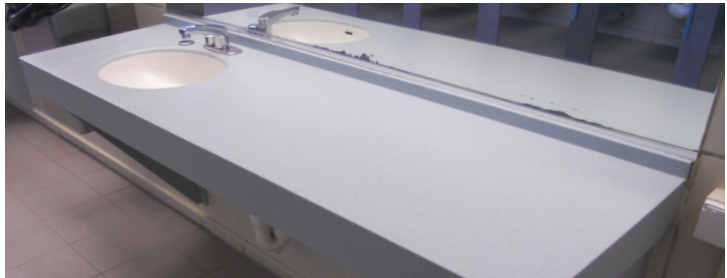
Review in 10 years		
2	Good	Counter tops are functioning but may contain some minor graffiti, damage to the top, or slight chipping.

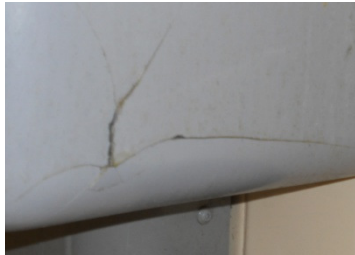
Review in 5 years		
3	Okay	Counter tops contain large areas of graffiti, are chipping or have some slightly sharp edges.

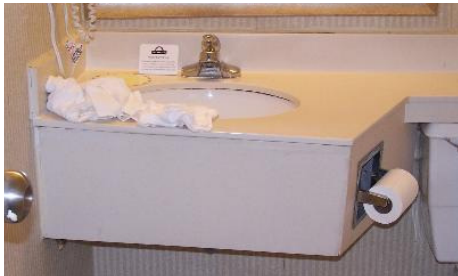
Review in 1 year		
4	Poor	Counter tops are not fully secured to the wall, contain sharp edges that need to be sanded, contain large amounts of obscene graffiti or are chipping.

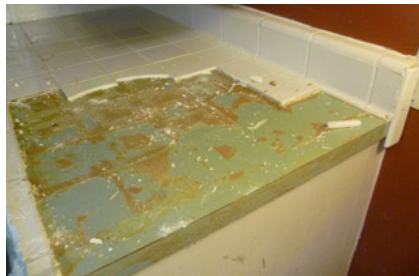
Schedule for Repair		
5	Bad	Counter tops are not secure to the wall.

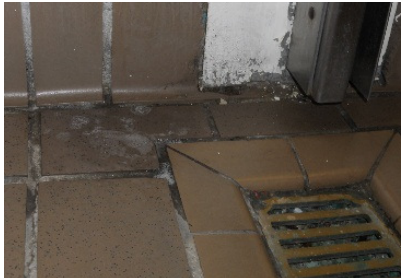
Review in 1 year		
4	Poor	Floors have a large amount of broken or missing tiles, large cracks that possess tripping hazard, or caulk is deteriorated.

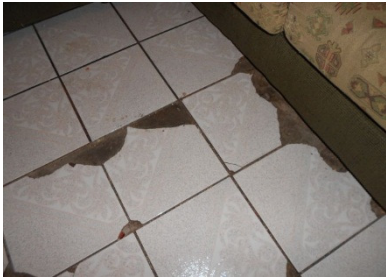
Schedule for Repair		
5	Bad	Floors are missing multiple tiles or multiple tiles are broken.

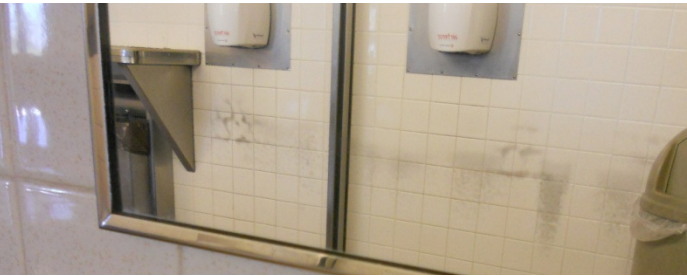
Review in 10 years		
2	Good	Mirrors are functioning but may contain some minor chipping or discoloration.

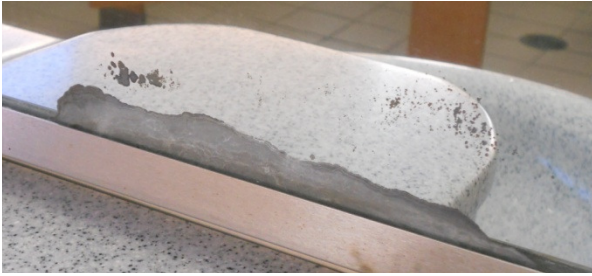
Review in 5 years		
3	Okay	Mirrors have some discoloration, graffiti, small sharp edges, cracks or are chipping.

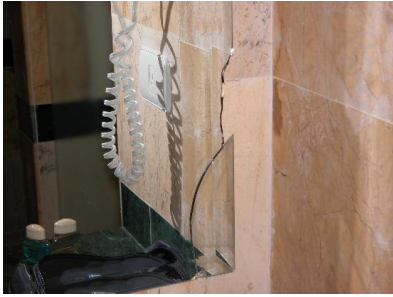
Review in 1 year		
4	Poor	Mirror is not fully secure to the wall, contains large discoloration or graffiti, or contains large sharp edges.

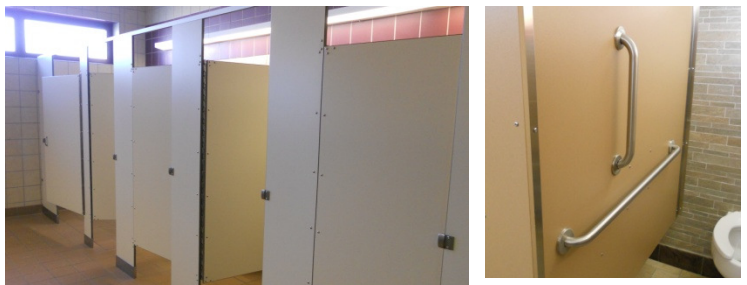
Rating	Condition/ Action	Description	Example
1	Excellent	Partitions are functioning as originally intended and are in good condition.

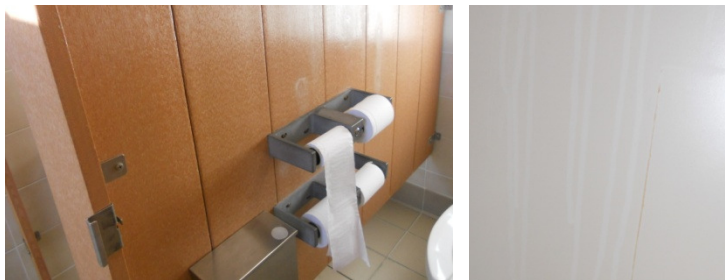
Review in 10 years		
2	Good	Partitions are functioning as they should but contain some graffiti or show signs of wear and tear.

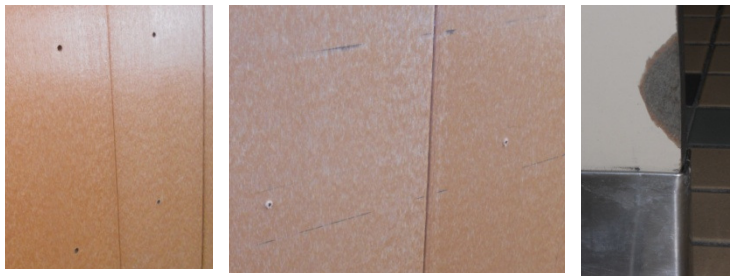
Review in 5 years		
3	Okay	Partitions contain graffiti or small holes, or door latches, hooks, shelves or toilet paper dispensers are not fully secure.

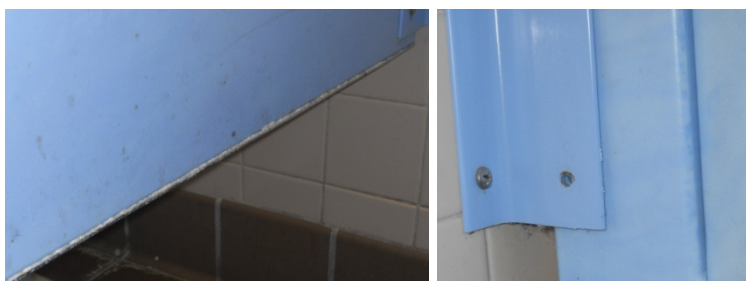
Review in 1 year		
4	Poor	Partitions are not secure in place, contain inappropriate graffiti, or door latches, hooks, shelves or other hardware are missing or not functioning.

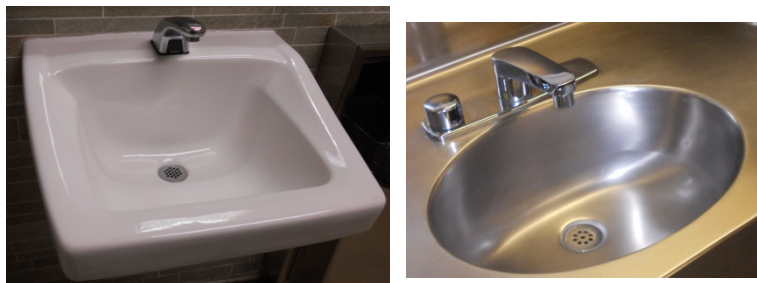
Rating	Condition/ Action	Description	Example
1	Excellent	Sinks are functioning as originally intended and are in good condition.

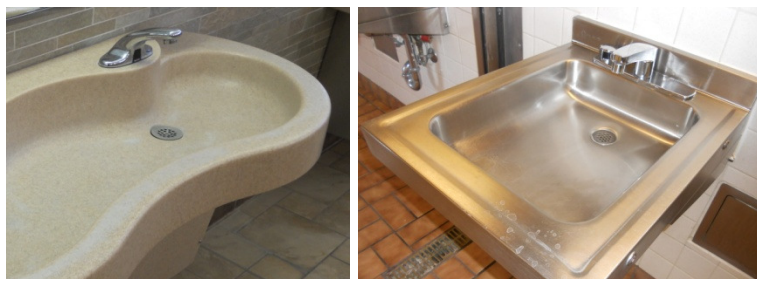
Review in 10 years		
2	Good	Sinks usually function but have some minor water stains or a little corrosion on the faucet.

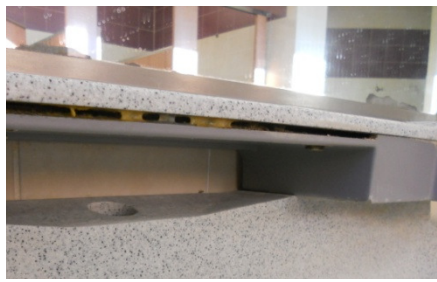
Review in 5 years		
3	Okay	Sinks may have low water pressure, small areas of water stains, or a little corrosion around the faucet.

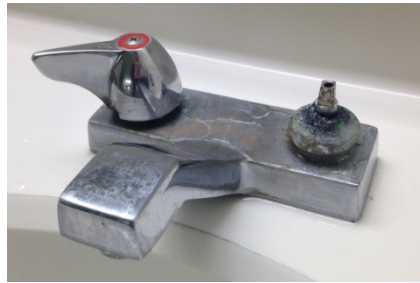
Review in 1 year		
4	Poor	Sinks have little to no water pressure, they are leaking, are not fully secured to the wall, or contain large amounts of corrosion on the faucet.

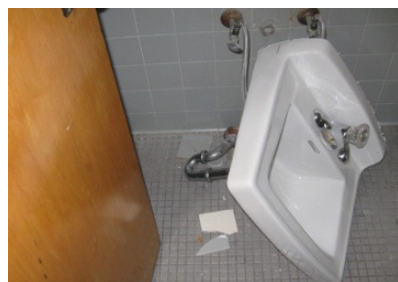
Schedule for Repair		
5	Bad	Sink is not secure to the wall, is no longer working, or the faucet is fully corroded.
