# Porous Asphalt Pavement Performance in Cold Regions

Minnesota  
Department of  
Transportation

Matthew Lebens, Primary Author  
Office of Materials and Road Research  
Minnesota Department of Transportation

Research Project  
Final Report 2012-12

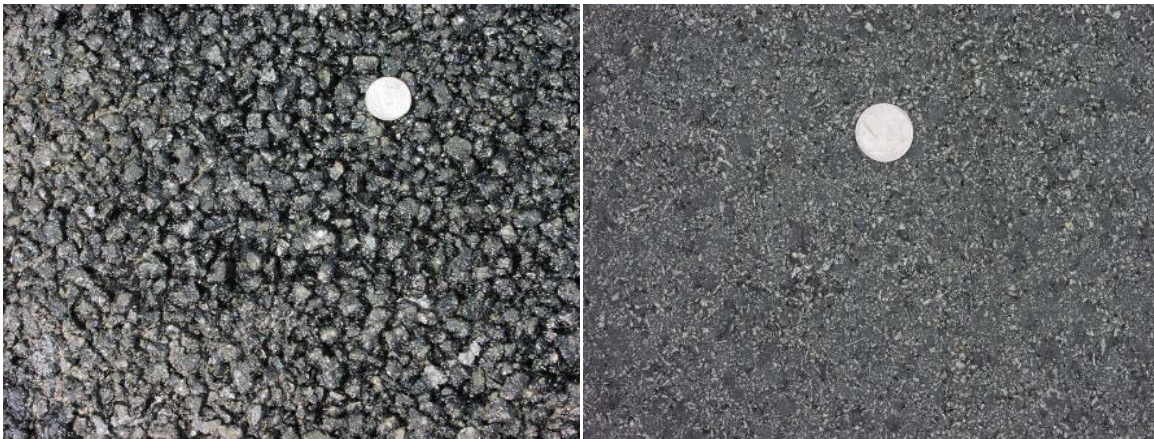
**Figure 1.2. Porous asphalt surface texture versus dense graded asphalt surface texture**

The main advantages of the use of Porous Asphalt pavements are improvements in safety, economy, and benefits to the environment [2, 6]. The main safety advantages of PA [2] in comparison to dense graded asphalt are related to the porosity and the surface texture (demonstrated in figure 1.2, below). The Porous Asphalt provides reduced hydroplaning, better (high-speed) wet pavement friction, and a reduction of splash and spray. Better visibility (especially in night conditions) results from reduced pavement surface glare.

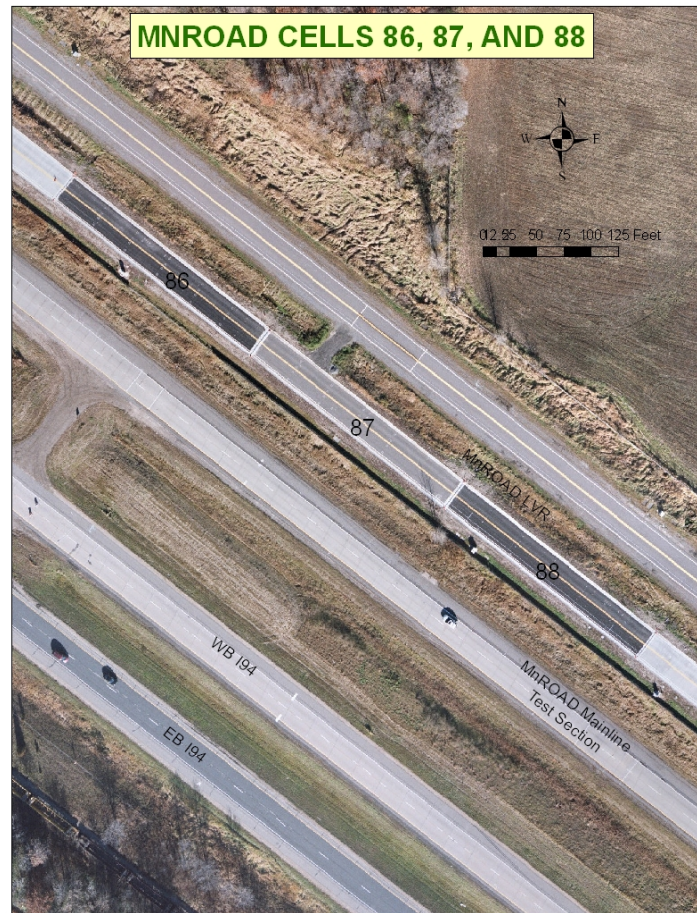
**Figure 1.4. MnROAD LVR cells 86, 87, and 88**

Construction of the porous asphalt pavement cells outlined in this report was completed in August 2009 on new LVR cells 86 and 88. A standard hot mix asphalt, impervious “control” cell (cell 87) was installed between cells 86 and 88 on the transition area between subgrade types. Pervious Portland Cement Concrete test cells 85 and 89 were installed adjacent to the PA cells and researched [42] under a separate project (LRRB 879). Table 1.1 contains the test cell descriptions, stationing, and lengths of the constructed cells 85-89 on the LVR. The locations of new cells 86 through 88 on the LVR are shown in Figure 1.4, on the following page.

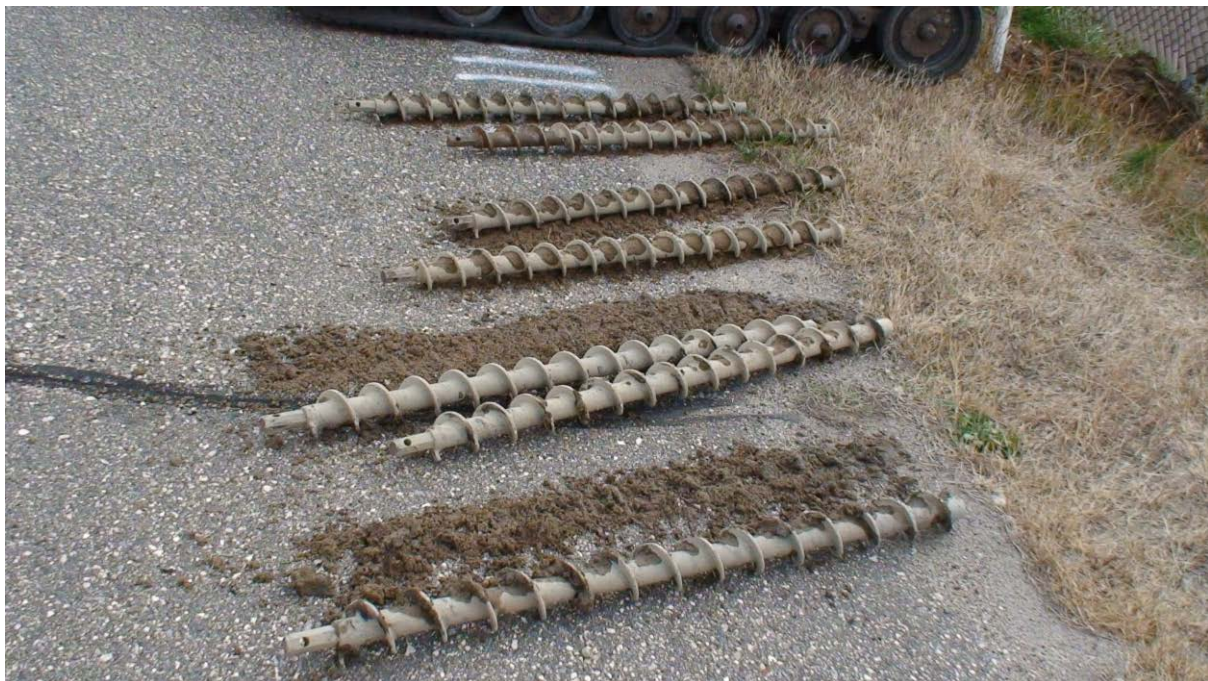
**Figure 1.5. Well #2: Saturated sands at up to 30-foot depths**

The granular saturated soils were fairly easily retrieved from the auger but the stiff clays tenaciously adhered even after auger sections were dropped on the pavement. The apparently westward sloping aquiclude was supported by the material shown in figure 1.6. It was encountered at 10 ft. in Wells #3 and #4 and at 30ft in Wells #1 and #2.

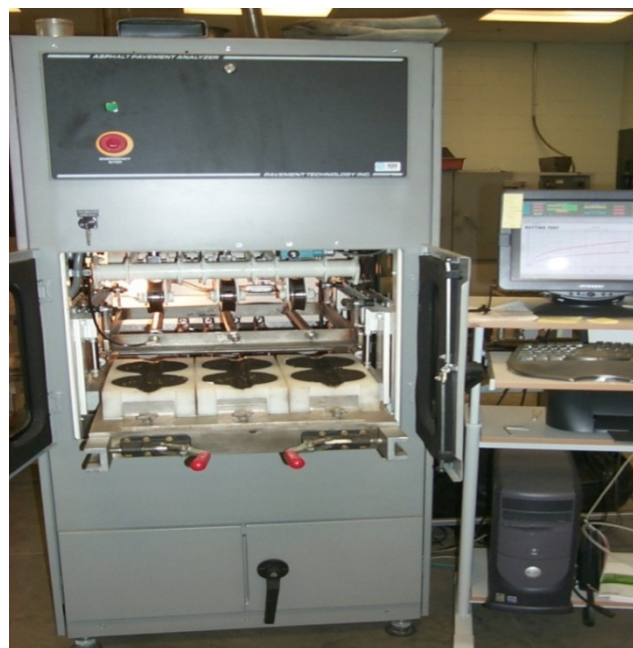
**Figure 2.1. Asphalt pavement analyzer (APA) apparatus**

The test was performed on both the PG64-34 and PG70-28 mixes. The APA test results for each binder are illustrated in figure 2.2. It can be seen that the mixture with PG70-28 has a better and more linear response than the mixture with PG64-34. This illustrates the PG64-34 has a higher potential for rutting. The PG64-34 mix also showed very poor results in comparison to those normally seen with a typical dense graded asphalt mix.

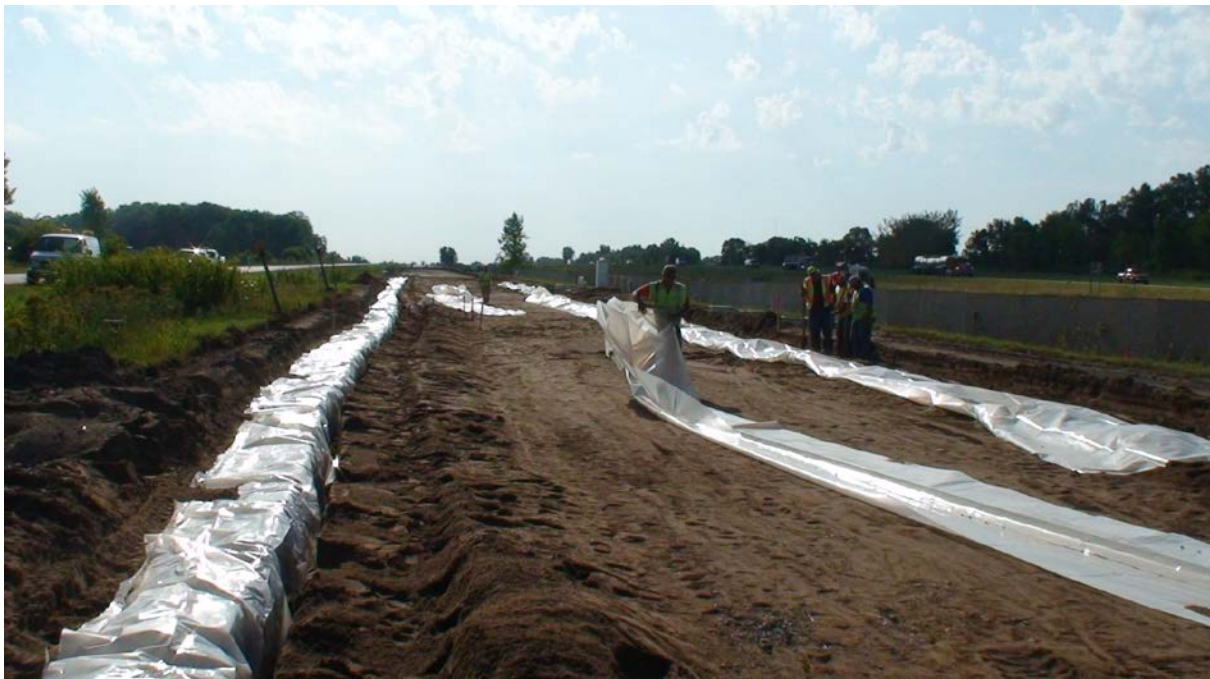
**Figure 4.1. Cell 86 (sand subgrade) installing plastic edge barriers**

Grading on these cells began June 25<sup>th</sup>, 2008. After preliminary instrumentation work was completed in early August 2008, existing pavement from previous LVR test cells 25 and 26 was removed to prepare for construction of cells 85 through 89. The cells were subcut to the sand and clay subgrades during the second week of September 2008. Plastic sheeting was installed vertically to a 4-foot depth around all four sides of each cell to isolate the water flowing through the pavement structure and prevent lateral flow into the system (figures 4.1 and 4.2).

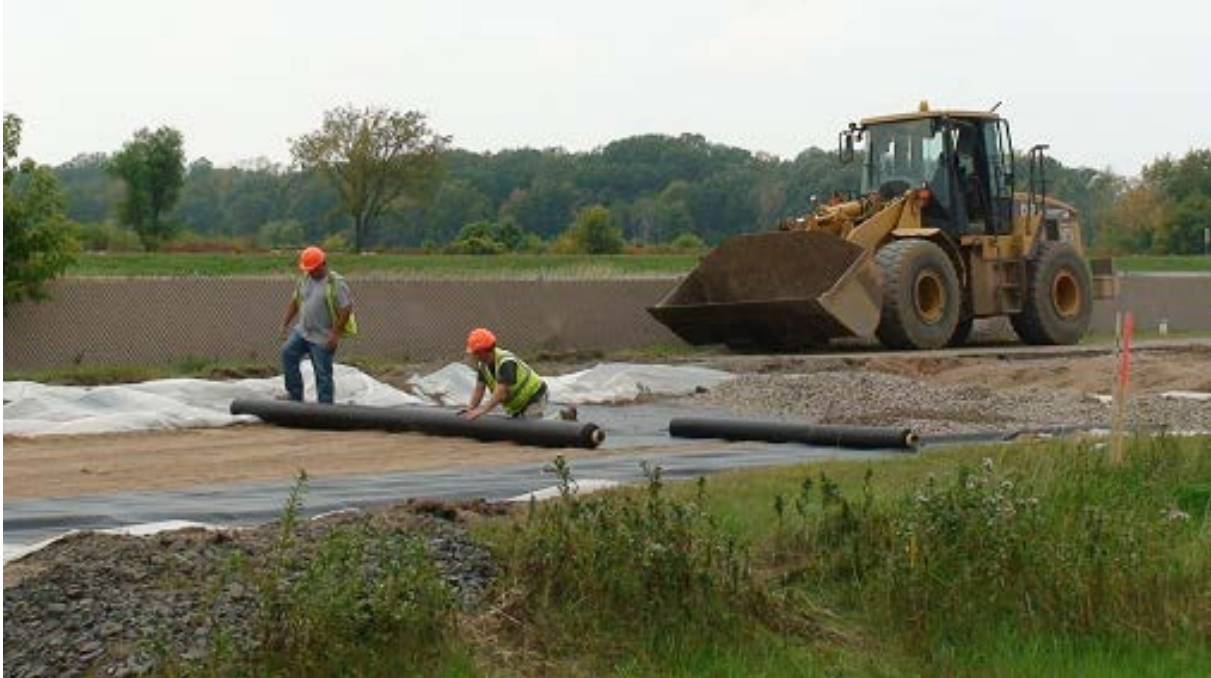
**Figure 4.3. Installation of type V geotextile**

Type V Geotextile fabric was installed (figure 4.3) on top of the prepared subgrade September 15<sup>th</sup>, 2008 and placement of the planned CA-15 base material was attempted the following week (figure 4.4). The CA-15 obtained by the contractor for cells 85 through 89 demonstrated insufficient stability for supporting construction operations. After on-site attempts at blending and layering other materials, it was decided to replace the top 4 inches of CA-15 base with crushed granite railroad ballast (figure 4.5). On cell 87 the top 4 inches were replaced with crushed iron ore ballast that was leftover from the construction of cell 23. Each lift of base material was lightly rolled to set the material without significant compaction (figure 4.6). The resulting composite base provided an adequate construction platform.

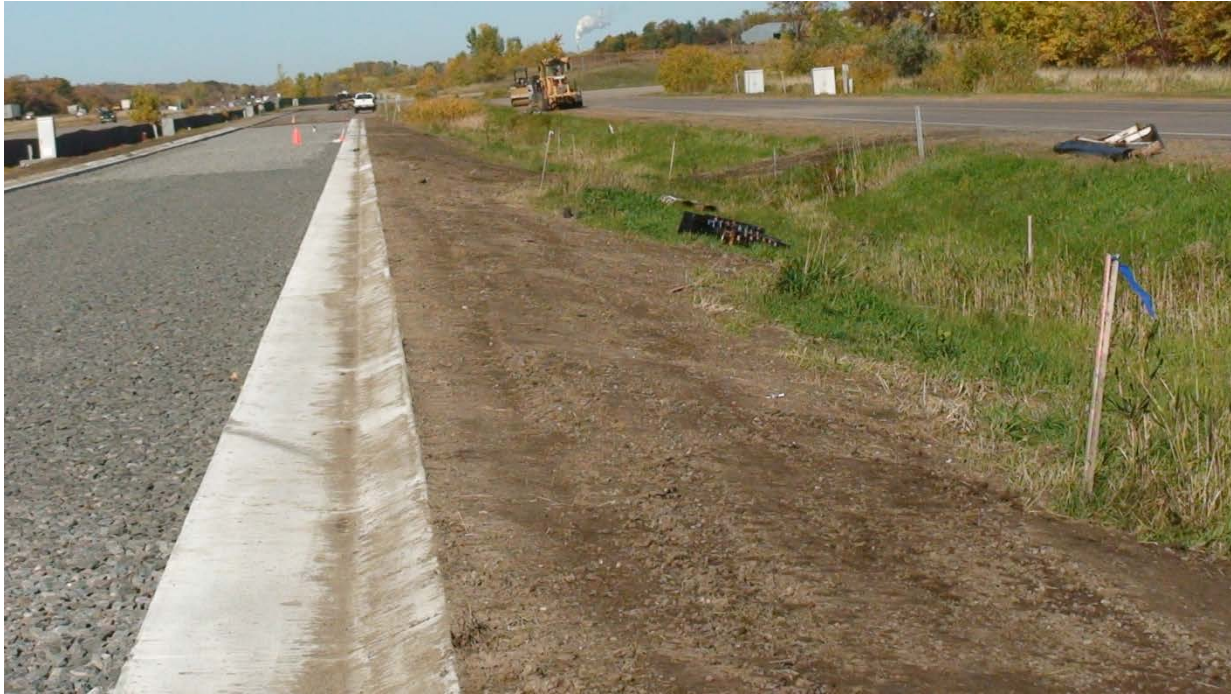
**Figure 4.7. Curbing and shoulder installation**

Curb and gutter was installed October 1<sup>st</sup>, 2008 directly over the vertical plastic barriers along the cell edges (figure 4.7). After curbing was sufficiently cured, topsoil was backfilled and seeded behind the curbing and the median was reshaped during the first week of October 2008.

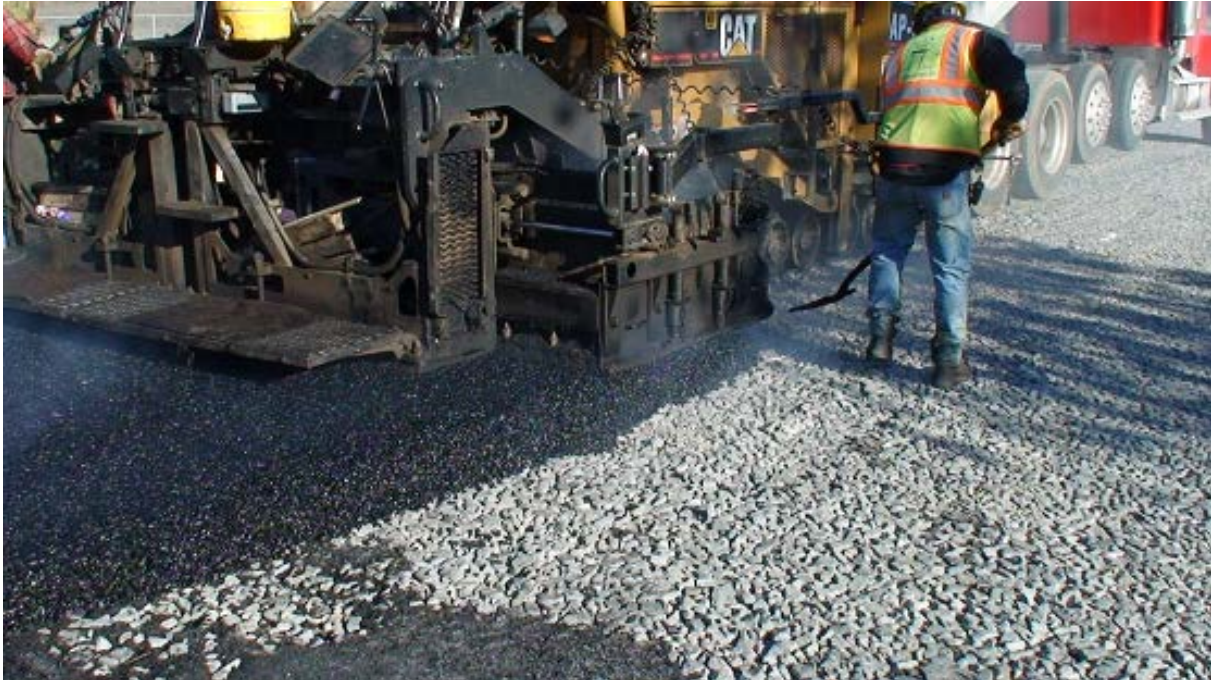
**Figure 4.8. Porous asphalt paving**

The porous asphalt was initially laid down approximately eight inches thick by the paver in order to obtain the five-inch specified final layer thickness after compaction (the average compacted thickness was later determined by coring to be approximately 6 inches.) The contractor waited about five hours until the surface temperature of the mix was below 100°F before starting the rolling (figure 4.9). Then the pavement mat was rolled once or twice to make it smooth, but no more so as to retain the desired surface porosity. After rolling the pavement appeared to have acceptable smoothness and porosity. This was a learning experience for MnDOT and contractor personnel alike.

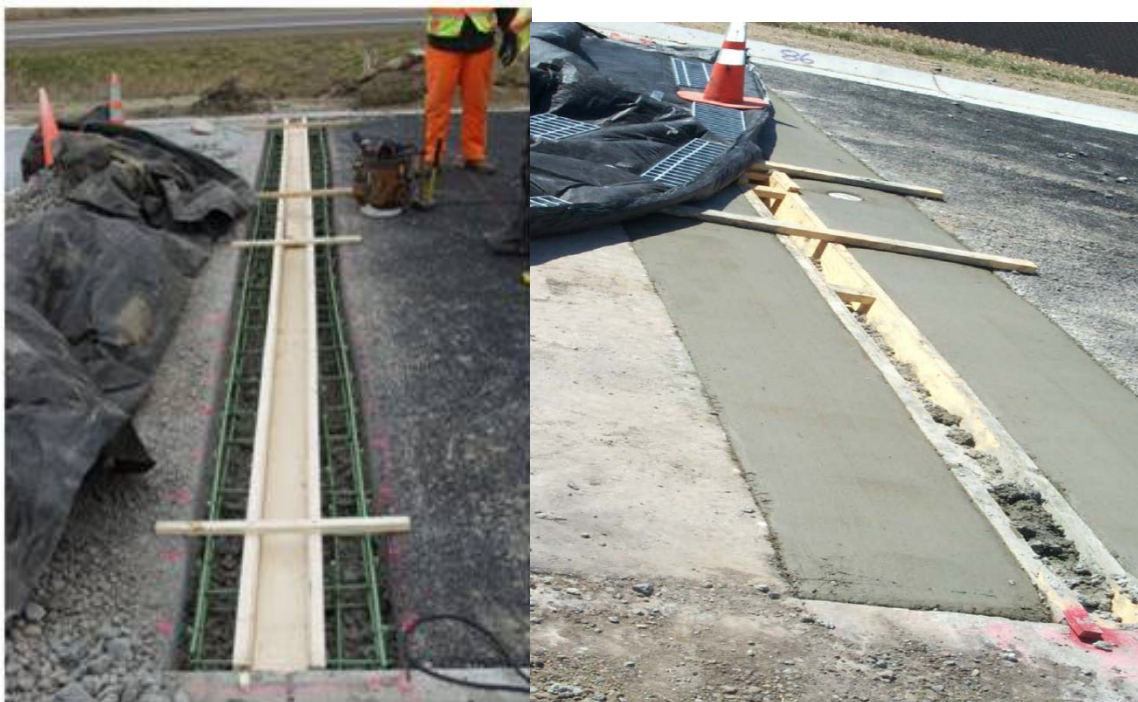
**Figure 4.10. Cell-separating transverse drains**

After paving was complete, MnROAD staff constructed transverse drains (figure 4.10) to capture any surface water runoff from the down-slope ends (a  $< 1\%$  slope exists from east to west) of each cell 85-89, and the up-slope end of cell 89 (to prevent water entering from the cell

before it). Saw-cut openings were made approximately two feet wide along the transverse joints directly above the transverse plastic barrier sheeting, and the pavement was removed down to the base material. Steel reinforcement was designed and placed in the trenches to support the concrete drains. Wood forms were fabricated to create a sloping trench to the center, and placed prior to the concrete pour. A PVC drainpipe was installed from the roadway centerline (the low point) of the formed trench to a collection tank in the inside ditch. Concrete was then poured and finished to create the drain. Four drains were built in the fall of 2008, and the remaining two were built in the spring of 2009 (figure 4.13).

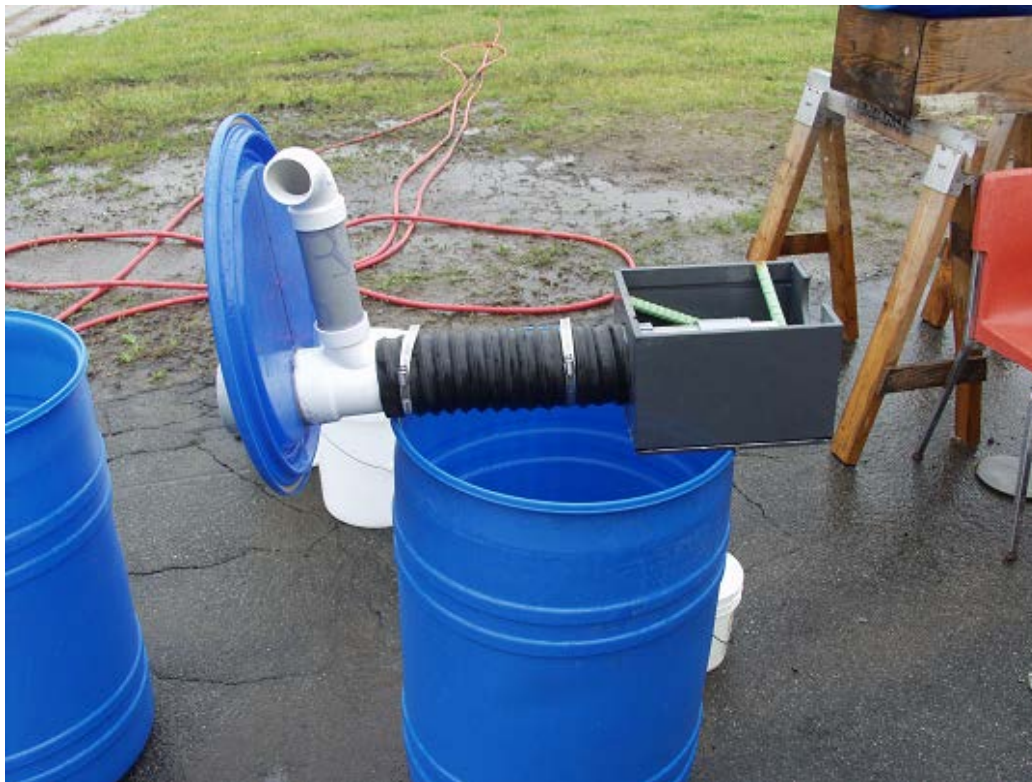
**Figure 4.12. Collection tank with flow meter**

In August of 2009, collection tanks for the transverse drains were installed. The tanks were equipped with improvised flow meters (figure 4.12) for monitoring surface water runoff. However, due to the low, intermittent flow, the meters malfunctioned and never produced reliable data. Water-sampling standpipes (figure 4.11) were also installed vertically in the concrete transverse drains. Three of them extended down to the bottom of the base material, and one into the groundwater. The groundwater sampling standpipe was used to compare water quality beneath the porous asphalt pavement to water samples taken in the piezometer outside of the cells; however, the standpipes in the base material never had any measureable quantity of water present when checked.

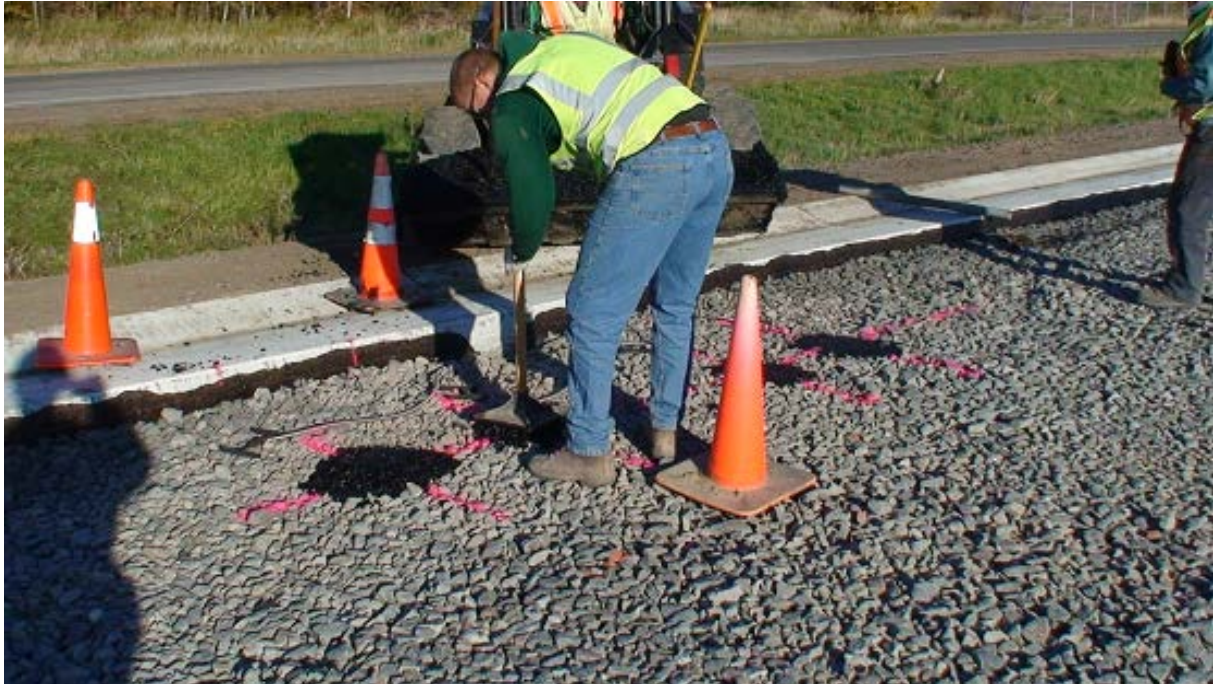
**Figure 4.14. Instrumentation installations**

The pavement gauges installed include thermocouples, water sensors, strain, and pressure gauges. Figure 4.14 shows installation of strain gauges at the bottom of the pavement just prior to paving. Ultimately some sensor malfunctions occurred on the porous asphalt cells – particularly among the strain gauges. However, enough data was collected with the functioning sensors to provide useful conclusions.

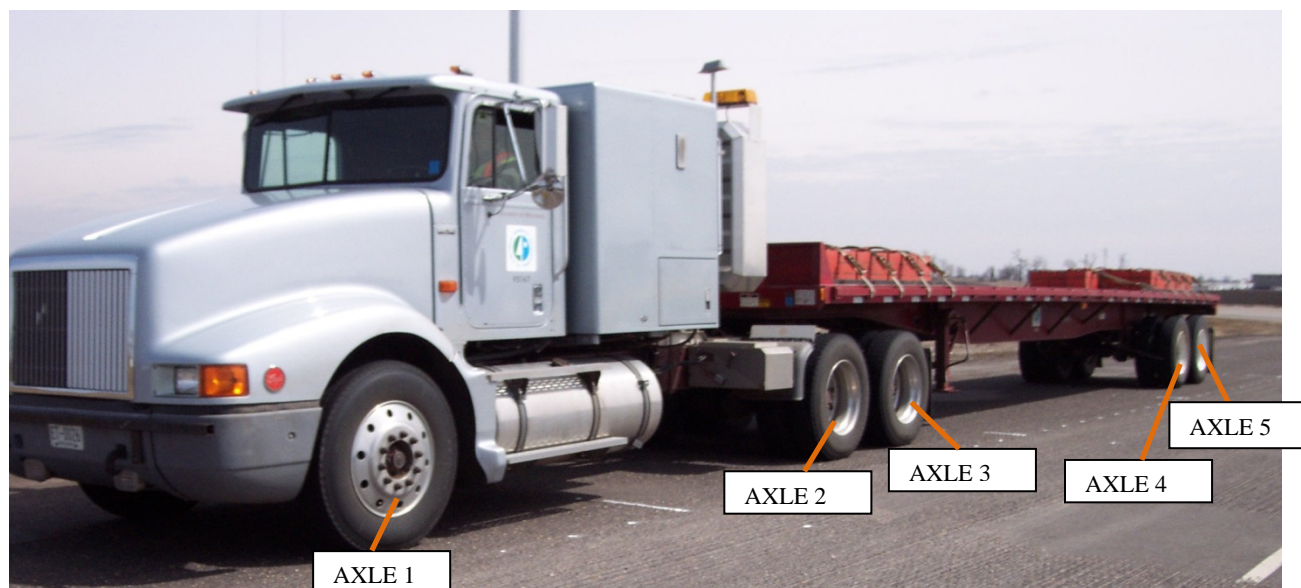
**Figure 5.1. MnROAD 80kip loading vehicle**

The equivalent single axle loads (ESALs) on the LVR are determined by the number of laps (averaging 80 laps per day and 6000 laps per year), and the cumulative loading data is recorded in the MnROAD database. Figure 5.1 shows the MnROAD loading vehicle in 2010, with vehicle axle numbers (referred to later in this report) labeled Axle 1 through Axle 5.

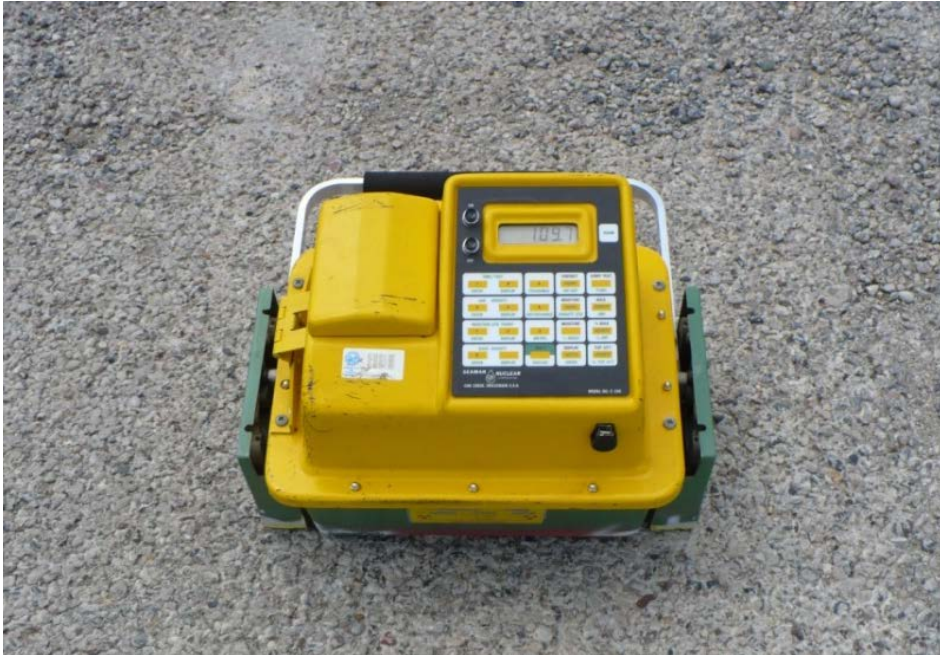
**Figure 5.3. Seaman C-200 nuclear density testing device**

MnDOT uses the Seaman C-200 Nuclear Density Testing device (figure 5.3) to rapidly and non-destructively measure the in-situ field density of bituminous pavement and granular base materials at the time of construction. The Seaman testing device is capable of making determinations of material densities in the range of 70 to 170 pounds per cubic foot (pcf). The device usually samples pavement to a depth of approximately 2 inches, and it can be adjusted to take measurements of thinner layers. It is assumed that density measurements of the top section of single-layer bituminous pavements that are thicker than 2 inches (such as the porous asphalt) are representative of the material conditions throughout the entire lift thickness.

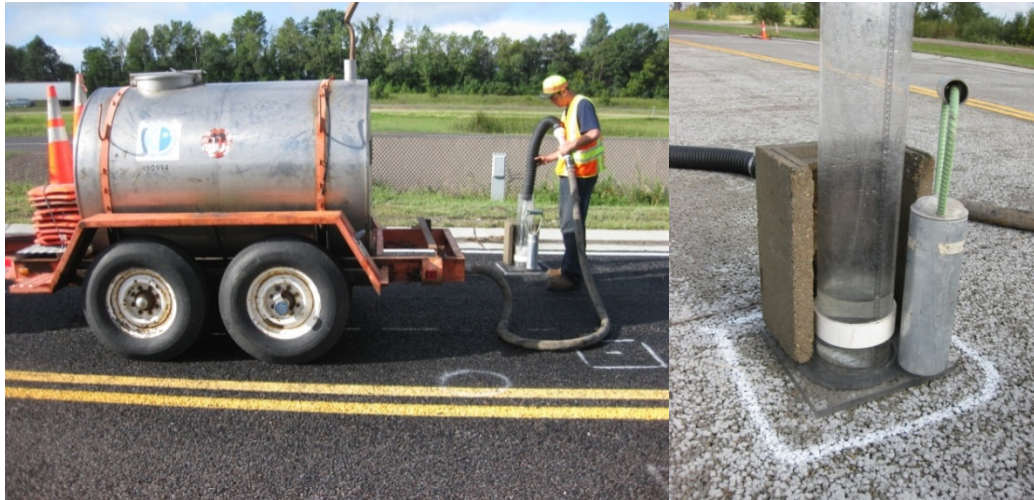
**Figure 5.6. MnROAD permeability testing apparatus**

Due to the rapid rate of surface infiltration in these test sections, and the need to regularly evaluate many test points, a simple falling-head apparatus was developed at MnROAD for permeability testing (figure 5.6). The device is a clear, six-inch outside diameter, graduated cylinder. A flexible seal (electrical sealant) is applied to the bottom of the cylinder, the device is weighted to the pavement, and a stream of water is supplied through a 4-inch tube from a water trailer. The cylinder is quickly filled approximately  $\frac{3}{4}$  full and the time (t) for the cylinder to empty from an initial to a final level ( $\Delta h$ ) is recorded. The rate of flow through the pavement surface is then computed by;  $Q = (A \cdot \Delta h) / t$ , where the area (A) of the pavement surface tested is  $167.53 \text{ cm}^2$  (the inside area of the tube). This test is not used to compute a measure of pavement porosity due to the difficulty of modeling the highly variable water flow through the 3 dimensional pavement pore structure. But it is a convenient and repeatable method of monitoring changes in the volume of water permeating through the surface of the pavement over time.

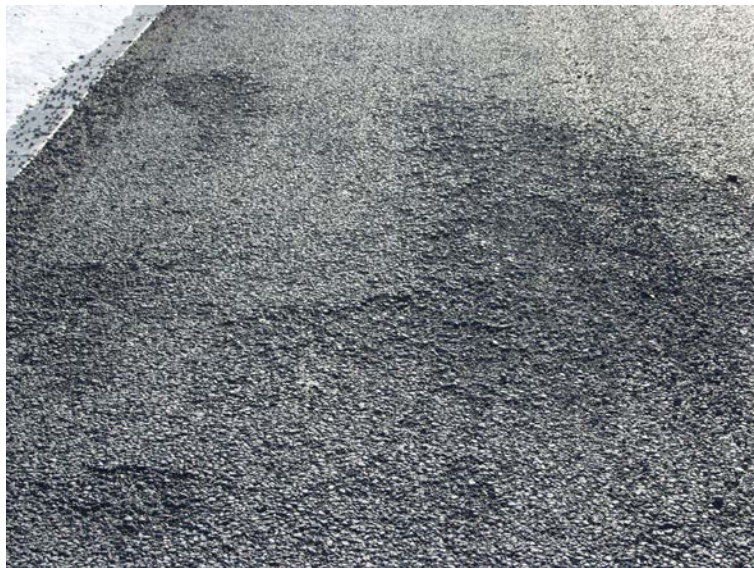
**Figure 5.10. Surface raveling, cell 88**

In early 2009, minor surface raveling was observed on the loaded lane of the porous asphalt test sections. The raveling first appeared in “patches” regularly spaced along the loaded lane of the test sections and was recorded within the initial visual distress survey in January 2009. A photo showing the raveled cell 88 porous asphalt surface in 2009 is shown in figure 5.10. The results of the most recent (October 2011) visual distress survey completed on the porous test cells are attached in Appendix N.

- Pavement deterioration in the form of raveling (first observed soon after construction) has progressed steadily, but affects only the top 1 inch (or less) of the pavement. Initial raveling appeared to be related to mixture temperature segregation; possibly caused by the long wait time to begin rolling the relatively thick pavement in low ambient temperatures.

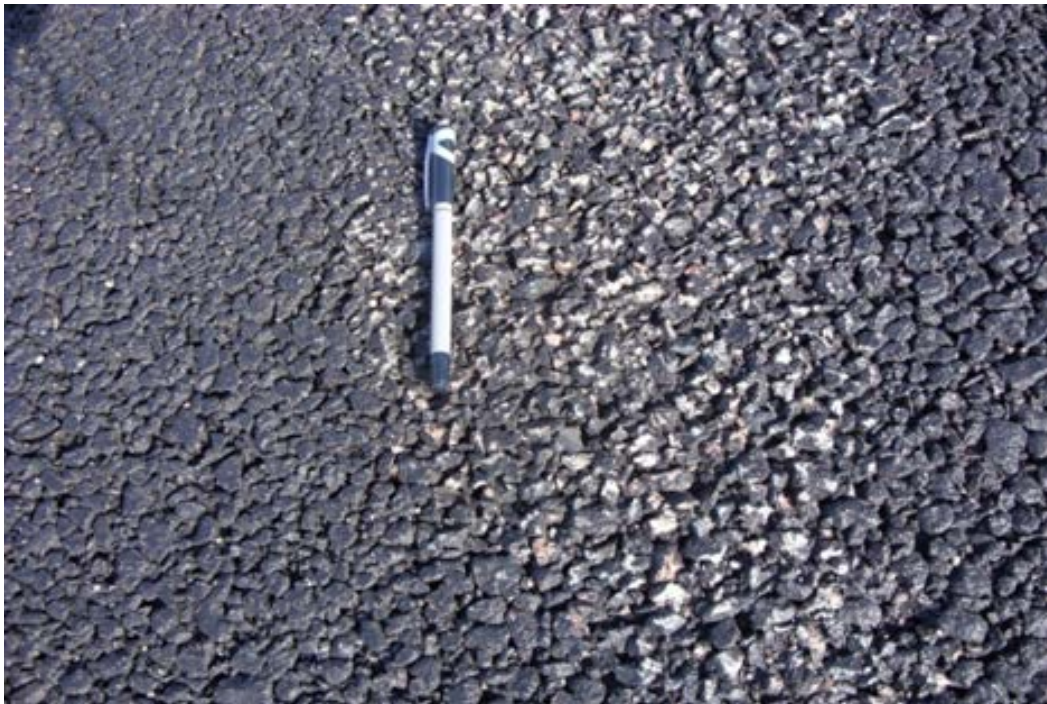
**Figure 5.11. Minor snowplow scuffing, cell 86**

As of fall 2011, no longitudinal or transverse cracking has been observed anywhere on the porous asphalt test cells. Other than minor raveling and very minor snowplow wear (figure 5.11), no distress is visible in the unloaded (environmental) lane of the porous asphalt test cells. Except for minor surface wear in the loaded wheelpaths, the standard HMA asphalt pavement “control” cell 87 has also not developed any visible cracking, raveling or other distresses to date.

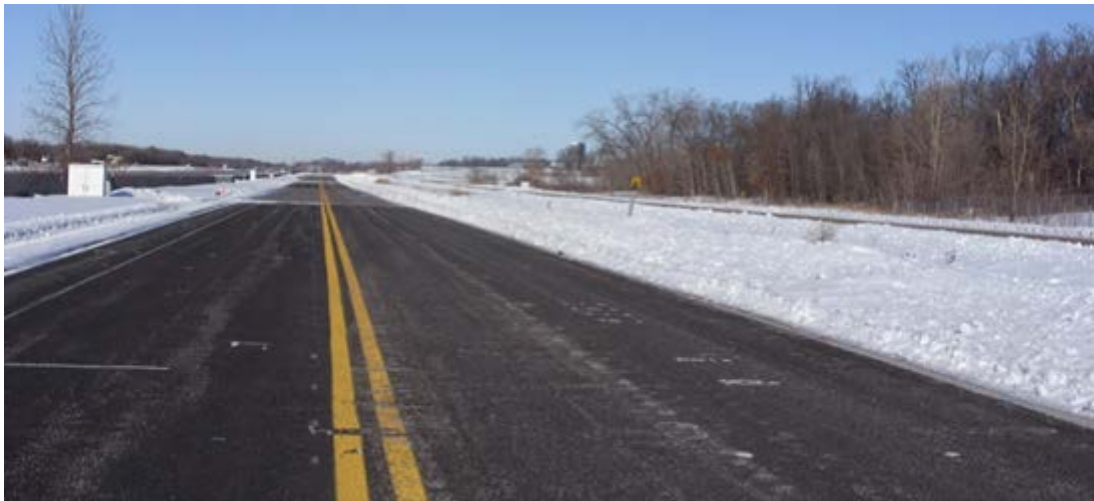
**Figure 5.12. Porous cell 88, October 2010**

Some rutting is expected given the severity of loading applied to the test sections. Rutting is visible in the wheelpaths of the inside (loaded) lane of each cell, but less so on cell 87. On all cells 86-88, the rutting process appears to be more complicated than what is often observed on a standard dense graded pavement. Figure 5.12 shows the surface of cell 88 (inside lane on the right) in October 2010, with control cell 87 in the background. The porous pavement rutting has been monitored at MnROAD using two different automated methods; “Pathways” Vans and Automated Laser Profiling System (ALPS).

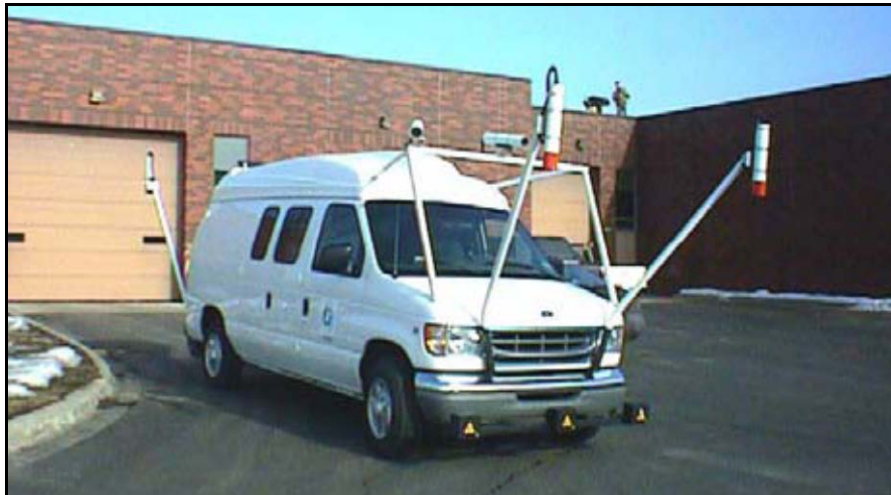
**Figure 5.13. Pathways surface evaluation device, 2009–2010**

Rutting is measured with the MnDOT Pathways vehicles, by the procedures of ASTM E-950. This vehicle was replaced in 2011 as part of a normal equipment upgrade. The two vans use a similar (but slightly different) laser testing process and the results are usually consistent. [figure 5.13 (old van) and figure 5.14 (new van)]

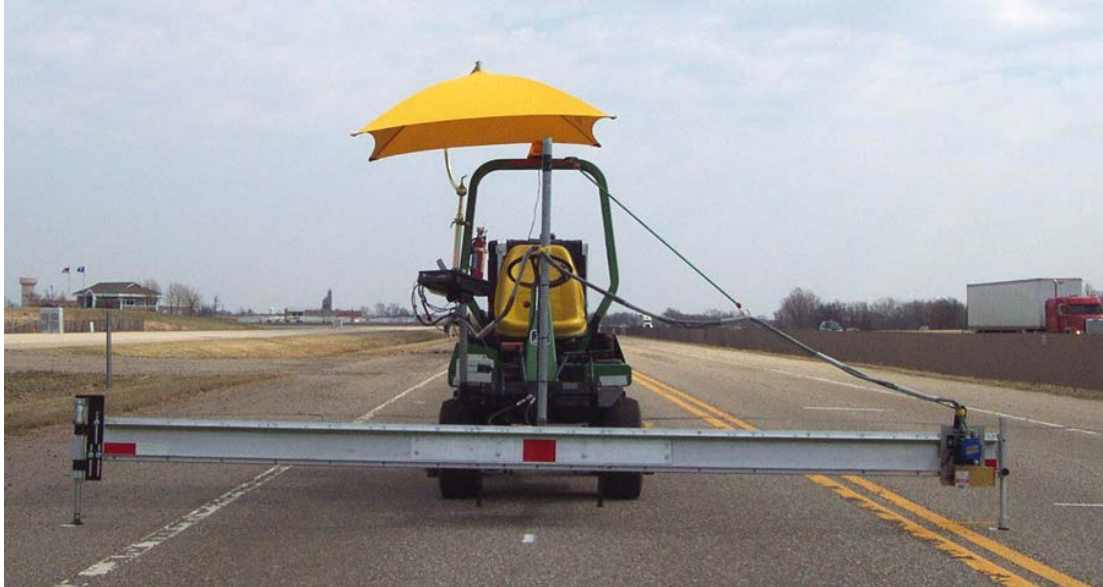
**Figure 5.18. Automated laser profiling system (ALPS)**

Rutting is also at MnROAD using the Automated Laser Profiling System (ALPS) shown in figure 5.18. The most recent ALPS rutting measurements were recorded in September 2011. As presented in the ALPS rutting data (figure 5.19) the average measured rutting on the loaded lane of the porous asphalt sections is similar to the Pathways data, with current values of approximately 0.50 inches on cell 86, and 0.60 inches on cell 88. Rutting on the loaded lane of the standard pavement on cell 87 is less than 0.15 inch.

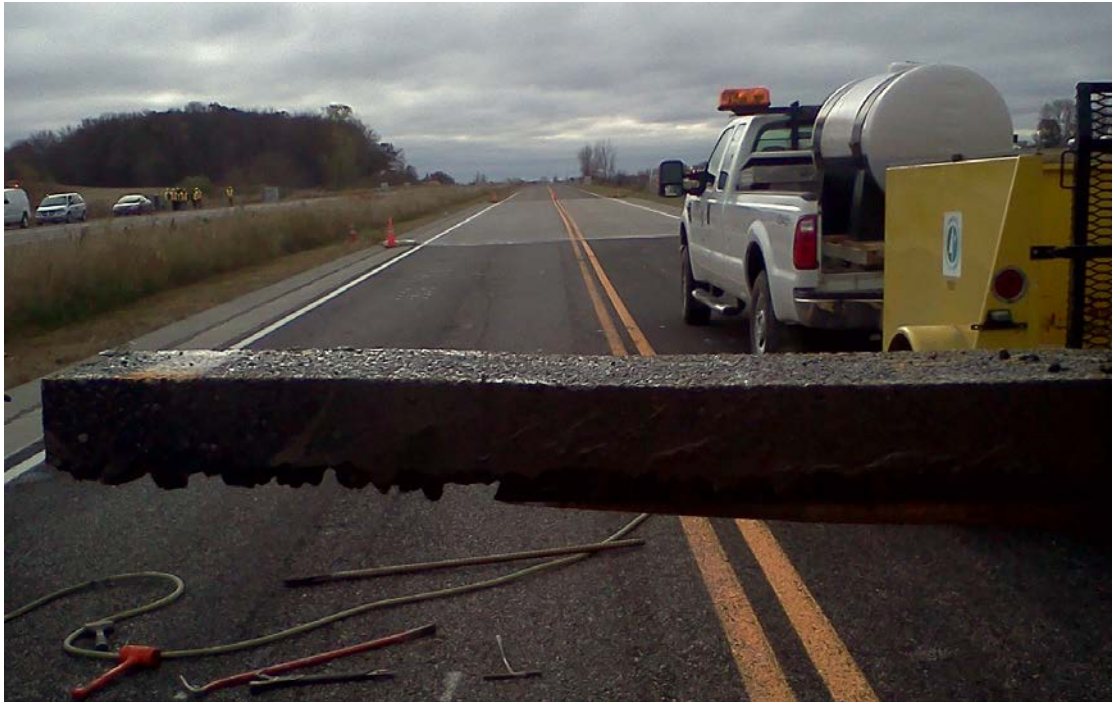
**Figure 5.20. Forensic pavement section removed**

section of porous pavement removed for forensic evaluation.

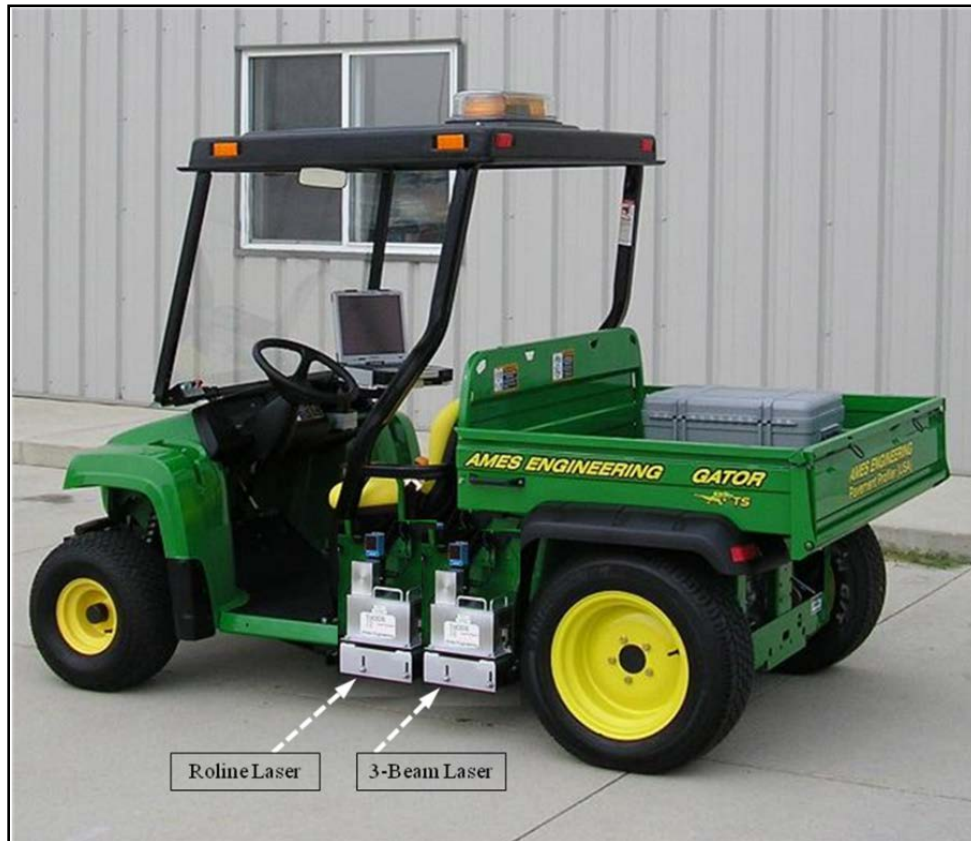
**Figure 5.23. Lightweight interval surface analyzer (LISA)**

The international roughness index (IRI) is used to quantify irregularities of the longitudinal profile of a roadway wheelpath, and is used by MnDOT as a standard roughness measurement (ASTM E-950). The IRI is based on the average rectified slope (ARS), which is a ratio of a standard vehicle's accumulated suspension motion, divided by the distance traveled by the vehicle during the measurement. The IRI has been regularly measured since 2009 for the porous asphalt cells and cell 87 with the Lightweight Interval Surface Analyzer (LISA) (Figure 5.23).

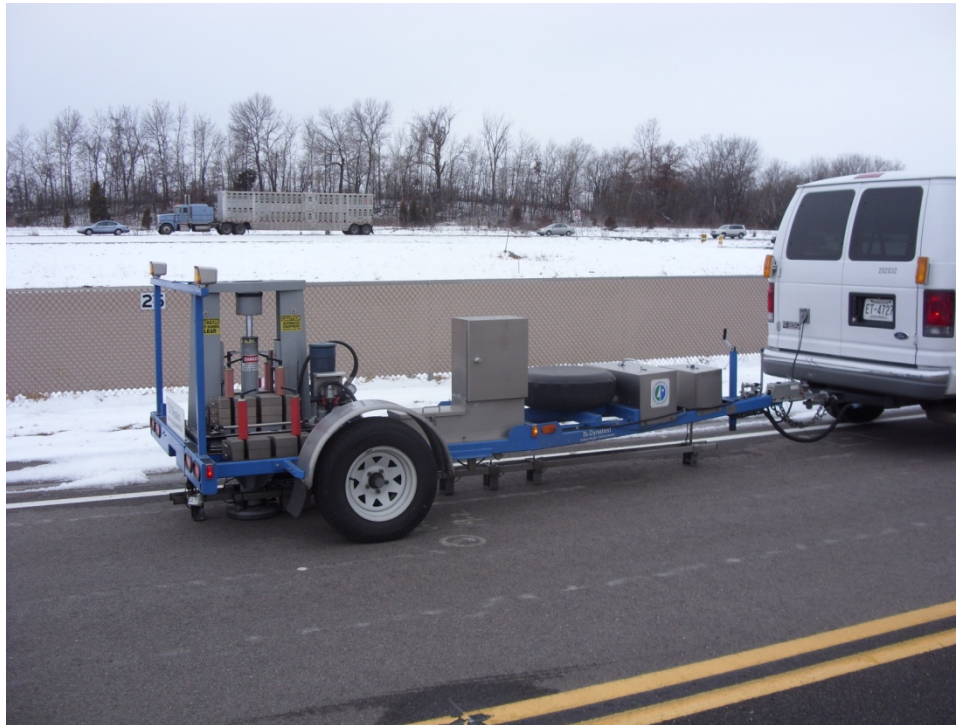
**Figure 5.26. MnDOT FWD testing vehicle**

Falling Weight Deflectometer (FWD) data was collected on cells 86 through 88 on multiple dates in 2009 through 2011. Testing is not always performed on the same day for all three cells due to staffing and equipment requirements, but an effort is made to regularly test all cells to monitor seasonal changes in stiffness. The data was collected during the spring, summer, and fall of 2009, 2010, and 2011. This allowed for the calculation of layer moduli values over wide ranges of subsurface moisture and pavement temperature. These two variables have a major influence on the stiffness of the unbound (base & subgrade) and bound (asphalt) materials. A trailer mounted FWD testing vehicle used at MnROAD is shown in figure 5.26.

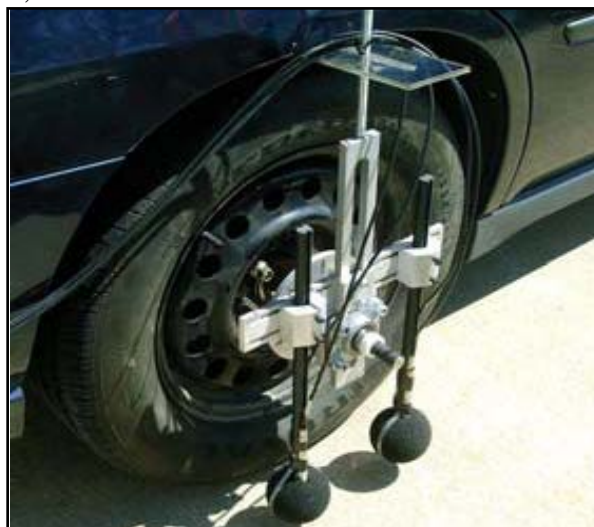
**Figure 5.43. MnDOT on-board sound intensity microphones**

OBSI measurements report a decibel value for the TPIN as recorded by a set of microphones positioned near the tire (figure 5.43). The sound is recorded for five seconds while the vehicle is traveling at a constant speed of 60 miles per hour, thus averaging the OBSI over a 440 foot section. The data is later parsed to separate out the porous asphalt readings.

The OBSI is measured at MnROAD according to AASHTO TP 76-08. The test is performed at 60 mph because freeway speeds are typically above the crossover speeds for all vehicle types, where the tire pavement noise is the dominant traffic noise source, much higher than the aerodynamic source and the stack source [41]. OBSI was measured on both porous asphalt cells in 2009, 2010, and 2011.

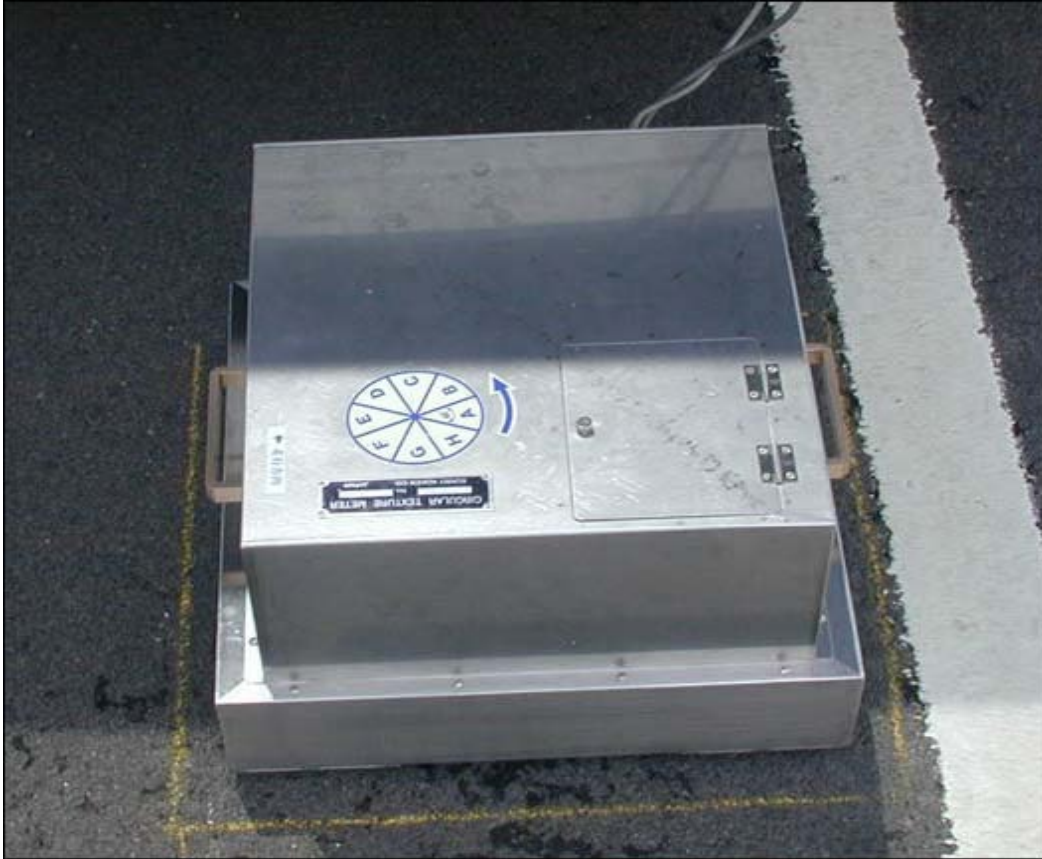
**Figure 5.51. Circular texture meter**

The Circular Track Texture Meter (CT Meter) is being used on the porous pavements at MnROAD to measure clogging of the porous asphalt voids. Measurements are made according to procedures of ASTM E 2157. The CT meter (figure 5.51) uses a laser to measure the profile of a circle 11.2 inches in diameter or 35 inches in circumference. The profile is divided into eight segments of 4.4 inches. The average mean profile depth (MPD) is determined for each of the segments of the circle. The reported MPD (mm) is the average of all eight segment depths for 3 measurements. Temperature, surface moisture, and distress observed at the test locations at the time of measurement are also noted.

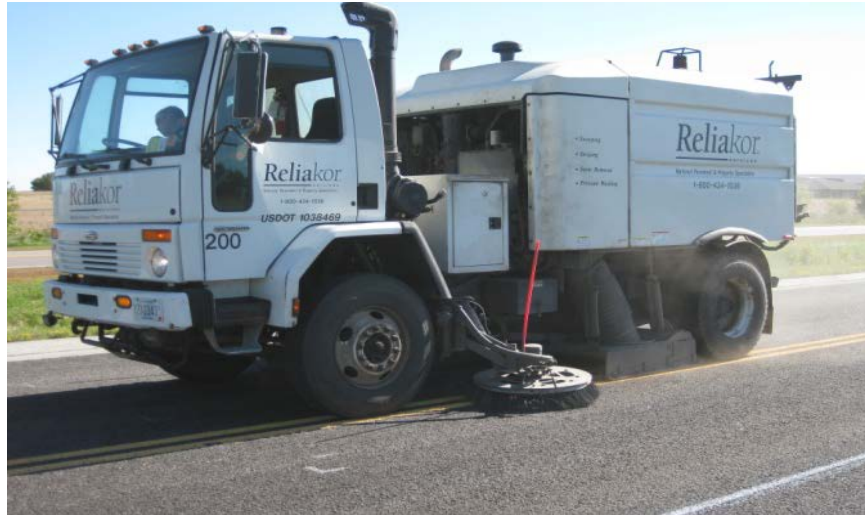
**Figure 5.59. Reliakor vacuuming**

Demonstrations of porous asphalt pavement vacuuming were performed on November 9<sup>th</sup>, 2009, September 6<sup>th</sup>, 2010 and May 4<sup>th</sup>, 2011, June 27<sup>th</sup>, 2011, and November 2<sup>nd</sup>, 2011. A Reliakor vacuum truck was employed each time to attempt to clean the porous pavement and determine possible changes in the pavement's hydraulic permeability. The brush on the vacuum truck was not used as to avoid introducing additional material into the pore structure. Figure 5.59 shows the Reliakor Vacuum Truck in operation on cell 88.

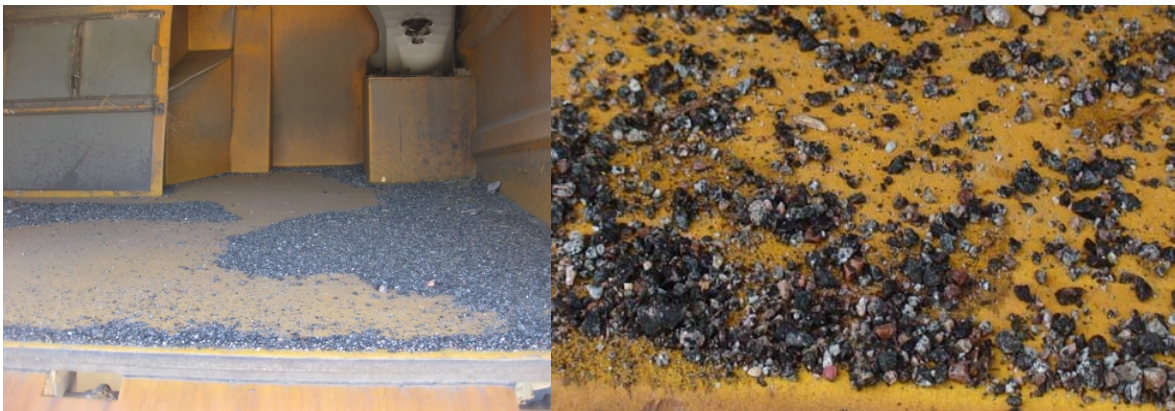
**Figure 5.60. Debris removed by vacuuming, 2009**

The porous pavement was approximately one year old at the time of the first vacuuming test in 2009. Except for the isolated areas of surface raveling, the pavement was in generally good condition. No pavement cracks, debris on the surface, or other distress was evident. During all the tests a small quantity of loose, fine aggregate particles (less than 1 ft<sup>3</sup>) was removed from each porous cell (figure 5.60). Almost no aggregate were observed to be removed from cell 87 during any of the vacuuming tests.
