# Porous Asphalt Pavement Performance in Cold Regions

Minnesota  
Department of  
Transportation

Matthew Lebens, Primary Author  
Office of Materials and Road Research  
Minnesota Department of Transportation

Research Project  
Final Report 2012-12

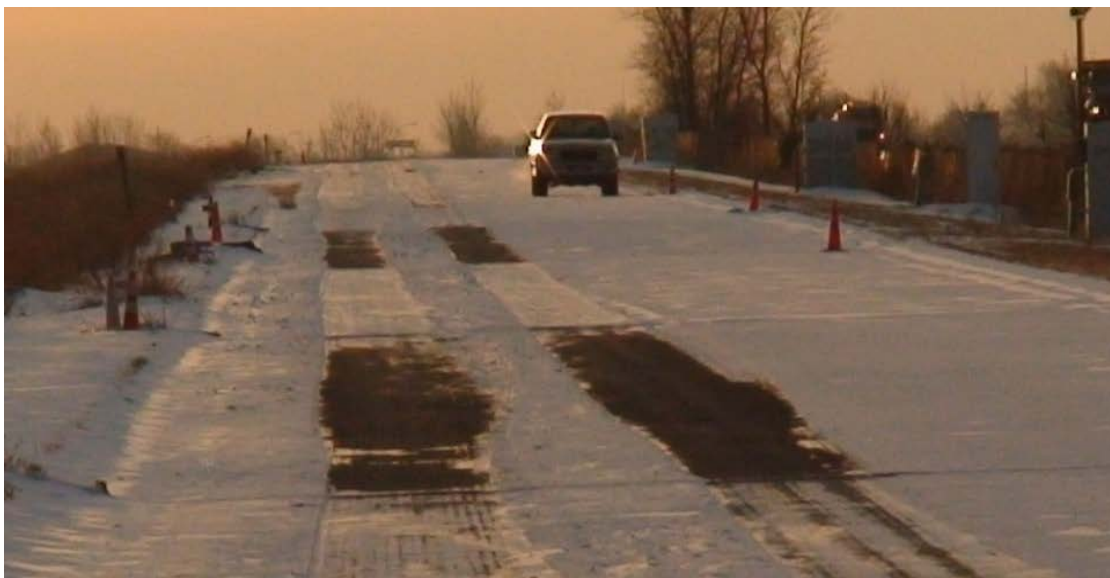
**Figure 5.61. Cell 86, 87, and 88 wheelpaths of loaded lane 01/30/2012**

Regular snow and ice removal operations are performed on the LVR after each significant snow event. However, little salt (and no sand) has been applied to the porous asphalt sections since pavement installation, and no salt has been applied since 2009. The porous cells are plowed in the same manner, and at the same time as all other cells on the LVR. One goal of this research was to monitor the porous pavements in terms of the rate of snow accumulation and melting, and differences were observed in certain conditions (figure 5.61).

It was observed that a faster rate of melting or sublimation was occurring on the porous cells, particularly when a small amount of snow ( $< 2$  inches) was on the surface of the pavement and in periods of sunny weather. The faster melting on the porous cells also occurred when the pavement was in a frozen condition and in low ambient temperatures. In order to accurately quantify any differences in snow accumulation and melting, a camera trailer was employed in 2011 (figure 5.62). It was installed at the transverse drain between cell 87 and 88 and configured to simultaneously record time-lapse images of the surface of the two pavement types; with cell 87 on the left side of the image and cell 88 on the right.

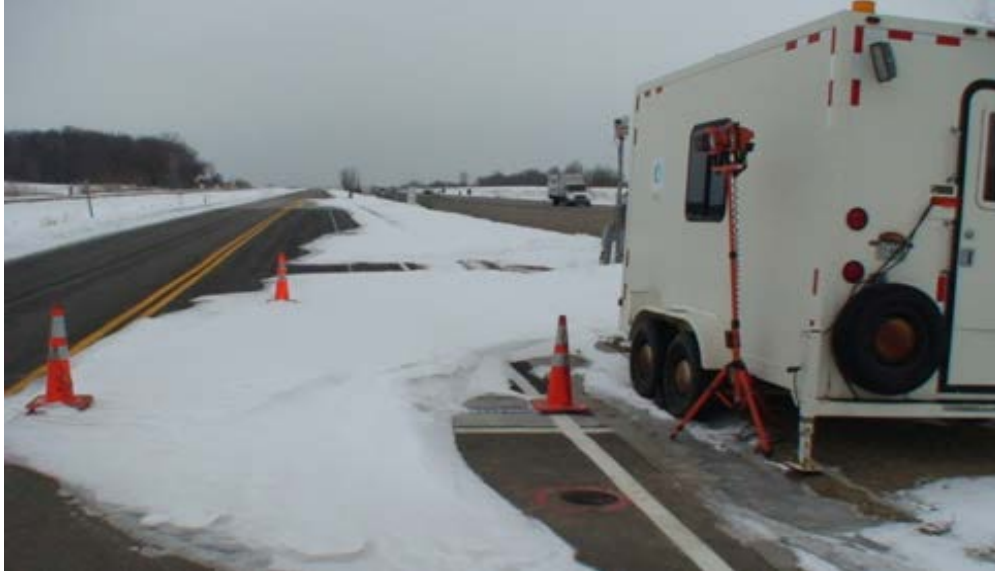
**Figure 5.62. Camera trailer at junction of cell 87 and 88, February 2011**

Problems with this system became immediately apparent. First, the trailer itself caused some unusual snow drifting on the surface of both pavements. Secondly, the location was not ideal in terms of correlating data – the subsurface thermocouples were located some distance from the camera. Lastly, the presence of the massive concrete transverse drain probably affected the snow melting rate to some extent. However, the time-lapse camera functioned well, and in late winter after the drifting subsided some interesting images and data were obtained.
