## Bridge Asbestos Inspection Report

**WisDOT Project ID:** 1080-12-00

**Structure Number:** B-64-0032, B-64-0033, B-64-0039, B-64-0040, B-64-0048, B-64-0049

**Structure Name:** USH 12 WB & EB over STH 120, Springfield Rd over USH 12,  
Como Rd over USH 12, STH 67 NB & SB over USH 12

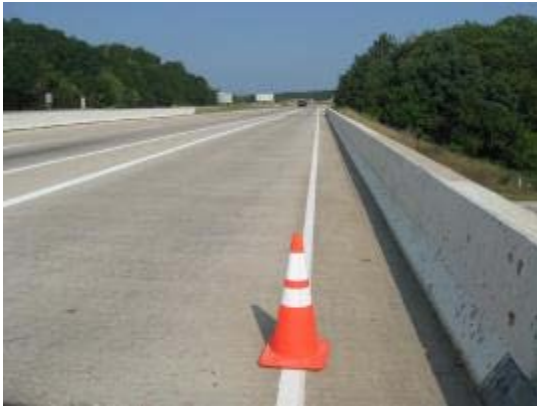
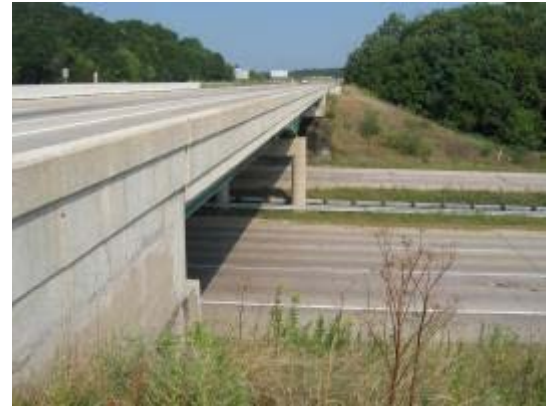
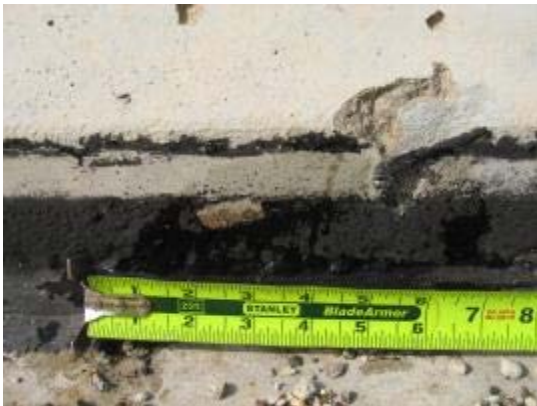
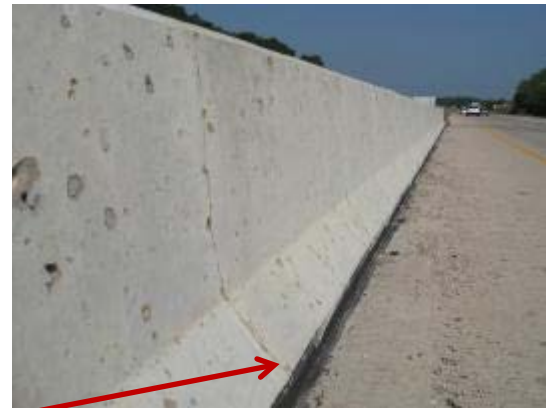
B-64-0032

| Sample Number | Sample Description | Sample Location | Analytical Results and Method | Friable/ Non-friable or No ACM | Quantity of ACM Material |
|---|---|---|---|---|---|
| 1 | Tar-like material | Where parapet meets bridge deck | PLM, non-detect | No ACM | 0 |

Tar-like material where parapet  
meets bridge deck

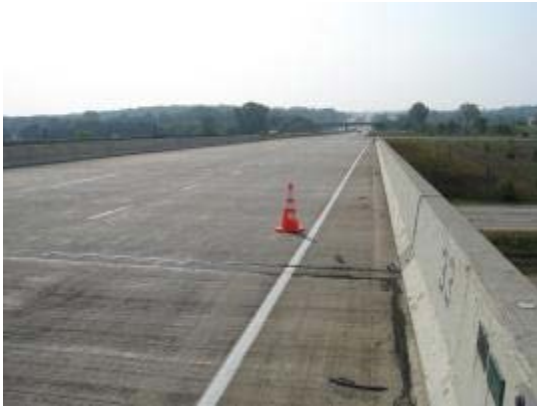
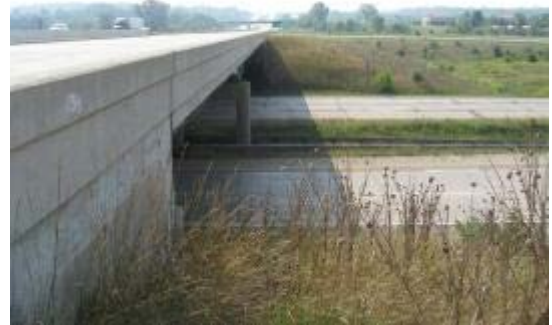
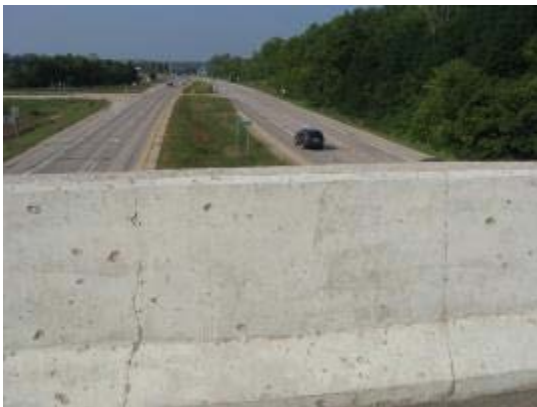
B-64-0033

No suspect materials

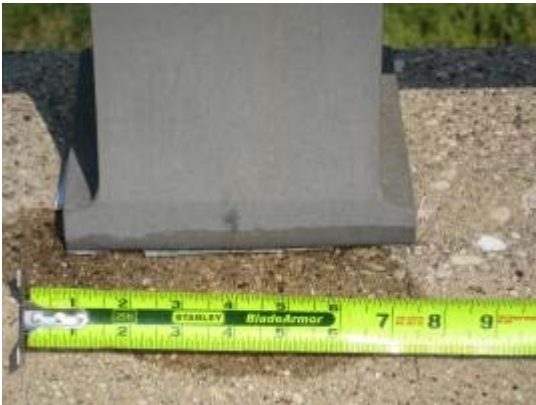
B-64-0039

| Sample Number | Sample Description | Sample Location | Analytical Results and Method | Friable/ Non-friable or No ACM | Quantity of ACM Material |
|---|---|--|---|---|---|
| 1 | Caulk | Parapet expansion joint | PLM, non-detect | No ACM | 0 |

Caulk in parapet expansion joint

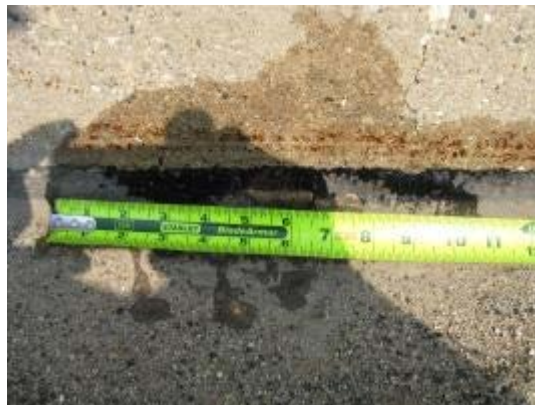
On B-64-0039 and B-64-0040, the gaskets under the railing attachment plates tested positive for asbestos greater than 1% and is therefore regulated ACM. The ACM will be likely be disturbed during the planned replacement, therefore the ACM must be removed prior to demolition. Standard Special Provision (STSP) 203-005 should be incorporated into the specifications.

| Sample Number | Sample Description | Sample Location | Analytical Results and Method | Friable/ Non-friable or No ACM | Quantity of ACM Material |
|---|---|--|---|---|---|
| 4 | Gasket | Under railing attachment plate | PLM, 10% | Non-friable | 20 sq ft |

Gasket under railing attachment plate

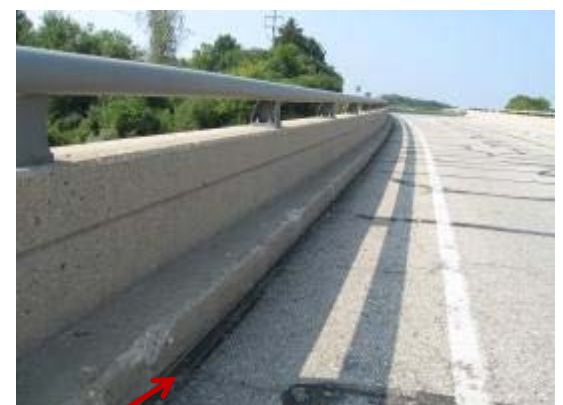
| Sample Number | Sample Description | Sample Location | Analytical Results and Method | Friable/ Non-friable or No ACM | Quantity of ACM Material |
|---|---|--|---|---|---|
| 7 | Tar-like material | Where parapet meets bridge deck & in deck cracks | PLM, non-detect | No ACM | 0 |

Tar-like material in deck cracks and where parapet meets deck

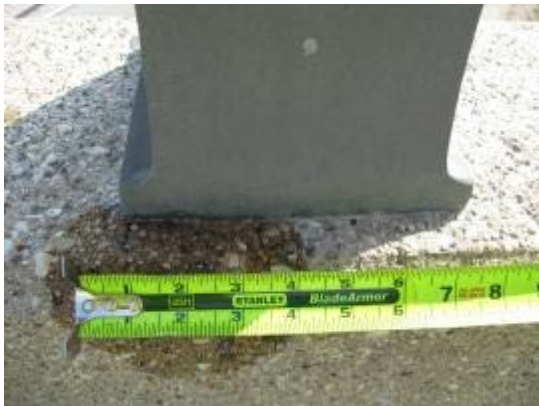
B-64-0040

| Sample Number | Sample Description | Sample Location | Analytical Results and Method | Friable/ Non-friable or No ACM | Quantity of ACM Material |
|--|---|--|---|---|---|
| 1 | Caulk | Parapet expansion joint | PLM, non-detect | No ACM | 0 |

Caulk in parapet expansion joint

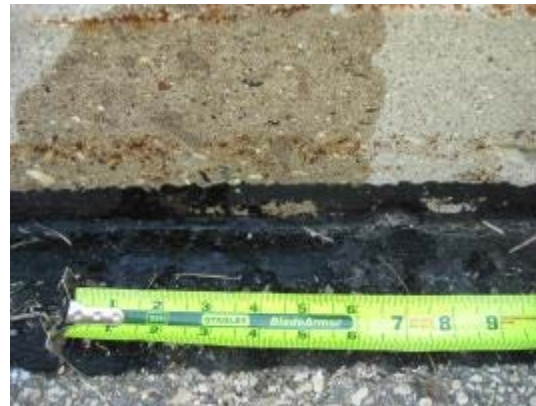
| Sample Number | Sample Description | Sample Location | Analytical Results and Method | Friable/ Non-friable or No ACM | Quantity of ACM Material |
|--|---|--|---|---|---|
| 4 | Gasket | Under railing attachment plate | PLM, 5% | Non-friable | 29 sq ft |

Gasket under railing attachment plate

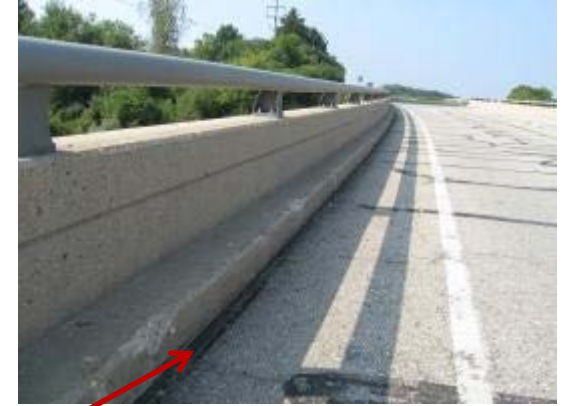
| Sample Number | Sample Description | Sample Location | Analytical Results and Method | Friable/ Non-friable or No ACM | Quantity of ACM Material |
|--|---|--|---|---|---|
| 7 | Tar-like material | Where parapet meets bridge deck & in deck cracks | PLM, non-detect | No ACM | 0 |

Tar-like material in deck cracks and where parapet meets deck

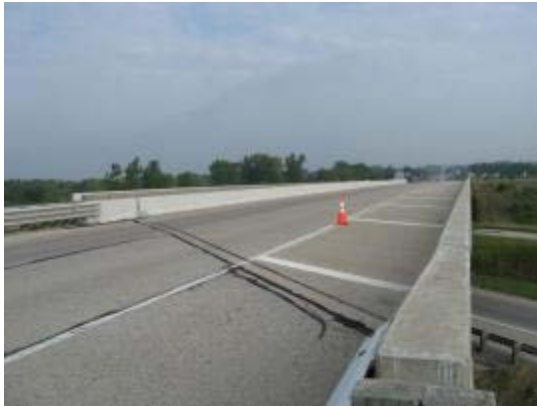
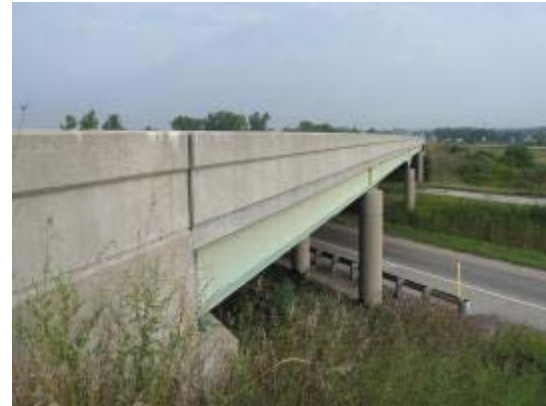
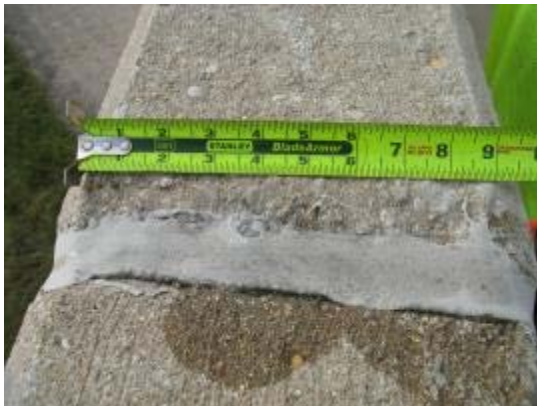
B-64-0048

| Sample Number | Sample Description | Sample Location | Analytical Results and Method | Friable/ Non-friable or No ACM | Quantity of ACM Material |
|--|---|--|---|---|---|
| 1 | Caulk | Parapet expansion joint | PLM, non-detect | No ACM | 0 |

Caulk in parapet expansion joint

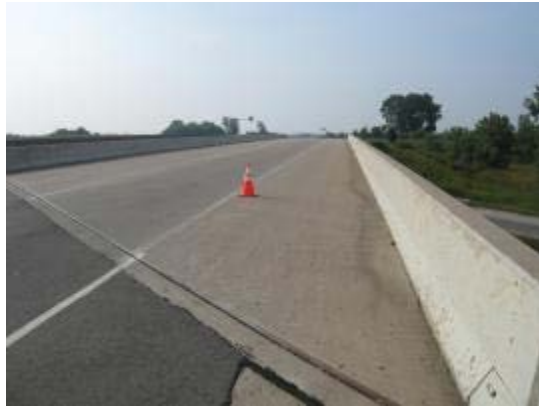
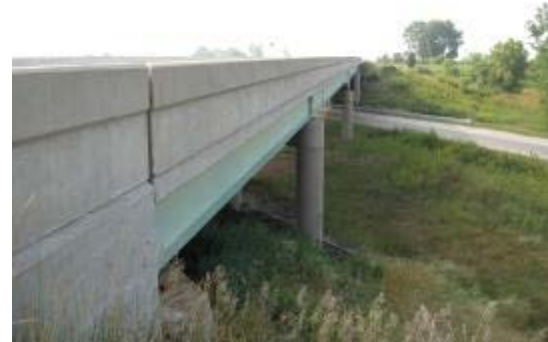
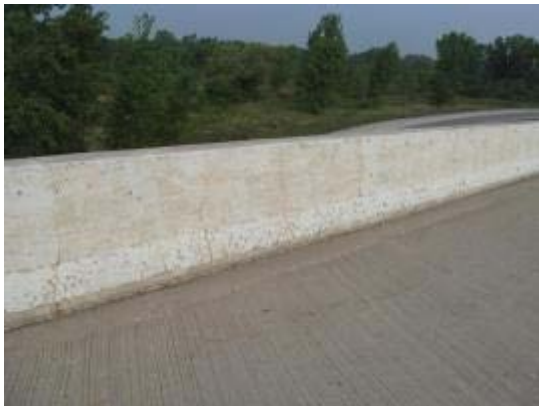
B-64-0049

No suspect materials
